**TECHNICAL ASSISTANCE REPORT
INVESTIGATION OF PAVEMENT PERMEABILITY: OLD BRIDGE ROAD**

**Brian D. Prowell, P.E.
Senior Research Scientist**

October 2001
VTRC 02-TAR5

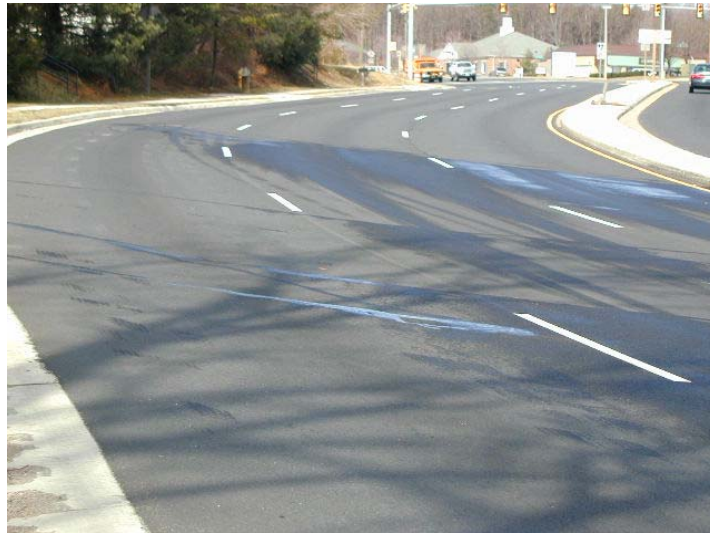
The section of Old Bridge Road is six lanes wide. The section is on a grade and has several curves. Near the curves where the worst icing has occurred, the combination of the down grade and curvature produces a cross-slope that forces water to drain across three lanes of traffic, as shown in Figure 1. Observations of the cores taken from this area indicate moisture damage in the base mix.

Figure 1. Drainage Across Old Bridge Road (After Coring)

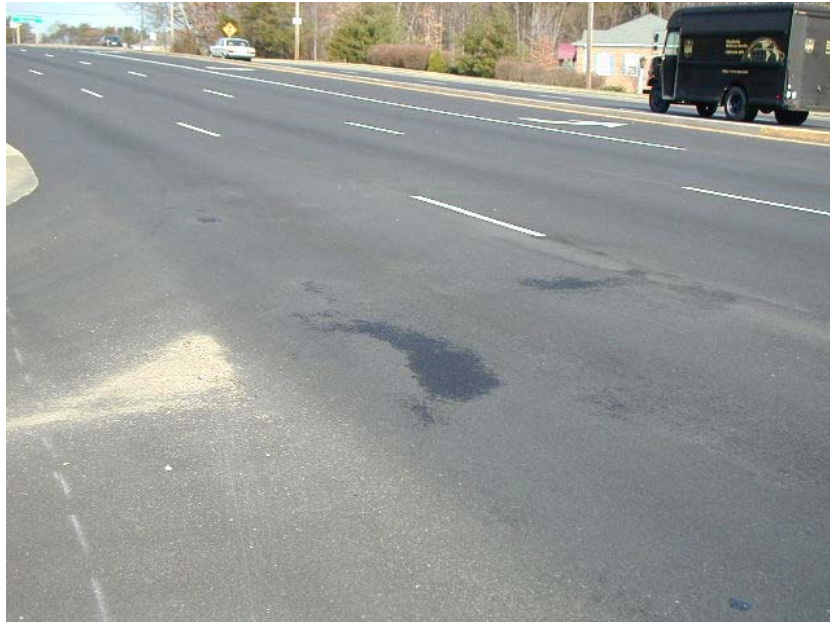
On February 21, 2001, no wet spots were observed in the curves between Elysian Drive and Occoquan Road. Two wet areas were observed at the intersection of Wood Hollow Drive, as shown in Figure 2. Another wet area, shown in Figure 3, was observed along the edge of

Figure 2. Wet Spot on Old Bridge Road Near Wood Hollow Drive

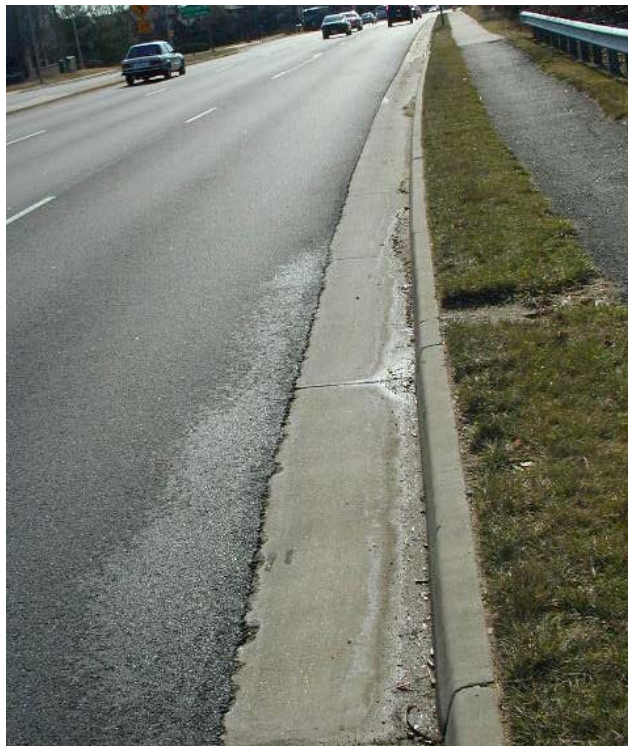
Figure 3. Wet Area at Edge of Pavement

the pavement just past Wood Hollow Drive (heading toward Occoquan Road). Based on data provided by the National Weather Service from their weather station at National Airport, no rain had fallen since February 17, 2001 (0.02 in, 0.5 mm); 0.58 in (14.7 mm) of rain fell on February 16, 2001.

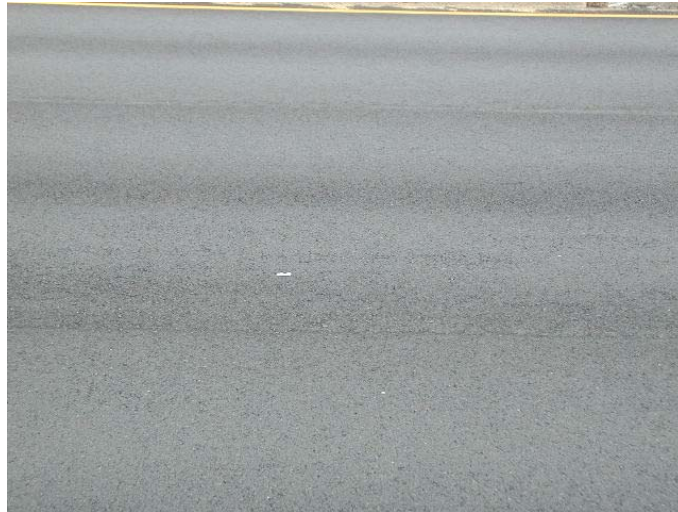
Segregation at the centerline, typically caused by the auger gearbox on the paver, and segregation at the longitudinal joints (indicated by the darker areas) were observed throughout the project, as shown in Figure 4. End-of-load segregation and segregation at the transverse joints were also observed, as shown in Figure 5. Typically, segregated areas are more permeable than non-segregated areas.

Figure 4. Centerline and Longitudinal Joint Segregation

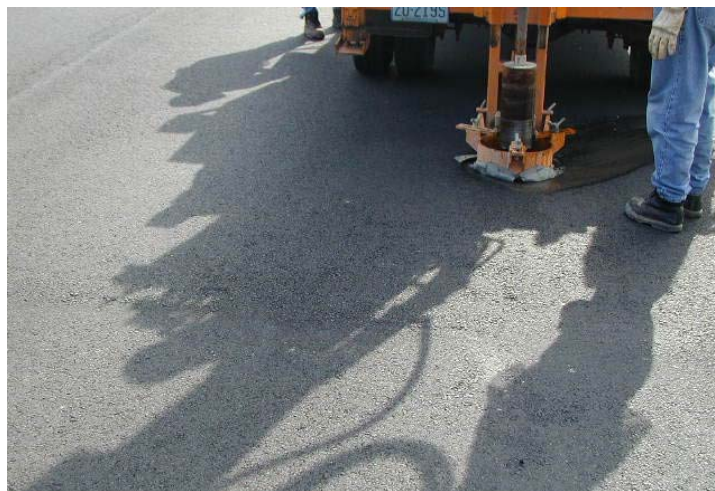
Figure 5. Segregation at Transverse Cold Joint

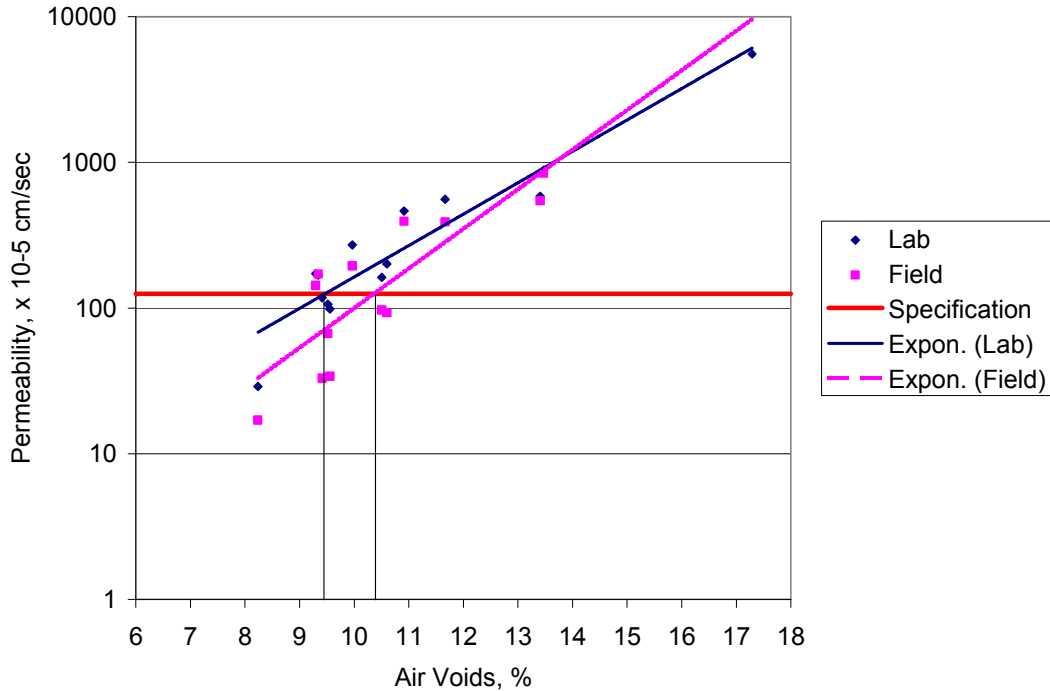
Figure 6. Permeability Versus Air Voids. Note: 1 cm/s = 2835 ft/day.

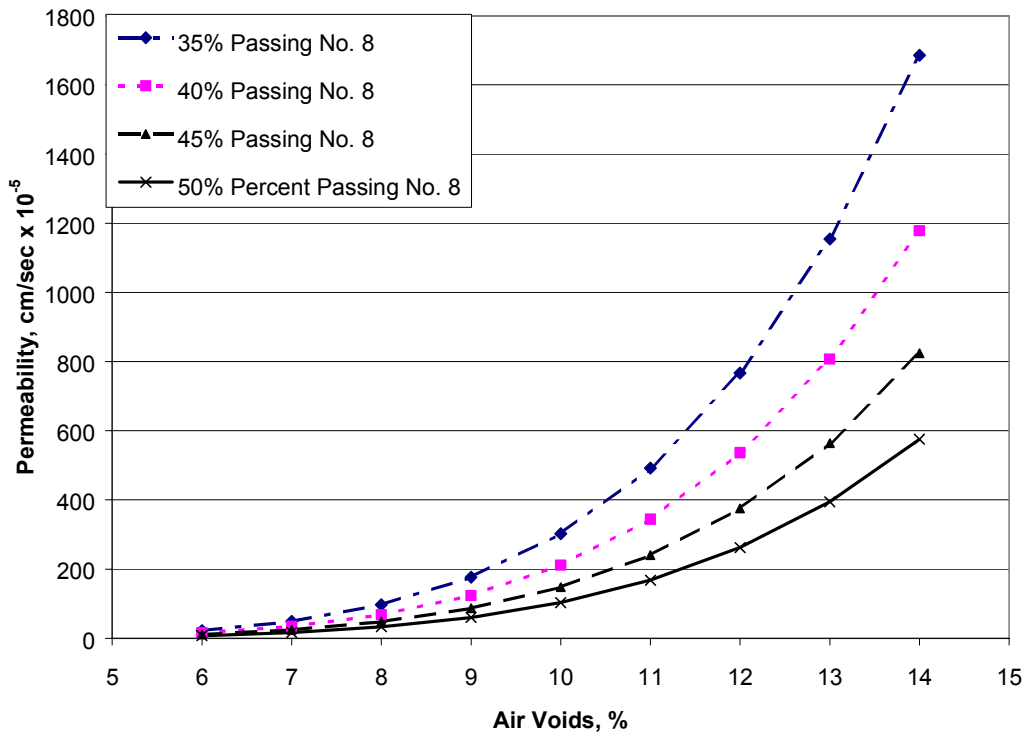
A multiple regression was performed using the natural log of air voids and the percent passing the No. 8 sieve (2.36 mm) as predictor variables for both the natural log of laboratory and field permeability. An R^2 of 0.97 with a standard error of 0.164 was determined for the laboratory permeability measurements. An R^2 of 0.94 with a standard error of 0.321 was determined for the field permeability measurements. Figure 7 shows the relationship between air voids and laboratory permeability for various percentages of material passing the No. 8 (2.36 mm) sieve. Figure 8 shows the relationship between air voids and field permeability for various percentages of material passing the No. 8 (2.36 mm) sieve. Both figures indicate how segregation can dramatically increase the permeability of a pavement at a given void level. In

Figure 7. Laboratory Permeability as Function of Air Voids and Percent Passing No. 8 Sieve. Note: 1 cm/s = 3.54 ft/day.

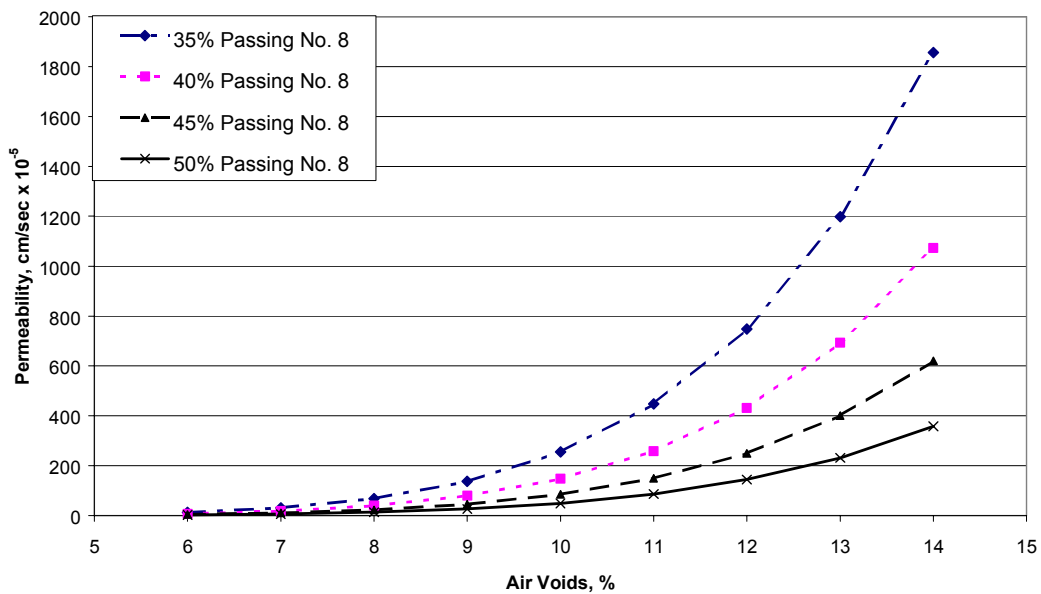
Figure 8. Field Permeability as Function of Air Voids and Percent Passing No. 8 Sieve. Note: 1 cm/s = 3.54 ft/day.

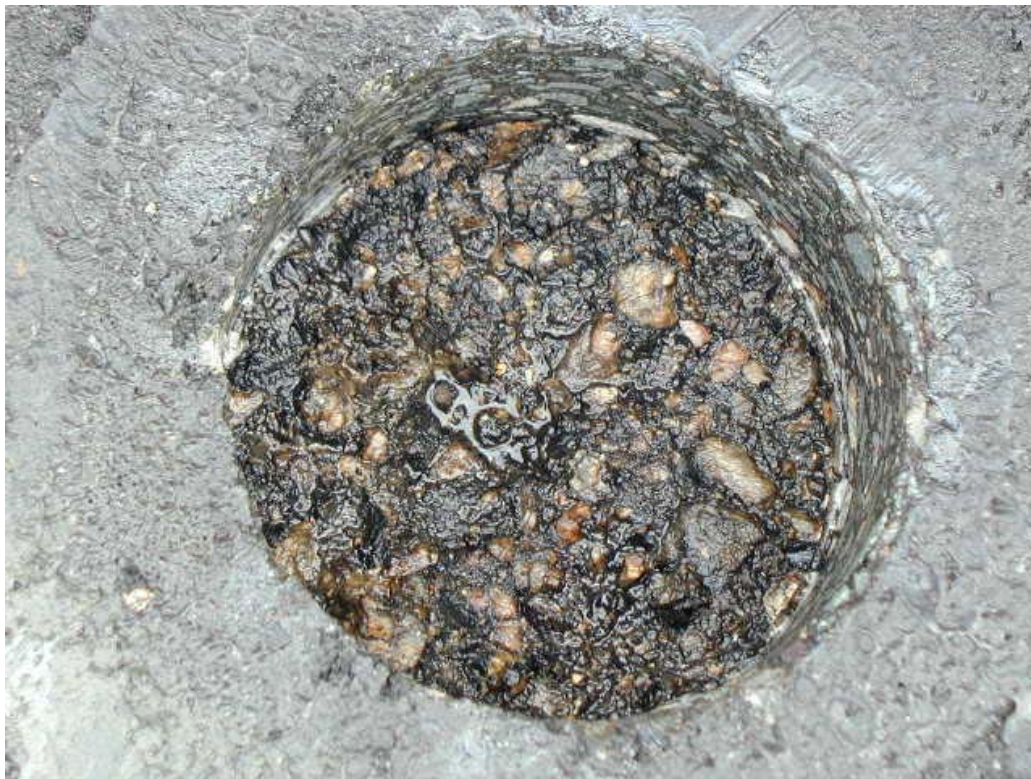
Moisture damage, characterized by stripping of the coarse aggregate, was observed in the majority of the base mix cores taken between Elysian Drive and Occoquan Road. An example is shown in Figure 9. Moisture damage occurs when the asphalt separates from the aggregate in the presence of moisture. Typically, moisture damage takes a number of years to occur. This may indicate that water has been trapped in the pavement structure for some time.

Figure 9. Typical Moisture Damage in Underlying Layer (Core 2-8)

To reduce water infiltration and the resulting weeping of water to the pavement surface, an impermeable pavement surface is required. However, moisture damage was present in the underlying layers throughout the section. Therefore, the treatment strategy needs to consider the potential for trapping water in the pavement structure. Doing so may increase the degree of moisture damage and lead to a pavement failure.

In some instances, a surface seal such as slurry seal or microsurfacing would be appropriate for preventing water from entering the pavement structure. However, judging from the moisture damage in the base mix near Elysian Drive, there is a significant amount of water in the pavement structure. Therefore, a surface seal may trap the moisture in the pavement, accelerating moisture damage (Aschenbrener et al., 1995). It is possible that a slurry seal or microsurfacing could be successfully used if it was placed after a lengthy period of hot, dry weather.
