**FORENSIC INVESTIGATION OF PAVEMENT DISTRESS:  
OLD AIRPORT ROAD IN BRISTOL, VIRGINIA**

**Thomas E. Freeman, P.E.  
Senior Research Engineer**

December 2003  
VTRC 04-R6

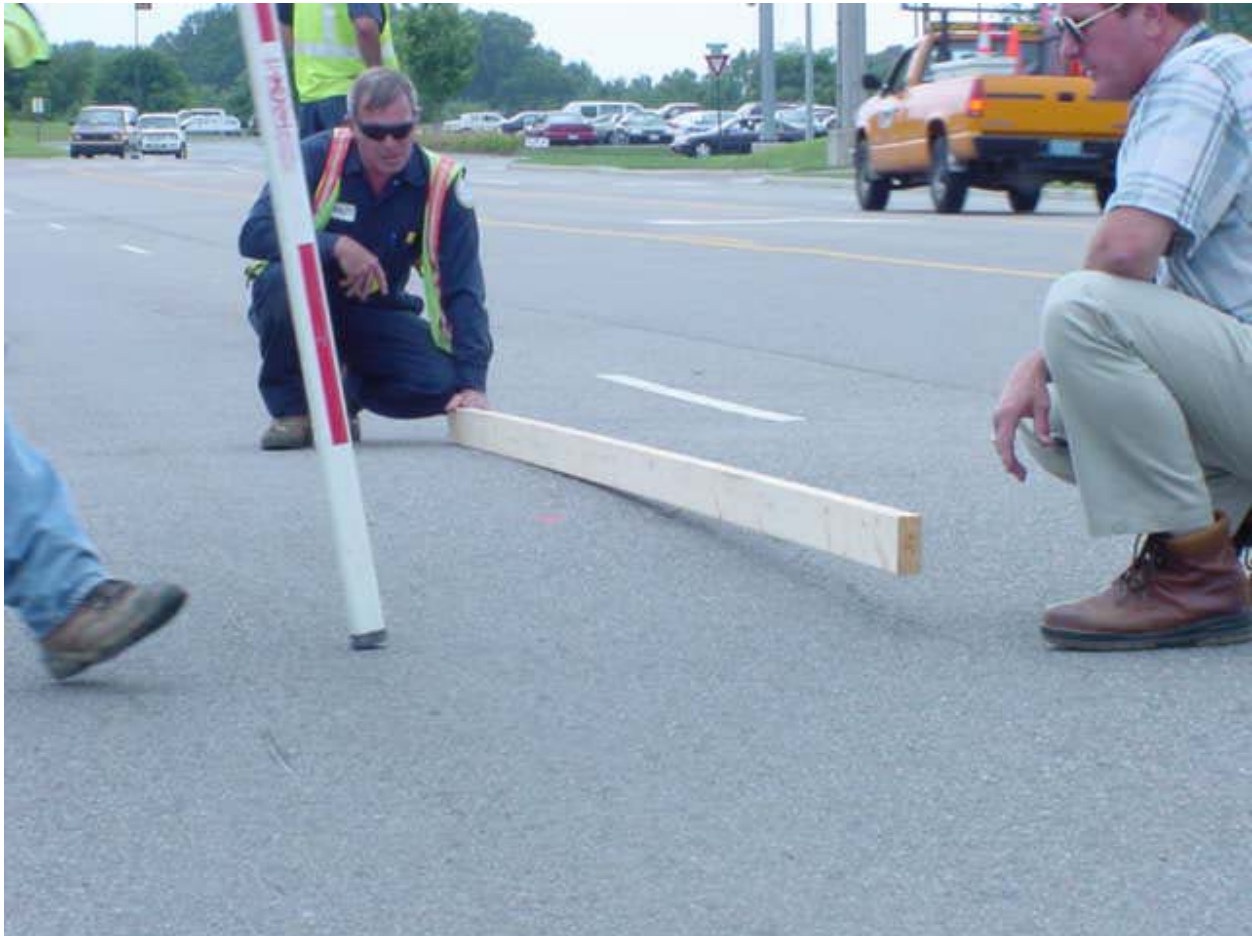
sites received one of three ratings—non-existent, slight or severe—to define the degree of distortion in the paved surface parallel with and above culverts. That exercise yielded no evidence of distortion above six culverts, whereas seven sites each were judged to exhibit slight and severe distortions. The Appendix includes a tabular summary of these results by culvert location. Figure 1 is a photograph of a severe surface distortion above one culvert.

**Figure 1. Pavement Surface Distortion, Old Airport Road Near Coronet Drive.**

Specifically, the 14 culverts identified in the Appendix as being slightly or severely heaved should be rehabilitated by removing all shale trench material and replacing with suitable non-expansive backfill. Sawing full-depth through the asphalt above those culverts to be reconstructed should be required to minimize damage to pavements beyond the zone of excavation. After shale backfill is completely removed and wasted, visibly damaged culvert pipe segments should be removed and replaced with new reinforced concrete pipe. Needed patch repairs to junction boxes, manholes, curb inlets, catch basins, trunk lines, etc., resulting from connections made during original construction and/or reconstruction should be included in this work. Likewise, needed repairs to curb and gutter resulting from reconstruction should be anticipated. Trenches should then be properly backfilled and compacted with a moisture controlled, non-shale granular material in accordance with applicable VDOT construction specifications. As an alternative to using a compacted granular material, consideration should be given to backfilling trenches with a low compressive strength, cementitious flowable fill. Although the initial material cost will be higher, the use of flowable fill should expedite construction by eliminating the need for compaction, thereby reducing the potential for trench settlement. After placement of the backfill, properly compacted asphalt patches should be constructed on top of the trench repairs. This may first require milling or neatly sawing approximately 1 foot beyond the edges of the disturbed area if damage to the adjacent pavement so warrants.

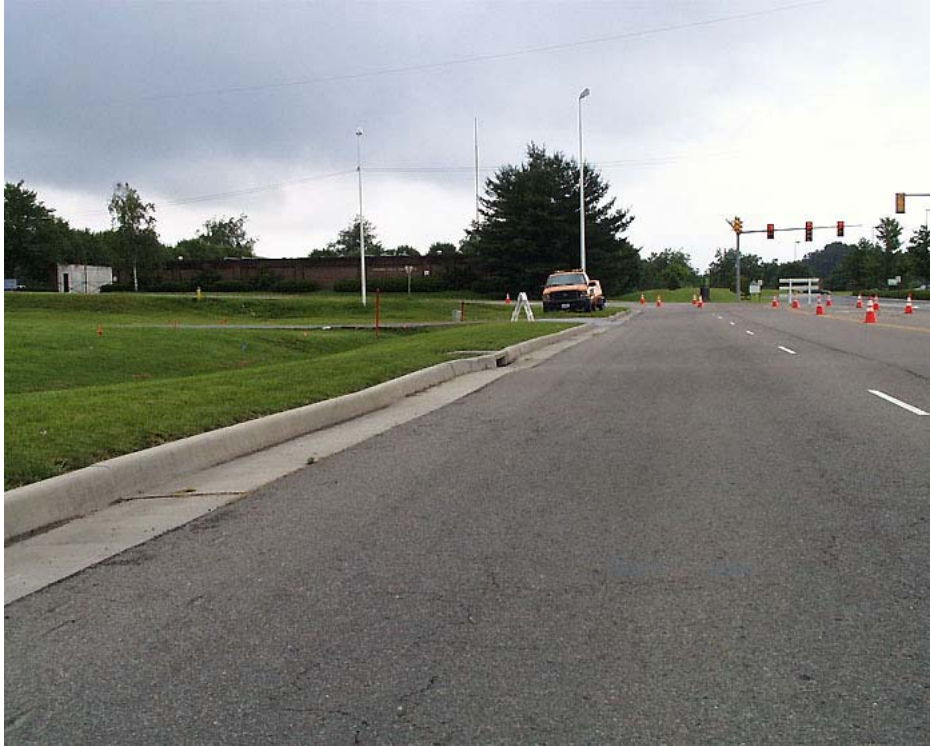
Close examination of the curb and gutter above some culverts revealed separated and/or vertically displaced joints and cracks. The configuration of these faulted joints and cracks is consistent with localized upward heaving of the pavement. Notice how the upward bow along the top of curb accentuates the distortion in Figure 2.

**Figure 2. Displaced Curb and Gutter Above Culvert Pipe, Old Airport Road.**

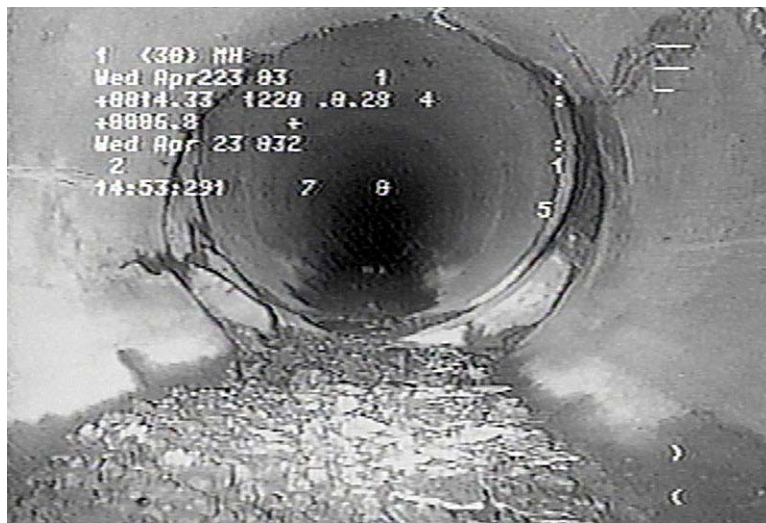
Video footage of the interior of culvert pipes, made by the City of Bristol in April 2003, was reviewed to look for evidence of heaving trench backfill or bedding material in the form of structural damage to pipes. The videotape clearly revealed structural damage to all four culverts between Bonham Road and Coronet Drive (three 18-inch- and one 24-inch-diameter reinforced concrete pipes), the tops of which were placed approximately 6 to 9 feet below the pavement surface according to construction drawings. The most prevalent distress observed was circumferential shear cracking near the end of the pipe segments at the edges of the bells. This distress afflicted on the order of 20 percent of the pipe segments comprising those four culverts.

Several sheared pipe segments exhibited some degree of vertical displacement at the pipe joints. A substantial quantity of material noted in the vicinity of some of the damaged joints was indicative of trench backfill infiltration through discontinuities in the pipe. Longitudinal cracking observed along the bottom of some pipe segments was judged to be significant. Figure 3 is a video image of a distressed pipe. Note the circumferential shear cracking at the left of the image and infiltrated backfill in the bottom of the pipe. The pipe's oval shape is indicative of structural failure.

**Figure 3. Video Image of Damaged Culvert Pipe Beneath Heaved Pavement.**

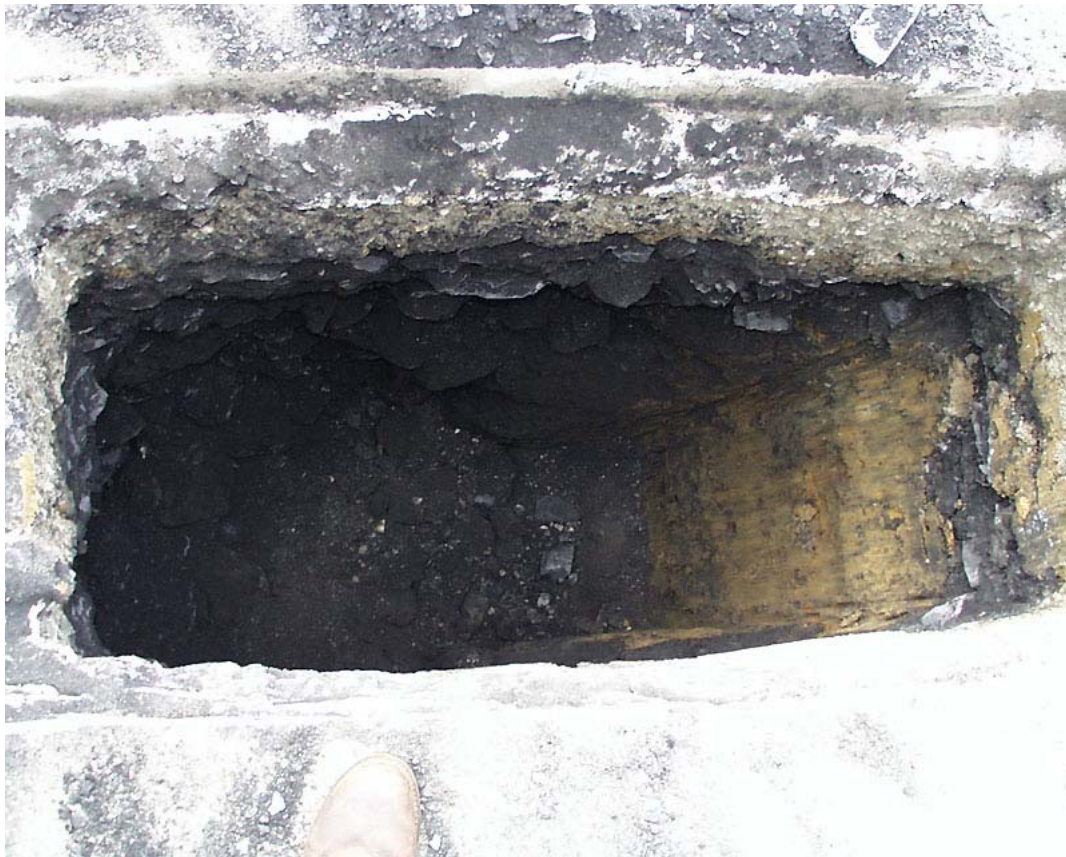
A backhoe was used to excavate a test pit in the center lane within the most severely distorted zone to permit recovery and examination of culvert trench backfill. The test pit was excavated to the top of the culvert at a depth of approximately 9 feet below the pavement surface. All trench backfill material from the bottom of the pavement base layer to the top of the culvert pipe was determined to be black shale consisting of particles ranging in size from coarse sand to boulders, with a significant quantity of the particles being at least 4 inches across. Two boulders removed near the bottom of the test pit were on the order of 18 inches across and were judged to weigh in excess of 100 pounds each. The shale backfill was quite damp, partially weathered, and friable at all depths and was uniformly black in appearance. Upon drying, the material became gray in color. Approximately 150 pounds of the backfill was placed in bags and transported to the Virginia Transportation Research Council's (VTRC) soils lab for further analysis. Figure 4 is a photograph of the partially excavated test pit. Note the tan colored material in the right side of the photograph, which is the clay/silt pavement subgrade beyond the boundary of the culvert trench.

**Figure 4. Test Pit Excavation of Culvert Trench.**

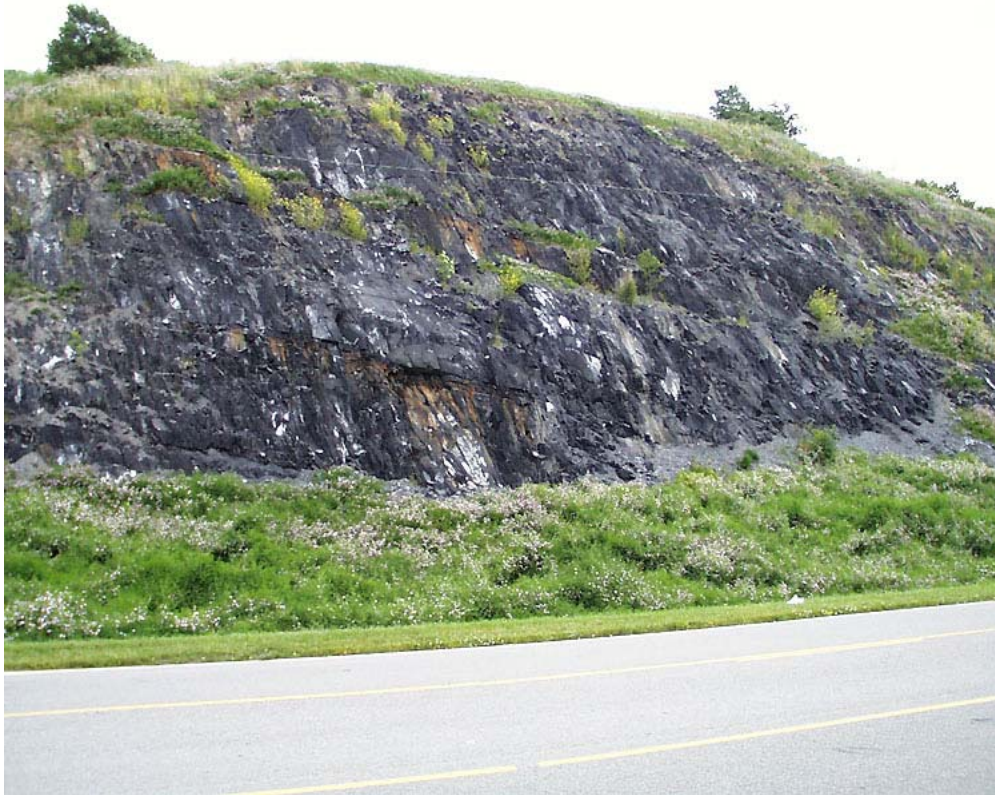
The source of the shale backfill was reported to be a borrow site located on the east side of Old Airport Road at the north end of the project between Stagecoach Road and I-81. One bag sample of relatively unweathered shale was taken from the borrow site and transported to the VTRC soils lab for further analysis. Figure 5 is a photograph of the borrow site.

**Figure 5. Shale Borrow Site.**

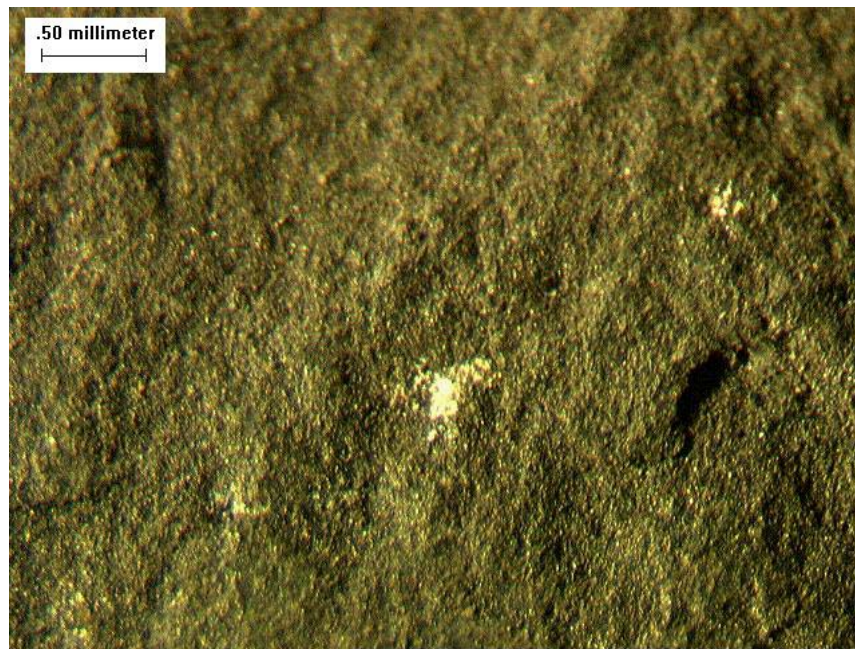
Microscopic examination of the unweathered shale sample taken from the borrow site revealed a significant quantity of pyrite and some oxidized pyrite. Figure 6 is an image of one such sample, which shows some of the finely disseminated pyrite. There are also areas of iron staining where the pyrite has oxidized, one of which is depicted by the horizontal arrow at the bottom of the image.

**Figure 6. Magnified Image of Relatively Unweathered Shale from Borrow Site.**

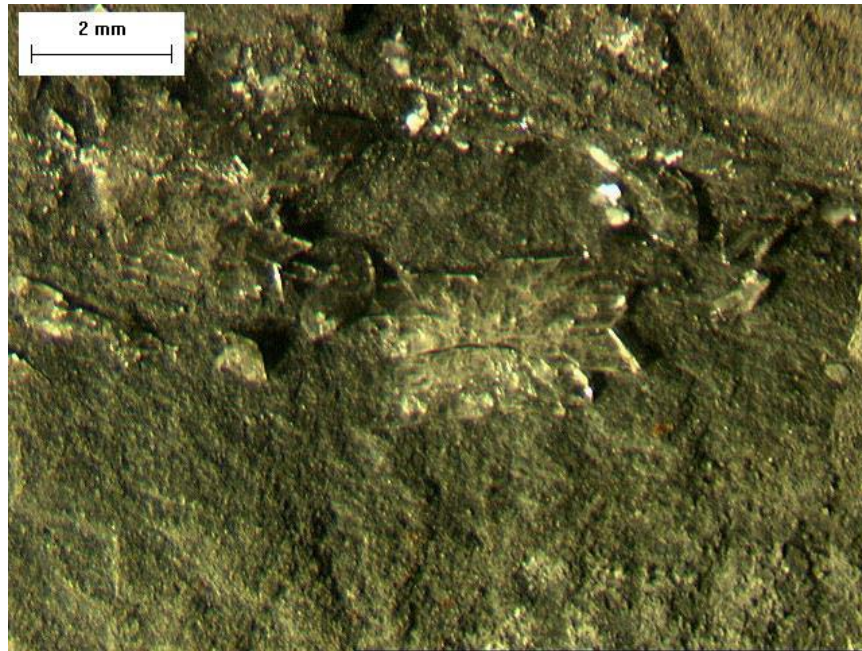
Figure 7 is an image of a weathered shale sample removed from the culvert trench. It illustrates gypsum crystals that have precipitated on the bedding and cleavage planes of the shale. Gypsum is recognized by its low hardness and optical properties (colorless, index of refraction and low birefringence). The shale has a carbonate component indicated by slight effervescence with dilute HCl.

**Figure 7. Magnified Image of Weathered Shale from Culvert Trench.**
