**DETERMINATION OF REMAINING FATIGUE LIFE OF WELDED STUD DETAILS
ON OVERHEAD ALUMINUM SIGN PANELS IN VIRGINIA**

Project Manager
Michael C. Brown, Ph.D., P.E.
Research Scientist
Virginia Transportation Research Council

March 2005
VTRC 05-CR10

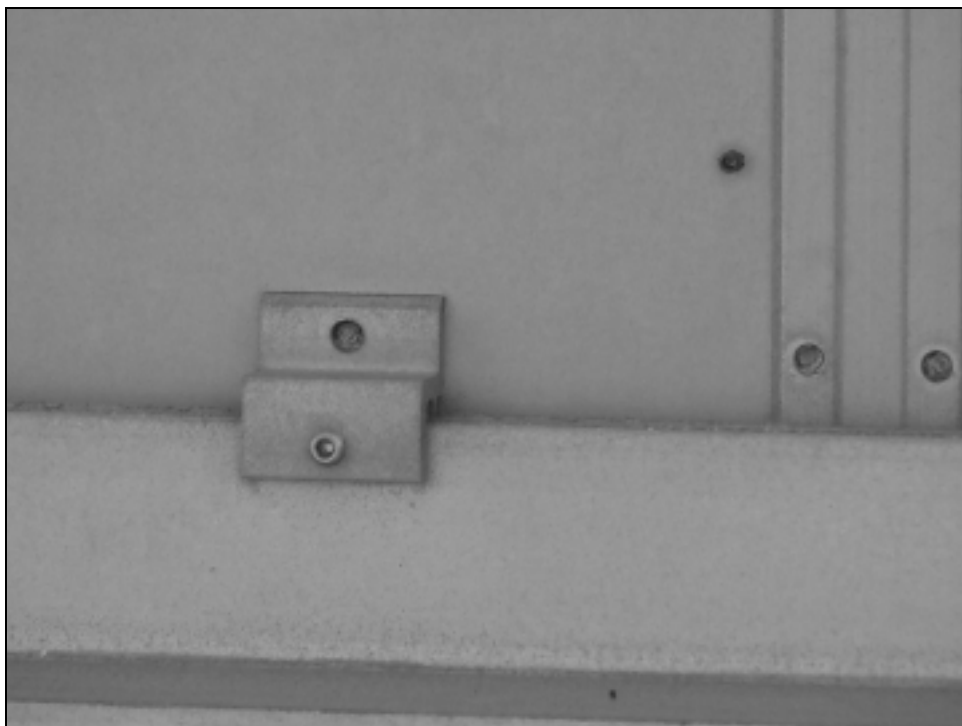
In April 2003, a sign failed and fell in the Hampton Roads District causing a traffic accident. Another sign failed in the Fredericksburg District in March 2004, luckily not causing injury. It was observed that these failures occurred due to the threaded studs “popping off” the sign panels. The failure mechanism was observed to be fatigue of the weld connecting the panel to the stud, caused by natural and/or truck-induced wind gusts. From inspection of other signs that had failed connections, but had not fallen, it was concluded that the bottom edge and corner connections are more susceptible to failing. After the edge connections fail, the interior connections start to fail. This can be described as an unzipping of the sign connections. A failed sign and stud can be seen in Figures 11 and 12.

Figure 11. Failed Stud on Sign.

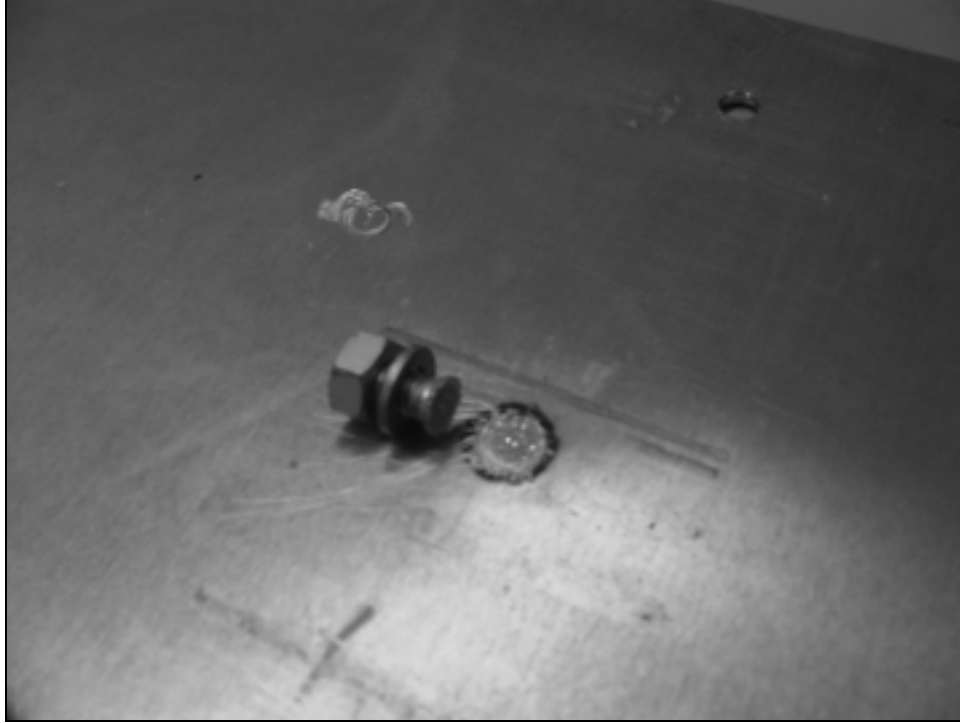
Figure 12. Failed Stud Due to Fatigue.

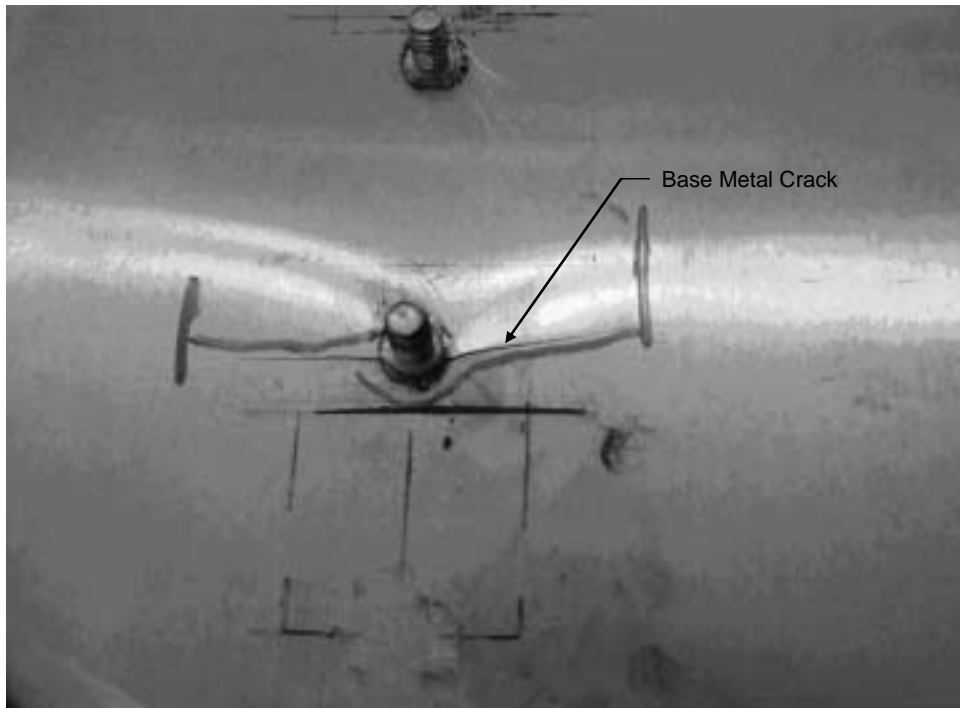
The connections tested for fatigue at stress range of 50-500 lb failed in the same manner as the pseudo-static tests. The connections tested cyclically at lower stress ranges developed cracks in the aluminum panel prior to the stud pulling out, as seen in Figure 24. In these cases, the welds did not fail. Crack initiation for these tests was estimated by changes in stiffness plots. Because these failures were not representative to any found in the field, the testing of interior connections was stopped. It was assumed that this was not the correct boundary condition and loading configuration that was in the field. The fatigue results can be seen in Table 4. There was no S-N curve developed for this loading condition because of the small number of samples tested.

Figure 24. Cracked Panel Leading to Stud Pullout.
