Report No. VTRC 06-R9	Report Date October 2005	No. Pages 30	Type Report: Final	Project No. 76634
				Contract No.
Title: Forensic Investigation of Concrete Pavement: U.S. 460, Appomattox Bypass				Key Words: Concrete pavement, Appomattox Bypass, pavement failure, drainage
Authors: Shabbir Hossain, Ph.D., P.E., and Mohamed Elfino, Ph.D., P.E.				
Performing Organization Name and Address: Virginia Transportation Research Council 530 Edgemont Road Charlottesville, VA 22903				
Sponsoring Agencies' Name and Address Virginia Department of Transportation 1401 E. Broad Street Richmond, VA 23219				
Supplementary Notes				
<p>Abstract</p> <p>This report describes the investigation of structural failure in a section of the Appomattox Bypass along U.S. 460 in the town of Appomattox, Virginia. The bypass is a four-lane divided highway. The section that was investigated is an 11-year-old section of jointed plain concrete pavement located approximately between mile post 8.10 and mile post 8.35 in the eastbound lane.</p> <p>A forensic investigation was conducted to identify the causes of failure and determine reasonable remedial measures. The investigation included a visual condition survey, non

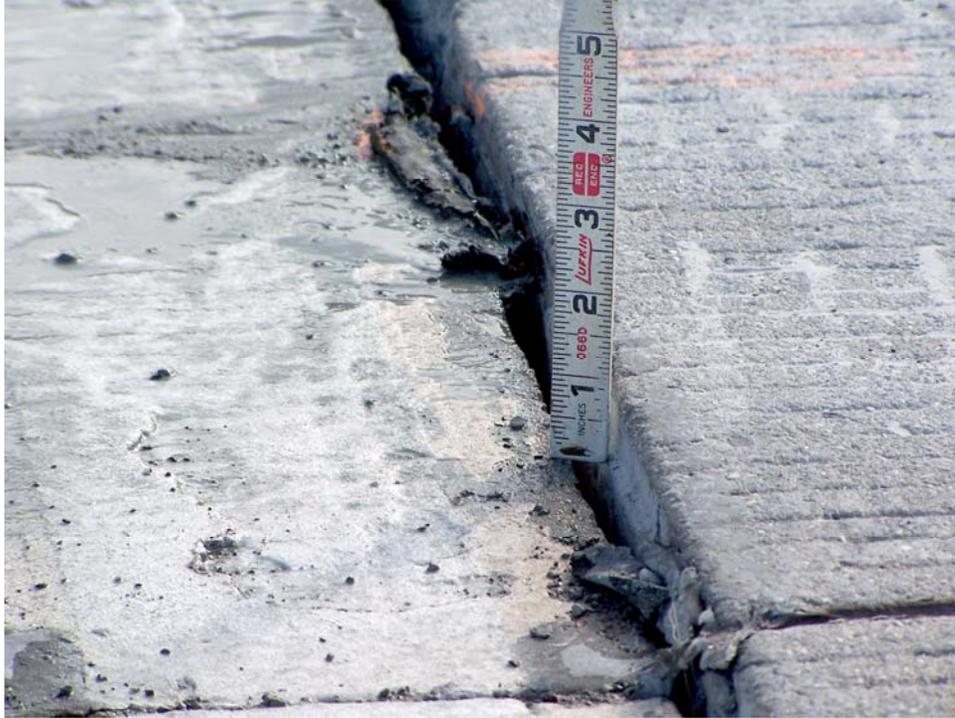
Figure 1. Differential Slab Movement at Longitudinal Joint

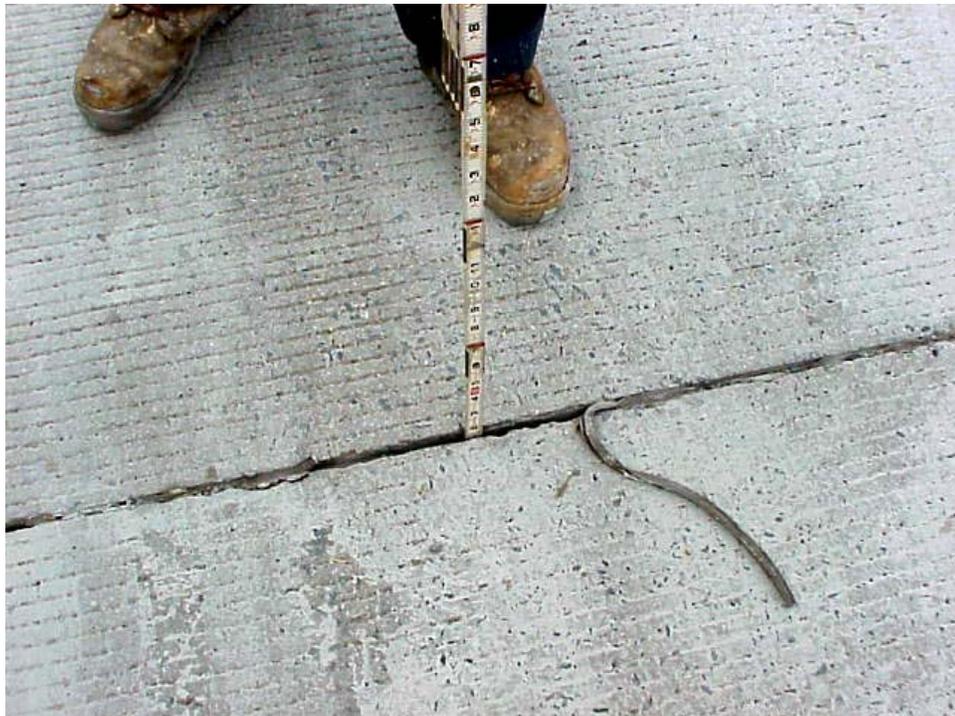
Figure 2. Broken Sealant at Transverse Joint

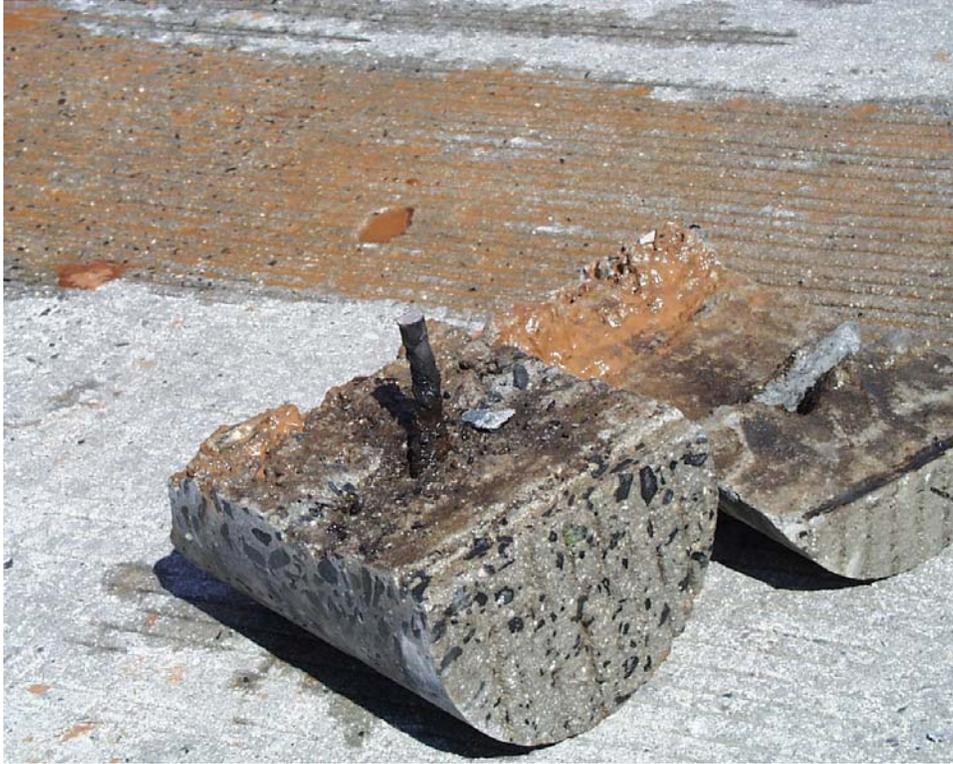
Core 2 was through a mid-slab crack. The crack propagated through the drainage layer but did not damage the soil cement layer. Core 4 was on a longitudinal joint and through a tie rod. Because of the differential settlement between the travel and acceleration lane, the tie rod was found bent as shown in Figure 6. Core 5 was on a transverse joint through a dowel bar. The dowel bar was found to be wobbly and the hole around the dowel bar was elliptical, as shown in Figure 7, instead of circular, indicating poor load transfer.

Figure 6. Core Through Faulted Longitudinal Joint and Bent Tie Rod

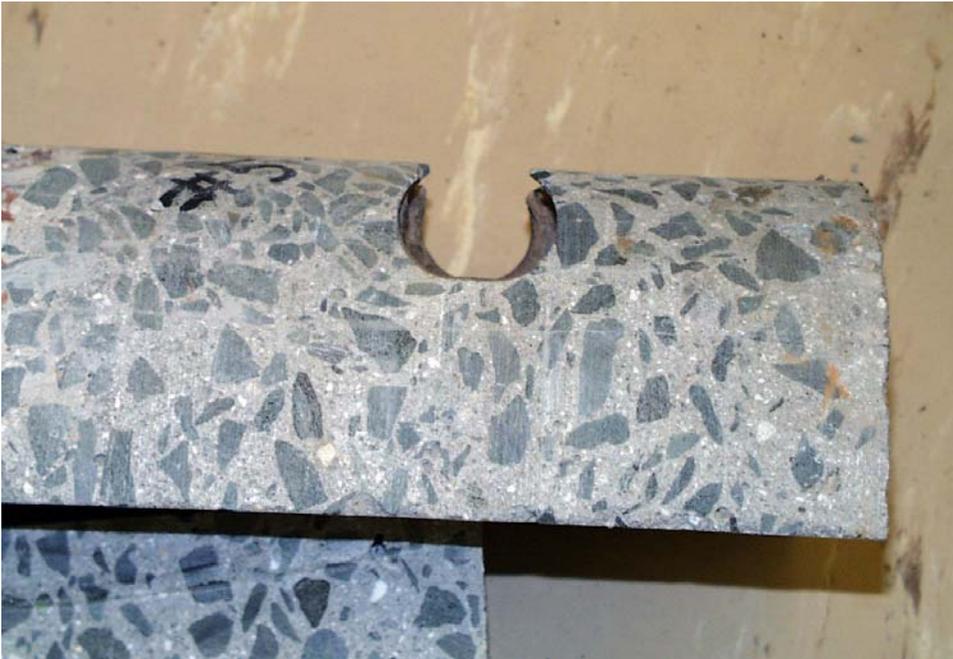
Figure 7. Core Through Faulted Transverse Joint and Wobbly Dowel Bar

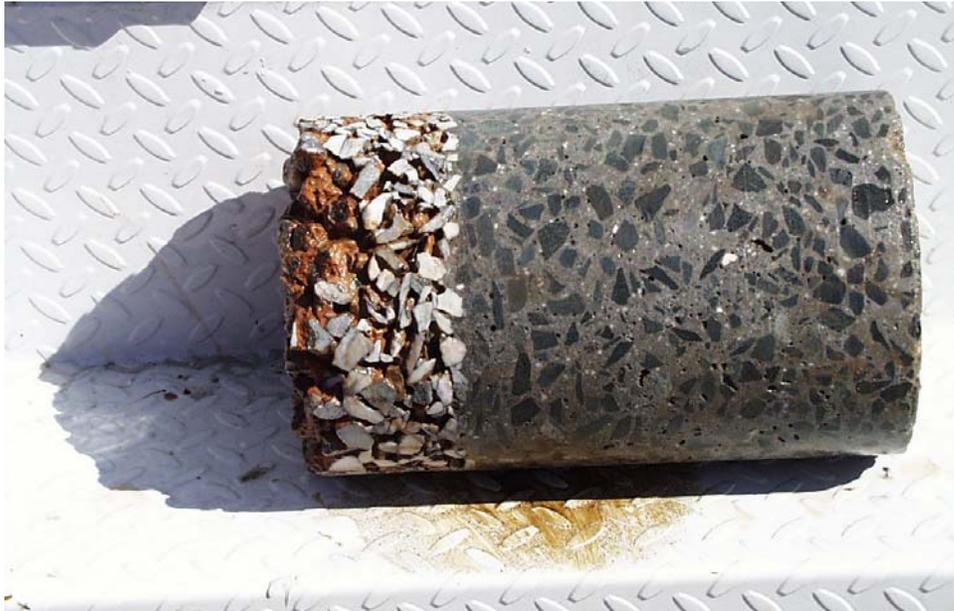
bore hole during the coring operation, especially for the most seriously damaged slabs such as those with cores 1 and 2. Another consistent observation for damaged slabs was partially clogged drainage layers with red soil as shown in Figure 8. On the other hand, the drainage layers for the undamaged slabs (cores 6 and 7) looked clean and there were no signs of even any soil stain. This is a clear indication of the drainage problem associated with the observed distresses.

Figure 8. Clogged Drainage Layer

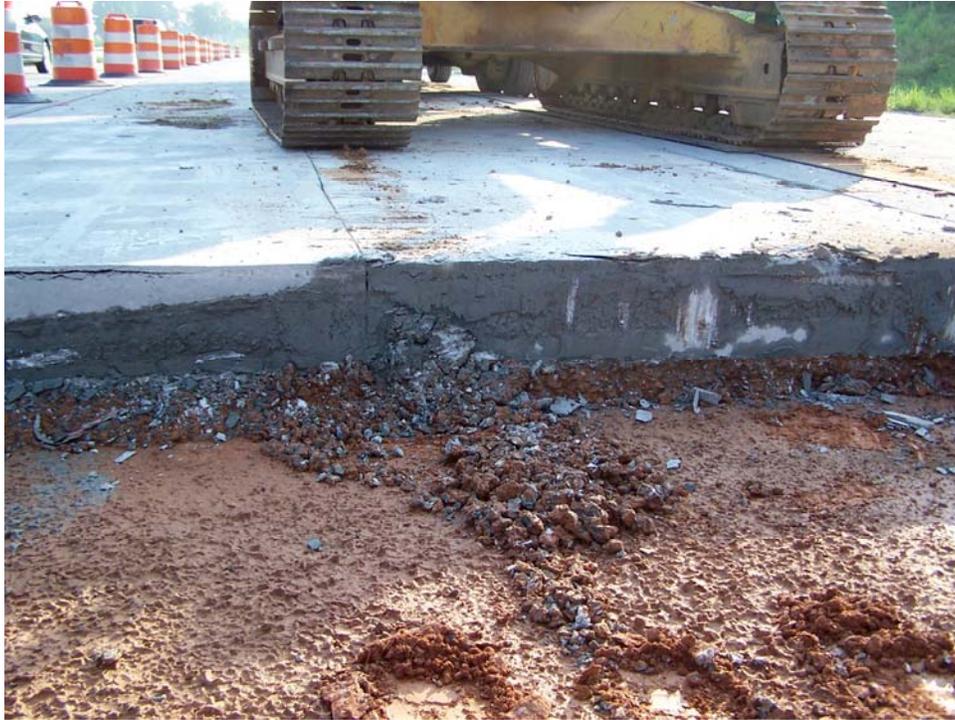
A very thin layer of red clay (residue) was observed on top of the soil cement with the indentation mark of the aggregate from the drainage layer after the removal of broken slabs. The condition of the soil cement is shown in Figure 9. This softer layer was later confirmed by chemical analysis as the disintegrated/ abraded soil cement. This layer was scraped off before the new base/subbase layer was constructed.

Figure 9. Soft Condition of Soil Cement Underneath Concrete Slab

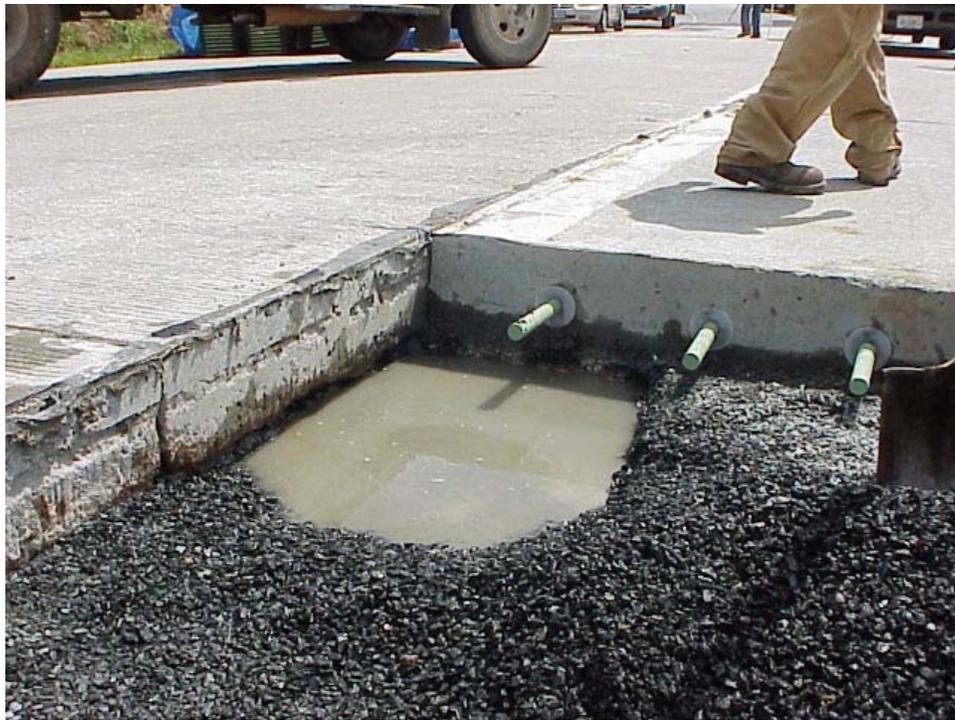
During the replacement operation near the site of this investigation, 4 to 5 inches of standing water was observed, shown in Figure 10, over the soil cement and through the No. 8 aggregate on the day after a heavy rain storm. The site was prepared up to the base layer and was ready for the casting of concrete the day before the storm. This standing water clearly indicated a blockage of the flow of water out of the pavement. Therefore, it was suggested that the shoulder slab be removed to locate the edge drain and that the area between the pavement edge and the edge drain be examined. It was observed that the OGDL was extended for only 8 inches beyond the edge of the auxiliary lane and was blocked by the impervious native soil (16 inches wide); adjacent to that was the edge drain. Figure 11 illustrates the field condition. This was the key finding of the forensic investigation to explain the failure mechanism for the investigated section which started as early as the original construction of the pavement.

Figure 10. Trapped Water After Rain storm During Slab Replacement

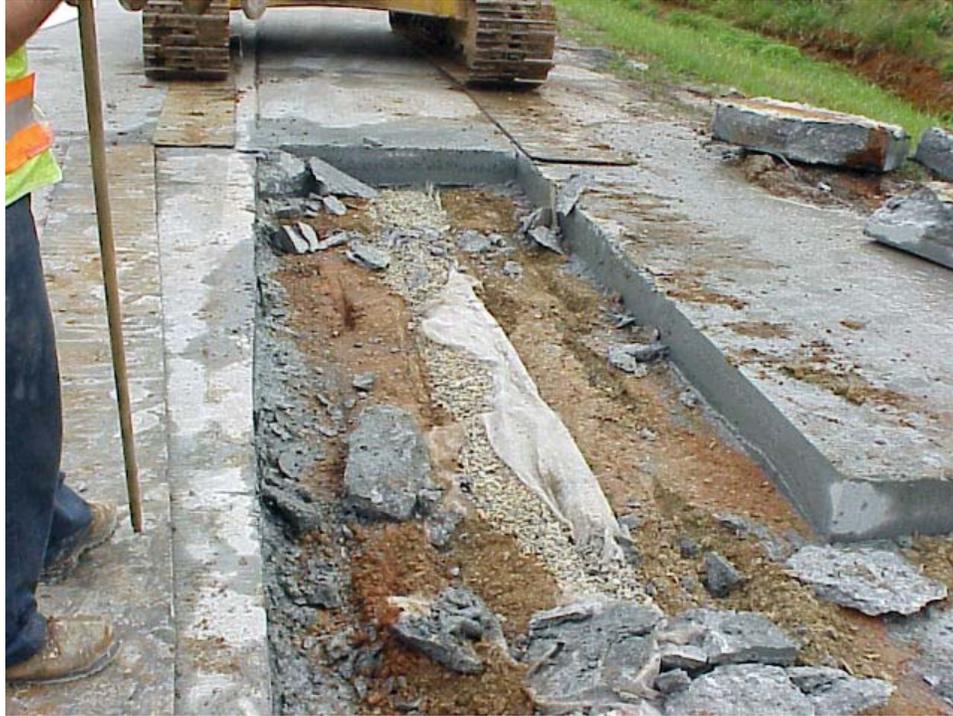
Figure 11. Discontinuity of Drainage Layer Under Shoulder Slab

1. Saw cut and remove 2 feet of the concrete shoulder immediately adjacent to the edge of the mainline pavement or the auxiliary lanes.
2. Dig out the 16 inches of native soil standing between the drainage layer and the edge drain to a depth at least equal to the depth of the existing edge drain, and replace it with AASHTO No. 57 aggregate to a level meeting the top of the OGD. This widened trench will provide all the needed elements for proper drainage, i.e., intercept, collect, and discharge.
3. Use capping materials, about 9 inches (replacing the 2 feet of concrete), of either concrete using tie bars or asphalt with its surface enhanced with rumble strips for added safety to reduce the potential of truck traffic wandering on top of the 2-foot repair.
