## Survey of Cathodic Protection Systems on Virginia Bridges

STEPHEN R. SHARP, Ph.D.  
Research Scientist

MICHAEL C. BROWN, Ph.D., P.E.  
Research Scientist

**FINAL REPORT**

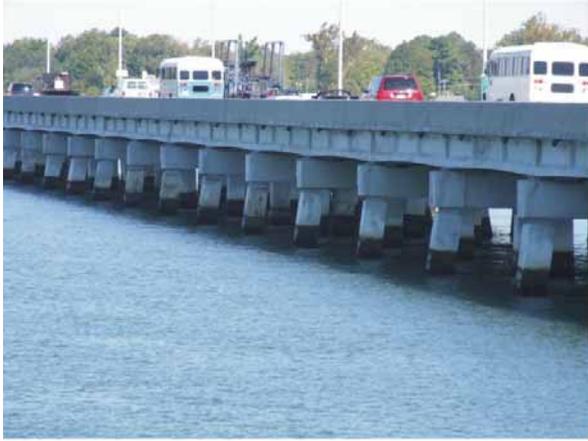
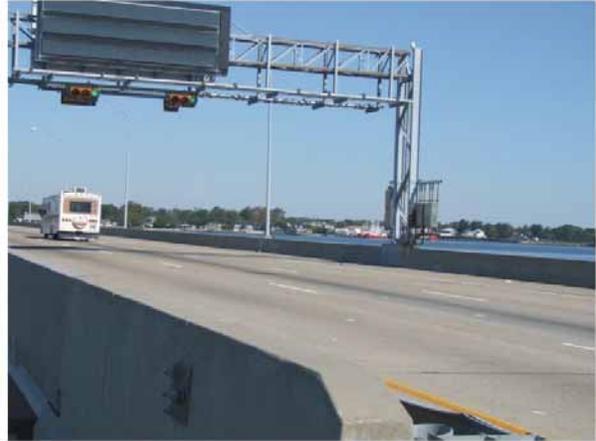
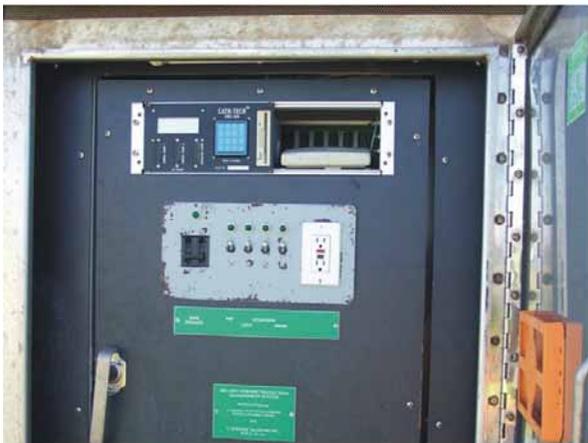
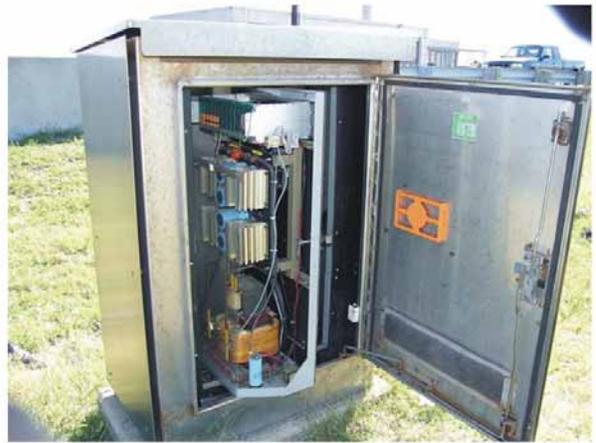
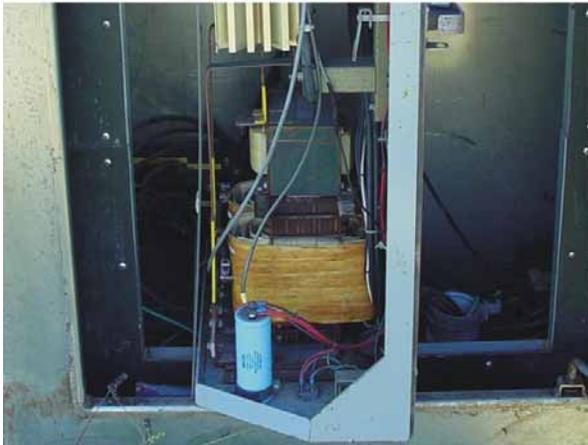
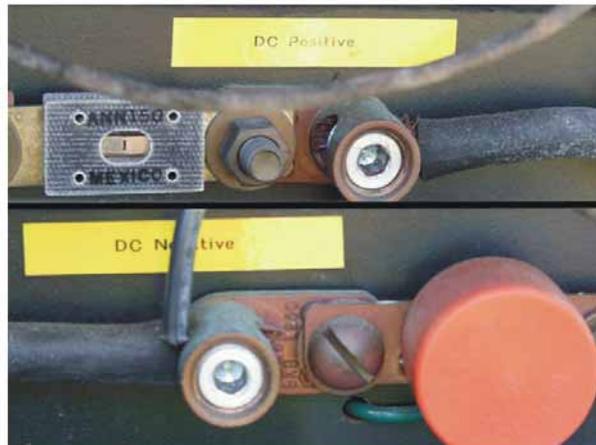
One of the largest CP installations in Virginia is on the Hampton Roads Bridge-Tunnel (SN 2902), which carries the westbound lane (WBL) of I-64 over Hampton Roads (Figure 2A) where the James and Elizabeth rivers meet the Chesapeake Bay. This structure, originally built in 1958, was rehabilitated in 1998 and received a latex-modified concrete overlay containing an embedded titanium anode mesh with a mixed metal oxide catalyst for an ICCP system. The installed system covered more than 400,000 ft<sup>2</sup> of deck surface. The most recent inspection report, dated August 12, 2005 (Williams and Futrell, 2005a), indicated that the deck is in good condition (Figure 2B), with some 1/16-in-wide cracks visible on the underside of the deck.

**Figure 2. Inactive Cathodic Protection System on I-64 WBL Hampton Roads Bridge-Tunnel: (A) Overview of Hampton Roads Bridge, (B) Bridge Deck Surface, (C) Face of Cathodic Protection Rectifier, (D) View Inside Electronics Cabinet, (E and F) Close-up of Electrical Components**

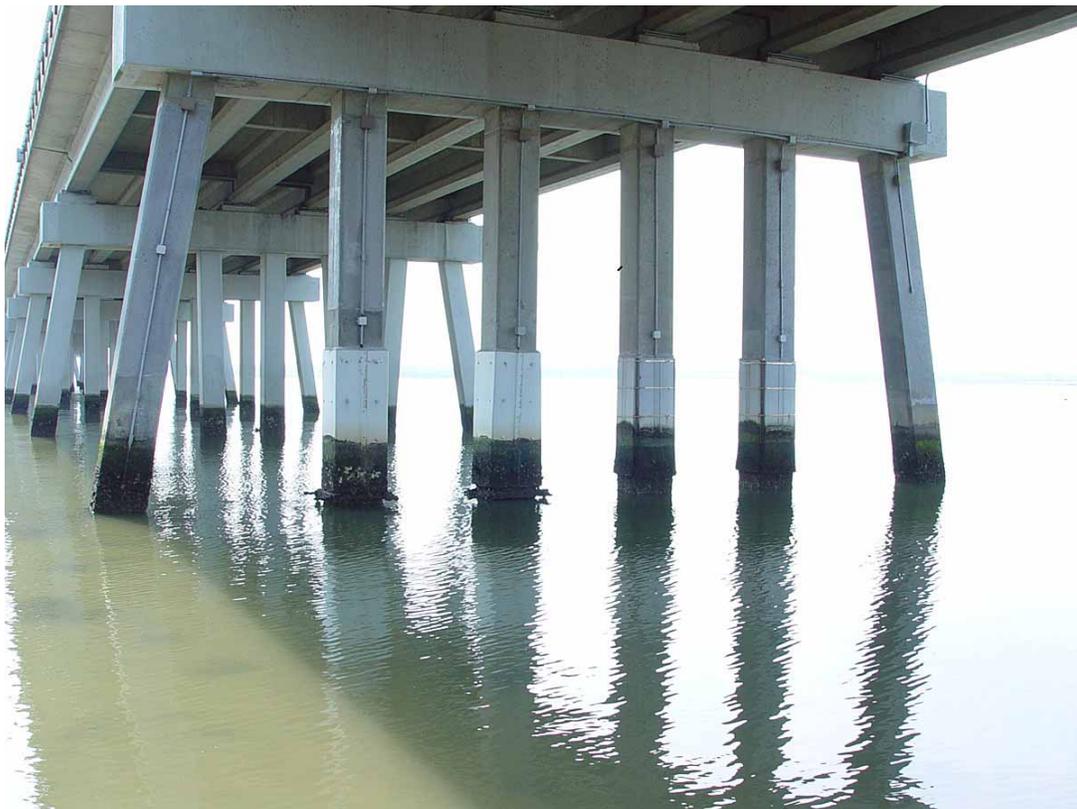
**Figure 3. Overview of Cathodic Protection Systems (Bent 2): I-64 EBL Over Willoughby Bay: Substructure**

A visual examination was conducted, and all of the anode systems on Bent 2 were noted to be in good shape, as shown in Figures 3 and 5A and B. Marine life had not appreciably grown under the compression panel (jacket) surface, although this phenomenon has been known to occur in similar installations, resulting in the development of expansive pressure that causes the stainless steel bands to break.

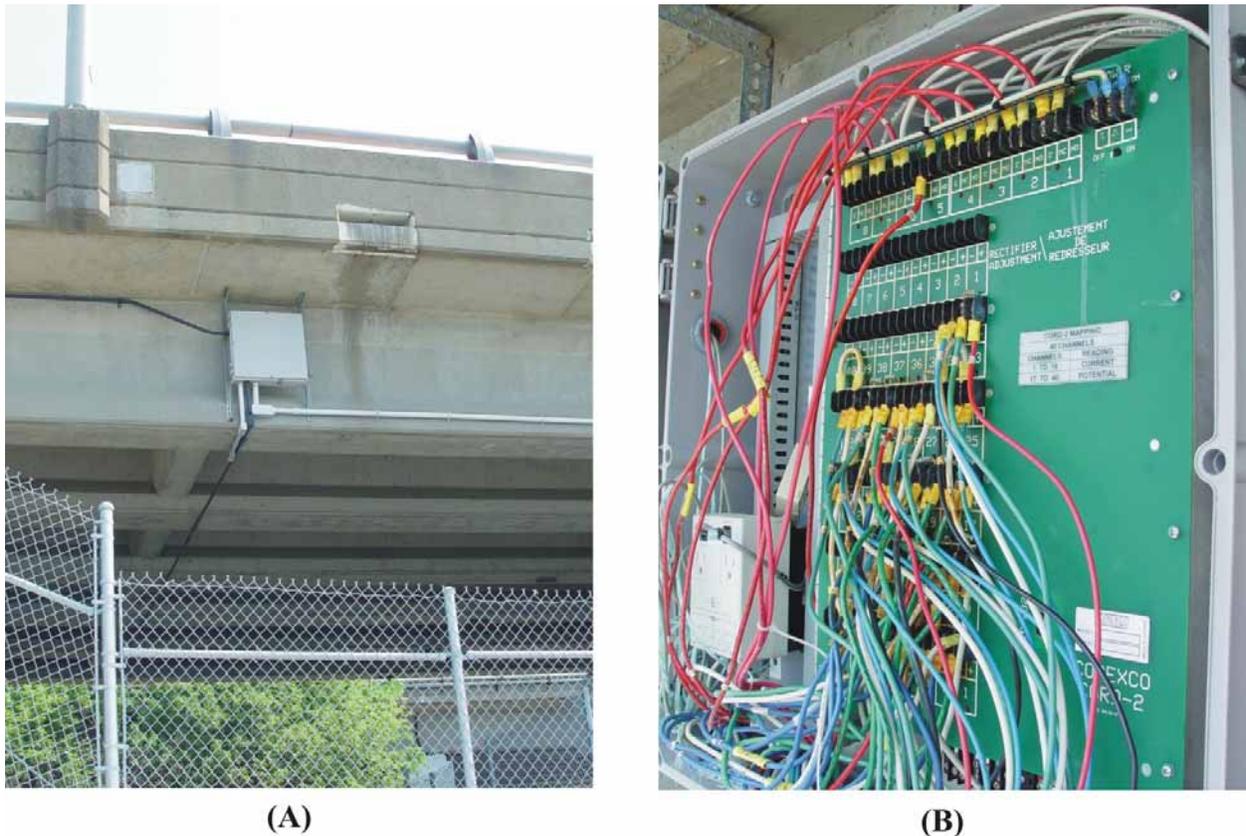
The initial inspection of the control unit for the substructure, shown in Figure 4, quickly revealed that evaluating the structure from this point would be difficult because the wires were numbered and a key to decipher the numbering system was not available. Since the timeline for the current project was limited, the researchers decided that (1) the evaluation should focus on Bent 2 and would include limited electrical measurements, and (2) only the pier jacket systems would be evaluated since they were the only commercially available systems at the time.

**Figure 4. Control Unit for Substructure Cathodic Protection Systems: I-64 Over Willoughby Bay**

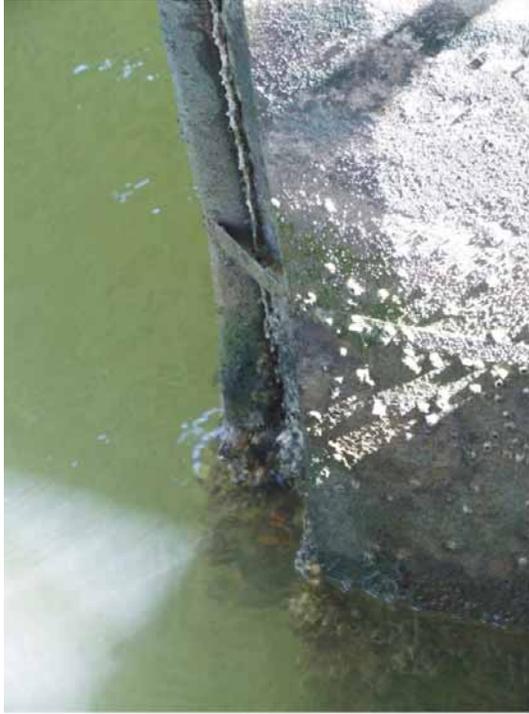
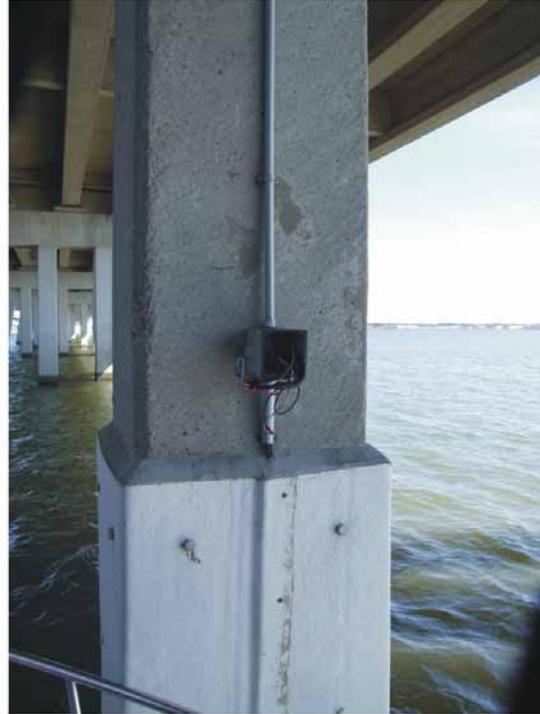
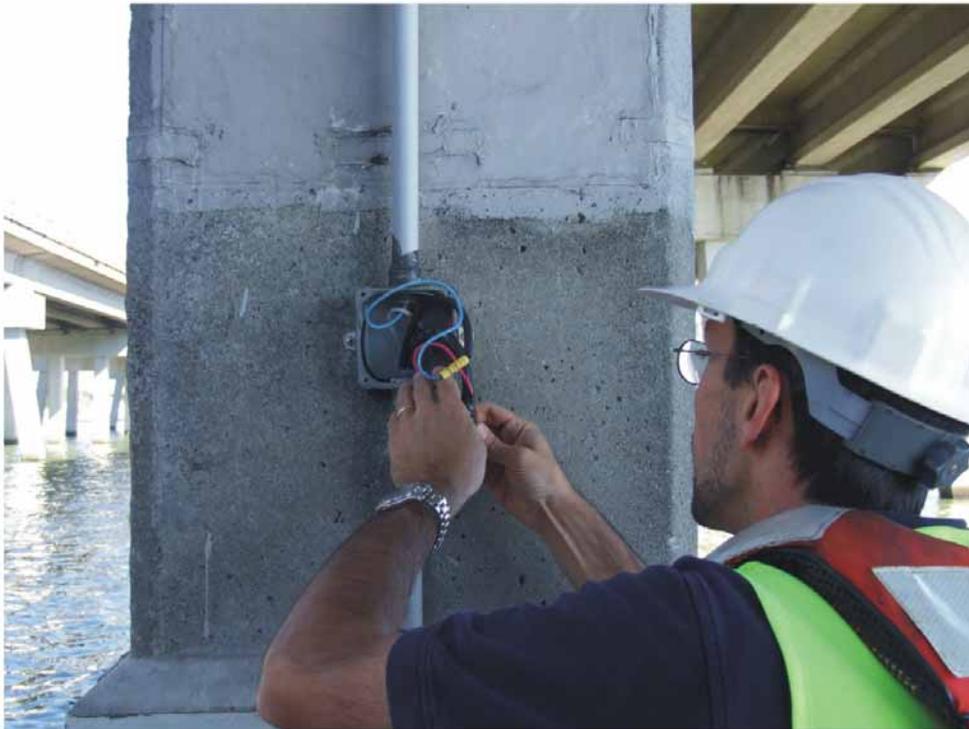
**Figure 5. I-64 EBL Over Willoughby Bay Substructure: (A) No Evidence of Sea Life Build-up Under Compression Panel, (B) Close-up of Structural Jacket Containing Galvanic Cathodic Protection System, (C) Zinc Hydrogel Anode (Upper Pile Region) in Contact with Concrete Surface and All Conduit in Place and Watertight**

Based on the researchers’ initial evaluation, a more rigorous survey of these systems, including the tracing of lead wires and detailed measurements of voltage and current, is recommended as a future activity. If the systems are found to be effective in protecting the piles, similar repairs might be recommended for the deteriorated piles noted by the inspection reports.

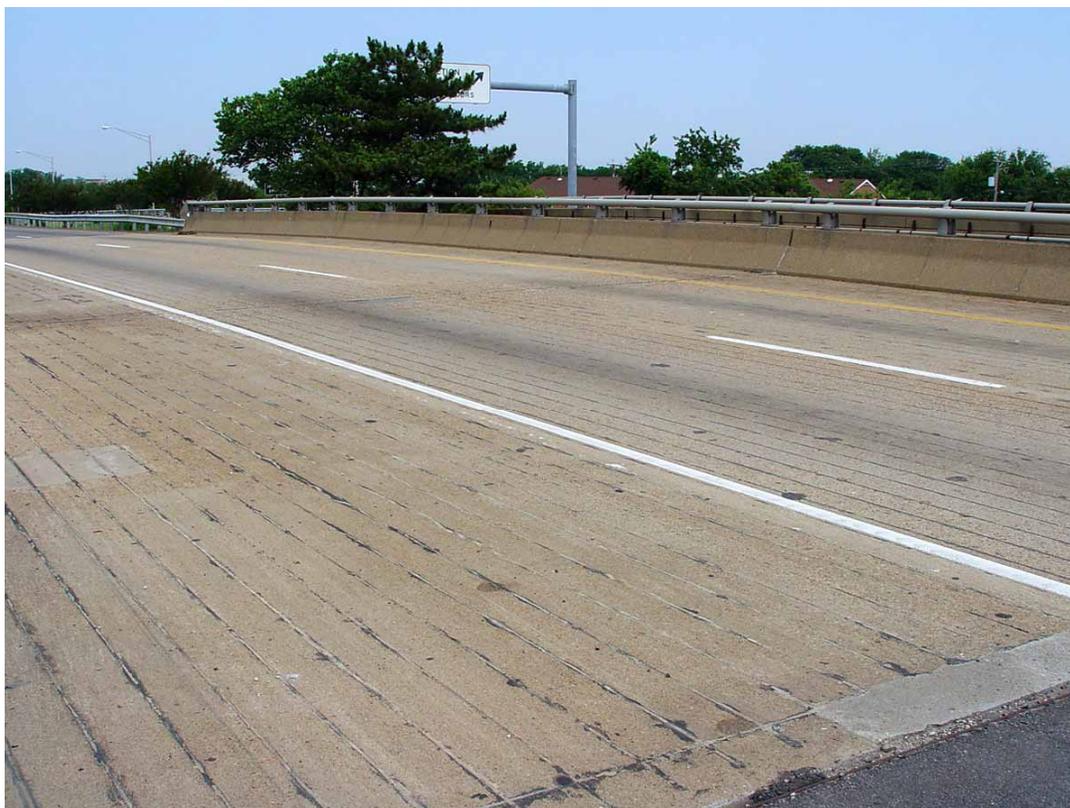
The slotted conductive polymer system installed in the deck (see Figure 7) contained niobium-copper primary anode wires and supplemental secondary anodes of carbon strand, each laid in saw slots 3/8 in to 1/2 in wide by 3/4 in deep and filled with a conductive polymer grout made of vinyl-ester resin and carbon black. A similar system had been installed in 1983 on an inland structure along Route 15 over the Willis River in Buckingham County, Virginia. Within the first 2 years of operation of this type of system on each structure, there was evidence of degradation of the conductive grout caused by acids generated at the anode surfaces (Virmani and Clemeña, 1998). A visual inspection of the deck (Zone 1) indicated discoloration in some areas of the concrete adjacent to the slotted anodes (Swiat and Bushman, 1989). Swait and Bushman (1989) concluded the life of the deck system would be directly related to the time it would take for the system to damage the concrete. Subsequently, Zone 1 of the 13th View Street structure was deactivated.

**Figure 7. Cathodic Protection System on Deck of I-64 EBL Bridge Over 13th View Street**

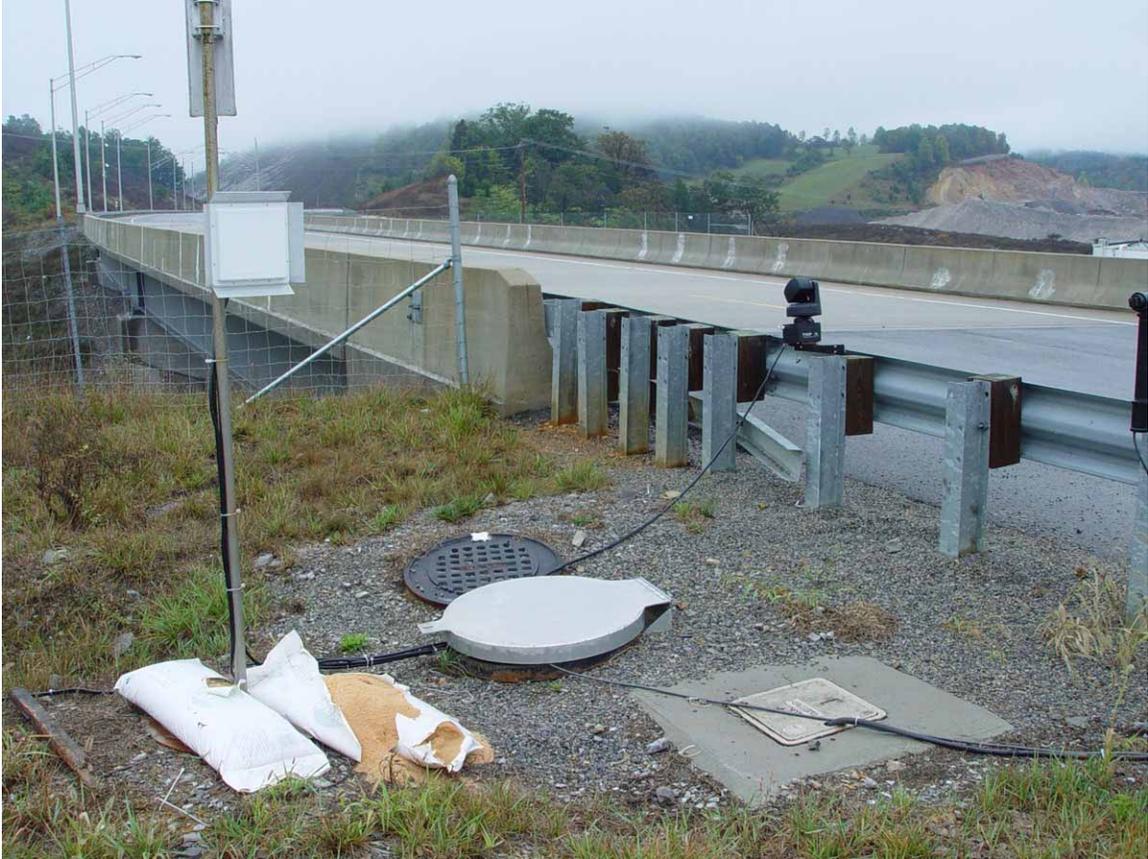
This bridge (SN 1071) in Blacksburg, Virginia, contains an ICCP system designed to mitigate corrosion in the bridge deck (Figure 8). The most interesting aspect of this research study was that this CP system was installed in a bridge deck while it was being constructed. The system was installed in five zones, with Zone 1 being at the west end of the structure. The system was designed to protect more than 14,000 ft<sup>2</sup> of deck through the installation of a titanium ribbon mesh anode with a mixed metal oxide coating embedded in the original cast-in-place concrete. The system incorporated a remote access monitoring system installed with the control system in a bunker at the west end of the bridge (Figure 9), which allows someone to measure the electrical potential and current from a remote location. This system was activated in January 2000 and subsequently monitored for 25 months (Clemeña et al., 2003).

**Figure 8. Overview of Bridge and Control Bunker: Smart Road Bridge Over Route 642**

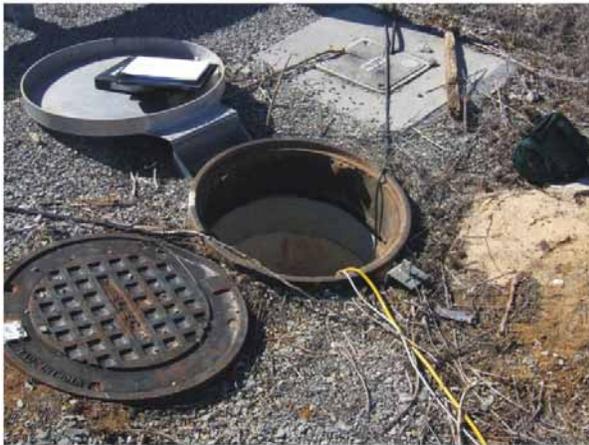
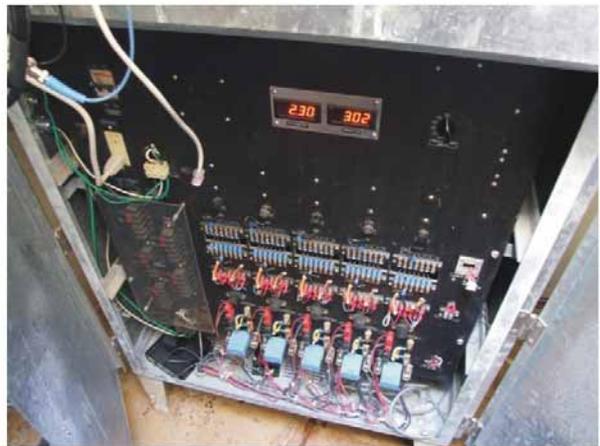
**Figure 9. Impressed Current Cathodic Protection (ICCP) Rectifier System Located in Control Bunker of Smart Road Bridge Over Route 642: (A) Open Bunker Access, (B) Control Panel for 5-Zone ICCP System (Note Missing Fuse for Zone 3) Shows Voltage and Current Display (with Switch on Zone 5)**

As noted, the system appears to be functioning, with the exception of Zone 3. It does not appear that regular monitoring of the CP system's current and voltage output has been documented since the original evaluation period concluded in early 2002. A complete system check and adjustment, as needed, are recommended.

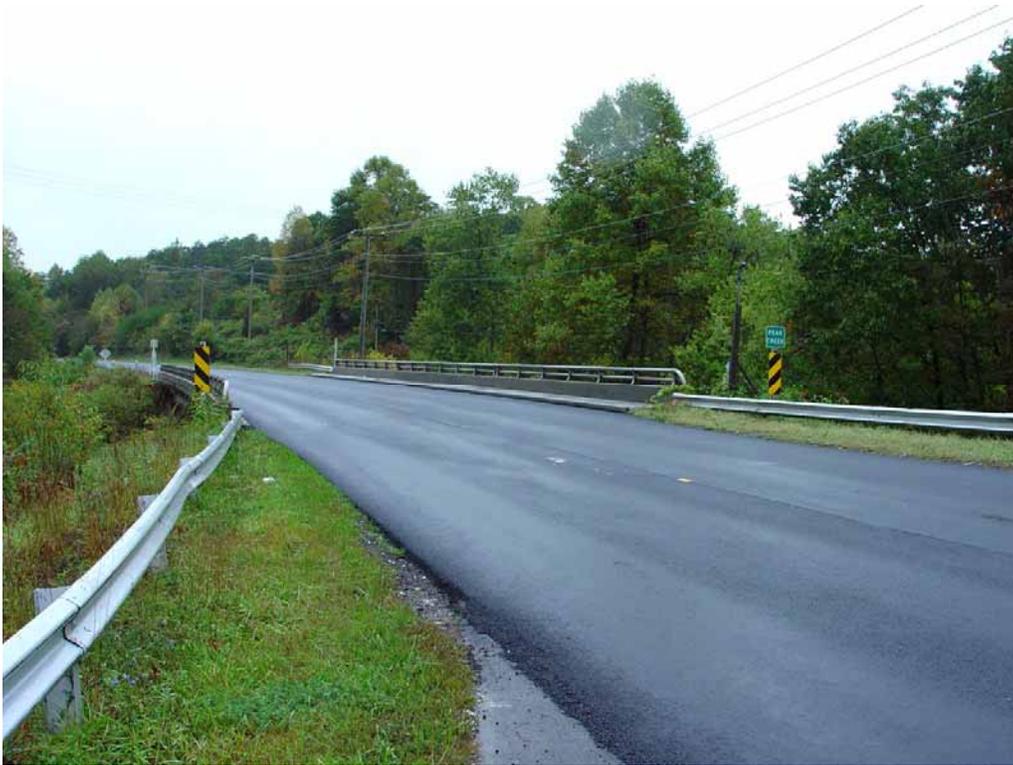
Upon inspection of this system in October 2005, it was observed that a new asphalt pavement layer had been placed on the surface of the bridge deck (Figure 10). Further, corrosion was seen along the underside of the bridge along the edge (Figure 11). This edge is located along the lower sloping side of the bridge deck. Leaks were also evident on the underside of the

**Figure 10. Deck Cathodic Protection System: Route 99 Over Peak Creek**

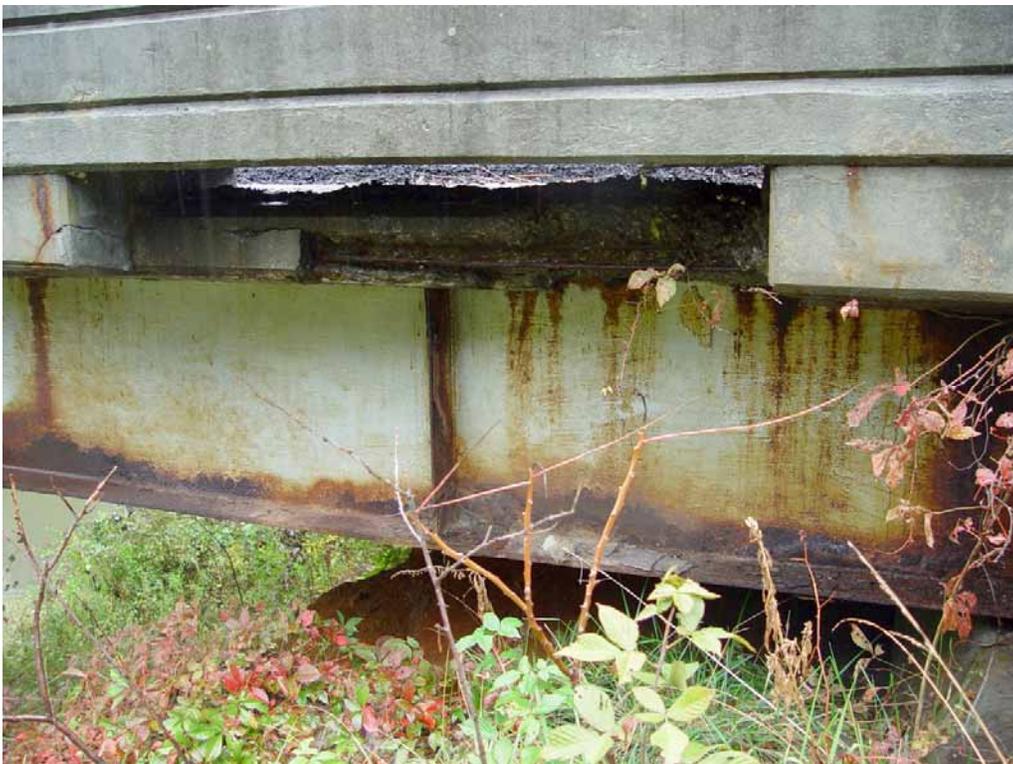
**Figure 11. Deteriorated Deck Soffit and Beams: Route 99 Over Peak Creek**

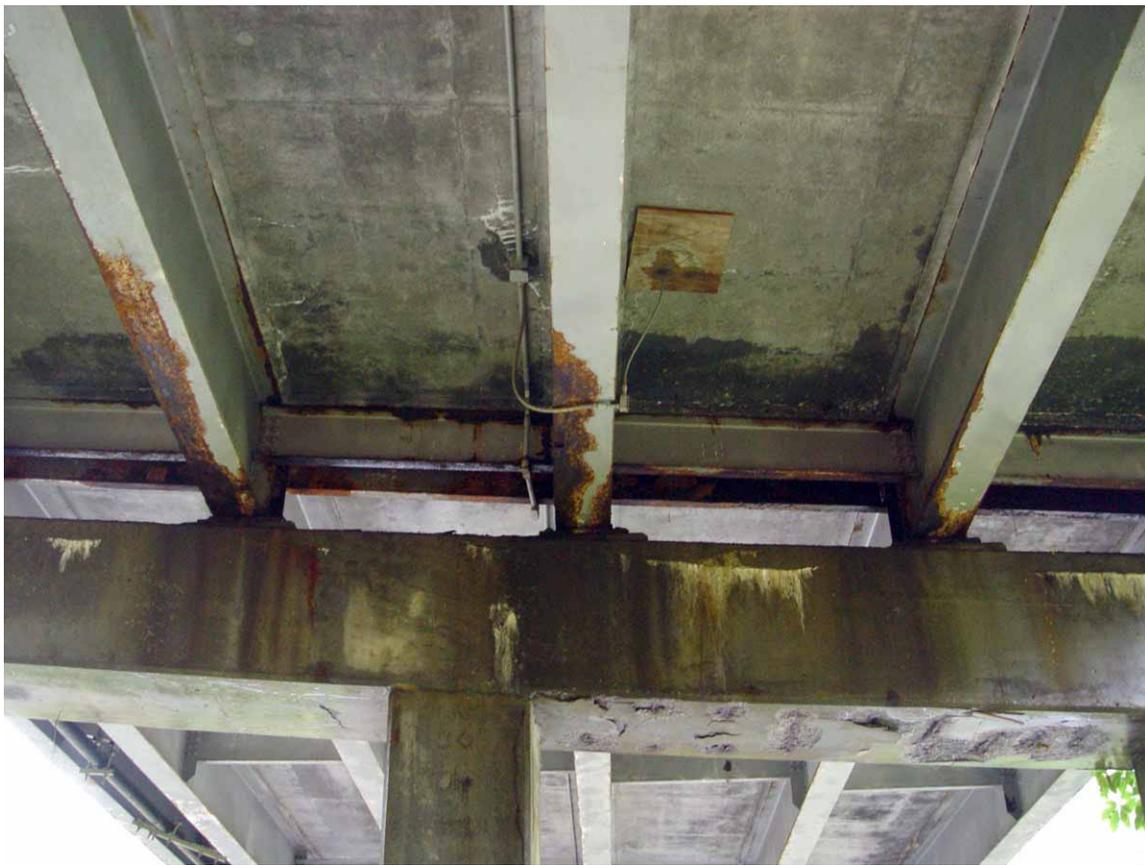
bridge deck (Figure 12) where the conduit for the CP system penetrates the bottom of the deck. The deck had similar deterioration along the lower edge when the CP system was installed.

**Figure 12. Underside of Deck with Cathodic Protection System Connections: Route 99 Over Peak Creek**

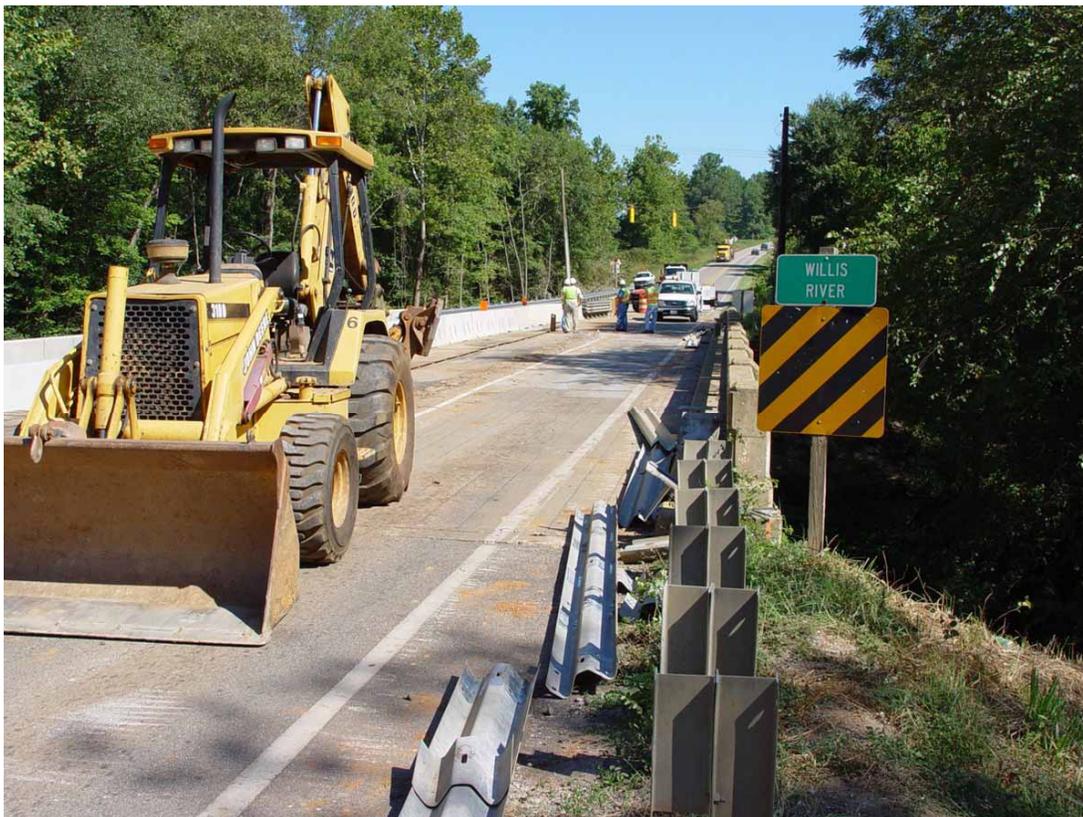
VDOT's Lynchburg District Structure and Bridge Safety Inspection Engineer reported that the Dillwyn Residency Maintenance Operations Manager indicates that the power to the system was likely disconnected around 1997 to 1998 (J. L. Milton, personal communication, April 20, 2007). The structure was replaced entirely in 2006 (as shown in Figures 13 and 14). The last inspection report prior to replacement, dated January 12, 2005 (Farris and Foster, 2005), confirmed the presence of hairline cracking and scaling over most of the deck surface as well as loose or missing sections of the conductive polymer concrete fill material. The underside of the deck also exhibited scaling, efflorescence, moisture seepage, and some delaminations. The overall deck was considered to be in poor condition.

**Figure 13. Deck Cathodic Protection System During Bridge Demolition and Replacement: Route 15 Over Willis River**

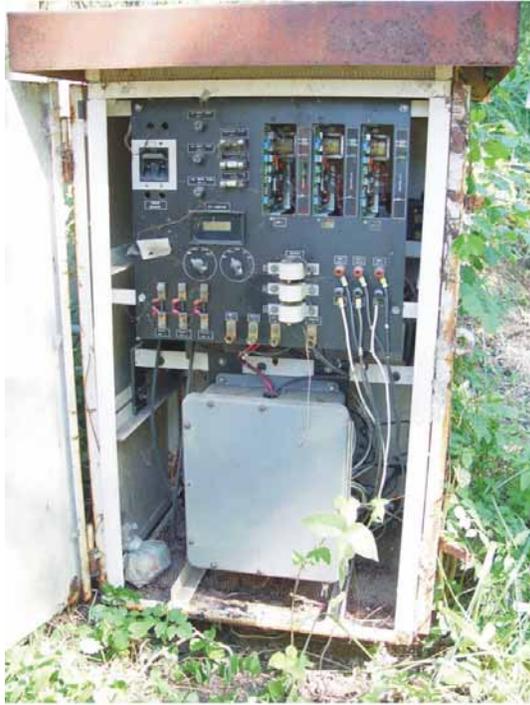
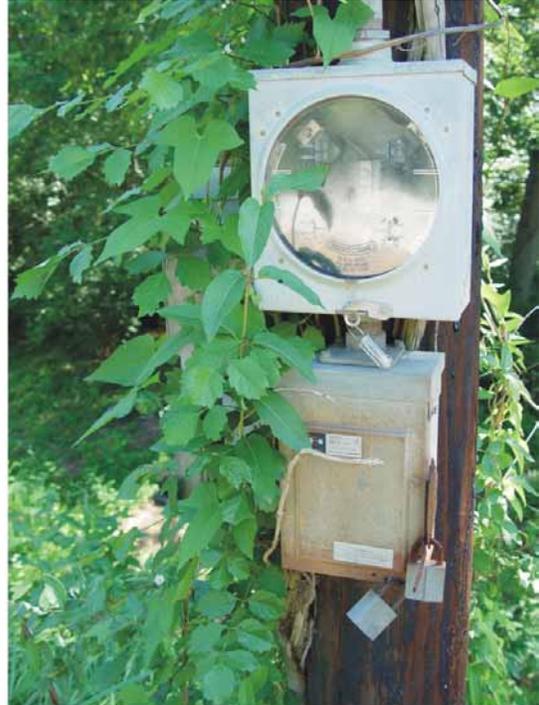
**Figure 14. (A) Control Unit and (B) Locked Out Power Meter for Decommissioned Cathodic Protection Deck System: Route 15 Over Willis River**

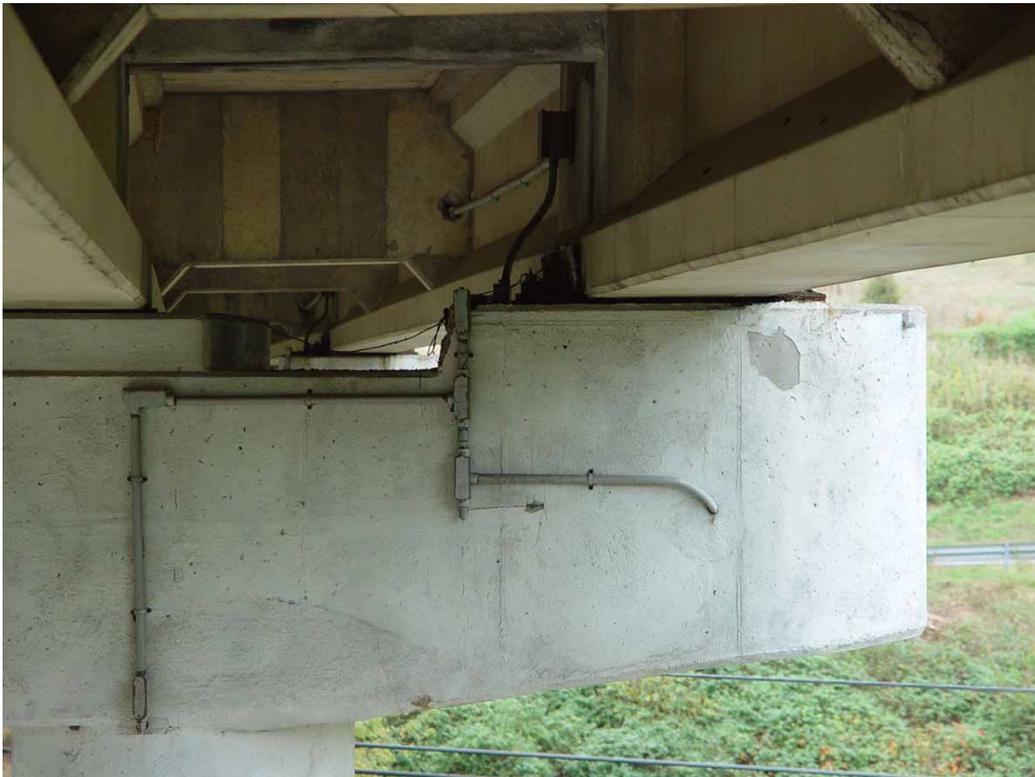
These bridges (NBL SN 2014, SBL SN 2015) in Mount Jackson, Virginia, received ICCP systems in 1989 designed to mitigate corrosion in the piers and caps (Clemeña and Jackson, 1997). These are parallel inland structures located over fresh water and a secondary highway, and they are exposed to chlorides during winter because of the use of deicing salts on I-81 (Figure 15). The anodes are an electrically conductive paint system with an embedded platinum-niobium-covered copper wire. The conductive paint shows signs of adhesion failure over approximately 5% to 10% of the surface, as shown in Figure 16.

**Figure 16. Conductive Coating Cathodic Protection System on Substructure of I-81 SBL Over Mill Creek**

At the present time, there appears to be power supplied to the system, but there are no records available of routine monitoring. Interviews of district structure and bridge personnel indicated that no one at the district or residency had been acquiring or receiving any sort of status reports on the systems. It is recommended that the system be more closely evaluated to determine if it is functioning and that the status of the remote access monitoring system be ascertained.

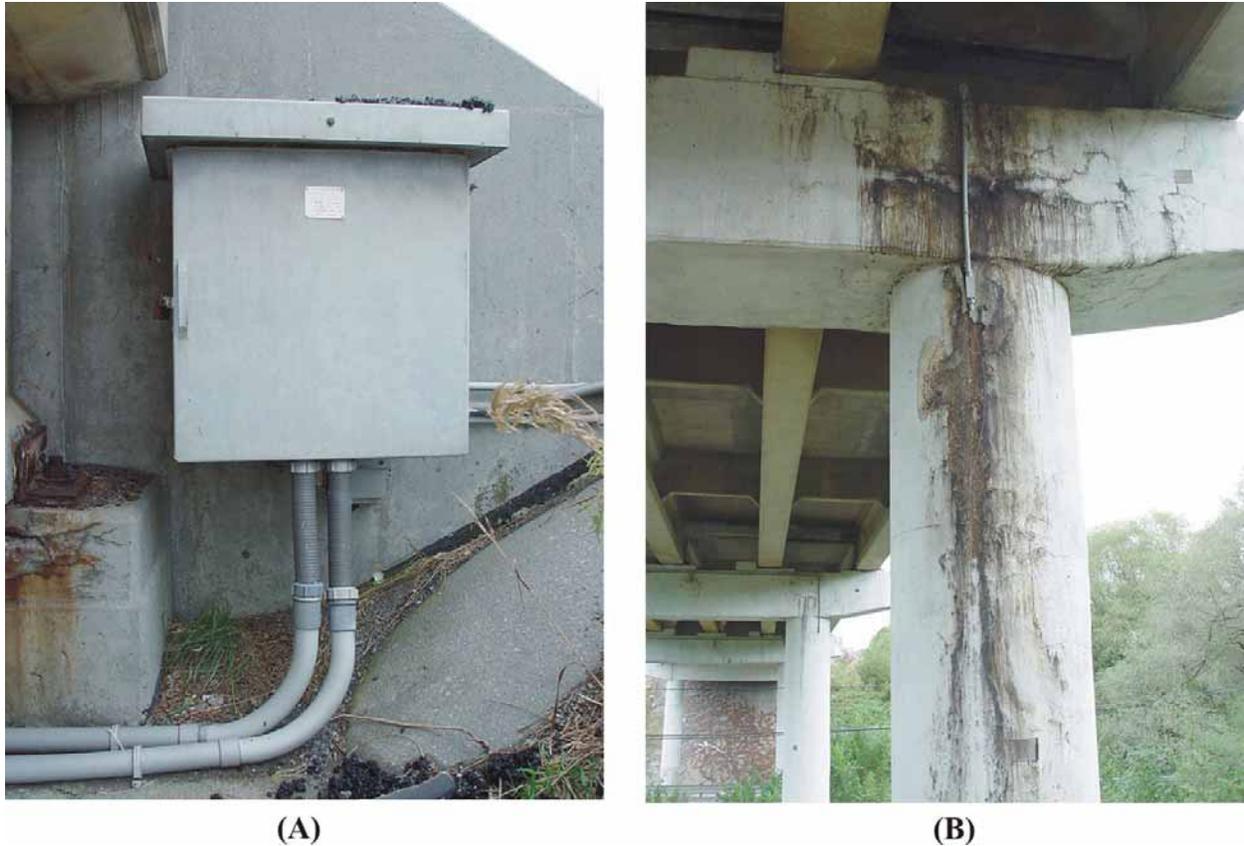
**Figure 17. (A) Control Unit and (B) Deteriorated Cathodic Protection Coating on Piers of I-81 SBL Over Mill Creek**

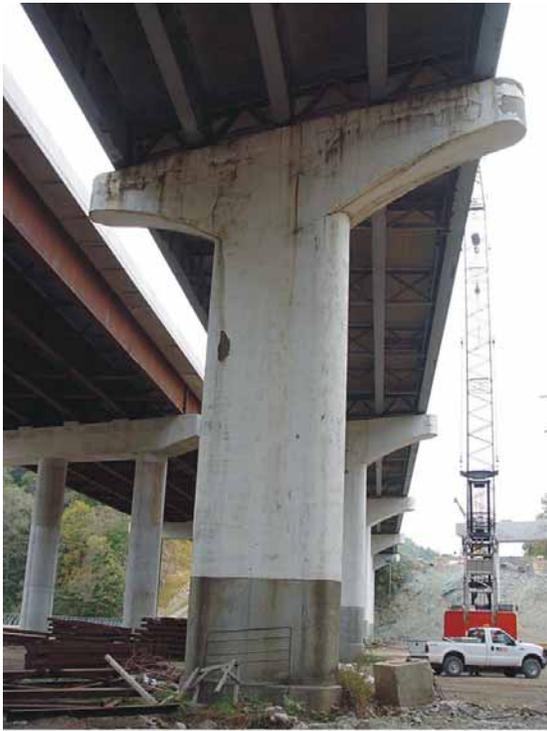
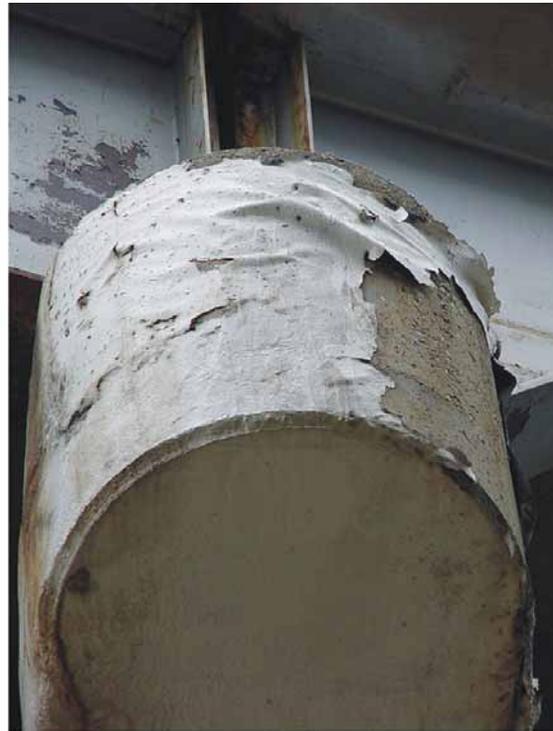
These bridges (NBL SN 2013, SBL SN 2014) in Lexington, Virginia, received ICCP systems in 1992 designed to mitigate corrosion in the piers and caps (as shown in Figure 18) (Clemeña and Jackson, 1997). These bridges were parallel inland structures over fresh water and were exposed to chlorides during the winter because of the use of deicing salts. This system was designed much like the system on I-81 over Mill Creek, and they were installed under the same research initiative. In the final report, Clemeña and Jackson (1997) noted that different contractors performed the work on the two systems and that the installation on this bridge was of lesser quality than that of the Mill Creek system.

**Figure 18. (A) Substructure Cathodic Protection Coating System with (B) Coating Adhesion Loss on I-81 NBL Over Maury River**

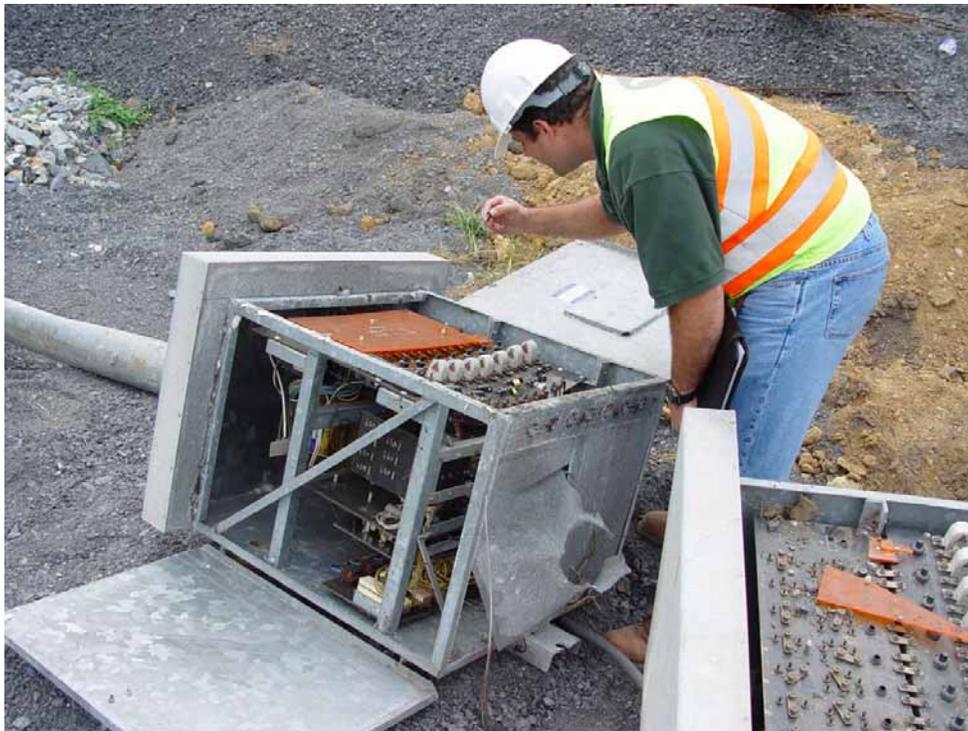
Currently, the CP systems on these bridges are out of commission because this section of I-81 is being widened and the bridges are being replaced (see Figure 19). The anodes comprised an electrically conductive paint system with embedded platinum-niobium-covered copper wires. Although the SBL bridge had been demolished and the NBL bridge was scheduled to be demolished, the coating on the NBL substructure could be visually evaluated. The conductive paint showed signs of adhesive failure over approximately 10% to 20% of the surface, with the end caps exhibiting the most significant damage. Overall, it is believed that the substructure system remained in service up until demolition of the host structure began. However, there are not consistent records to indicate that the system was properly monitored or adjusted.

**Figure 19. Inspecting Decommissioned Cathodic Protection Control Units: I-81 NBL Over Maury River**

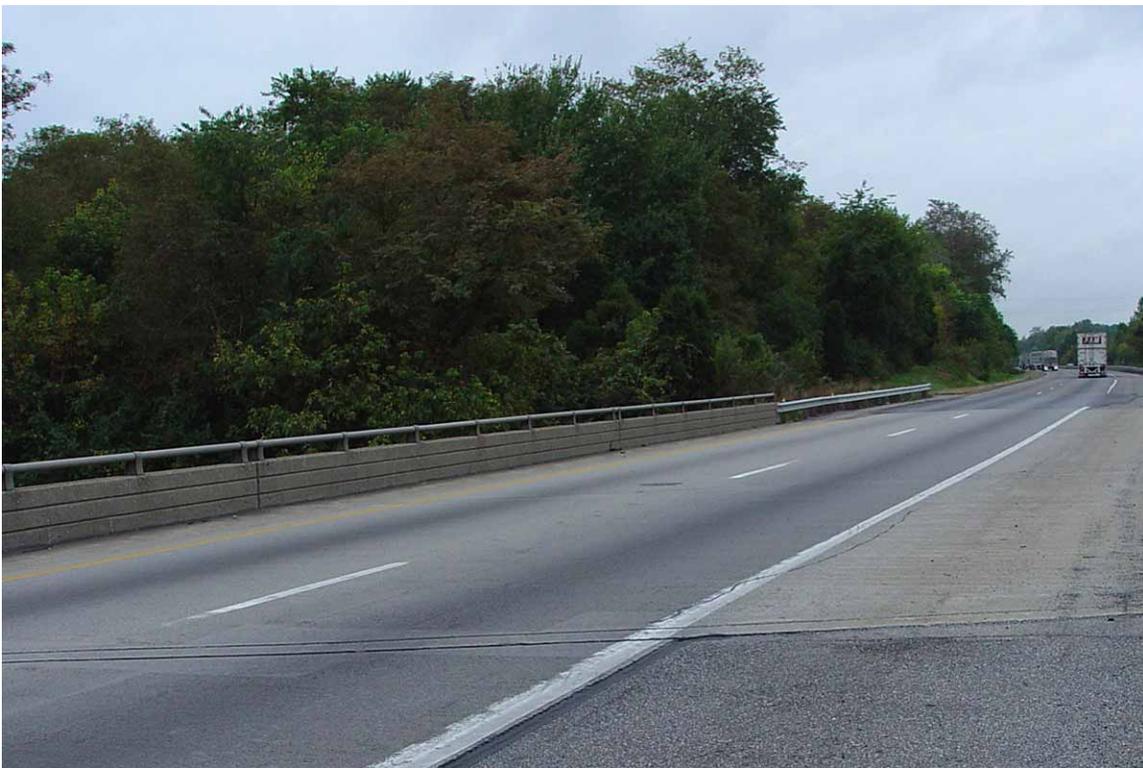
The system is currently not functioning and was believed to have been subject to a lightning strike that damaged the control unit. According to VDOT's Salem District Structure and Bridge Engineer, the deck of the SBL structure was subsequently rehabilitated by re-overlaying the deck. The embedded anode system was removed by milling operations. It is possible that the remaining overlay system on the NBL structure could be revitalized if the control unit was repaired or replaced. Although there are some cracks in the middle section of the NBL structure, overall, the concrete surface looks good.

**Figure 20. ICCP Deck Overlay System: I-81 SBL Over Route 640**

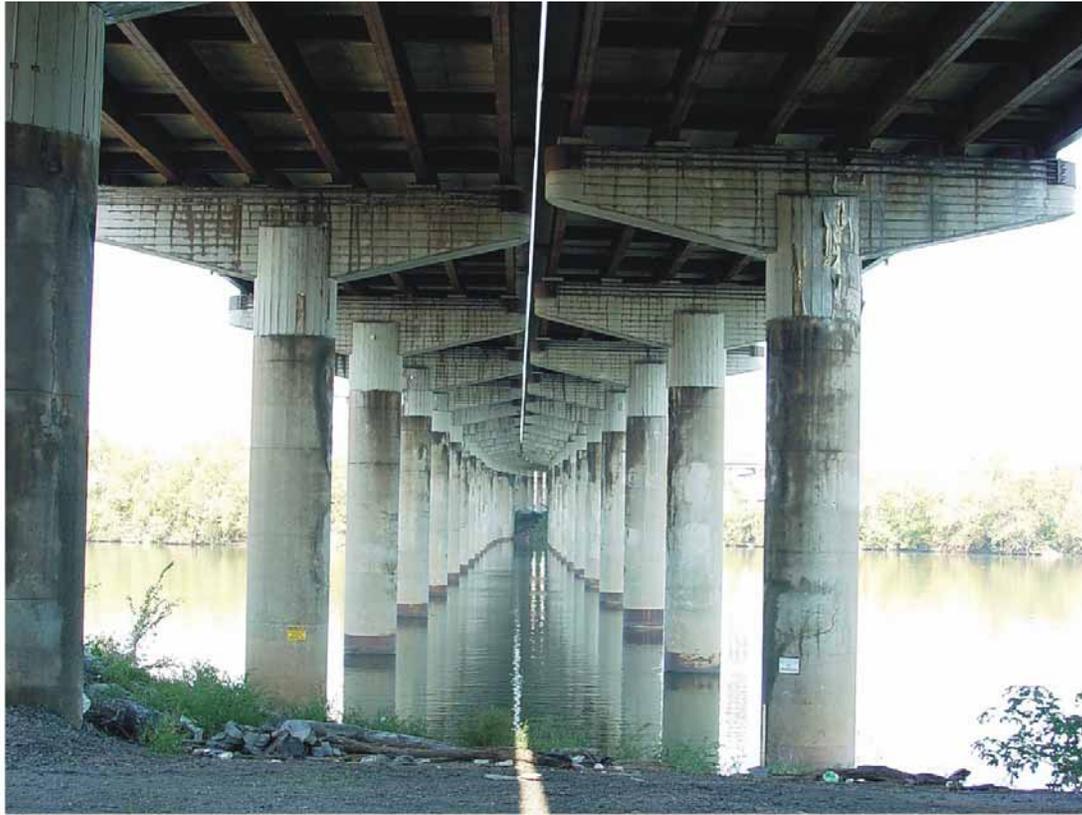
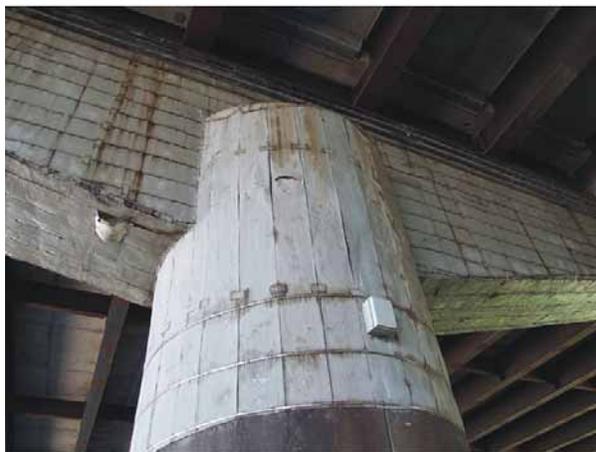
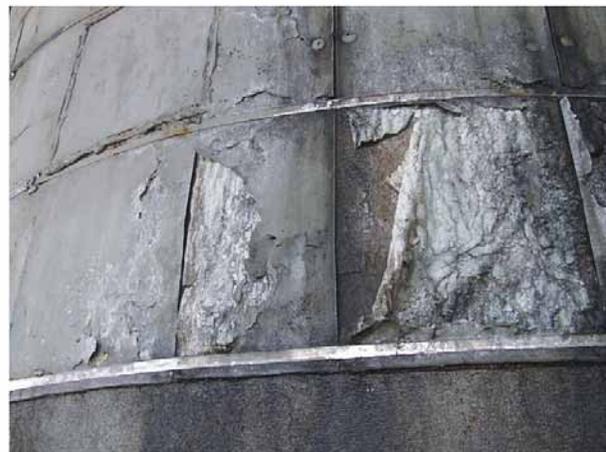
attaching the zinc foil to the concrete surface. This system was first evaluated on some of the piles that support the I-64 Bridge over Willoughby Bay in Norfolk, Virginia (Clemeña and Jackson, 1999). The galvanic anode material used on this structure was marketed by the 3M Company as Zinc Hydrogel™, which is no longer available. As may be seen in Figure 21, a significant portion of the anode material is in place; however, metal loss and peeling are evident in some areas.

**Figure 21. Zinc Foil Cathodic Protection System on Substructure of I-95 Over James River: (A) Series of Substructure Columns, (B) Typical View of Column And Bent, (C) Close-Up Showing Metal Loss and Peeling of Foil**

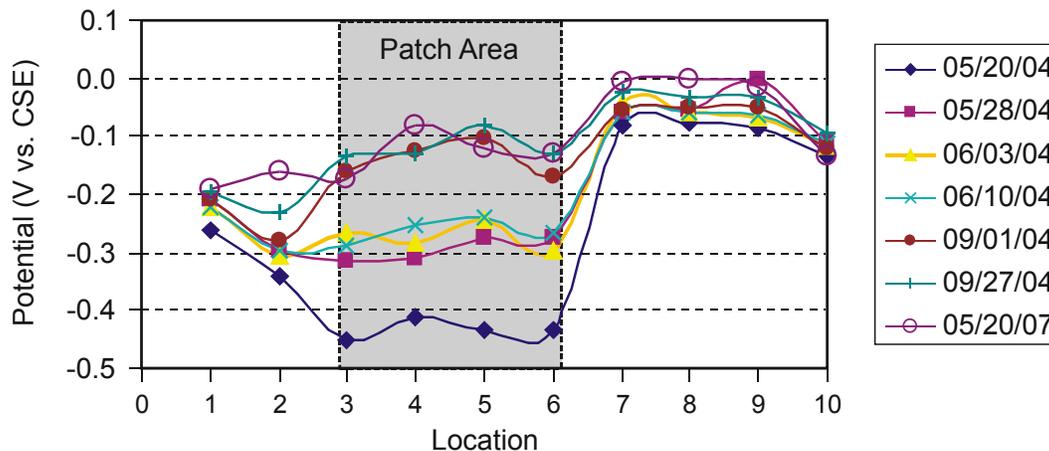
Recently, CSE half-cell measurements were made on Column P12, which had required the largest repair. The half-cell results, shown in Figure 22, are overlaid on the measurements shown in the report by Brown and Sharp (2005). The gray area of the plot indicates the area along the circumference that was patched. It is clear that the recent half-cell values are similar to those near the conclusion of the previous study.

Figure 22. Column P12 Cu/CuSO<sub>4</sub> (CSE) Half-Cell Results: Route 29/Route 250 Over Route 654.

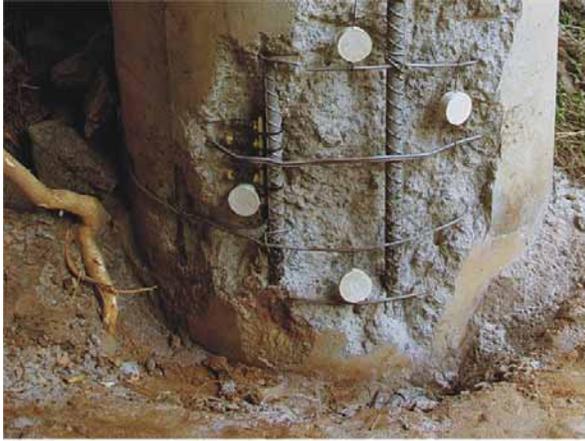
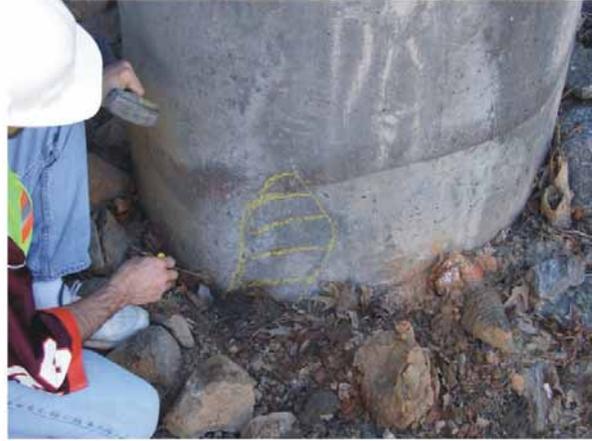
A hammer was used to determine if delaminations were present adjacent to the patch repairs in Columns P1 and P12. The survey revealed that about 1 ft<sup>2</sup> of the concrete had delaminated adjacent to the patch in Column P1 within 3 years after repairs were made. The delamination in Column P1 is located near the bottom of the column (shown in Figure 23) and is oriented approximately 6 in from the nearest anode. It is apparent that this region is not receiving sufficient protection from the anode, although the area remains moist (presumably keeping the resistivity of the concrete lower) and the distance to the closest anode is not great. No delaminations were present in Column P12.

**Figure 23. Column P1 (A) Prior to Shotcrete and (B) with Subsequent Delamination (hatched area): Route 29/Route 250 Over Route 654**
