## Survey of Cathodic Protection Systems on Virginia Bridges

STEPHEN R. SHARP, Ph.D.  
Research Scientist

MICHAEL C. BROWN, Ph.D., P.E.  
Research Scientist

**FINAL REPORT**

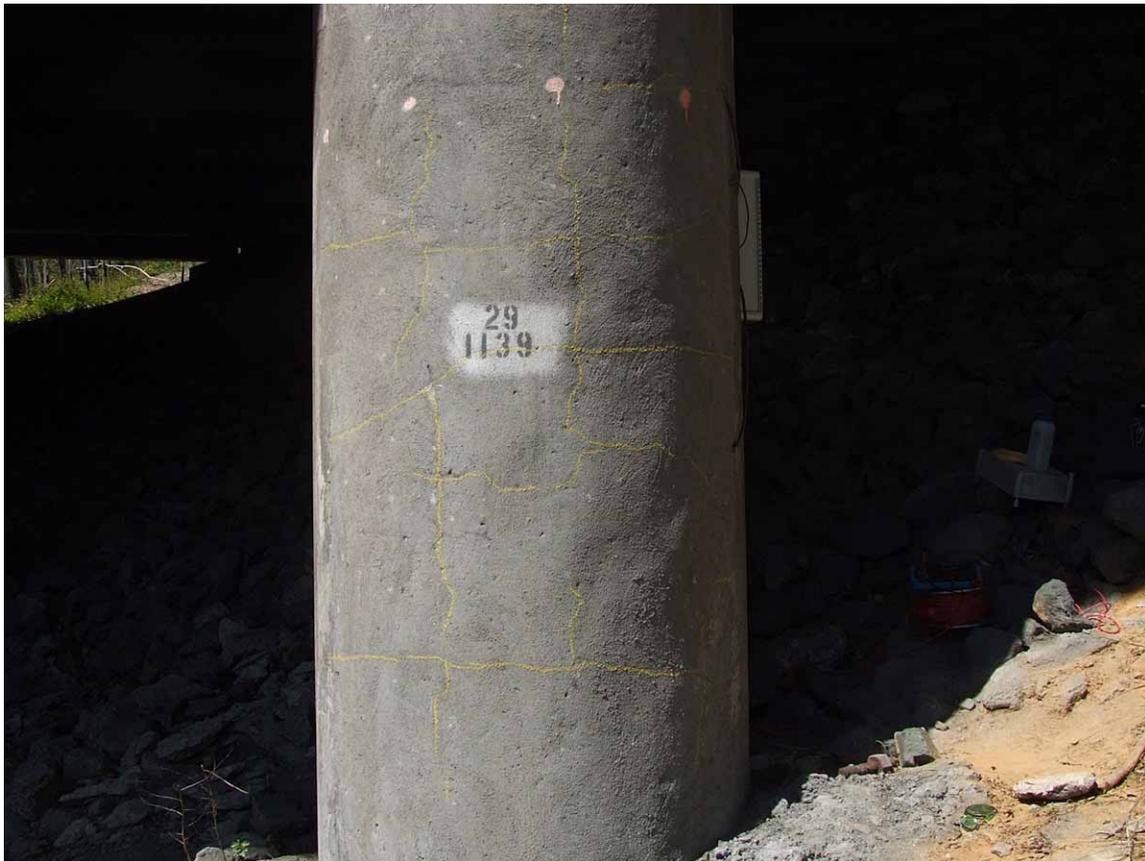
Visible cracks were observed in the patch area on Column P12 (see Figure 24). Based on the crack pattern and the short time after repairs in which they were first observed, these cracks are most likely related to drying shrinkage of the patch material rather than corrosion of the underlying reinforcing steel.

**Figure 24. Highlighted Shrinkage Cracks (visible as light lines in grid pattern) in Column P12: Route 29/Route 250 Over Route 654**

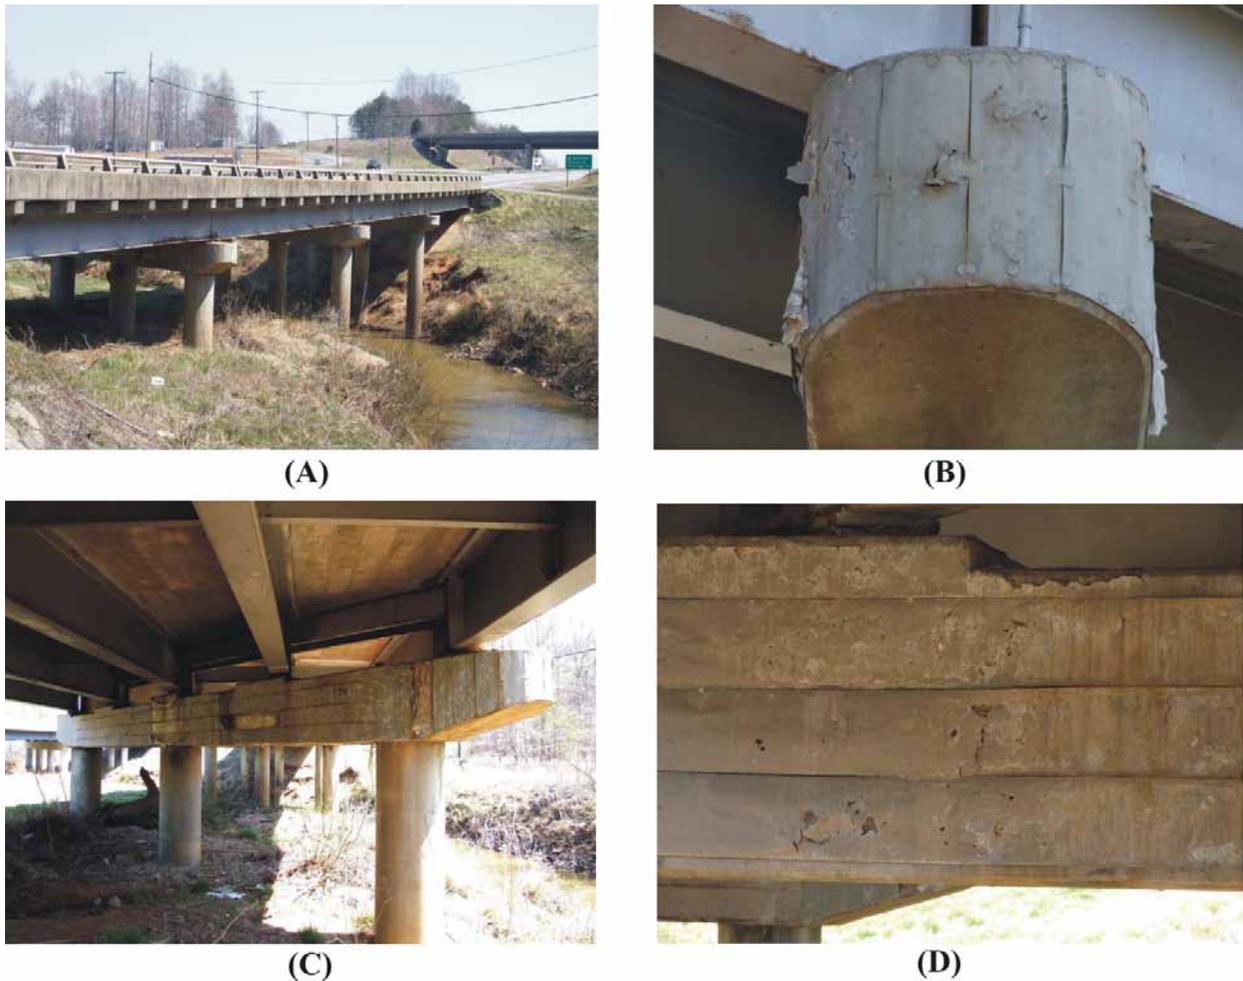
The substructure GACP system uses zinc hydrogel that is applied to the pier caps, shown in Figure 25. According to the December 11, 2006, inspection report (Maynard and Perkins 2006), the zinc hydrogel anode is trapping water behind the anode, against the concrete surface. Although the water trapped behind the anode will still allow for the conduction of an ionic current, it can also result in the loss of anode adhesion to the concrete. Approximately 110 ft<sup>2</sup> of the GACP anode material is missing from the caps. Although the zinc hydrogel still covers regions of the caps, it is most likely not protecting the entire cap and, therefore, the GACP system is in need of repair or replacement.

**Figure 25. Conductive Coating on Substructure: Route 58 EBL Over Leatherwood Creek**
