Short-Term Evaluation of a Bridge Cable Using Acoustic Emission Sensors

1. Report No.: FHWA/VTRC 10-R24	2. Government Accession No.:	3. Recipient's Catalog No.:	
4. Title and Subtitle: Short-Term Evaluation of a Bridge Cable Using Acoustic Emission Sensors		5. Report Date: May 2010

FINAL REPORT
SHORT-TERM EVALUATION OF A BRIDGE CABLE
USING ACOUSTIC EMISSION SENSORS

May 2010
VTRC 10-R24

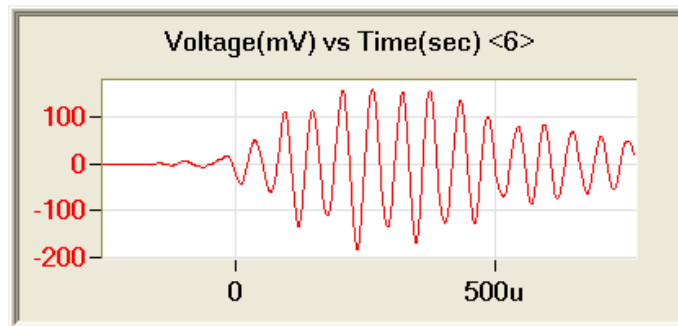
Figure 8. AE Event Representing Pre-Existing Concrete Crack Rubbing Recorded by Sensor 6

The walls of a pre-existing crack in concrete near Sensor 6, mounted on the west face of the saddle, rub against each other, producing long-duration (~ 750 microseconds) but low-energy counts (up to $\sim\pm 180$ mV) during an event shown in Figure 8. Figure 9 shows another event representing crack rubbing followed by crack expansion demonstrated by short-duration (~75 microseconds) high-energy (up to $\sim\pm 680$ mV) counts recorded by Sensor 6. An AE event representing initiation of a higher energy (up to $\sim\pm 200$ mV) but shorter duration (~100 microseconds) micro crack followed by a longer duration (~ 400 microseconds) crack rubbing is shown in Figure 10. In all such cases, crack rubbing has been prominent and has been a common feature in crack expansion and crack initiation. New crack formation has invariably been found to be followed by crack rubbing.

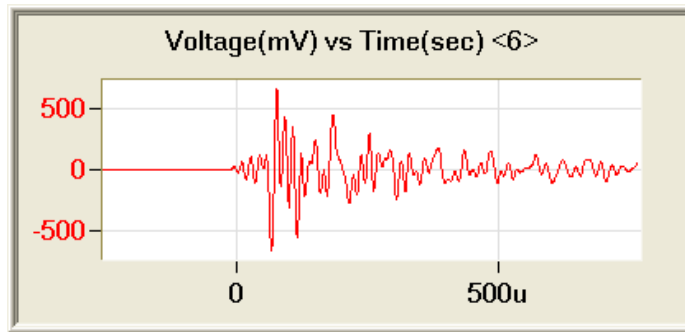
Figure 9. AE Event Representing Pre-Existing Concrete Crack Rubbing Followed by High Energy Counts of Short Duration Representing Initiation of Crack (Crack Expansion) Recorded by Sensor 6

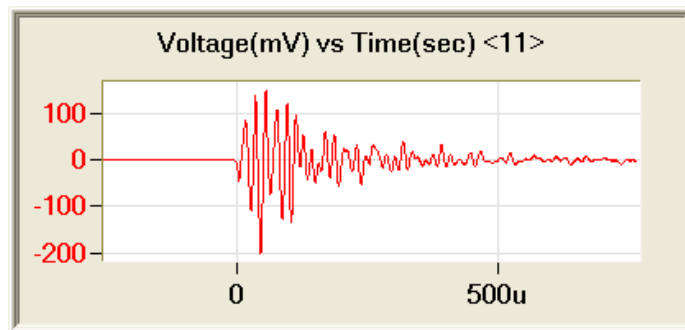
Figure 10. AE Event Representing Initiation of Concrete Crack Followed by Rubbing (Friction) Recorded by Sensor 11

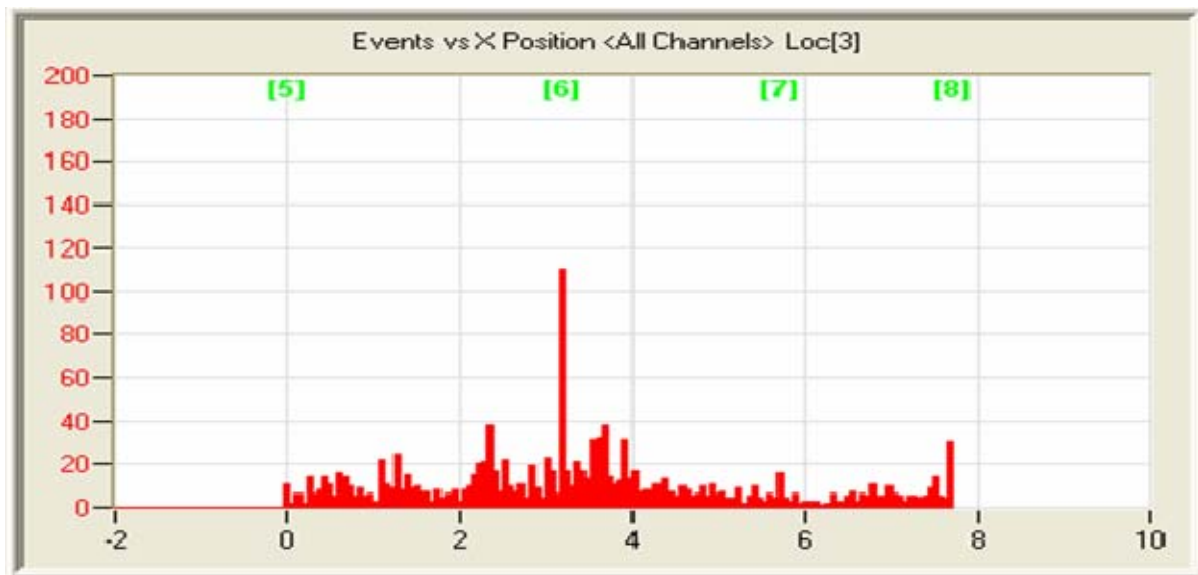
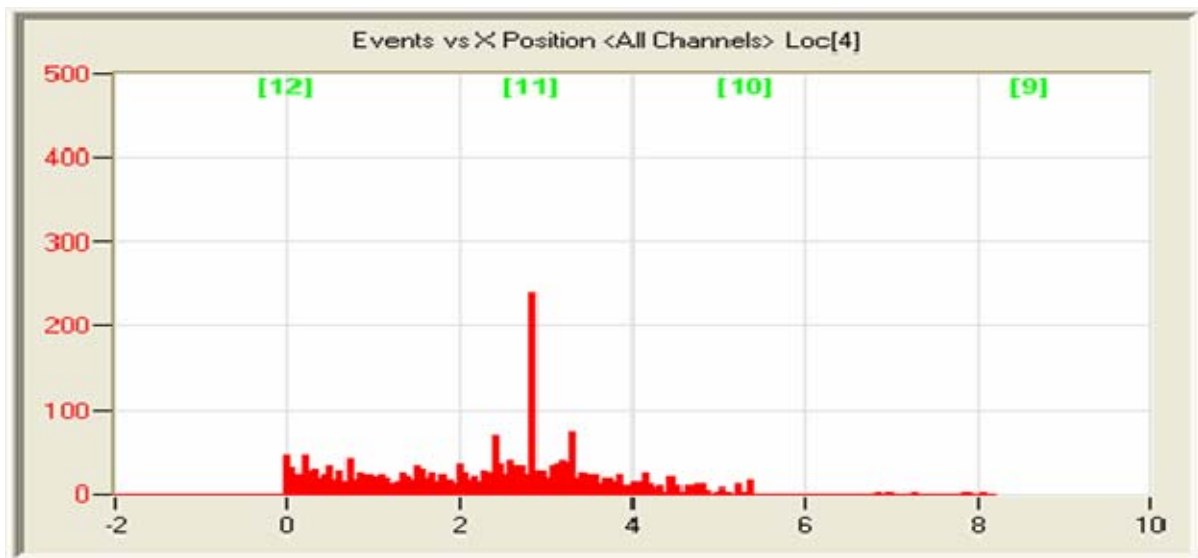
Figures 11 and 12 show intense AE activity across the center of the saddle region. Sensors 6 and 11 are located near the center of the saddle on its west and the east faces, respectively (Figures 11 and 12). The most likely source of this activity is the initiation of a new crack or growth of a pre-existing crack. AE signal signatures and data analysis show the presence of both. The dates and times of the activities in Figures 11 and 12 are shown in Figure 13, where the number of hits is plotted against the date and time of occurrence on August 28 and

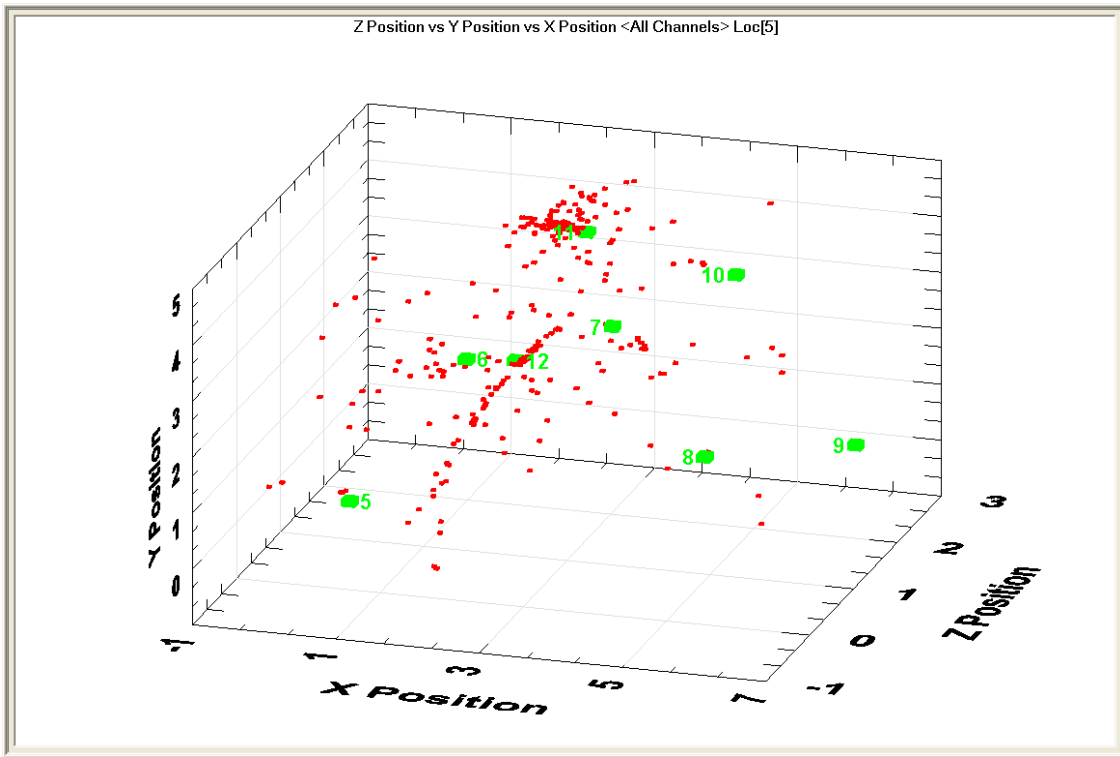
Figure 23. 3D Plot of Crack-Related AE Hits Recorded August 12-September 25, 2008, in Concrete Structure Under Cable Saddle. The coordinates (X,Y,Z) are defined in Figure 22.

Both plots establish the existence of a heavy concentration of AE activity in the region between Sensor 6 on the west face and Sensor 11 on the east face. These plots also establish the existence of crack-related AE activity in the larger area of the saddle structure, a fact that could not be established by 2D analysis. The analysis of AE signal amplitudes and sensor coordinates bore out the fact that of 743 hits near Sensor 11, only 147 were above the minimum energy of cracking (75 energy counts) and of 147 significant hits, only 3 were related with cracking; the rest were related with rubbing (friction). Accordingly, ~98% of the AE activity was related with crack friction and ~2% with cracking through microbursts. Further, the crack activity covered both the width and the depth of the saddle, being larger near the surface in comparison to that in the bulk. The new cracks seemed to initiate on the surface and grow in length, width, and depth with time, resulting in the increase of crack growth toward the bulk.

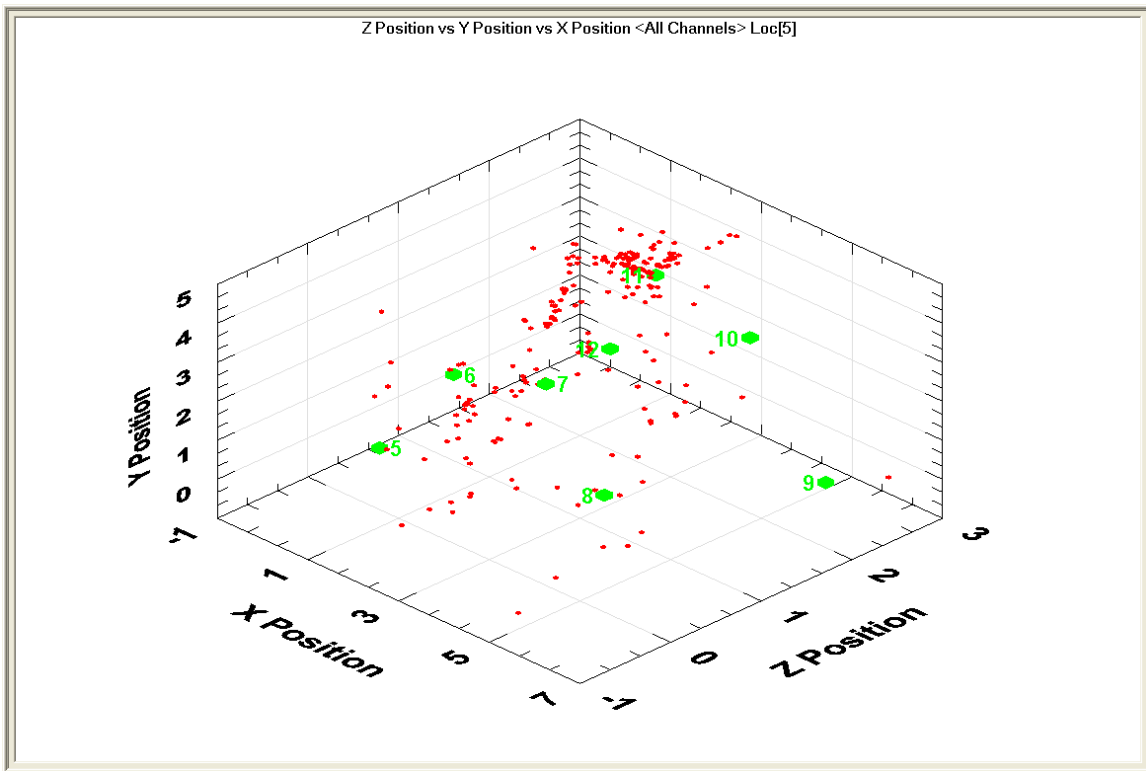
Figure 24. 3D Plot of Crack-Related AE Hits Recorded November 13-December 13, 2008, in Concrete Structure Under Cable Saddle. The coordinates (X,Y,Z) are defined in Figure 22.

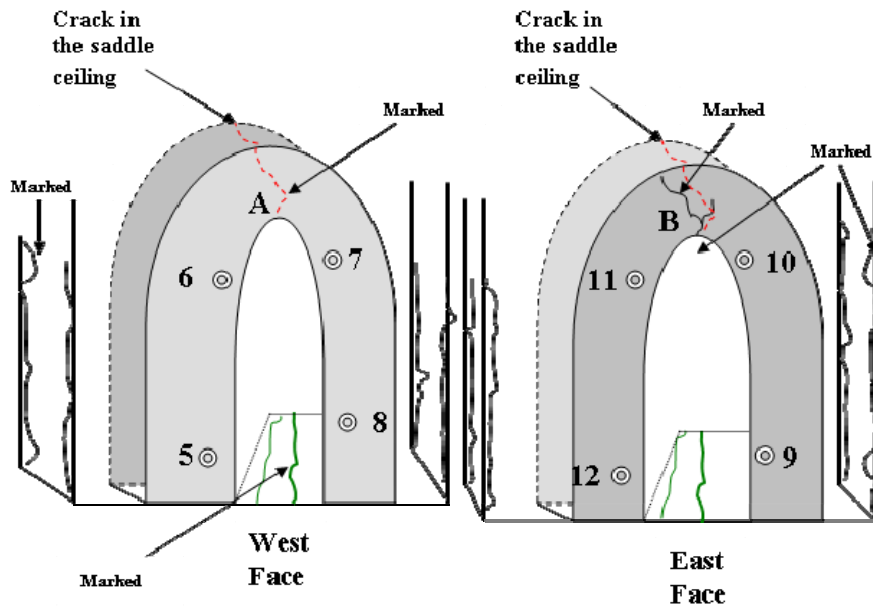
Based on the results of AE events and their analysis, on-site inspections of the saddle area were conducted for physical verification. Physical verification confirmed the growth of the pre-existing cracks and initiation of new cracks in the concrete structure of the saddle walls. A schematic of the areas of the locations of cracks is shown in Figure 25. Physical verification revealed pre-existing (shown as marked on Figure 25) and new cracks on the saddle walls. The crack sizes in different locations were measured, as shown on Figures 26 and 27 and summarized in Tables 9 and 10. Figure 28 shows photographs of some of the typical and prominent cracks in different locations of the saddle area. Based on the AE results, some of the cracks observed inside the pylon are active and have grown during the period of this study.

Figure 25. Cracks Detected by Sensors and Verified During Site Visit to Saddle Area. A and B are the highest points on the ceiling of the saddle. Cracks identified as “marked” were pre-existing. Unmarked cracks are new.

1. *VDOT's Richmond District Bridge Division should measure and map the cracks in both the northern and southern stay-cable pylons of the Varina-Enon Bridge.*

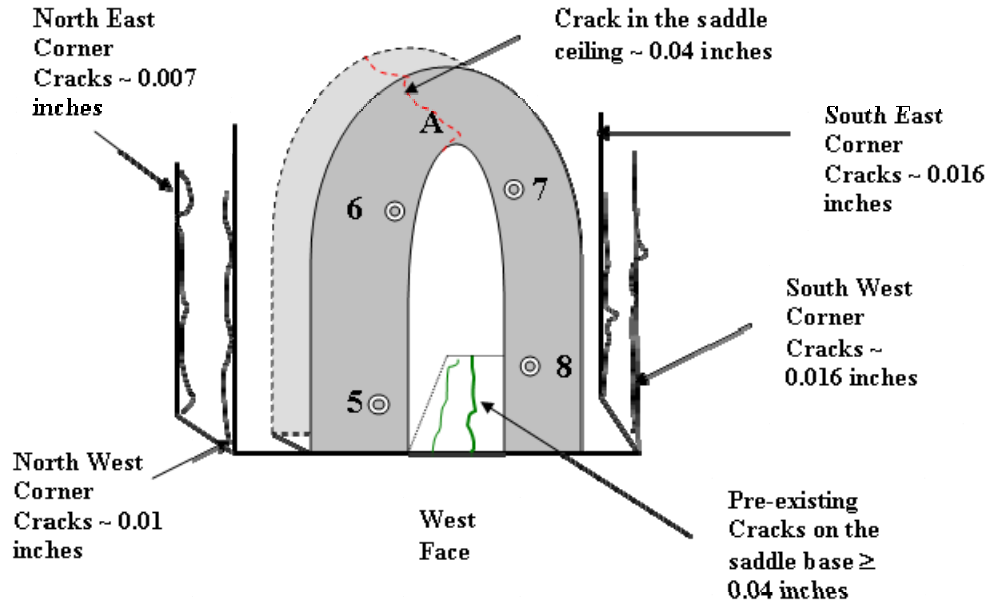
Figure 26. Cracks Detected by Sensors and Verified by Site Visit in Saddle area. A and B are the highest points on the ceiling of the saddle. Some cracks identified as “marked” were previously (before the commencement of this investigation) observed. Unmarked cracks are new. Both marked and unmarked cracks grew in size. See Table 9 for a summary of crack sizes.

Table 9. Crack Sizes (Inches) on West Side of Saddle as Shown in Figure 26

On West Face	On Ceiling of Saddle Curve	On Southeast Corner of East Face	On Southwest Corner of East Face	On Northeast Corner of East Face	On Northwest Corner of East Face
None	0.04	0.016	0.016	0.007	0.01

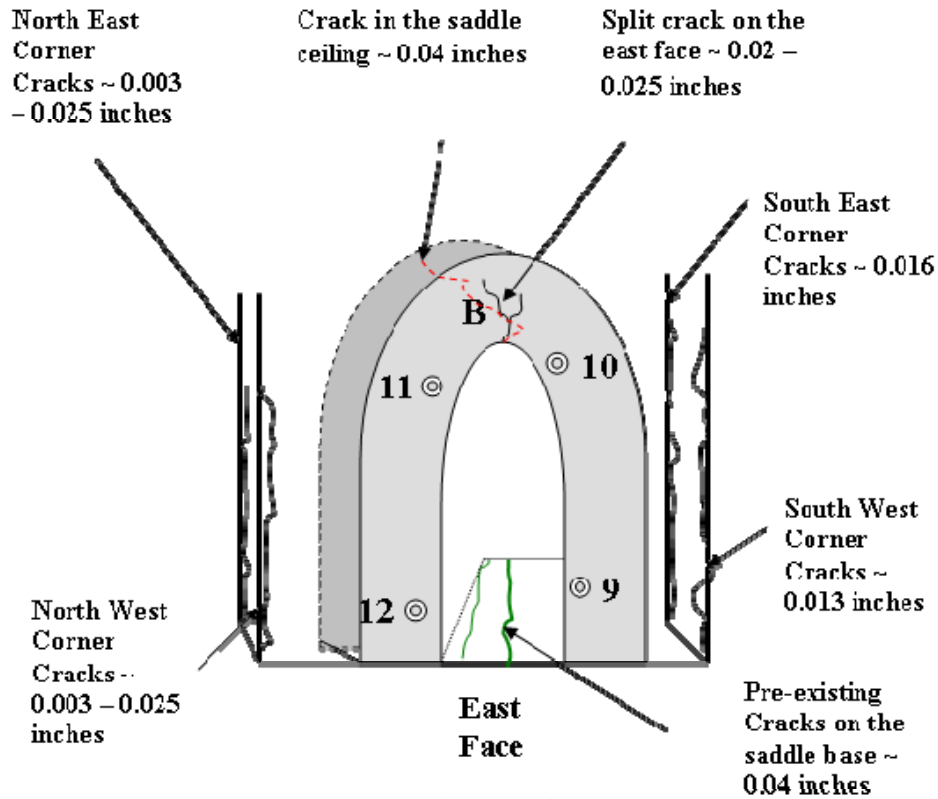
Figure 27. Cracks Detected by Sensors and Verified by Site Visit in Saddle Area. A and B are the highest points on the ceiling of the saddle. See Table 10 for a summary of crack sizes.

Table 10. Crack Sizes on East Side of Saddle As Shown in Figure 27

On East Face (Split Crack)	On Ceiling of Saddle Curve	On Southeast Corner of East Face	On Southwest Corner of East Face	On Northeast Corner of East Face	On Northeast Corner of East Face
0.02-0.025	0.04	0.016	0.013	0.003-0.025	0.003-0.025

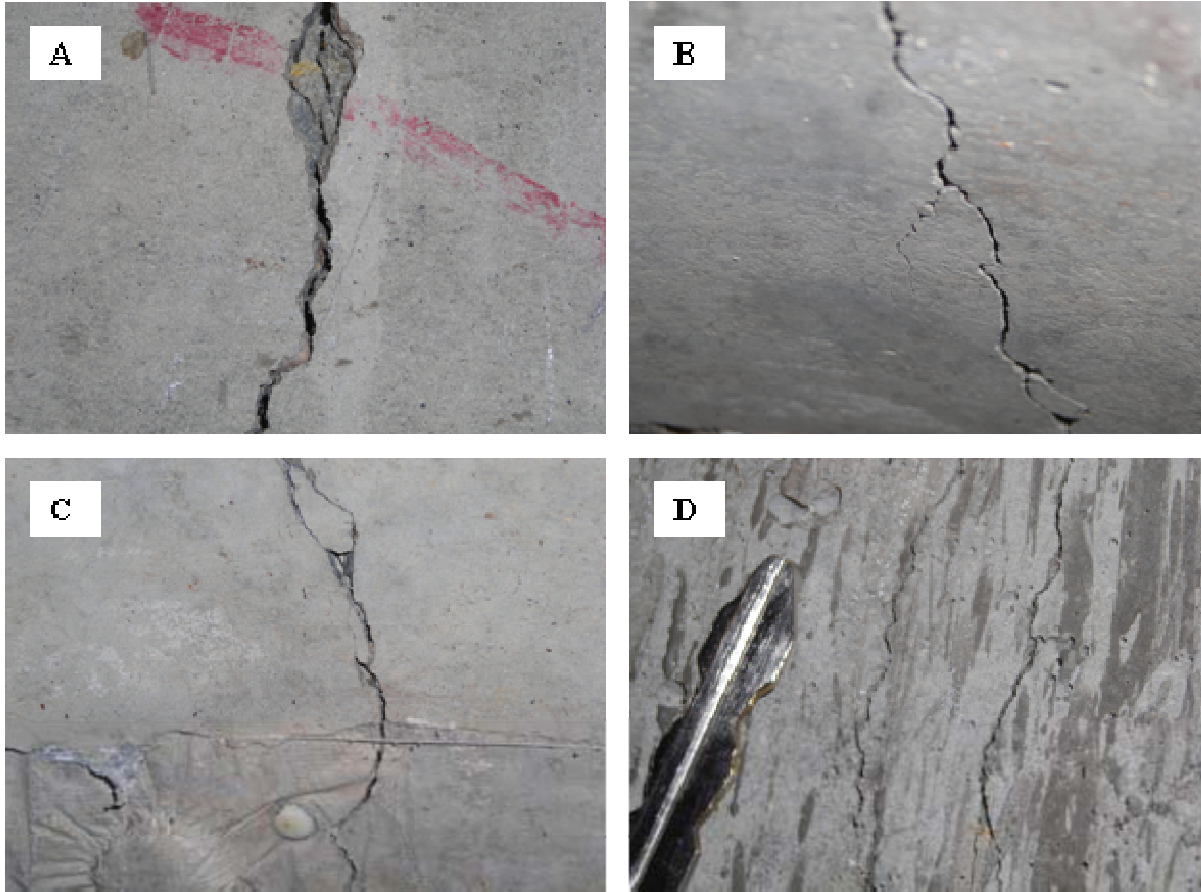
Figure 28. *A, B, C, Cracks in center of saddle ceiling; D, Crack on fast face of saddle. Car key is placed for comparison of the size.*
