# A Case Study of the Loop-Welded Eyebars Removed from the Advance Mills Bridge in Albemarle County, Virginia

Final Report VCTIR 11-R13

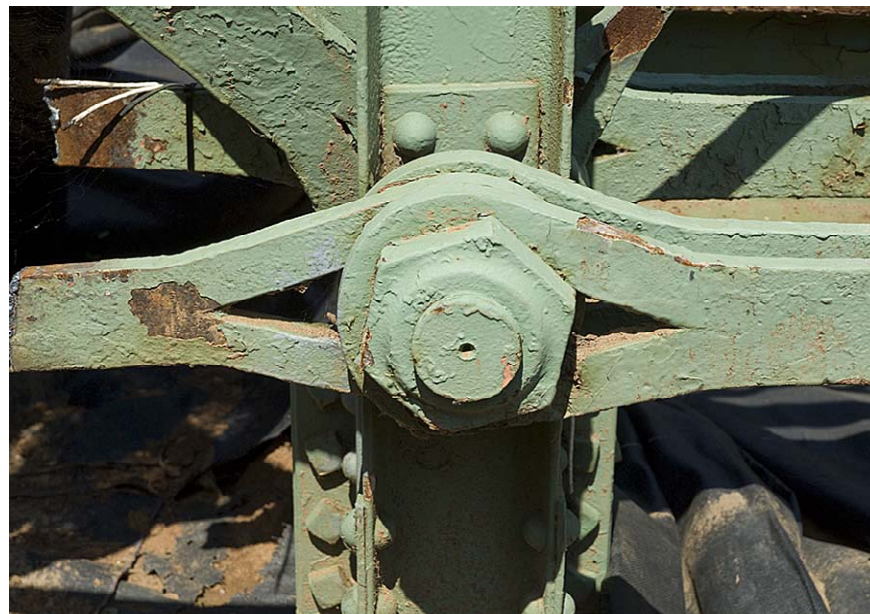
**Figure 2. Pin-Connected Panel Point With Loop-Welded Eyebars**

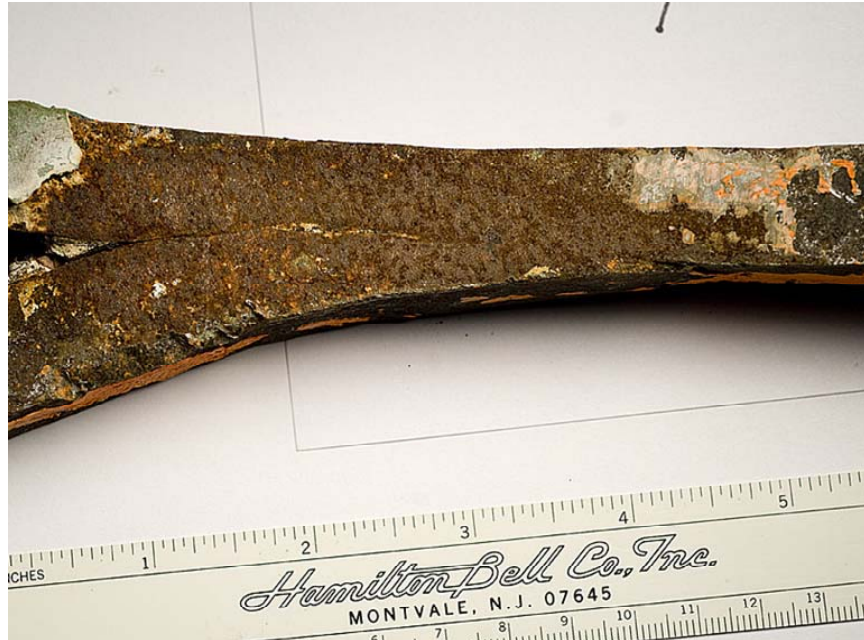
**Figure 3. Hairline Crack Along Forge Line of Loop-Welded Eyebars**

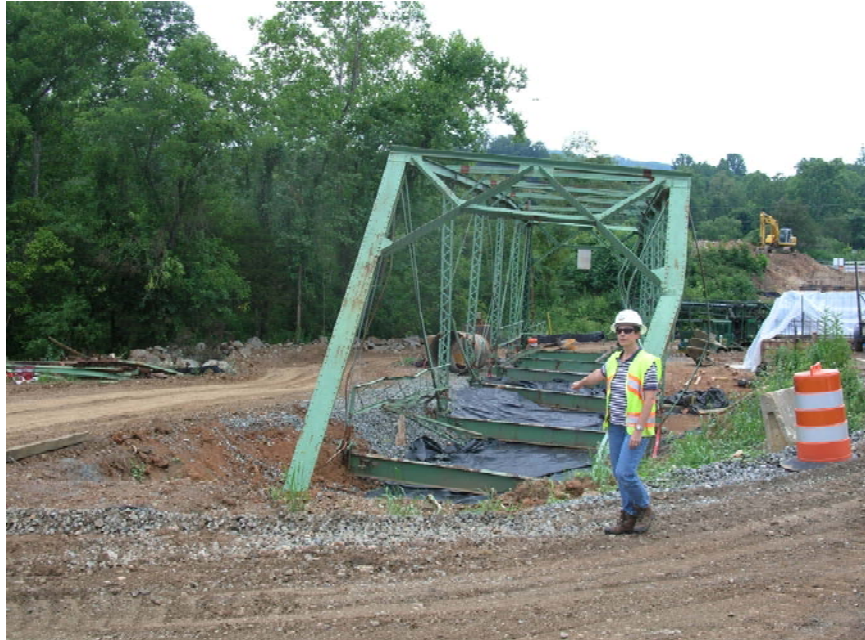
**Figure 8. More Severe Distortion Resulting From Racking of Truss After Its Move to Facilitate Construction**

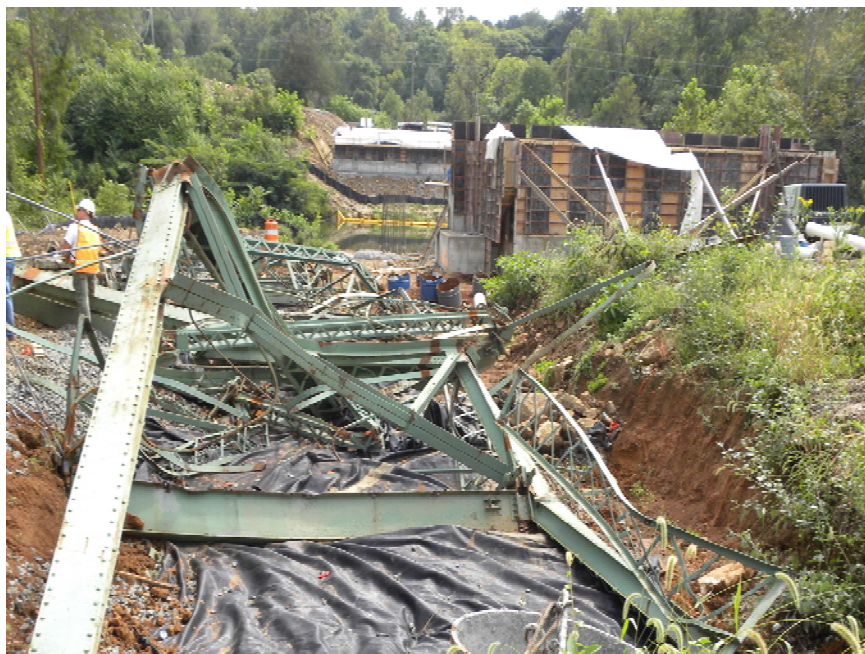
**Figure 9. Total Collapse of Truss Because of Inadequate Support During Dismantling**

Although a discussion of the difficulties encountered during the dismantling of the Advance Mills Bridge is outside the scope of this study, a review of several steps might be useful to those dismantling other historic bridges. It is acceptable to move the truss intact by lifting it by connections at the top hip panel point if the lower chord is braced against bending. Once removed from its bearings, the truss should be placed on substantial supports set in a convenient location. Prior to disassembly, the truss should be supported at every panel point, and during disassembly, the truss should be stabilized by cranes to prevent its collapse and ensure the safety of workers

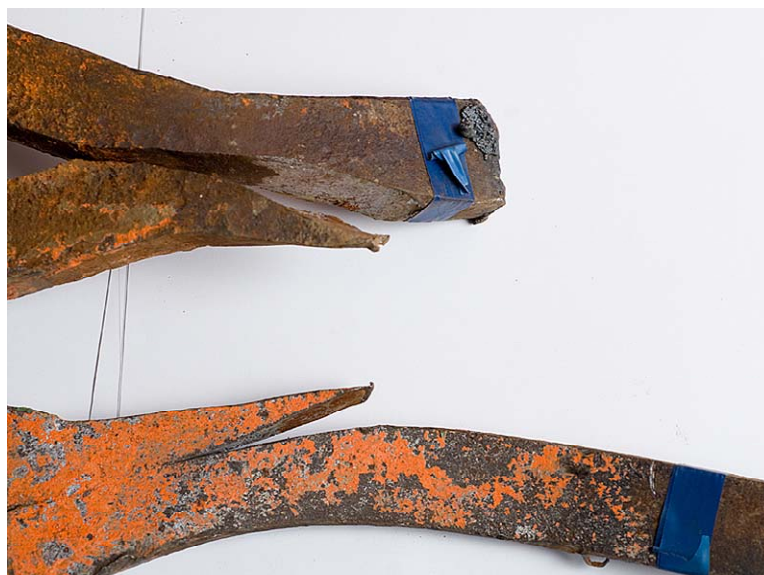
Prior to pick up of the panel joints at the site, they were run over by a piece of grading equipment working on the approach roadway, further distorting many members and fracturing several at the forge lines (Figure 11). The effects of this series of incidents on the findings of this study, both good and bad, are noted in the "Discussion" section.

**Figure 11. Eyebars Damaged by Grading Equipment**

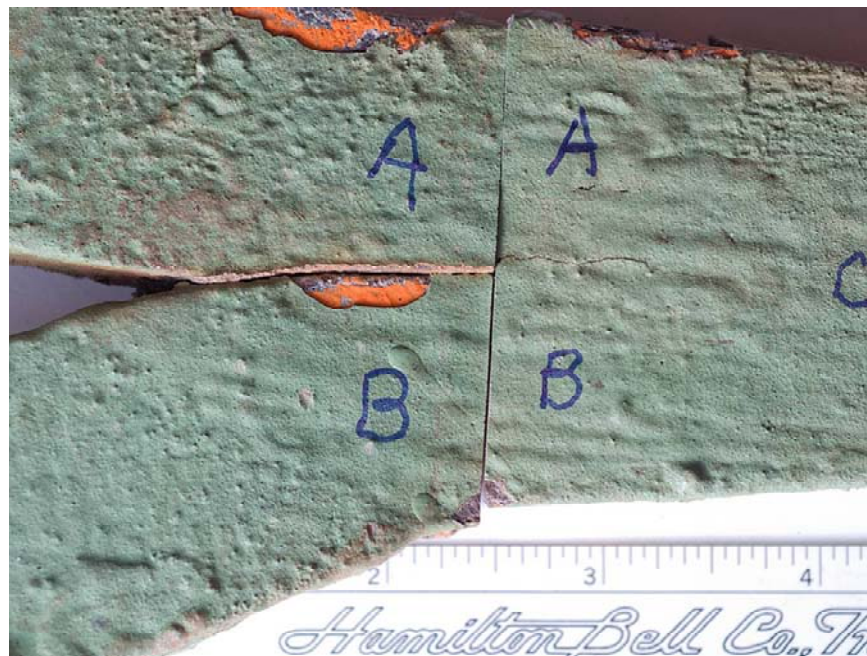
Figure 12. Eyebar Cut at End of Separation and Beyond End of Visible Hairline Crack

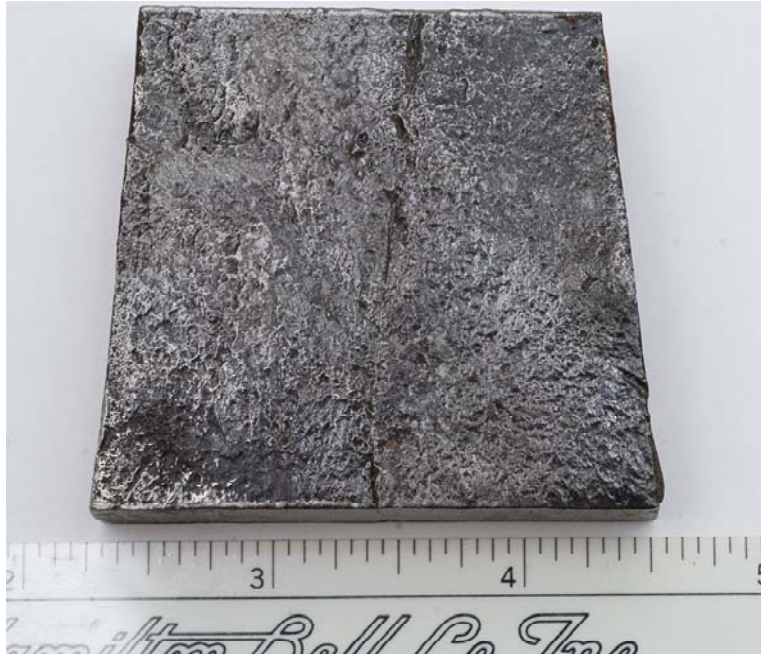
Figure 13 indicates the presence of the forge line running the full length of the specimen, and the radiograph in Figure 14 shows an apparent separation extending almost to the uncracked Face C, with the forge line visible to that face. Figure 15, Cross Section A-B, clearly indicates the presence of a tight but visible crack where it was indicated by the inspector. There was

**Figure 13. Forge Line Through Entire Length of Cleaned Specimen**

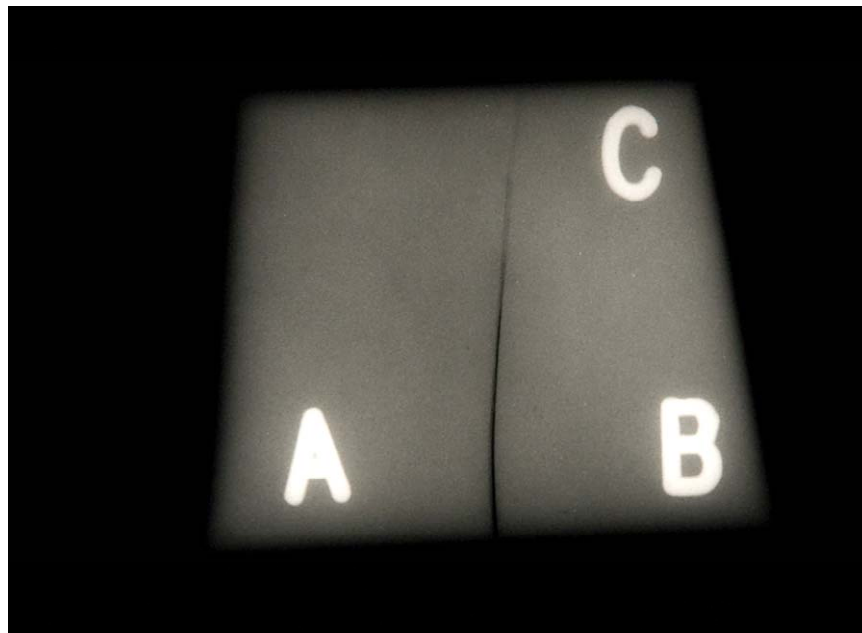
**Figure 14. Radiograph Confirming Presence of Crack Through Most of Length of Specimen**

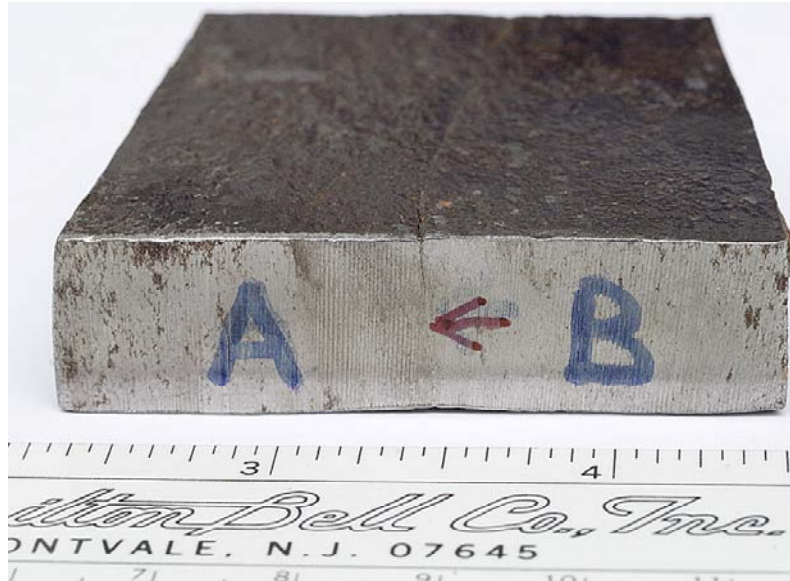
**Figure 15. Face A-B Showing Tight Crack**

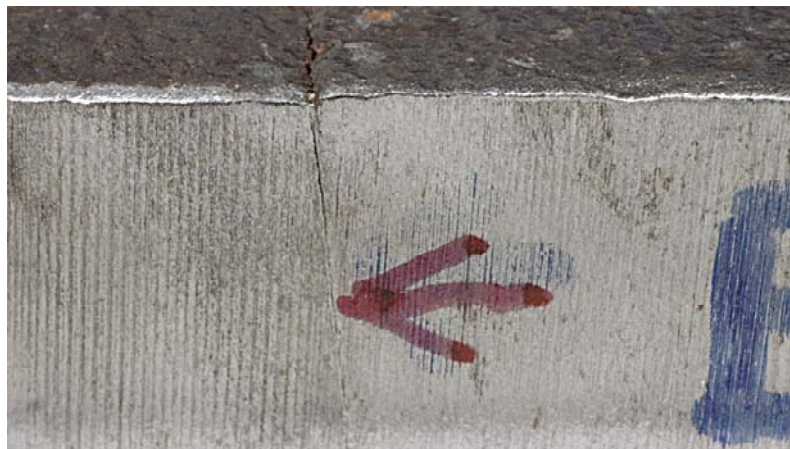
however, no evidence of cracking at Section C (Figure 16). The lack of separation is visible at Face C and, along with other radiographs, confirms the adequacy of a rigorous hands-on safety inspection.

**Figure 16. Close View of Crack at Forge Line**

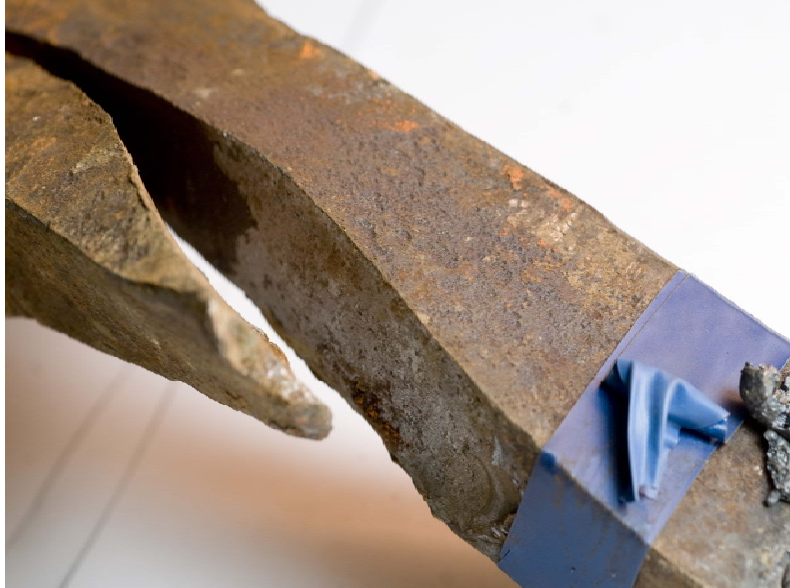
Rusting at portions of the forge line on some bars, as shown in Figure 17, indicates that the separation is progressive because of corrosion, possibly affecting the performance of the bar. It is realized that the transverse loading by the track hoe has no relation to the service loading on the eyebars, but the nature of the failure at the forge line does indicate the meaning and the importance of the hairline cracks and rust stains noted during the safety inspection.

**Figure 17. Fractured Forge Line of Bar Broken by Grading Equipment. Rust in upper portion indicates preexisting crack.**

The warnings, cited earlier, that steel welds are not reliable indicates that care must be taken into account in making welded repairs on steel eyebars produced in the late 19th and early 20th centuries.

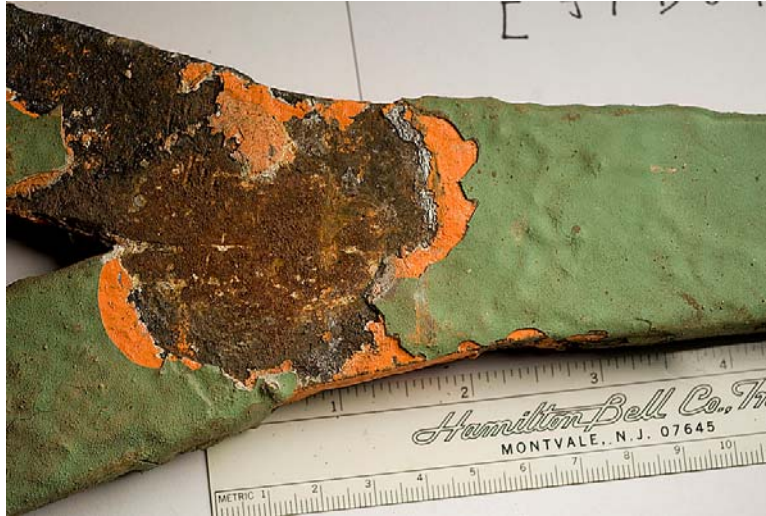
Photographs of both bars show the forge lines and the existing cracks, which would have been clearly visible to an inspector. The radiographs confirm the cracking and provide faint traces of the forge lines beyond the cracks. Not surprisingly, each of the bars failed at its forge line. Both fractures were similar to those caused by the accidental loading shown earlier, and rust on the forge line indicates the extent of preexisting cracks.

**Figure 18. Crack Extends Short Distance on Bar 4. Extension of forge line is generally covered by paint.**

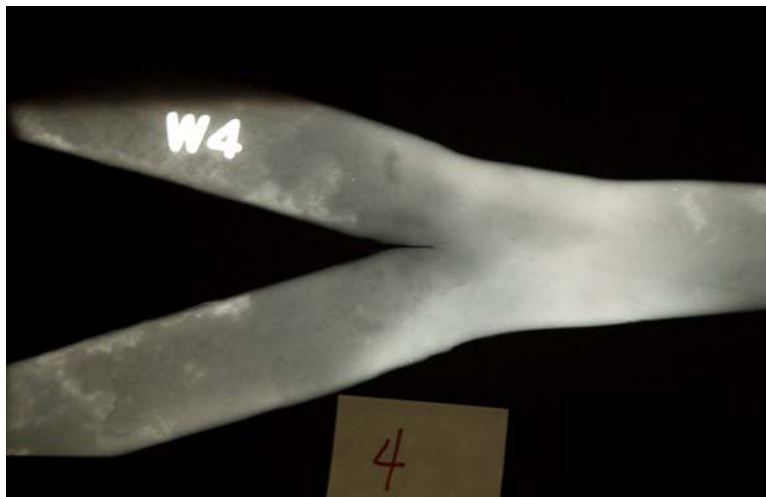
**Figure 19. Radiograph Confirms Small Crack in Bar 4. Remainder of forge line is visible, but faint.**

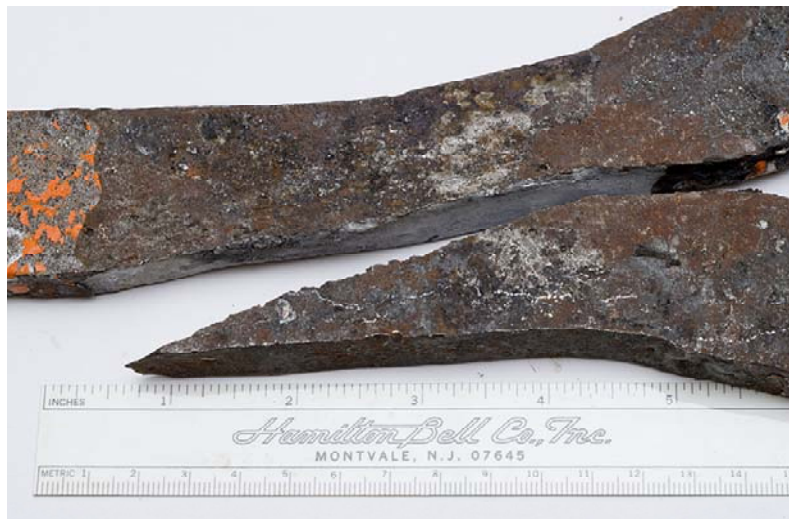
The strengths obtained during load testing, shown in Appendix D, were high, however, with maximum loads of 39,910 lb for Bar 4, which was relatively intact, and 33,380 lb for Bar 5; the respective tensile strengths were 40,787 psi for Bar 4 and 48,766 psi for Bar 5. The tensile strength was computed by dividing the maximum load by the cross-sectional area of the bar shank ( $0.8184 \text{ in}^2$ ).

**Figure 20. Forge Line of Bar 4 After Strength Testing. Small area of rust indicates previous crack along forge line.**

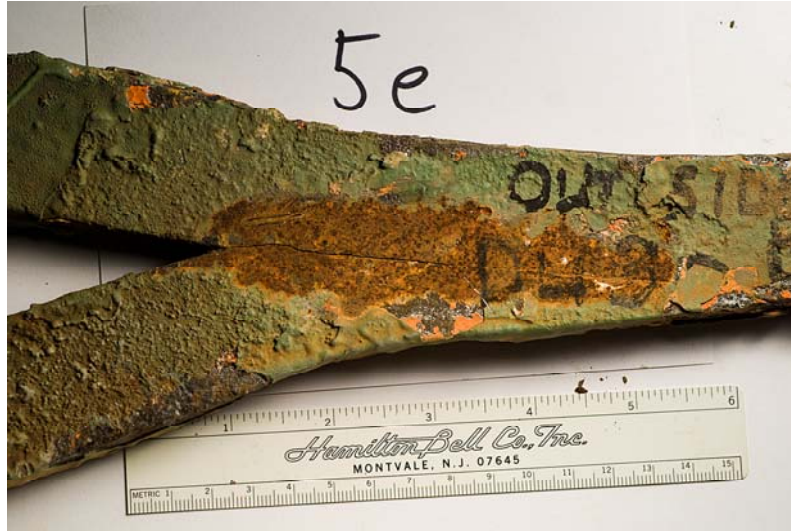
**Figure 21. Bar 5 As Removed From Bridge. Visible crack extends along left side of forge line. Uncracked forge line is visible to right of crack.**

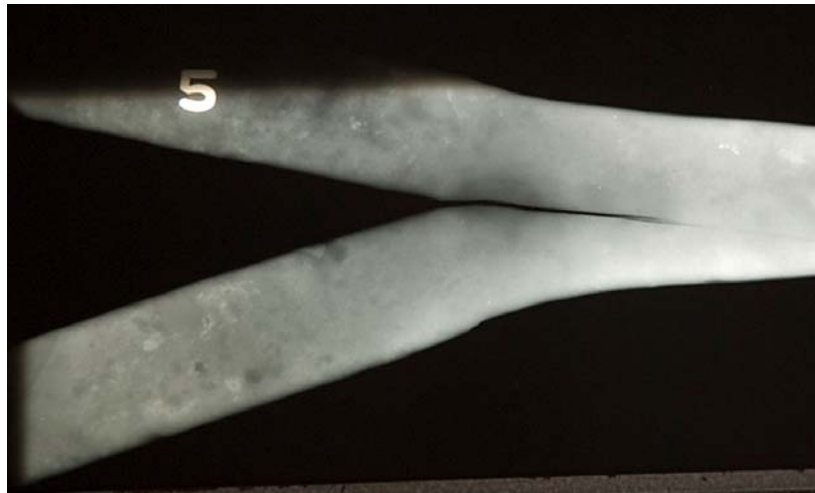
**Figure 22. Radiograph of Bar 5 Showing Partial Length Crack. Forge line is faintly visible beyond crack.**

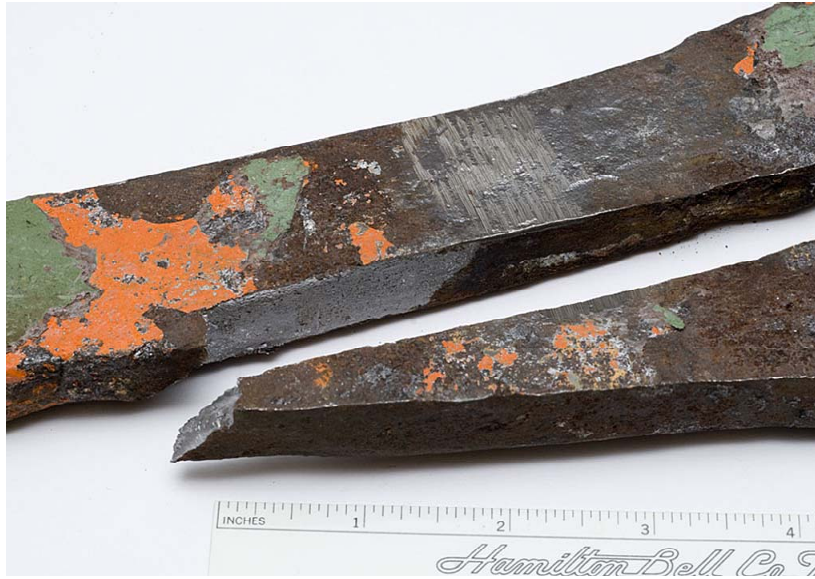
**Figure 23. Forge Line of Bar 5 After Strength Testing. Rust indicates existing crack.**

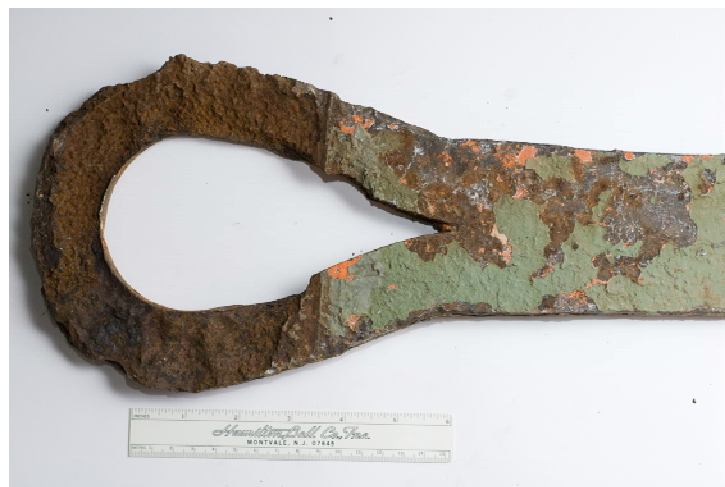
During the examination of the bridge it became evident that inspection and maintenance of those portions of the pinned connections that were under the deck, where the access to the bars at the panel points was obscured, were difficult. Examination of those members disclosed much more severe corrosion and section loss, such as shown in Figure 24, than that found on the outside members. Evaluation of these members during inspections requires special effort to ensure their adequacy, as they are hidden from view.

**Figure 24. Extreme Section Loss in Lower Chord Eyebar**
