A Management Plan for Historic Bridges in Virginia: The 2017 Update

Final Report VTRC 18-R6

FINAL REPORT
A MANAGEMENT PLAN FOR HISTORIC BRIDGES IN VIRGINIA:
THE 2017 UPDATE

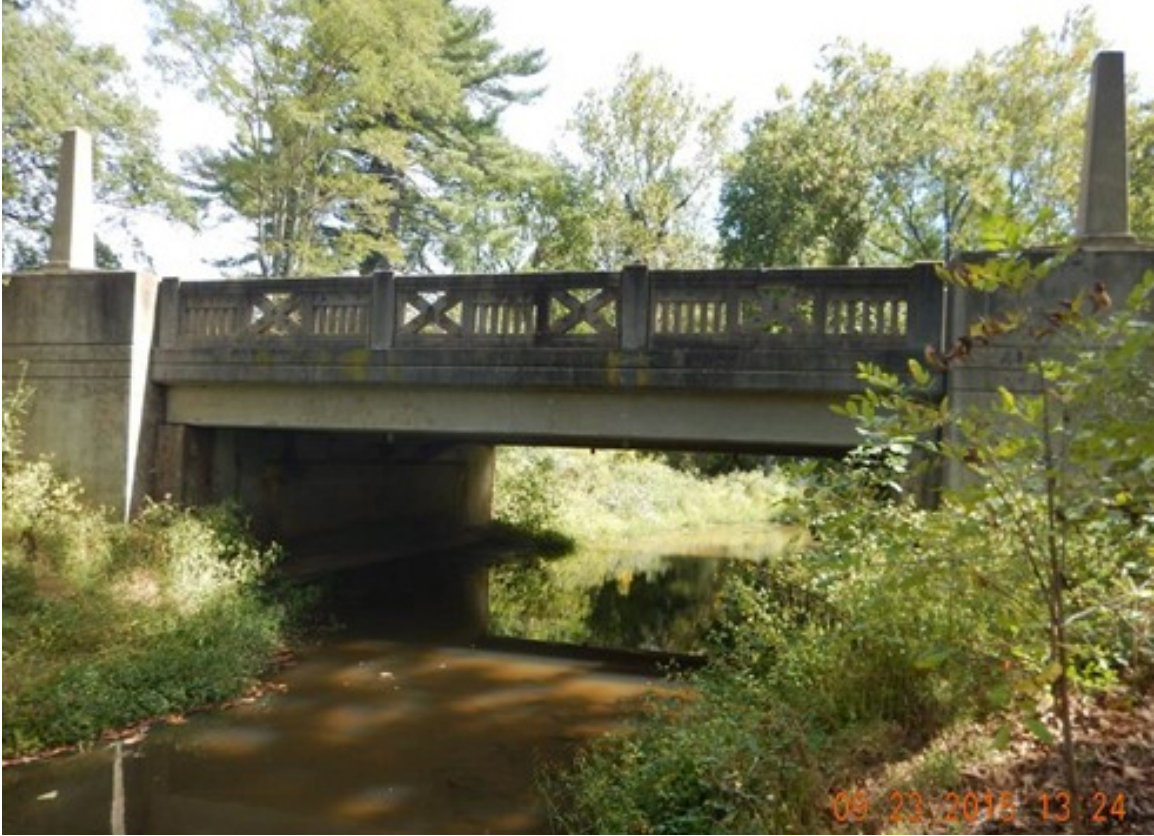
Figure B1. Appomattox County Structure No. 1002

Current Historic Structures Task Group Observations and Recommendations: The current inspection report indicates that the bridge is in satisfactory condition. Previous and planned repairs are in accordance with Recommendation 1 in the 2001 Management Plan. The task group reiterates the recommendations of repair and maintain for vehicular use with subsequent preventive maintenance as needed in the 2001 Management Plan. This work should specifically continue to keep vegetation from encroaching on the bridge and to repair areas of delaminated/spalled concrete.

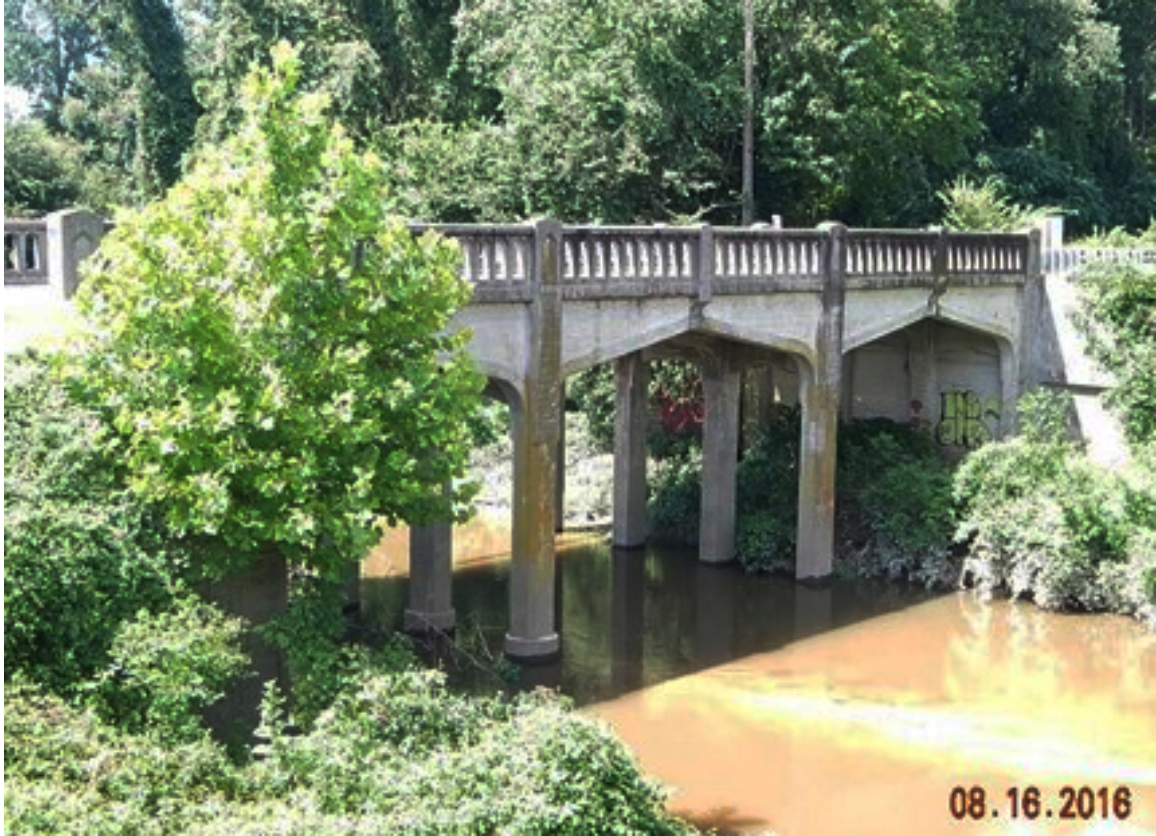
Figure B2. Henrico County Structure No. 1001

Current Historic Structures Task Group Observations and Recommendations: The current inspection report indicates that this structure is in fair condition. Previous and planned repairs are in accordance with the Recommended Treatment in the 2001 Management Plan. The task group reiterates the recommendations of (continued) repair and maintain for vehicular use, with subsequent preventive maintenance as needed, in the 2001 Management Plan.

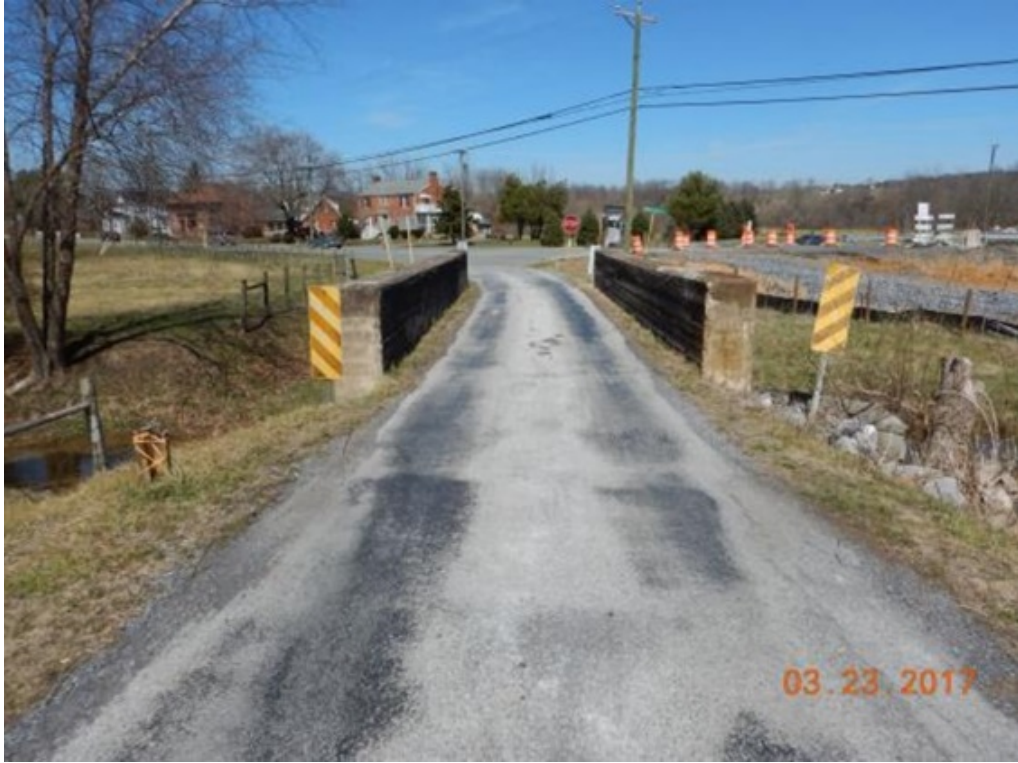
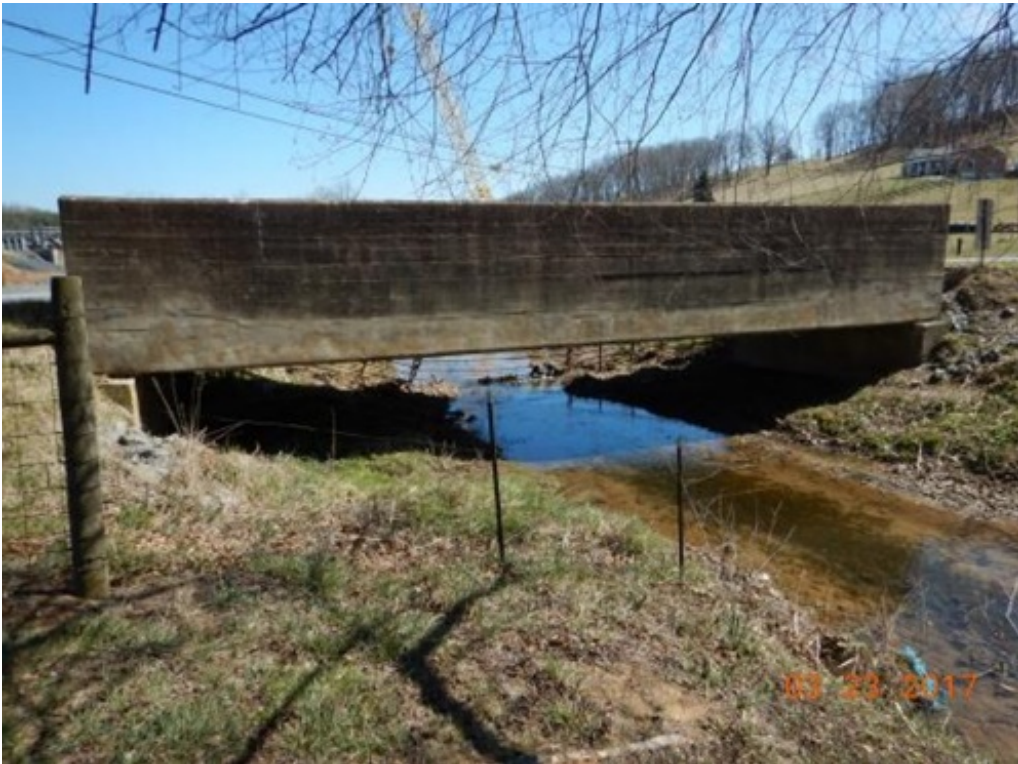
Figure B3. Augusta County Structure No. 6113: End View

Current Historic Structures Task Group Observations and Recommendations: The current inspection report indicates that this structure is in fair condition. Previous and planned repairs are in accordance with the Recommended Treatment in the 2001 Management Plan. The task group reiterates the recommendations of (continued) repair and maintain for vehicular use, with subsequent preventive maintenance as needed, in the 2001 Management Plan.

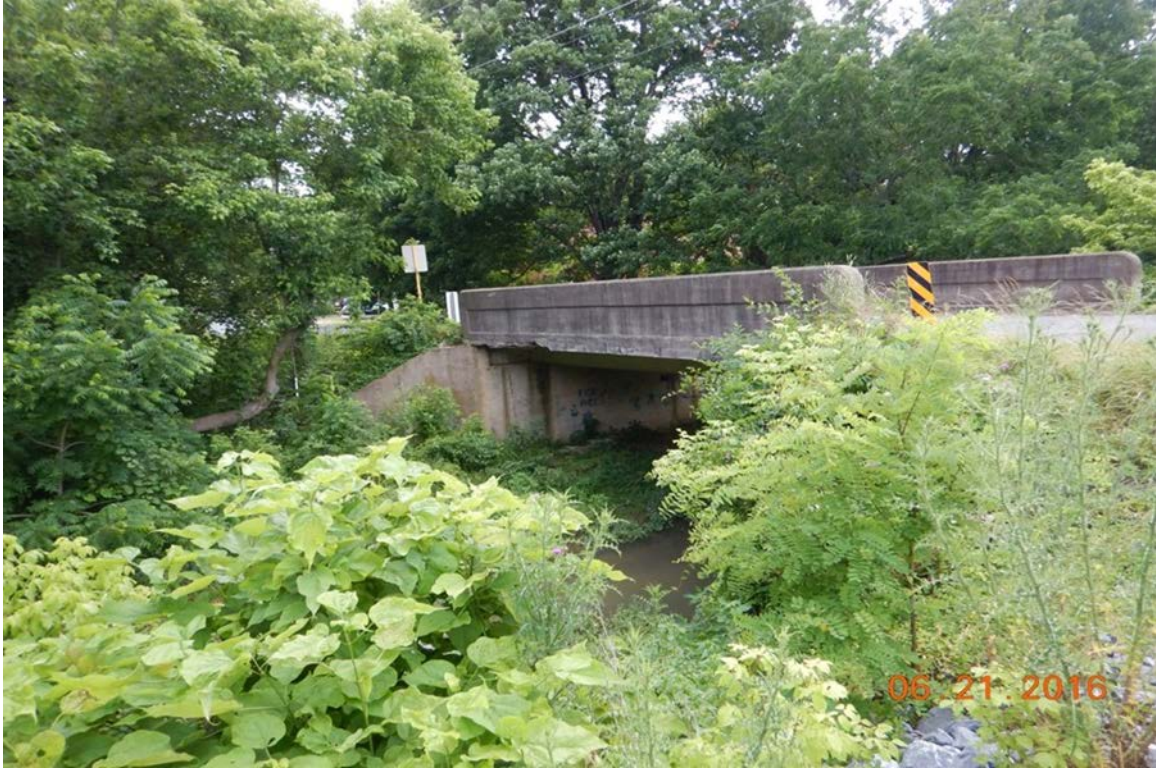
Figure B5. Augusta County Structure No. 6553

Current Historic Structures Task Group Observations and Recommendations: The current inspection report indicates that this structure is in fair condition. Previous and planned repairs are in accordance with the Recommended Treatment in the 2001 Management Plan. The task group reiterates the recommendations of (continued) repair and maintain for vehicular use, with subsequent preventive maintenance as needed, in the 2001 Management Plan.

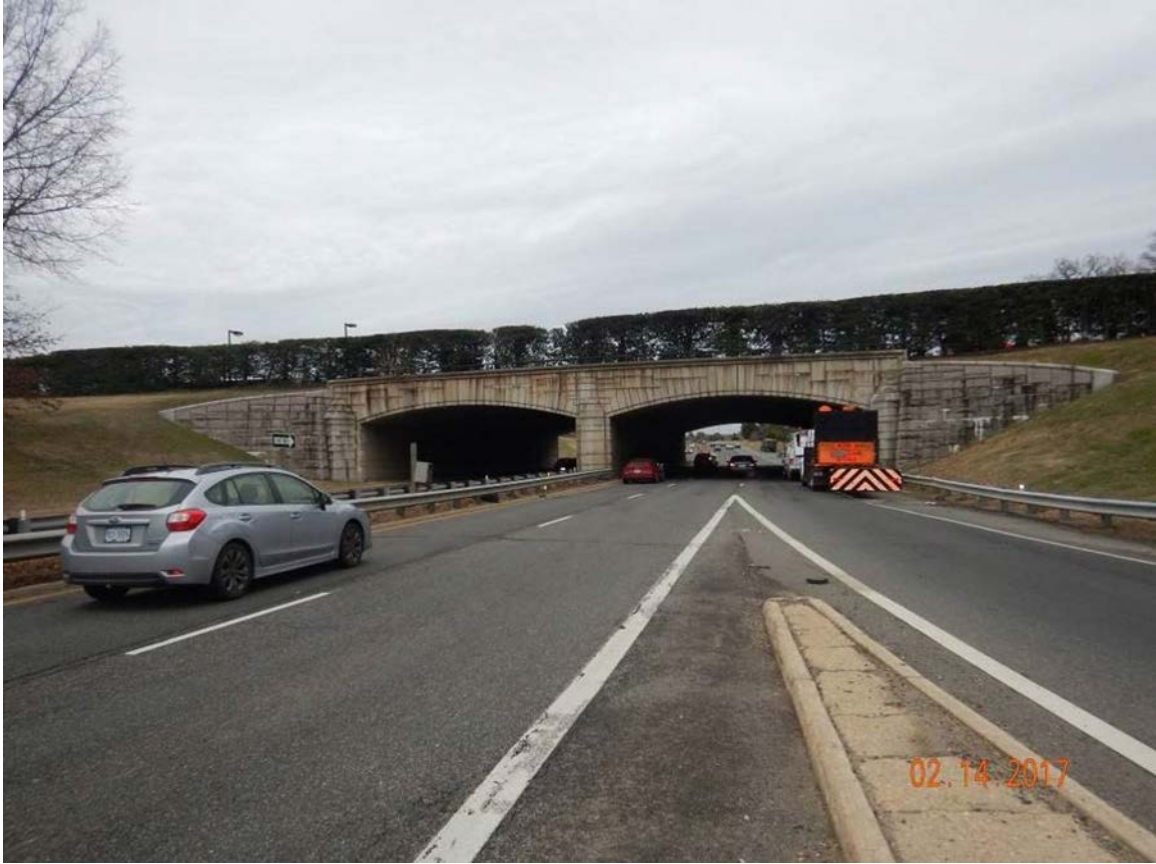
Figure B6. Arlington County Structure No. 5020

Current Historic Structures Task Group Observations and Recommendations: The current inspection report indicates that this structure is in fair condition. The task group reiterates the recommendations of repair and maintain for vehicular use, with subsequent preventive maintenance as needed, in the 2001 Management Plan.

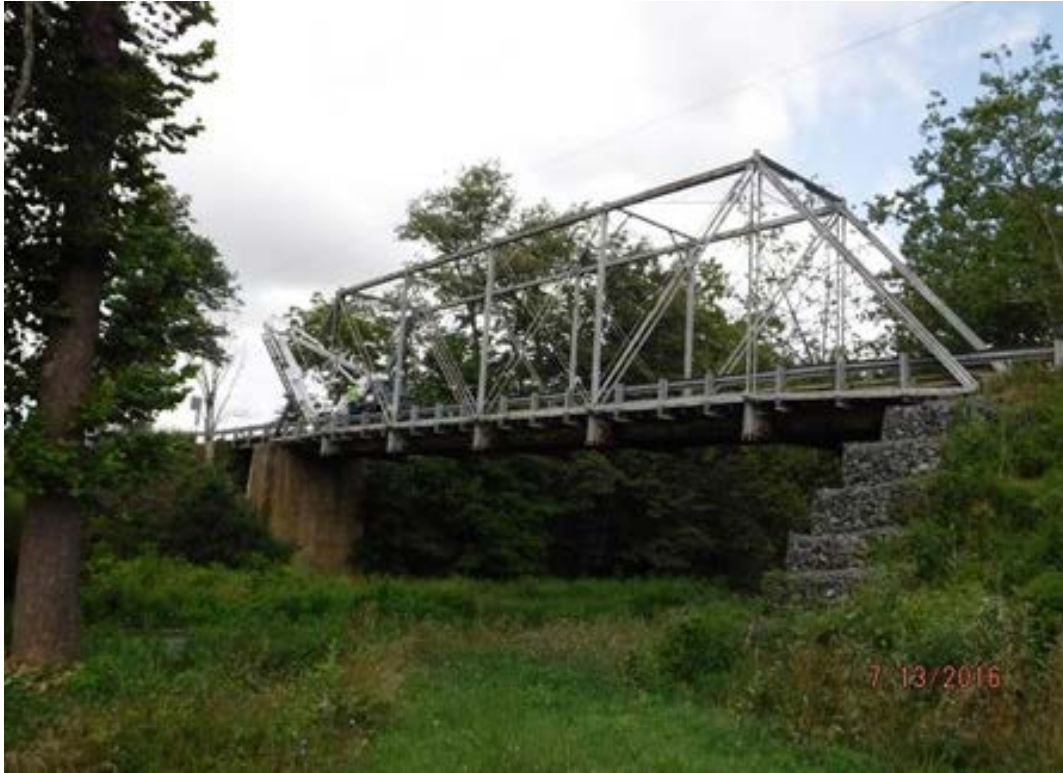
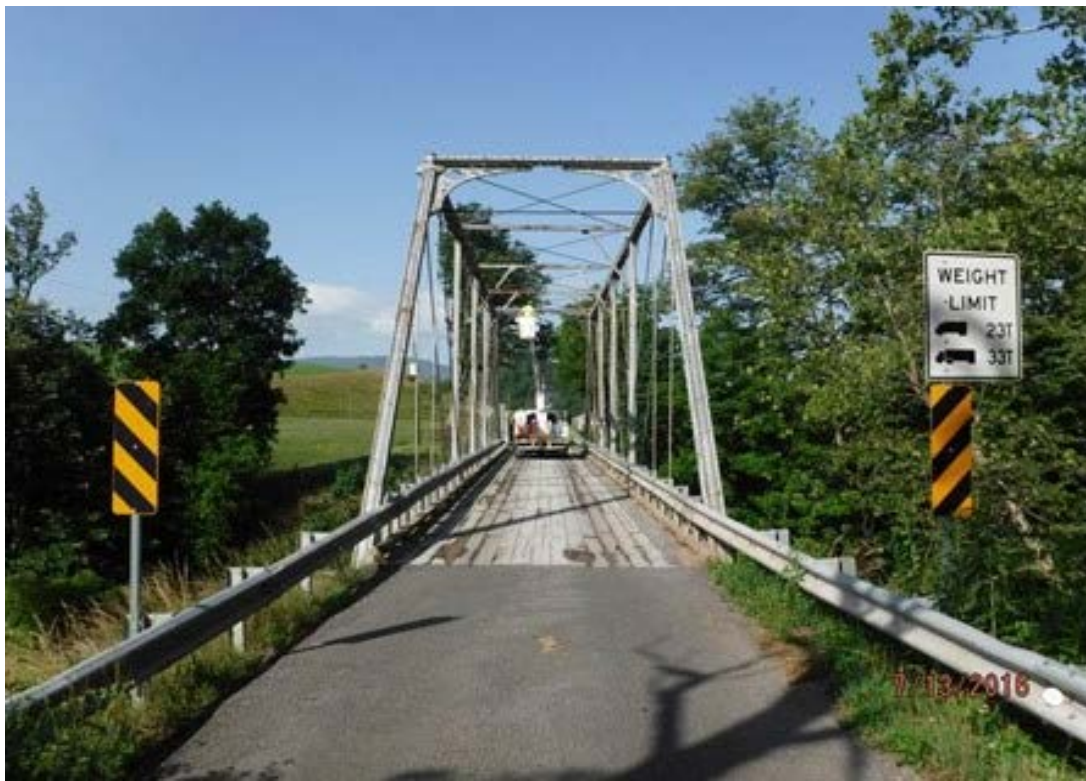
Figure B7. Wythe County Structure No. 6016

Current Historic Structures Task Group Observations and Recommendations: The current inspection report indicates that this structure is in poor condition. Previous and planned repairs are in accordance with Recommendation 1 in the 2001 Management Plan. The task group reiterates the recommendations of repair and maintain for vehicular use, with subsequent preventive maintenance as needed, in the 2001 Management Plan.

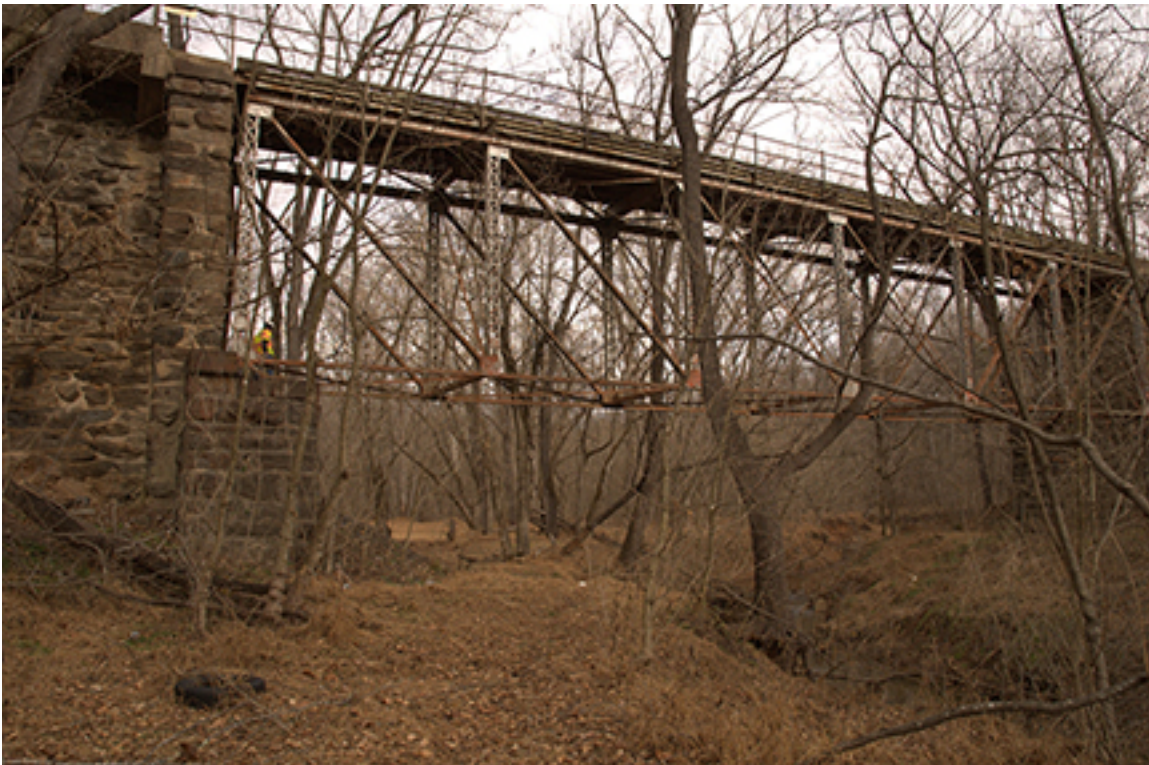
Figure B9. Bedford County Structure No. 6087

Current Historic Structures Task Group Observations and Recommendations: The current inspection report indicates that this structure is in poor condition. Previous repairs are in accordance with Recommendation 1 in the 2001 Management Plan. The task group defers further recommendations pending the results of the consultant’s evaluation.

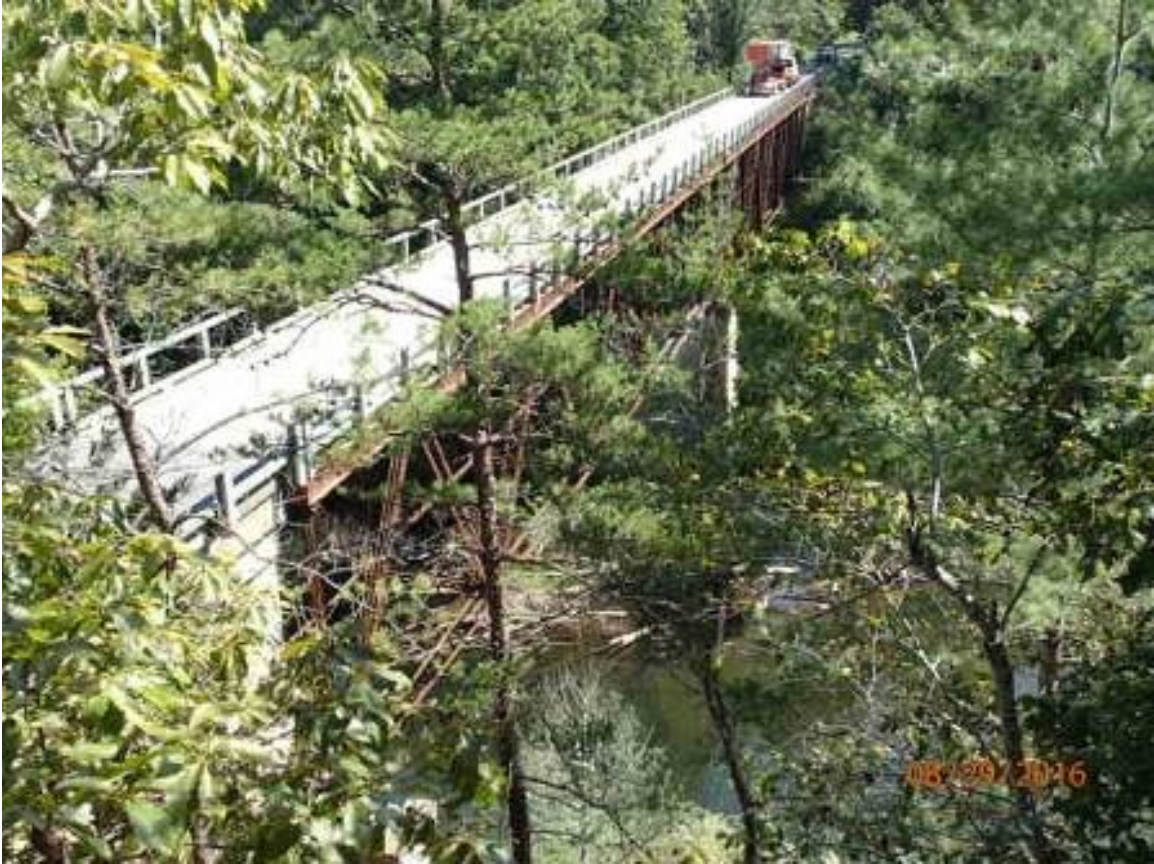
Figure B10. Botetourt County Structure No. 6100

Current Historic Structures Task Group Observations and Recommendations: The current inspection report indicates that this structure is in fair condition. Previous and planned repairs/maintenance are in accordance with Recommendation 1 in the 2001 Management Plan. The task group reiterates the recommendations of (continued) repair and maintain for vehicular use, with subsequent preventive maintenance as needed, in the 2001 Management Plan.

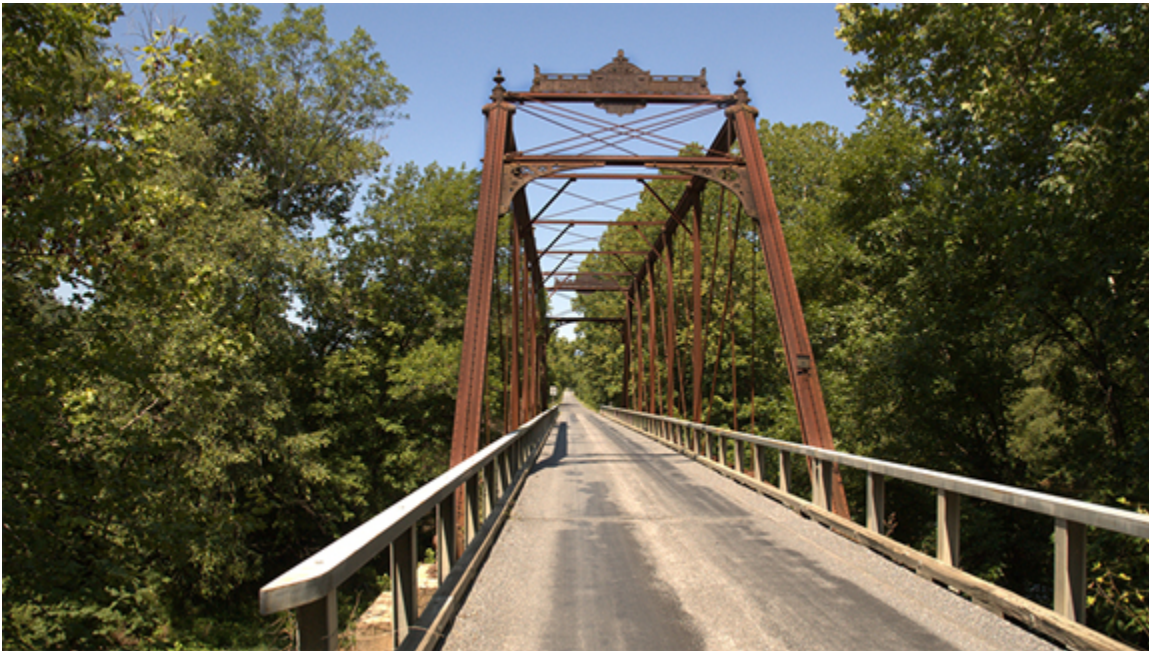
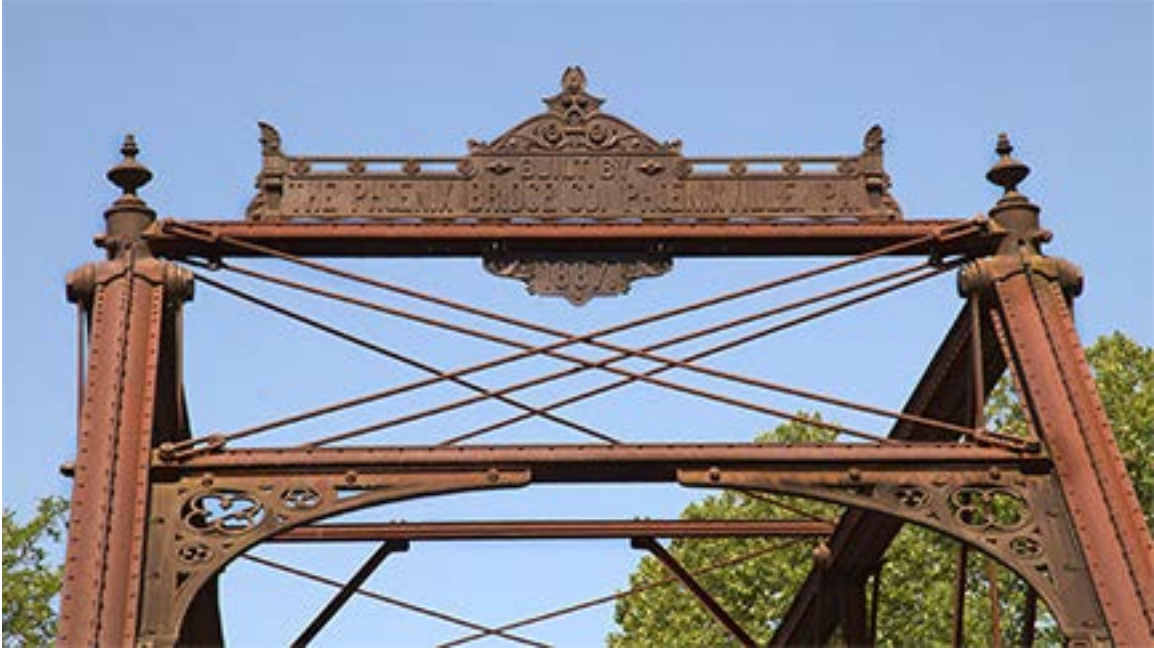
Figure B11. Botetourt County Structure No. 6386

Current Historic Structures Task Group Observations and Recommendations: The current inspection report indicates that this structure is in poor condition. Previous repairs are in accordance with Recommendation 1 in the 2001 Management Plan. A rehabilitation of this structure is planned. The task group concurs with this plan.

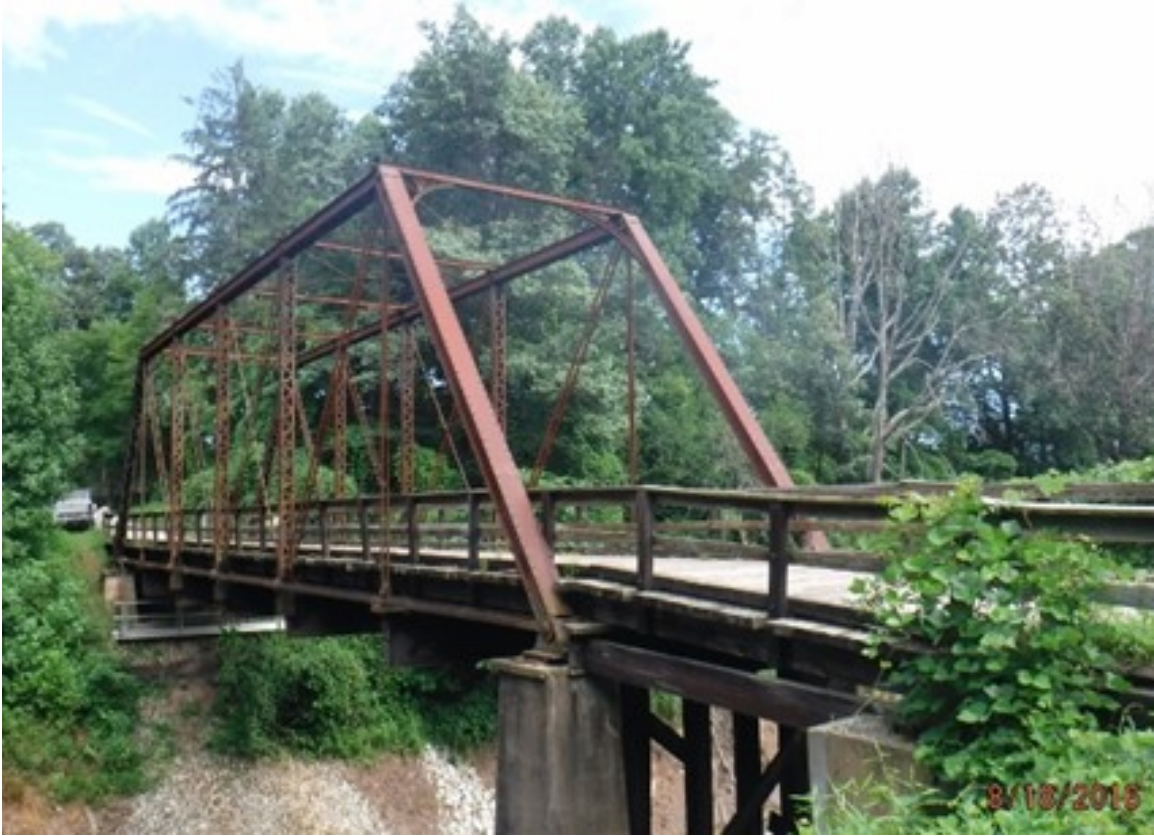
Figure B13. Nelson County Structure No. 6052

Current Historic Structures Task Group Observations and Recommendations: The current inspection report indicates that this structure is in poor condition. Previous repairs are in accordance with the Recommended Treatment in the 2001 Management Plan. The task group defers further recommendations pending the results of the district structure and bridge office's assessment of this structure.

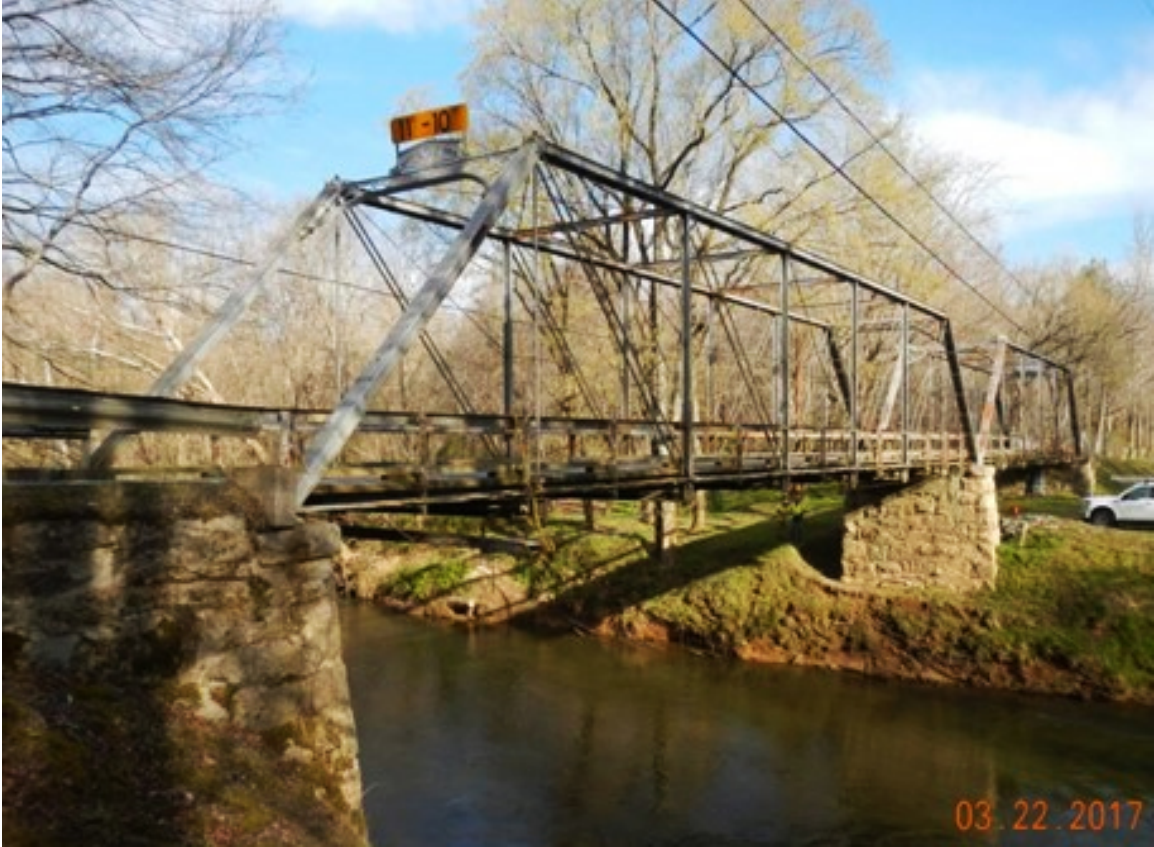
Figure B14. Brunswick County Structure No. 6104

Current Historic Structures Task Group Observations and Recommendations: The current inspection report indicates that this structure is in fair condition. Previous repairs are in accordance with the Recommended Treatment in the 2001 Management Plan. A rehabilitation of this structure is planned. The task group concurs with this plan.

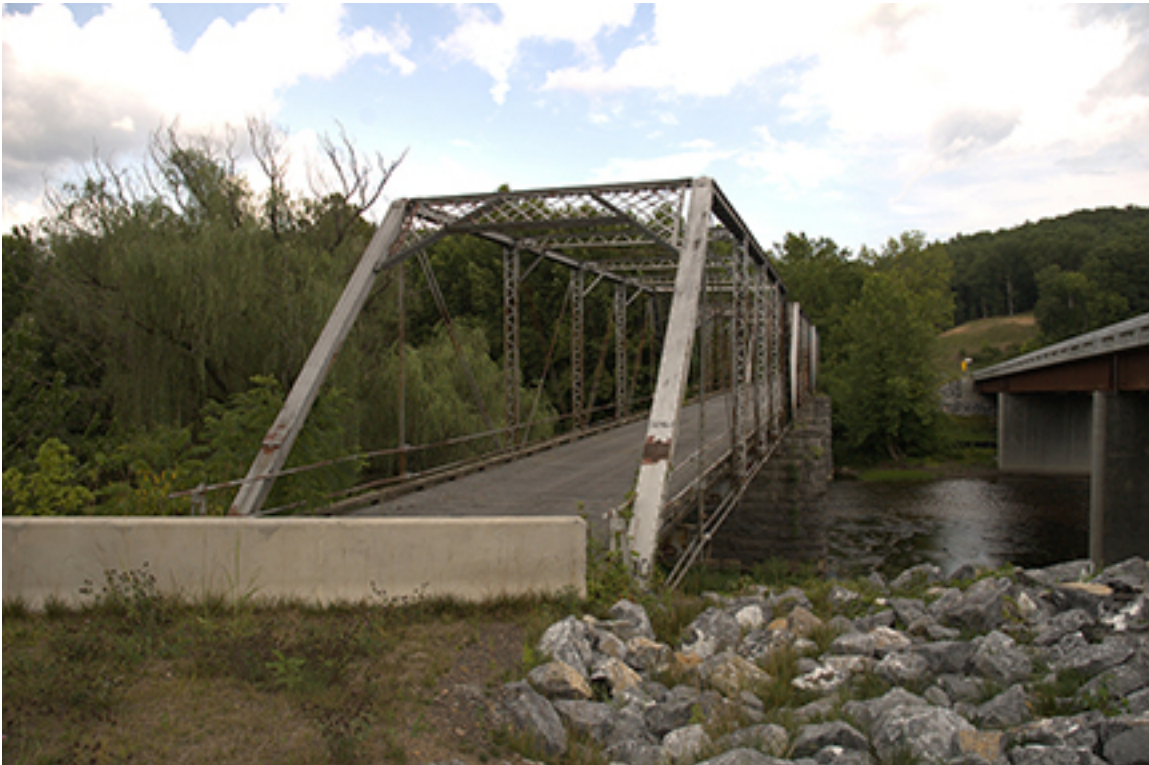
Figure B15. Alleghany County Structure No. 9008 (formerly No. 6064)

Current Historic Structures Task Group Observations and Recommendations: The current inspection report indicates that this structure is in poor condition. Currently, the 2009 agreement is being followed. The task group defers further recommendations at this time.

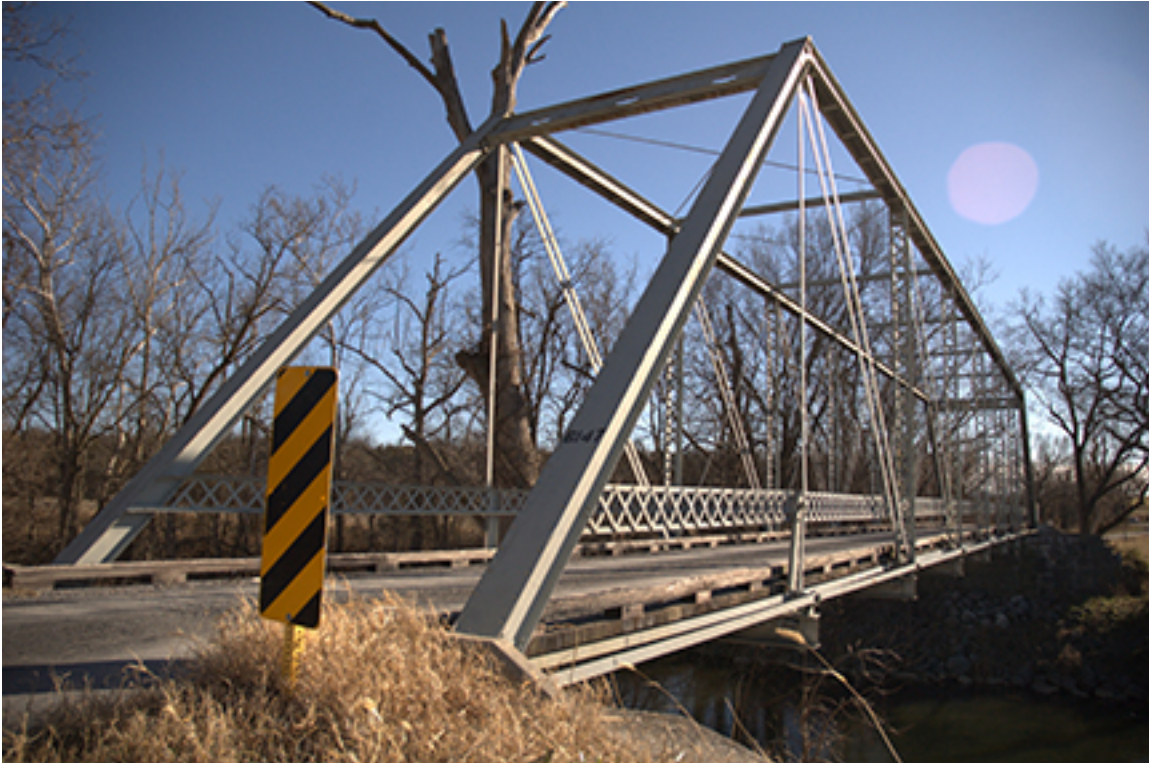
Figure B17. Augusta County Structure No. 6147

defers further recommendations pending the results of the district structure and bridge office's evaluation of this structure. However, the task group notes that (1) the crossing should be evaluated for its potential for non-vehicular use or (2) if necessary, the old abutments could be evaluated for the potential to support a new truss.

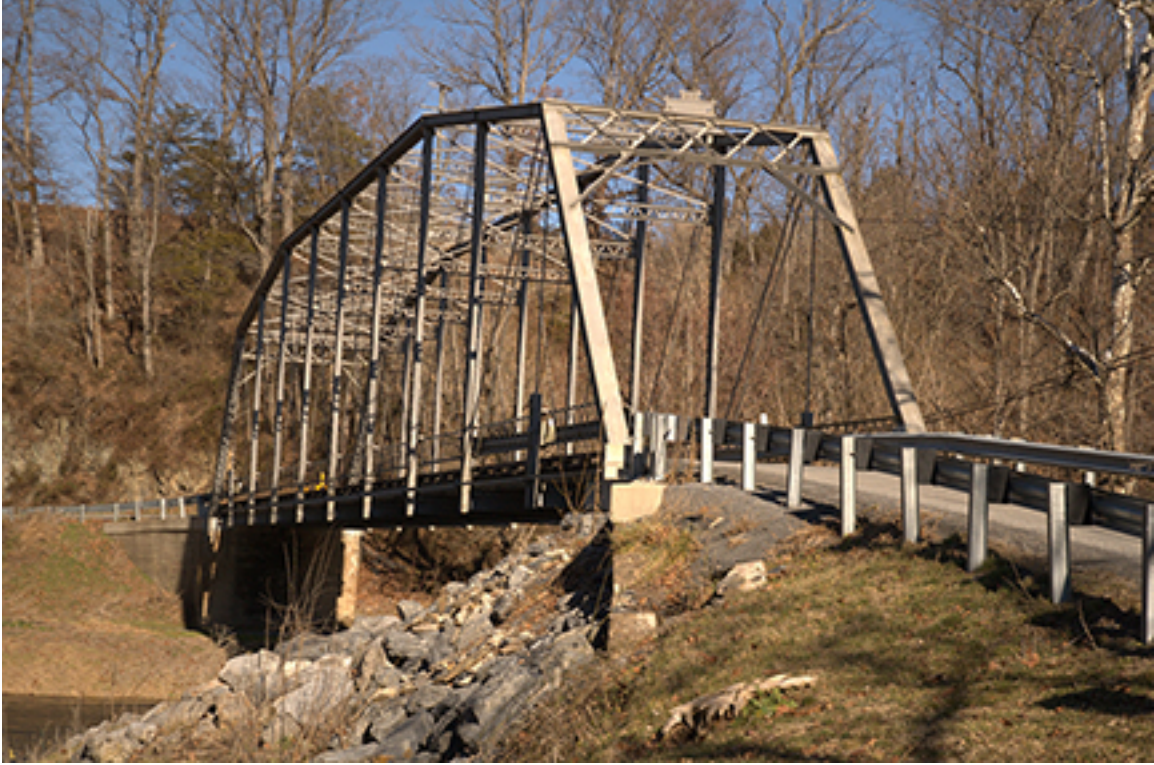
Figure B18. Augusta County Structure No. 6149

Current Historic Structures Task Group Observations and Recommendations: The current inspection report indicates that this structure is in poor condition. Previous repairs are in accordance with the Recommended Treatment in the 2001 Management Plan. The task group defers further recommendations pending the results of the district structure and bridge office's evaluation of this structure. However, the task group would support a rehabilitation of this structure.

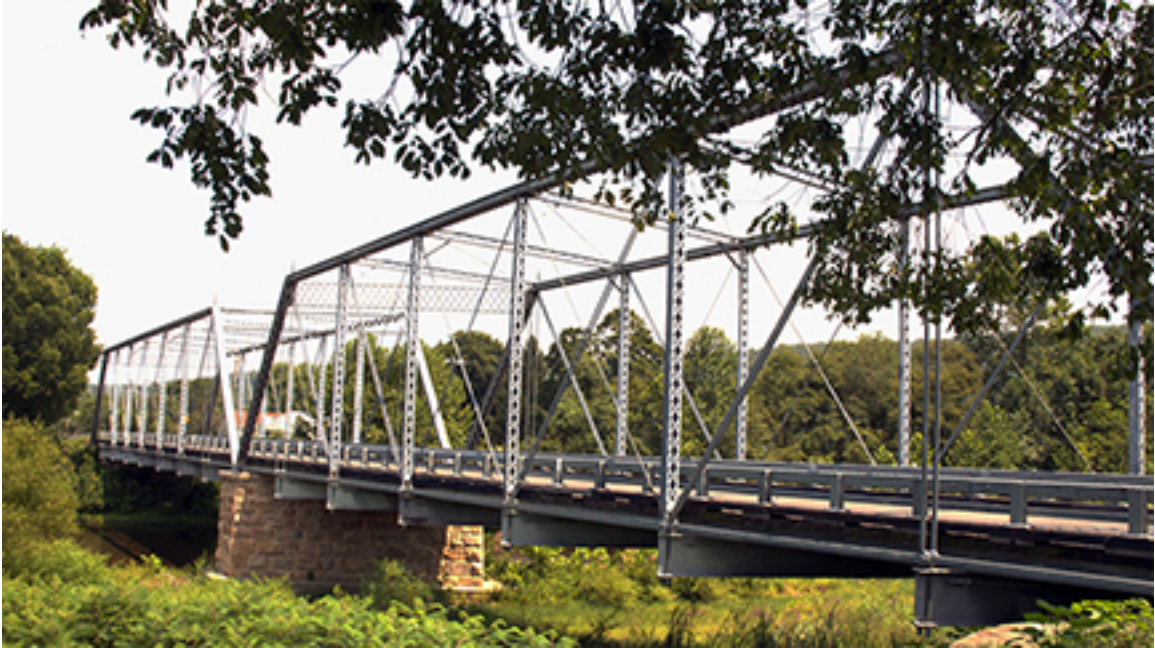
Figure B21. Rockbridge County Structure No. 6145

Current Historic Structures Task Group Observations and Recommendations: The current inspection report indicates that this structure is in good condition. The task group concurred with the planned 2001-2002 rehabilitation of this structure as noted under *Recommended Treatment* in the 2001 Management Plan. The task group recommendation is to continue maintenance and repairs if needed for vehicular use, with subsequent preventive maintenance as needed.

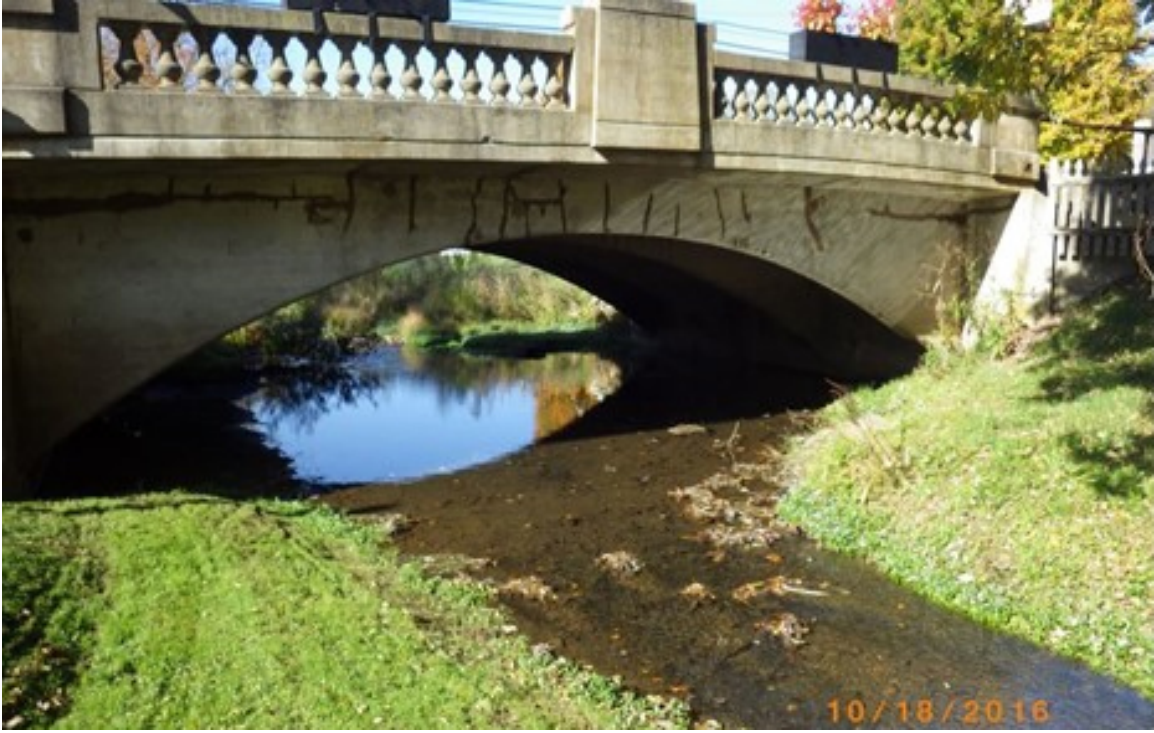
Figure B22. Bland County Structure No. 1021

Current Historic Structures Task Group Observations and Recommendations: The current inspection report indicates that this structure is in fair condition. Previous and planned repairs are in accordance with Recommendation 1 in the 2001 Management Plan. The task group reiterates the recommendations of (continued) repair and maintain for vehicular use, with subsequent preventive maintenance as needed, in the 2001 Management Plan.

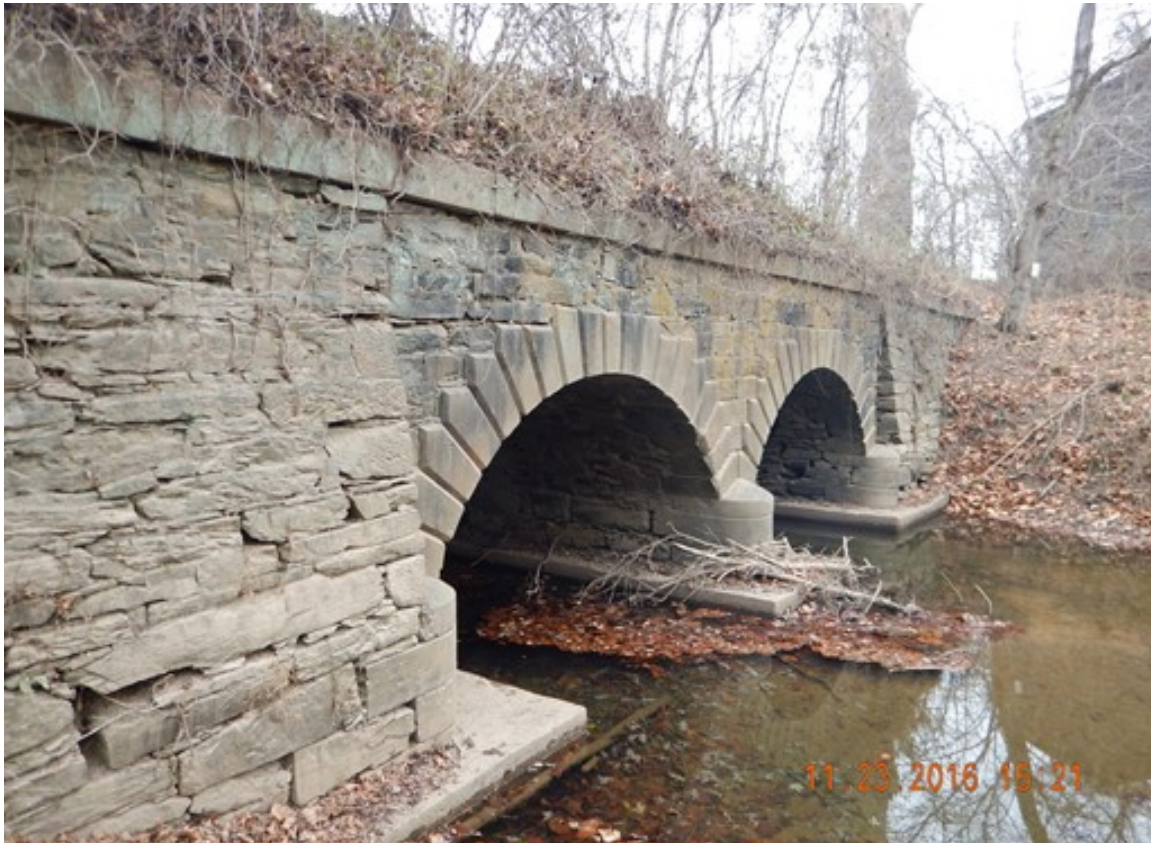
Figure B24. Nelson County Structure No. 6070

Current Historic Structures Task Group Observations and Recommendations: The current inspection report indicates that this structure is in fair condition. Previous repairs are in accordance with the Recommended Treatment in the 2001 Management Plan. The task group reiterates the recommendations of (continued) repair and maintain for vehicular use, with subsequent preventive maintenance as needed, in the 2001 Management Plan.

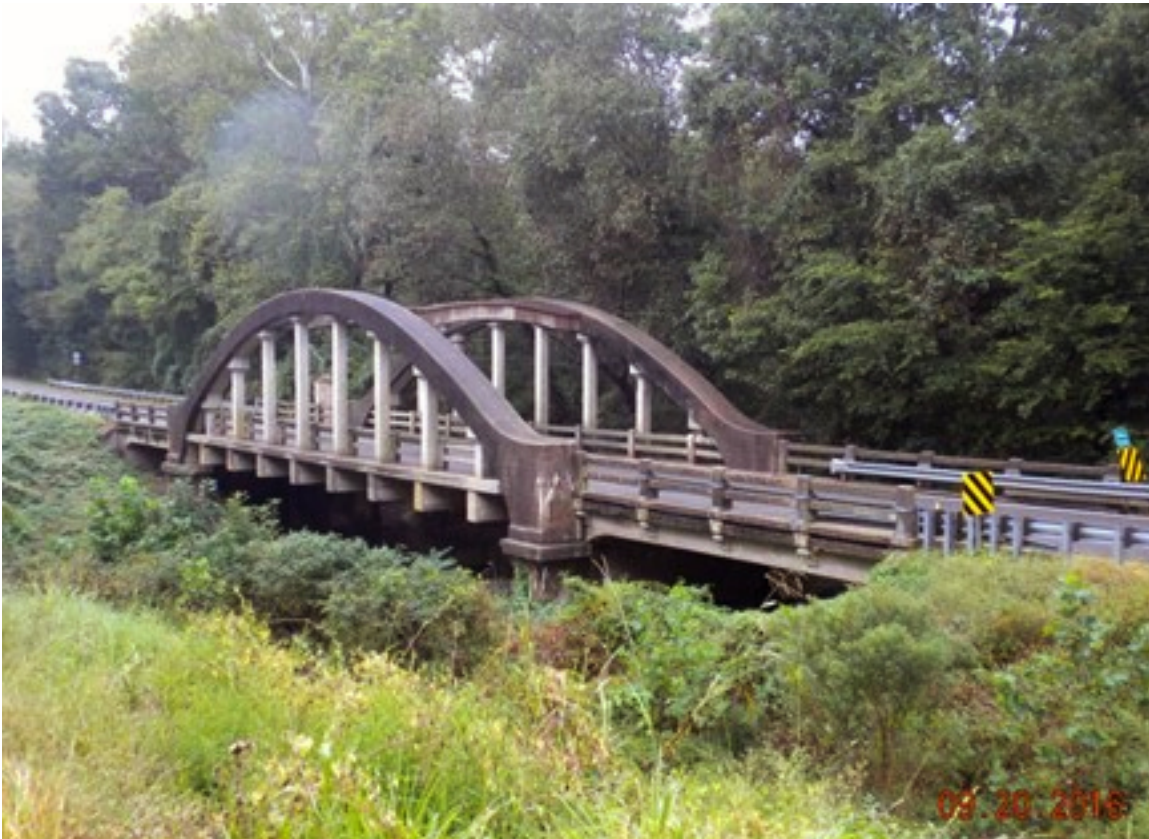
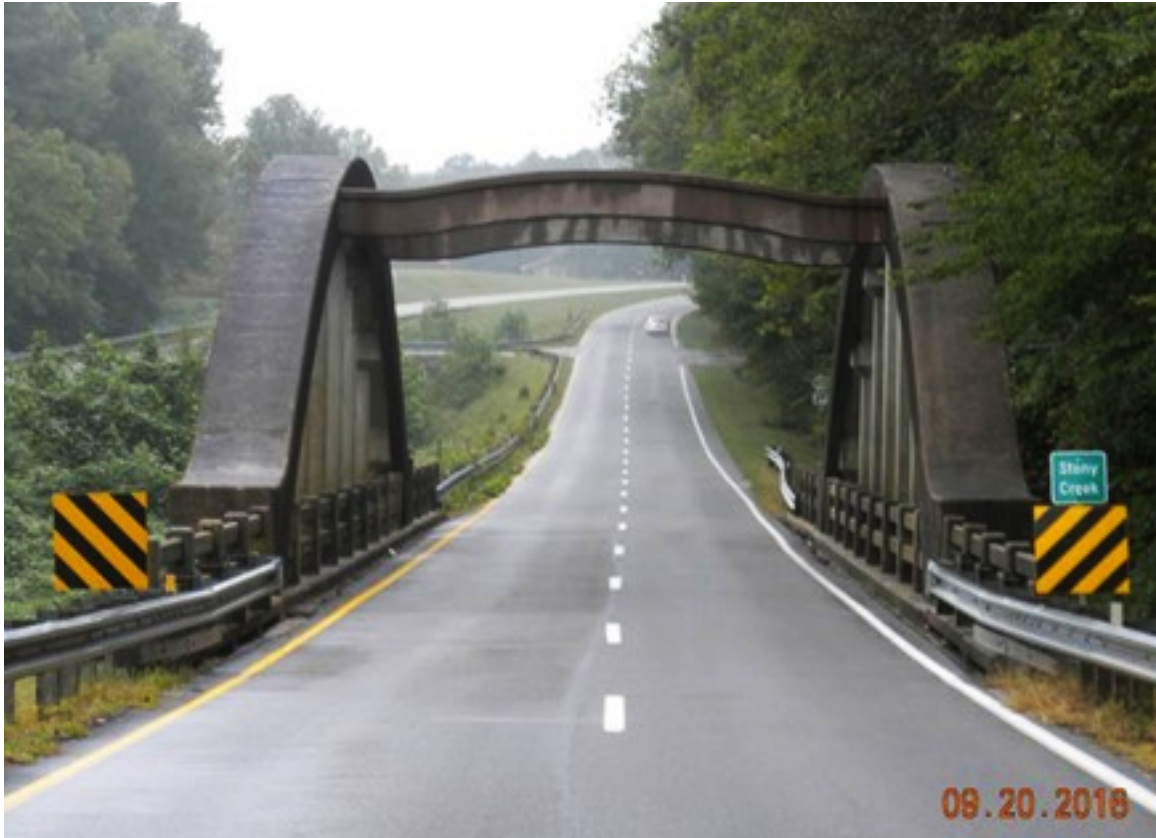
Figure B26. Dinwiddie County Structure No. 1005

Current Historic Structures Task Group Observations and Recommendations: The current inspection report indicates that this structure is in fair condition. Previous and planned repairs are in accordance with Recommendation 1 in the 2001 Management Plan. The task group reiterates the recommendations of (continued) repair and maintain for vehicular use, with subsequent preventive maintenance as needed, in the 2001 Management Plan.

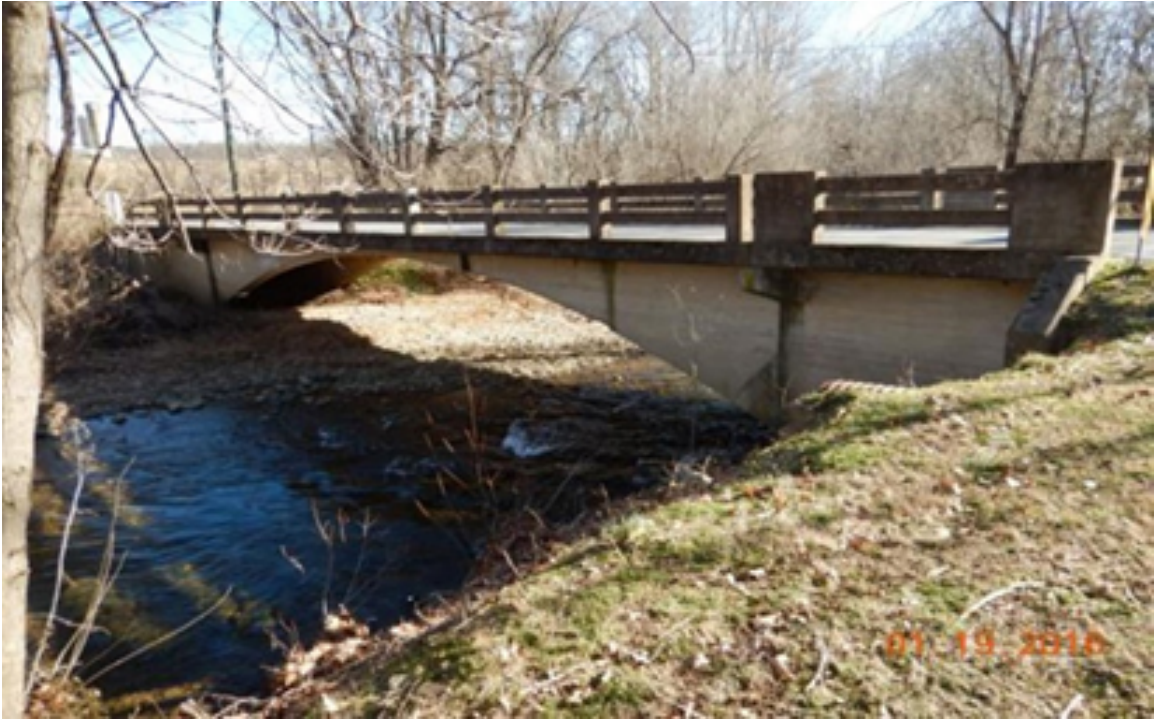
Figure B28. Augusta County Structure No. 6165

Current Historic Structures Task Group Observations and Recommendations: The current inspection report indicates that this structure is in fair condition. The task group reiterates the recommendations of (continued) repair and maintain for vehicular use, with subsequent preventive maintenance as needed, in the 2001 Management Plan.
