A Management Plan for Historic Bridges in Virginia: The 2017 Update

Final Report VTRC 18-R6

FINAL REPORT
A MANAGEMENT PLAN FOR HISTORIC BRIDGES IN VIRGINIA:
THE 2017 UPDATE

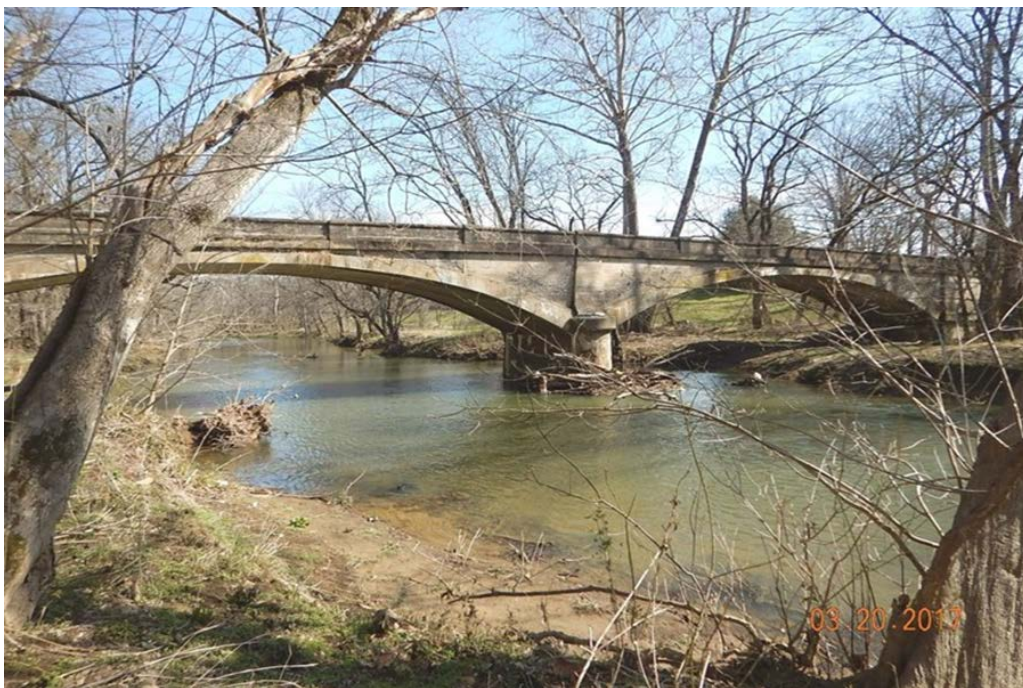
Figure B30. Frederick County Structure No. 6903

Current Historic Structures Task Group Observations and Recommendations: The current inspection report indicates that this structure is in fair condition. Previous and planned repairs are in accordance with Recommendation 1 in the 2001 Management Plan. Excluding the recommendation to pursue a transportation enhancement grant, the task group reiterates the recommendations of (continued) repair and maintain for vehicular use, with subsequent preventive maintenance as needed, in the 2001 Management Plan. The task group strongly recommends and supports the rehabilitation of this structure.

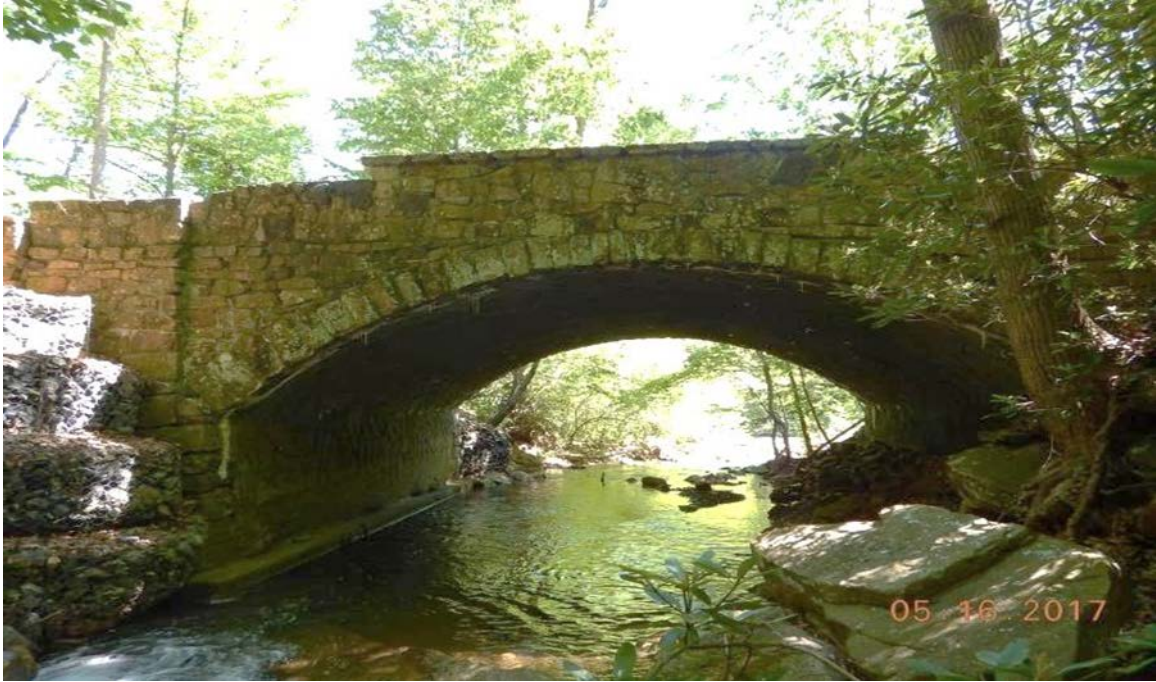
Figure B31. Rockbridge County Structure No. 1012

Current Historic Structures Task Group Observations and Recommendations: The current inspection report indicates that this structure is in good condition. Previous and planned repairs are in accordance with the Recommended Treatment in the 2001 Management Plan. The task group reiterates the recommendations of (continued) repair and maintain for vehicular use, with subsequent preventive maintenance as needed, in the 2001 Management Plan.

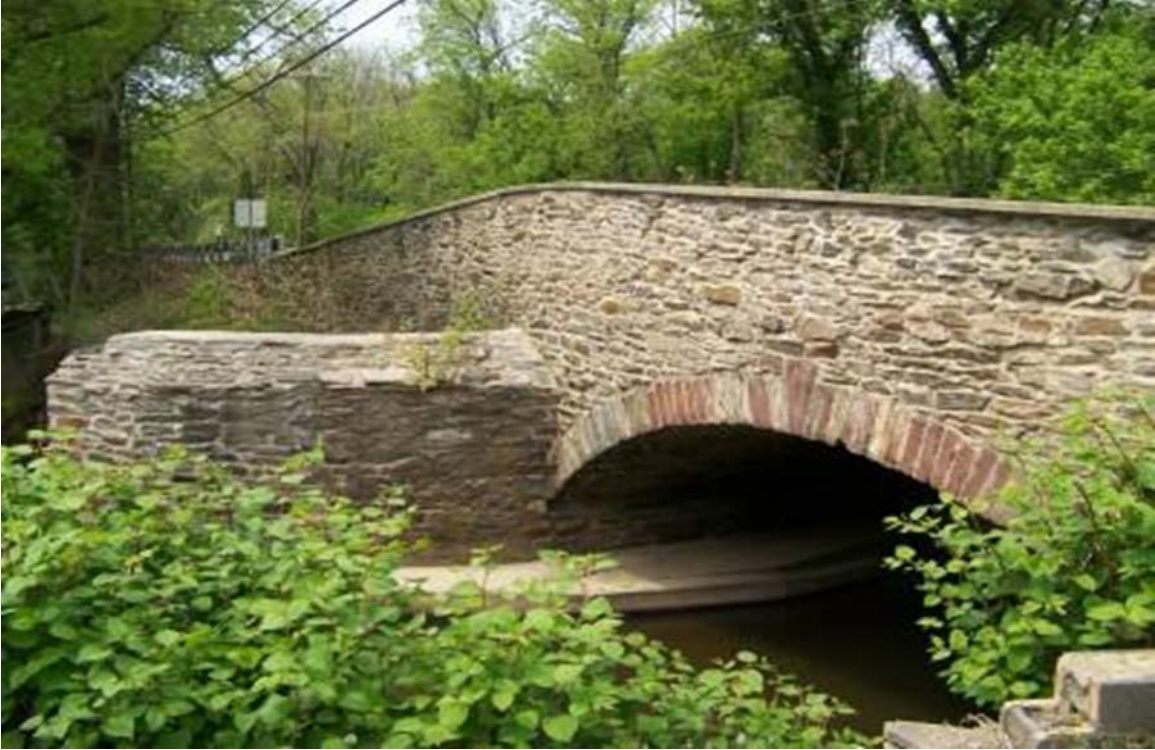
Figure B32. Loudoun County Structure No. 1025

Current Historic Structures Task Group Observations and Recommendations: The current inspection report indicates that this structure is in fair condition. Previous and planned repairs are in accordance with the Recommended Treatment in the 2001 Management Plan. The task group reiterates the recommendations of (continued) repair and maintain for vehicular use, with subsequent preventive maintenance as needed, in the 2001 Management Plan.

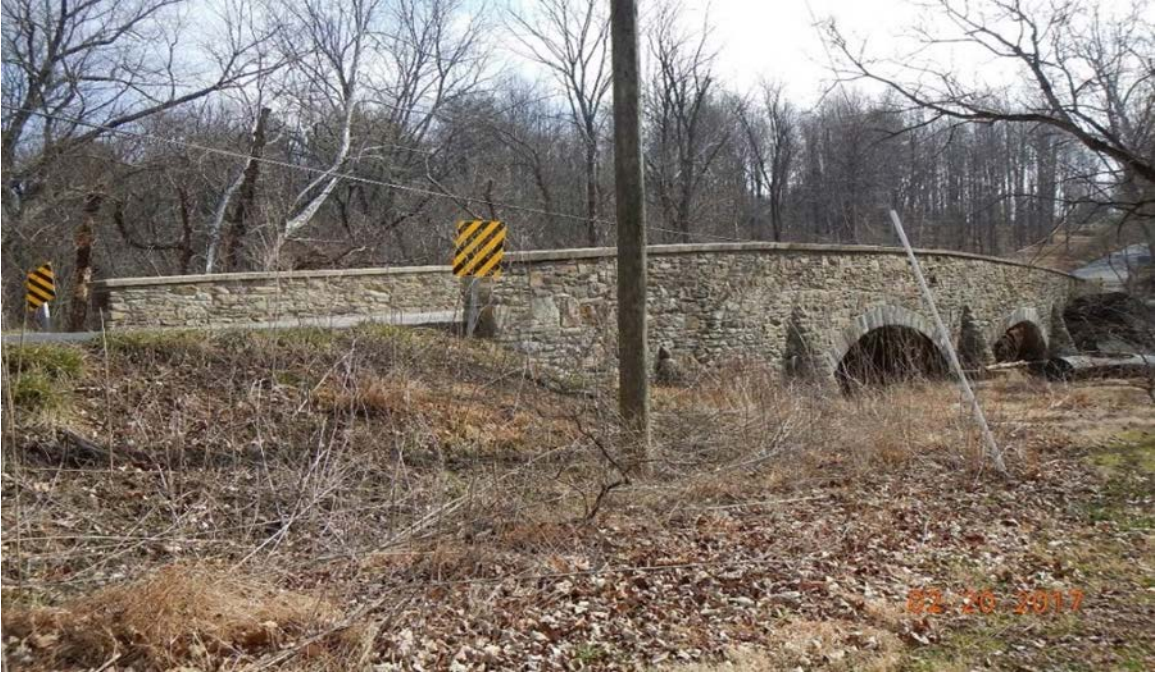
Figure B33. Loudoun County Structure No. 6088

Current Historic Structures Task Group Observations and Recommendations: The current inspection report indicates that this structure is in good condition. Previous and planned repairs are in accordance with Recommendation 2 in the 2001 Management Plan. The task group reiterates the recommendations (Recommendation 2) of (continued) repair and maintain for vehicular use, with subsequent preventive maintenance as needed, in the 2001 Management Plan.

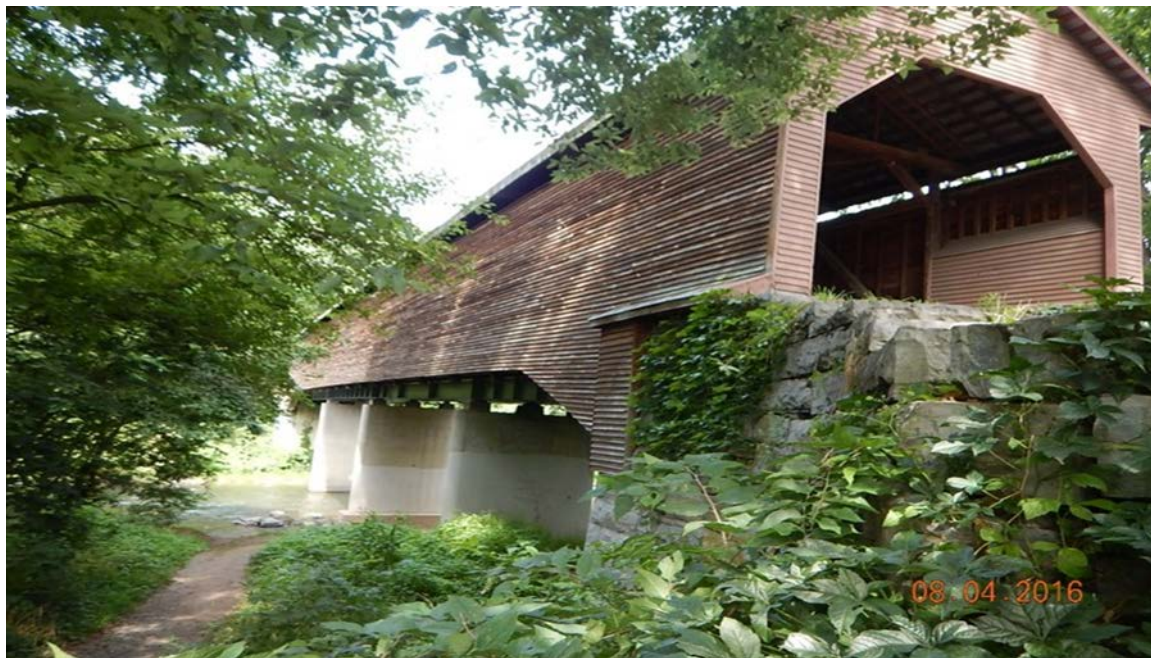
Figure B35. Shenandoah County Structure No. 6078

Current Historic Structures Task Group Observations and Recommendations: The current inspection report indicates that this structure is in good condition. Overweight and over-height and/or over-width vehicles must be prevented from accessing this bridge. Posted weight and height/width limitation signs have been repeatedly disregarded by drivers. The district structure and bridge office reports that physical limitations such as height-limiting bars (“bang” or “headache” bars) were previously considered and rejected because of potential liability concerns. But this issue is being revisited given the repeated damage to the bridge. Through traffic on the road has been restricted. The task group supports assessing all warning and signage opportunities to ensure signage in all directions. Sensors with audible alarms to detect over-height vehicles are also potential treatment options. There are several locations approaching the bridge from either direction that would support sensors with audible alarms and turn-arounds for over-height vehicles. The task group reiterates the recommendation of (continued) repair and maintain for vehicular use, with subsequent preventive maintenance as needed, in the 2001 Management Plan. As a second option, adaptive use (Recommendation 2 in the 2001 Management Plan) could be considered by the district structure and bridge office.

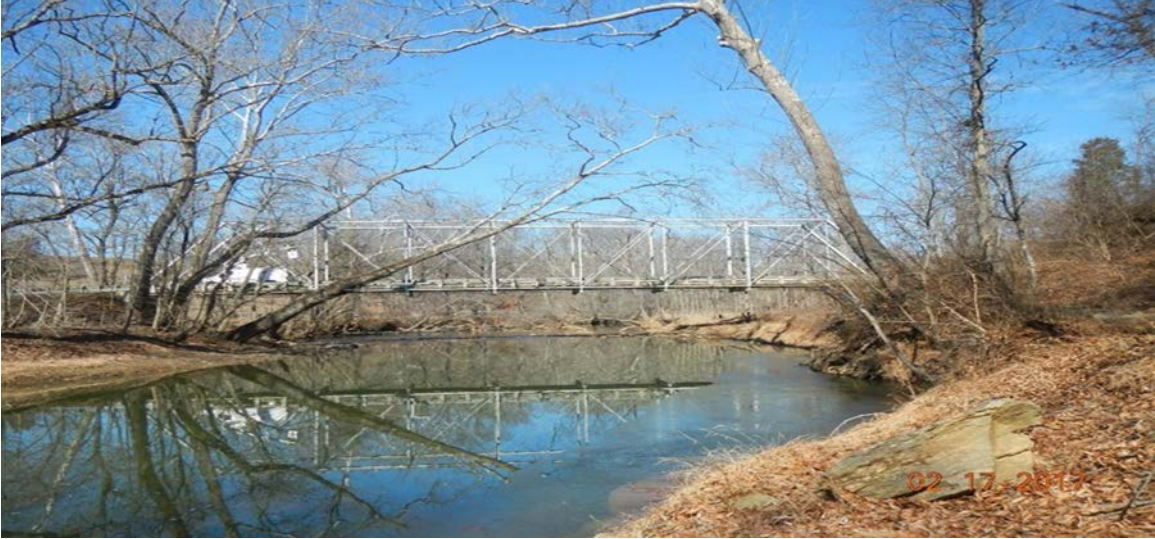
Figure B39. Loudoun County Structure No. 6051

Current Historic Structures Task Group Observations and Recommendations: The current inspection report indicates that this structure is in poor condition. The previous work was in accordance with the Recommended Treatment in the 2001 Management Plan. This structure was not considered for task group recommendations in the current management plan update because of ongoing Section 106 review.
