Premature Failure of Concrete Patching: Reasons and Resolutions

Final Report VTRC 19-R14

FINAL REPORT

The performance of concrete patches in continuously reinforced concrete pavement in Virginia varies from less than 1 year to many years. The purpose of this study was to determine the causes of premature repair failure in continuously reinforced concrete pavement.

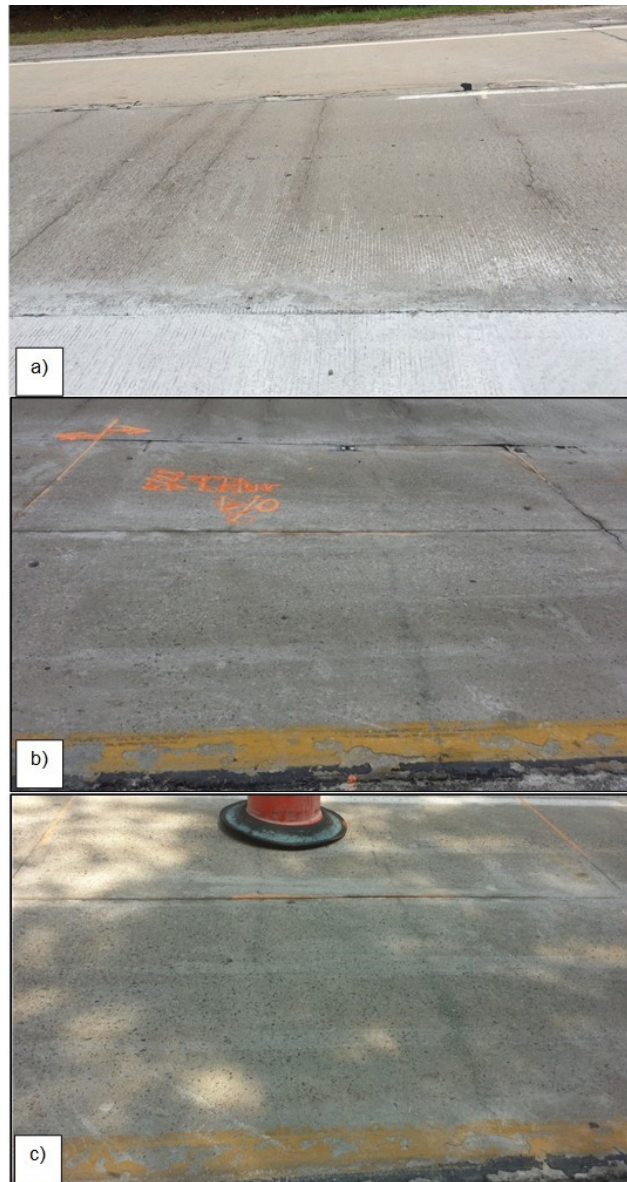
Site visits did not identify this as a cause. Typically, concrete was being replaced that one could argue could be left in place, as shown in Figure 3. The 40-year-old pavement (Figure 3b and 3c) to be removed has fewer and tighter cracks than a recent patch (Figure 3a).

Figure 3. Forty-Year-Old I-85 Pavement That Appears to Be in Good Condition: a) patch a few years old; b) section marked for removal; c) section marked for removal

- *One of the most significant causes of premature failures of patches was the use of high early strength concrete mixtures with high cement contents (as high as 800 lb) that cause excessive shrinkage cracking, as shown in Figures 3a and 10.* The narrow concrete sections between the transverse cracks soon crack in the longitudinal direction, providing weakened concrete sections that are prone to breaking into smaller sections, punchouts, and eventually spalls, typically in 1 to 5 years.

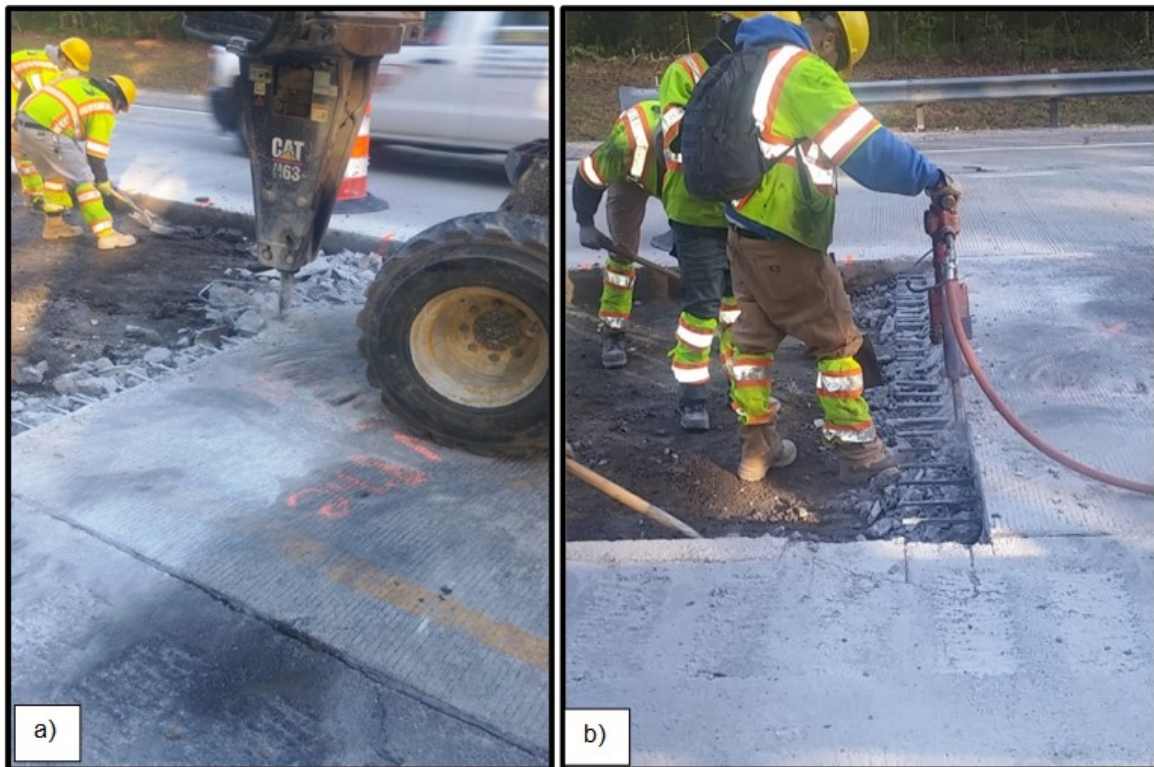
Figure 4 shows concrete being removed along the edges of the area to be patched on I-85. The larger hammer shown in Figure 4a removes the concrete faster than the smaller hammer shown in Figure 4b. In theory, the larger hammer has the potential to cause more damage, but this was not verified in this project. Figure 5 shows damage to the pavement adjacent to the patch that was likely caused by poor workmanship during concrete removal.

Figure 4. Hammer Breaking Concrete Next to Joint for Patching on I-85: a) larger hammer; b) smaller hammer

- damage to concrete adjacent to the patch during concrete removal (possibly because of the use of heavy removal equipment) (e.g., see Figure 4a)
 - poor concreting practice with respect to the proper consolidation of the concrete in the vicinity of the adjacent hardened concrete (e.g., see Figure 7)

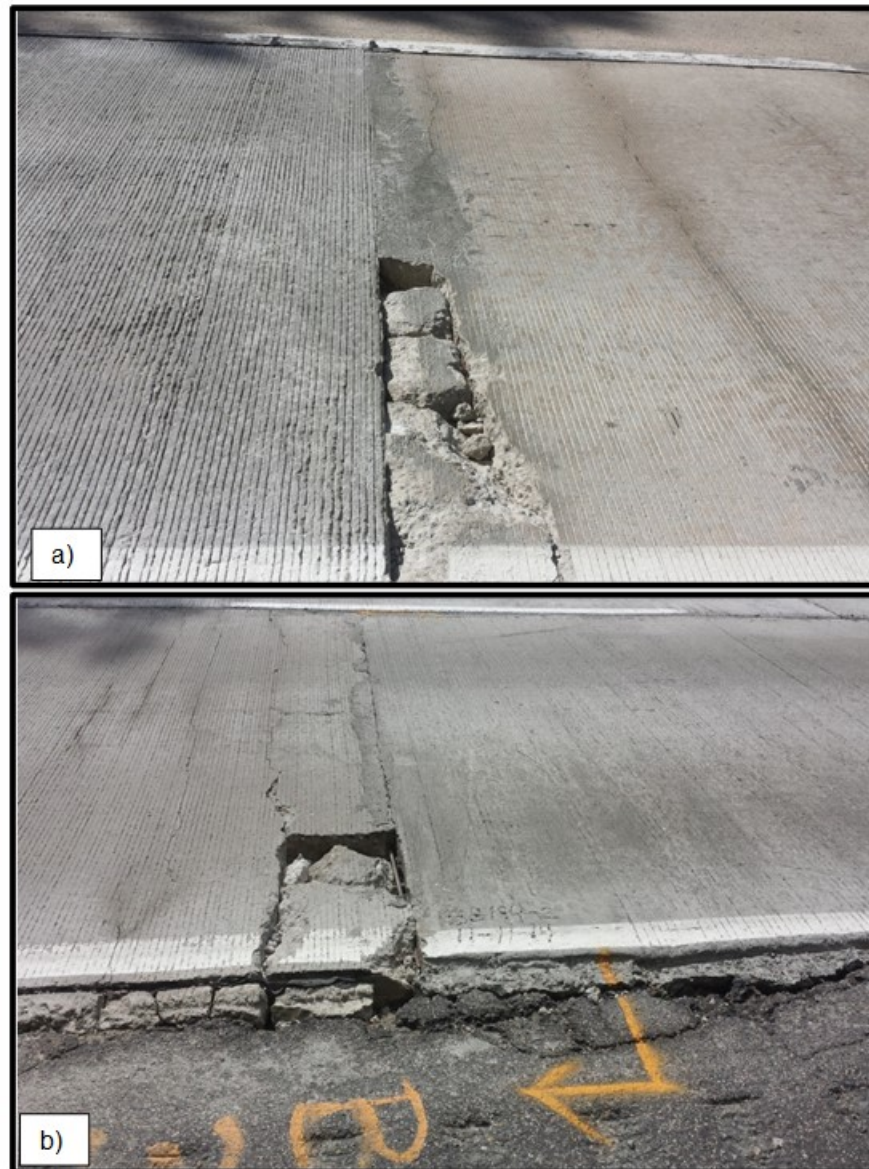
Figure 7 shows that the concrete may not have been consolidated properly in the vicinity of the splice location on the longitudinal steel in the 4-year-old patch (on the right in Figure 7a and on the left in Figure 7b) on I-85. The 4-year-old patch in both cases shows closely spaced cracks, indicating poorly proportioned concrete with a high cement content. It can be argued that the distress was caused by the concrete removal for the new patch on the left.

Figure 7. Joint Deterioration at Patches on I-85: a) new patch (*left*) next to 4-year-old patch (*right*); b) new patch (*right*) next to 4-year-old-patch (*left*)

The damage near the joints in the old patch as shown in Figure 7 could be attributed to the following causes:

- improper consolidation of concrete at the joint because of congestion of reinforcement because of splicing
- damage because of concrete removal during the installation of the new patch
- base erosion near the joint (as shown in Figure 5)
- poor quality concrete (high cement content) and excessive cracks in old patches.

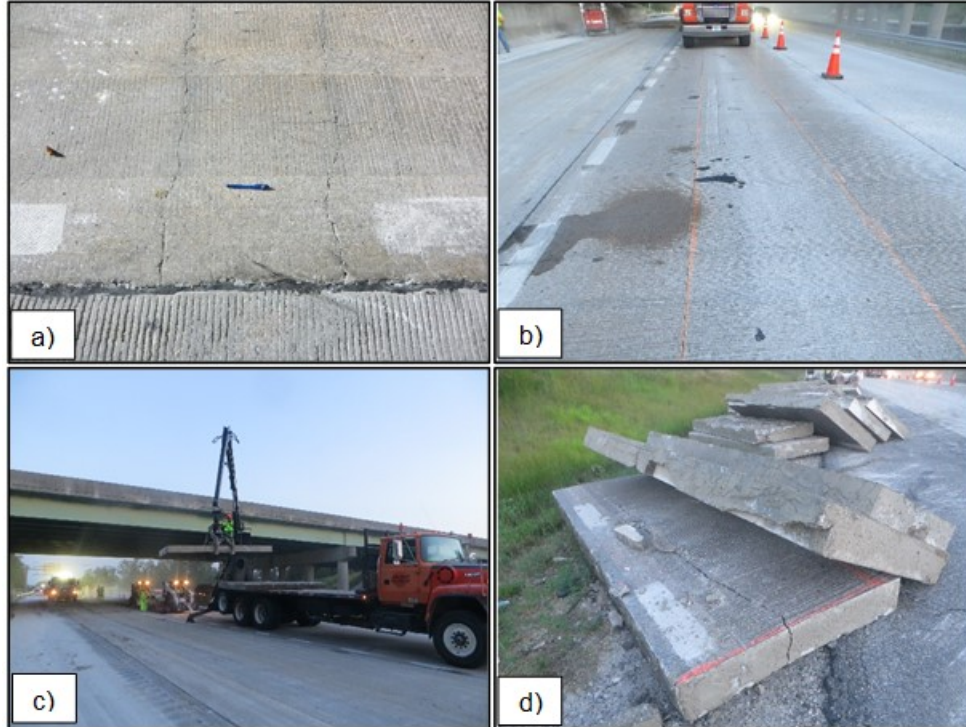
CRCP patching was performed on SR 288. Selection of the areas to be patched was based on visual observation. Conditions that influenced the decision to patch included existing temporary patches, spalls, and cracks, especially where the transverse and longitudinal cracks intersected, as shown in Figure 12a and 12b. Removal of old concrete to prepare for patching is shown in Figure 12c.

Figure 12. Patching on SR 288: a) area to be patched with closely spaced cracks; b) area selected for patching; c) old concrete slabs being removed; d) removed concrete slabs

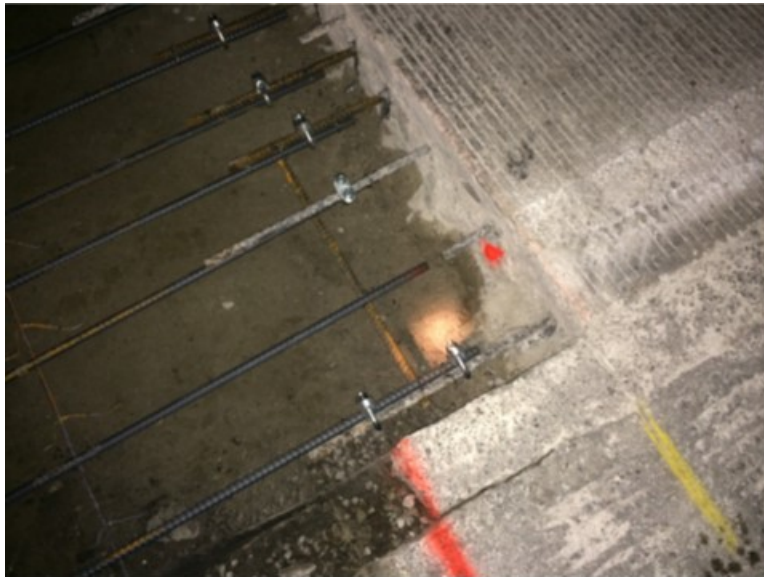
In the cases where the exposed reinforcing bar (rebar) was either missing or too short to be connected to the new rebar, extra steps were taken to ensure the new reinforcements could be firmly secured to the reinforcements exposed in the existing section. Figure 23 shows the results of the extra steps taken to ensure secure attachment of new reinforcement. If the rebar already in place was too short to connect with the newly installed rebar, a short bar was added to the new longitudinal rebar. If the original rebar was missing, a new piece was inserted into the hole and secured with epoxy. If the bar was missing in the existing section, a transverse bar was added.

Figure 23. Exposed Reinforcement Is Absent or Too Short on SR 288

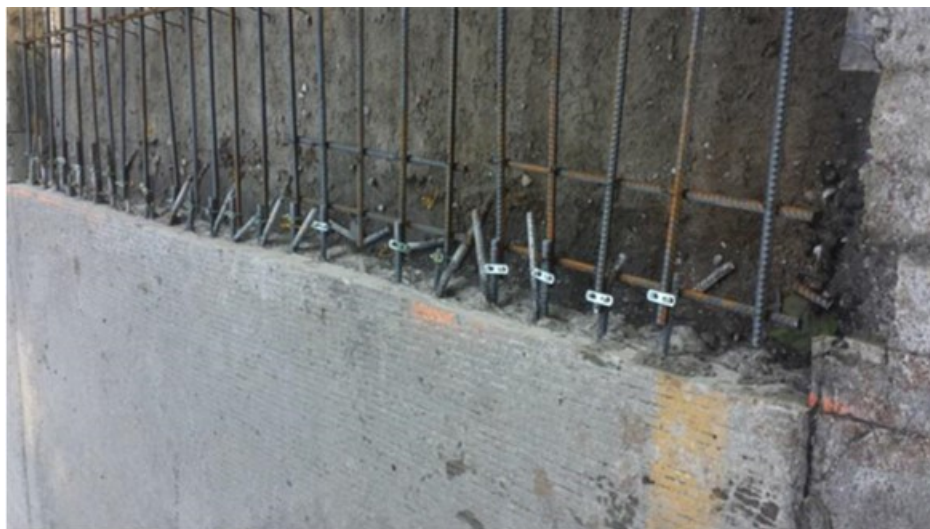
In some places, there were two bars present in the existing pavement when an old patch was being patched again; splicing was done with only one bar. Sometimes, existing reinforcement was bent so badly that splicing became difficult and additional transverse bars had to be installed to secure the splicing, as shown in Figure 25 for I-85.

Figure 25. Short and Bent Reinforcing Bars on I-85 Patching
