## Experimental and Analytical Evaluation of Residual Capacity of Corrosion-Damaged Prestressed Concrete Bridge Girders

**Final Report VTRC 25-R18**

### **EXPERIMENTAL AND ANALYTICAL EVALUATION OF RESIDUAL CAPACITY OF CORROSION-DAMAGED PRESTRESSED CONCRETE BRIDGE GIRDERS**

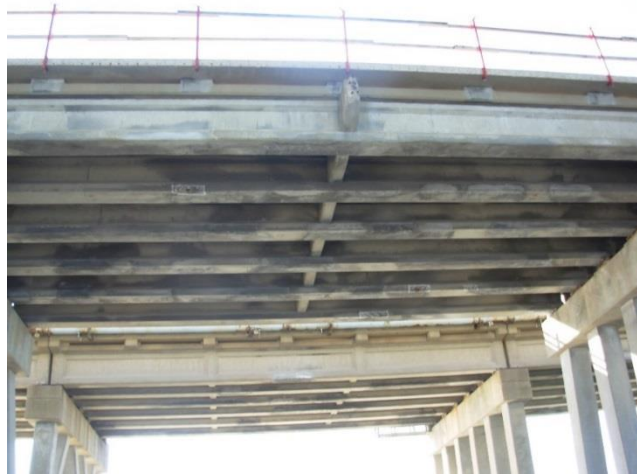
After almost 50 years of service, the bridge was demolished and replaced beginning in 2016. In the spring of 2017, nine beams were retrieved during the demolition process and delivered to Virginia Tech for testing. The slab between the beams was saw-cut to allow for the retrieval of beams to include a section of their cast-in-place composite deck. Figure 1 is a photograph of Span 7, showing the extent of deterioration in typical beams. The Lesner Bridge was repaired several times over the years, so patching is evident in many locations.

**Figure 1. Typical Deterioration on the Lesner Bridge**

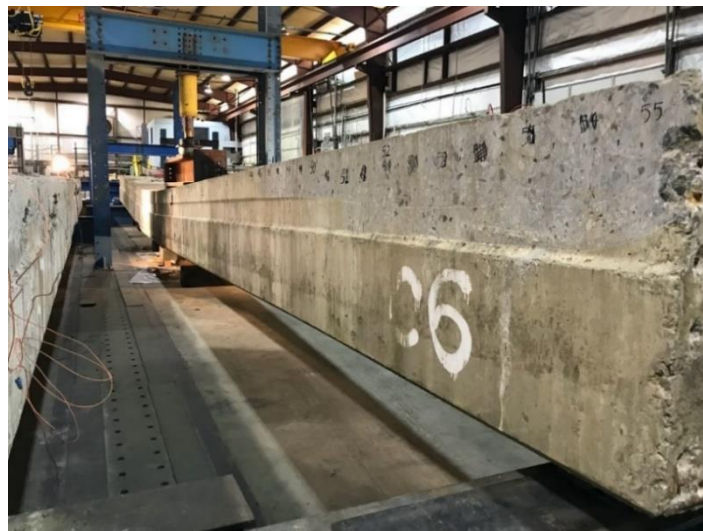
**Figure 59. Large Deflection of Box Beam 1**

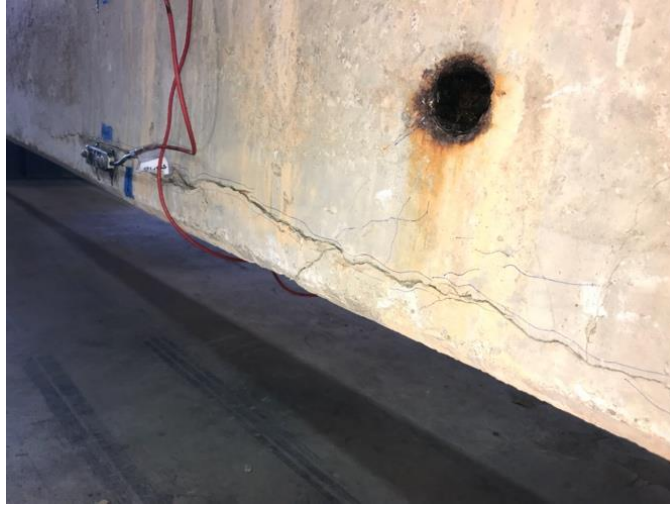
**Figure 62. Condition of the East Side of Box Beam 1 Before the Test**

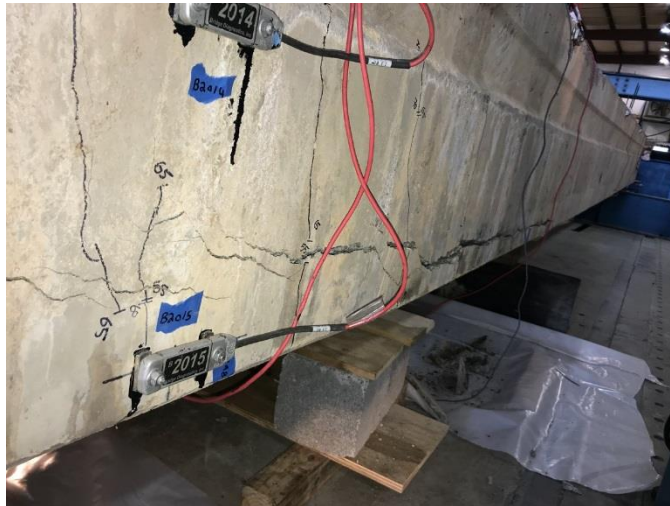
**Figure 63. Propagation of the Cracks of the East Side of Box Beam 1 During the Test**

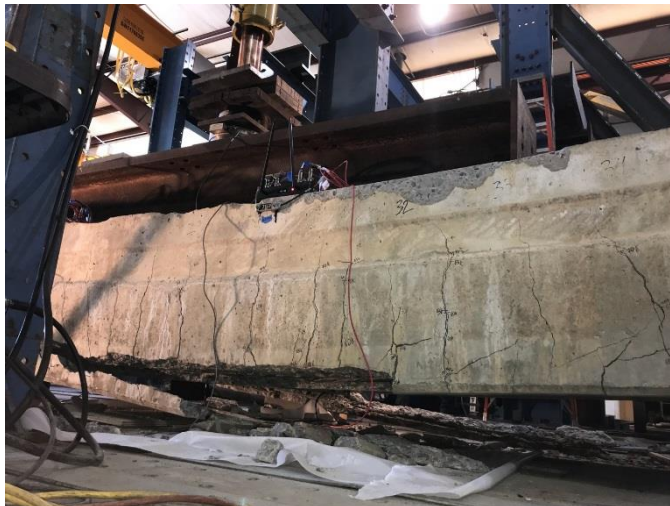
**Figure 64. Condition of the East Side of Box Beam 1 at the End of the Test**

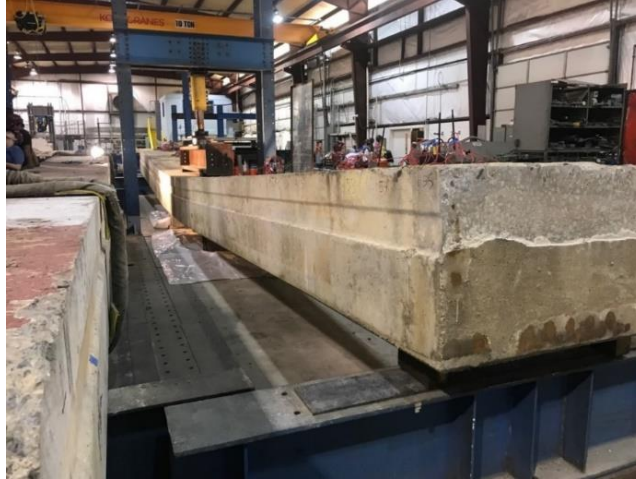
**Figure 74. Large Displacement of Box Beam 2**

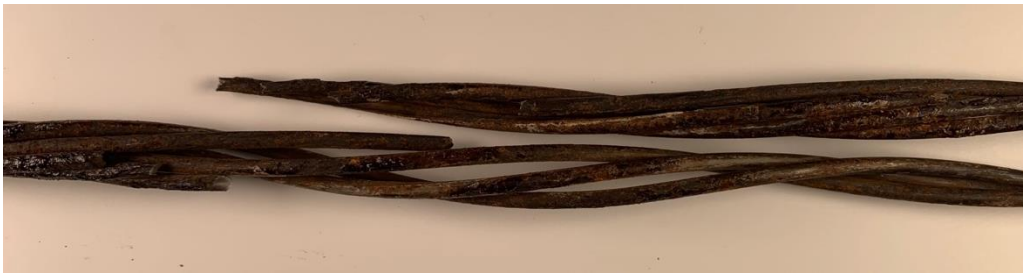
**Figure 93. Strand Taken from Box Beam 2 after Testing**
