FINAL REPORT  
EVALUATION OF EPOXY COMPOUNDS AS A MATERIAL FOR  
PATCHING AND PROTECTING CONCRETE

Wallace T. McKeel, Jr.  
Highway Research Engineer

Virginia Highway Research Council  
(A Cooperative Organization Sponsored Jointly by the Virginia  
Department of Highways and the University of Virginia)

VHRC 70-R33

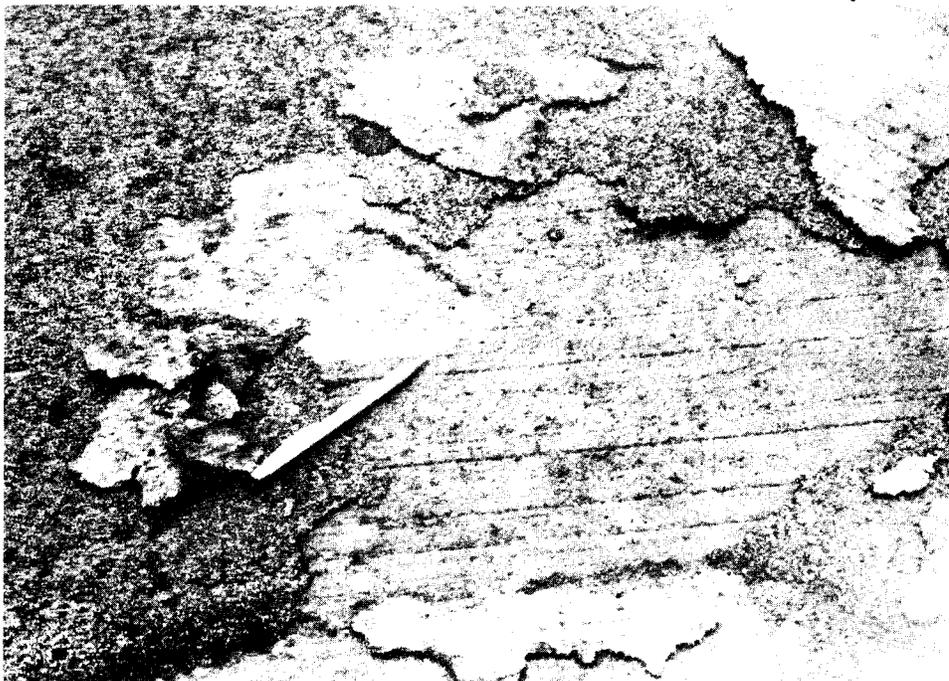
The MRAX grit strip on the Occoquan Creek bridge displayed several small areas of separation of the overlay with the underlying concrete attached due to the poor quality of the concrete. The final inspection of the ramp bridge disclosed one area of concrete spalling in the grit strip and two in the sand strip, indicating that wear had negated the protective qualities of the overlay.

Figure 4. Area of delamination in the Shell MRAX strip with aluminum oxide grit on the Ramp C bridge.

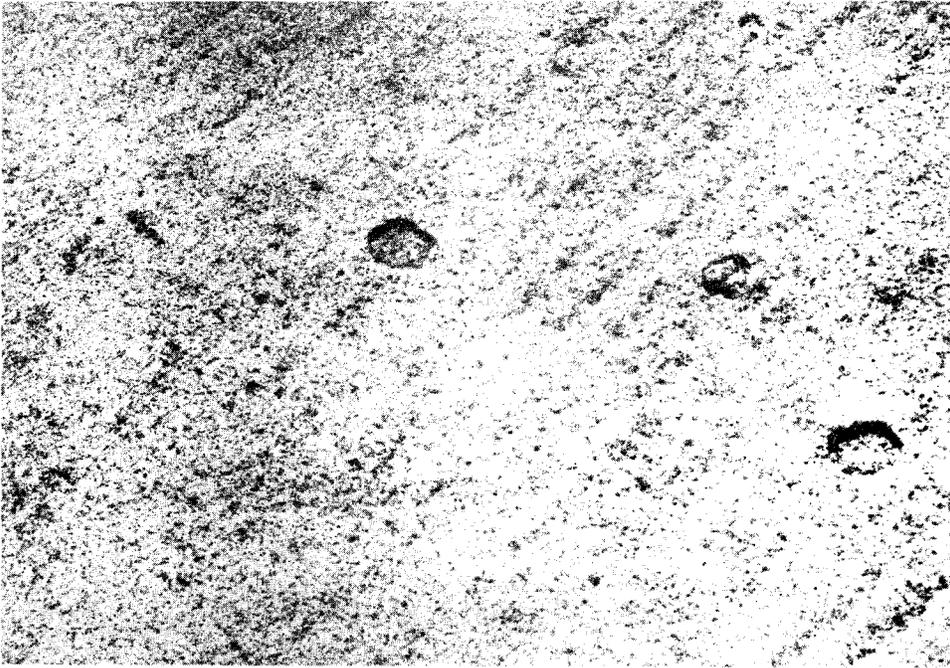
While some of the grit strips exhibited isolated flows which might have been blisters, the distress was generally noted only in the strips with sand deslicking aggregate. This does not indicate a superior characteristic of the grit strips; instead, it seems likely that the grit strips tended to form open voids through the overlay, allowing the escape of the expanding vapor. Research reported by Kubitschek, who investigated the effect of aggregate size and shape on the formation of open voids in epoxy resin overlays, disclosed that in general the number and size of open voids decreased as particle shape changed from angular to round and as particle size decreased.<sup>(7)</sup> Overlays containing rounded particles passing the number 20 sieve, such as the silica sand used in the test strip applications, were found to be essentially free of open voids or pinholes. Overlays containing large angular particles, such as the aluminum oxide grit used in this study, would tend to develop open voids. The performance of the test strips indicates that the use of a rounded silica sand aggregate of a size similar to that shown in Table 1 is essential to the application of a void-free protective membrane.

Figure 5. Close view of blisters in epoxy overlay with sand aggregate. Largest blister has a diameter of approximately 1".

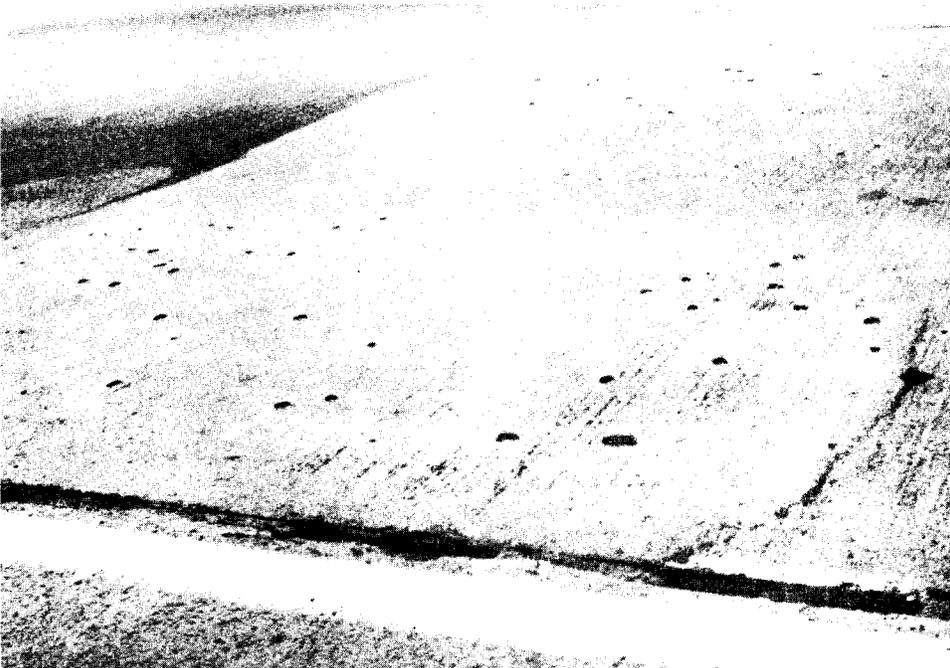
Figure 6. Overall view showing distribution of blisters in epoxy test strip with sand aggregate.

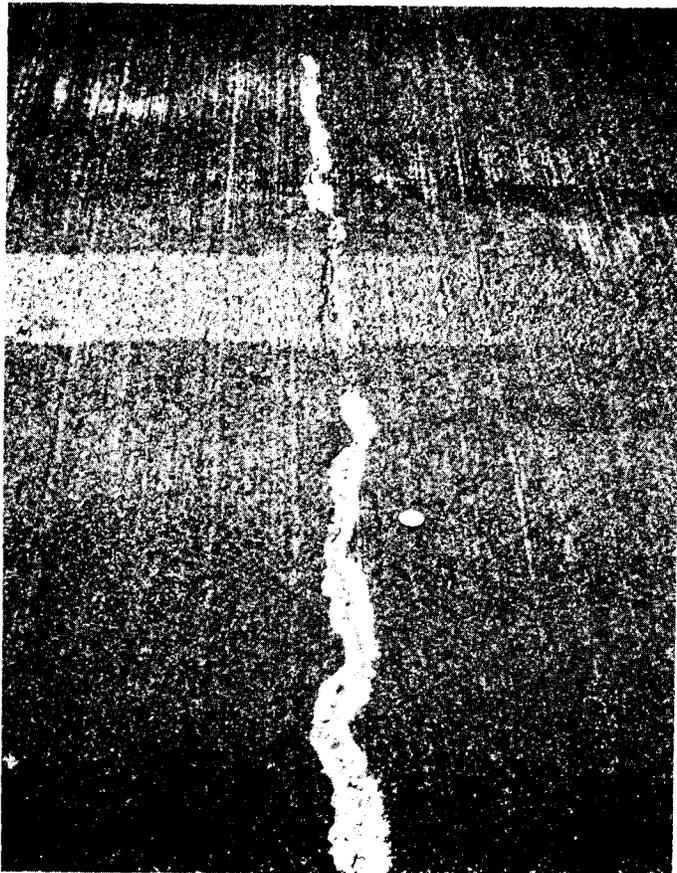
As noted in the performance records for the individual epoxy resin compounds, areas of separation of the overlay with a layer of concrete attached occurred in five of the grit strips on the Occoquan Creek bridge and a similar separation was observed adjacent to cracks, as shown in Figure 7, in four of the strips. The deck concrete in the area of the grit strips generally appeared to be of poor quality, and bond tests conducted adjacent to one point of overlay distress produced breaks in the concrete at very low stresses, 48 and 80 psi. It appears likely that the failure in the concrete may have been caused by stresses resulting from thermal expansion and contraction of the overlay. As described previously, the coefficient of thermal expansion of the epoxy resin and grit mixture comprising the overlay is significantly higher than that of concrete.

Figure 7. Typical separation of the overlay with a thin layer of concrete attached, adjacent to a reflective crack in the grit strips on the Occoquan Creek bridge.

A loss of the overlay for a distance of up to one inch adjacent to the length of reflective cracks was noted in some instances in the grit strips on the Occoquan Creek bridge. This phenomenon, which did not occur in the other groups of test strips, is ascribed to the presence of poor concrete in that portion of the deck and is not considered to be a normal result of reflective cracking. The pattern cracking in the surface of the Shell MRAX overlays containing silica sand aggregate is not reflective in nature. It is apparently due to some characteristic of the epoxy resin system, which exhibited the greatest difficulty with cracking during the test strip study.

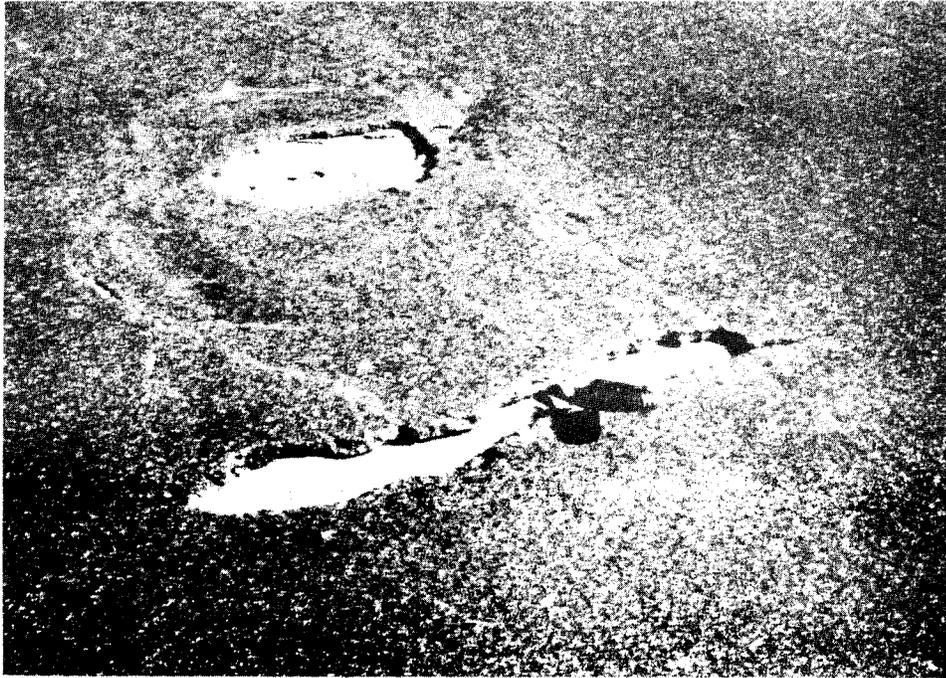
lost, as shown in Figure 11, but the large areas were unbonded. A second application, also applied to a severely deteriorated deck, exhibited extreme distress including loss of the overlay and the development of severe cracking quite rapidly. The third overlay, a more recent application, has been inspected only once, slightly less than one year after its placement. No distress of any sort was noted at that time.

The delamination of the overlay is due to loss of bond rather than the presence of inferior concrete, and it appears that the problem is one of application. In spite of the fact that the mortar mixture was pulled aside periodically to ensure proper wetting of the deck surface by the epoxy binder, the bottom of pieces of the overlay removed during inspections have a porous appearance with many voids apparent, indicating poor wetting of the surface. There is no indication that the failure was due to the nature of the oil modified epoxy resin system, which is not 100 percent reactive.

Figure 11. Delamination of the Guardkote 250 overlay due to loss of bond.

Because of the poor performance of two of the three mortar overlays, use of the procedure cannot be recommended.
