CULVERT STUDIES

Progress Report No. 4

A Comparative Study of Aluminum and Steel Culverts

May 1971  
VHRC 70-R38

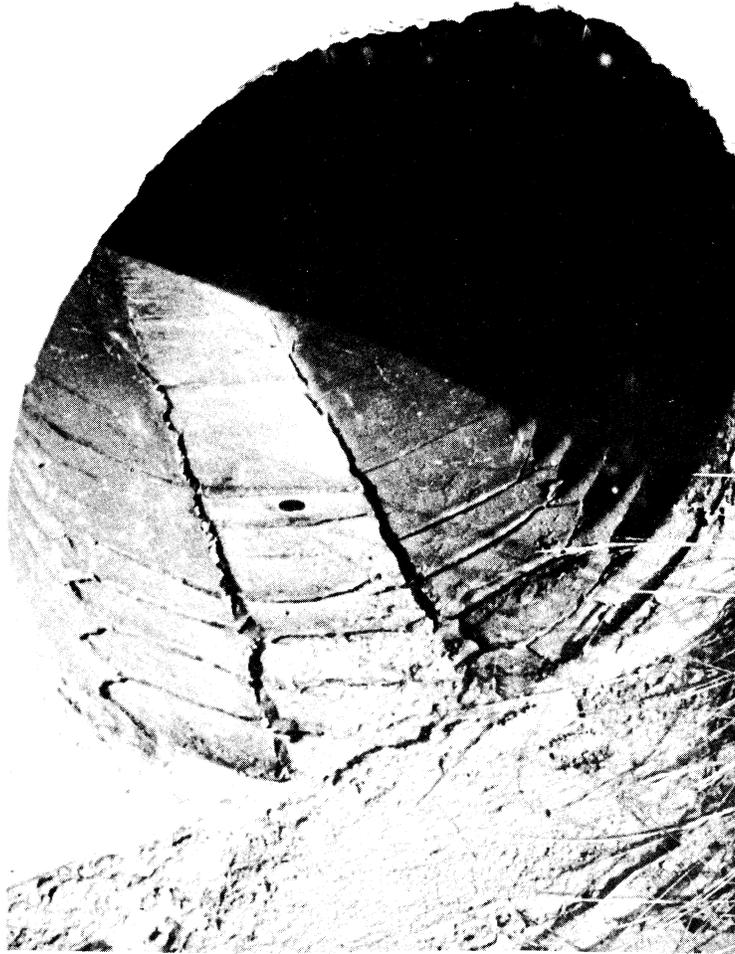
The bituminous coating on the pipes is not an ideal protective measure, but it is probably the best system routinely available. The deterioration of the coating follows a definite form. Rectangular pattern cracking, shown in Figure 1, develops in the heavy paving layer in the invert early in the life of the culvert, probably due to a combination of oxidation and shrinkage of the asphalt and flattening of the cross section of the pipe. Cracking of the invert paving was in fact, noted in culverts on a portion of Interstate 64 opened in the fall of 1970, although no loss of the protective coating or rusting of the steel was observed. The distress is accelerated

Figure 1. Rectangular pattern cracking of the paving layer in the invert of a steel culvert.

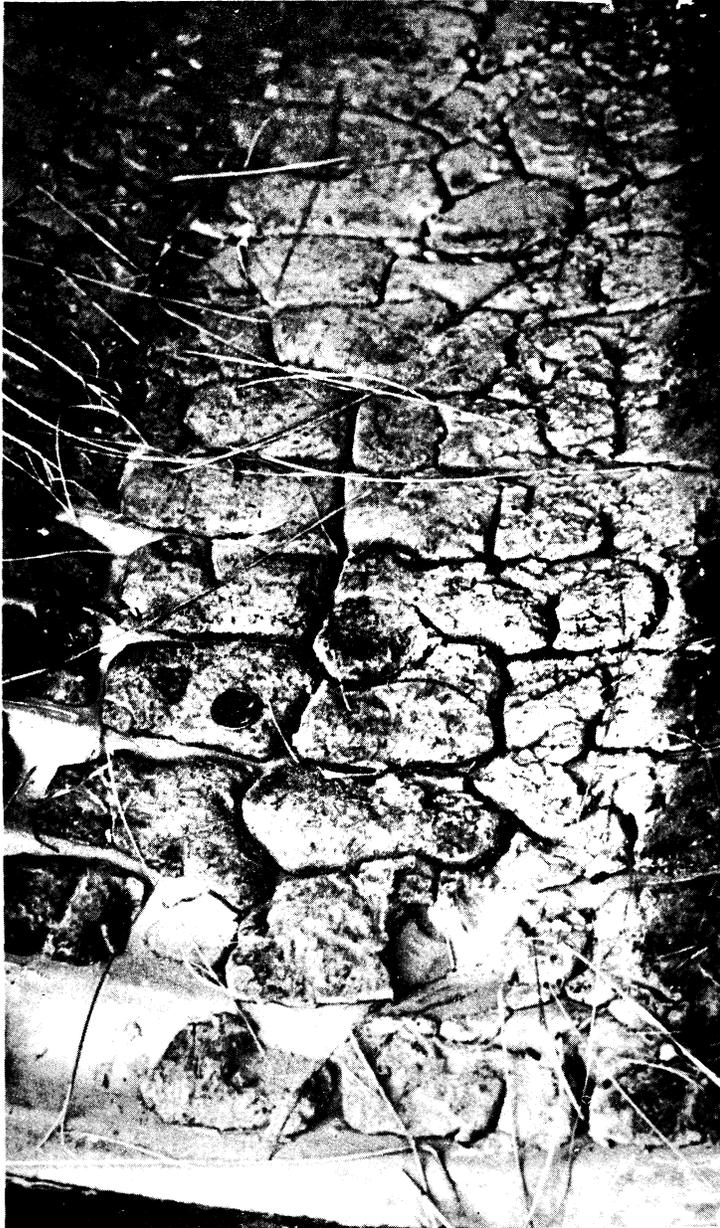
at the ends of the culvert where oxidation is more severe, and the cracks often reach a width of more than  $\frac{1}{4}$  inch as shown in Figure 2. The material is generally well bonded to the culvert wall, but the large pieces between the cracks are occasionally removed, as shown in Figure 3, by the force of the flow or the passage of rocks or debris through the pipe. The zone of severe cracking and subsequent loss of the protective coating generally extends a maximum of 5 to 6 feet into the barrel of the culvert. The coating in the interior of the pipe often exhibits a few narrow cracks, but the distress is never serious.

Figure 2. Widening of cracks in the paved invert at the end of the culvert due to oxidation of the bituminous material.

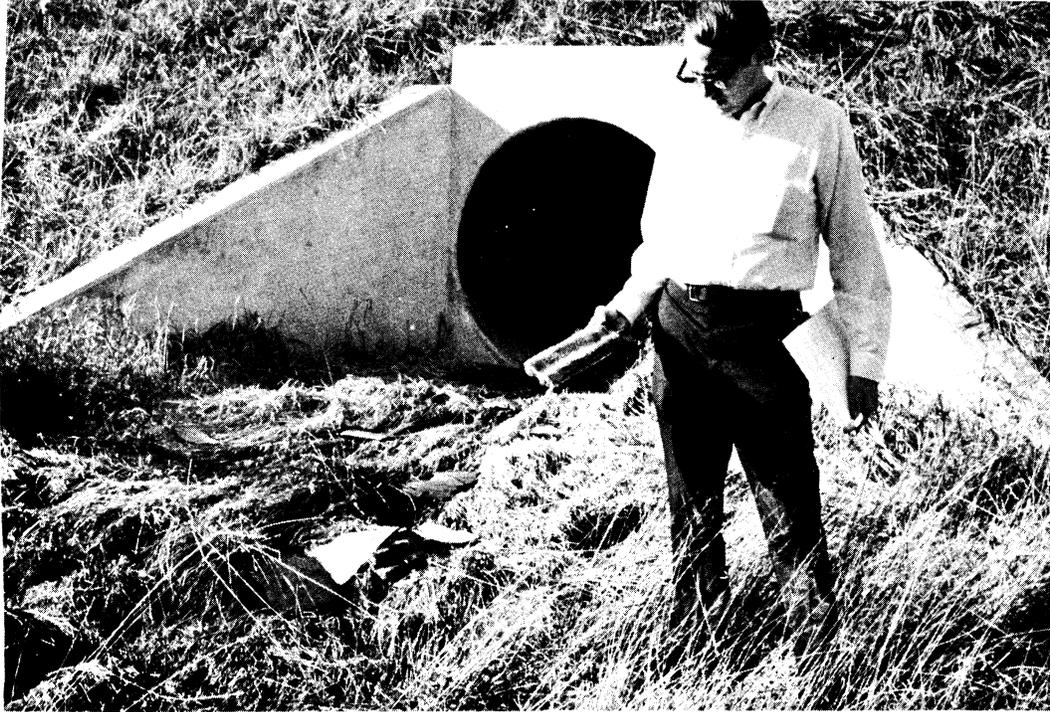
Figure 3. Large sections of the invert paving layer forced out of the culvert.
