INSTALLATION REPORT  
THE USE OF FABRIC REINFORCED OVERLAYS  
TO CONTROL REFLECTION CRACKING OF  
COMPOSITE PAVEMENTS

K. H. McGhee  
Highway Research Engineer  
and  
C. S. Hughes  
Senior Highway Research Scientist

Virginia Highway Research Council  
(A Cooperative Organization Sponsored Jointly by the Virginia  
Department of Highways and the University of Virginia)

February 1973  
VHRC 72-R27

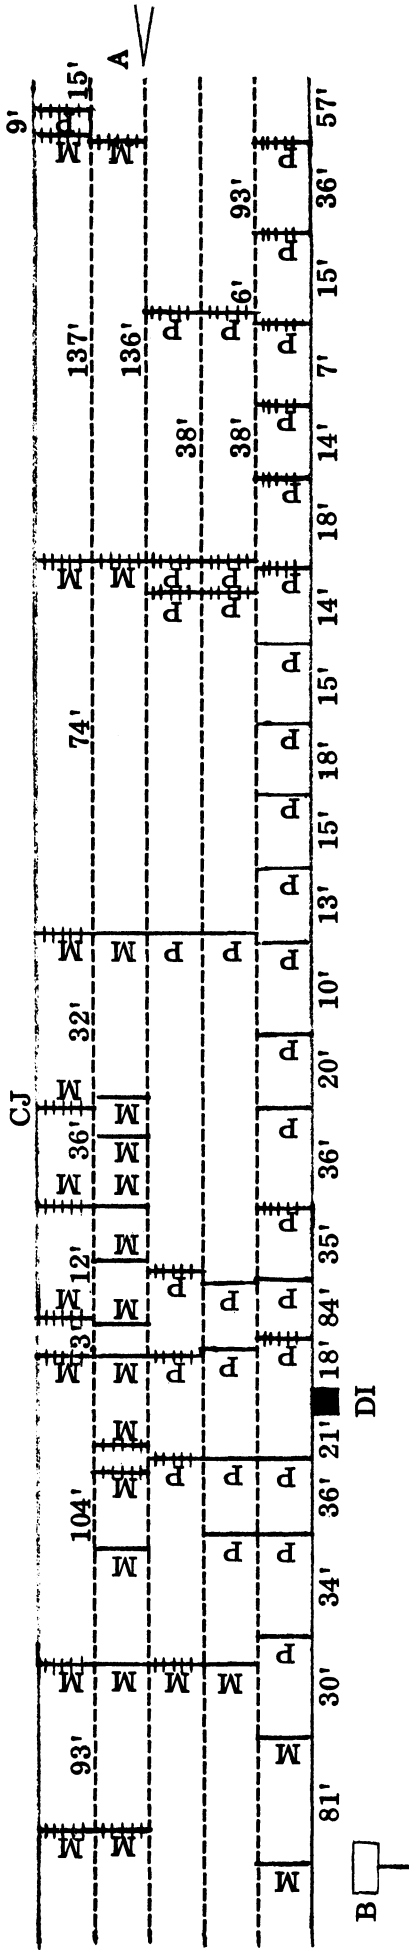
Figure 2. Site #1 — Southbound I-95. (Not to scale.)

- 35 Petromat 18 Petromat void = 17
- 27 Monsanto 17 Monsanto void = 10

All cracks dashed out were damaged prior to application of plant mix and cannot be considered in evaluation.

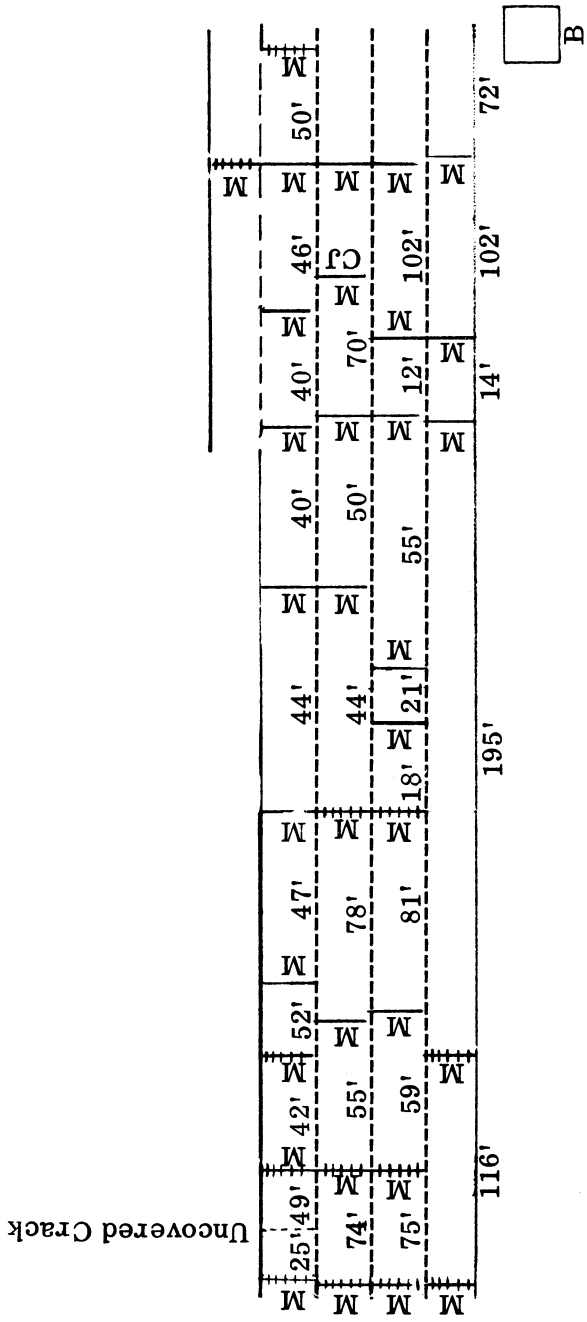
Figure 3. Site #2 - Southbound I-95. (Not to scale.)

33 Monsanto 13 void = 20

Cracks dashed out damaged by construction and cannot be considered in evaluation.

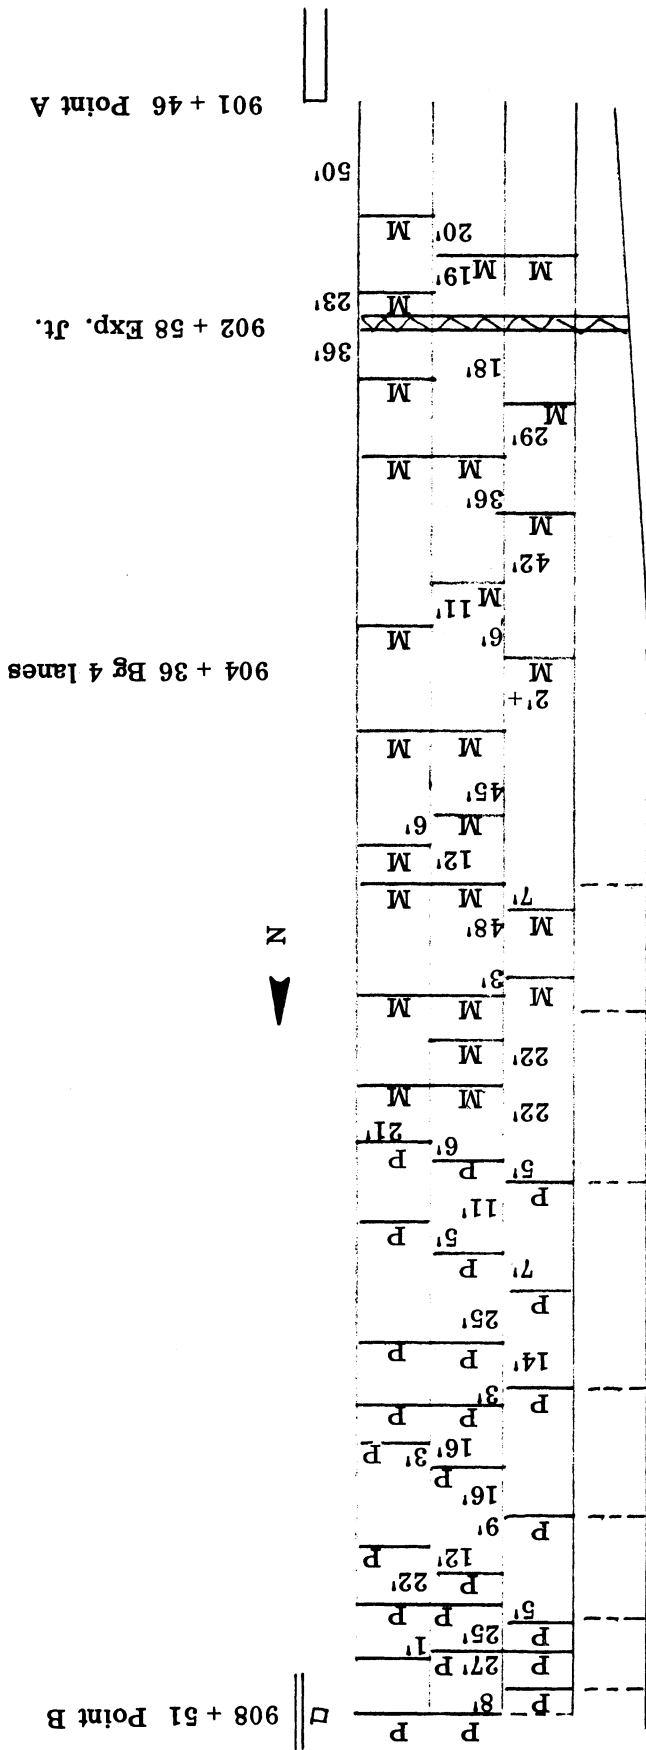
Figure 5. Site #4 - Southbound I-95. (Not to scale.)

M indicates crack covered with Monsanto. Total = 25

P indicates crack covered with Petromat. Total = 25.

Dashed line indicates uncovered crack. Total = 8.

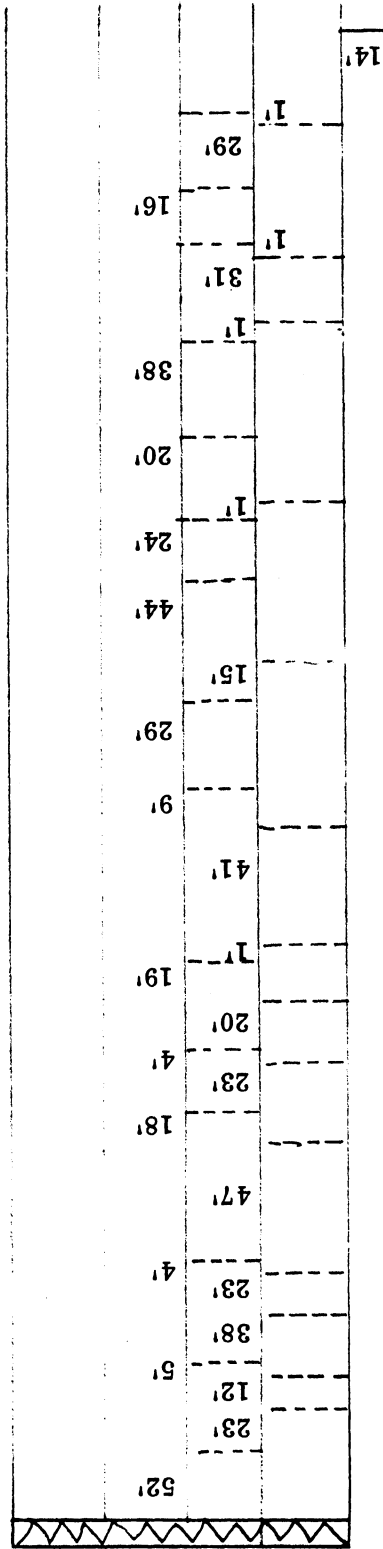
Figure 6. Site #5 - Southbound I-95. (Not to scale.)

- (c) On some sections the fabric had been severely damaged or completely destroyed by construction traffic before the overlay could be applied. Records were kept on all sites to provide a basis for comparison between the cracks where reinforcement is intact and cracks on an untreated control section. When all sections had been overlaid there were 64 Petromat and 55 Chemstrand treated cracks for evaluation purposes. The numbers and location of these reinforced cracks are listed in Table 1 and illustrated in the attached Figures — where cross-hatched cracks indicate pre-overlay fabric damage. Note that Figure 6 shows the location of the control section of untreated cracks.

Dashed line indicates uncovered crack. Total cracks = 29
