A FIELD EVALUATION OF TRANSFLEX  
BRIDGE JOINT PERFORMANCE

Marvin H. Hilton  
Highway Research Engineer

Virginia Highway Research Council  
(A Cooperative Organization Sponsored Jointly by the Virginia  
Department of Highways and the University of Virginia)

November 1972  
VHRC 72-R16

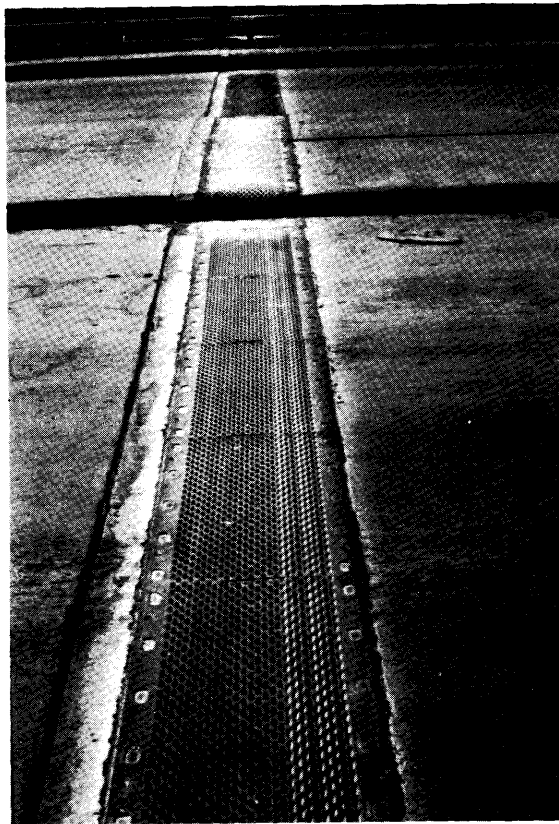
Figure 1. View of an old model Transflex 400 joint with the "honeycomb" type surface texture. (Rte. 154 over Jackson River.)

The model 400 joint (shown earlier in Figures 1 and 2) is in service on three bridges. One, the Route 154 bridge over the Jackson River at Covington, has a steel joint installed at one abutment and a Transflex joint at the other. Inspection of the bridge revealed a number of stained streaks down the face of the abutment backwalls, which suggests that leakage of both joints has occurred. Assuming that joint leakage caused the streaks, it was apparent from a comparison of the two backwalls that the Transflex joint was allowing much less water to pass through.

1. If any older model Transflex 400 type expansion joints remain to be installed on bridges under contract, this design should be replaced with the newer model 400-A in order to achieve better joint performance.
2. The short-term performance of the newer model Transflex designs warrant that they be considered as a viable alternative to other types of bridge expansion joint designs. It should be recognized, however, that the long-term performance of the Transflex joints is yet to be proven.
3. The feasibility of the following suggestions might be considered by the manufacturer:
  - (a) Increase the section length in order to minimize the leakage potential at the ends of the sections.
  - (b) The neoprene wall of the anchorage slot openings might be strengthened by placing the sloped side of the expansion dam wall on the anchorage slot side.

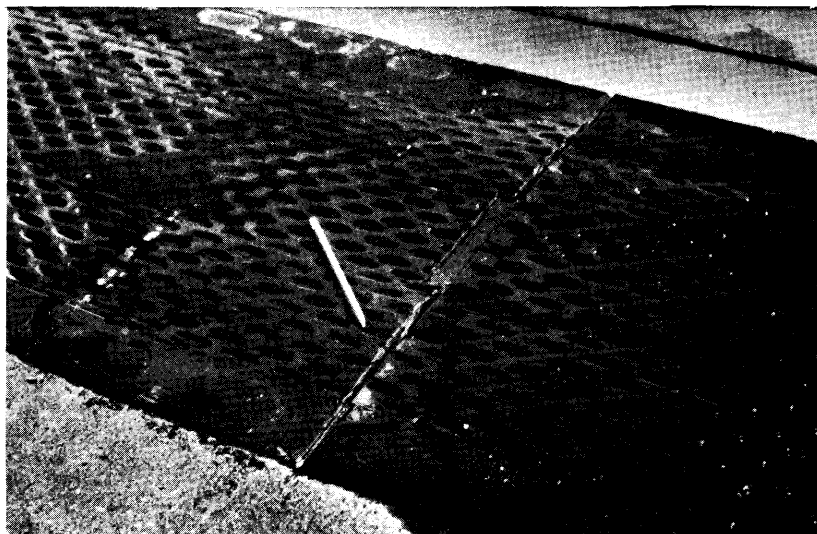
All of the model 400 joints made considerable noise under traffic impact, and one of the joints on a Rte. 58 bridge appeared to be slightly bulged. This effect is shown by the curvature in the ends of the joint sections which is detectable in Figure 4. The upward bulge and the slapping noise effect could be related to the fact that the full 26 inch width of the joint is not reinforced with steel.

Figure 4. View of a joint in a Transflex 400 joint.  
(Rte. 58 over Arrons Creek.)

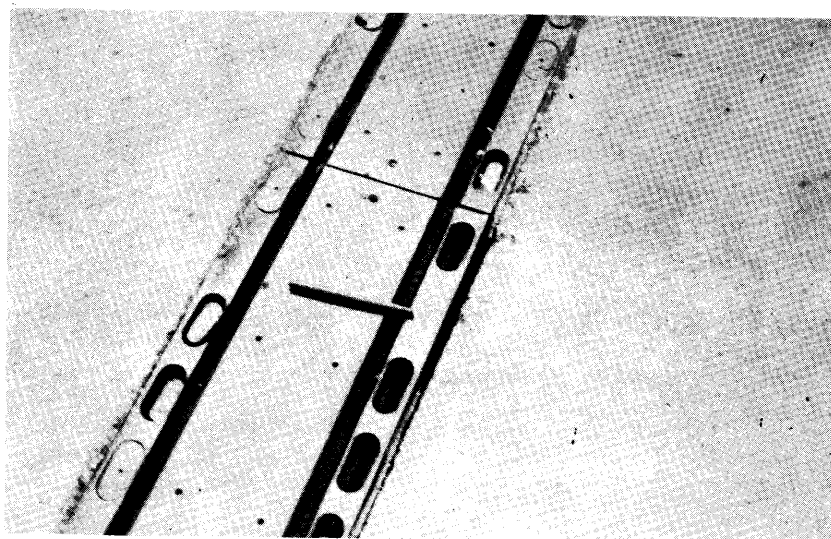
On several installations, such as the model 200-A joint on the Rte. 501 bridge over the Dan River, the major leakage problem appears to be at the end of the 6 foot sections, i.e., at the "joints in the joint". In some cases, however, the source of the leakage could be related to a failure or lack of sealant material at the anchorage bolts or at the interface between the concrete deck and neoprene joint. This possibility is illustrated in Figure 5, which shows an area with a sealant failure and missing slot plugs. This particular joint, an old model 200, has a large number of slot plugs missing — particularly those from the expander slots. While an occasional plug was found missing from the anchor slots in the newer models, the design modifications described earlier have improved upon joint performance and appearance.

Figure 5. A Transflex 200 installation showing missing slot plugs and sealant material. (Rte. 6 over Deep Run Creek.)

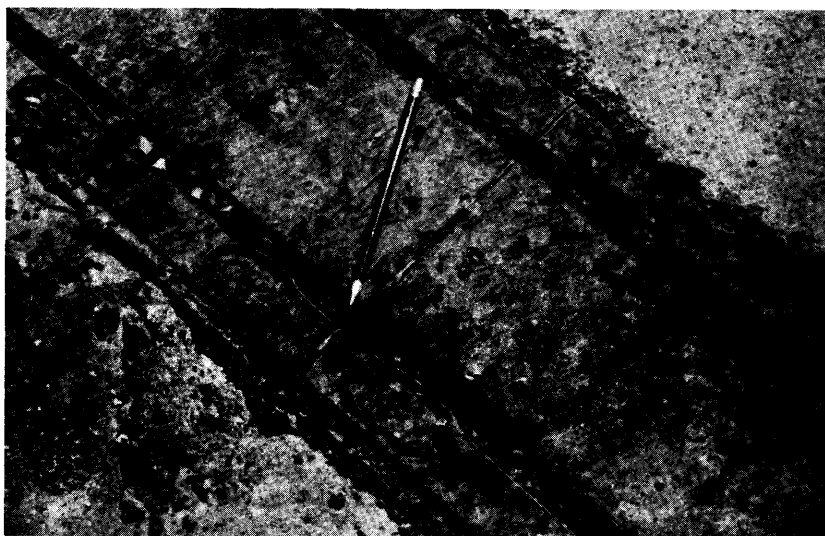
As shown in Figure 6, gravel and loose material can accumulate in the expansion dams of the joints. No detrimental effects were observed, however, and in one instance the loose debris was wedged upward, indicating that the joint was functioning as designed.

Figure 6. Debris accumulation in the expansion dams of a Transflex 200 joint. (Rte. 601 near Goshen.)

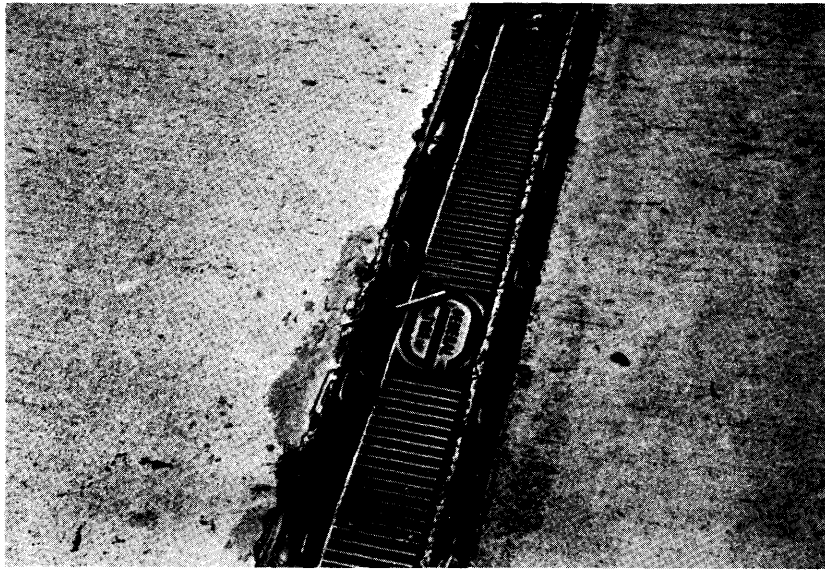
None of the joints showed distress due to wear. On the other hand, several joints had minor cuts or scrapes that possibly were caused by snowplows (see Figure 7.)

Figure 7. A Transflex 200-A joint with a cut in the neoprene.  
(Rte. 501 over the Dan River.)

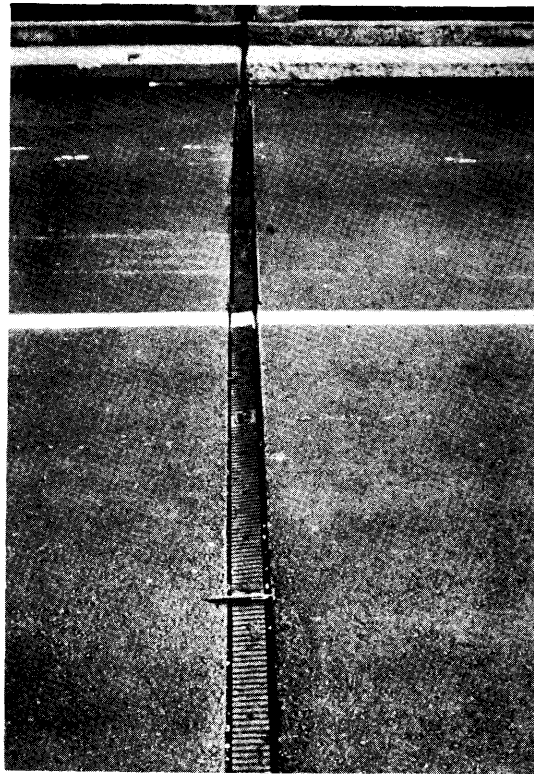
Traffic impact on the 150-A joints produces a rather loud thump. This is probably due to two factors: (1) The vertical web of each of the two inverted steel "T" sections is approximately  $1/8$  inch higher than the  $3\frac{3}{4}$  inch neoprene surface in between, and (2) in most cases the joints were installed slightly lower than the finished grade on the deck surface.

Compared to the models discussed earlier, the 150-A is apparently more difficult to install to grade and alignment. Typical unevenness of a 150-A joint can be noted in Figure 8, where the center line stripe crossing the joint accentuates the mismatched joint alignment.

Figure 8. A Transflex 150-A maintenance type joint on a resurfaced deck.
