MEASURES FOR PREVENTING WRONG-WAY ENTRIES ON HIGHWAYS

N. K. Vaswani  
Highway Research Engineer

Virginia Highway Research Council

June 1973  
VHRC 72-R41

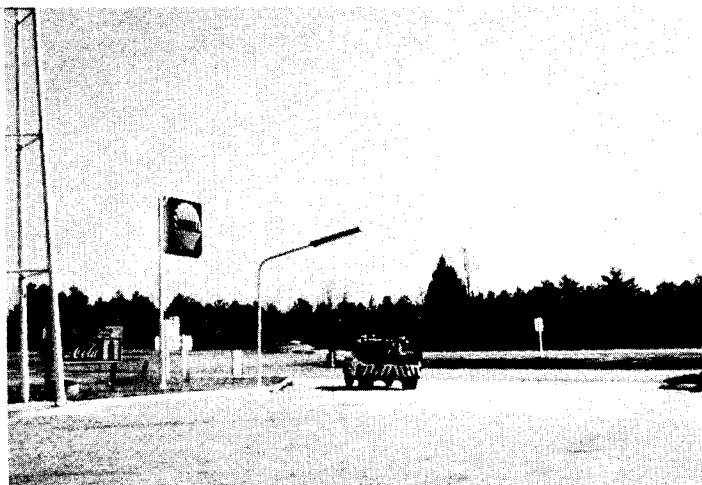
Figure 1. Example of an intentional wrong-way exit from a gas station. (Rte. 207 near Carmel Church.)

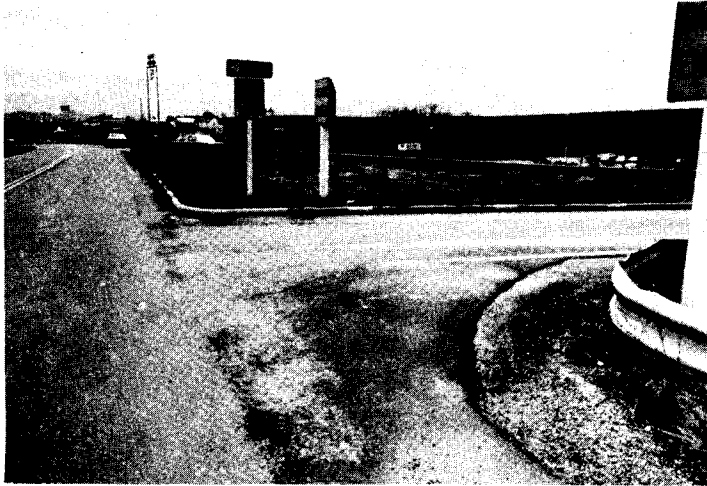
During this investigation it was observed that on almost all interchanges on which wrong-way entries had been made into the exit ramp and from the exit ramp into the crossroad, the left corner of the left lane of the exit ramp flared into the right pavement edge of the crossroad. An example of the flared end is shown in Figure 4 (a).

It was also observed that in the case of divided crossroads, some of the flares had collected dust, thus indicating their disuse. Examples are given in Figures 4 (a) and 5 (a). These flares may be either due to construction expediency or the design requirement for a left-turn curve from the exit ramp to the crossroad. When they have been provided to satisfy the left-turn curve designs, it is recommended that their designs be checked and the flares be removed or their use be prevented if they are not required. If these flares are found to be necessary, the following two alternative designs are suggested:

Figure 4(a). Present condition — view from crossroad of exit ramp where wrong-way entry took place.

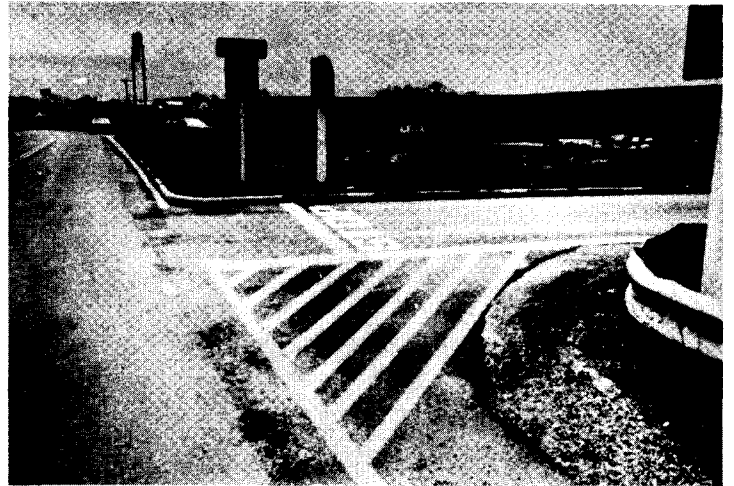
Figure 4(b). Suggested improvement of exit ramp shown in Figure 4(a) by marking pavement in flared corner and providing a stop line.

- (1) Provide pavement marking only or marking and rumble stripping over the flare such that the left edge of the left lane of the exit ramp makes a right angle with the pavement edge of the crossroad. This will discourage cars and other light vehicles — which for the most part are those involved in wrong-way entries — from using the flares. An example of flare marking is shown in Figure 4 (b).

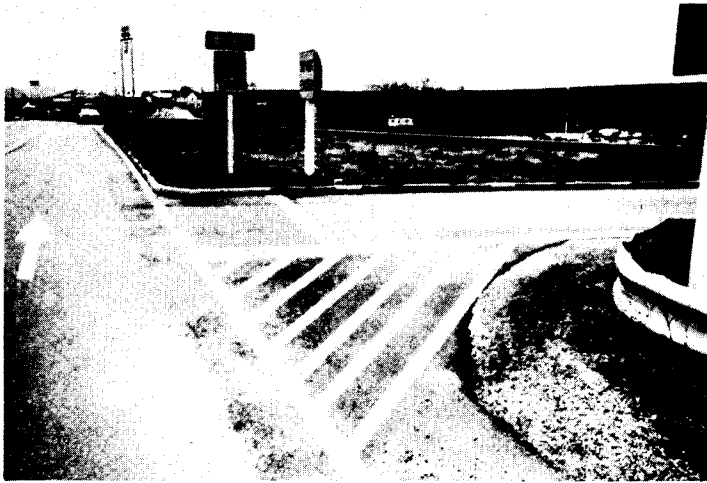
Figure 4(c). Further improvement of exit ramp over that shown in Figure 4(b) by continuing pavement edge line (broken) across exit ramp junction and adding an arrow.

It is therefore recommended that continuation of the pavement edge line — either broken or solid — as shown in Figures 4 (c) and 4 (d) be tried. It is obvious that the solid line should be more effective than the broken one.

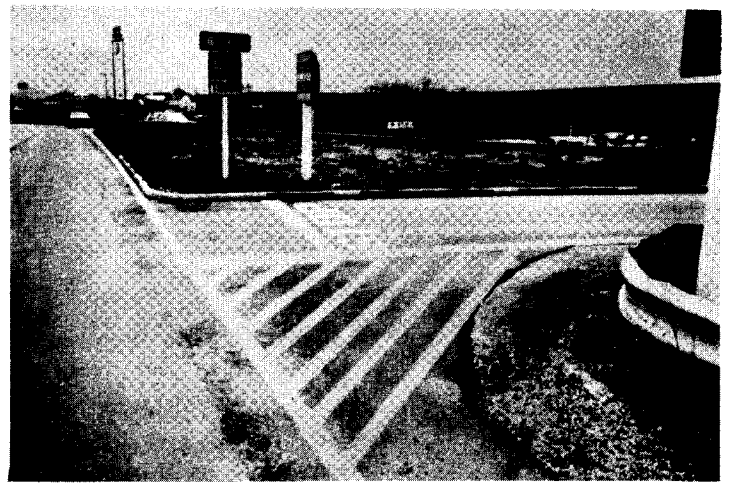
Figure 4(d). Continuation of pavement edge line (solid) across exit ramp junction would be an improvement on dotted line shown in Figure 4(c).

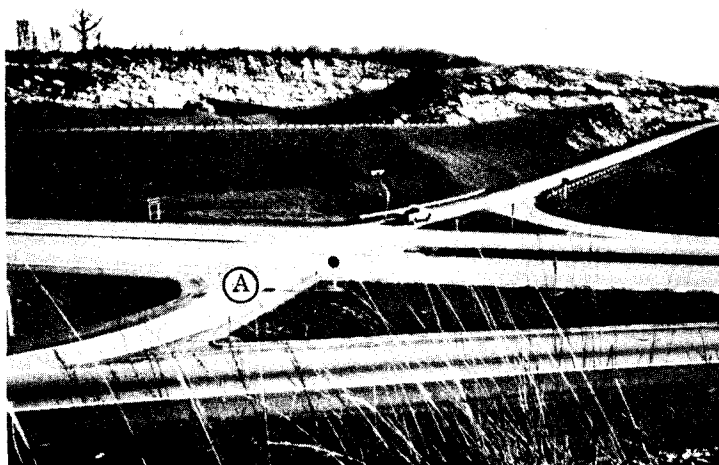
A wide pavement at the junction of the exit ramp with the crossroad makes wrong-way entry onto or egress from the exit ramp easy; narrow pavements will discourage them. Some of the lanes of the exit ramps could be narrowed considerably, as shown in Figure 5 (a). This figure shows the excess width has collected dust, indicating disuse.

Figure 5(a). Present condition — elevated view of exit ramp with its left lane and junction with crossroad, marked 'A'. Note (1) the dark patches of unused pavement at flare and left edge, and (2) one-way, do not enter, and wrong-way signs are not provided for the crossroad.

Figure 5. Interchange 53 on I-81 south. Site of two wrong-way entries on crossroad, both by non-drunken drivers.

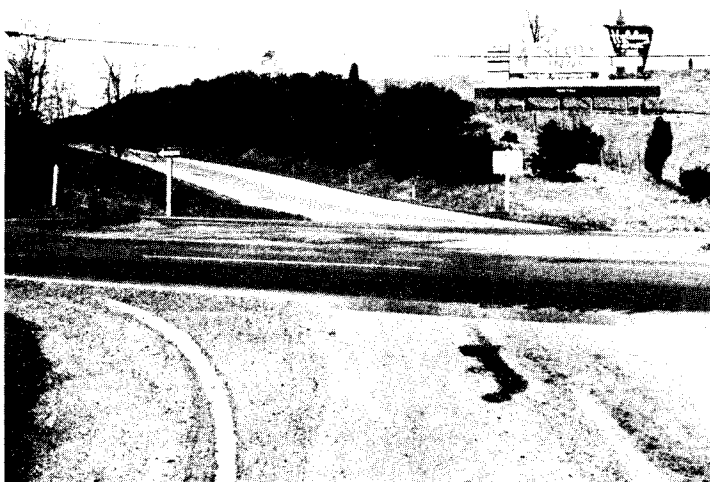
Figure 6(a). Interchange 7 — view from I-81 south exit ramp onto Route 140 south. Site of wrong-way entry from the crossroad by a non-drunk driver. Remove flare by pavement marking.

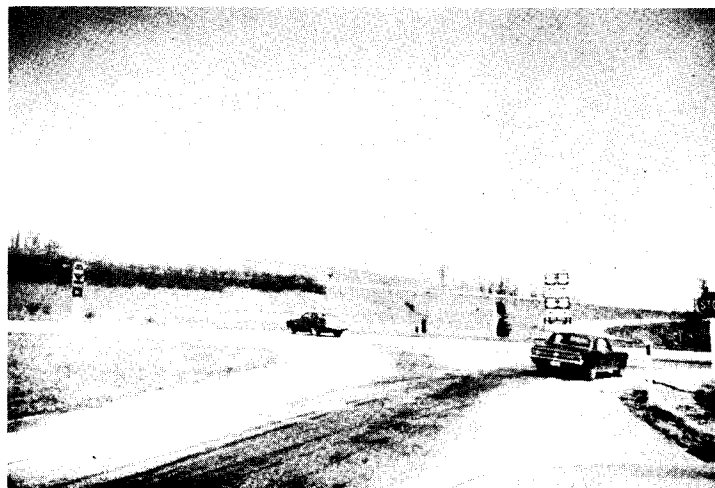
Figure 6(b). Interchange 9 — view from I-81 north exit ramp onto Route 11. Site of wrong-way entry by drunken driver from the crossroad. Channelize left lane by eliminating flare on left and dividing island on right.

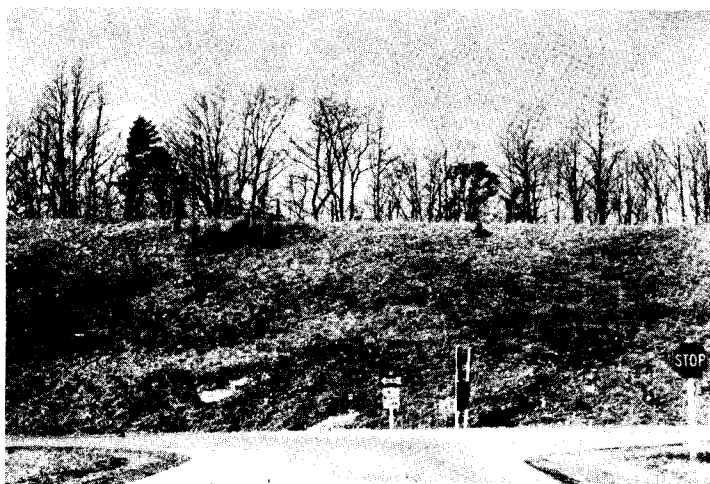
Figure 7(a). Condition after accident — view from crossroad of right exit ramp and left entry ramp. Note stop sign on crossroad and low height of no right turn sign.

Figure 7. Interchange 49 on I-81 south. Example of improvement in signing and marking. Site of wrong-way entry from crossroad by drunken driver. Two killed, five injured.

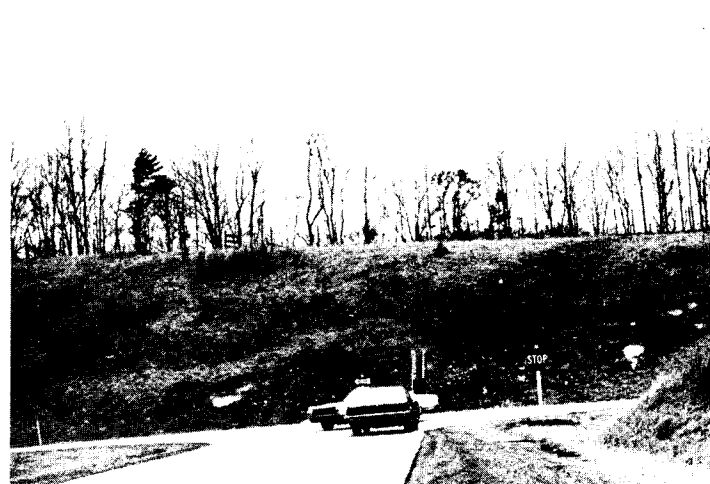
Figure 7(b). Same signs as in Figure 7(a). No right turn sign not visible due to vehicle interference.

Figure 7 (b) shows that due to interference from a car, the driver approaching a T-junction is unable to read a "no right turn" sign, shown in Figure 7 (a). Such signs need to be elevated, as shown in Figure 7 (d).

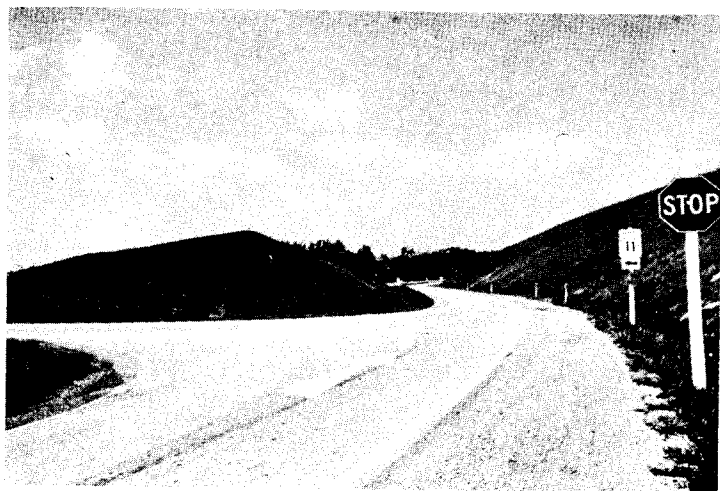
Figure 7(c). View from the exit ramp of the same interchange. The signs have been changed and pavement marking provided. The stop sign and stop line are now on the exit ramp.

For optimum viewing conditions, one assumes a need for one inch of letter height for each 50 feet of viewing distance.<sup>9</sup> Thus a 4-inch high letter would be legible from a distance of 200 feet. Then, taking 10 degrees as the cone of vision (i. e. 5 degrees to each side of center line) the 4-inch letter sign placed 8 feet from the right edge of a pavement having 12-foot lane width can be read by a driver at 200 feet and will go out of his cone of vision after he has travelled 25 feet (he can read the sign for a period of 0.57 second at 30 mph). The 4-inch letter sign placed at 15 feet from the edge of the pavement will not come within the 10 degrees cone of vision of the driver. A sign placed at 10 feet from the pavement edge would be visible to the driver for a period of less than the wink of an eye. An example of how far from the pavement edge the signs are sometimes being placed is shown in Figure 7 (c).

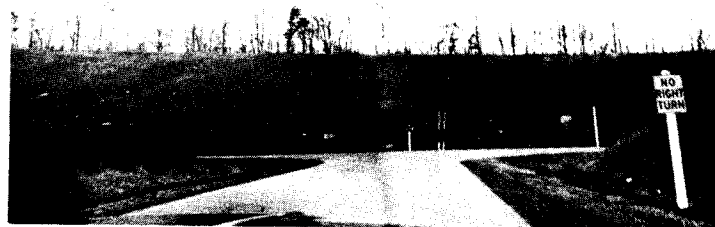
Figure 7(d). Same interchange as in Figure 7(c). View from crossroad. Note the location of the no right turn sign on the extreme edge of the right shoulder.

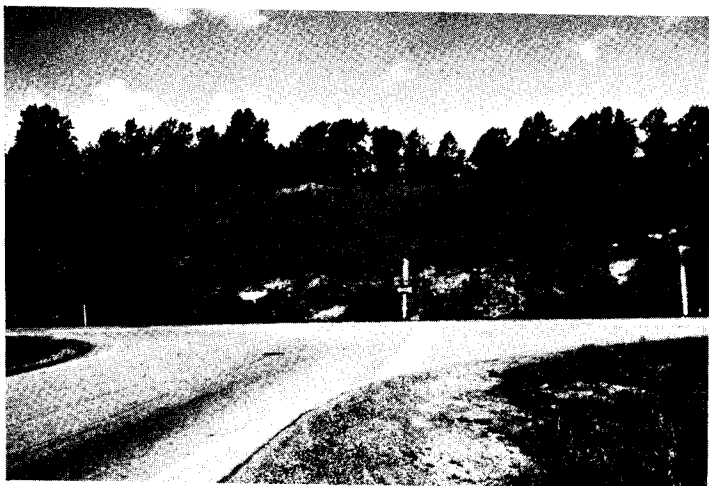
Figure 7(e). View from crossroad closer to the junction with the exit ramp on right and entry ramp on left.

During the investigation it was found that at two intersections the stop line was closer to the edge of the crossroad than the minimum distance specified in the Virginia manual. This is an improvement because the line is clearly visible from a considerable distance in both the lanes. An example of this is shown in Figure 7 (e).

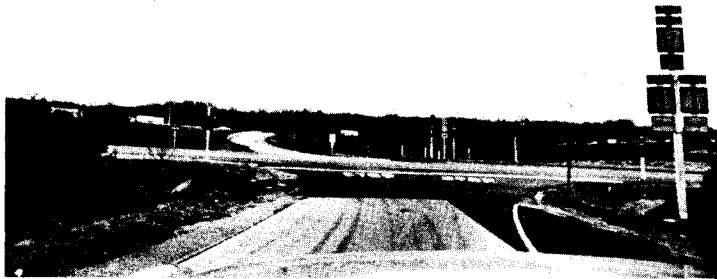
Figure 8(a). Present condition — view of Route 1 crossroad from I-95 south exit ramp.

Figure 8. Interchange of I-95 South with Route 1. Example of improvement. Place of six wrong-way entries on crossroad by non-drunken drivers.

The sign shown in Figure 13 (a) could replace the road intersection sign of Figure 8 (a) as shown in Figure 8 (c). Another alternative is to provide a sign such as shown in Figure 13 (b) at the left corner of the exit ramp as shown in Figure 8 (d).

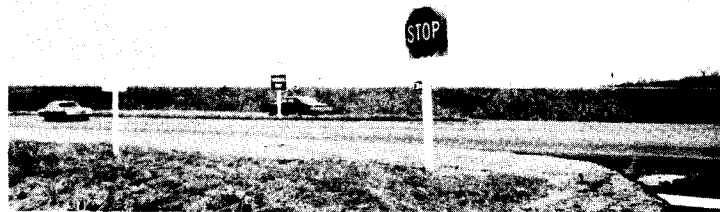
Figure 8(b). Closer view from I-95 south exit ramp.

In Figure 8 (b) no delineators are provided at the nose of the median, and the nose seems to be quite far from the left turn path of a vehicle. The design of the median space should be checked and decreased if possible; otherwise nose marking should be provided.

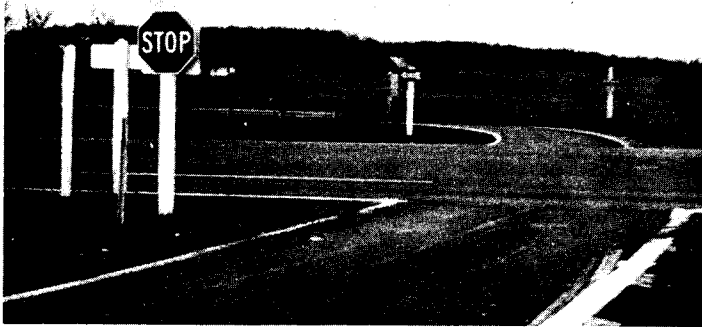
Figure 10(a). Interchange 32 on I-81 south — view from exit ramp. Right-angled intersection and conspicuous one-way median crossing on 4-lane crossroad. Compare channelization and pavement marking with median crossing in Figure 16(a).

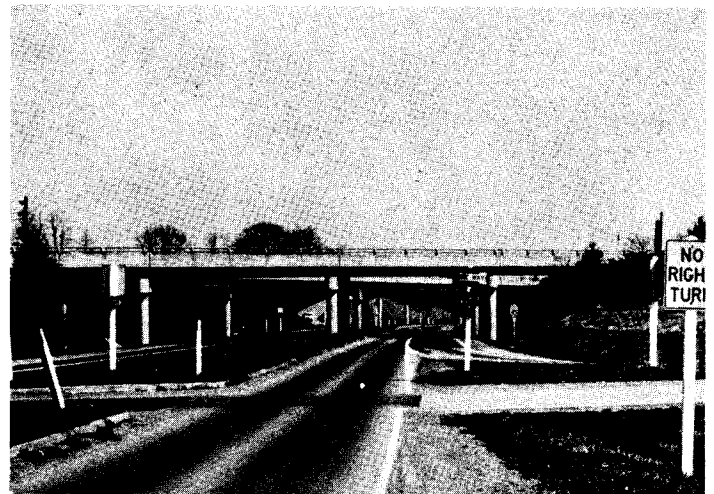
Figure 10(b). Interchange 7 on I-81 north — view from crossroad of exit ramp on right. Right-angled intersection with conspicuous median on 2-lane crossroad. Compare with Figure 6(a). The no right turn sign is close to intersection. Compare location of sign with those in Figures 7(c) and 7(d).

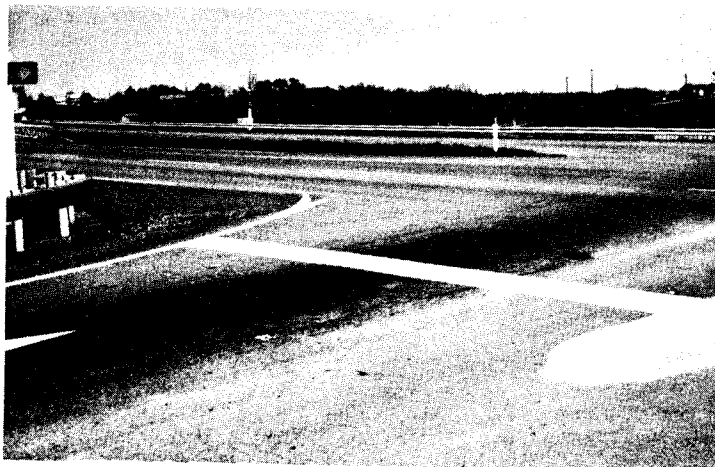
Figure 12(a). Interchange at I-64 West and Rte. 340 — view from exit ramp. One-way, do not enter, and wrong-way signs not provided on median of crossroad. No accident so far.

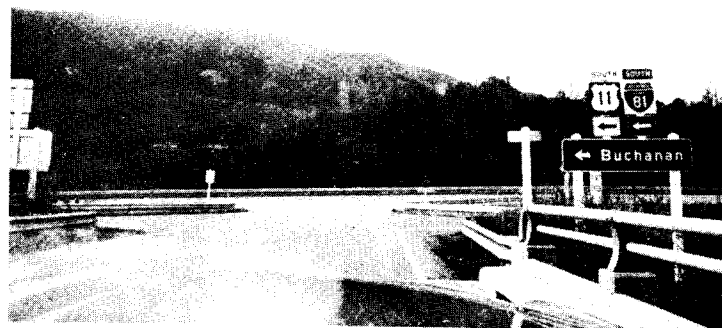
Figure 12(b). Interchange 48 on I-81 — view from crossroad with exit ramp on right. Site of two wrong-way entries by drunken drivers. No right turn sign missing. Other exit ramp of same interchange had one wrong-way entry (by normal driver). No right turn sign missing here also. No lane separation marking provided.

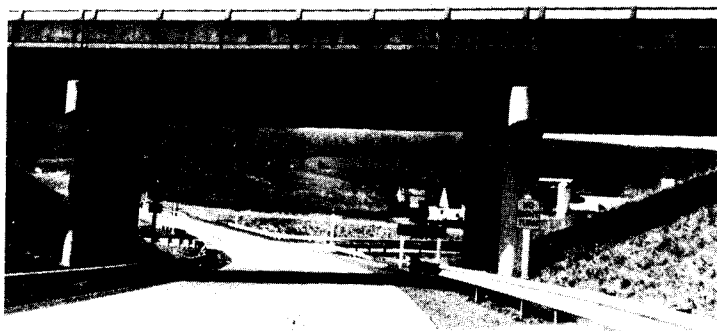
Figure 12(c). Interchange 53A on I-81 — view from crossroad with exit ramp on right across the bridge underpass. Site of two wrong-way entries from crossroad both by drunken drivers. No right turn sign improperly placed. Should be as shown in Figure 12(d). No lane separation marking provided.

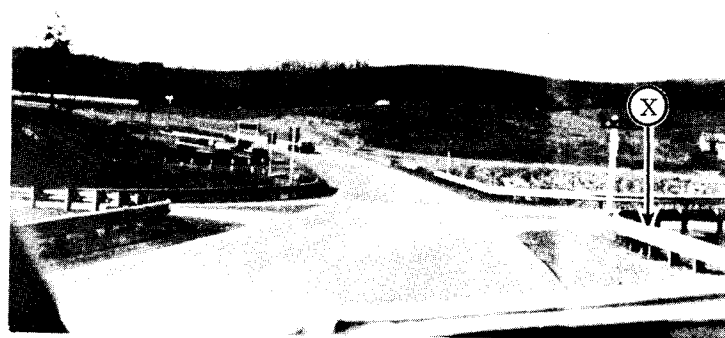
Figure 12(d). Interchange 53A and 81 south exit ramp on right. Site of two wrong-way entries. The arrow shows a better location of no right turn sign. See Figure 12(c). No lane separation marking provided.

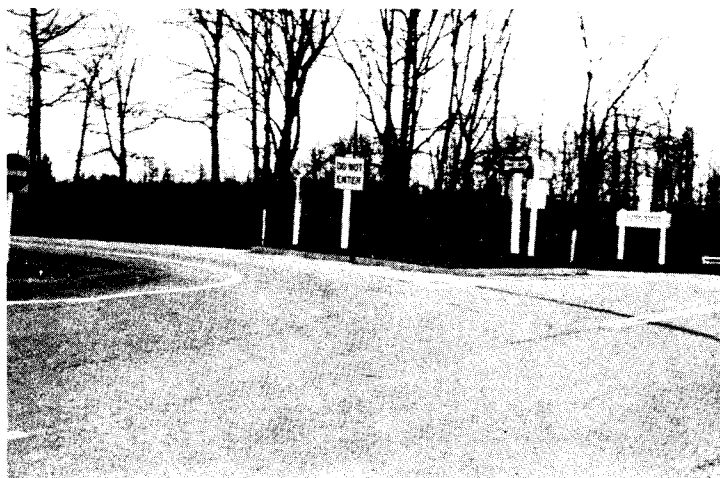
Exit 33 on I-81, the site of a recent accident in which six people were killed, might be improved through a change in pavement marking. At this exit, an opening was made in the double yellow lines, probably to enable drivers coming from I-81 via the right lane of the exit ramp to go back to the same lane of the interstate via the entry ramp. An opening is provided to the left lane too. Figure 14 shows this opening. A drunken driver coming from the gas station went through this opening into the right lane of the exit ramp as shown by the arrow in Figure 14 (b). To discourage wrong-way driving provision of about a 24" wide stop line and continuation of the yellow lines as shown in Figure 14 (c) is recommended.

(a) View of the exit of the right turn lane of I-81 south exit ramp, as seen from across the road while coming out of a service station. Notice the opening in the double yellow lines dividing the two lanes.

Figure 14. Exit 33 on I-81 — Site of wrong-way entry by a drunken driver. Six persons killed.

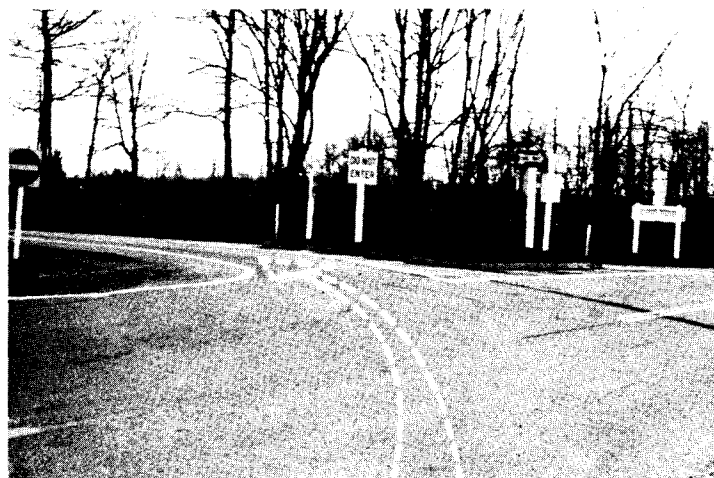
(b) The driver went through the opening in the double yellow lines and entered the wrong way through the right lane of the exit ramp as shown by the arrow. Recommended improvements are: (1) Provision of yellow lines and pavement edge lines as shown in Figure 15; and (2) provision of stop lines.

The signing system was good except for a slight congestion of sign posts on the dividing island of the exit ramp. The deficiencies are (1) the opening in the yellow lines as shown in the figures, and (2) no stop line is provided on the right lane of the exit ramp before entry into the crossroad. Recommendations for improving the intersection are given in Figure 14 (b).

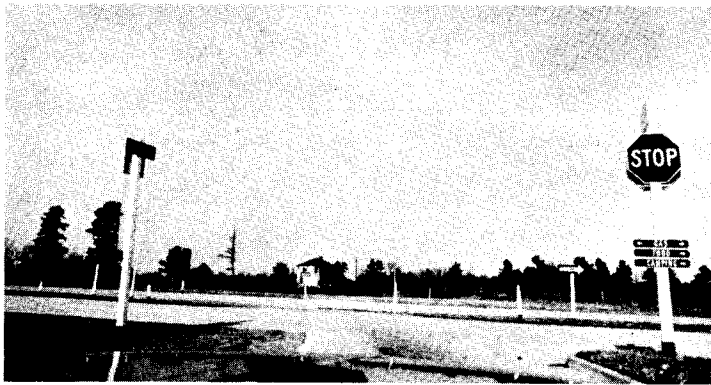
Figure 16(a). Exit ramp of I-85 to Rte. 460 and Rte. 1. Cross-over for left turn is one-way, has gravel nosed median and hence hardly visible, even at stop sign. Pavement marking around nose or concrete nose painted yellow might prevent possible wrong-way incident. No wrong-way incident reported so far.

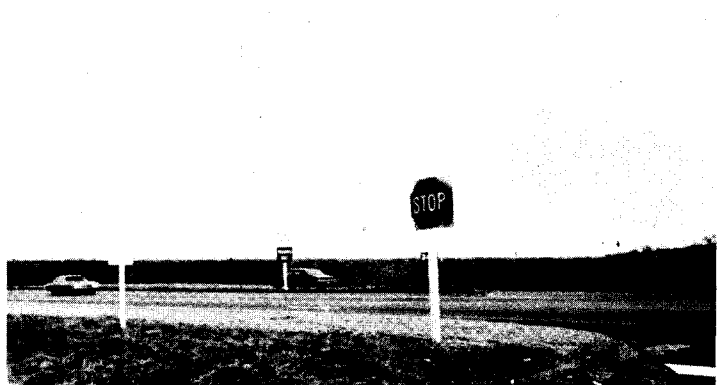
Figure 16(b). Exit ramp of I-95 south and Rte. 1 median. Site of six wrong-way incidents. Left median nose needs to be delineated and median opening reduced as shown in Figure 8(d).
