EVALUATION OF SEVERAL TYPES OF
CURING AND PROTECTIVE MATERIALS
FOR CONCRETE

Interim Report

Part III - Performance

July 1973
VHRC 73-R1

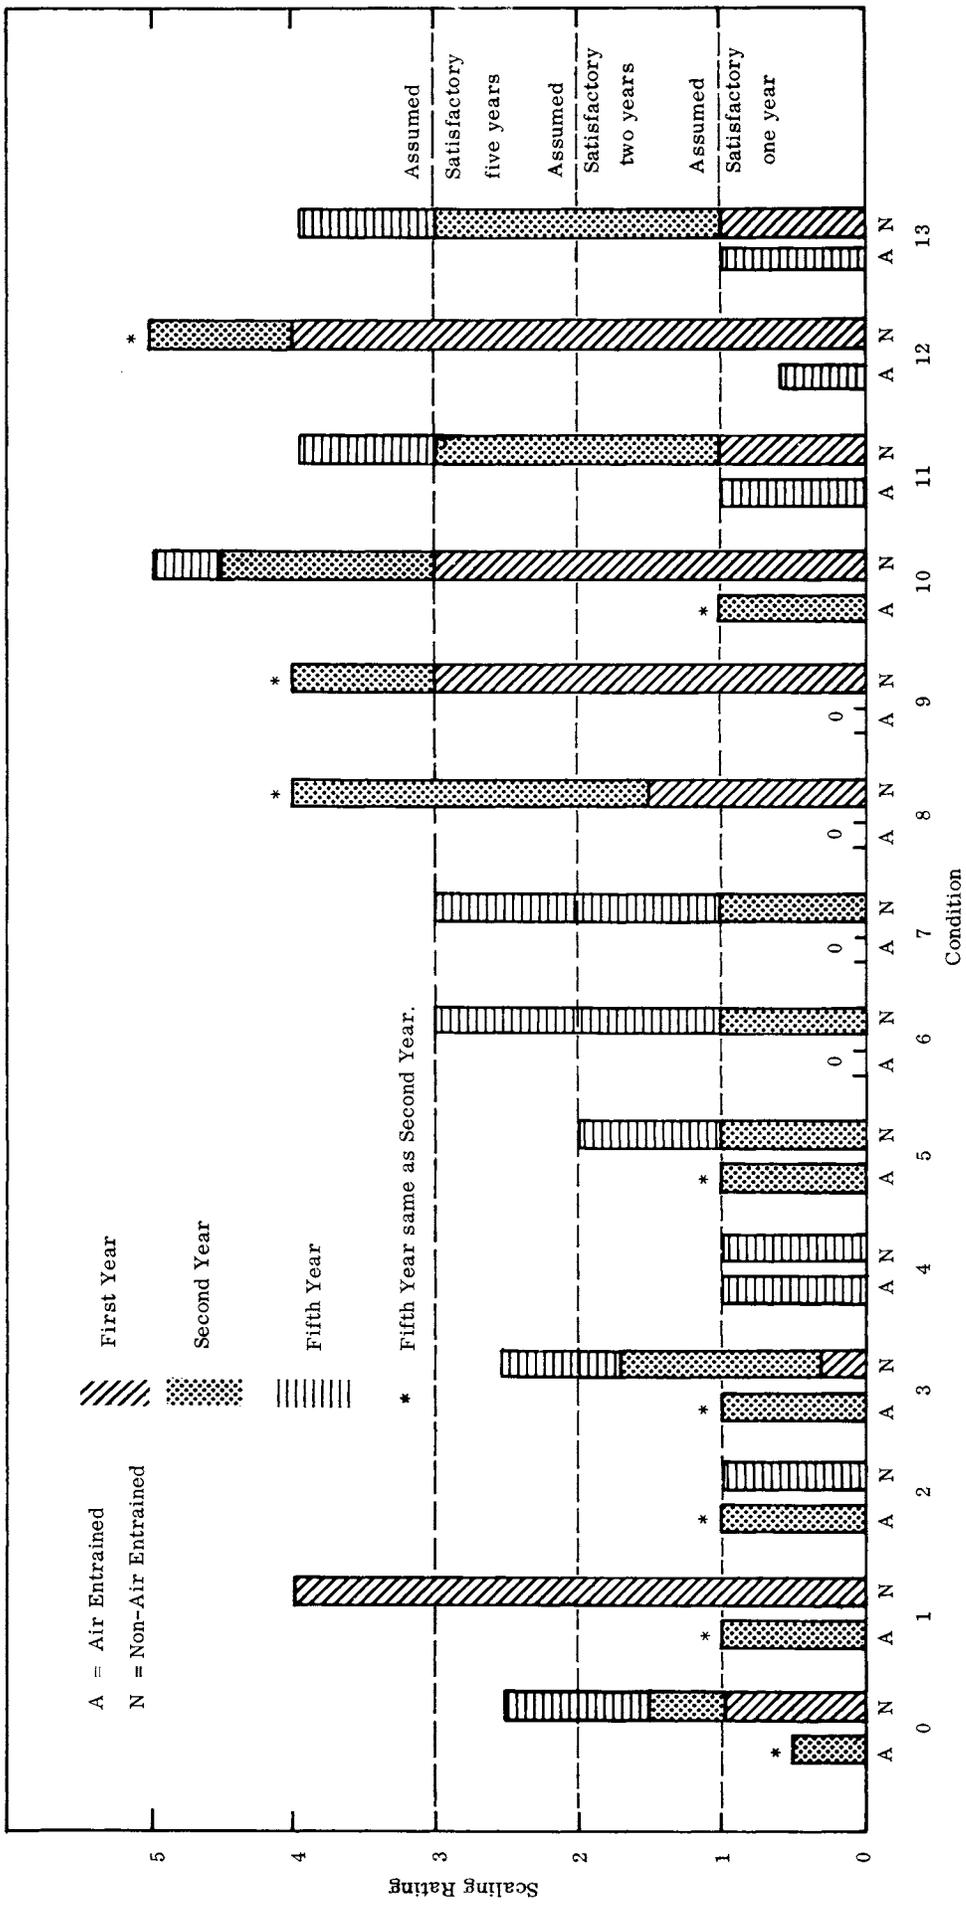
The scaling ratings for the slabs after one, two, and five winters are shown in Figure 3. In Part I, which included data for the slabs after two winters of exposure and the results from accelerated laboratory freezing and thawing tests after 300 cycles, it was concluded that non-air entrained specimens representing conditions 2, 3, 4, 5, and 6 and all air entrained specimens performed significantly better than did those representing the remaining conditions. Specimens for conditions 3, 4, 5, and 6 received linseed oil treatments. These treatments were particularly effective during the early exposure as evidenced by the results after 100 cycles of laboratory testing or one winter of exposure in the outdoor scaling tests. In all testing the several chlorinated rubber compounds performed poorly when compared with various curing methods followed by a treatment with linseed oil.

Figure 3. Scaling ratings of slabs in outdoor exposure. Average values are given for multiple occurrences of a test condition.

Reference to Figures 3-9 will show that the major portion of the scaling appeared on the non-air entrained slabs during the first or second winter. The progression of scaling has slowed. The obvious influence of the surface treatments placed upon different quadrants is particularly evident in Figures 5, 6, 7 and 9. But by far the most dramatic comparison is between the performance of the air entrained and non air-entrained slabs (B and C in each figure). On the air entrained slabs many of the protective treatments are still intact. This reconfirms the well documented fact that the best defense against deicer scaling is properly proportioned air entrained concrete.

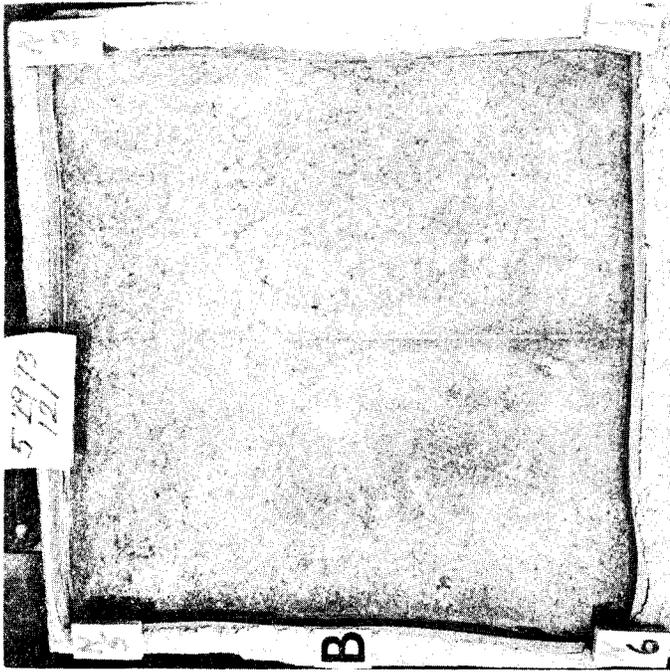
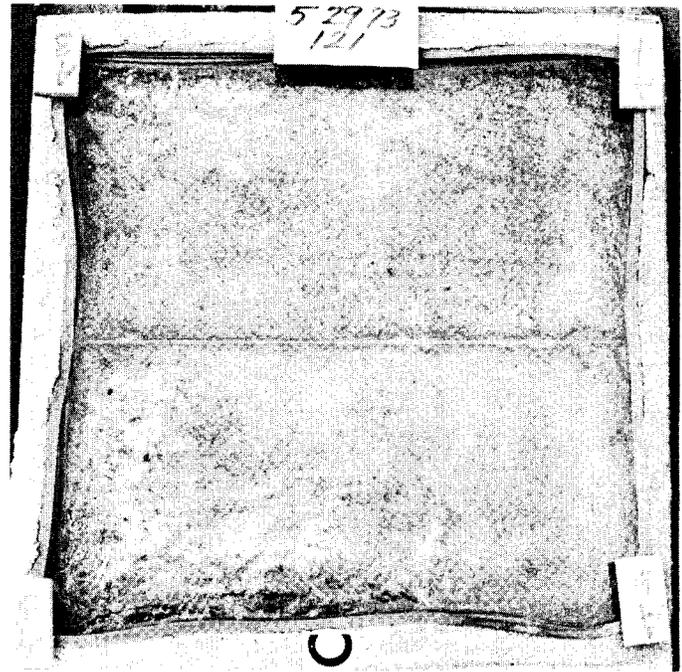
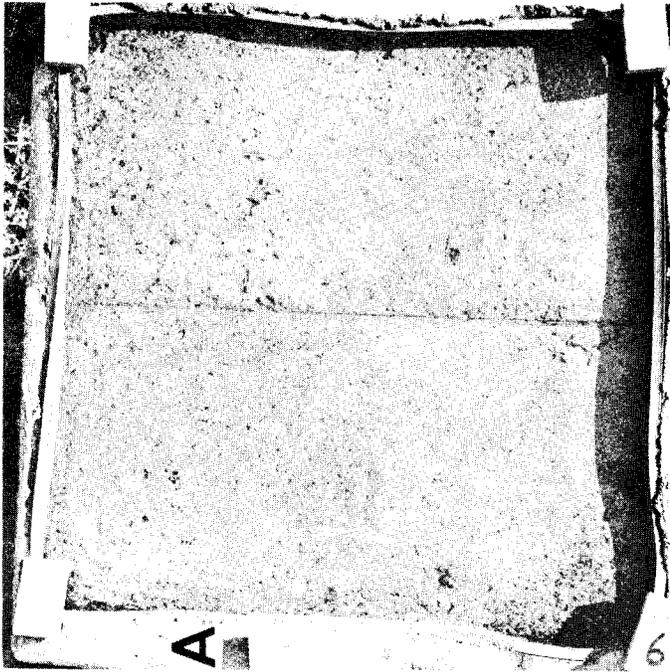
Figure 4. Appearance after deicing of conditions 3 (LMS + LOT), 4 (WPS + LOT), 5 (MEF + LMS + LOT) and 6 (MEF + WPS + LOT).

(A) Non-air entrained — 77 cycles (three winters)
 (B) Non-air entrained — 123 cycles (five winters)
 (C) Air entrained — 123 cycles (five winters)

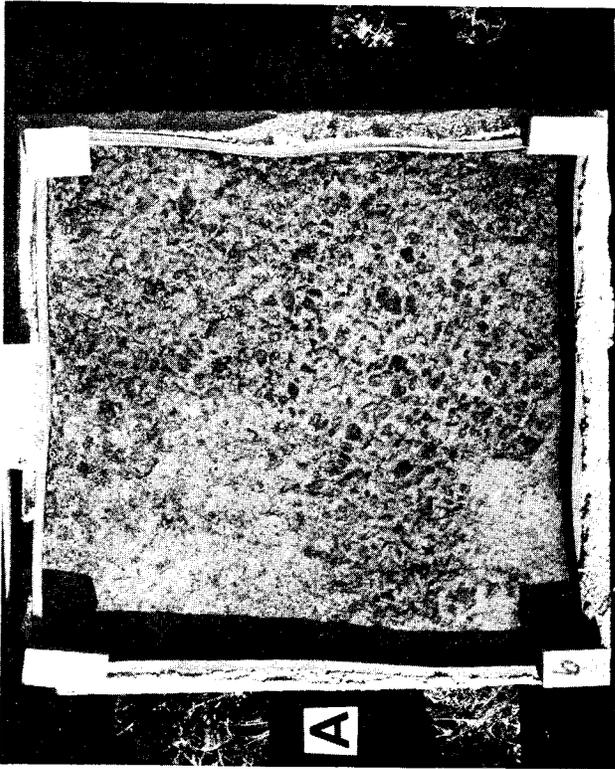
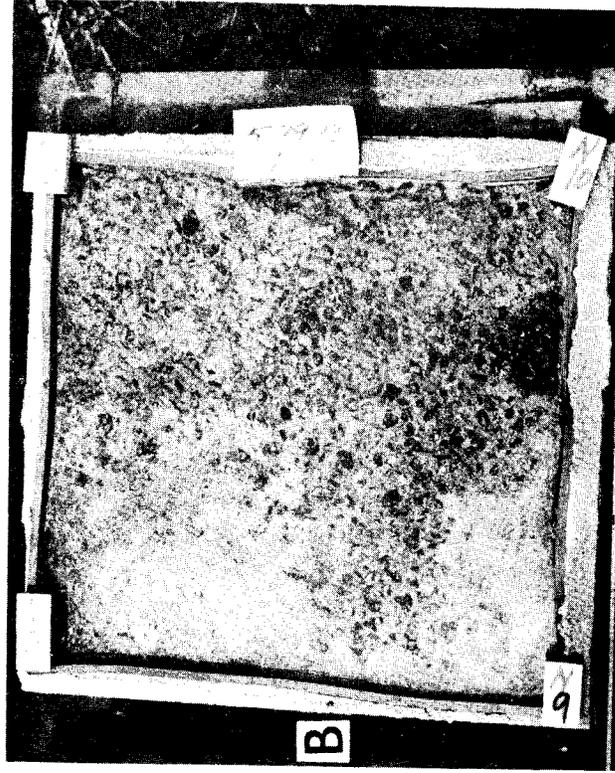
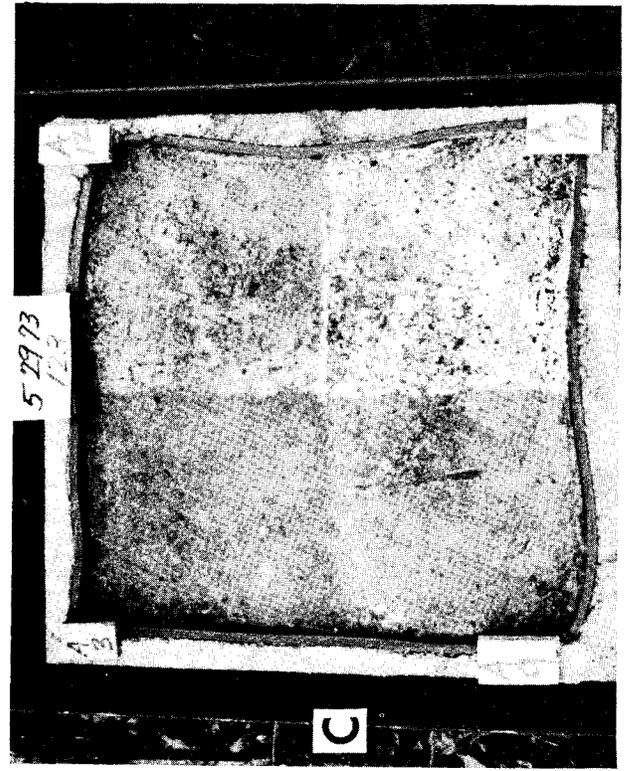
Figure 5. Appearance after deicing of conditions 3 (LMS + LOT), 9 (CRS₂ - L), 10 (CRS₂(LP)), and 12 (CRS₃ - H).

- (A) Non-air entrained — 77 cycles (two winters)
- (B) Non-air entrained — 123 cycles (five winters)
- (C) Air entrained — 123 cycles (five winters)

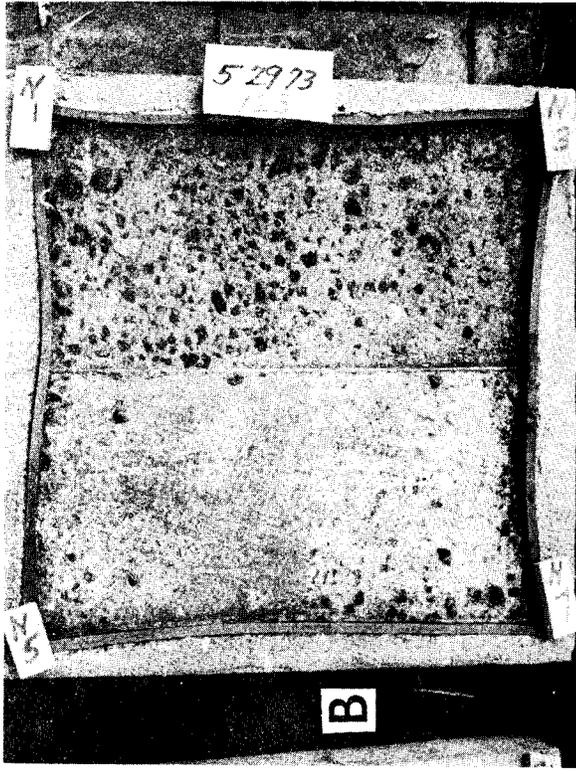
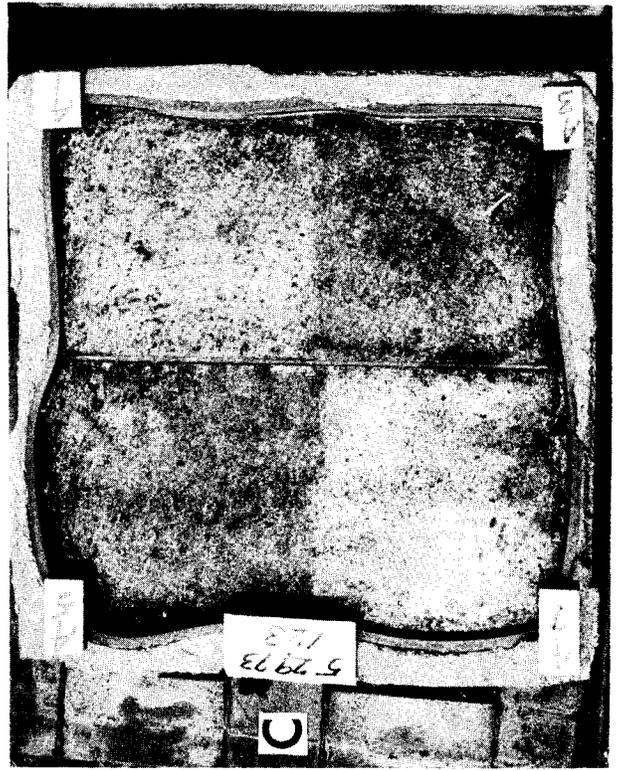
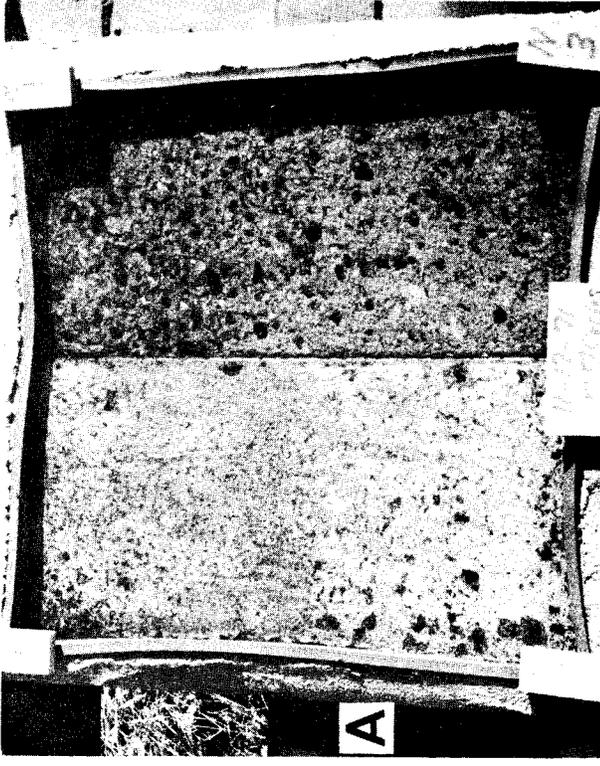
Figure 6. Appearance after deicing of conditions
 1 (LMS), 3 (LMS + LOT), 5 (MEF + LMS + LOT), and
 7 (MEF + LMS).
 (A) Non-air entrained — 77 cycles (two winters)
 (B) Non-air entrained — 123 cycles (five winters)
 (C) Air entrained — 123 cycles (five winters)

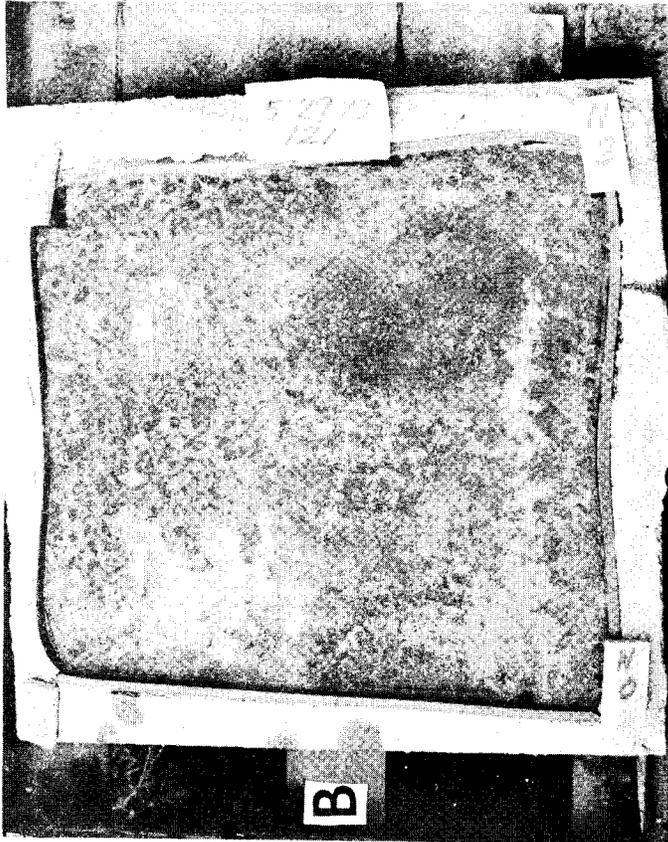
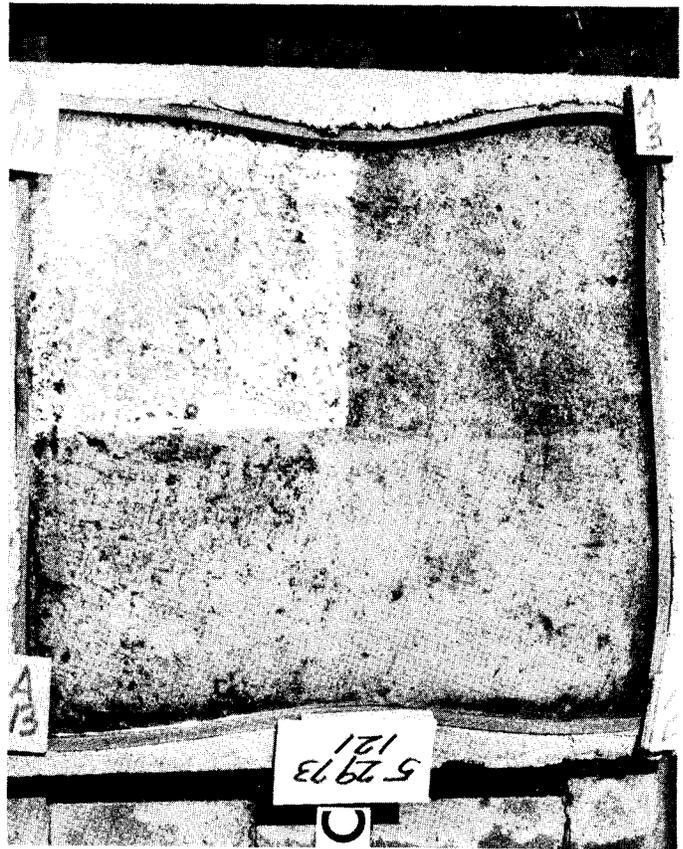
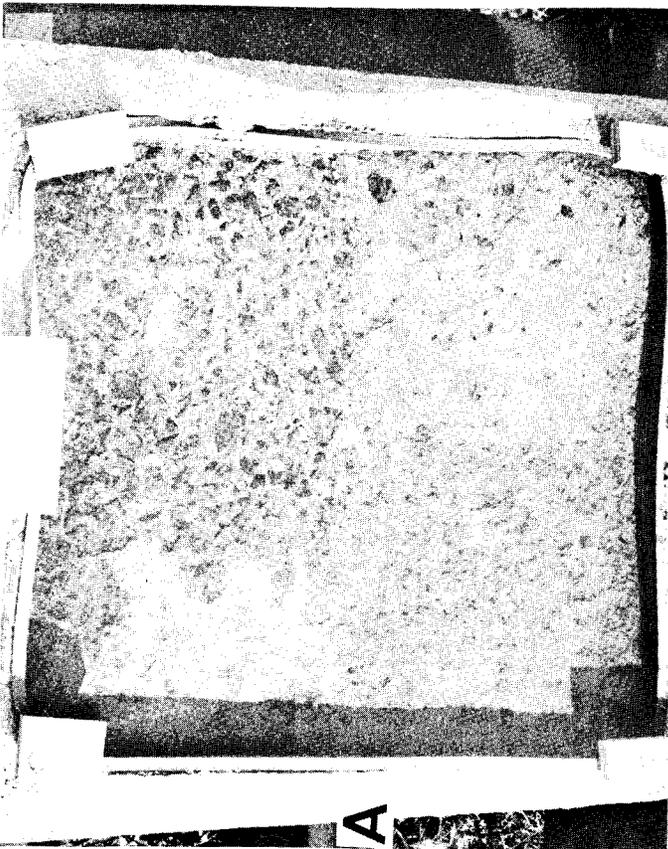
Figure 7. Appearance after deicing of conditions 0 (no cure), 3 (LMS + LOT), 10 (CRS₂ - L), and 13 (CRS₄ - L).

- (A) Non-air entrained — 77 cycles (three winters)
- (B) Non-air entrained — 123 cycles (five winters)
- (C) Air entrained — 123 cycles (five winters)

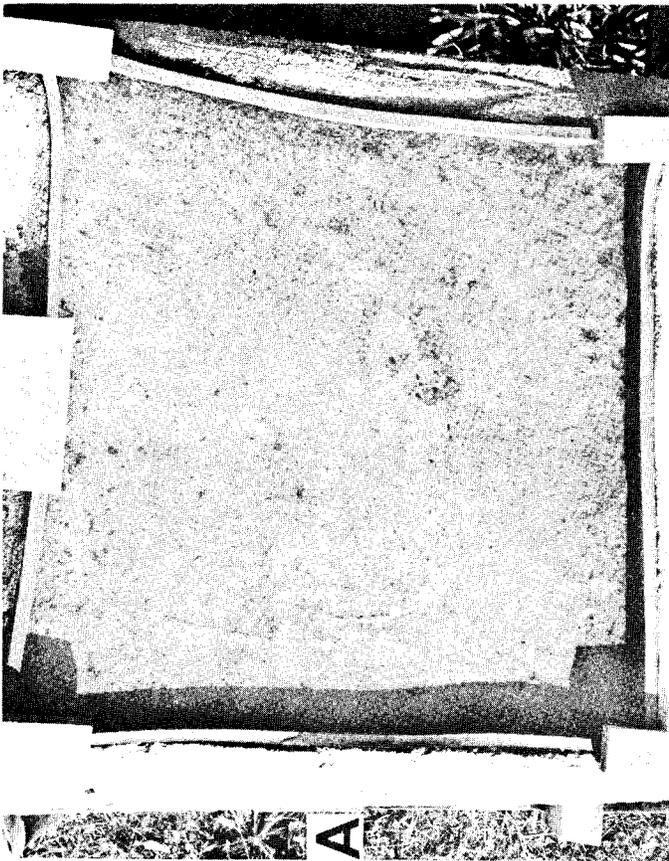
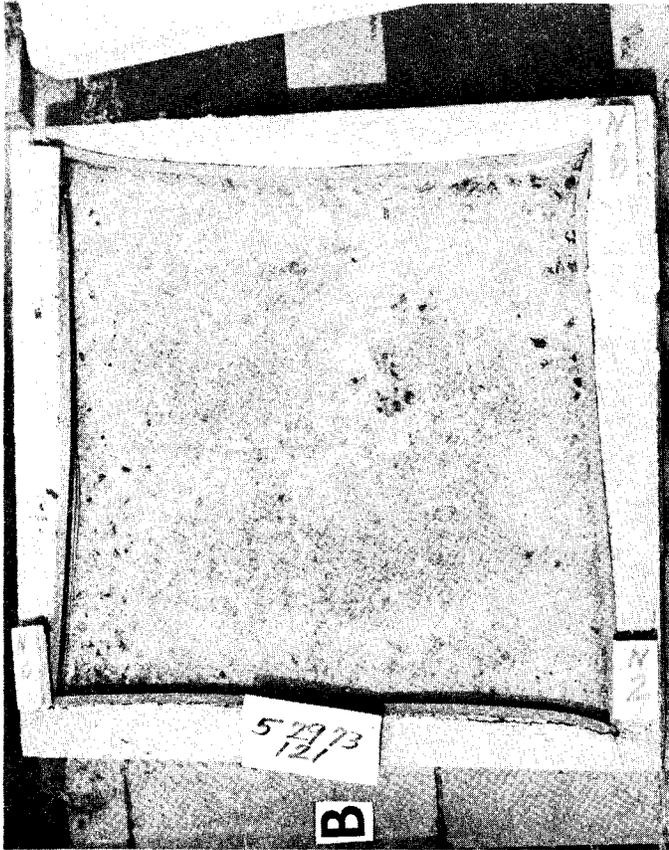
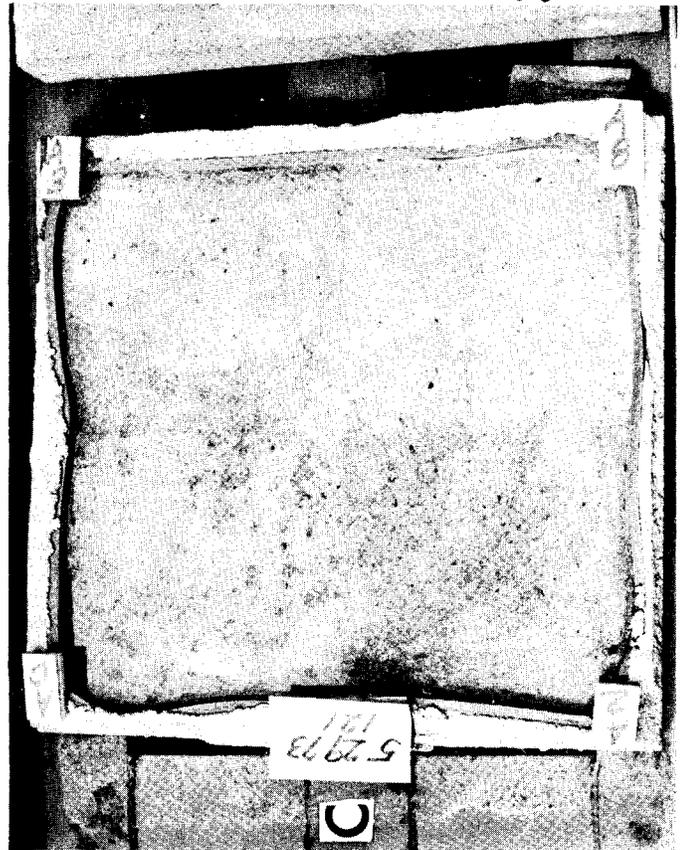
Figure 8. Appearance after deicing of conditions 0 (no cure), 2 (WPS), 3 (LMS + LOT) and 8 (CRS₁ - H).

- (A) Non-air entrained — 77 cycles (three winters)
- (B) Non-air entrained — 123 cycles (five winters)
- (C) Air entrained — 123 cycles (five winters)

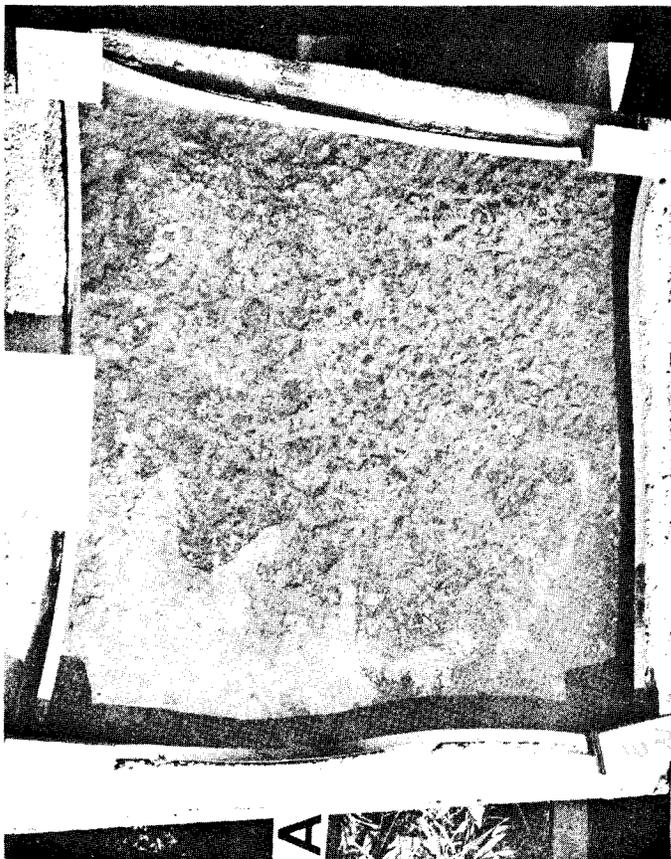
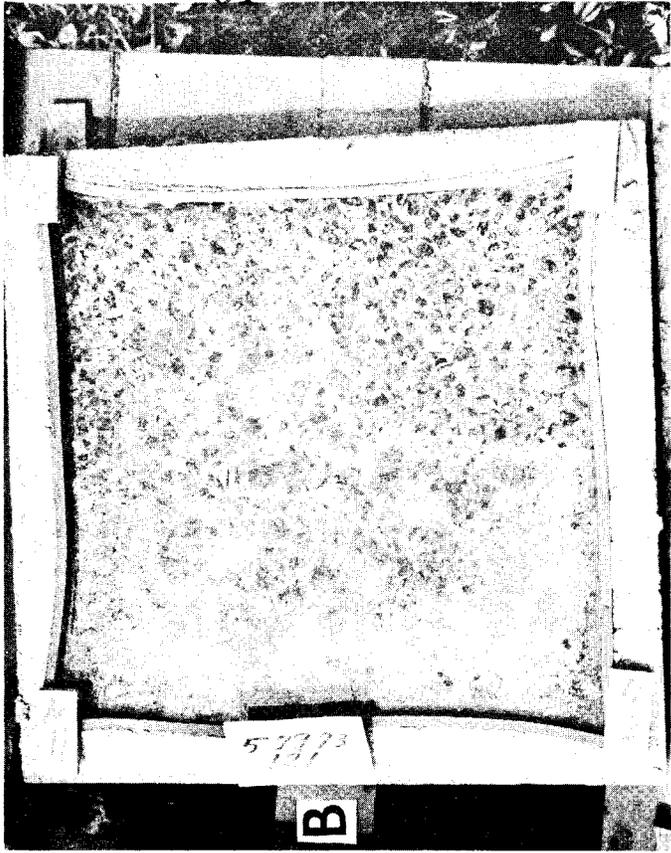
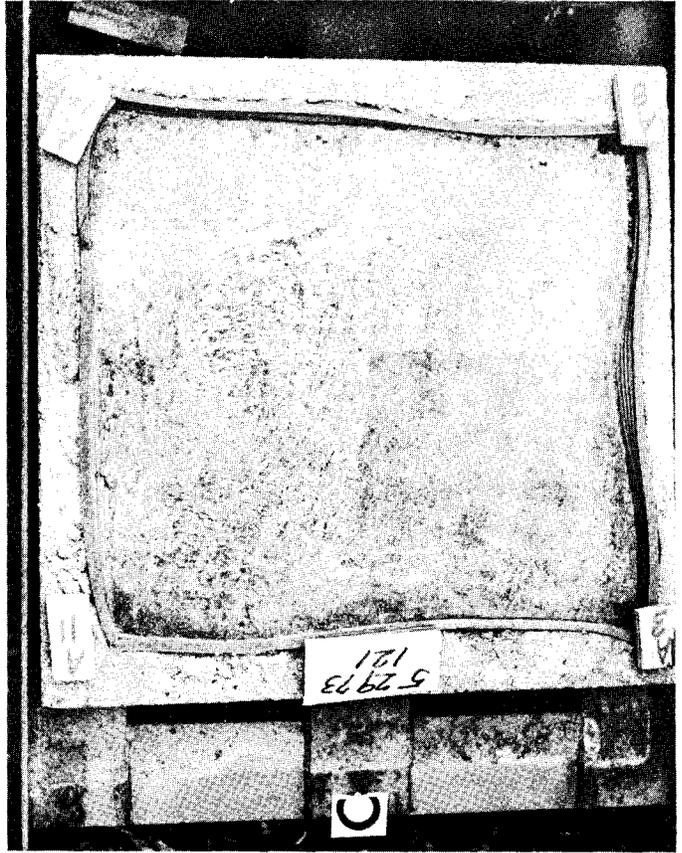
Figure 9. Appearance after deicing of conditions 3 (LMS + LOT), 8 (CRS₁ - H), 11 (CRS₃ - L), and 12 (CRS₃ - H).

- (A) Non-air entrained — 77 cycles (three winters)
- (B) Non-air entrained — 123 cycles (five winters)
- (C) Air entrained — 123 cycles (five winters)
