A CASE STUDY

EARLY CRACKING OF UNREINFORCED CONCRETE PAVEMENT

K. H. McGhee
Highway Research Engineer

October 1973
VHRC 73-R20

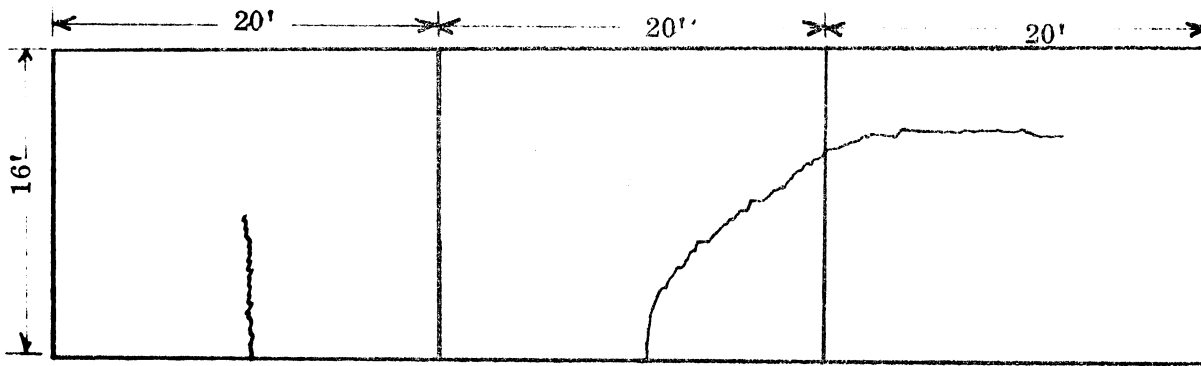
Of the two cracked ramps on the interchange one (Ramp A) exhibits both longitudinal and transverse cracking, as indicated in Figure 1. The other (Ramp B) has longitudinal cracks wandering from approximately the centerline to approximately the one-third points of the pavement width. (Except for widening at curb sections all ramps on the interchange are 16 feet wide.)

a) Cracking typical of Ramp A

Further study of the pavement cores showed that the top portion of the crack (down to about 2-inches) had occurred very early in the life of the pavement, while approximately the bottom 6-inches had not cracked until the concrete had achieved a significant level of its design tensile strength.

rate played a strong role in the cracking of the Ramp A concrete placed at an average evaporation rate of 0.18 lb./sq. ft./hr. The evaporation rate of 0.11 lb./sq. ft./hr. probably played some part in the cracking of the Ramp B pavement, but the nature of the cracking (longitudinal only) suggests that other factors also were present.

The study of cores from both the concrete and subbase, along with an examination of the in-place subgrade and subbase, suggest that there has been no structural damage to the pavement except for the cracking. The situation has been aggravated by the poor lateral drainage, which is being corrected by the excavation of shoulder material and backfilling with an open-graded aggregate. Since this action will probably stabilize the condition of the pavement, no further corrective action other than sealing of the longitudinal cracks is recommended at this time.

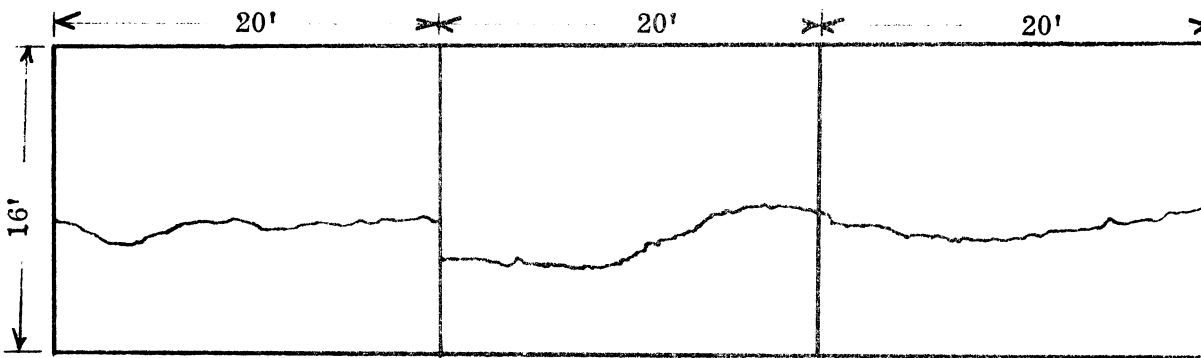
b) Cracking typical of Ramp B

The nature of the cracking as observed from cores discussed earlier suggests that warping stresses, which are usually too low to cause a problem, may have been significant in the present case. This is particularly true in the case of Ramp B, which cured for the first 24 hrs. at an average ambient temperature of 36°F and consequently could have gained but little strength during this period. Note in Figure 2 in the first few days concrete cured at 40°F gains only a fraction of the strength gained by concrete cured at 73°F or even 55°F.

Note in Table II that the warping stresses for the cracked portion of Ramp B are nearly twice those for the uncracked sections of pavement. While the computed tensile stresses of from 50 to 98 psi would cause no problem with mature concrete, it is entirely possible that they would exceed the tensile strengths of the present concrete, which obviously gained strength very slowly due to the low curing temperatures.
