PARTIAL-DEPTH PRECAST CONCRETE PATCHING

Marion F. Creech
Materials Research Analyst

Virginia Highway & Transportation Research Council
(A Cooperative Organization Sponsored Jointly by the Virginia
Department of Highways & Transportation and the University of Virginia)

October 1974
VHTRC 75-R13

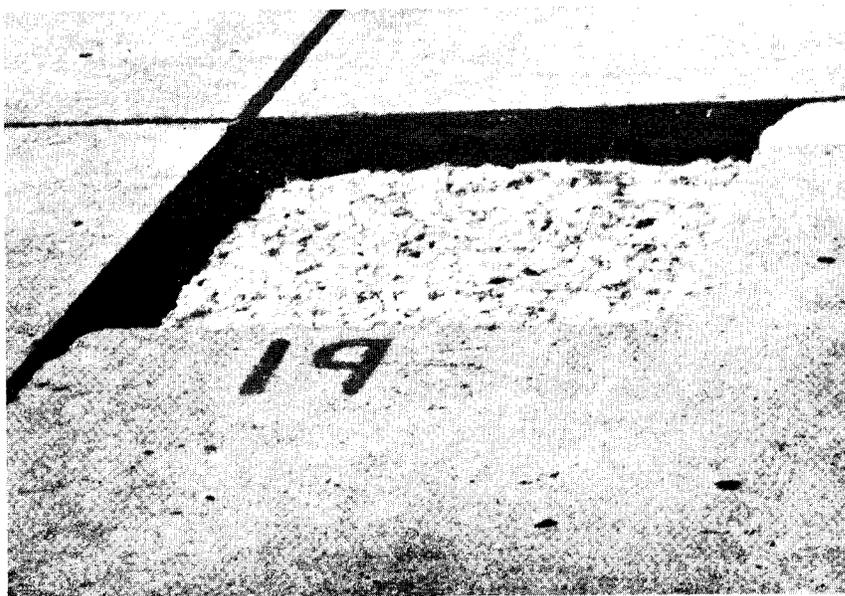
Figure 7. Hole prepared for precast patching.

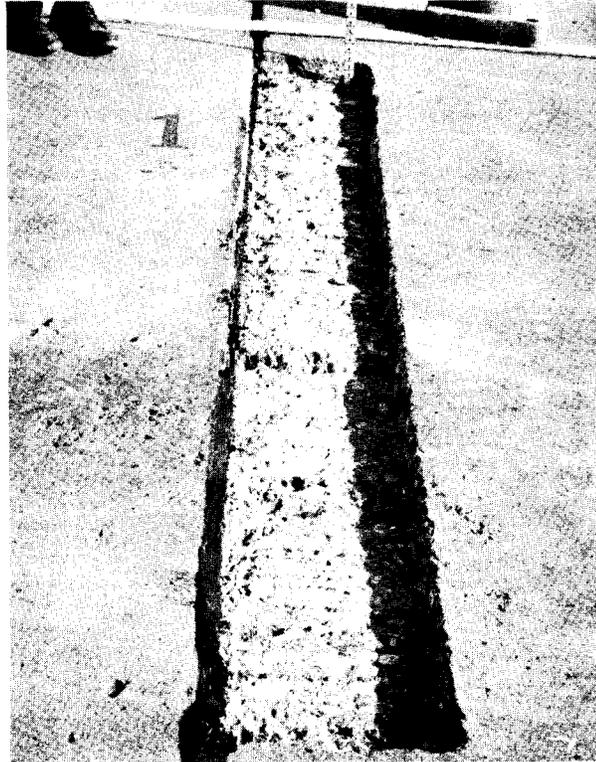
Figure 8. Hole Number 1 after cutting and cleaning. The cutting machine had to be repositioned three times to cut this hole.

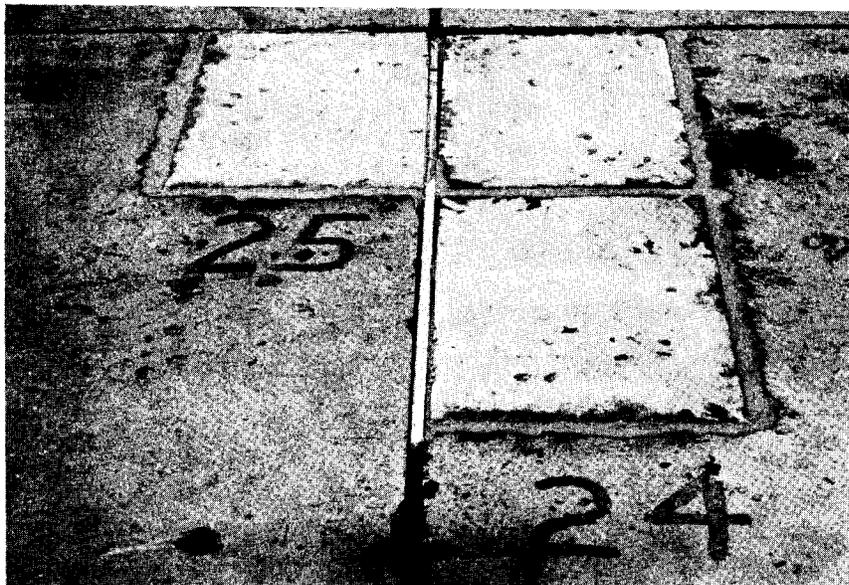
Figure 9. Patched area requiring more than one slab.

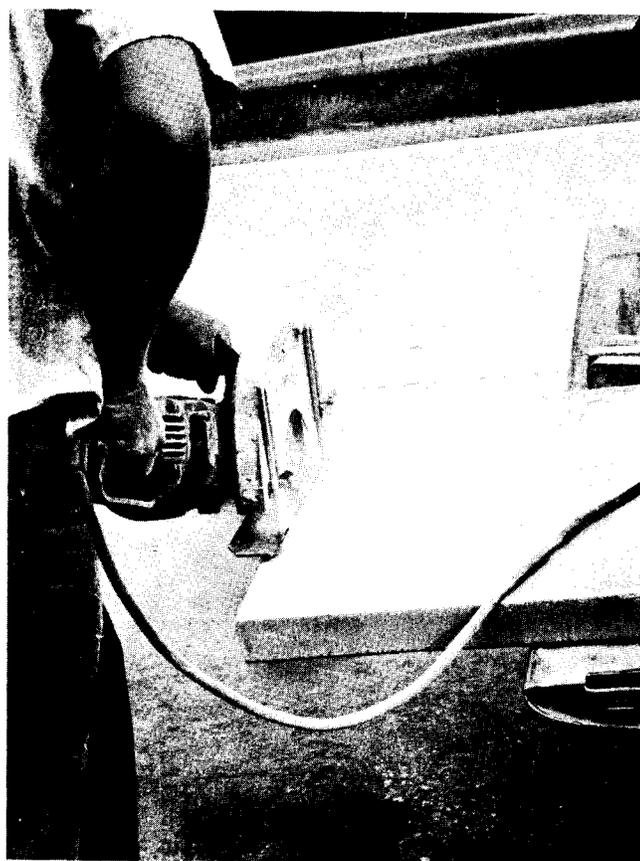
Figure 10. Precast slab being sawed to proper dimension.

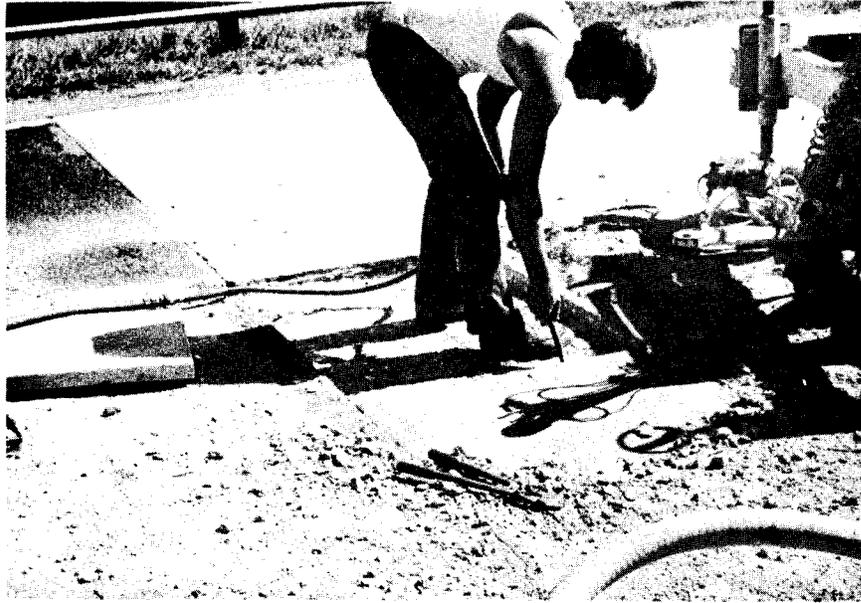
Figure 11. Steel mesh being removed from hole with hand tool.

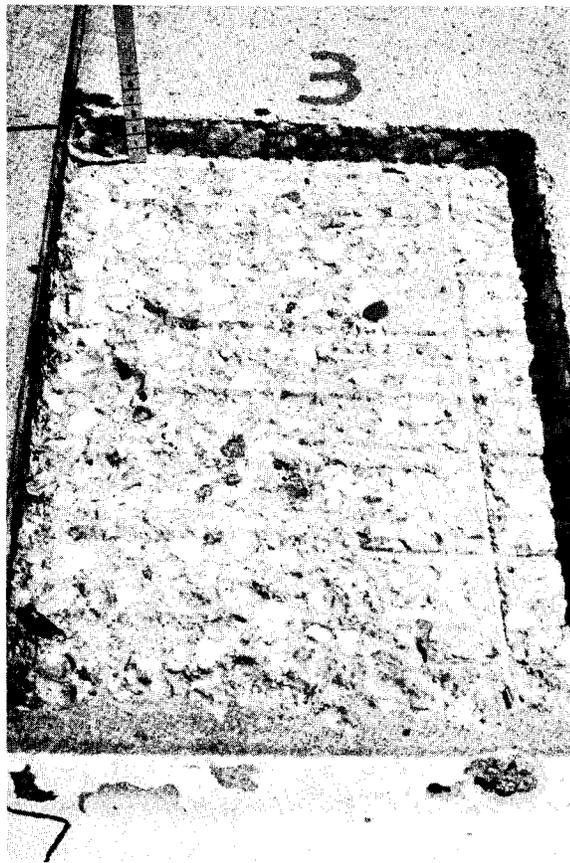
Figure 12. Grid pattern left after removal of steel mesh.

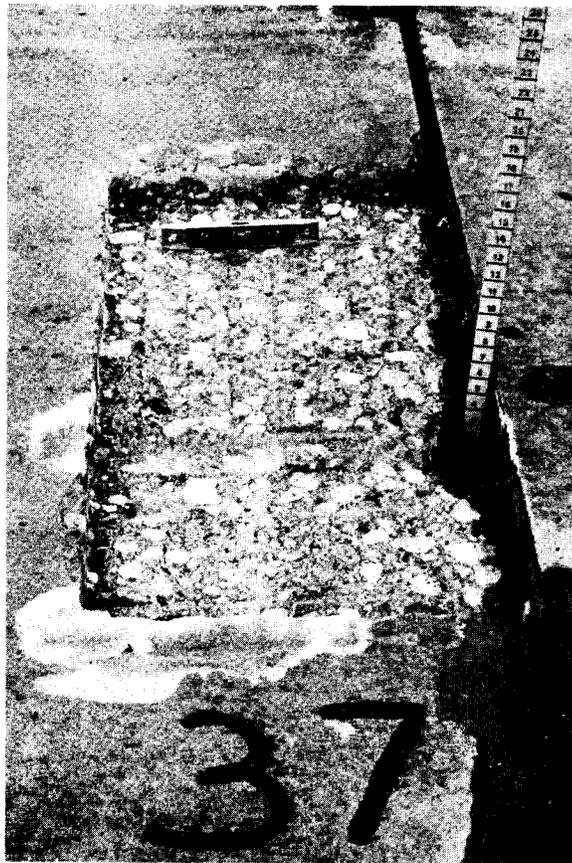
Figure 13. Hole from which deteriorated concrete along joint had to be removed with hand tool.

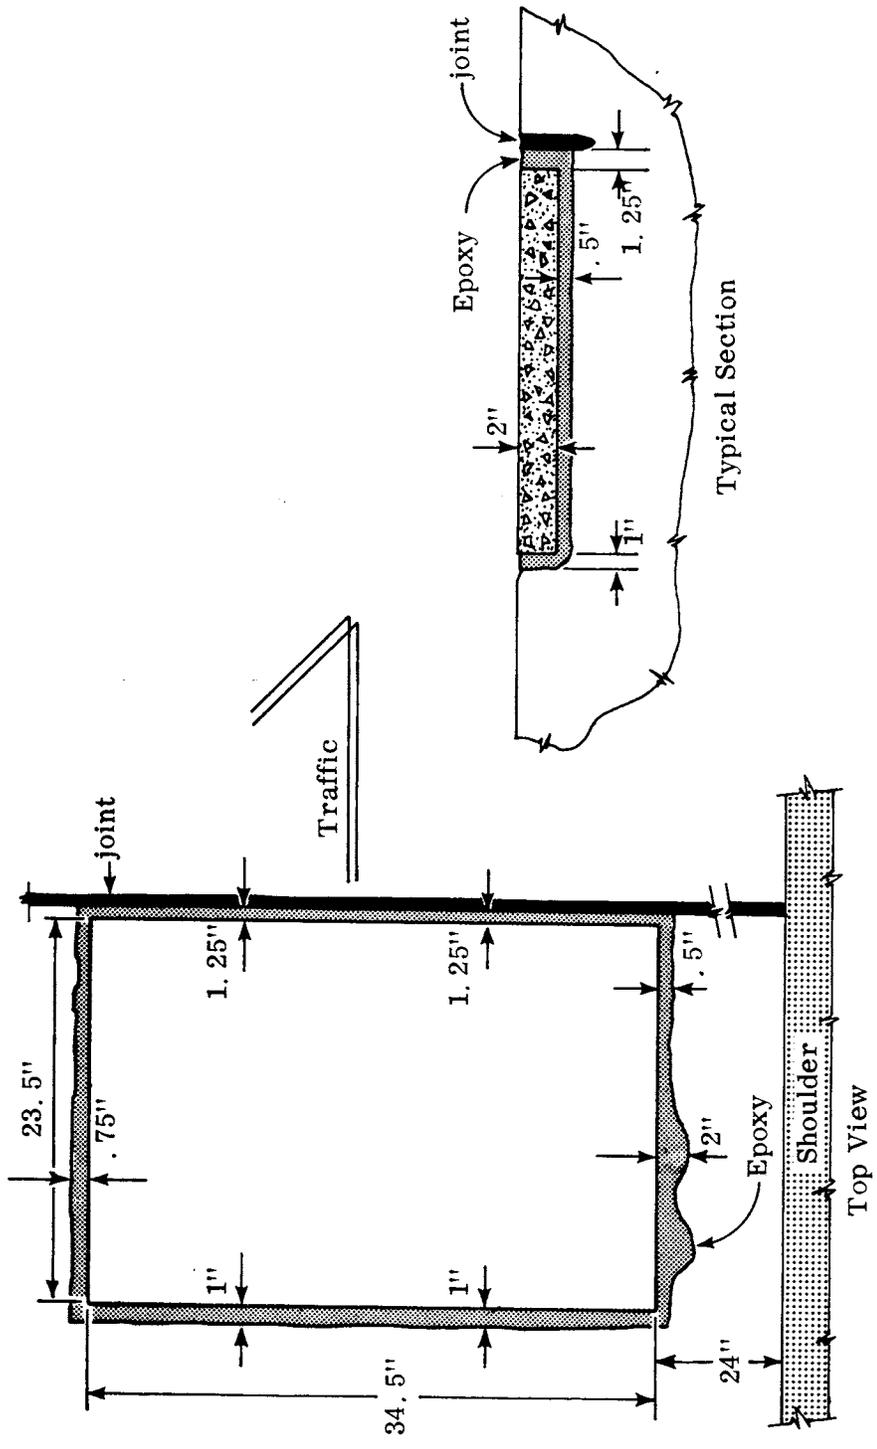
Figure 14. Sketch of patch showing dimensions of crack around patch. Basic conversion unit: 1" = 25.4 mm.

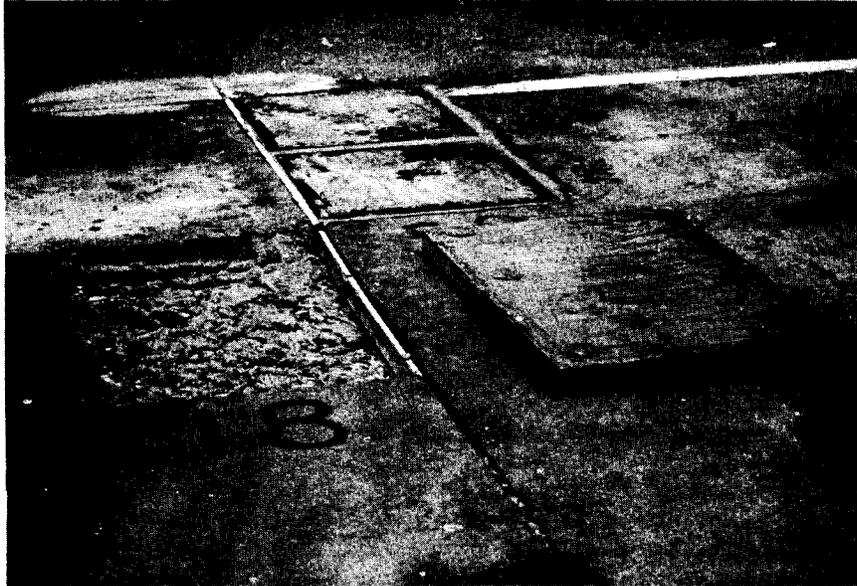
Figure 15. View of two patches, one with two slabs in place, and a second with the epoxy grout in the hole. Note the back of the slab to be installed has been painted with epoxy.

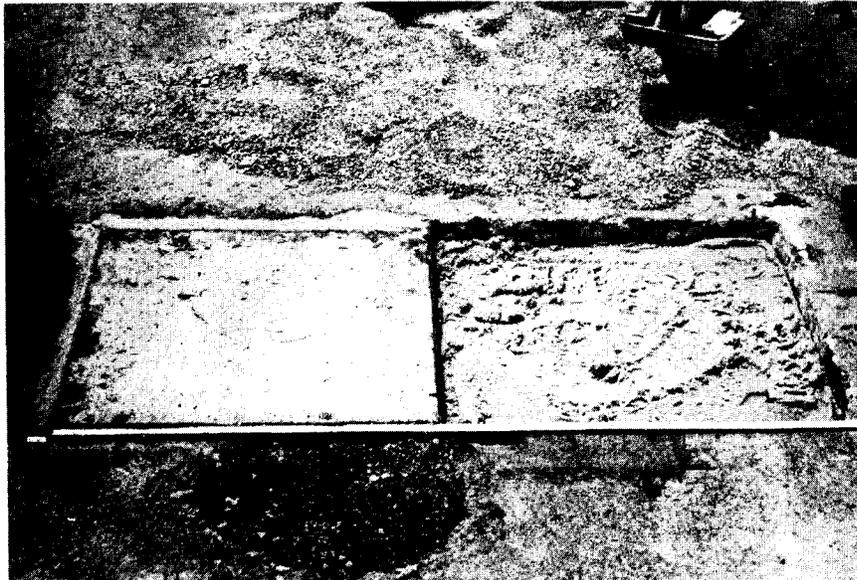
Figure 16. Half finished patch showing epoxy grout in right-hand portion of hole.

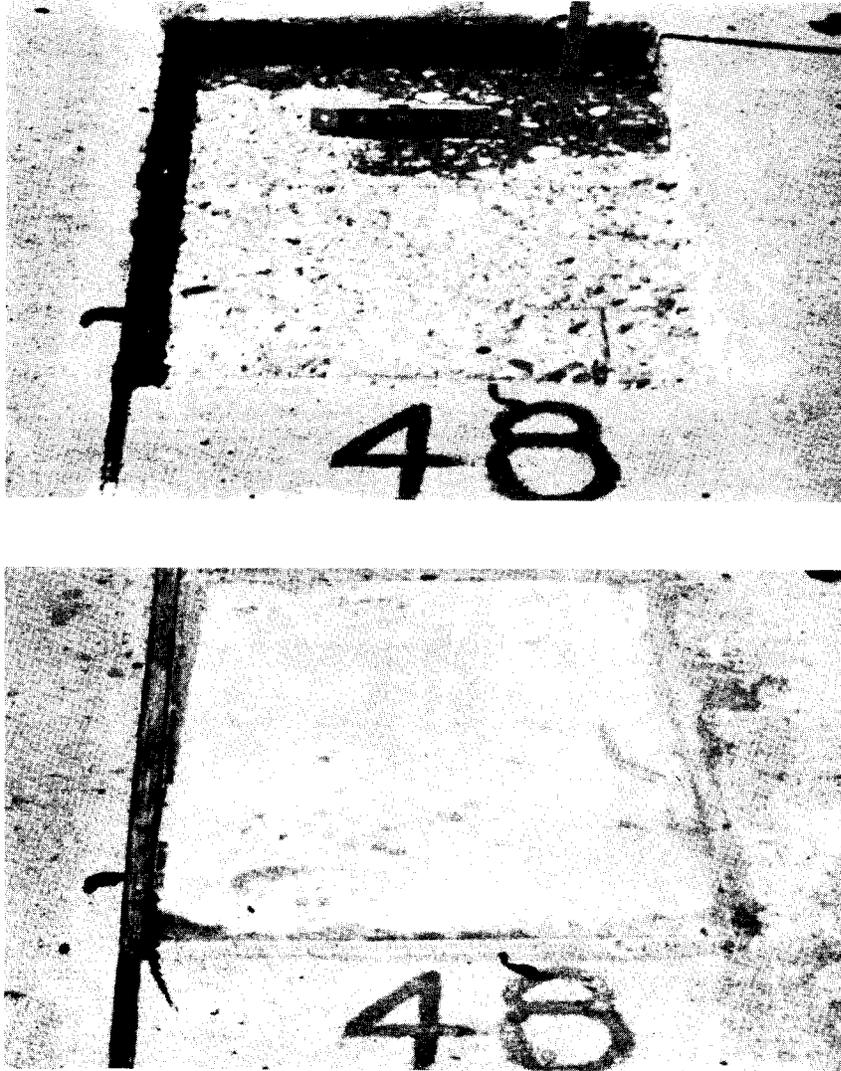
Figure 17. Patch Number 48 showing the finished hole and the completed patch. The dimensions of the slab are 24" x 34" and the hole 25" x 35". Basic conversion unit: 1" = 25.4 mm.

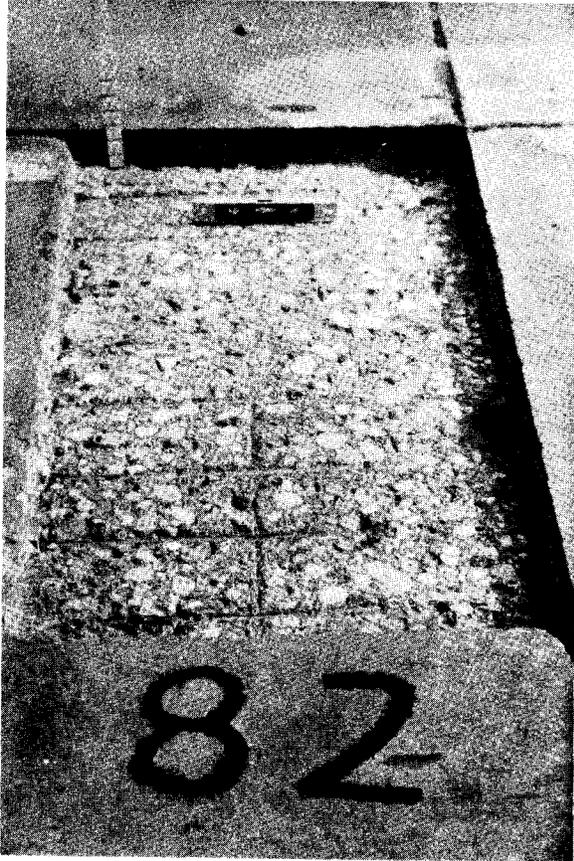
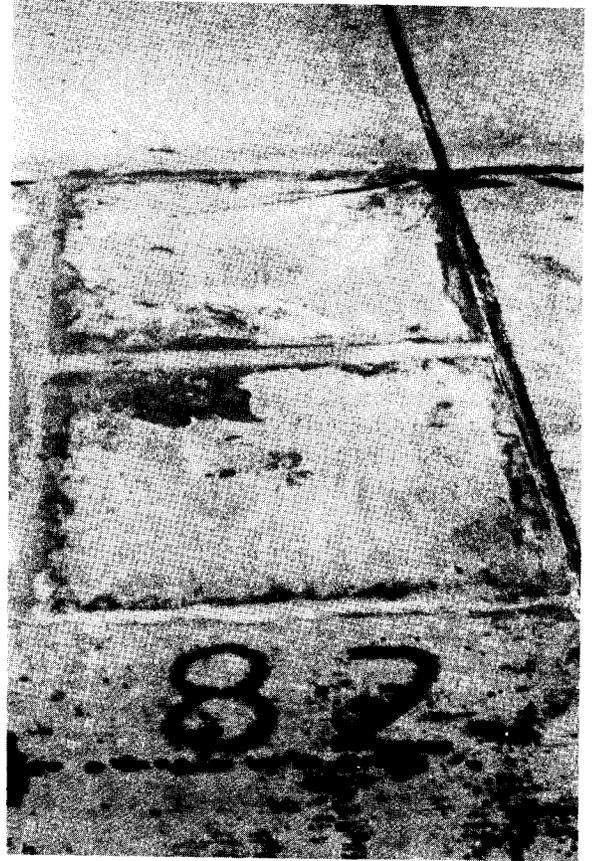
Figure 18. Patch Number 82 showing the finished hole and the completed patch. The hole is 51" in length and 26" wide. The slabs are each 2' x 2'. Basic conversion unit: 1" = 25.4 mm.

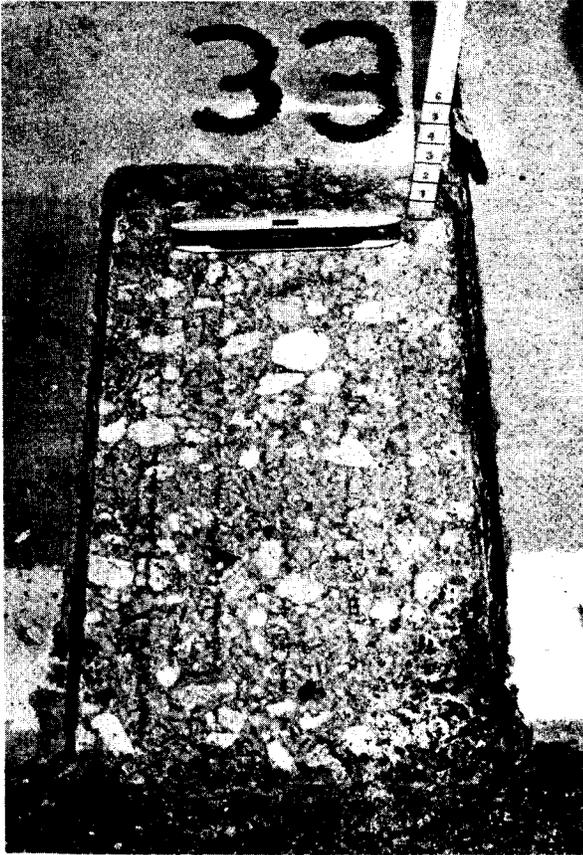
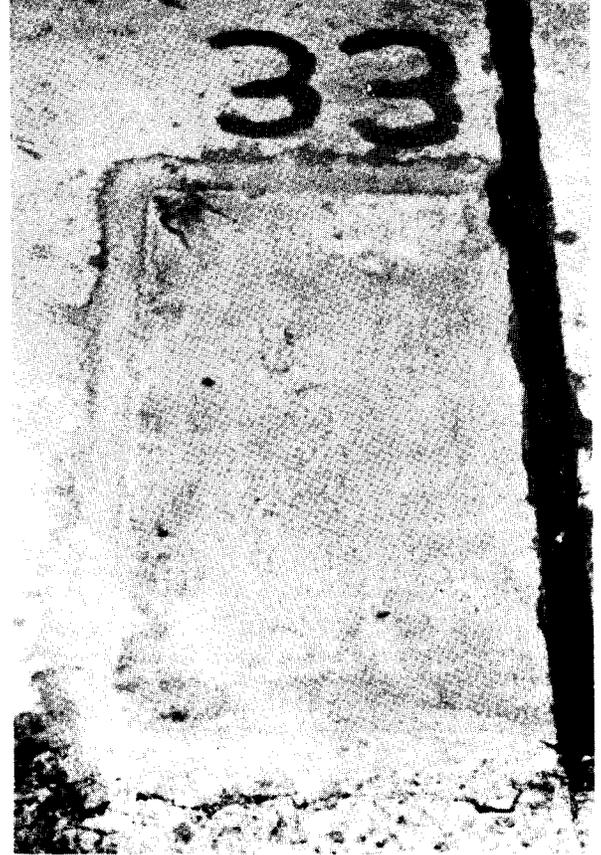
Figure 19. Patch Number 33 showing the finished hole and the patch installed. Patch size is 1' x 2' and the hole size is 13.5" x 25". Basic conversion unit: 1" = 25.4 mm.

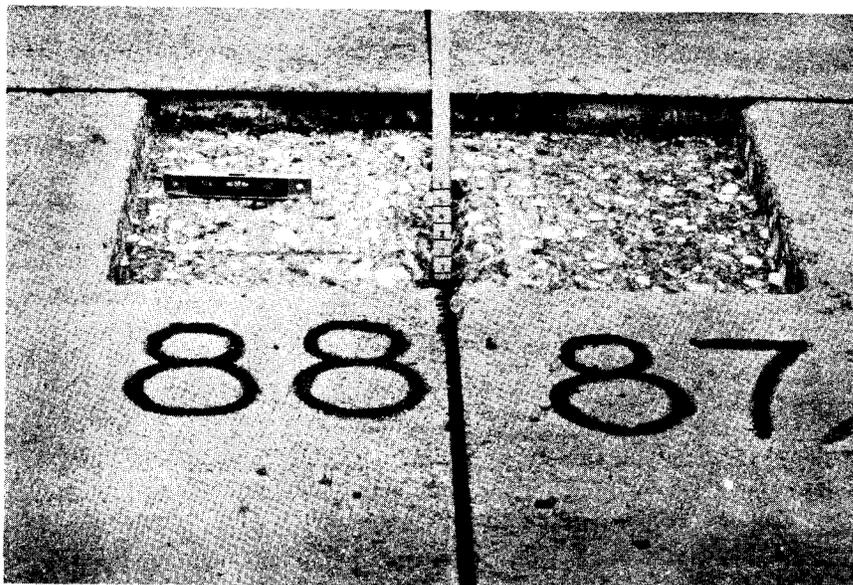
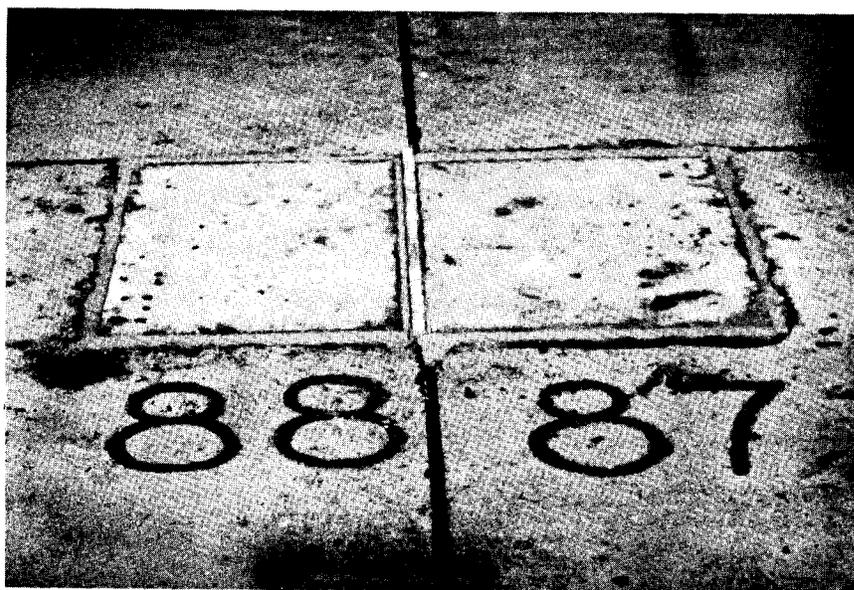
Figure 20. Patches Number 87 and 88 showing the holes after cleaning and the completed patches. The patches are 25" x 17" and the holes are 24.5" x 18". Basic conversion unit: 1" = 25.4 mm.
