DETERIORATION OF JOINTED
PORTLAND CEMENT CONCRETE PAVEMENTS

Samuel S. Tyson
and
Kenneth H. McGhee
Research Engineers

Virginia Highway & Transportation Research Council
(A Cooperative Organization Sponsored Jointly by the Virginia
Department of Highways & Transportation and
the University of Virginia)

November 1975
VHTRC 76-R19

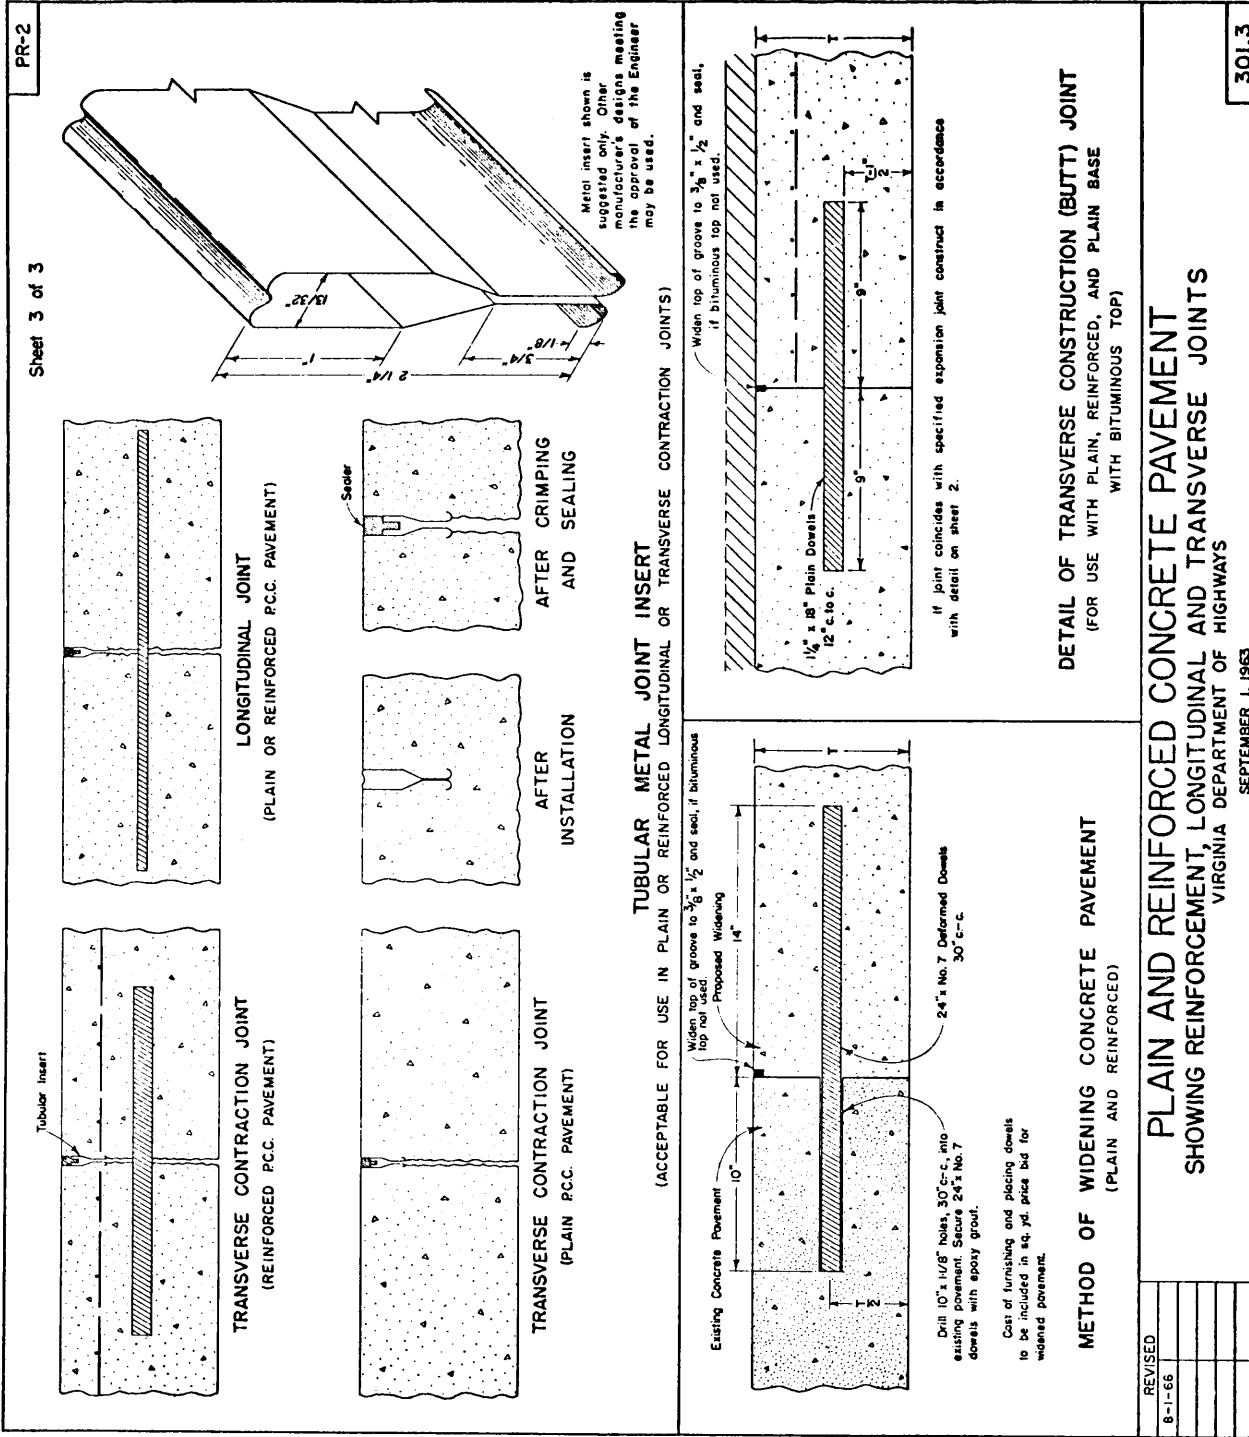
Figure 1. Tubular metal joint insert as it was accepted for use in PCC pavements in Virginia.

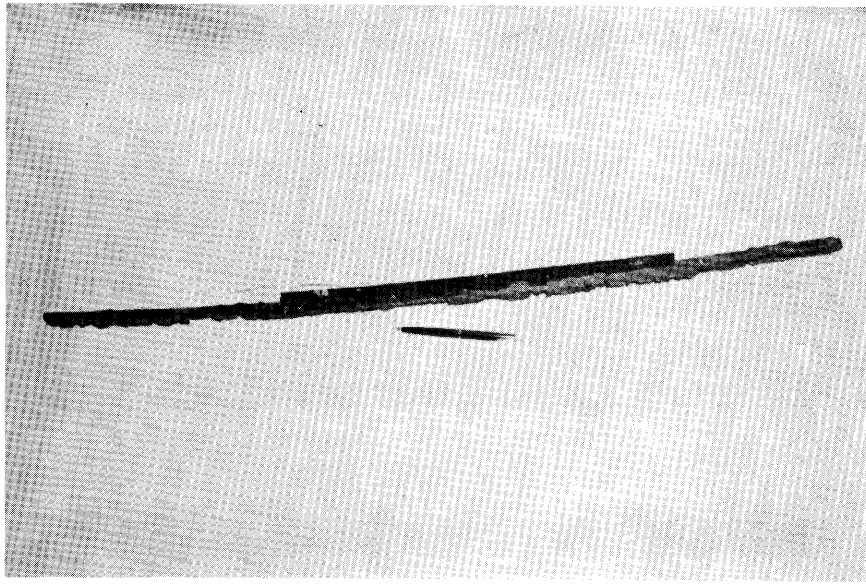
A survey of these metal joint inserts in 1968 found their condition to be "fair to rusted" and badly rusted after four to six years of service.⁽³⁾ Because the inserts were anchored by small flanges extending into opposing faces of concrete at the contraction joints, weakened planes existed and were aggravated by corrosion products. Remnants of a corroded metal insert lifted easily from a joint are shown in Figure 2.

Figure 2. Remnants of corroded metal insert.

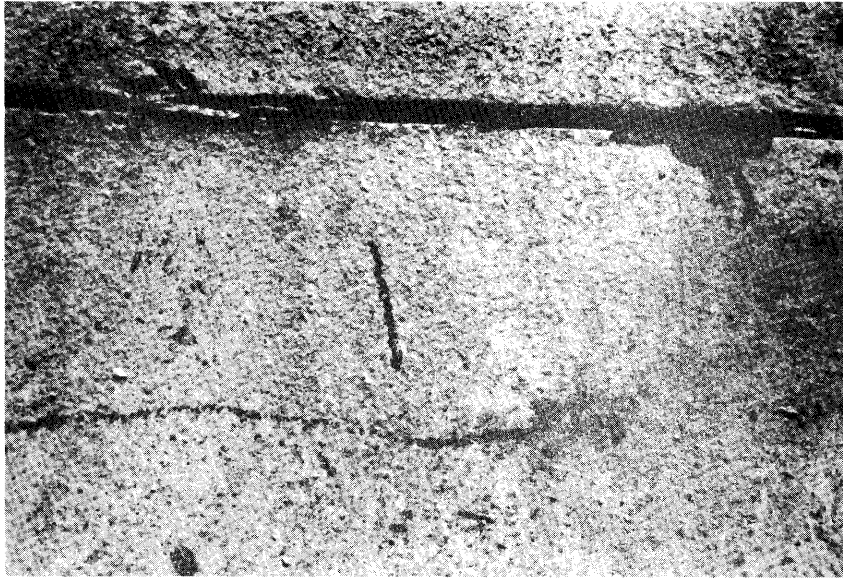
The insidious nature of the concrete deterioration resulting from insert corrosion is indicated in Figures 3 and 4. Figure 3 shows a pavement area adjacent to a transverse joint containing the metal insert. The location of delaminated concrete was outlined on the pavement surface by sounding the pavement with a ball peen hammer. This technique for locating unsound concrete is documented in a report dealing with the detection of deteriorated concrete in bridge decks.⁽⁴⁾ Figure 4 shows a core taken vertically through the joint. The metal insert and well-formed contraction joint are in the central portion of the core. The embedded flange of the insert had corroded sufficiently to rupture the concrete approximately two inches below the roadway surface. Weakened planes of this type, initially not evident from the surface, propagate under repeated wheel loadings and eventually intercept the pavement surface at 6 to 12 inches from the joint face.

Figure 3. Pavement area adjacent to transverse contraction joint formed with metal insert.

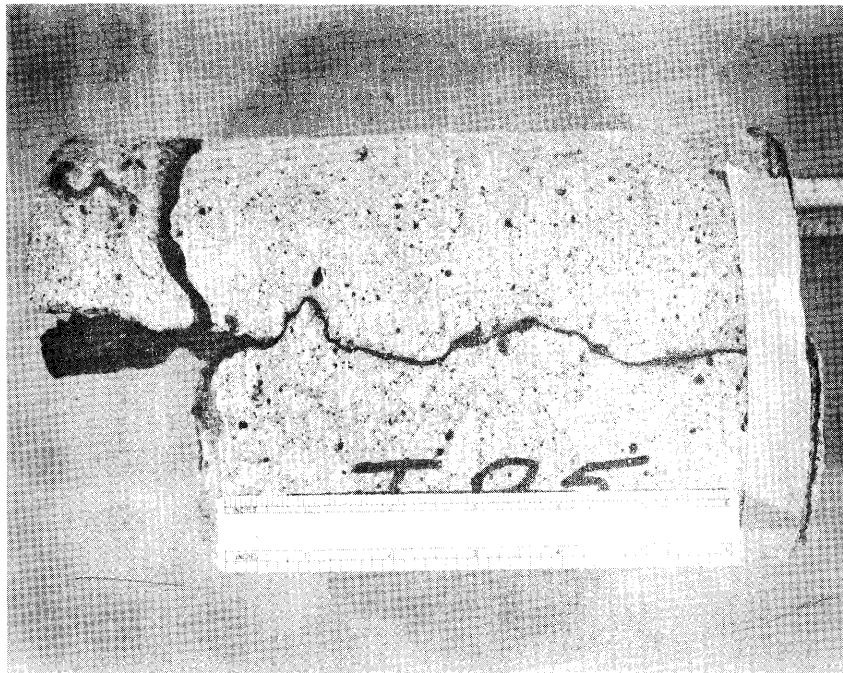
Figure 4. Core from area shown in Figure 3 showing vertical contraction joint and horizontal plane of weakness.

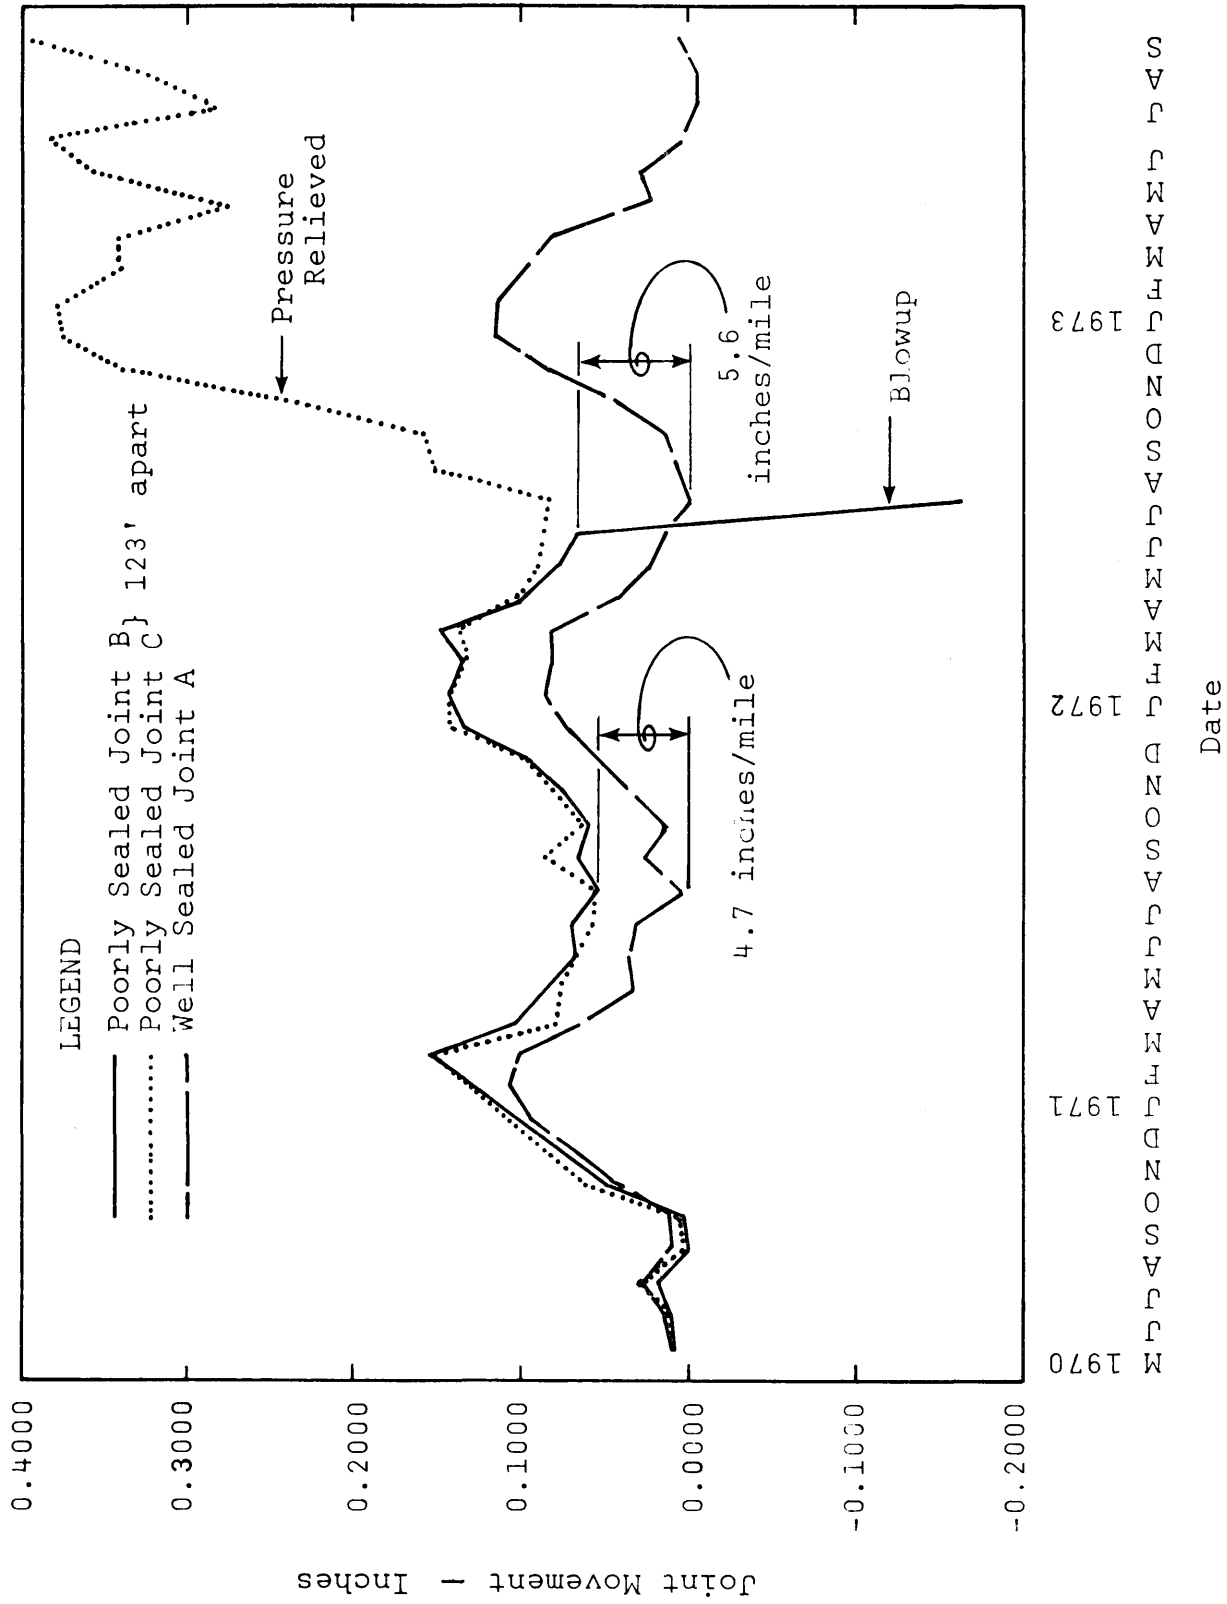
In the summer of 1972 these stresses overcame the compressive strength of the concrete so that joint B sustained a crushing failure. Note in Figure 5 that in mid-1972 the "locked-in" movements amounted to 0.065 inch and 0.085 inch for joints B and C, respectively. When the failure occurred at joint B, the gauge points moved dramatically closer together as shown by the graph plunging below the base line in Figure 5. At the same time, a reduction of stresses took place at joint C so that its graph shows a dramatic increase in joint opening even during warm weather. Joint C then returned to cyclical type movements, but from a different datum.

Figure 5. Seasonal movement of 3/8-inch contraction joints (slabs 61.5 feet long).

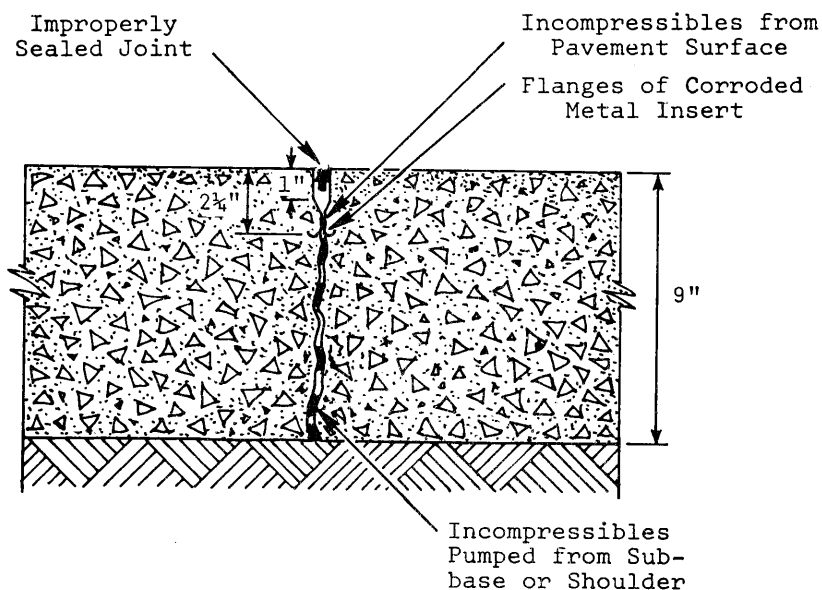
Even though the actual stress distribution at a joint is unknown, it is not difficult to illustrate schematically how a relatively low average stress in the region of the transverse joint can result in failure of the concrete. In Figure 8 a transverse contraction joint is depicted in an open state. The widest opening occurs in the winter months when fine aggregate, associated with snow and ice control, is present on the pavement surface. If the joint sealant has pulled away or is missing, and the metal insert has corroded, this incompressible material can readily be intruded into the narrow, irregular portion of the joint. The lower portion of the joint may also be infiltrated with fines from the subbase material transported by traffic induced pumping.

The weakened planes in Figure 8 resulting from the corroded or partially corroded metal insert make the upper region of the joint face particularly susceptible to becoming overstressed.

Figure 8. Transverse contraction joint with infiltration from pavement surface, shoulder and subbase.

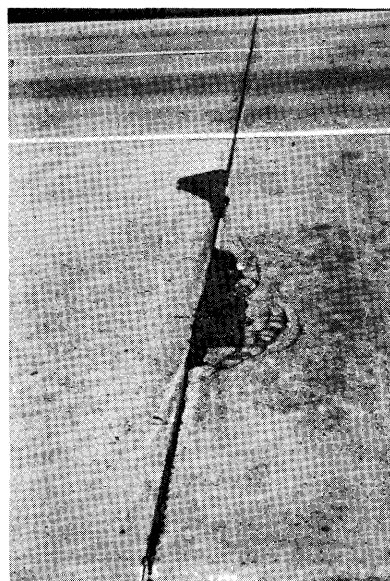
Stress concentrations have been shown to be produced by infiltrated particles as the joints tend to close. In the upper portion of the joint face, those highly stressed zones, in the presence of weakened planes due to the corroded insert flanges, produce an easily recognizable half-moon spall shown in Figure 9. With poured sealants, incompressibles are able to enter the joint at the earliest time where tire contact has helped to disrupt the sealants.

Figure 9. Semicircular (half-moon) spall caused by insert corrosion.

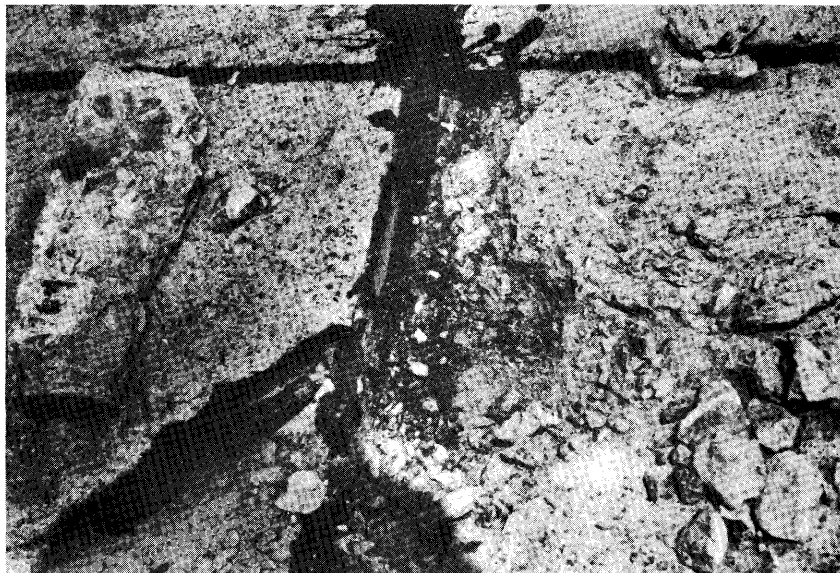
To demonstrate the fact that areas recognizable as half-moon spalls are partial-depth types of distress, a typical area has been exposed in Figure 10. The unsound concrete in this case can be removed entirely by chipping away less than one inch of additional material.

Figure 10. Partial-depth deterioration from spall chipped lightly to show limited depth of defect.

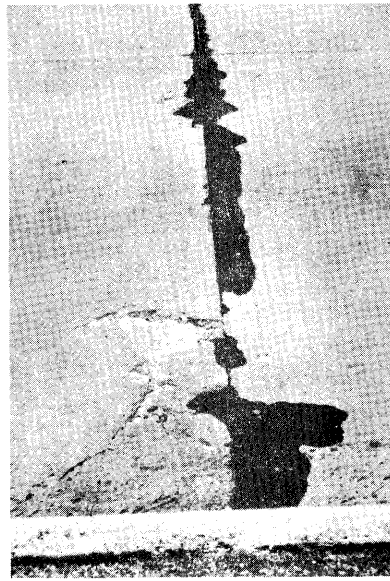
The visible signs of distress in this case are joint spalls at the corners and general corner deterioration. This deterioration usually extends about 12 inches from the corner at the pavement surface and is even more limited with increasing depth. Because corner breaks do not extend more than a few inches into the lower portion of the joints, they are appropriately classified as partial-depth failures.

Figure 11. Corner break in left foreground with extensive spall and probable full-depth deterioration extending from corner break.

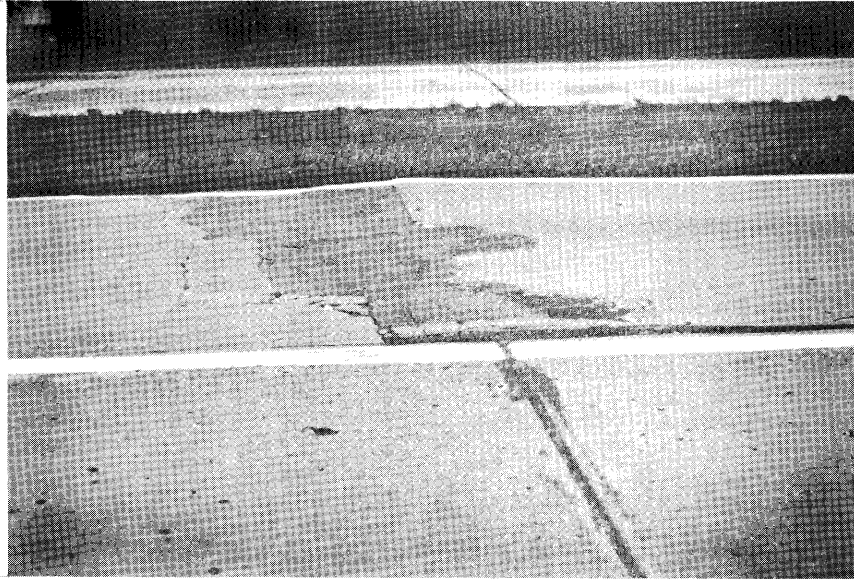
The relief of increased joint stresses by failure of the concrete may result in nearly complete destruction of the joint. This failure, or blowup, may be sudden, with obvious distress at the joint as in Figure 12. The joint movements associated with this type of failure were depicted in Figure 5.

Figure 12. Blowup with bituminous patch.

Blowups and other failures which affect the full slab thickness can be repaired only by full-depth patches. Such patches can be either cast-in-place or precast. Where there is evidence that excessive pavement pressures have contributed to failure, it has recently become customary in Virginia to provide pressure relief joints at intermittent locations either as other repairs are undertaken or as a preventive maintenance measure. The details of full-depth repairs and the use of pressure relief joints are to be discussed in a later report.

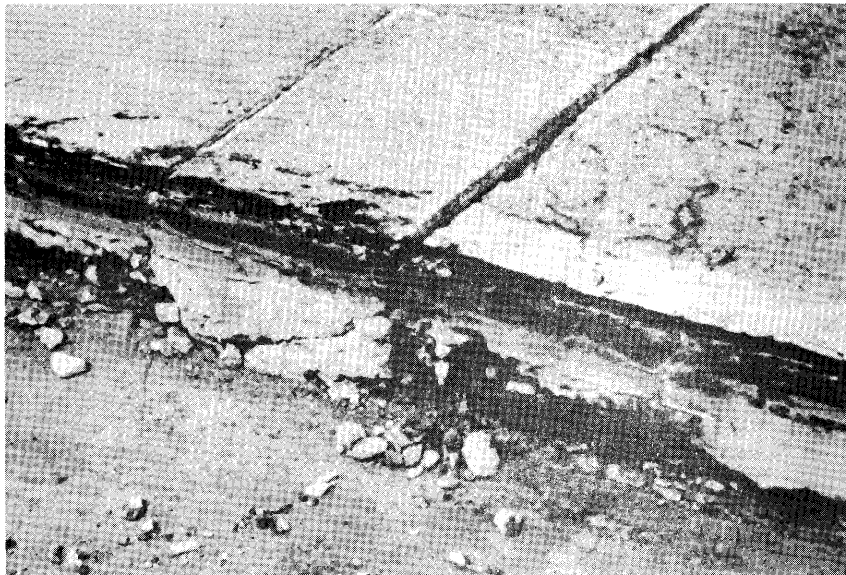
Extensive deterioration from a blowup type of failure may not be readily apparent at the pavement surface. In Figure 13 it can be observed that the joint closing has resulted in spalling of the underside of the joint area while the pavement surface is apparently intact. This actual case is very similar to the case depicted earlier in Figure 6.

Figure 13. Underside of slab spalled due to infiltrated fines.

The deterioration depicted in Figure 13 cannot be visually detected from the pavement surface, but it can be located by the manual sounding technique cited earlier,⁽⁴⁾ and it can be inferred from instrumented joint records.
