LATEX MODIFIED PORTLAND CEMENT OVERLAYS: AN ANALYSIS
OF SAMPLES REMOVED FROM A BRIDGE DECK

Virginia Highway & Transportation Research Council
(A Cooperative Organization Sponsored Jointly by the Virginia
Department of Highways and Transportation and the University of Virginia)

November 1975

VHTRC 76-R25

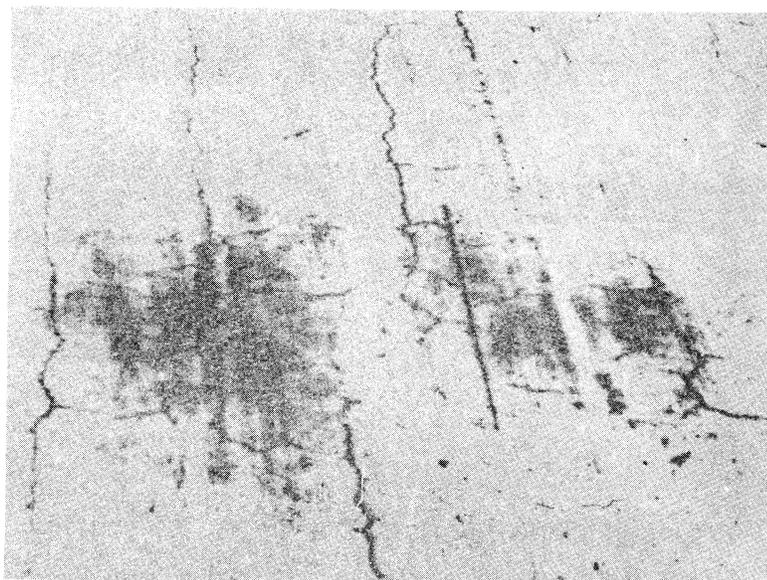
Typical surface cracking in the deck at the time the cores were taken is shown in Figure 1. As can be noted, the crack patterns can be easily detected as water evaporates from the wetted deck surface. The cracking is generally more extensive in the transverse direction, but shorter length longitudinal cracking, propagating outward from the transverse cracks, is prevalent also. The longitudinal cracking usually appears more random and of shorter length than the transverse cracking, but often intersects adjacent transverse cracks. The general cracking pattern could be described as a fine pattern type cracking as defined and illustrated in the ACI guide for concrete condition surveys. (5) A typical core showing a transverse crack associated with and approximately over a reinforcing steel bar is shown in Figure 2. A core taken at a longitudinal crack location is shown in Figure 3. It can be noted that in the latter case the crack is also over a steel bar.

Figure 1. Typical cracking in the latex modified mortar overlay. Note that the deck is damp, which makes the cracks easily discernible.

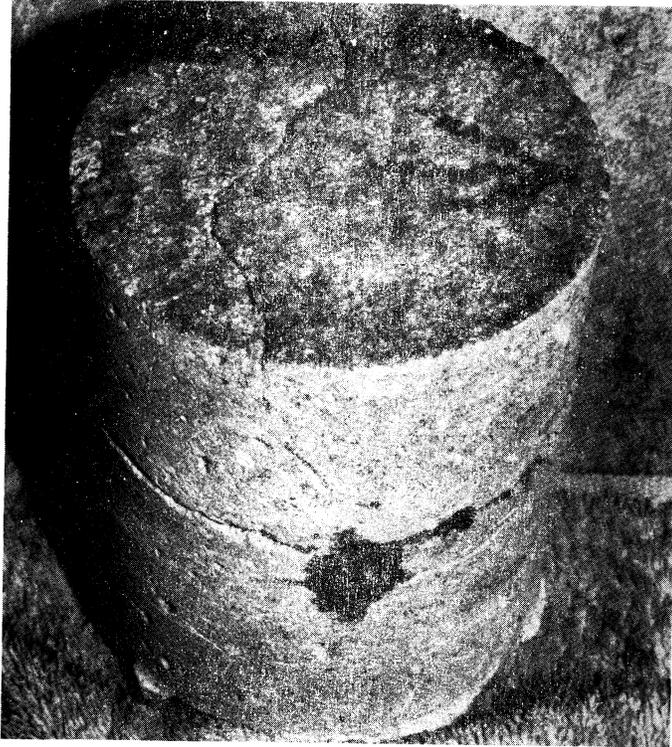
Figure 2. Transverse cracking in a concrete core with latex mortar overlay. Arrow on top of core denotes direction of traffic.

2. Major horizontal cracking occurring at the level of the top steel and associated with corrosion of the steel (see Figure 2). This occurs in Cores 1-1, 1-2, 3-1 and 5-1 which are the ones with the transverse vertical cracking.

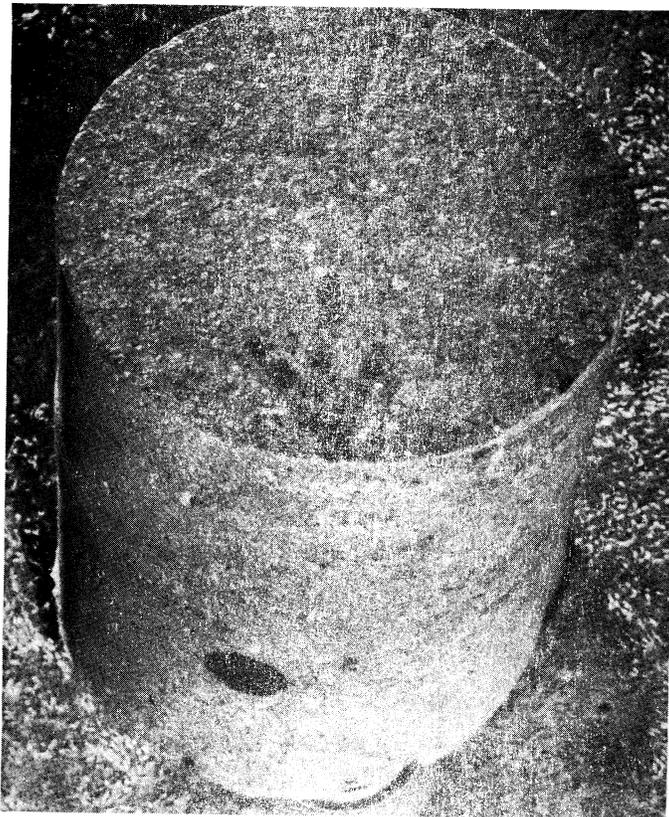
Figure 3. Longitudinal cracking in a concrete core with latex mortar overlay. Arrow on top of core denotes direction of traffic.

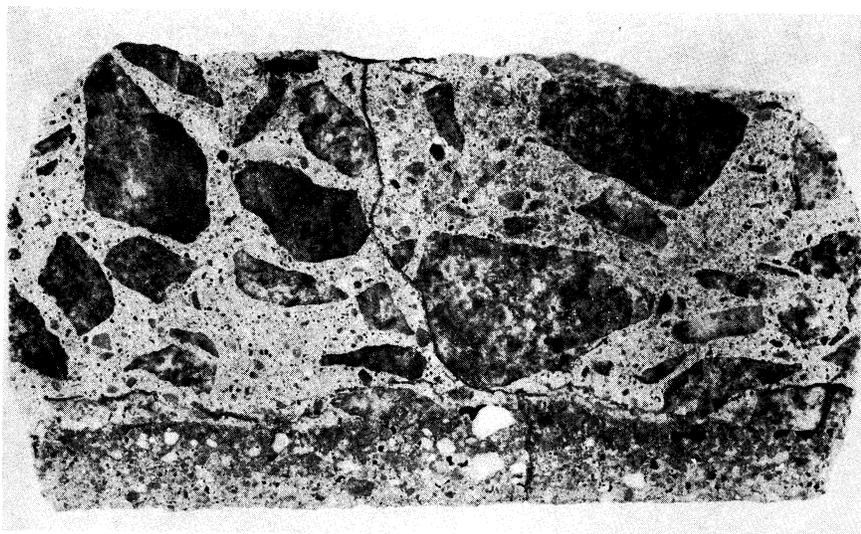
3. The below-the-bond weakness zone (Figure 4) was detectable in all the samples, including those taken from Cores 1-4 and 5-2 representing uncracked areas. In the cores exhibiting pattern cracking this zone is sometimes as widely cracked and more easily seen than the vertical system. In less deteriorated samples, it exists as a discontinuous series of voids and short cracks. At the bond between the latex mortar and the portland cement concrete, the PC concrete is carbonated to a depth of 0.5 - 4 mm (Figure 5). The zone of weakness occurs just below the carbonation zone. The latex mortar is firmly bonded to the carbonated paste and apparently as well bonded to the aggregate as to the paste. No explanation for the zone of weakness is advanced. It certainly is more advanced in areas of pattern cracking which are associated with the steel. The heavy layer of carbonation may indicate that the weakness is due to some form of surface deterioration which occurred before the application of the latex mortar overlay.

Figure 4. Section of core showing transverse cracking in the latex mortar overlay and the original concrete. A horizontal crack just below the bond line can be detected in the photograph.

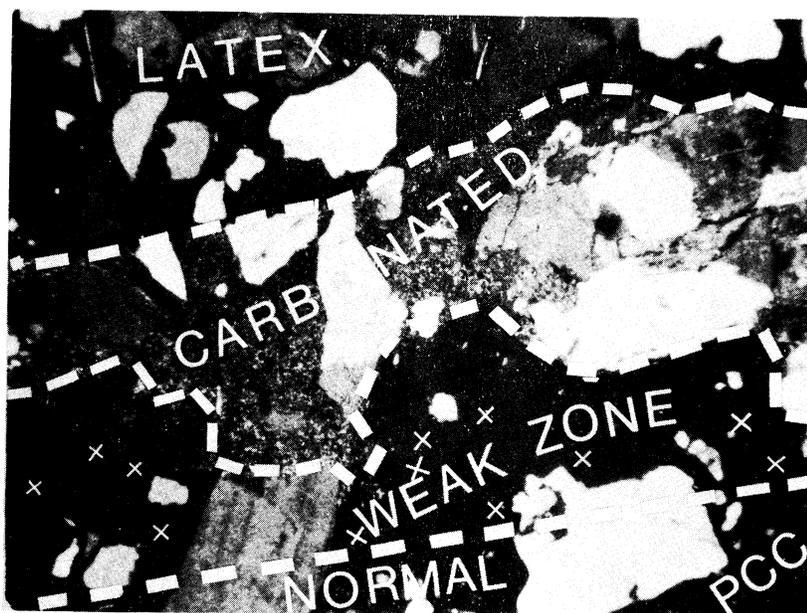
Figure 5. Thin section of bond area of core 5-2 showing latex mortar, carbonated zone, zone of weakness below the carbonated zone and normal PCC. The small x's indicate irregularly shaped voids. (50x, crossed polarizers.)

All cores showed the just-below-the-bond weakness zone; even those with no surface cracking but the latex mortar was strongly bonded to the carbonated surface of the deck concrete. There was no cracking or zone of weakness found at the bond line itself.

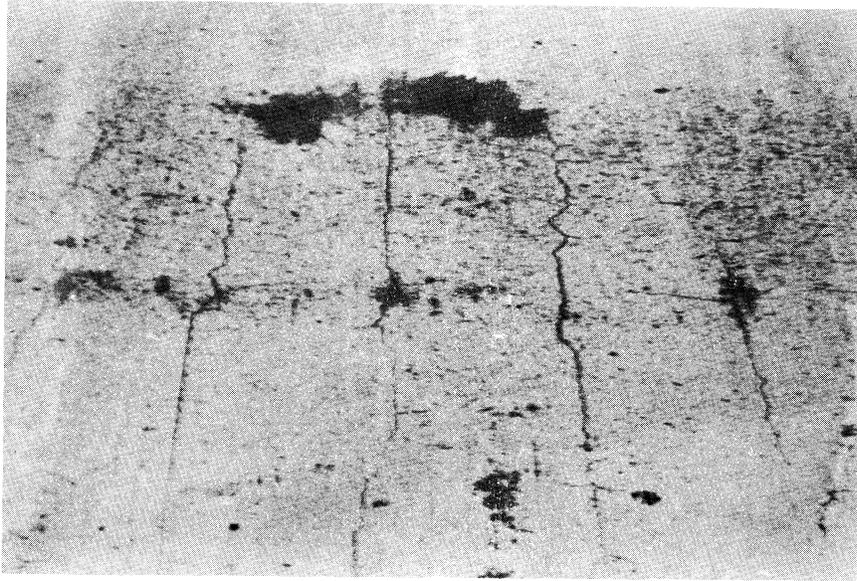
Visual inspections of the bridge deck were conducted in October 1975 to evaluate the performance of the overlay with respect to the cracking distress reported earlier. (1) As compared to four years earlier, the cracking appears more apparent and more extensive in many areas of the deck (see Figure 6 as compared with Figure 1).

Figure 6. Recent cracking above transverse reinforcing steel in span 5. Hairline longitudinal cracking can be detected also.

The horizontal cracking observed in the sample cores, as discussed earlier, suggests the possibility of future delamination problems. Consequently, some randomly selected cracked areas were sounded with a hammer. Although no areas of total disintegration and spalling of the overlay have been found within a span to date, a small area of delamination has occurred in span 8. In this particular instance the delamination has developed in an area in which the transverse and longitudinal cracking intersects. An additional small area has spalled off adjacent to an expansion joint. It appears likely that other areas of delamination will occur as the cracking grows more severe.
