POTENTIAL PROBLEMS ON I-77 CONCRETE CULVERT

Virginia Highway & Transportation Research Council
(A Cooperative Organization Sponsored Jointly by the Virginia
Department of Highways & Transportation and the University of Virginia)

May 1976

VHTRC 76-R55

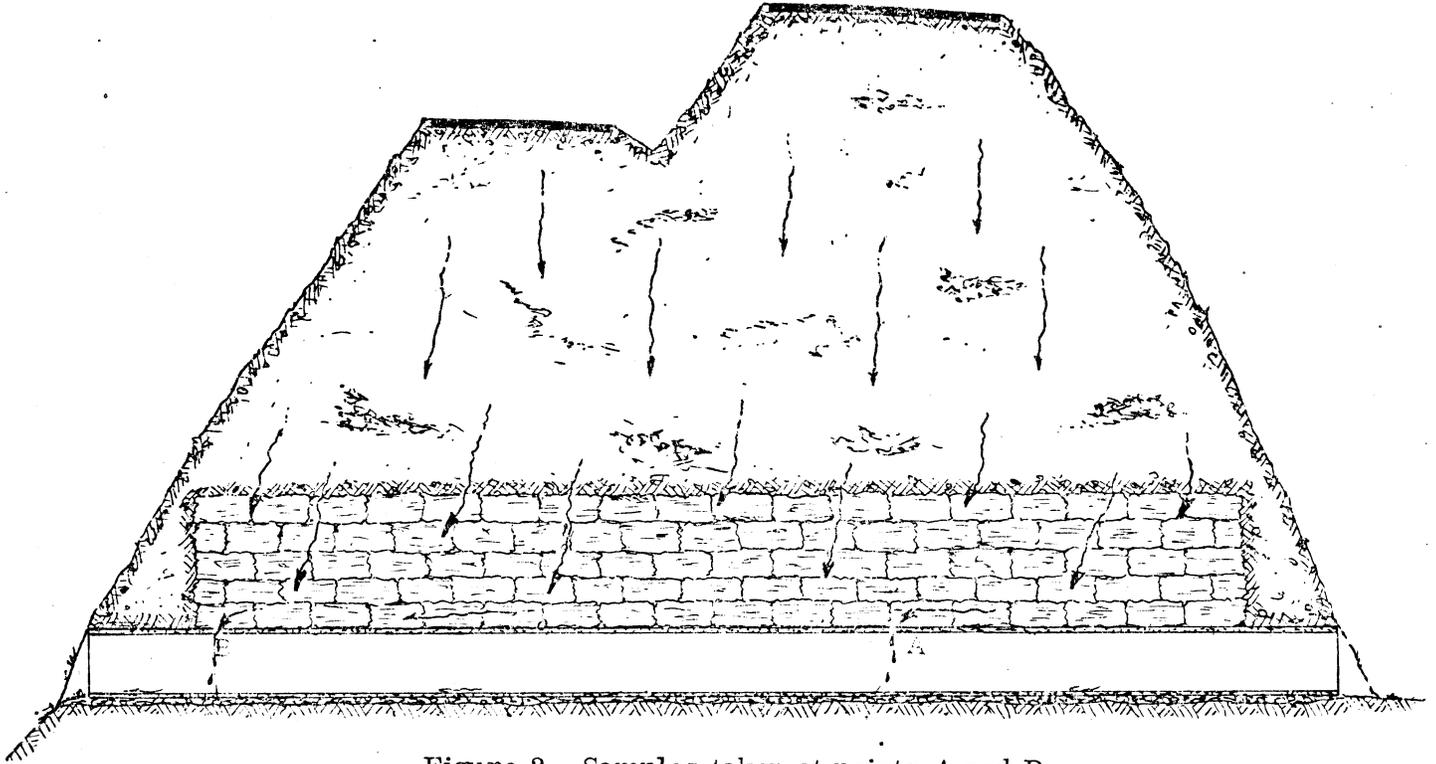
Because it was impossible to examine the exterior of the culvert, the water seeping in from the top was sampled and analyzed for the presence of organic acids. The locations of the sampling points are shown in Figure 2.

Figure 2. Samples taken at points A and B.

The results indicate the possibility that chemical attack of the concrete is occurring. The higher values for pH, alkalinity, and dissolved solids at site B all indicate that some of the concrete is being dissolved as the water flows from site A to site B. The low SO_4 values indicate that no sulfate attack is occurring.

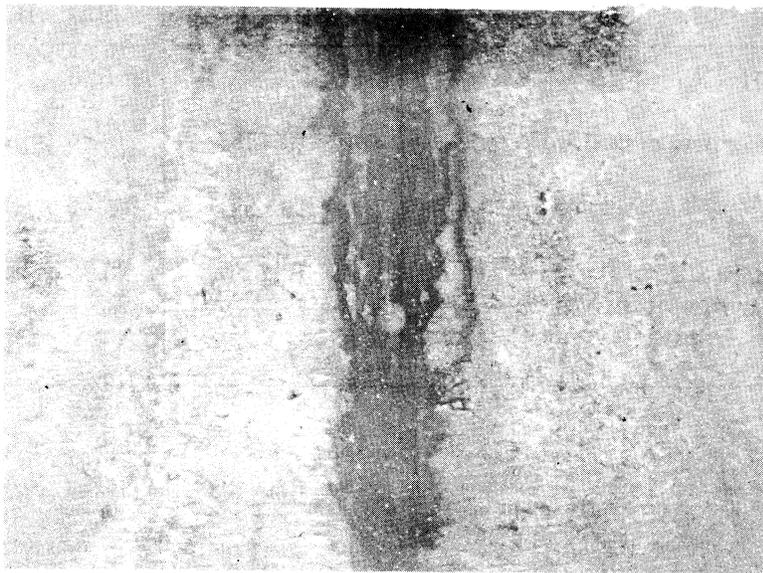
The chemical attack on the concrete associated with the decay of the straw is a slow process and a secondary problem when compared to the problem caused by the small cracks and fissures which were noticed during the collection of the water samples. The water now penetrating the cracks and reaching the reinforcing steel in the culvert is causing corrosion of the reinforcement and spalling of the concrete, which is a major structural problem. The corrosion of the reinforcing steel is evidenced by the discoloration along many of the cracks as illustrated in Figures 3 and 4.

Figure 3. Discoloration from corrosion of reinforcing steel.

1. It is recommended that measures be initiated to arrest and repair the deterioration on the reinforced concrete culvert on I-77. Structural repairs may be considered, but at the least, the corrosive water should be neutralized to reduce the chemical deterioration. The injection of a lime slurry is a possible solution.
2. It is recommended that in future construction of concrete on which water from a nearby source, such as a spring, has ready access to the overlying straw, an alternate method of backfill be used instead of the straw or imperfect trench method.

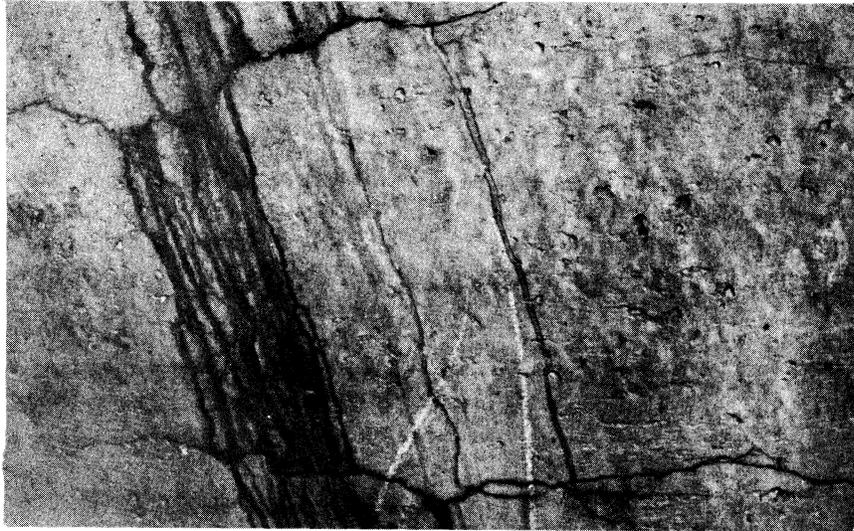
Figure 4. Large number of small cracks showing discoloration.

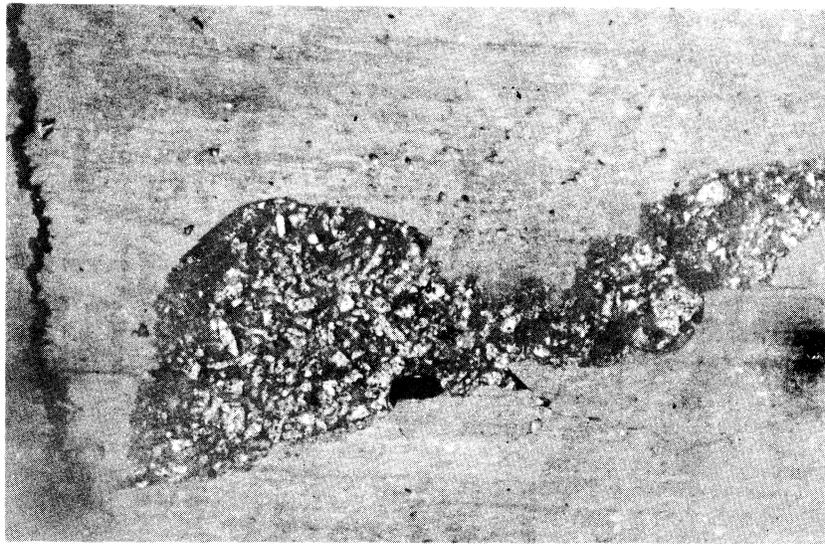
The structural cracks and spalled areas are quite large in the culvert sections under the deep part of the fill (Figure 5). The large cracks with exposed reinforcement occur at 10 and 2 o'clock on the inside of the culvert. The cracks are the largest in these areas because the culvert was designed with the straw backfill to reduce the earth pressure on top of the culvert and distribute the pressure to its sides. With the large inward pressure on the culvert's sides and only minimal pressure on the top, it is quite possible that tensile cracks are present on the outside of the top of the culvert. With these cracks being probable and the corrosive water being readily available, it is quite certain that the reinforcement is being corroded and the structural strength of the culvert is being reduced.

Figure 5. Large spalled area.
