MINIMIZATION OF REFLECTION CRACKS  
ROUTE 17 GLOUCESTER COUNTY INSTALLATION REPORT 1976

C. S. Hughes  
Senior Research Scientist

December 1976  
VHTRC 77-R30

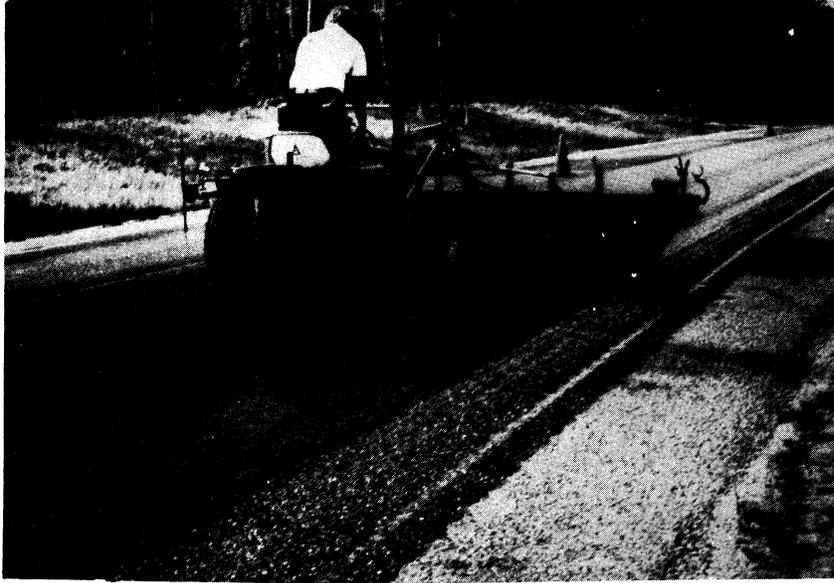
In placing the Petromat, .25 gsy of AC-20 tack was shot in the southbound lane for the six rolls used. The installation was made quickly and with the exception of wrinkles that occurred near the edge of the pavement (Figure 2) no difficulties were noted. After the sixth roll of Petromat was placed, the process was repeated in the northbound lane.

Figure 2. Tractor placing Petromat and resulting wrinkles in fabric.

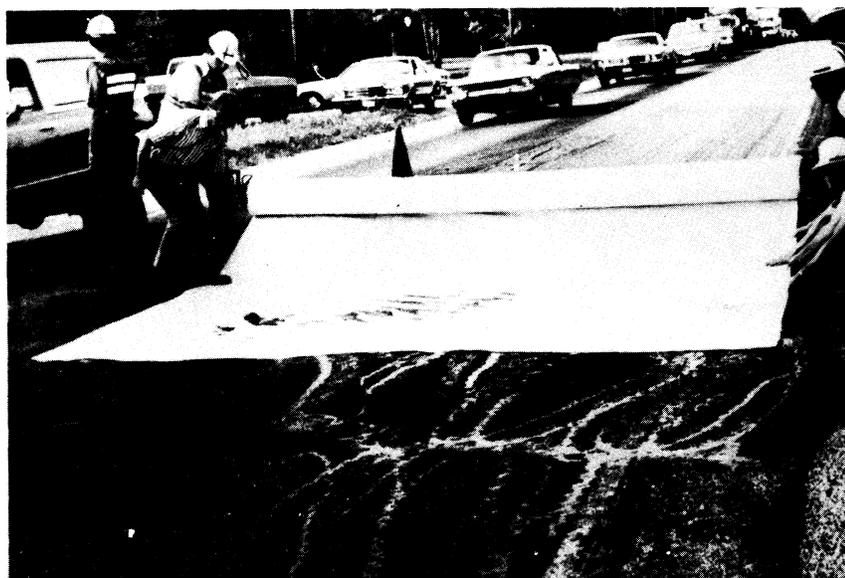
Starting at the north end of the southbound lane, prior to placing the Mirafi, .15 gsy of AC-20 asphalt was applied as a tack coat as recommended by the manufacturer. The single roll of Mirafi was placed, as previously mentioned, using hand brakes. Although the installation of this material went smoothly, placing any fabric by hand is more time-consuming than placing fabric mechanically and does tend to hold up the paving operation.

Figure 3. Mirafi being placed with the aid of hand brakes.

It is further recommended that future fabric installations be accomplished by mechanical means as opposed to hand methods to speed up the work and reduce the amount of labor required.

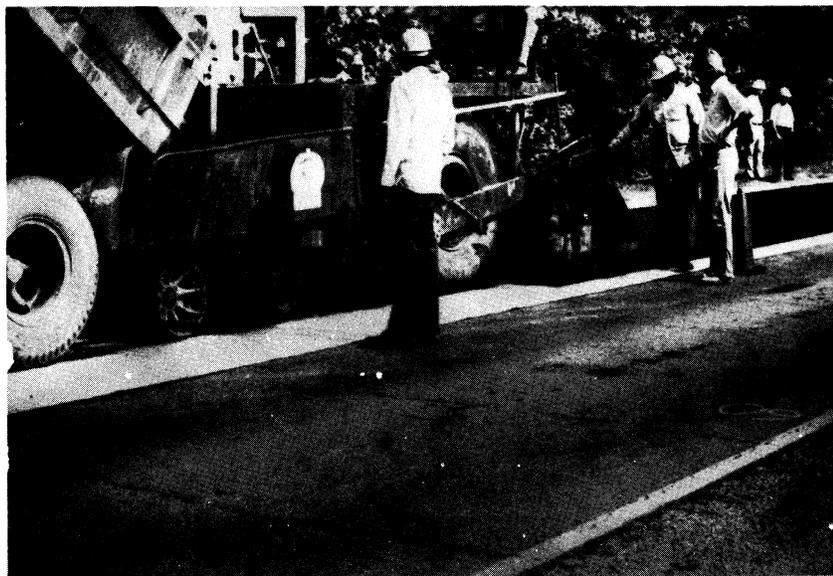
The section was badly cracked as shown in Figure 4. In fact, the poor riding quality caused by the numerous transverse cracks was the primary reason for overlaying.

The performance of the test and control sections will be watched closely. The presence of transverse cracks and what appears to be faulting at these cracks may create a very severe test for the ability of fabrics to minimize cracks from reflecting through the overlay. If there is appreciable vertical movement at the cracks, it is likely that the fabrics will not be able to minimize the shear stress and influence the formation of reflection cracks.

Figure 4. Typical transverse cracking in foreground.
