ROADWAY LIGHTING: ILLUMINATION STUDY
OF RTE. I-95, SHIRLEY HIGHWAY

Marvin H. Hilton
Research Engineer

Virginia Highway & Transportation Research Council
(A Cooperative Organization Sponsored Jointly by the Virginia
Department of Highways & Transportation and the University of Virginia)

VHTRC 77-R4

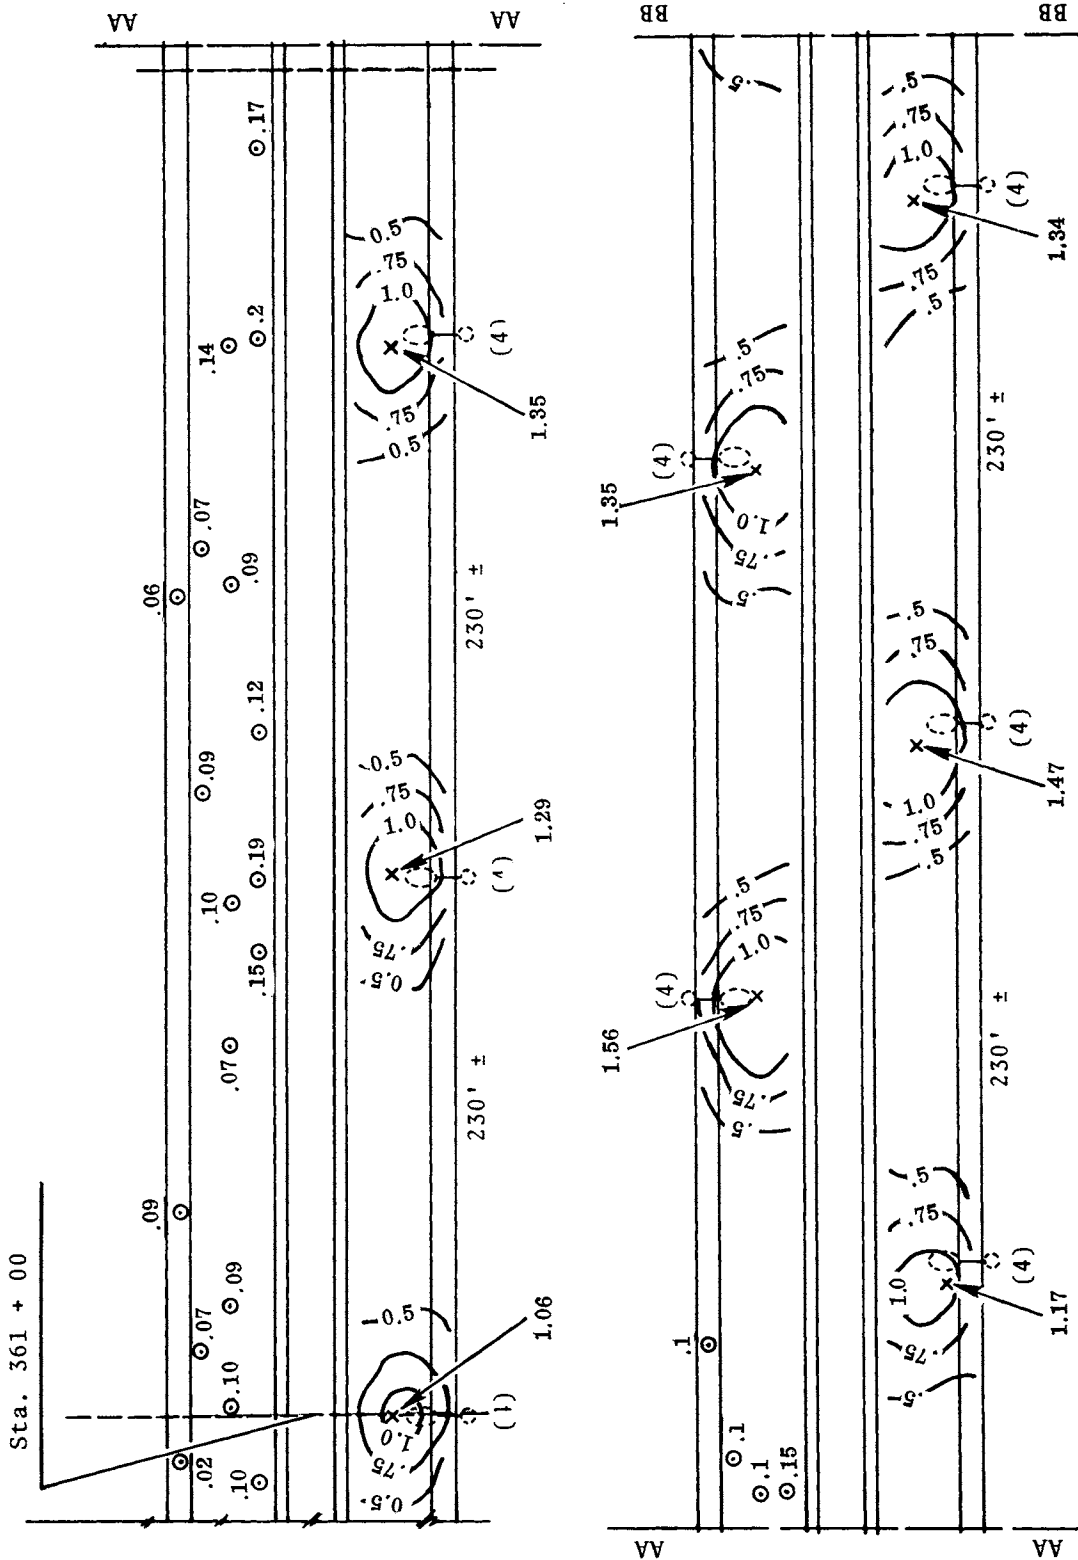
Isofootcandle diagrams for the transition zone are shown in Figures 6 and 7. These data were plotted from the data tapes and the isofootcandle lines developed by interpolation between plotted points where required. These particular lights had been in service for over a year when the initial measurements were taken. Therefore, the levels of illumination shown on the figures can be expected to be lower than those that would have existed initially. As can be noted from the diagrams, however, the highest level of illumination in the areas where luminaires are located only on the NBL was 1.35 fc. (14.53 lux [lx]) directly beneath a light source. The average level of illumination was 0.56 fc. (6.03 lx). Halfway between the luminaires the light levels dropped to the general range of 0.2-0.3 fc. (2.15-3.23 lx). Taking the section of roadway between the broken lines shown on Figure 6, the uniformity ratio on the NBL was 3.51:1. Although this was higher than the 3 to 1 ratio recommended in the American Standard Practice for Roadway Lighting,⁽⁶⁾ it is probably relatively good for the lamp post spacing used.

On the opposite side of the road in the SBL (for traffic leaving the lighted area) the general lighting levels ranged between 0.1 - 0.2 fc. (1.08-2.15 lx) and averaged 0.11 fc. (1.18 lx). These levels were less than the 0.25 fc. (2.69 lx) minimum suggested by the standards⁽⁶⁾ but were quite uniform at a 1.54:1 ratio.

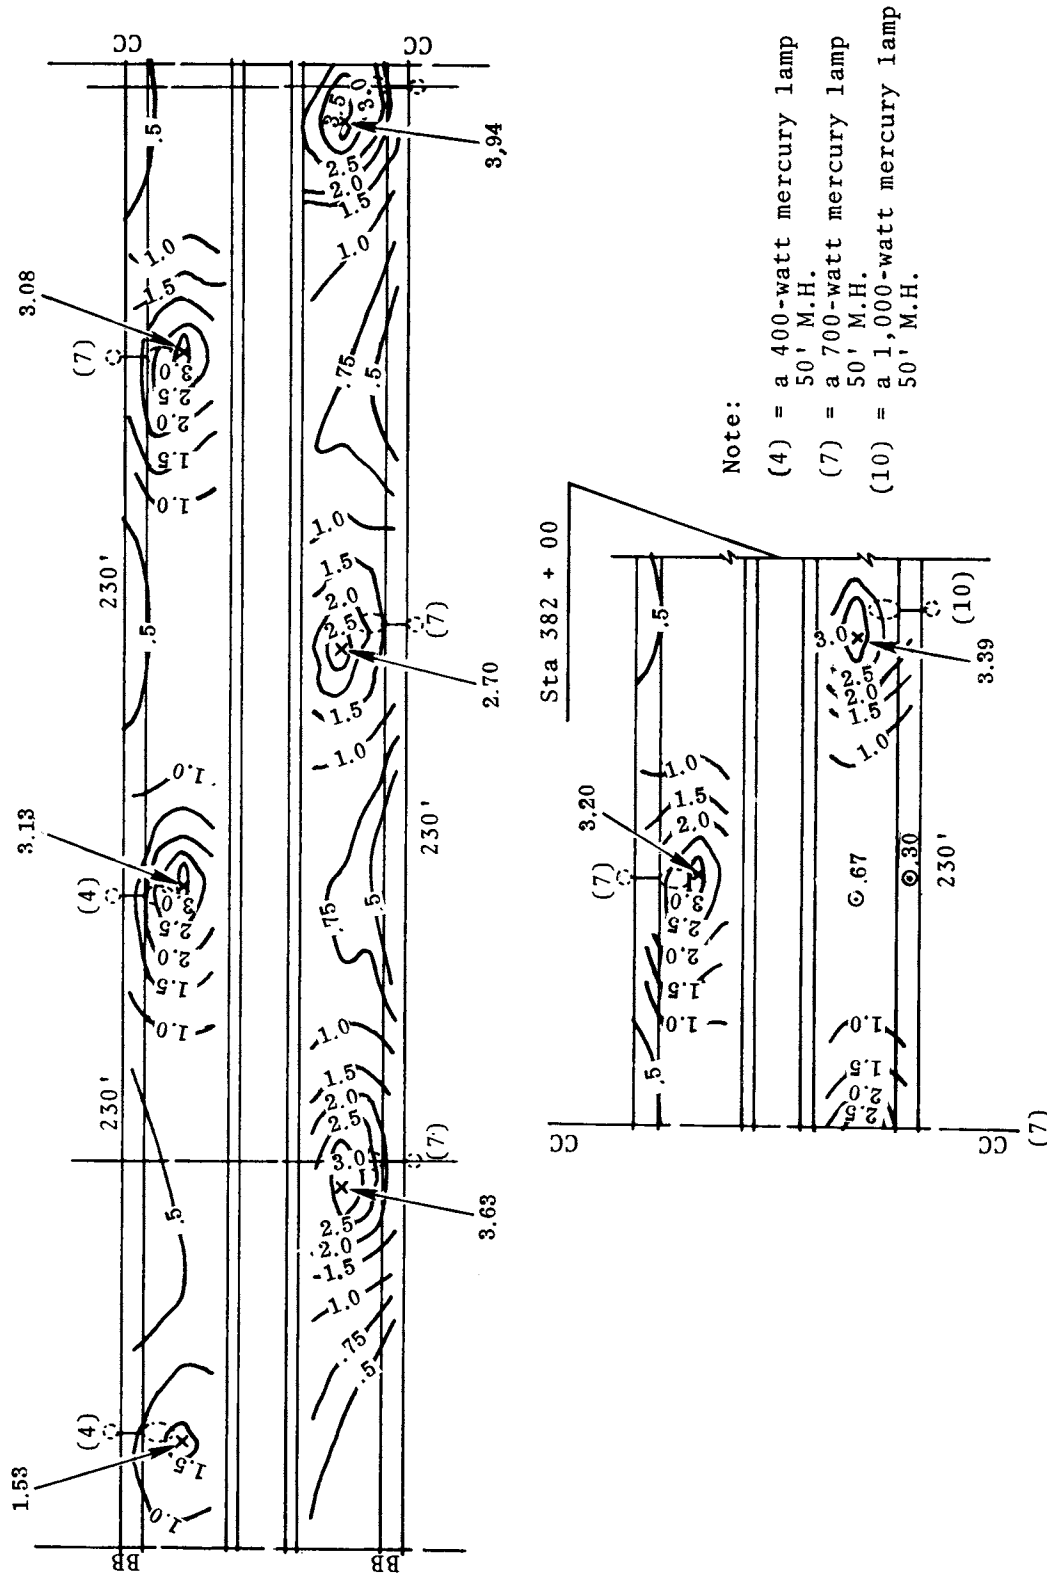
Figure 7 shows the continuation of the isofootcandle diagram of Figure 6. Here the luminaires have 700-watt lamps in the NBL and the 400-watt lamps begin on the SBL. Considering the area between the broken lines shown in Figure 7, which includes only 700-watt lamps, the highest levels beneath the light sources were on the order of 3-4 fc. (32.29-43.06 lx) and the lows in the range of 0.30-0.40 fc. (3.23-4.31 lx). The overall average level of illumination was 1.28 fc. (13.78 lx)—slightly more than double that of the previous sector and very close to the desired

standards.(6) The uniformity ratio was 4.12:1, which was not as good as that for the area discussed previously-- which indicates that the luminaire spacing may be too great to cover the shoulder areas adequately. Also, lamp output could be slightly high, which would increase the illumination level in the vicinity of the lamp posts and in turn can cause poorer uniformity of the lighting. Since the standards suggest that the lighting level of an adjacent sector be one-half that of the preceding sector in transition zones, reduced output at the light source might improve the situation. From a practical viewpoint, however, the average illumination levels are only slightly more than double that of the previous sector and could be considered reasonably good.

Figure 7. Isofootcandle diagrams continued from Figure 6 showing distribution of illumination levels in the transition zone. Areas between the broken lines were tested for uniformity (Test sector 2). (1 fc = 10.76 lx)

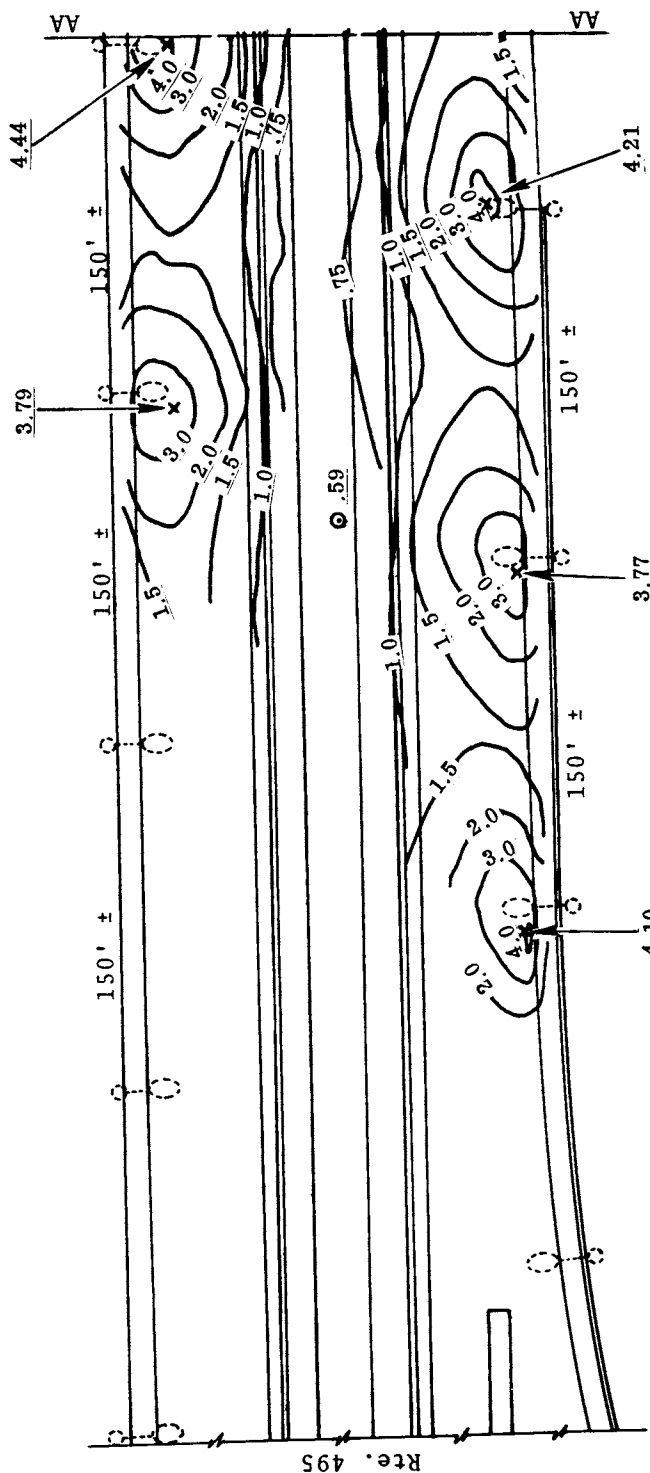
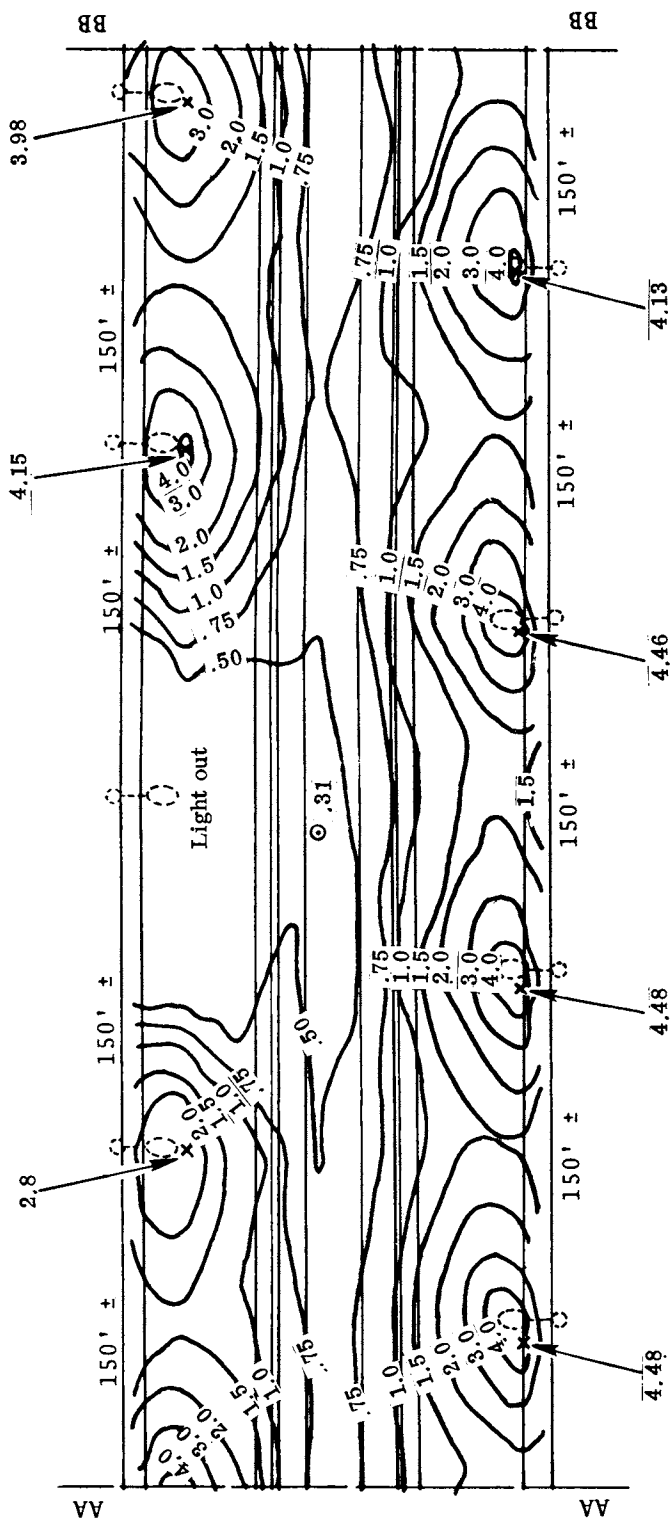
An examination of the data reveals that the output of the luminaires varies considerably. The maximum illumination levels near the light sources are usually in the 4 to 4.5 fc. (43.04 to 48.42 lx) range but some have maximums only slightly greater than 2 fc. (21.52 lx). This leads to some variation in the iso-footcandle patterns but in general the lighting was uniform. Taking a typical area such as that indicated by the broken lines in Figure 9, the overall average illumination was 1.38 fc. (14.85 lx) with a uniformity ratio of 2.38:1.

Figure 8. Isofootcandle diagram showing the distribution of illumination on a 10-lane section of Rte. 95 beginning north of the Rte. 495 interchange. 1,000-watt mercury luminaires, 50 ft. M.H., 12 ft. mast arm. (1 fc. = 10.76 lx)

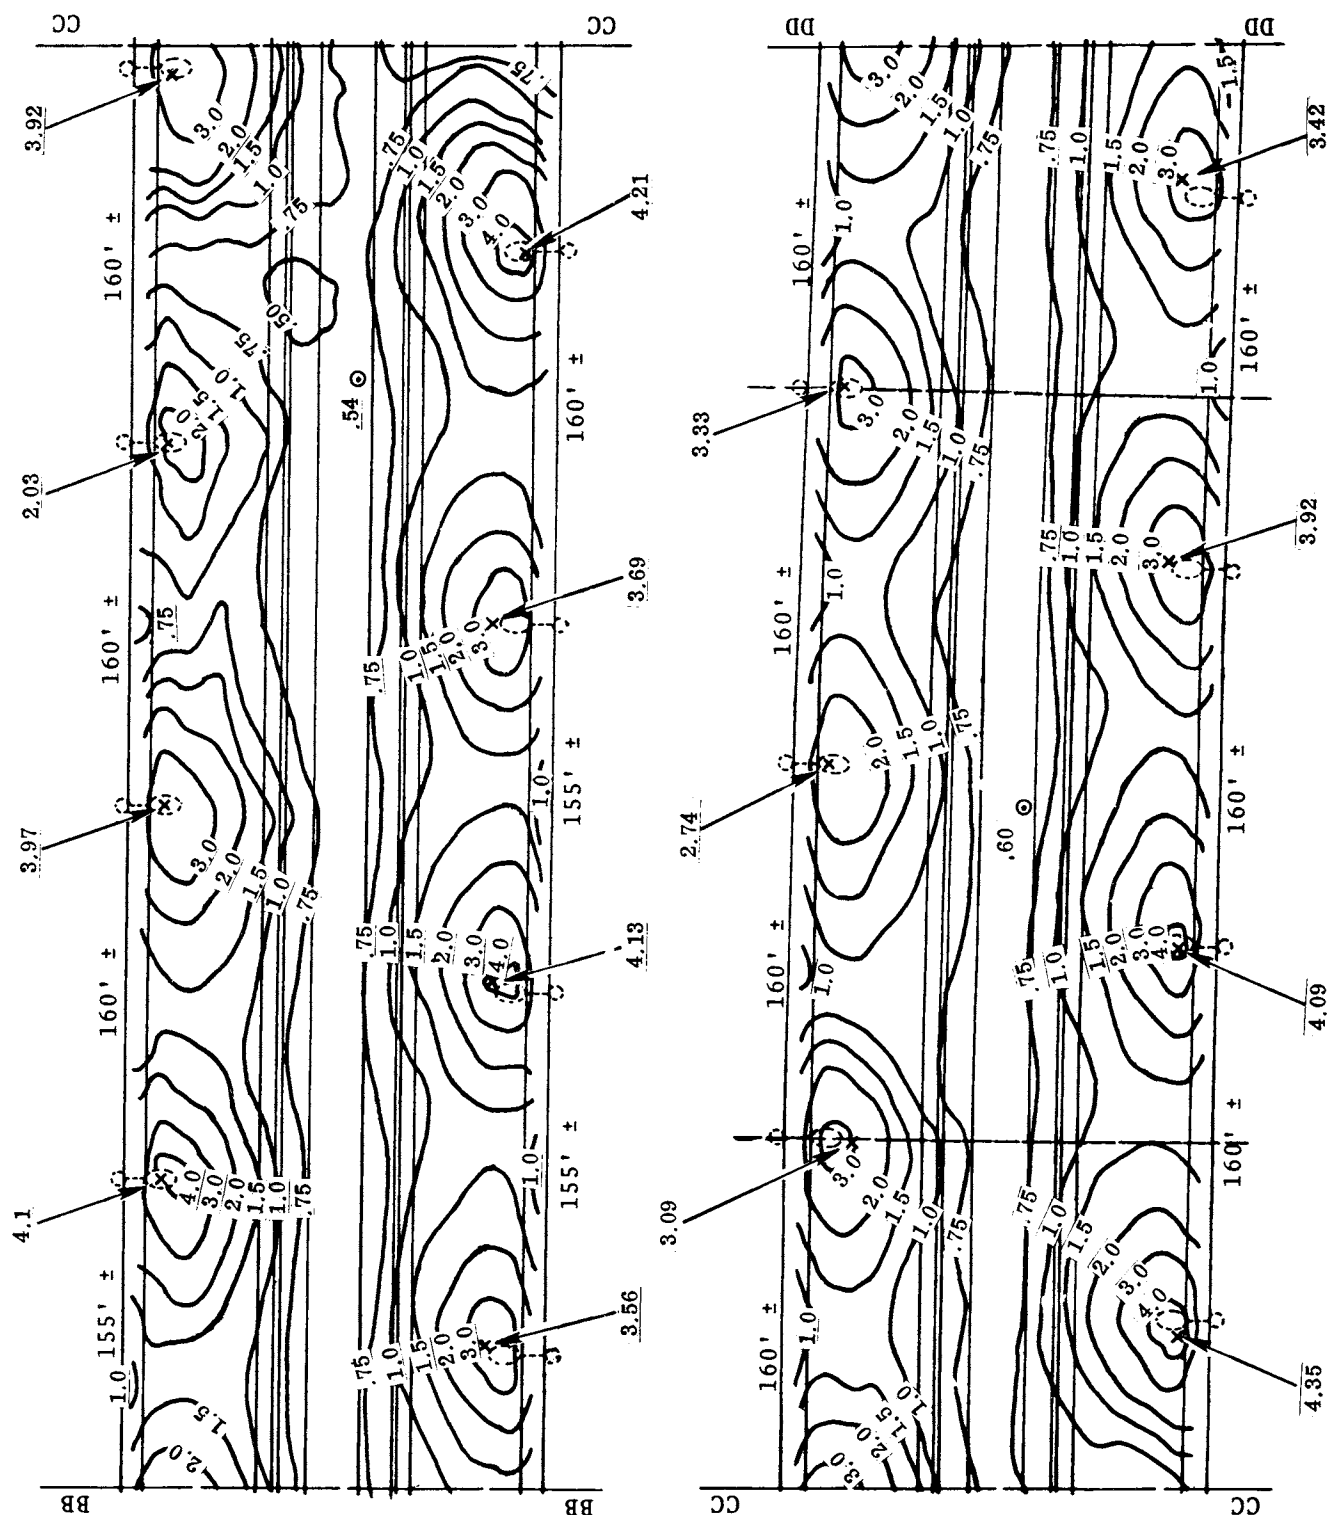
Figure 9. Continued isofootcandle diagram showing the distribution of illumination on a 10-lane section of Rte. 95 between the Rte. 495 and Edsall Road interchanges. Broken lines indicate area used for determining uniformity ratio. (1 fc = 10.76 lx)

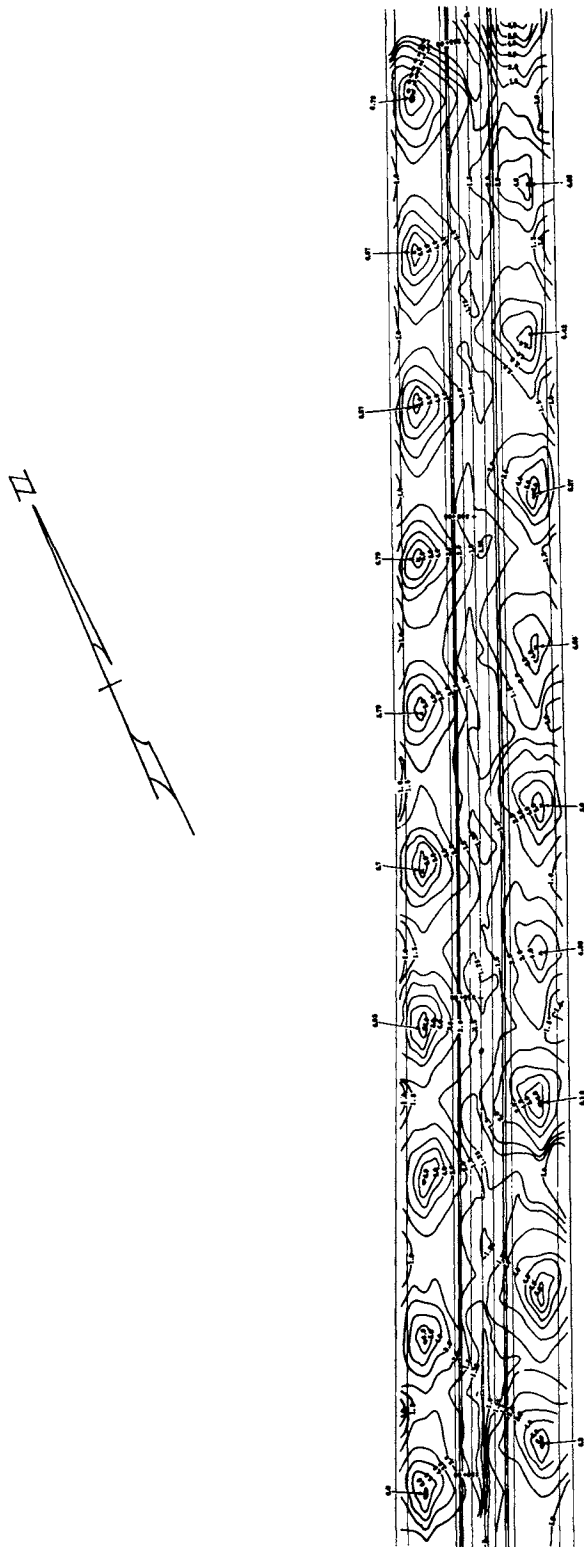
All of the data charts for the full main line roadway, including the shoulders on both the NBL and SBL were used to develop the isofootcandle diagram shown in Figure 15. The initial distribution and levels of illumination for the whole roadway section can be clearly viewed on this diagram. The uniformity of the lighting was excellent— particularly in the reversible lanes. There was some variation in the maximum output of the lamps— some being brighter than others— but this

Figure 15. Isofootcandle diagram of the main line roadway area north of Glebe Road. (1 fc = 10.76 lx)

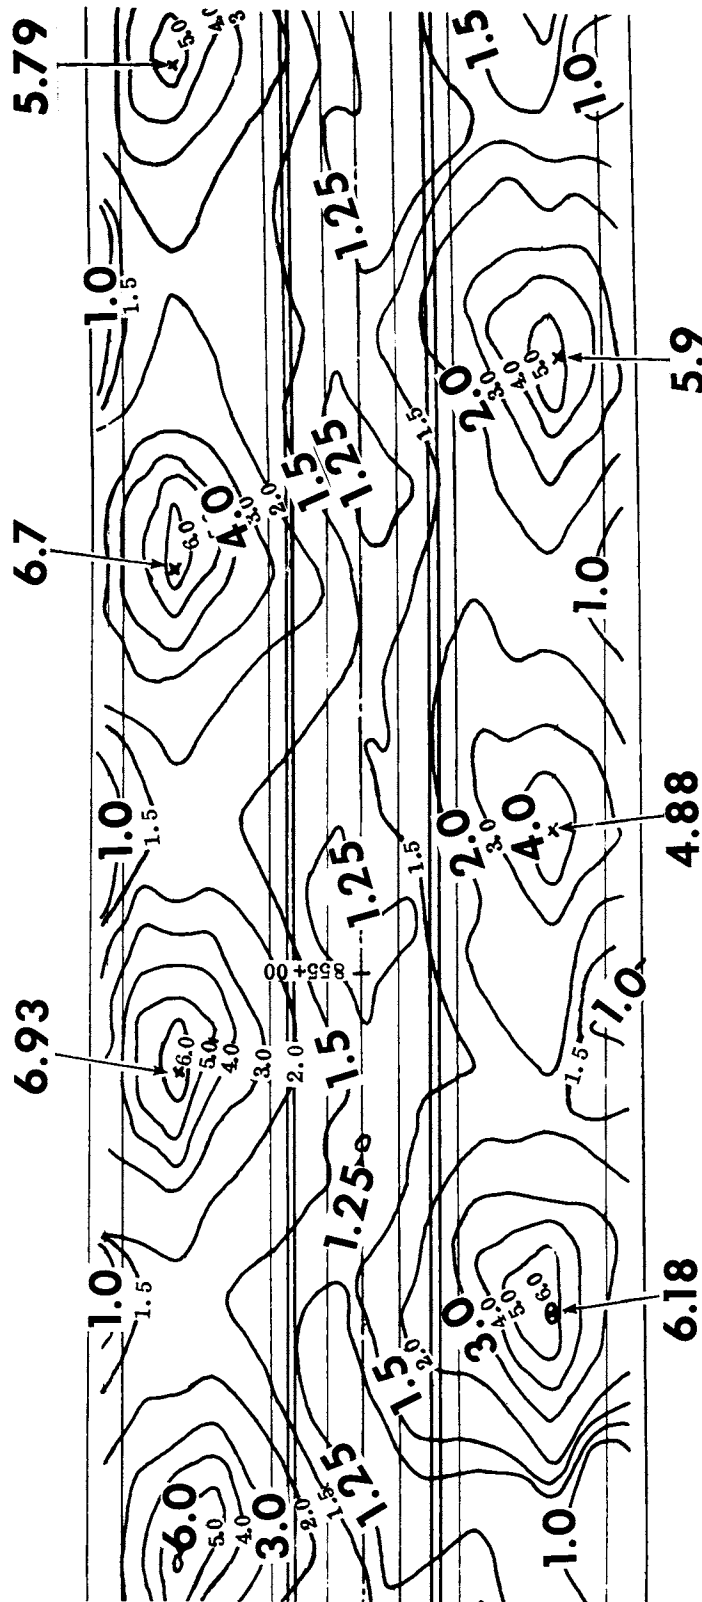
appears to be a consistent characteristic throughout the project. Therefore, a smaller section of the roadway was extracted from that shown in Figure 15 in such a manner that these typical lamp output variations were included. This section, shown in Figure 16, was used to calculate the average illumination level and the uniformity of the lighting. The uniformity of the total section was found to be 2.57:1. Considering only the reversible lanes, the uniformity was 1.45:1. These uniformity results were very similar to those discussed earlier for the main line lighting north of the Rte. 495 interchange that had been in service for some time when the illumination measurements were made.

Figure 16. Enlarged section used for uniformity calculations. Variation in lamp output is typical of that found on the main line. (1 fc = 10.76 lx)

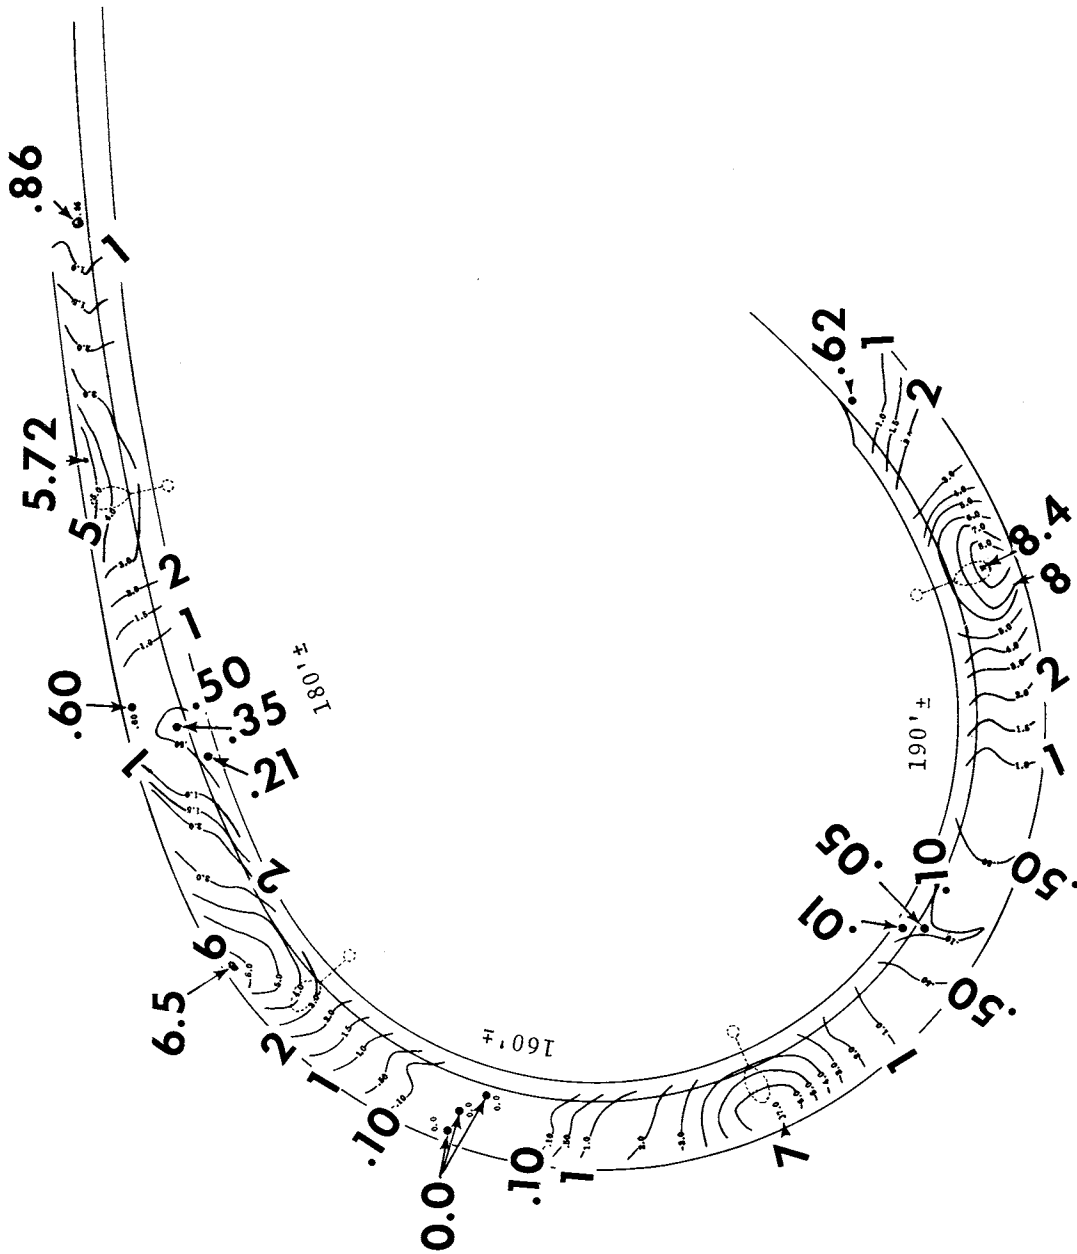
some of the lighting on this area of ramp B was probably designed to be provided by the lamps on the adjacent ramp A. Halfway between the first two luminaires on ramp B, however, the lighting levels were low—some points on the order of 0.01 fc.(0.11 lx) on the shoulder—as indicated in Figure 18. Between the next two lights the illumination levels are nearly zero. The low levels at these points are due partially to the fact that the data were taken from the roof of the vehicle and thereby did not include light that might have been on the pavement. Consequently, hand measurements were taken at the pavement level, and a low value of 0.12 fc.(1.29 lx) was obtained. This value would yield a uniformity ratio of 19.25:1 on the paved area of ramp B, with the average level of illumination being 2.31 fc.(24.86 lx). The distribution of the lighting would probably be better if the lamp posts were spaced closer or if more light were contributed to the ramp from the luminaires on ramp A.

The distribution and maximum levels of illumination at the last two lights on ramp B are unusual in that the isofootcandle patterns are not the same as those normally existing beneath the light source. The maximum level of 6.5 fc.(69.94 lx) near the third luminaire from the beginning of the ramp was not directly under the lamp as would be expected. The same situation exists for the last luminaire shown. This result was probably due to a combination of the grade on the ramp and the influx of additional light on the area from the main line. In general the lighting on the ramp was not particularly good due to the low levels halfway between the luminaires.

Figure 18. Isofootcandle diagram for ramp "B" of the Glebe Road interchange. (1 fc = 10.76 lx)

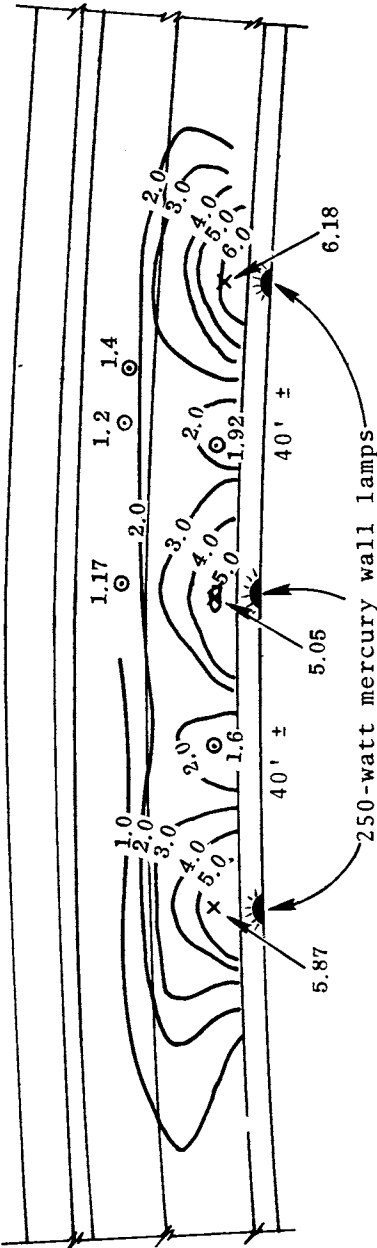
The average illumination level on the ramp G underpass was 2.87 fc.(30.89 lx) and the uniformity ratio was 4.41:1. On ramp D, the average illumination was 2.76 fc.(29.71 lx) and the uniformity was 3.17:1. There was a difference in the measurements in that only the merging lane of ramp D was included whereas the full ramp width was included for ramp G. The uniformity on ramp D, therefore, would not be as good if the full ramp width were included in the data. While the uniformity of the under bridge lighting on ramp G does not meet the 3:1 desirable ratio, it appears to be good, except in the right corner at the entrance end of the underpass (Figure 20). A slight redirection of the lighting from the end luminaire could probably correct this deficiency.

Figure 21. Isofootcandle diagram for ramp "D" underpass lighting.
(1 fc = 10.76 lx)

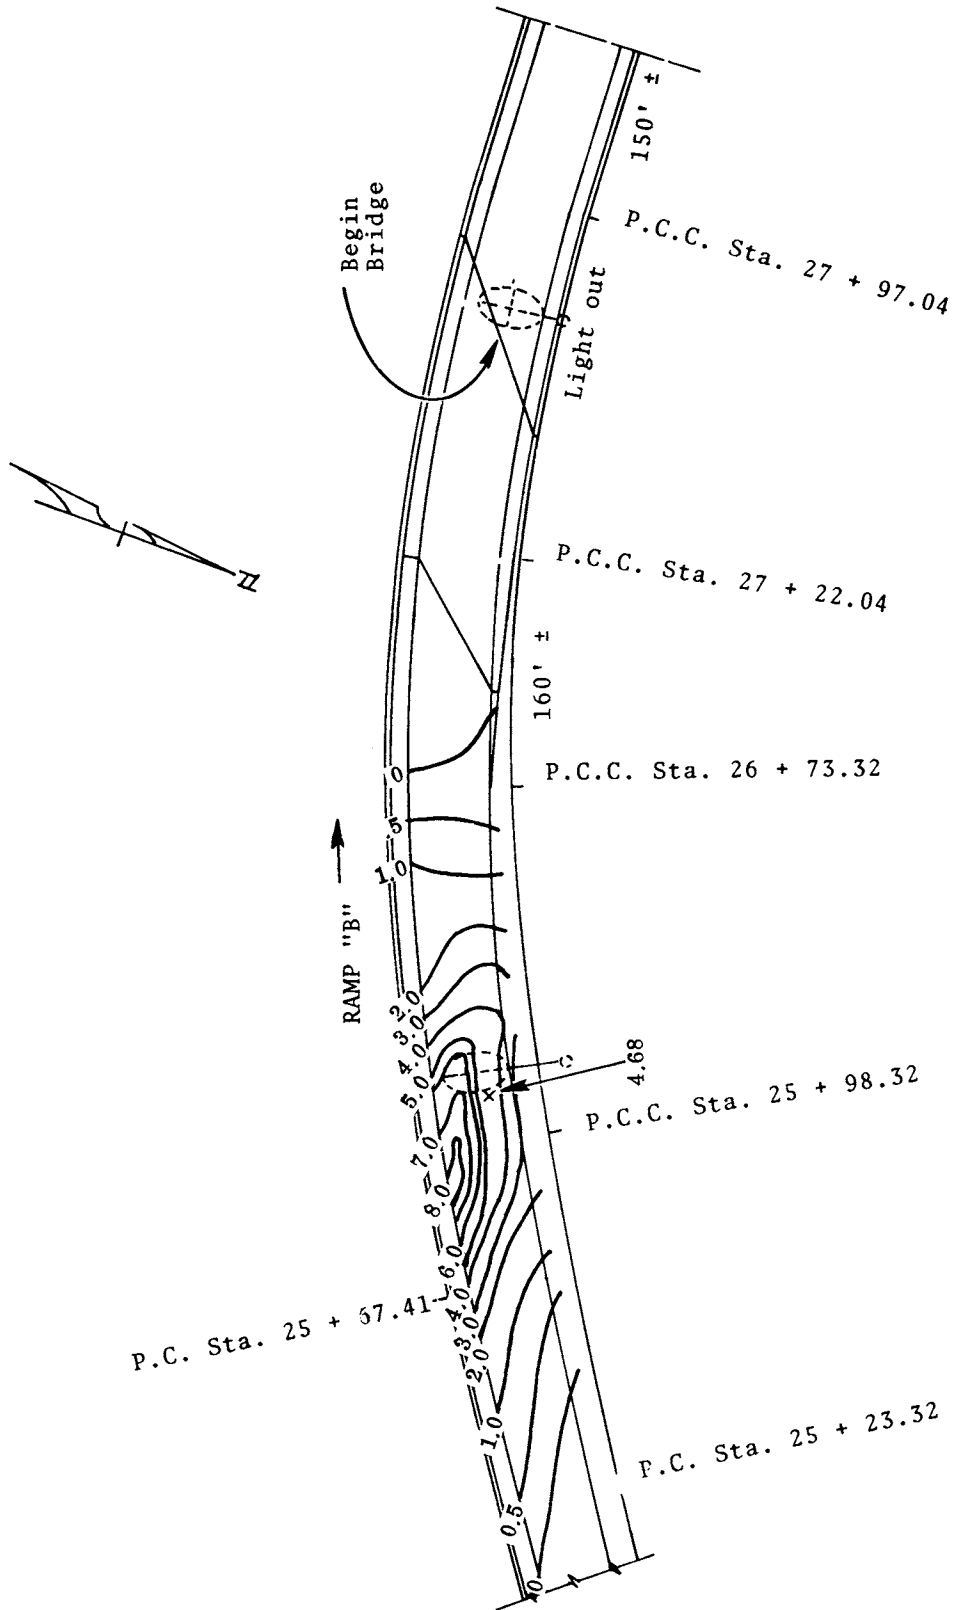
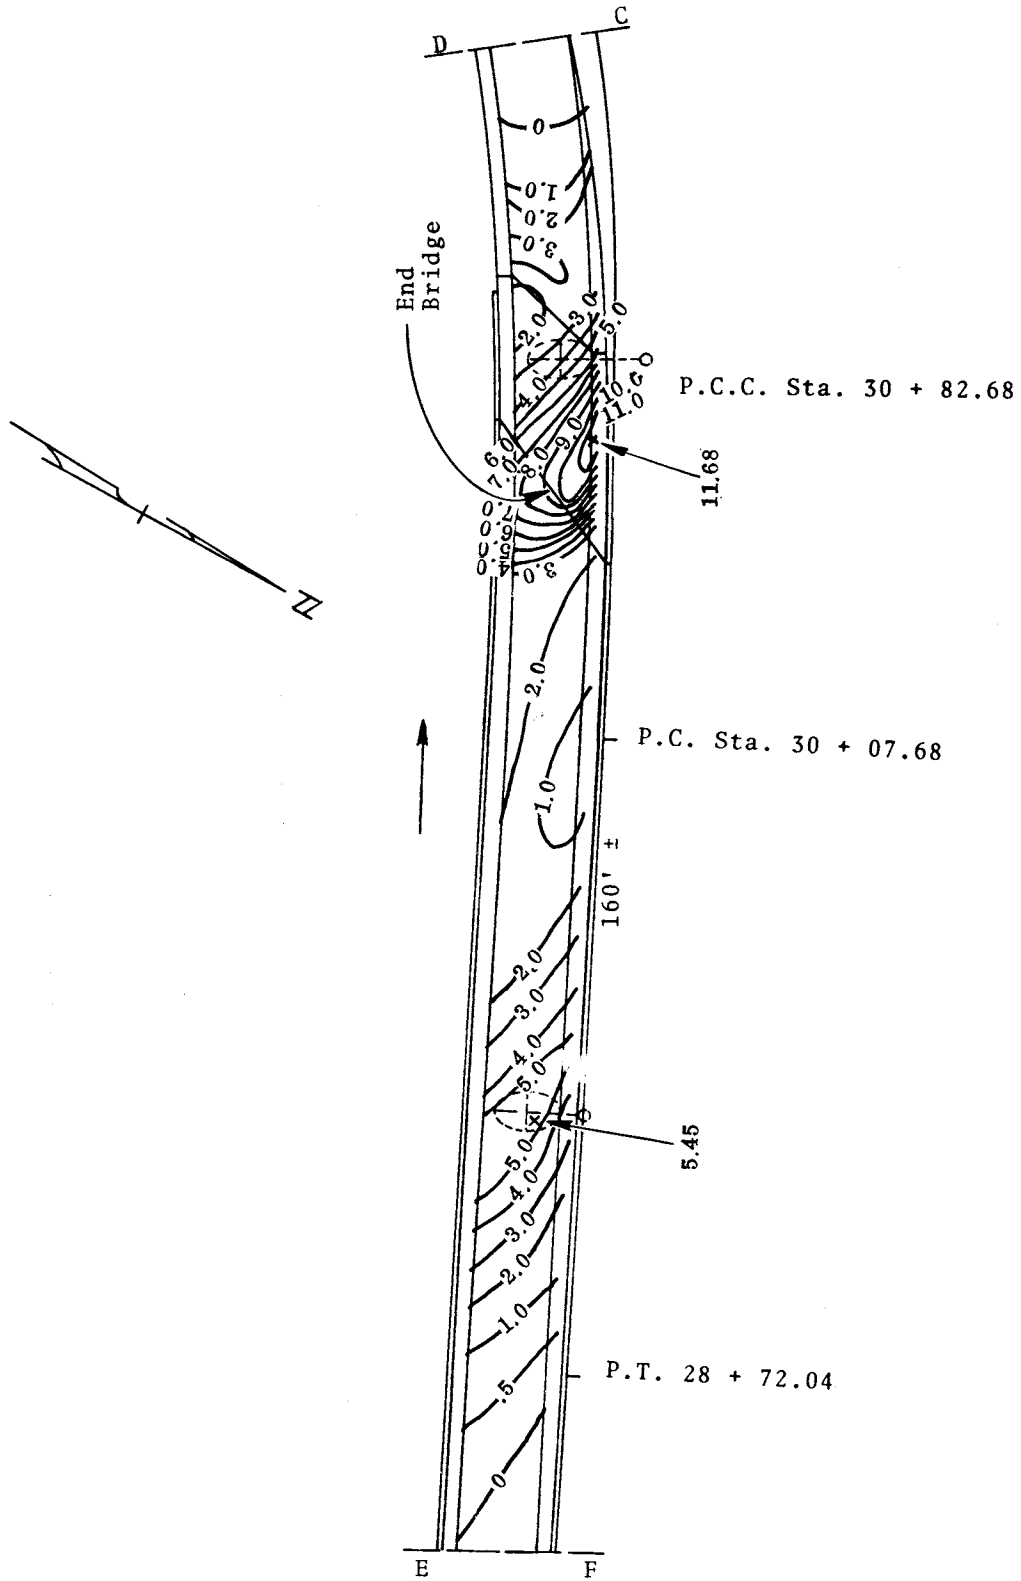
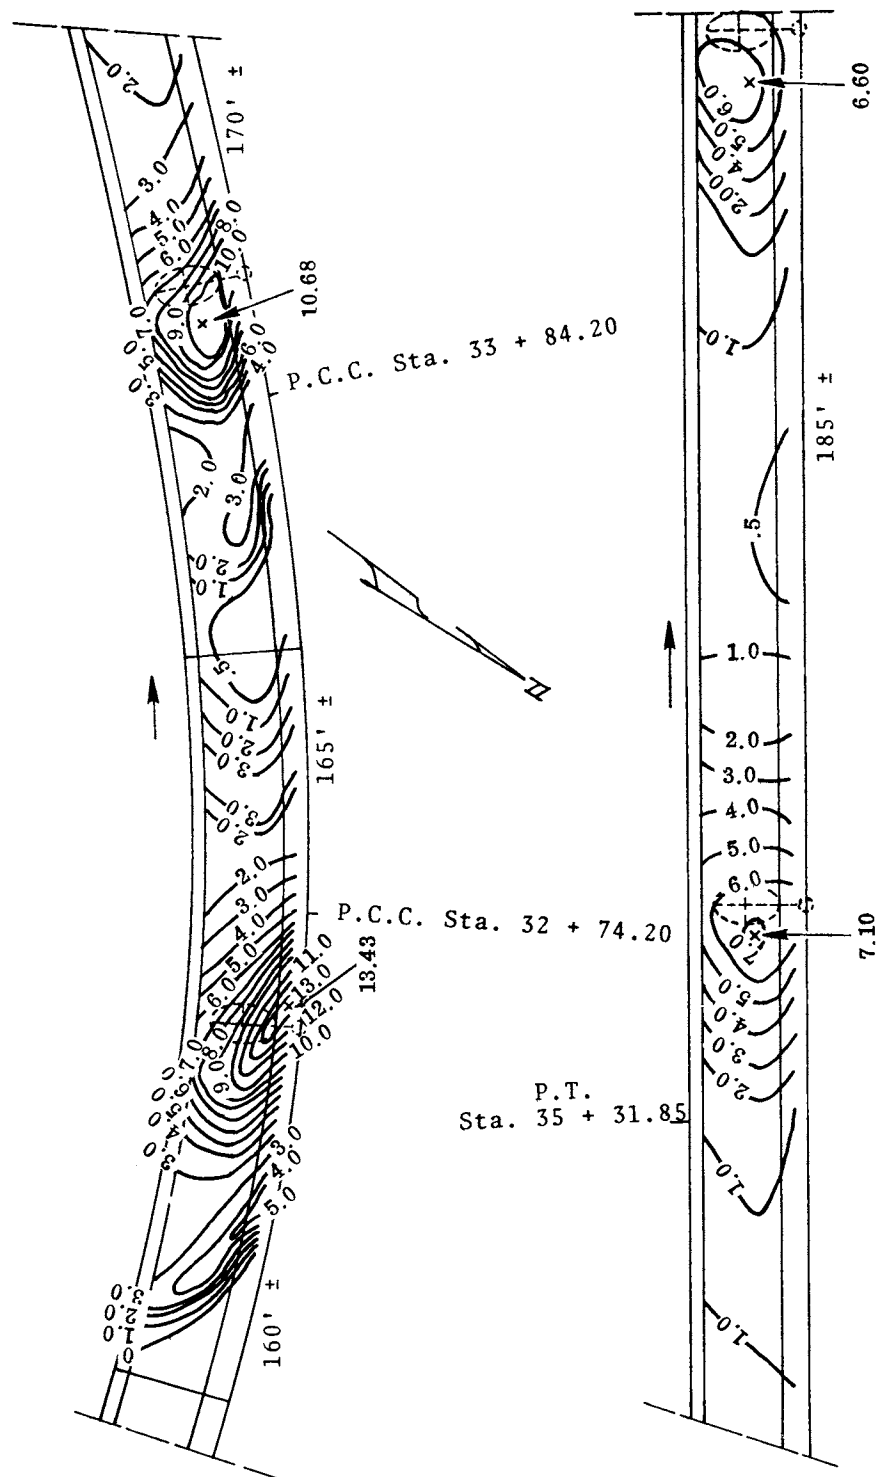
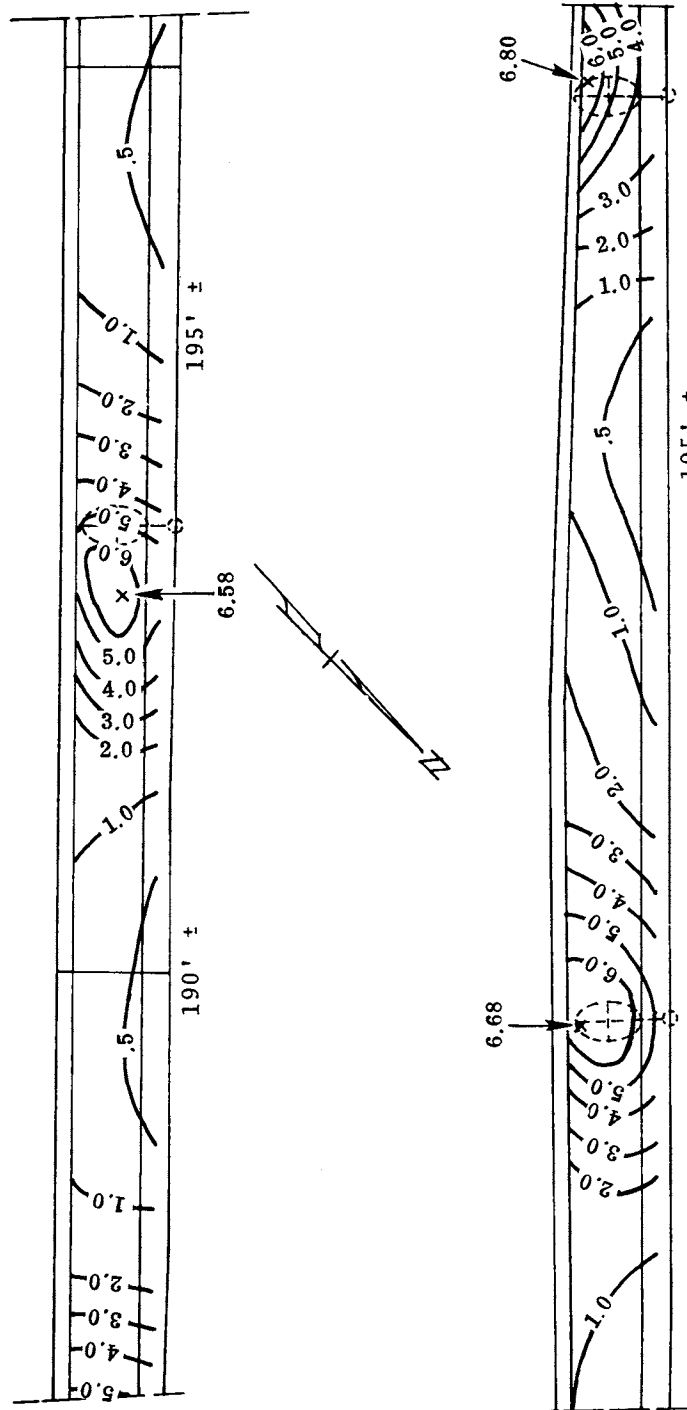
Several things are of interest in the ramp data shown in Figures 23-26. First, the spacing between the lamp posts varies from 150 ft.(45.72 m) on the curved section of the ramp to 195 ft.(59.44 m) near the intersection with the SBL of the main line. Secondly, the maximum level of illumination is much higher under the first three luminaires beyond the end of the bridge (Figures 24 and 25) than it is on the remainder of the ramp.

On the curved section of the ramp the average intensity was 3.75 fc.(40.36 lx), whereas on the straight section it was 2.14 fc.(23.02 lx). Noting that one lamp was out at the time data were taken and excluding this area from the calculations, the average intensity of the lighting over the length of ramp B shown was 2.63 fc.(28.31 lx). This value would yield a uniformity ratio of 11.4:1 for the roadway including the paved shoulders. The low value of the lighting was 0.23 fc.(2.48 lx), which was found on the pavement at several spots located approximately halfway between adjacent luminaires. Due to the higher average intensity in the curved section, the uniformity of the lighting was not as good in this region as it was on the straight section having the lower average intensity. The uniformity thus varied from 9.3:1 on the straight section of the ramp to 16.3:1 on the curved section.

The unusual distribution of the illumination and the maximum level of intensity falling slightly upgrade from the luminaire location indicate that there could be some spillover of light from the main line and that the luminaires may need to be oriented vertically on the support so that the light rays strike the surface equidistance from the luminaire.

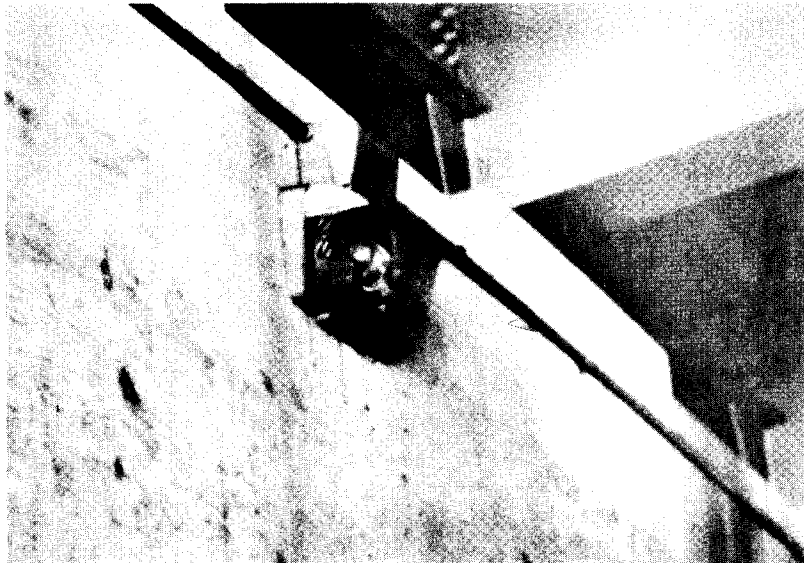
A final problem encountered during the data collection periods involved vandalism, which appears to be a particular problem in the interchange, ramp, and underpass areas. Several wall-mounted luminaires such as the one shown in Figure 29 were found to be broken during data collection. It is likely in this case that rocks were thrown at the lighting. A lesser but similar problem seems to exist on some ramps having the lower mounted luminaires such as the one shown in Figure 30. Vandalism will probably be a reoccurring problem with the lighting— particularly on the ramp underpasses such as those at the Glebe Road interchange.

Figure 29. A wall-mounted bridge underpass luminaire that was probably broken by vandals.

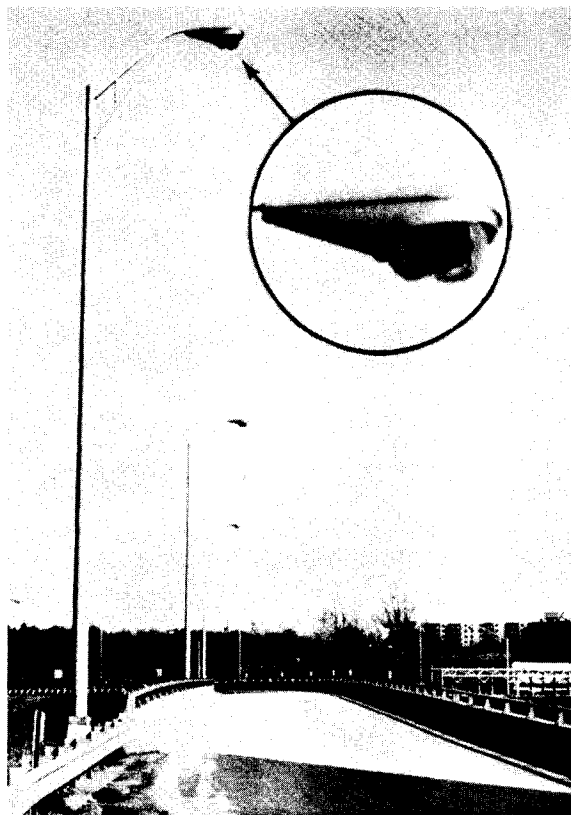
Figure 30. A 40 ft.(12.19m) high interchange ramp luminaire that was broken by vandals.
