INSTALLATION REPORT
USE OF FABRIC IN FLEXIBLE PAVEMENTS— 1980

C. S. Hughes
Senior Research Scientist

Virginia Highway and Transportation Research Council
(A Cooperative Organization Sponsored Jointly by the Virginia
Department of Highways & Transportation and
the University of Virginia)

VHTRC 81-R43

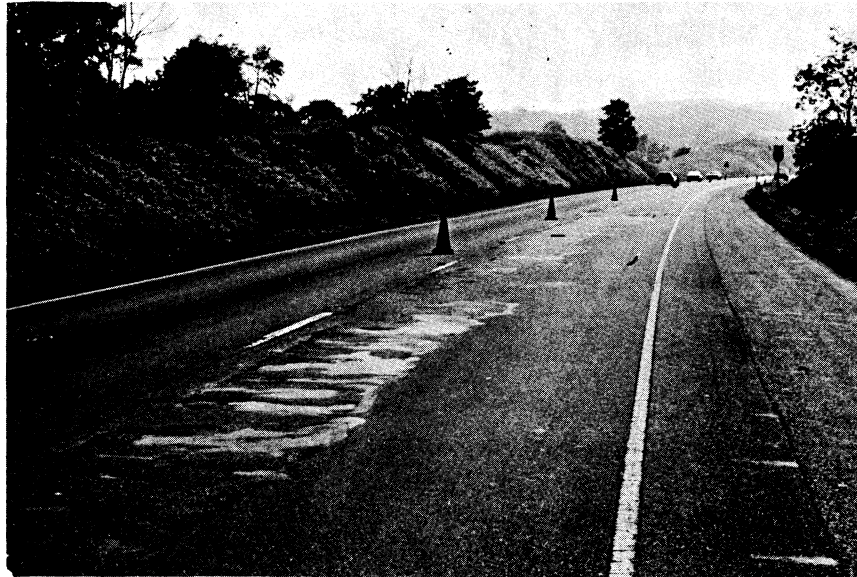
One installation was made on a section of I-81 in Pulaski County that had been overlaid in 1976 with 125 psy of S-5. The overlay did not perform well and, as shown in the attached Figures 1 and 2, was breaking away from the original surface, apparently because the tack coat had been insufficient.

Figure 1. Distress prior to fabric installation,
Route 81, Pulaski County.

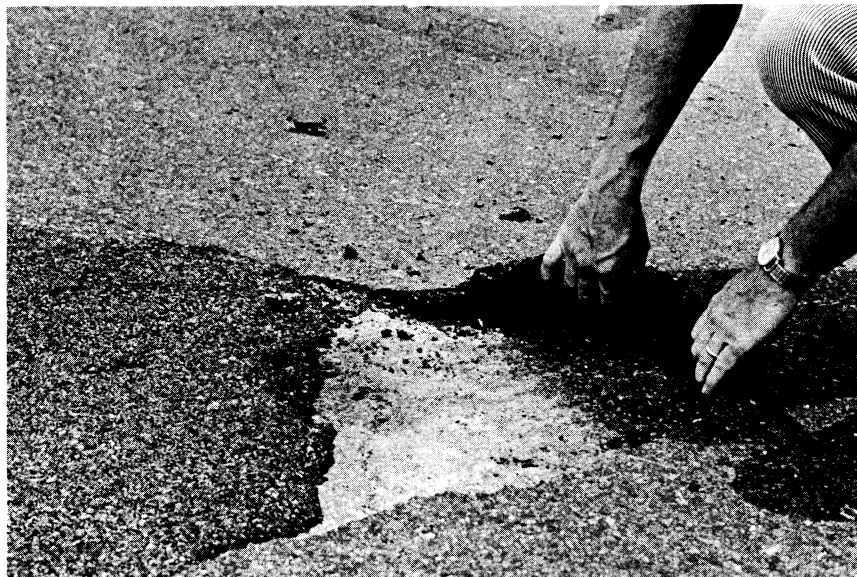
Figure 2. Disbonding prior to fabric installation,
Route 81, Pulaski County.

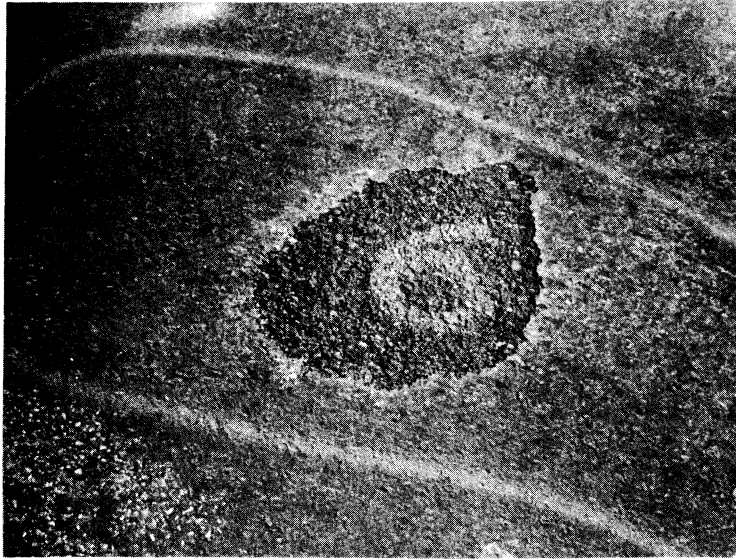
After about three months, small areas in the fabric started showing distress in the form of disbonding of the overlay from the fabric (Figures 4 and 5). The distress was confined to the section with fabric, which appeared to be pushing and raveling. Several of the distressed areas showed the 1980 overlay to be less than 1-in. thick although the application rate was 130 psy of S-5.

Investigation of cores from the failed areas by Phillips Petroleum Company and the Research Council indicated that the recovered asphalt was much softer than would have been expected of an AC-20. Penetrations on the recovered material were about 80 and the viscosities were (140°F) 2930 poises and (275°F) 540 cs. Since the failed areas were in the fabric section, it is speculated that the tack coat may have been contaminated with a fuel oil or kerosene.

Figure 4. Distress 3 months after fabric installation,
Route 81, Pulaski County.

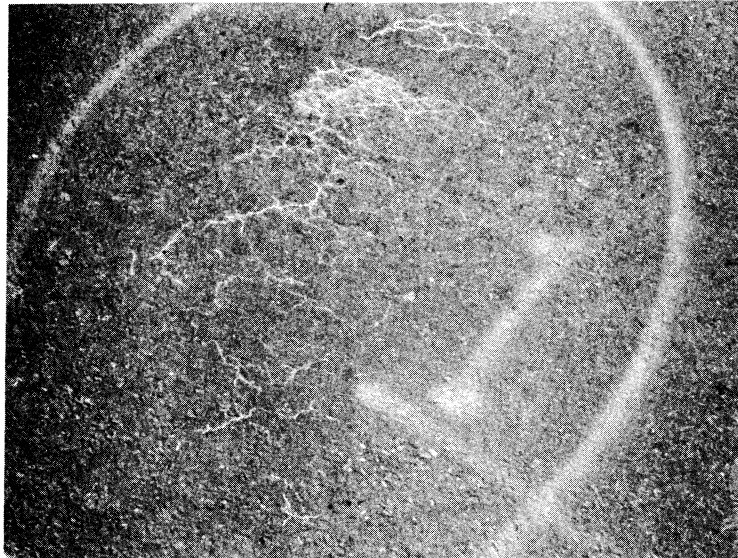
Figure 5. Distress 3 months after fabric installation,
Route 81, Pulaski County.

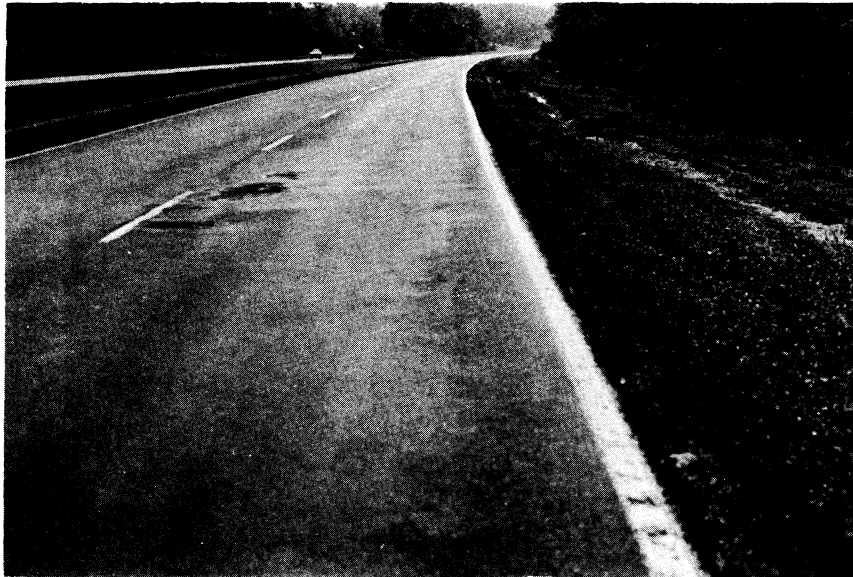
A section of Route 460 immediately west of Route 627 was showing severe deterioration in the inside wheel path of the westbound traffic lane (Figure 6). The existing S-5 surface,

Figure 6. Distress prior to installation of membrane, Route 460, Dinwiddie County.

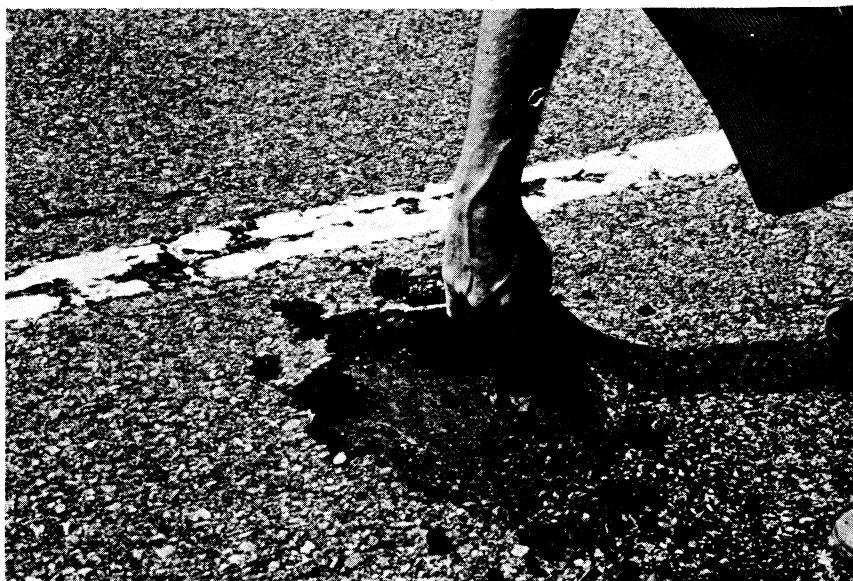
placed in new construction in 1974, was constructed by scratching with about 65 psy and then applying a final lift of 100 psy. The two courses were not well bonded and once again the top course could be lifted away from the underlying course (Figure 7).

Figure 7. Disbonding of surface prior to installation of membrane, Route 460, Dinwiddie County.

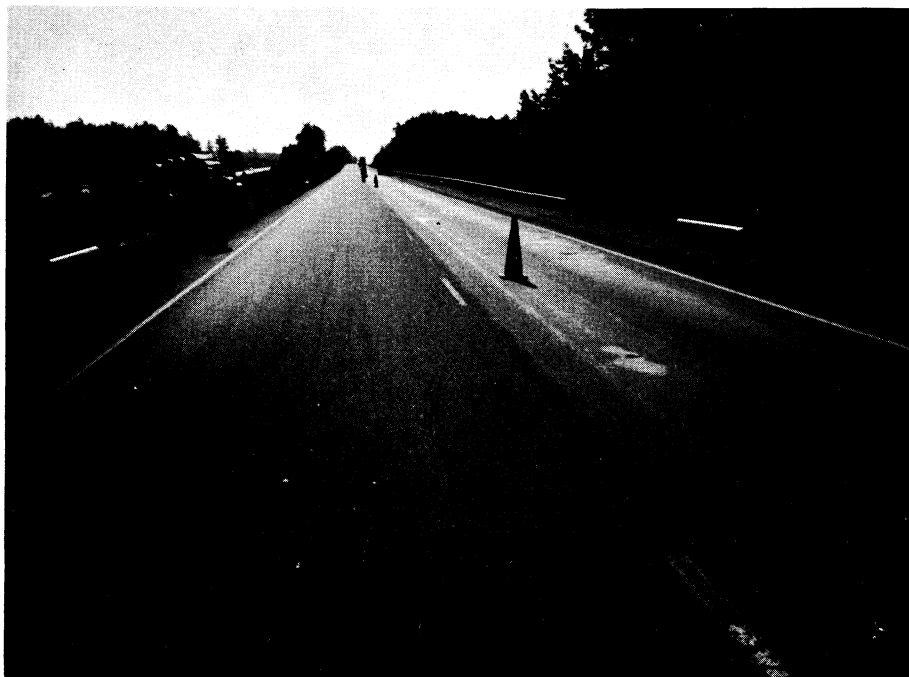
A slurry seal that had been applied in 1978 was badly cracked (Figure 10), and the results of deflection tests indicated that several inches of resurfacing were necessary. The recommended overlay thickness was not economically feasible so, as a practical solution to the high deflections, it was decided to try a heavy overlay of 250 psy of I-2 and two sections with a medium overlay of 160 psy of I-2 plus a fabric (Petromat) over the three weakest sections, and a control section of 160 psy of I-2 over the strongest section.

Figure 10. Cracked and patched areas prior to fabric installation, Route 64, Goochland County.
