AN INVESTIGATION OF SAFETY PROBLEMS AT
SKEWED RAIL-HIGHWAY GRADE CROSSINGS

Eric Paltell
Graduate Research Author

Virginia Highway & Transportation Research Council
(A Cooperative Organization Sponsored Jointly by the Virginia
Department of Highways & Transportation and
the University of Virginia)

June 1984
VHTRC 84-R47

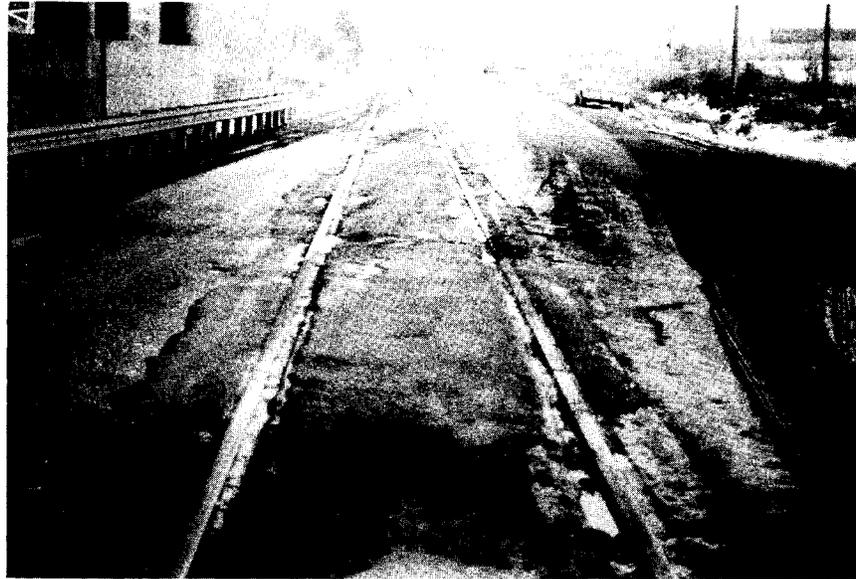
<u>Location</u>	<u>Crossing Angle</u>	<u>Type of Surface</u>	<u>Condition of Surface</u>	<u>Type of Accident</u>	<u>Frequency of Accidents</u>	<u>Special Circumstances</u>
Rte. 974 City of Harrisonburg (DOT #842230B)	10°	1,5	very poor	motorcycle and bicycle	2-3 per month	4" to 5" wide ruts have developed along flangeways. Heavy cyclist traffic due to nearby university. See Figure 3
Rte. 655 Rockingham Co. (DOT #842198K)	20°	1,4	poor	bicycle	3 per year	Asphalt cracked and broken. Ruts developing. See Figure 4
Rte. 67 Tazewell Co. (DOT #468893D)	20°	1,5	very poor*	motorcycle	2 per month	No accidents observed in 5 months since resurfacing.
Rte. 29 Prince William Co. (DOT #714363S)	20°	1,5	good	motorcycle	1 per year	High ADT (17,000) See Figure 5
Rte. 11 City of Harrisonburg (DOT #859981U)	25°	2,4	good	motorcycle and bicycle	2-4 per month	Heavy cyclist traffic due to nearby university. See Figure 6

Figure 3. Rte. 974 city of Harrisonburg (DOT #842230B):
10° angle of intersection, asphalt surface with timber
headers, 3 in. (7.6 cm.) double flangeways. 4 in. to
5 in. (10.1 cm. to 12.7 cm.) wide ruts along
flangeways.

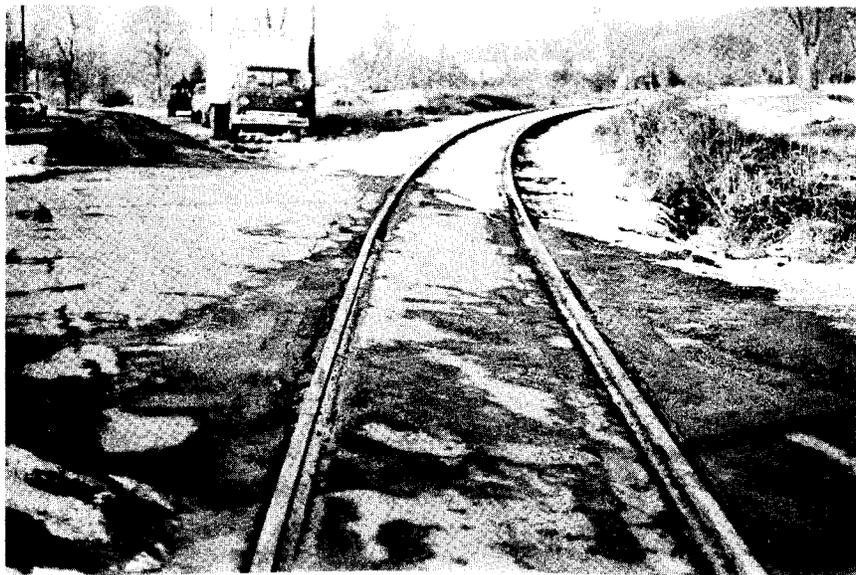
Figure 4. Rte. 655 Rockingham Co. (DOT #842198K):
20° angle of intersection, asphalt surface with
timber headers, 3½ in. to 4 in. (8.9 cm. to
10.1 cm.) inside flangeway only. Note broken
asphalt along flangeways.

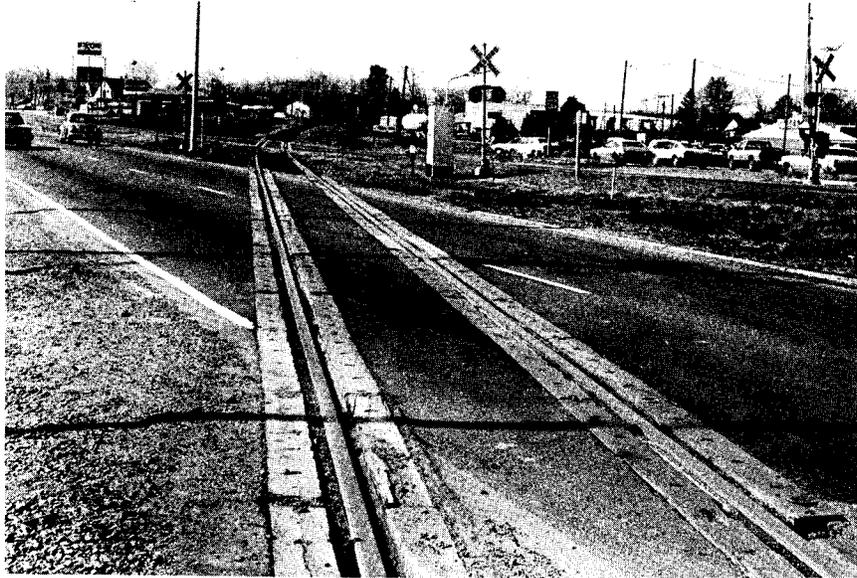
Figure 5. Rte. 29 Prince William Co. (DOT #714363S):
20° angle of intersection, asphalt surface with
timber headers, 3 in. (7.6 cm.) double flangeways.
Crossing in good condition.

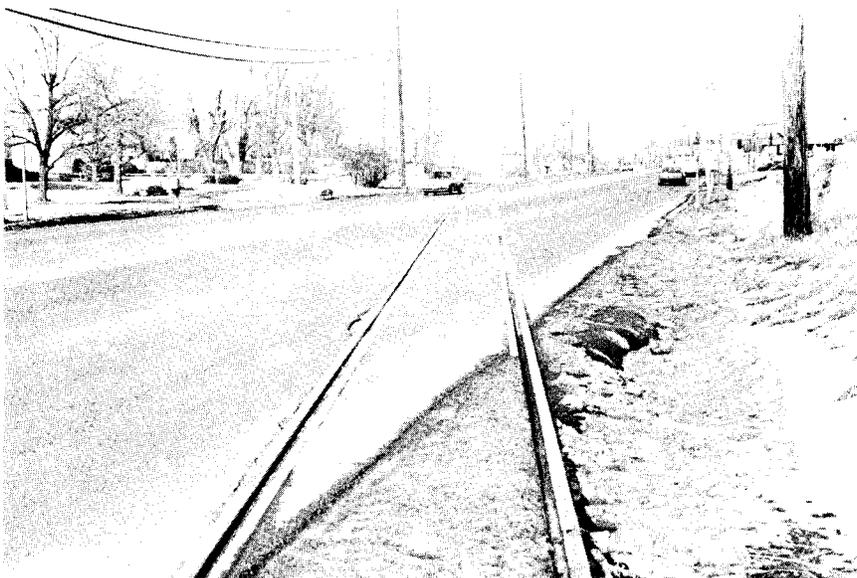
Figure 6. Rte. 11 city of Harrisonburg (DOT #859981U):
25° angle of intersection; asphalt surface with
flange rails; 2 3/4" (7.0 cm) inside flangeway only.
Crossing in good condition.

Interviews with students at James Madison University in Harrisonburg indicated that some students who rode bicycles or motorcycles across the Rte. 11 crossing (DOT #859981U) were not aware of the sign and that others who had noticed the sign did not believe that it effectively identified the nature of the hazard. Although the railroad advance warning sign identifies an upcoming grade crossing and the cyclist warning sign advises the cyclist to use caution, neither sign conveys the message that the crossing is a skewed one.

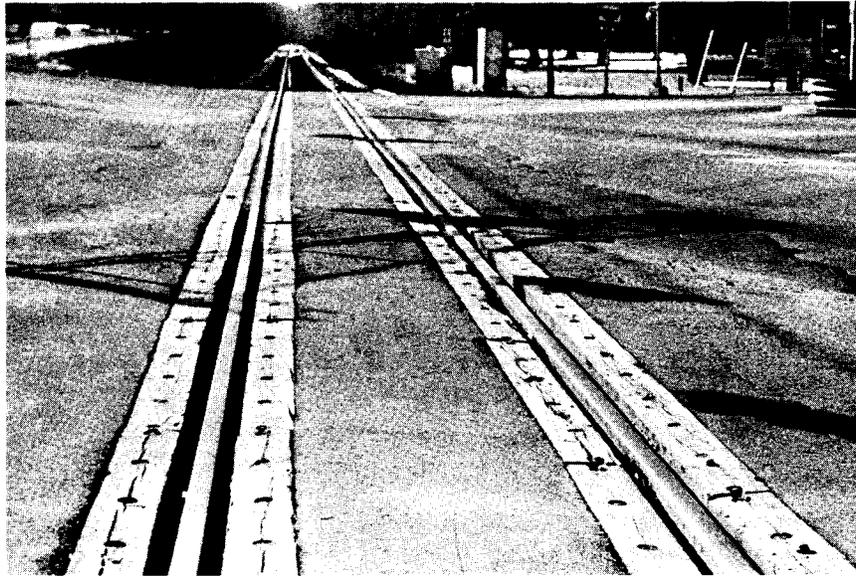
Rte. 147 Chesterfield Co. (DOT #715248N)	30°	1,5	good	moped and bicycle	2-3 per year	High ADT (18,500) See Figure 7
Rte. 11 Frederick Co. (DOT #517961N)	30°	1,4	poor*	motorcycle	6 per year	No accidents observed in 7 months since resurfacing. Wooden inserts in outer flangeways.
Rte. 669 Louisa Co. (DOT #225072C)	30°	3,5	fair	motorcycle	1 per year	Hazard exists from east approach only.

Figure 7. Rte. 147 Chesterfield Co. (DOT #715248N):
30° angle of intersection, asphalt surface with
timber headers, 2½ in. (6.3 cm.) inside flangeway,
3 in. (7.6 cm.) outer flangeway. Crossing in good
condition.
