EVALUATION OF DECK DURABILITY ON CONTINUOUS BEAM HIGHWAY BRIDGES

Wallace T. McKeel, Jr.  
Research Scientist

Virginia Highway & Transportation Research Council  
(A Cooperative Organization Sponsored Jointly by the Virginia  
Department of Highways & Transportation and  
the University of Virginia)

April 1985  
VHTRC 85-R32

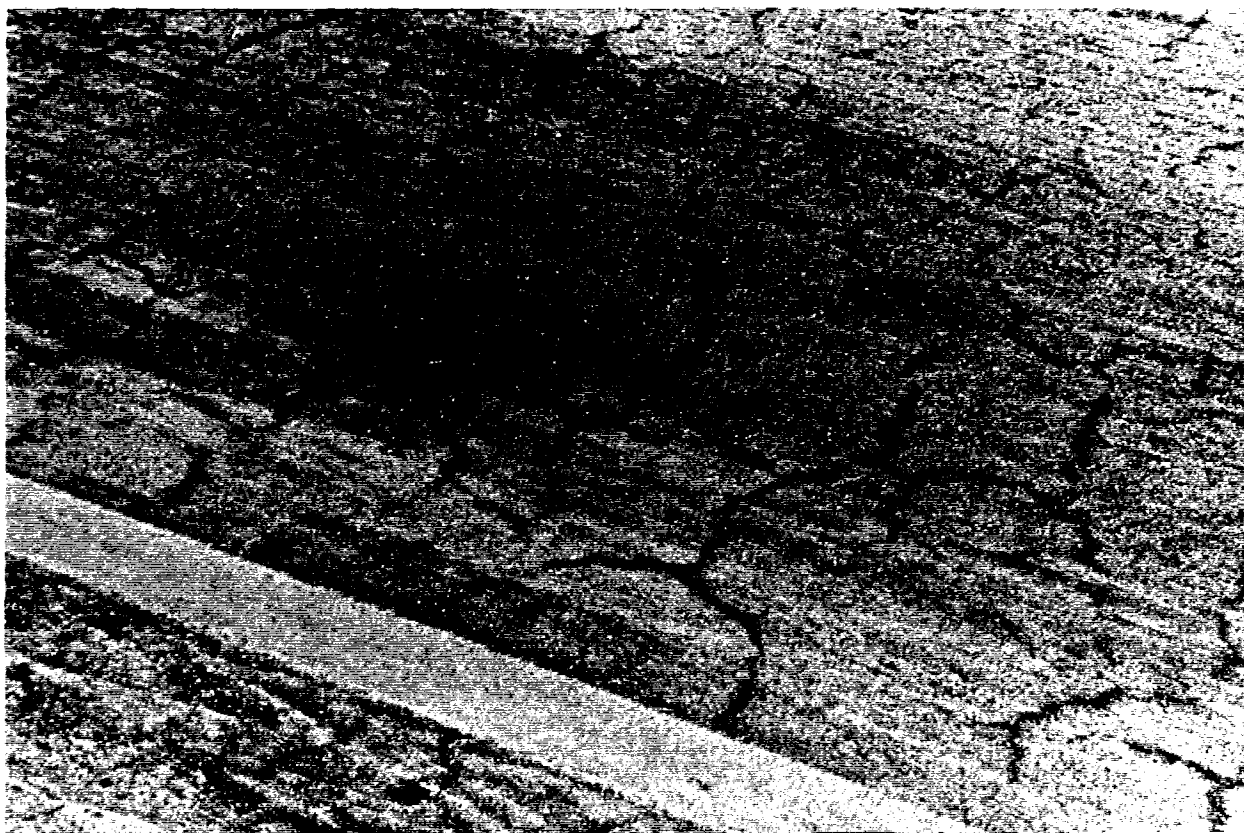
Fine pattern cracking, shown in Figure 1, was noted in the great majority of the decks in the general survey. The cracking, which was usually very fine, often covered substantial areas of the decks. Its cause appears to be differential consolidation, as the top reinforcing steel obstructs the subsidence of the concrete, along with some contribution by plastic shrinkage of the concrete mass.(1) The effect has long been recognized.

Figure 1. Fine pattern cracking on bridge deck.

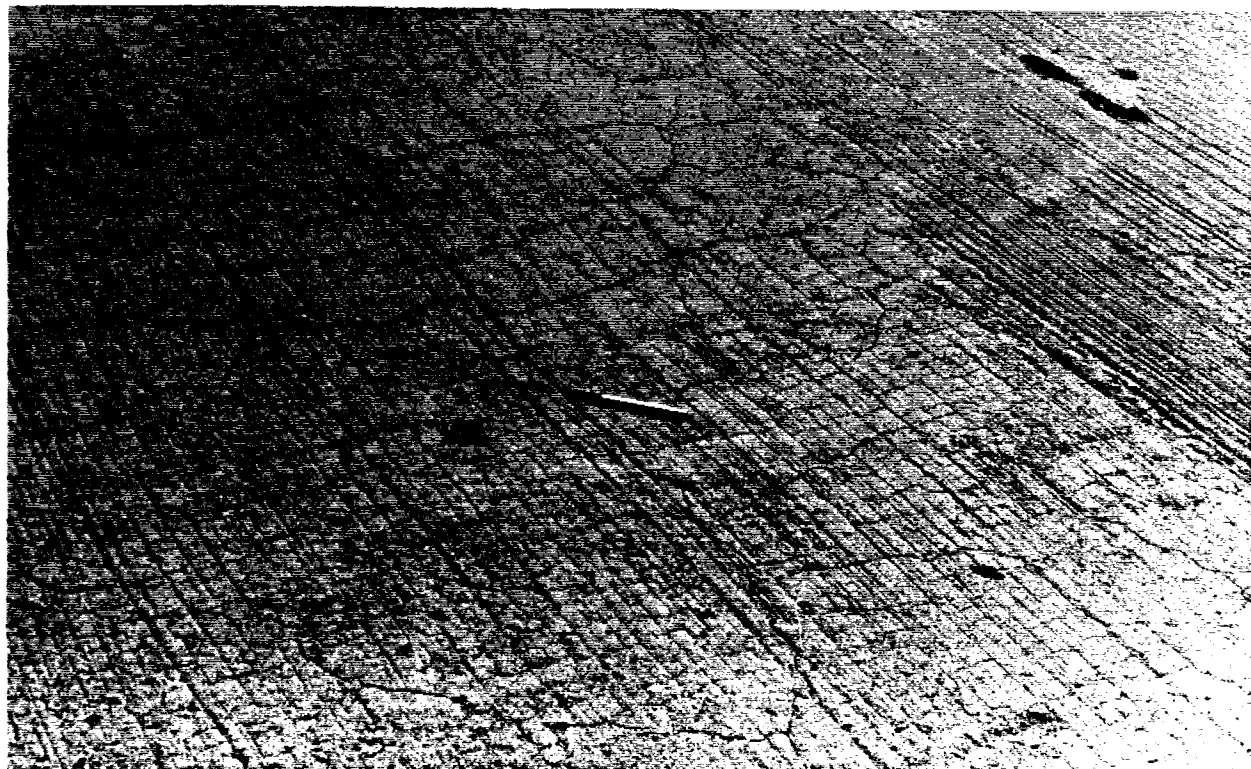
Figure 3. Transverse crack across roadway width.

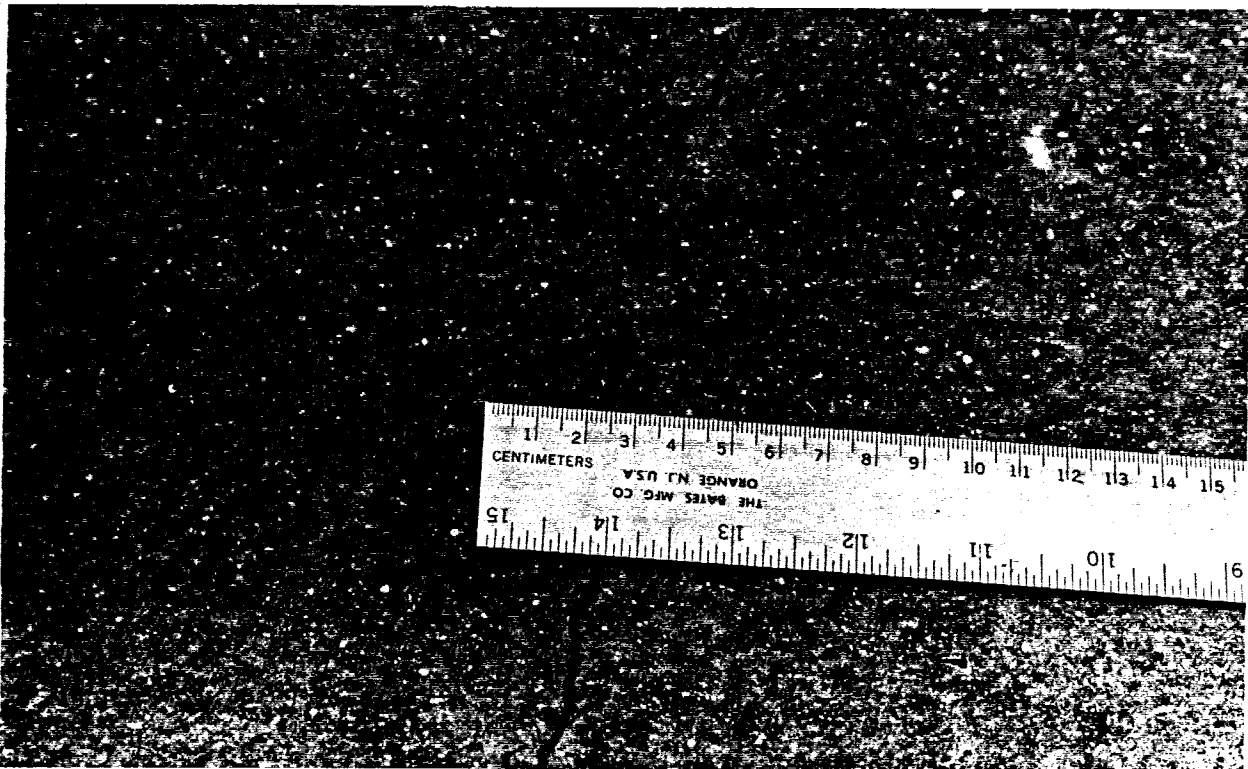
Figure 5. Transverse crack widened at top.

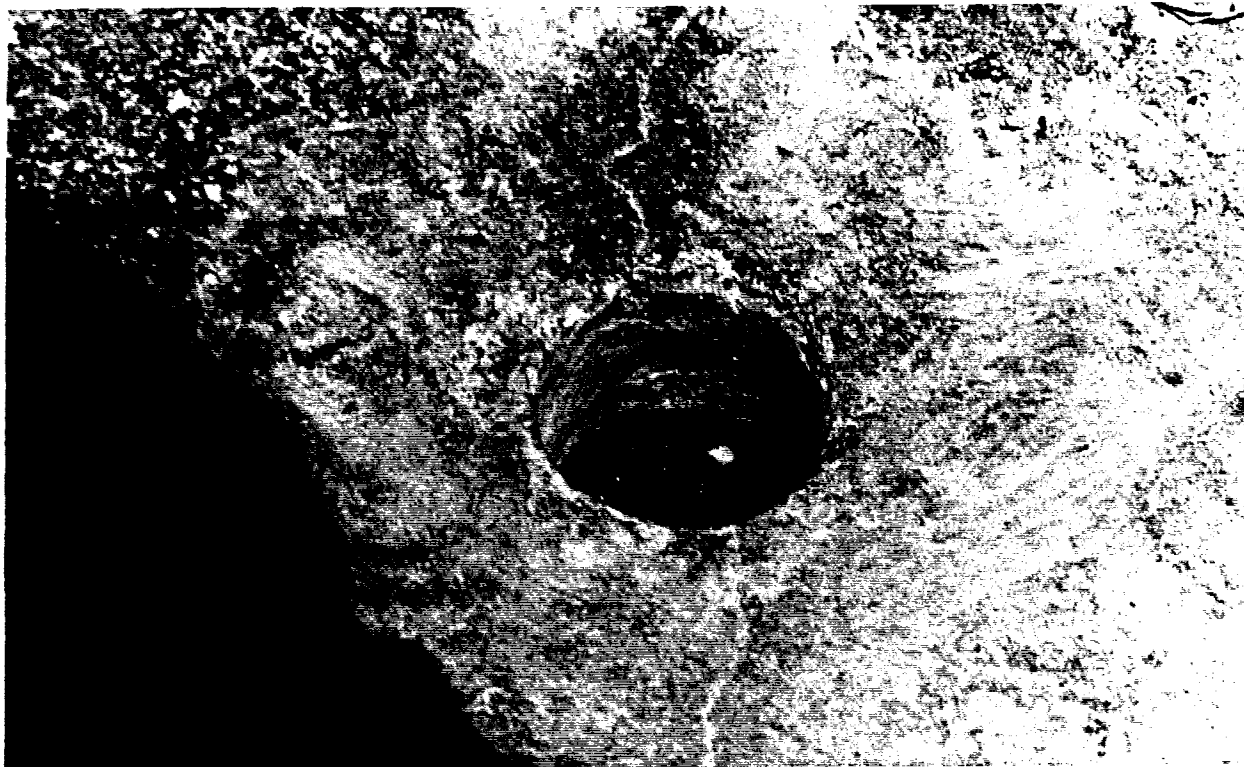
Figure 6. Core through transverse crack. Path of crack in depth of concrete has been marked.

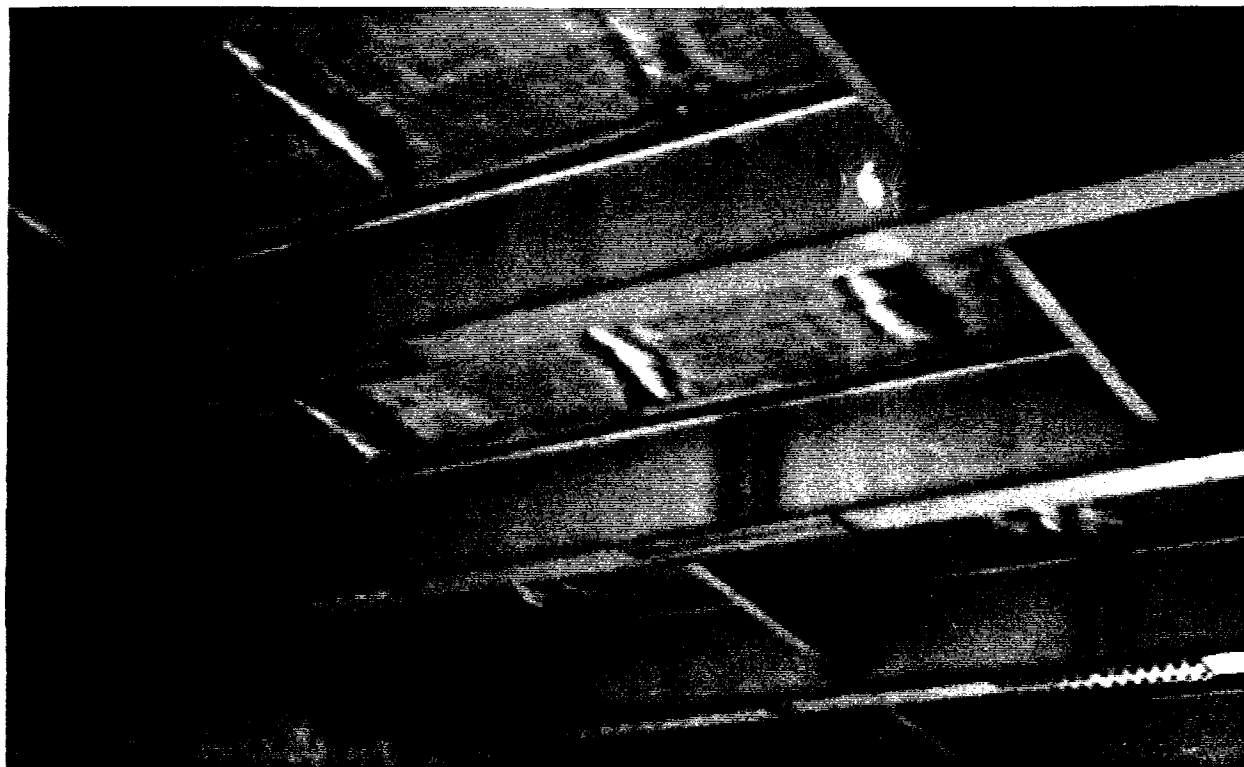
Figure 7. Underside of bridge deck slab with efflorescence marking crack locations.

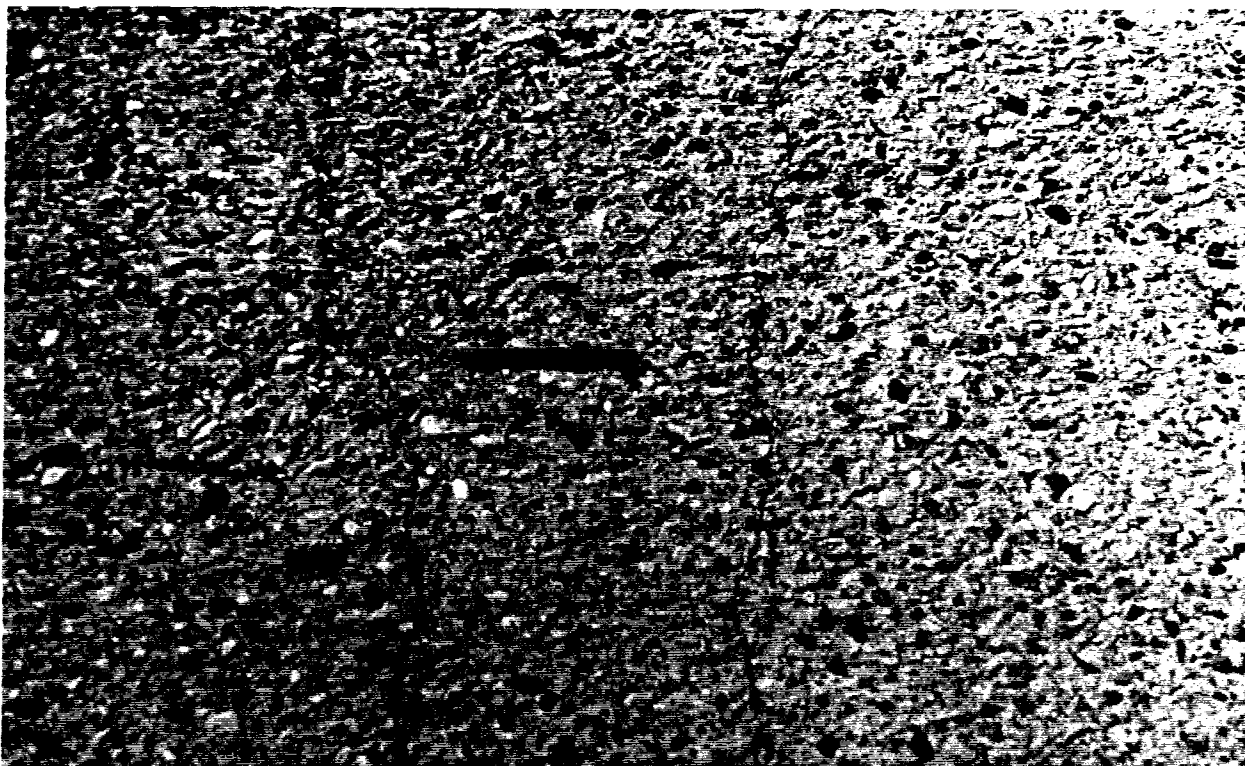
Figure 8. Surface of Colonial Parkway bridge (Figure 7). Exposed aggregate finish is used on parkway pavements.

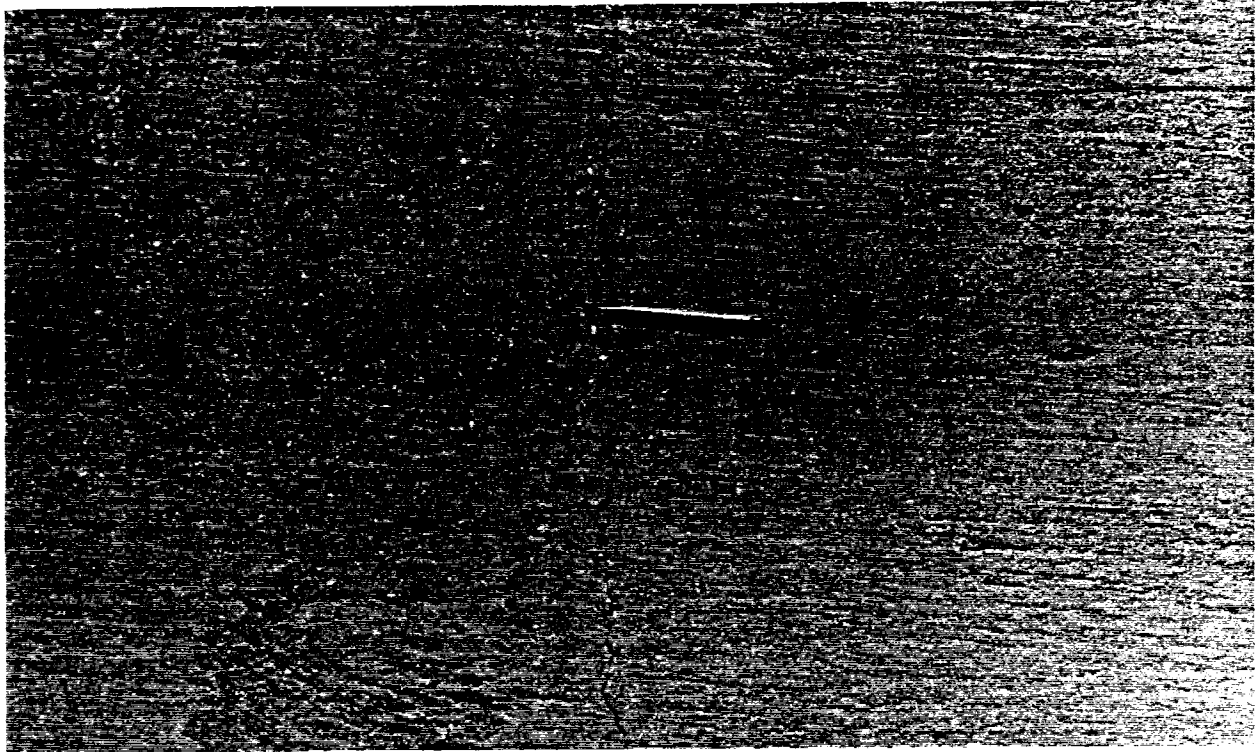
The contributions of vibration and other dynamic loading effects to the propagation of transverse cracking were indicated often by comparisons of bridges on the same limited access highway but exposed to different traffic conditions. Although the bridges were of essentially the same age, overpasses carrying fewer trucks and at lower speeds exhibited less cracking than bridges on the main highway. Despite the apparent correlation between the severity of cracking and the traffic volume, transverse cracking was noted to some extent on structures with very low traffic volumes. Figure 9 shows a transverse crack in the positive moment area of the single-lane service road bridge shown in Figure 10 that serves a single residence and small orchard.

Figure 9. Crack in positive moment area of single-lane service road bridge (Figure 10).

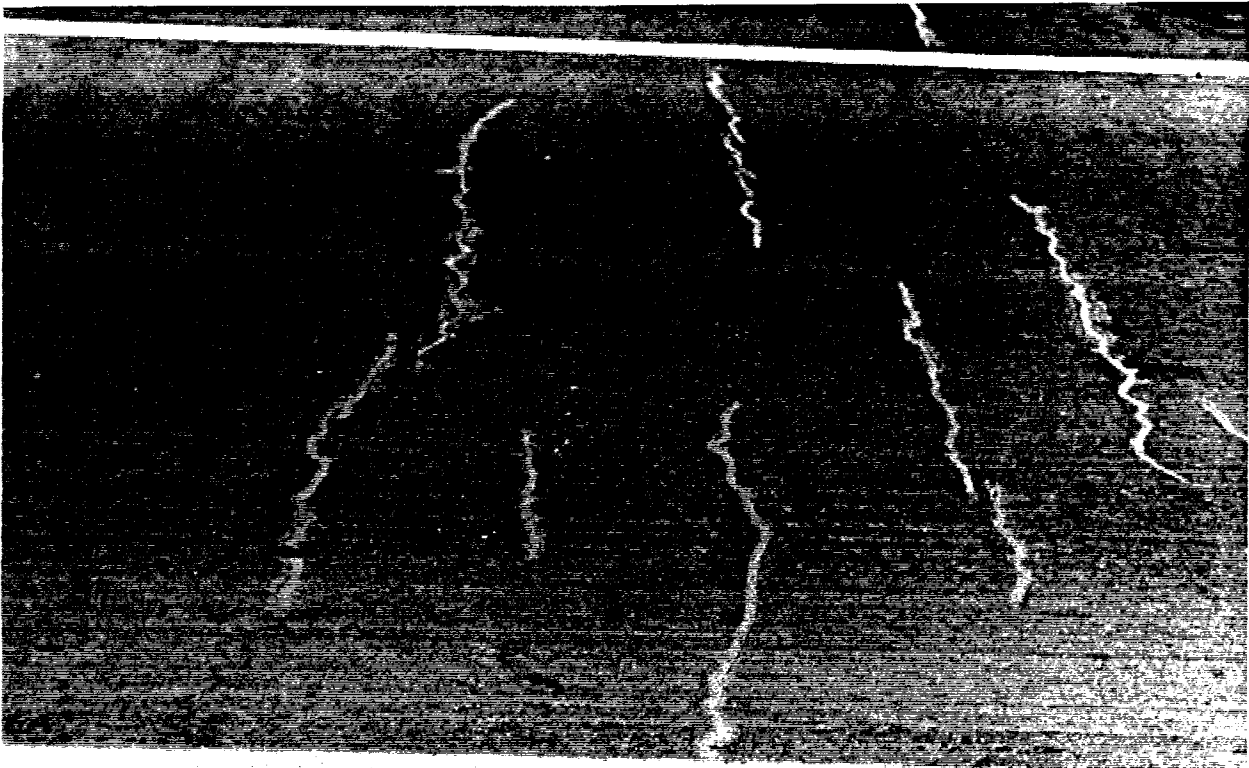
The Staunton River bridge, built in 1973, is composed of 4 continuous spans with lengths of 125, 148, 148, and 125 ft. The general survey noted the presence of fine transverse cracks at close spacings as little as 15-18 in throughout the length of the structure. Some of the older cracks had been routed and filled, Figure 11; however, cracking had continued after the sealing operation. Typically, the cracks are routed to a minimum depth of 1/4 in using sandblasting equipment with a fine nozzle and filled with a low viscosity, low modulus epoxy adhesive as shown in Figure 12, where a chloride sample was taken over a crack.

Figure 11. Sealed transverse cracks on Staunton River bridge.

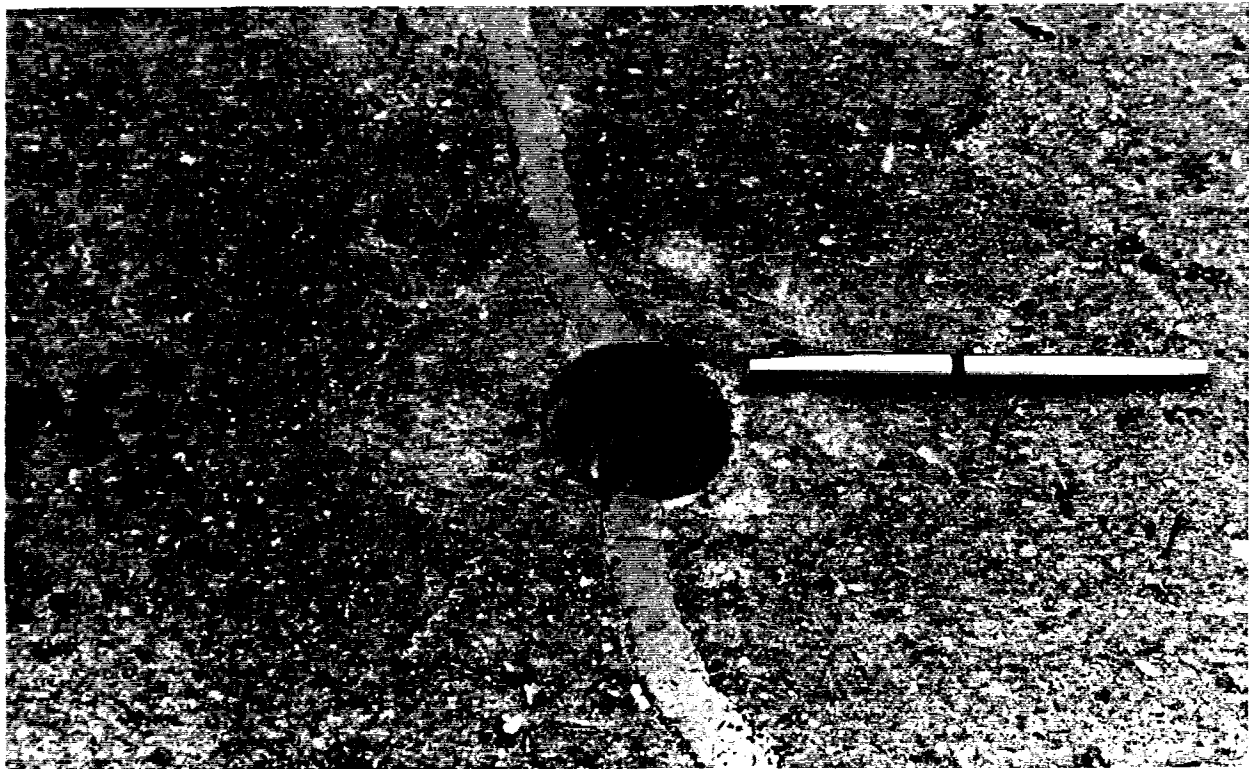
Figure 12. Cracks routed to a depth of 1/2 in and sealed.

Some separation at the edges of the sealing compound was noted, as was the formation of short cracks adjacent to the sealed cracks. It appeared that the deck offered an opportunity to evaluate the effectiveness of the sealing operation. Accordingly, the traffic lane, where the oldest and most extensive cracking had occurred, was tested.
