1. Report No. FHWA/VA-87/18	2. Government Accession No.	3. Recipient's Catalog No.	
4. Title and Subtitle Field Evaluation of Three Joint Sealants		5. Report Date June 1987	6. Performing Organization Code

FINAL REPORT
FIELD EVALUATION OF THREE JOINT SEALANTS

June 1987
VTRC 87-R18

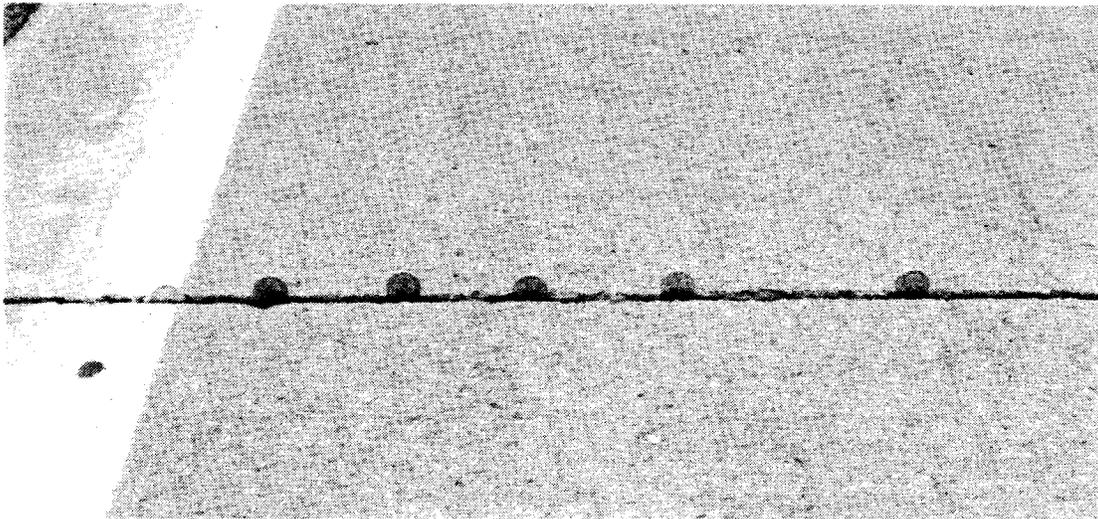
Figure 4. Type A sealant with depths of 0.45 to 0.55 inches.

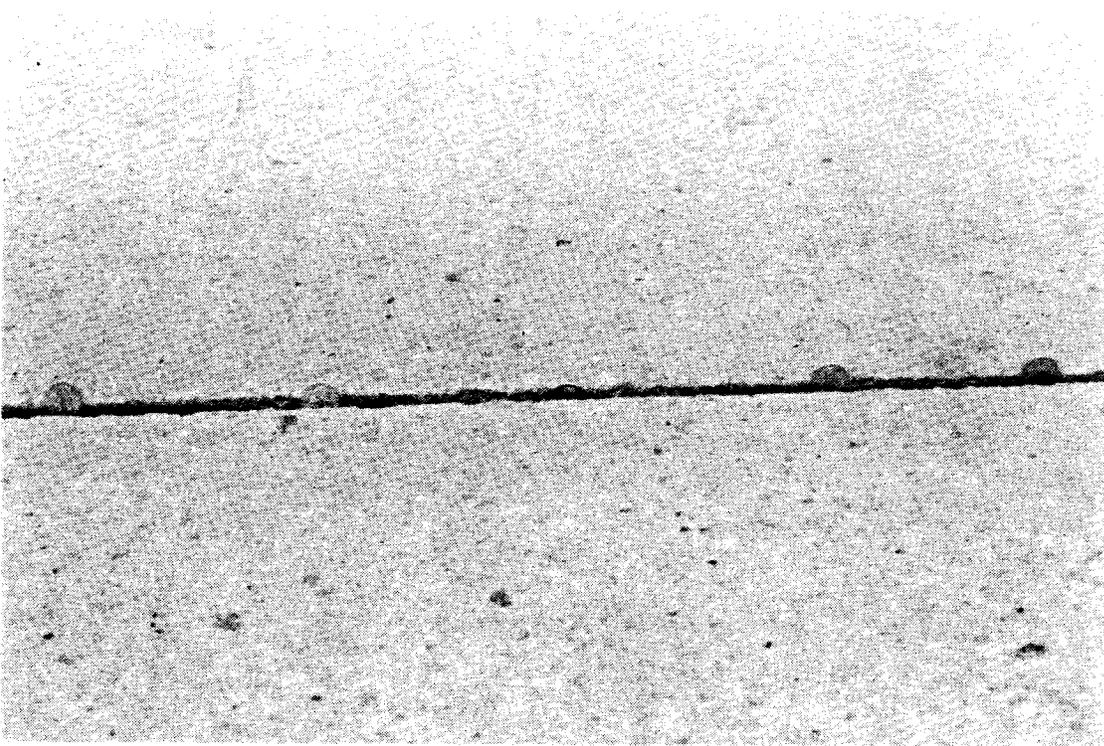
Figure 5. Type A sealant with depths of 0.7 to 0.8 inches.

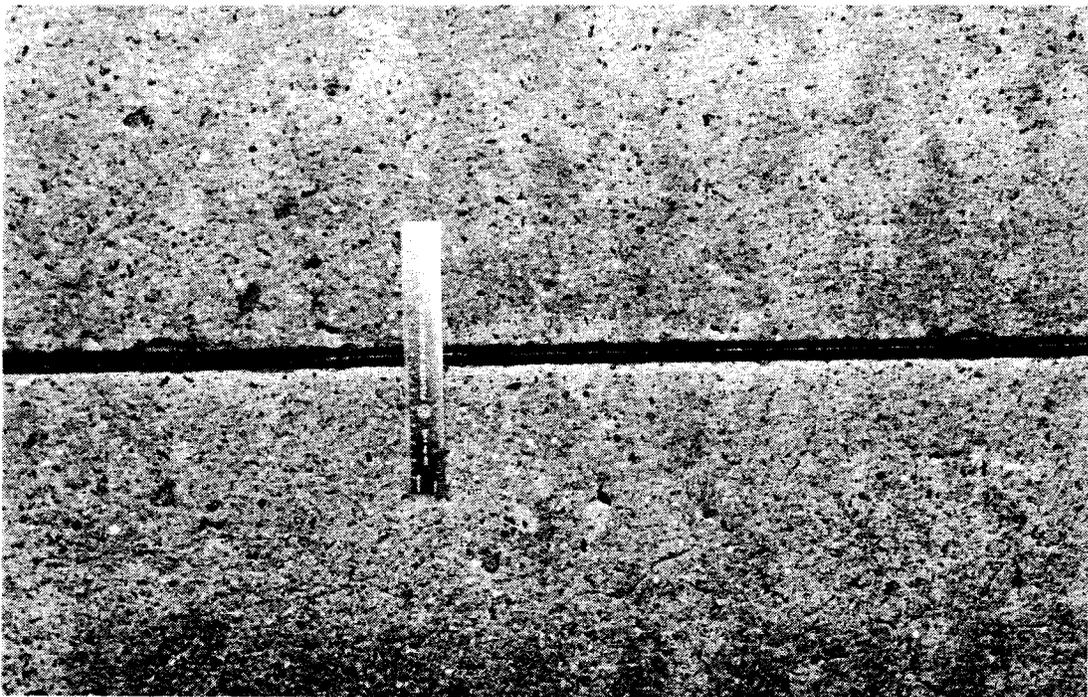
The other types of installation mistakes that were observed were twisted type A sealant (Figure 6), incorrectly sawn joints (Figure 7), and type C sealant that was too close to or at the surface at the Route 250-E interchange (Figure 8).

Figure 6. Type A sealant - twisted.

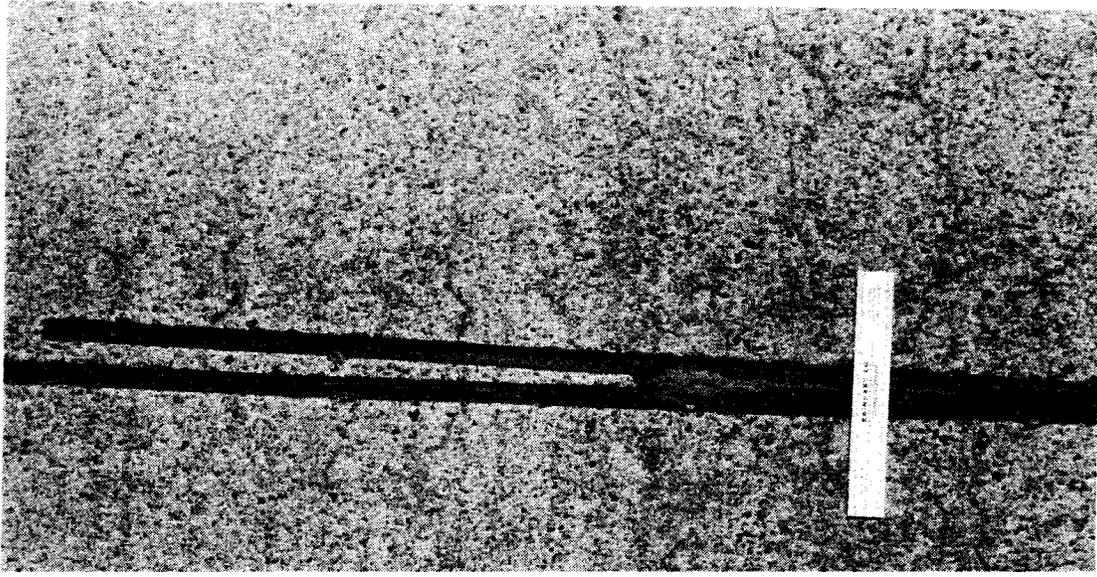
Figure 7. Incorrectly sawn joint.

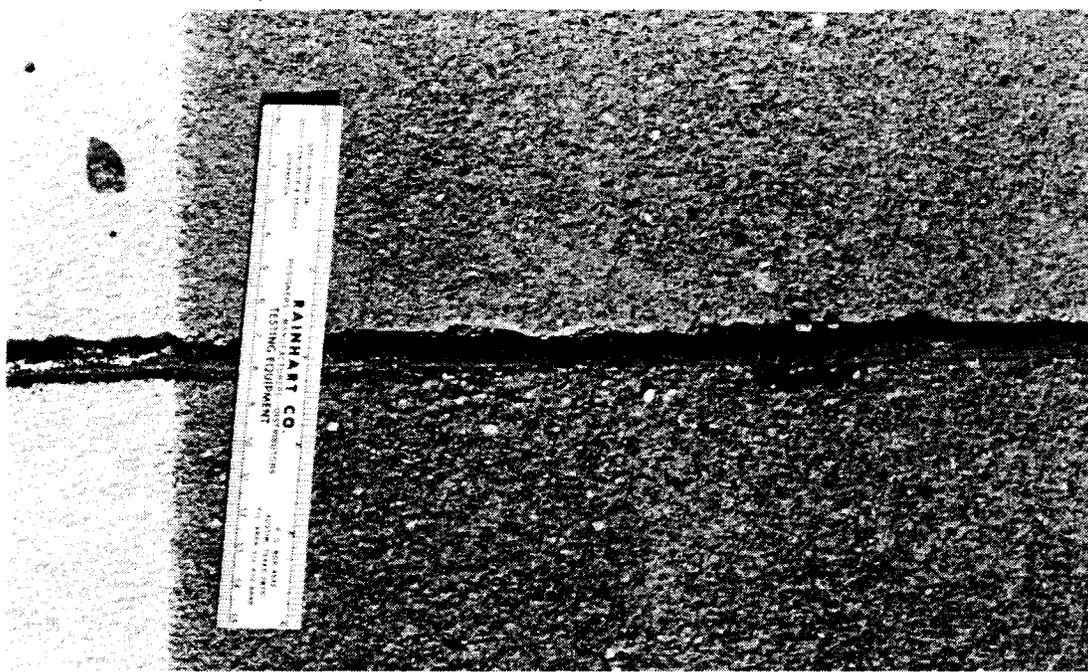
Figure 8. Type C sealant that is above pavement surface.

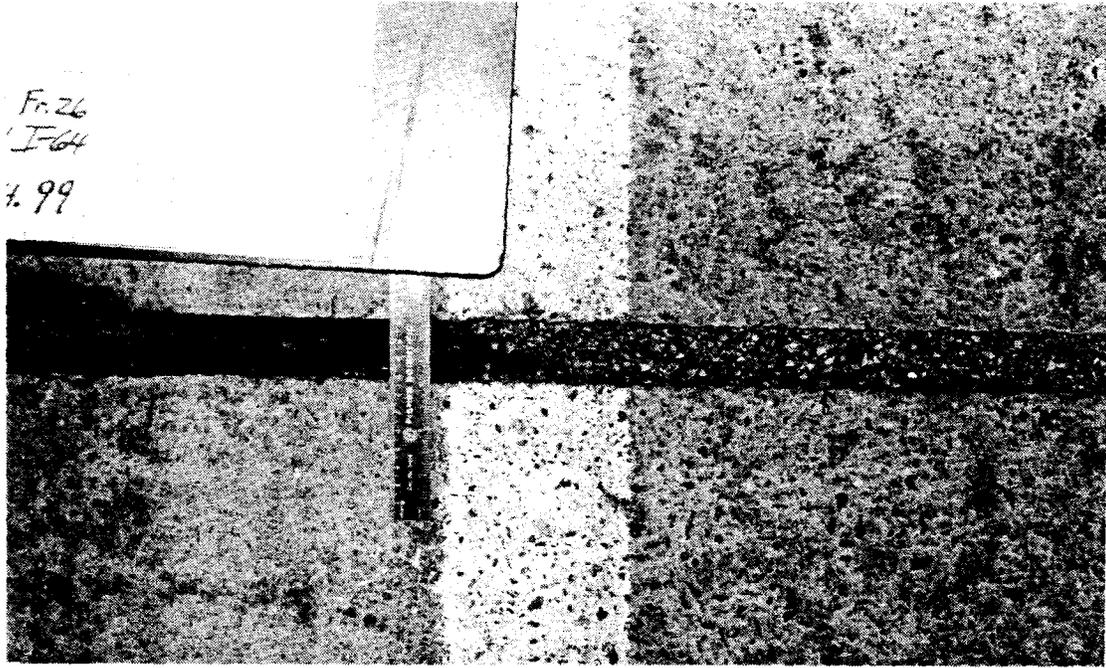
The incidence of adhesive loss for the preformed sealants (A and B) was quite low. This type failure occurred only within the relatively unconfined areas of the ramps for those sealants. Apparently the movement in the joints within the unconfined areas had been so large that a few joints experienced total failure of the sealant, though this did not often occur. At two or three joints, the sealant was missing, and at one it was buried under 1.5 inches of particles (See Figures 9 and 10). These sealants (A and B) did not have any cohesive loss.

Figure 9. Type A sealant missing at Rt. 631 interchange.

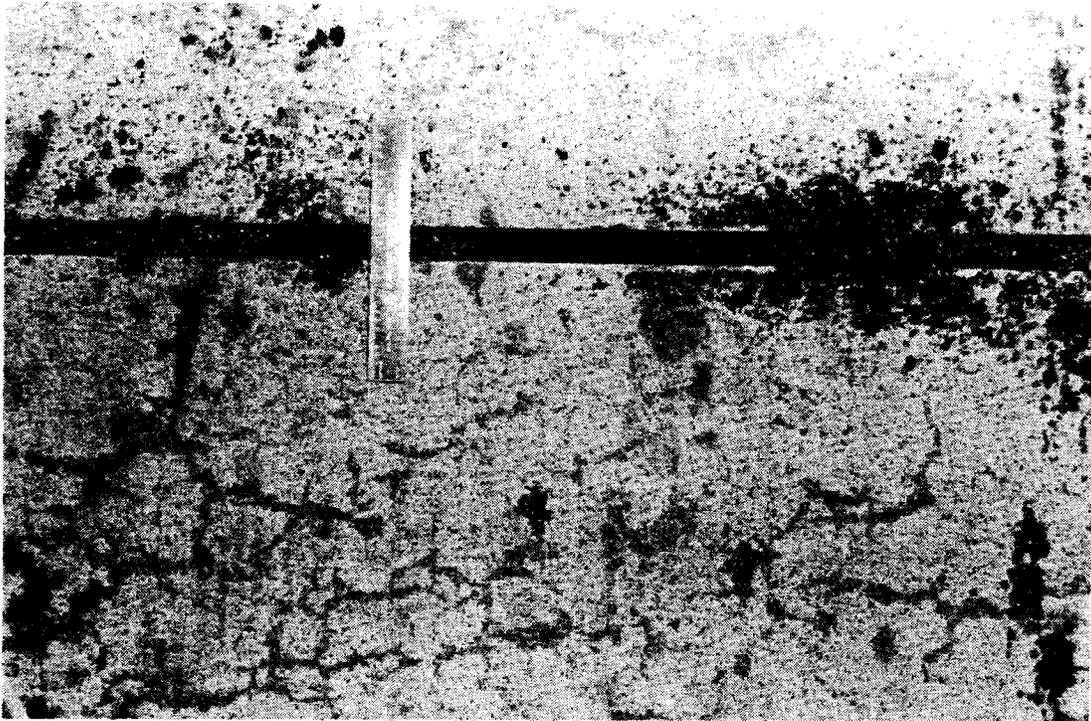
Figure 10. Type B sealant buried at rest stop.

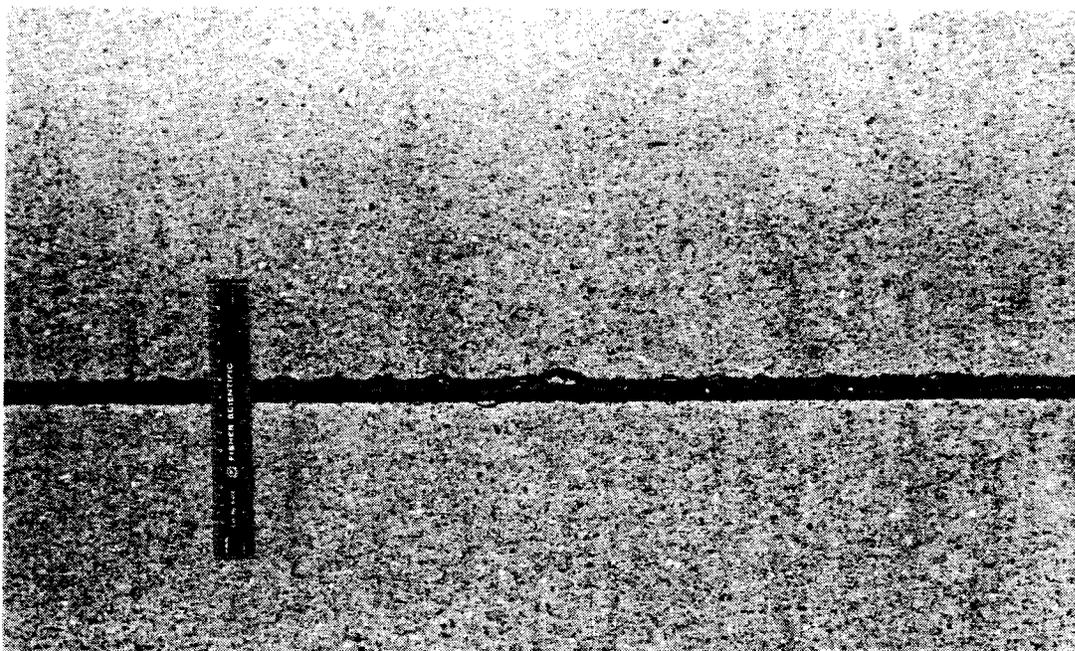
The incidence of adhesive and cohesive losses for the type C sealant was very high. The failures occurred in all portions of the ramps. The severest failures were located within the least confined areas of the ramps. Most of the joints were their specified width; and it can be assumed that the sealant initially filled the joint because where there was cohesive failure, the sealant was firmly fixed to both sides of the joint. Inasmuch as the gaps that were created by the adhesive and cohesive losses were easily observed, it appears that the polysulfide sealant suffered compressive set (loss of elasticity while in the compressed state) followed by loss of adhesion and cohesion (See Figure 11).

Figure 11. Cohesive and some adhesive loss for the type C sealant.

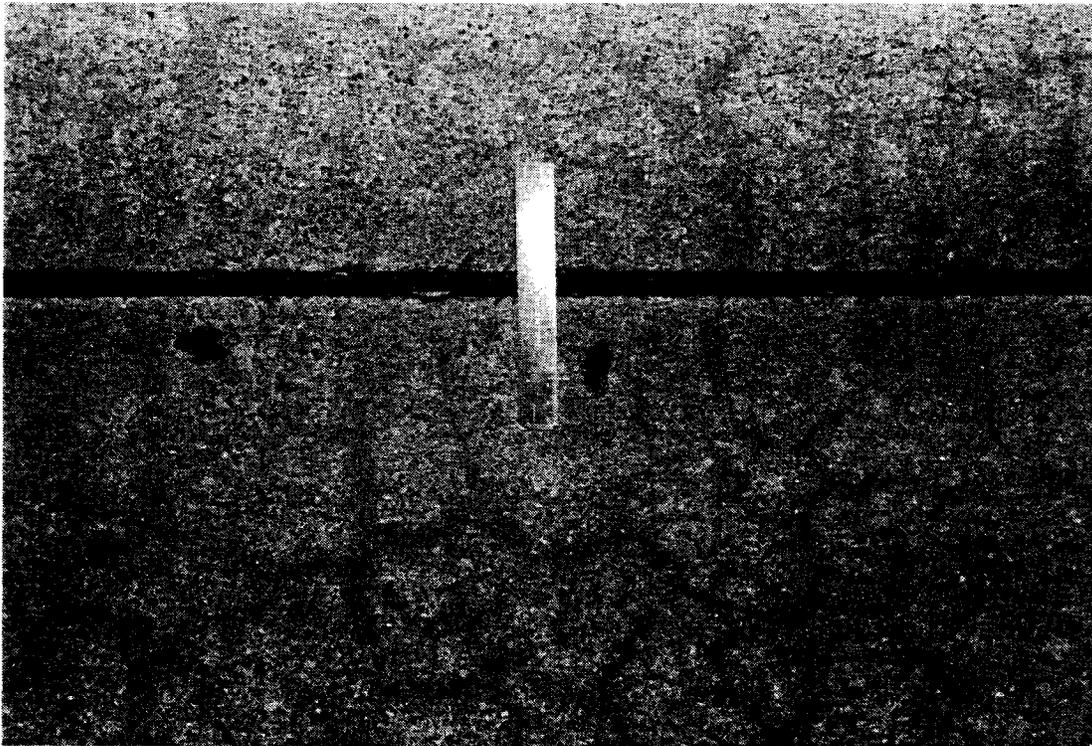
Interestingly, many of the joints with type C sealant had both adhesive and cohesive losses within the same length of sealant (Figure 12); consequently, they suffered 100 percent failure.

Figure 12. Overlapping failure for type C sealant.

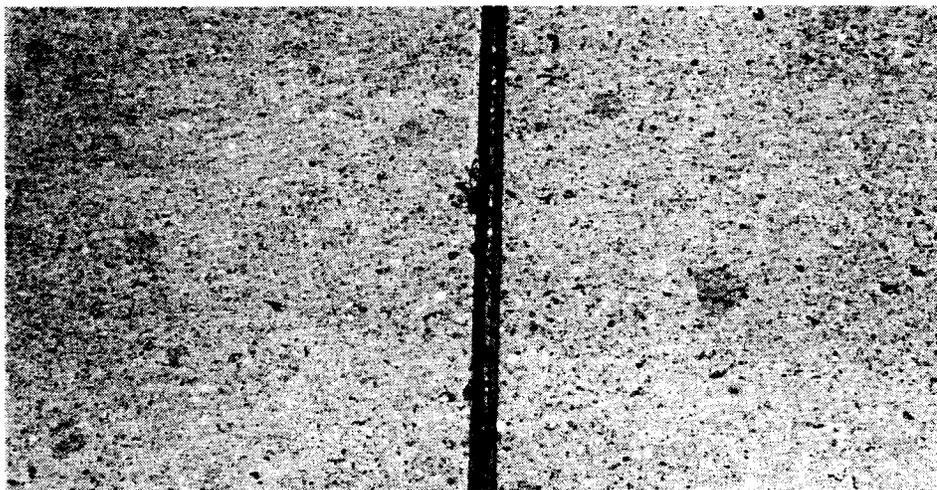
Wherever the integrity of the sealant was disrupted, particles were in the joint and below the sealant in varying concentrations. Other than participating as part of the mechanism by which the slabs in the unconfined areas were pushed further apart each year by the seasonally controlled contraction and expansion of the slabs, this intrusion did not seem to be responsible for any specific and widespread failure of the slabs (Figure 13).

Figure 13. Large content of particles with minimal distress of slab.

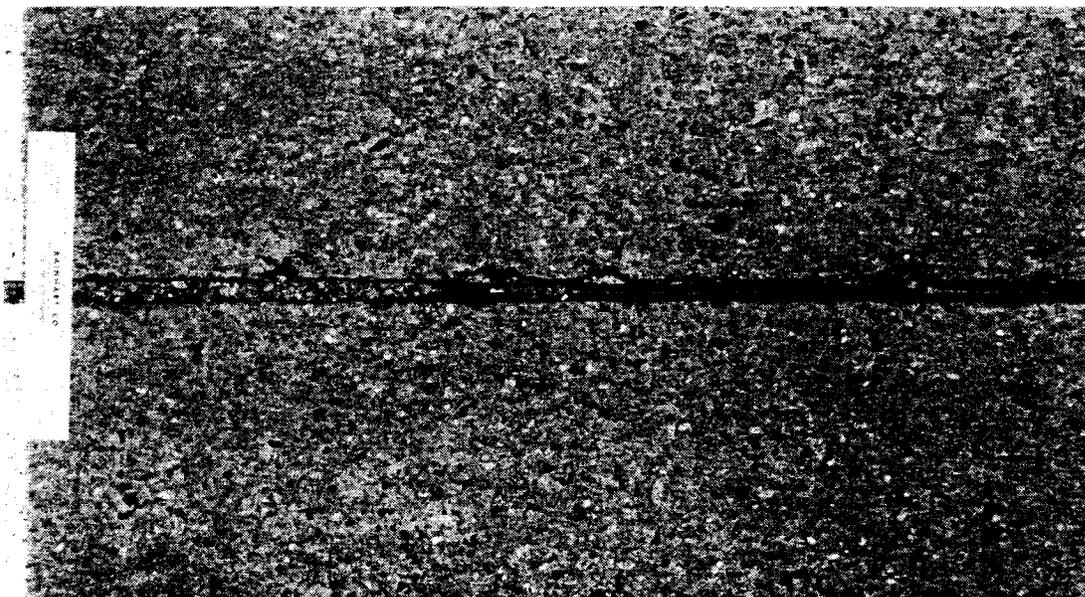
Minor spalling, which may have been caused by the saw blade at the time the joint was cut, was widespread, but did not have any detrimental effect on the slabs. Relatively few large spalls were observed that could disrupt the integrity of the sealants and with the intrusion of particles into the joint, eventually contribute to distress within the slab (See Figures 14 and 15).

Figure 14. Small spalls.

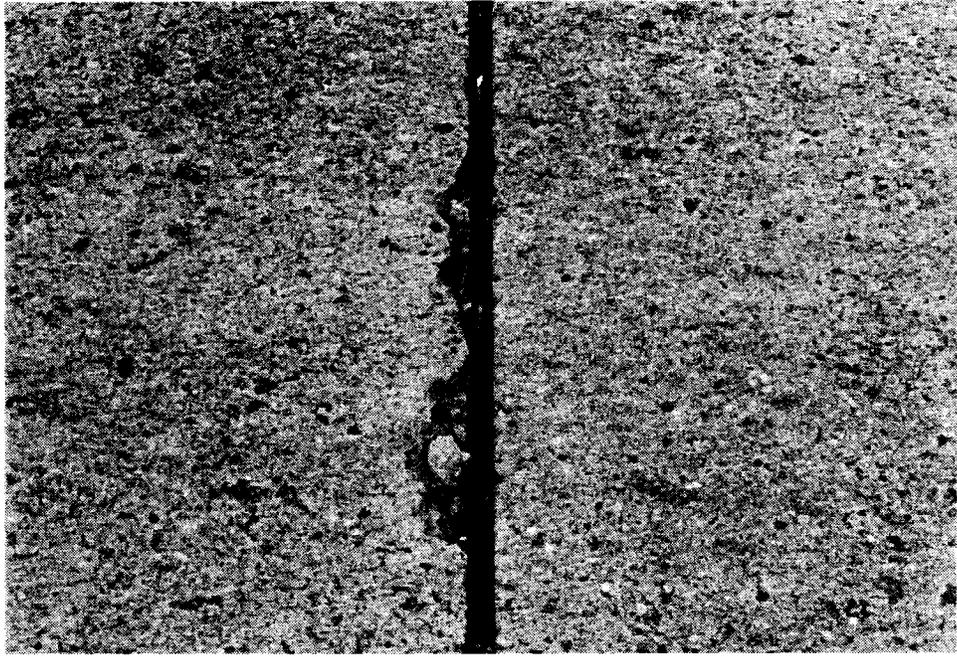
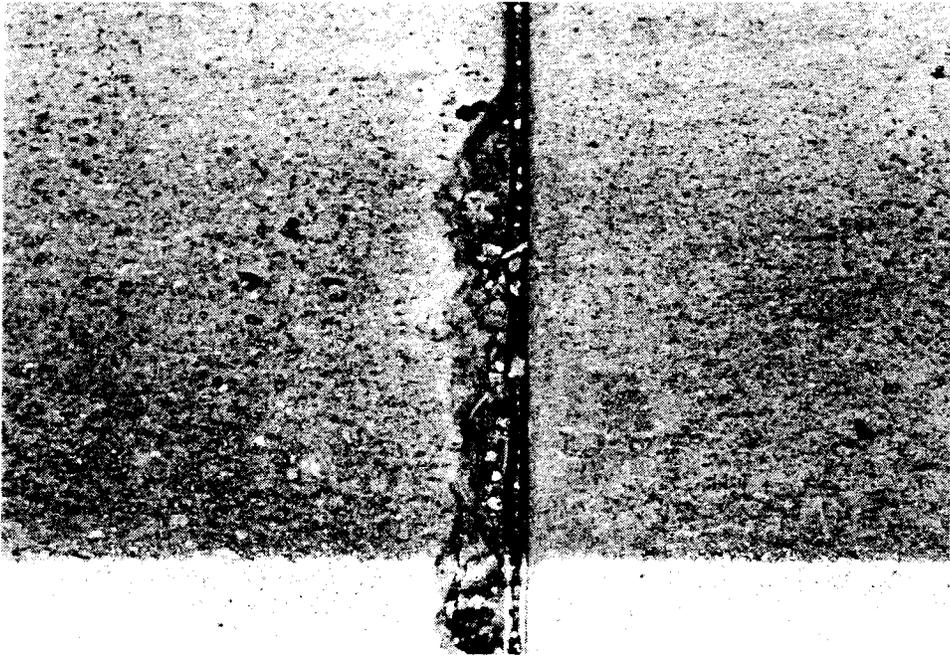
Figure 15. Large spalls.

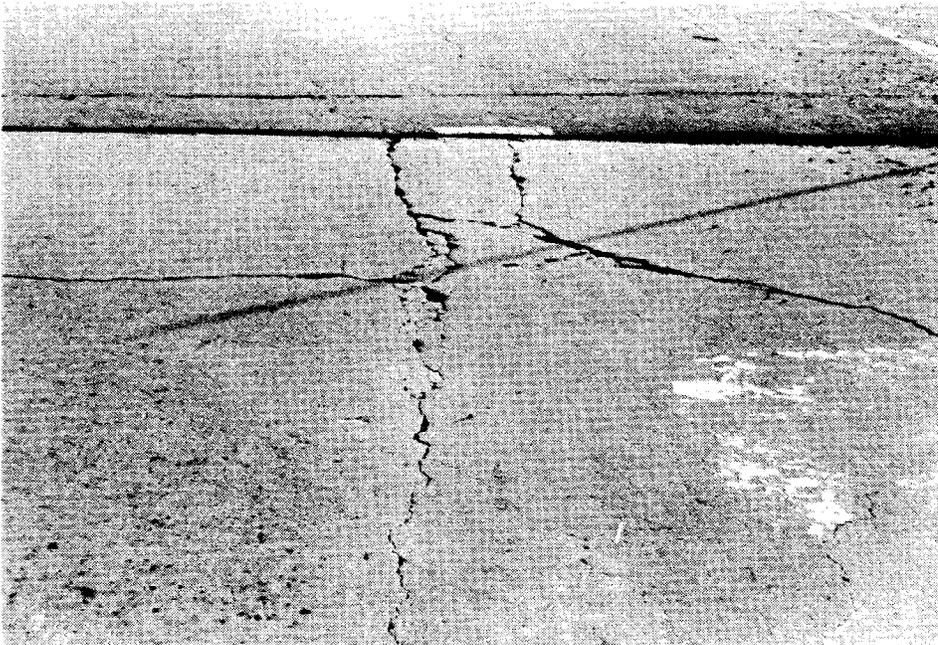
Figures 16, 17, and 18 show the type of cracking that occurred close to the open ends, expansion joints, and the confined areas. The cracks pictured in Figures 19 and 20 illustrate the significance of a slab's being relatively unconfined or confined. The Route 250-E interchange did not have expansion joints cut. Figure 19 shows the severity of the cracking and the width of joint 1 near the open end of the west bound "on" ramp. Figure 20 shows the relatively mild cracking of the slabs in the location where expansion joints would have been located; but because these slabs remained confined, they maintained their load-transfer mechanism.

Figure 16. Severely cracked slab at open end of ramp.

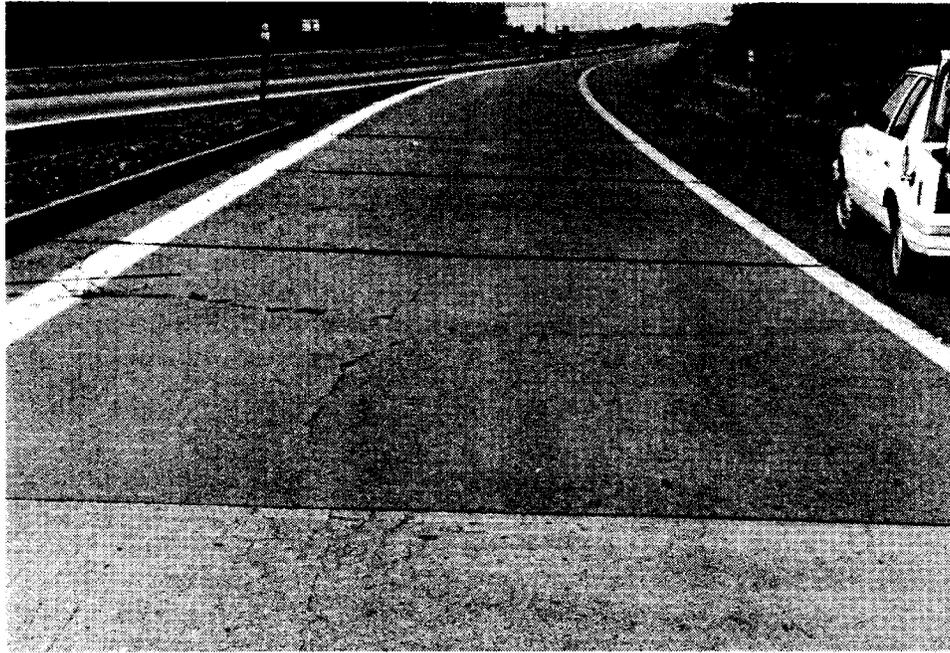
Figure 17. Severely cracked slab adjacent to expansion joints.

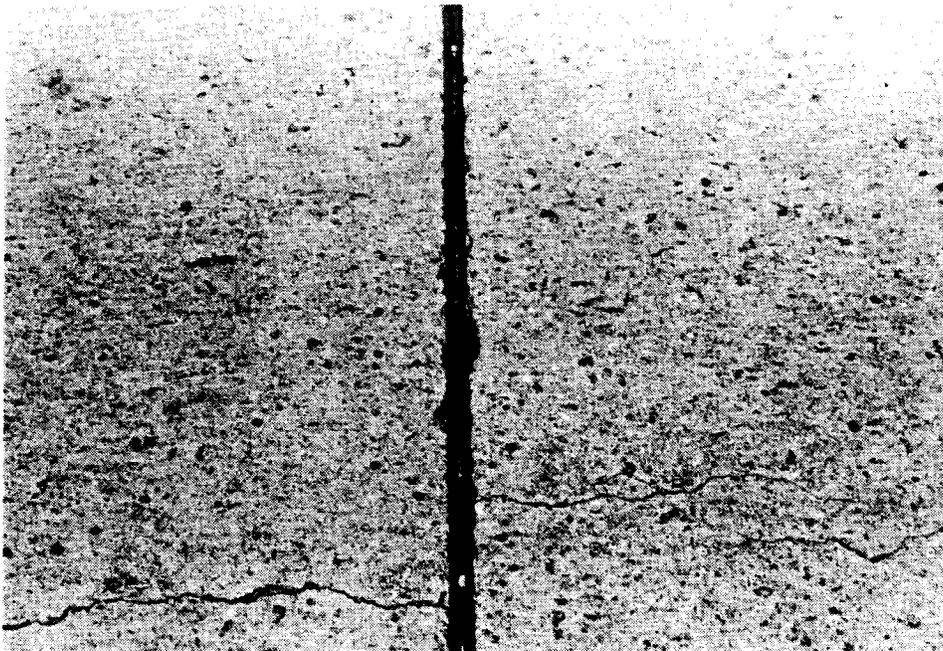
Figure 18. Cracking of slabs within a confined area.

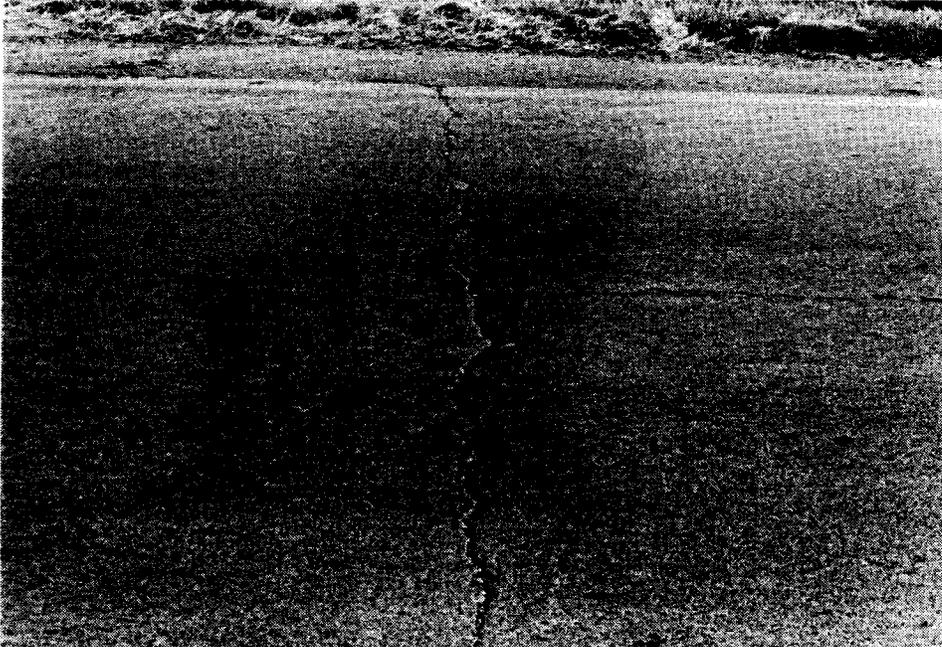
Figure 19. A - Cracking of 1st slab WBL on 250 E.
B - 1st Joint - 1/34 inches wide.

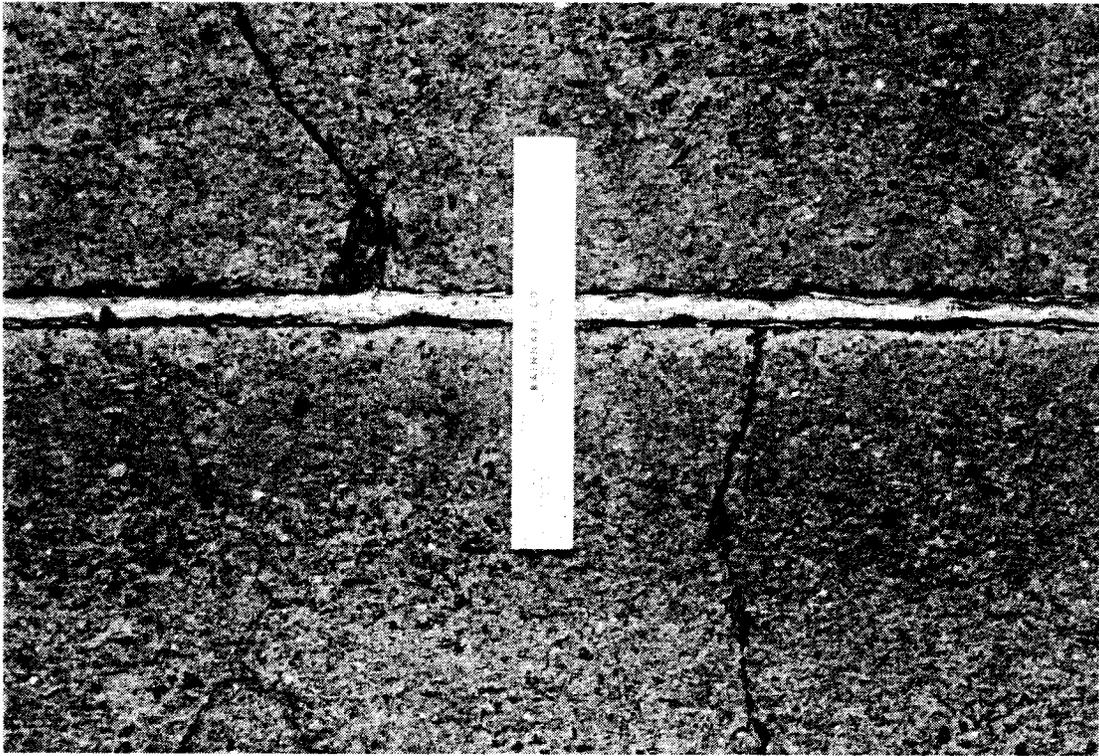
Figure 20. Mildly cracked slabs.
