**FINAL REPORT****A FIELD INVESTIGATION OF A CONCRETE OVERLAY CONTAINING  
SILICA FUME ON ROUTE 50 OVER OPEQUON CREEK**

**February 1993  
VTRC 93-R15**

The bridge was built in 1941 and is located on Route 50 over Opequon Creek near Winchester, Virginia. The deck carries westbound traffic and has two lanes and four spans. Each span is 13.0 m (42.5 ft) long and 7.3 m (24 ft) wide. The bridge is on a 5-degree grade and is lower at the west end.

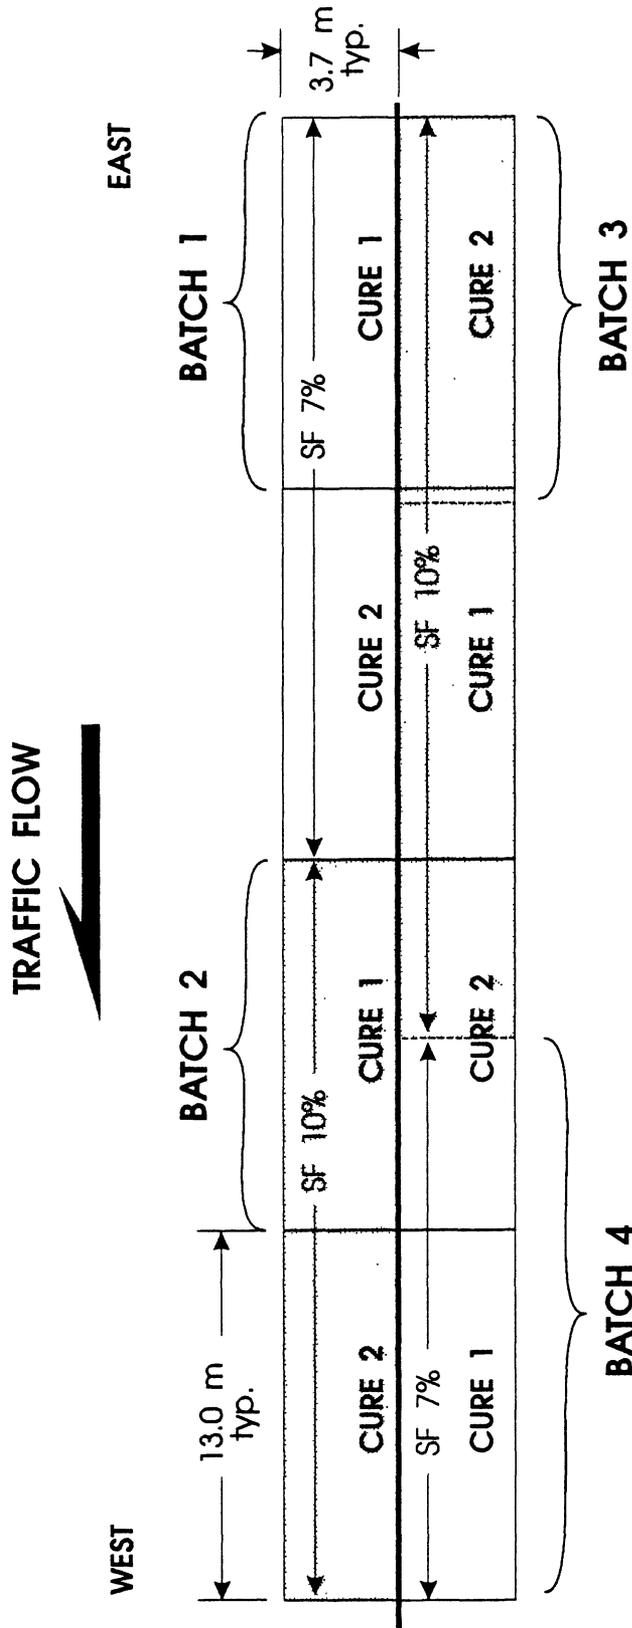
The bridge deck was overlaid with concrete containing 7 percent or 10 percent SF by mass of portland cement following the sequence shown in Figure 1. The concrete was placed on the traffic lane on May 13, 1987, and on the passing lane on June 5, 1987. A total of 22.6 m<sup>3</sup> (29.5 yd<sup>3</sup>) of concrete was placed: 13.0 m<sup>3</sup> (17 yd<sup>3</sup>) with 10 percent SF and 9.6 m<sup>3</sup> (12.5 yd<sup>3</sup>) with 7 percent SF. The reported w/c was 0.39. In order to minimize the time between batching and placement, the concrete was furnished in four trucks, each carrying about 3 m<sup>3</sup> (4 yd<sup>3</sup>), for the traffic lane and in three trucks, each with 3.5 m<sup>3</sup> (4 1/2 yd<sup>3</sup>), for the passing lane. The travel time for the truck mixers was about 20 minutes, and the average time from batching to discharge was about 35 minutes.

Figure 1. Westbound lanes. Cure 1: wet burlap and polyethylene sheet followed by a curing compound.  
Cure 2: curing compound.
