EVALUATION OF A THIN-BONDED PORTLAND CEMENT CONCRETE PAVEMENT OVERLAY

VIRGINIA TRANSPORTATION RESEARCH COUNCIL

December 1996
VTRC 97-R9

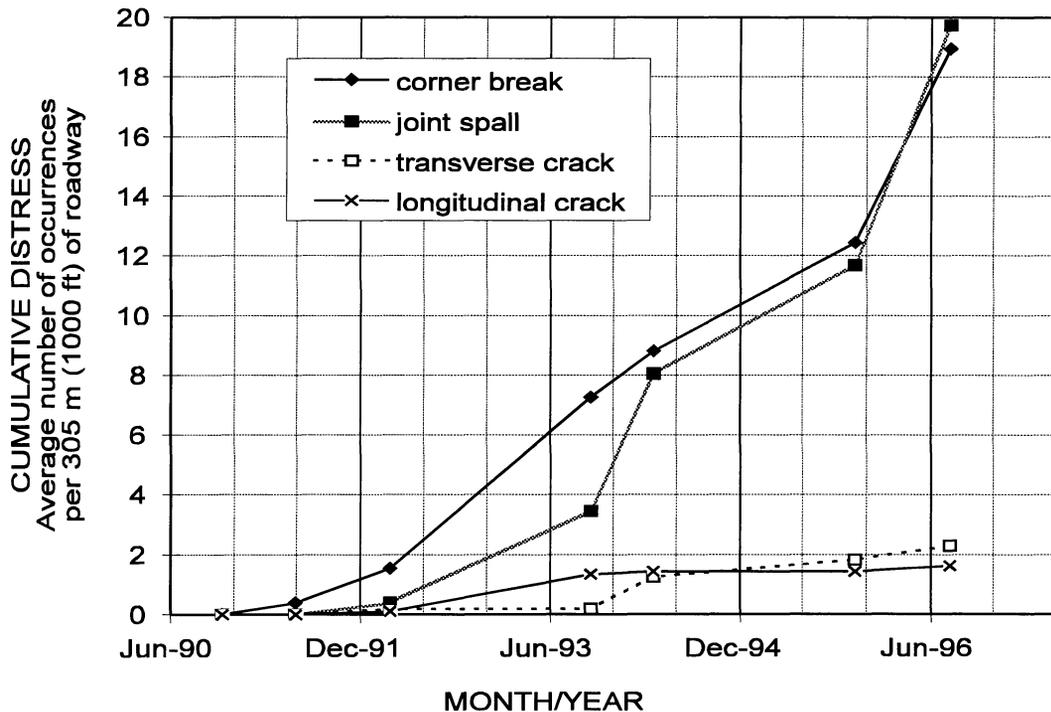
Figure 1. Occurrence of Distress Over Time

The final distress survey demonstrated that although the overall condition of the experimental pavement was still quite good, deterioration of the surface had accelerated somewhat. This was supported by the dramatic increase in new occurrences of transverse joint spalls and corner breaks. Visible discoloration in the immediate vicinity of joints exhibiting extruded seals was evident. Likewise, most of the length of the longitudinal centerline joint, which was generally judged to be slightly to moderately distressed, exhibited similar staining. Recorded occurrences of new longitudinal and transverse cracks were not significantly increased. Figure 1 illustrates the manifestation of corner breaks, joint spalls, and transverse and longitudinal cracks over the evaluation period.

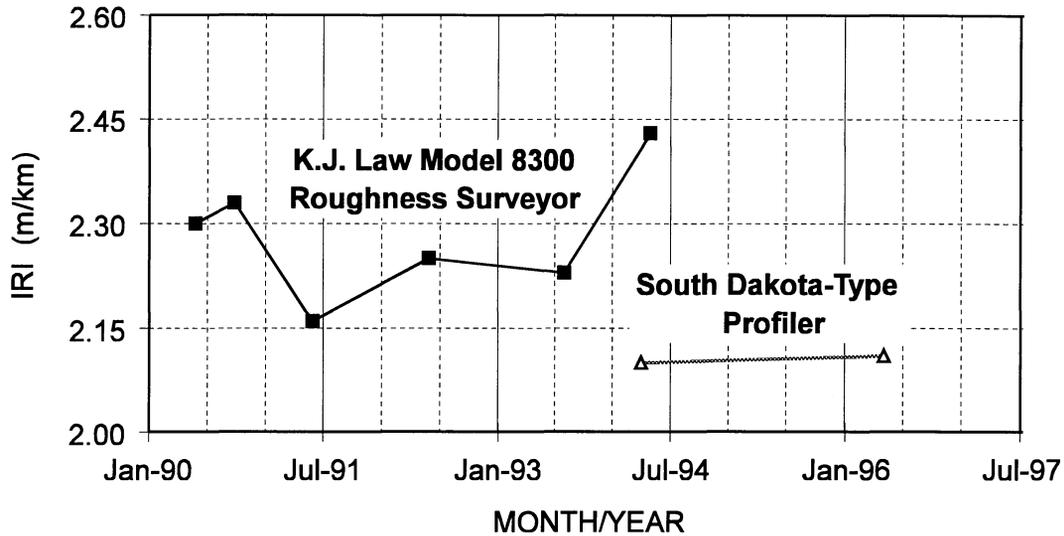
Figure 2. Pavement Roughness Over Time, Outer Lane

Figures 2 and 3 summarize the results of the roughness surveys for the two lanes over time. When differences between the capacities of the two devices to measure are considered, the graphs demonstrate that the roughness of the overlay changed very little throughout the evaluation period. Results obtained with the K.J. Law Model 8300 device indicated that the

pavement was only moderately smooth, with IRI values ranging from approximately 2.21 to 2.37 m/km (140 to 150 in/mi) each year in the outside lane. The inside lane consistently yielded IRI values on the order of 2.52 m/km (160 in/mi) with the same device. Roughness surveys performed in 1995 and 1996 with the South Dakota Road Profiler consistently resulted in IRI measurements of 2.10 to 2.15 m/km (133 to 136 in/mi) in both lanes. Since it is unlikely that the ride quality of the overlay actually improved during the evaluation period, it is the author's
