FINAL
CONTRACT REPORT
VTRC 10-CR3

**RAPID REPLACEMENT OF TANGIER ISLAND
BRIDGES INCLUDING LIGHTWEIGHT AND DURABLE
FIBER-REINFORCED POLYMER DECK SYSTEMS**

1. Report No.: FHWA/VTRC 10-CR3	2. Government Accession No.:	3. Recipient's Catalog No.:	
4. Title and Subtitle: Rapid Replacement of Tangier Island Bridges Including Lightweight and Durable Fiber-Reinforced Polymer Deck Systems		5. Report Date: September 2009

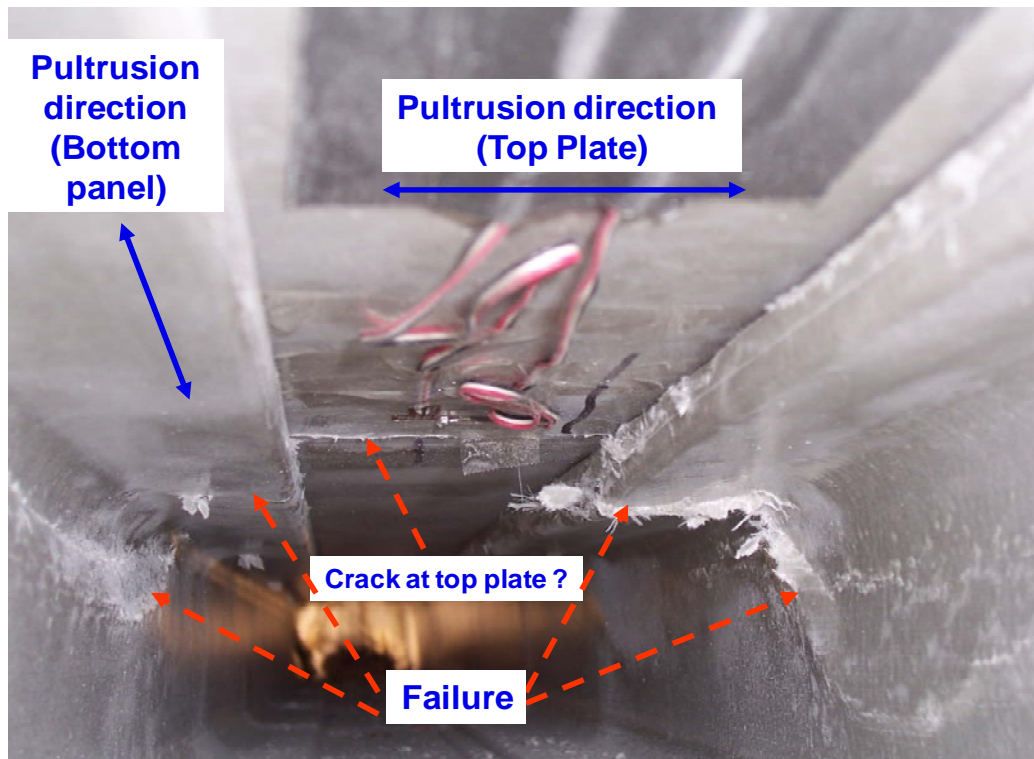
Figure 14. Failure mode under loading patch

The strength test was carried out at Joint 1 with a tire-patch loading. The load was increased in increments until a sound was heard coming from the deck at about 43 kips. The location or cause of the sound was not determined but was probably due to internal fiber breakage. The test was continued in increments until no higher load could be resisted. The amount of sound coming from the deck increased as the load increased. Failure occurred at 77.9 kips with a loud cracking sound and sudden drop in load, strain, and deflection. Table 5 shows critical strains (in $\mu\epsilon$) and deflection at 42.6 kips (when sounds were first heard) and at 77.9 kips (failure). For a bridge deck designed according to AASHTO LRFD Bridge Design Specifications (2007) the strength design load for one wheel is 37.2 kips (the HL-93 16 kip wheel load increased by 33% to account for dynamic effects and further increased by a 1.75 load factor). A 2.09 factor of safety against failure was achieved when comparing the failure load from the test with the strength design load.

Approximately linear load versus deflection behavior was observed during these tests with the exception that a small deviation from linearity in load versus deflection behavior was observed at around 45 kips. This also indicates the beginning of damage accumulation within the deck. After completion of the strength test the deck panel was dismantled so an autopsy of the damaged deck could be performed. Figure 14 shows a view of the area of damage immediately under the load point. The damage is characterized by cracking of the top plate and severe damage to the web and flange of the bottom panel.

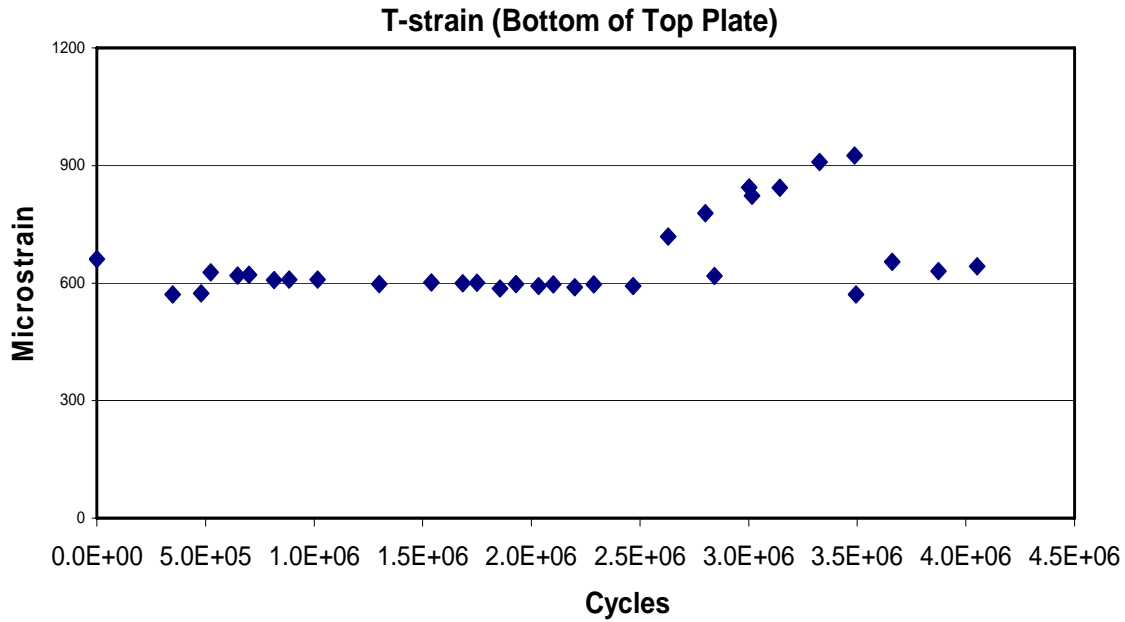
Figure 15. Transverse (along fiber of top plate) strain at bottom of top plate

A fatigue test of the flat test panel was conducted at Joint 2. The fatigue test was done after the test to failure at Joint 1 but no damage was observed at Joint 2 due to the strength test conducted at Joint 1. The fatigue test was performed for 5,000,000 cycles. A slight loss in stiffness was observed during the test and no change in the longitudinal strains was noted. There were significant changes in recorded transverse strain and readings from the crack detection gage. Figure 15 shows a plot of transverse strain on the bottom of the top plate during the fatigue test. Note the sharp increase in measured strains at about 2,500,000 cycles. This may indicate the beginning of damage to the screw fasteners that attach the top panel to the bottom T-section. Also, the crack detection gage readings showed a change in response at about 1 million cycles of load indicating the lap joint had deteriorated somewhat. An autopsy of the deck after the fatigue test was completed did not reveal any visual evidence of structural deterioration at or near the lap joints. However, the changes in stiffness and crack detection readings described above are an indication of the onset of damage to the fasteners.

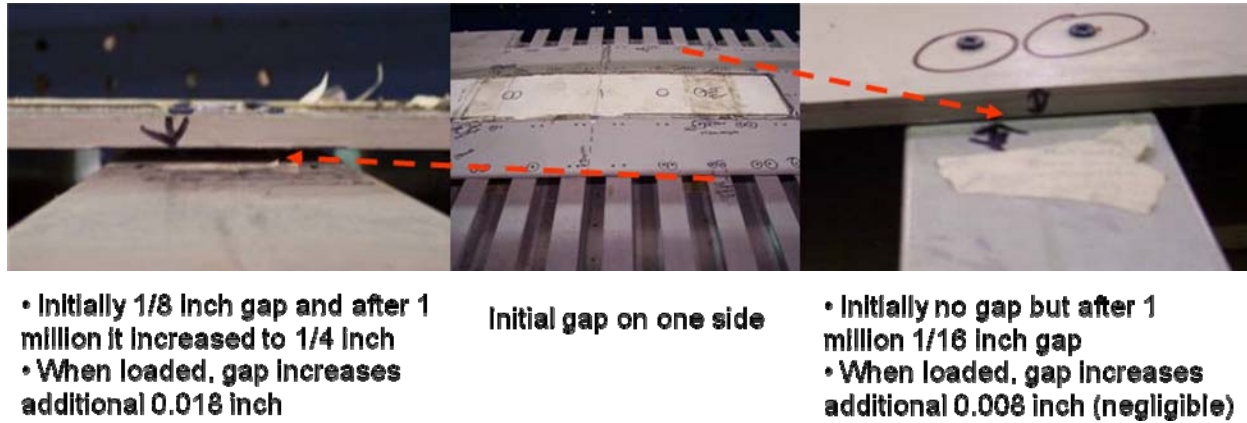
Figure 16. Opening of gap between top plate and bottom part

The constructability of the continuous, bent top plate was a primary focus of the testing program. After screwing one end of the top plate to the supporting T-sections, the other end was forced down to the supporting T-section on the other side of the joint. Unfortunately, the top plate could not be bent enough to close the gap completely. There was a 1/8 in gap between the top plate and supporting T-section on one side of the top plate as shown in Figure 16. There was a small difference in elevation of the supporting stringers. This difference, although consistent with typical bridge construction tolerances, resulted in the gap between the top plate and supporting T-sections. Another constructability consideration was the large number of screws needed to secure this connection. This is a manpower issue that should be considered when using the Zellcomp deck in similar applications.

- The bent lap joint connection was difficult to construct. A permanent gap between the top plate and supporting T-sections resulted due to inherent construction tolerances.

1. *VDOT's Structure and Bridge Division* should not use the sloped deck transition on any applications of the Zellcomp bridge deck system.
2. *VDOT's Structure and Bridge Division* should consider close inspection of all screw connections on the Zellcomp deck during regularly scheduled bridge inspections.

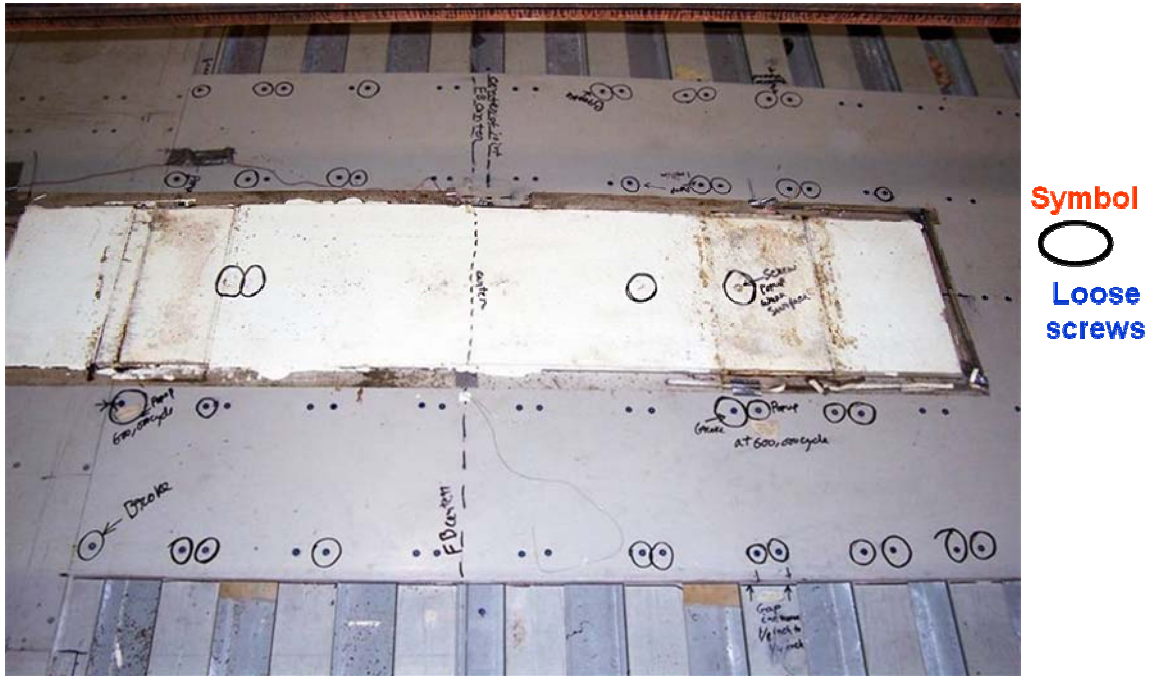
Figure 17. Loose screws

After fabrication of the Zellcomp deck system was complete, fatigue testing of the test specimen commenced. Based on load versus strain and deflection data, no discernable pattern of change or loss of stiffness was noticed. However, significant loosening of the screws began being observed after 250,000 cycles of loading. The test was stopped at 600,000 cycles of load and the screw connections were closely inspected. Approximately two thirds of the visible connections were visually determined to have loosened with the most loosened screws pultruding as much as 0.25 in above the surface of the top plate. Several of these loosened screws good be further loosened by hand. Note that the tops of screws under the wearing service could not be seen, therefore, there performance could not be evaluated. Figure 17 shows a plan view of the test specimen after 600,000 cycles of loading with the loosened screws labeled. In addition to the loosened screws, several screws heads fractured during testing. Figure 18 shows photographs of loosened screws as well as one broken screw at after 600,000 cycles of load.

- More screws were observed to have loosened.
- Several more screws fractured.
- A horizontal or sliding movement was noted between the top plate and supporting T-section during testing.
- The size of the built-in gap between the top plate and T-section doubled.

- The slope Zellcomp deck specimen experienced significant deterioration during the first 600,000 cycles of load. Numerous top plate screw connection loosened with several completely fracturing. The damage to the deck increased for the next 400,000 cycles.
