Experimental and Analytical Evaluation of Residual Capacity of Corrosion-Damaged Prestressed Concrete Bridge Girders

Via Department of Civil and Environmental Engineering Virginia Tech

Final Report VTRC 21-R6

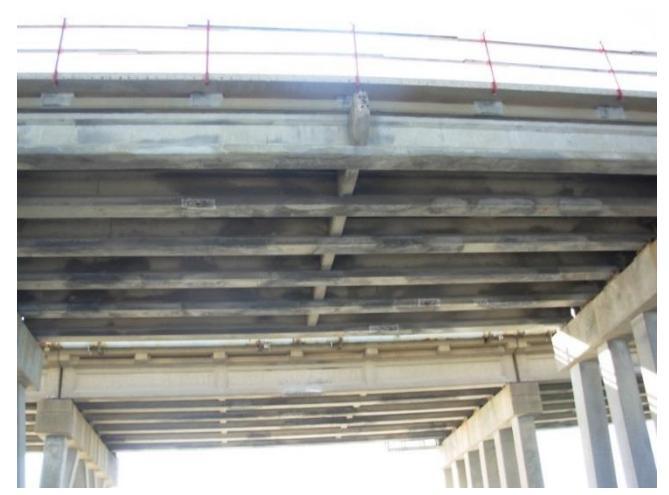
After almost 50 years of service, the bridge was demolished and replaced beginning in 2016. In the spring of 2017, nine beams were retrieved during the demolition process and delivered to Virginia Tech for testing. The slab between the beams was saw-cut to allow for the retrieval of beams to include a section of their cast-in-place composite deck. Figure 1 is a photograph of Span 7, showing the extent of deterioration in typical beams. The Lesner Bridge was repaired several times over the years, so patching is evident in many locations.

Figure 1. Typical Deterioration on the Lesner Bridge

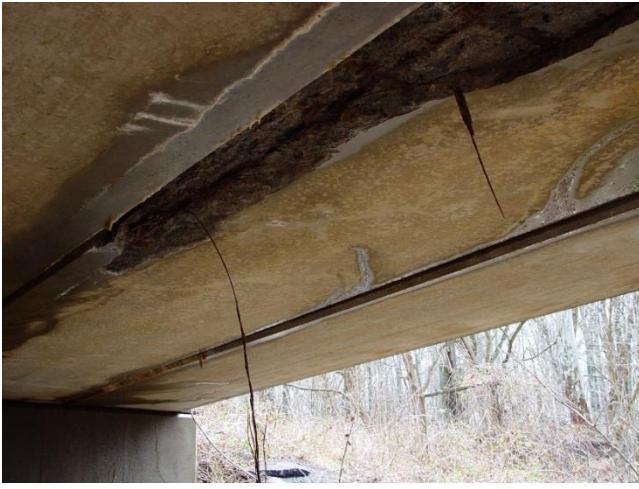
After slightly over 30 years of service, the joints had failed and the bridge was showing signs of severe deterioration, including exposed and fractured prestressing strands (see Figure 2). In 2013, the bridge was demolished and replaced. During demolition, six of the interior beams were transported to Virginia Tech for future testing, three of which were tested in this project. The Aden Road Bridge beams will be referenced by the names Box Beam 1 through Box Beam 6, but their original positions in the bridge is unknown.

Figure 2. Typical Corrosion Damage on Aden Road Bridge

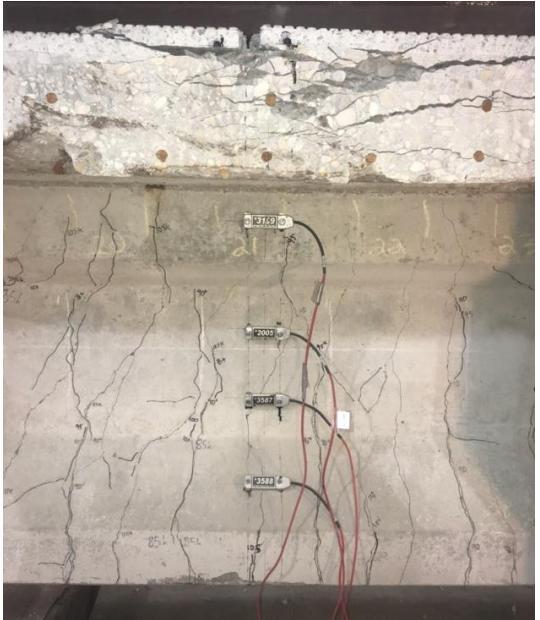
One week later, the beam was re-tested. The load was applied in increments of 20 kips until reaching 140 kips, at which point 10-kip increments were applied until the failure load of 190 kips with a deflection of 8.93 in. The failure was caused by crushing of the top slab as shown in Figure 43. The beam after testing is shown in Figure 44.

Figure 43. Crushing Failure in Top Slab of I-Beam 7

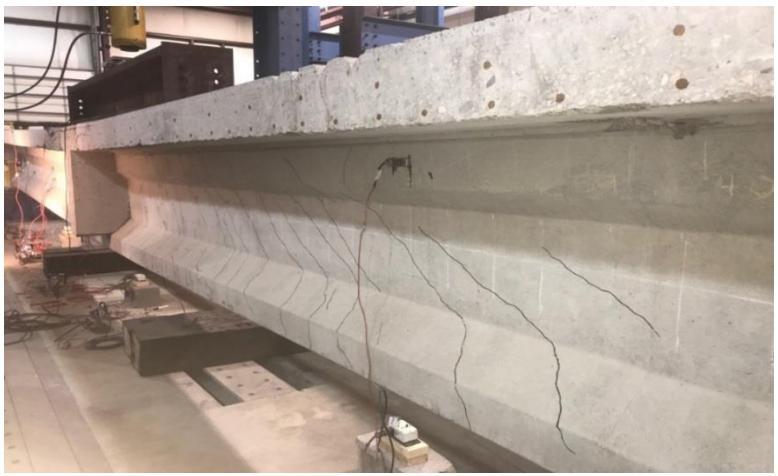
Figure 44. Residual Deflection after Testing I-Beam 7

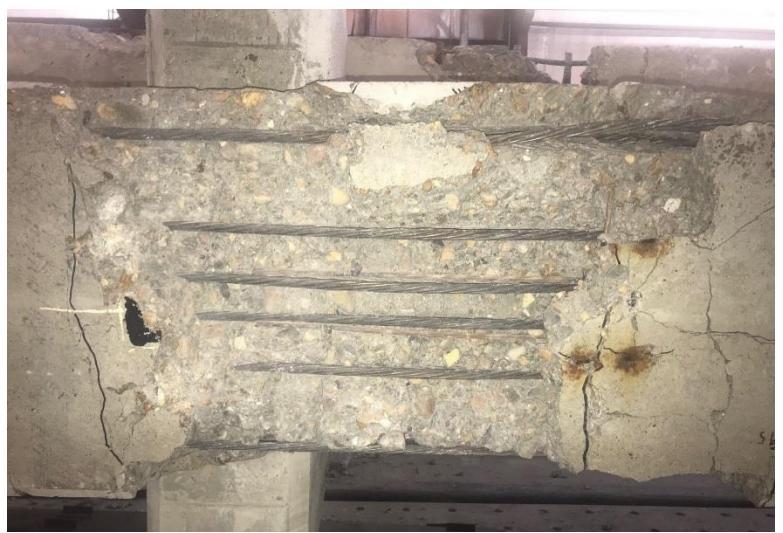
After testing, the concrete cover over the bottom strands was chipped to expose the strands. As can be seen in Figure 47, all strands were bright and shiny, showing no signs of corrosion.

Figure 47. Bottom of I-Beam 7 after Testing

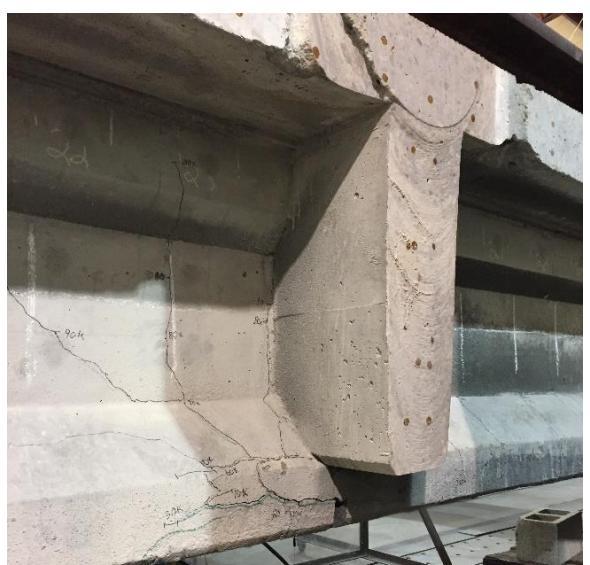
This beam was considered to be in medium condition. Near the mid-span on the bay side of the bridge there was a patch on the bottom flange that extended a few feet on either side of the mid-span diaphragm of the beam. Figure 50 shows the cracking that developed along the patch during testing.

Figure 50. Cracking along Patch During Testing of I-Beam 6

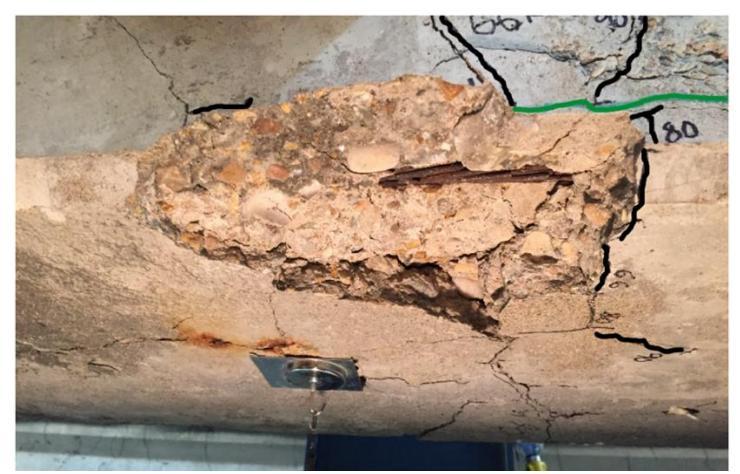
The opposite side of the beam showed very little sign of corrosion damage, except for one 8-in long hairline crack 2 in up on the bottom flange. As testing progressed, a spall occurred at the crack, revealing the corroded strand beneath (see Figure 51). Also in Figure 51, rust staining can be seen on the bottom flange; a post-test autopsy confirmed that the chairs supporting the reinforcement during concrete placement were in fact corroded. This type of staining was also seen on I-Beam 7 (see Figure 47).

Figure 51. Hairline Crack Observed Prior to Testing (marked in green) Related to Corroded Strand Beneath on I-Beam 6

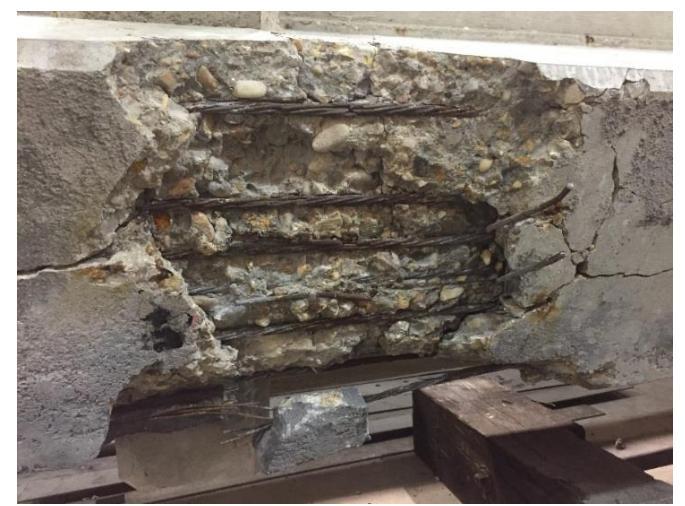
After testing was completed, the concrete on the bottom flange was removed to investigate the condition of the strands, as shown in Figure 52. Upon careful inspection, it was determined that five of the six bottom row strands showed signs of severe corrosion with most wires broken, apparently due to the aforementioned corrosion. A few wires appeared to have broken during testing and showed a shiny surface. Interestingly, the fourth strand, counting from the top of Figure 52, showed no evidence of corrosion damage. The bottom strand in the photo, still embedded in a piece of the patch material, showed evidence of being broken before testing, and most likely at the time the patch was applied. The strand in the same position, but in the second row, was also in the patch and was in similar condition.

Figure 52. Bottom Flange of I-Beam 6 after Testing

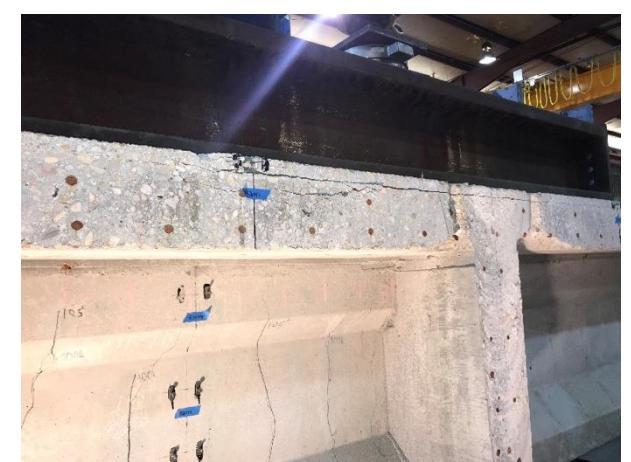
The first flexural crack of the I-beam in "bad condition", I-Beam 3, was observed at a load of 80 kips. For reasons of safety, the beam was no longer closely inspected between load intervals after an applied load of 125 kips. The load deflection plot is presented in Figure 53. Based on strain measurements through the depth of the beam, the neutral axis, just before the cracking load, was 26 in from the bottom of the beam (see Figure 54), which is comparable to the calculated neutral axis of 26.7 in, which was based on the cross-sectional area of the remaining strands and the concrete compressive strength from testing. The beam ultimately failed due to crushing of the top flange (see Figure 55), with an applied load of 166 kips and a deflection of 8.19 in.

Figure 55. Crushing of Top Flange at Failure of I-Beam 3

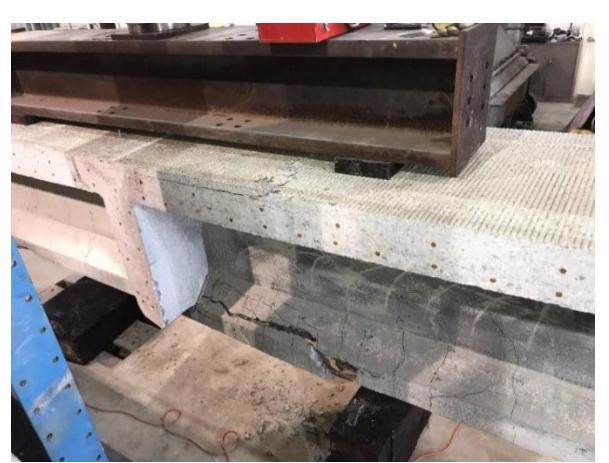
This beam was considered to be in poor condition, with considerable patching and spalling all along the bay side of the bottom flange. Figure 56 shows the top flange crushing at the completion of testing, and also the bottom flange cracking associated with the corroded strands and patching.

Figure 56. I-Beam 3 after Testing

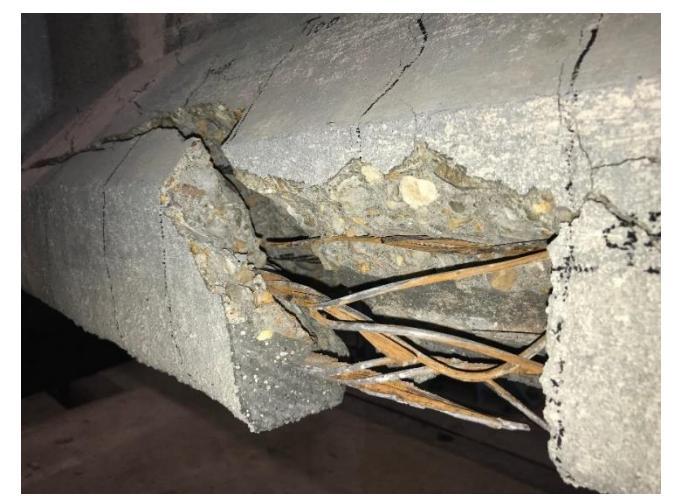
Figure 57. Corrosion-Damaged Strands in and above Patch in I-Beam 3

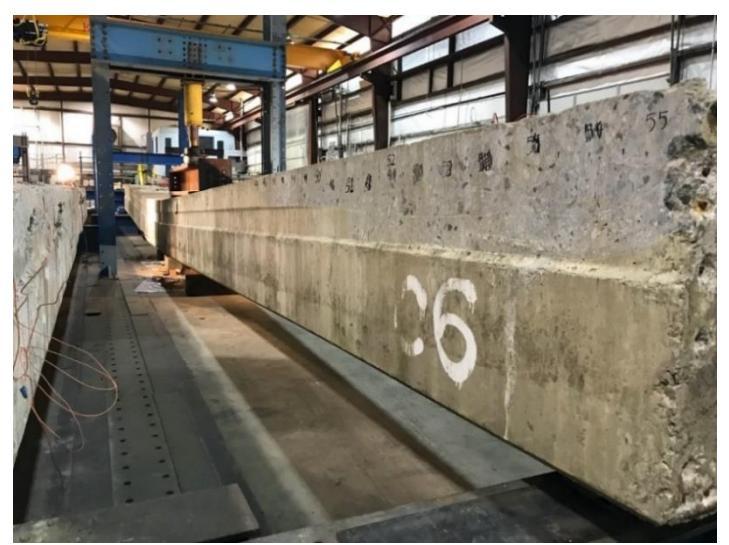
Figure 59. Large Deflection of Box Beam 1

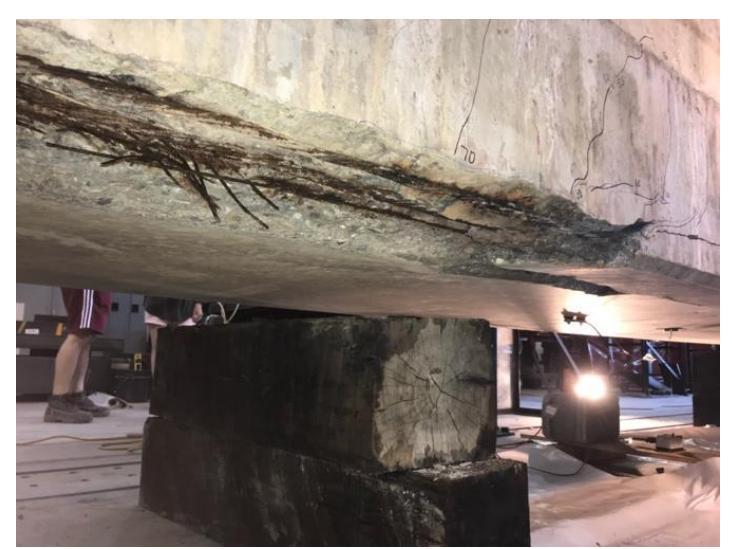
Before the test, severe corrosion was observed in the three bottom strands on the west side of the beam (see Figure 61). The cracks during the test were marked and the propagation was observed (see Figure 62 and 63). Figure 64 shows the beam at the completion of testing.

Figure 61. Condition of the West Side of Box Beam 1 Before the Test

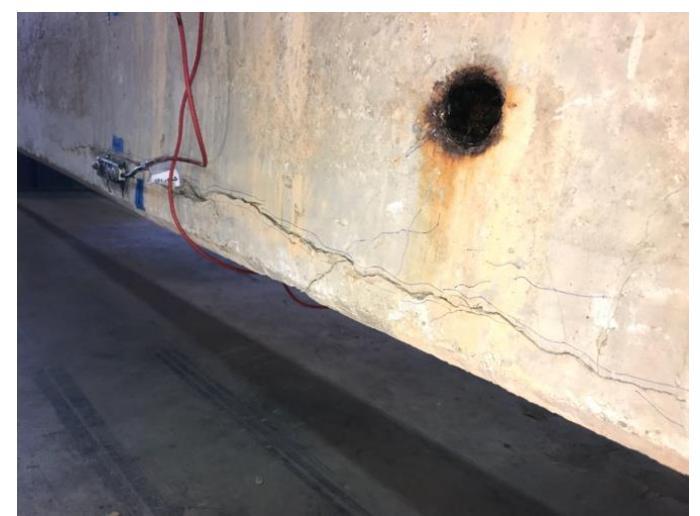
Figure 62. Condition of the East Side of Box Beam 1 Before the Test

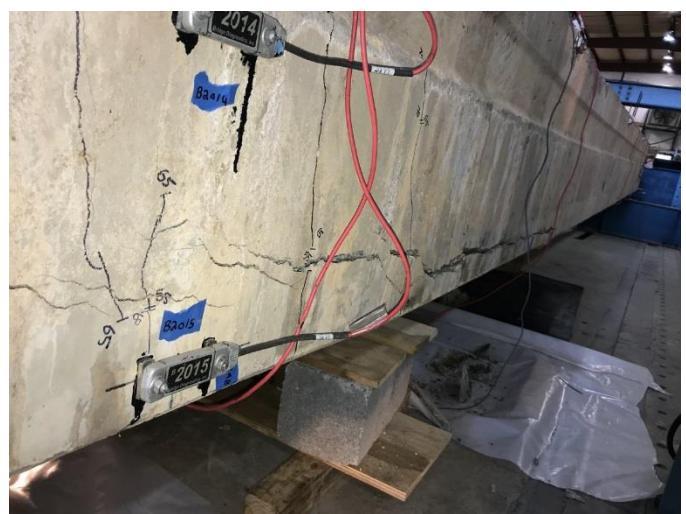
Figure 63. Propagation of the Cracks of the East Side of Box Beam 1 During the Test

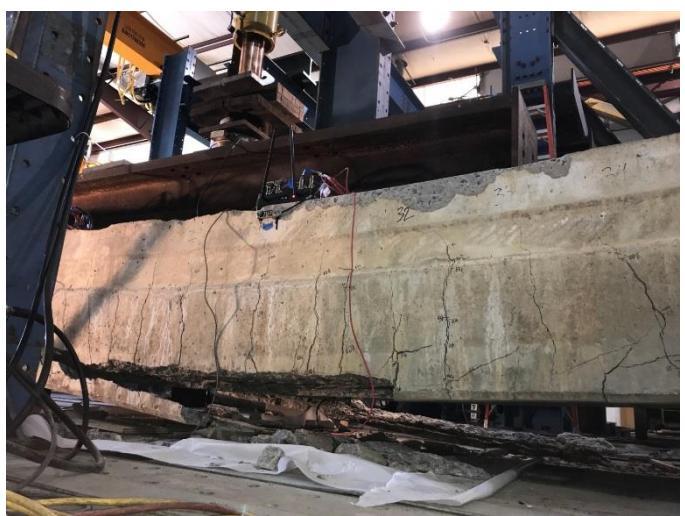
Figure 64. Condition of the East Side of Box Beam 1 at the End of the Test

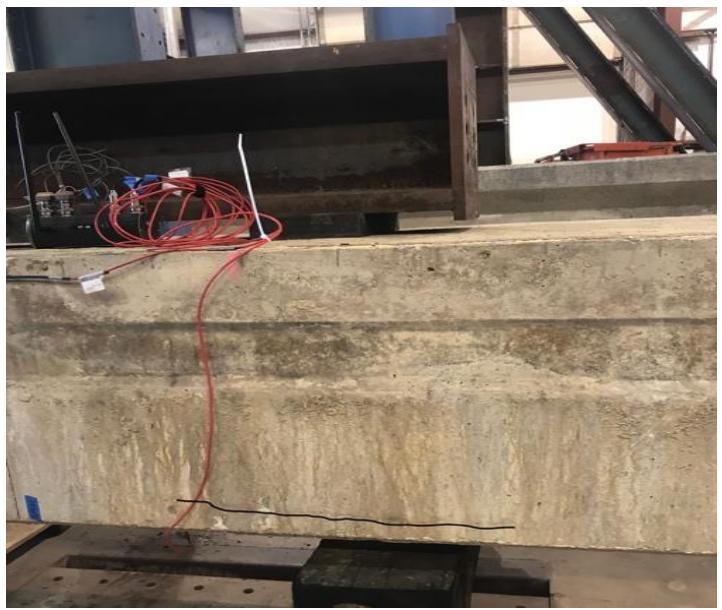
Figure 66 shows a horizontal crack along the east side of the beam prior to testing. Upon examination after the test, strands along that side did not show significant corrosion, but the strands had yielded (see Figure 67). Figure 68 shows the condition of the west side before testing. It can been seen that the edge strands in the lowest level had severe corrosion, possibly exacerbated by the water that had been trapped in the beam. Figure 69 and Figure 70 show the condition of the west side of the box beam after testing. After the bottom concrete cover had spalled off, it was apparent that the three outermost bottom layer strands were severely corroded.

Figure 66. Box Beam 4 East Side Before Testing

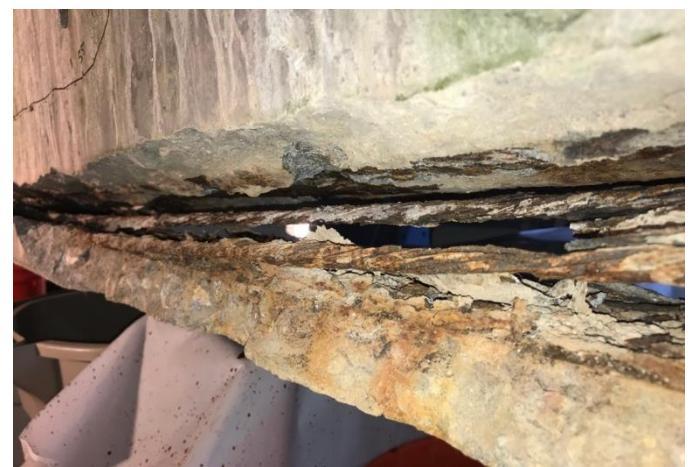
Figure 70. Strand Condition for Box Beam 4 West Side

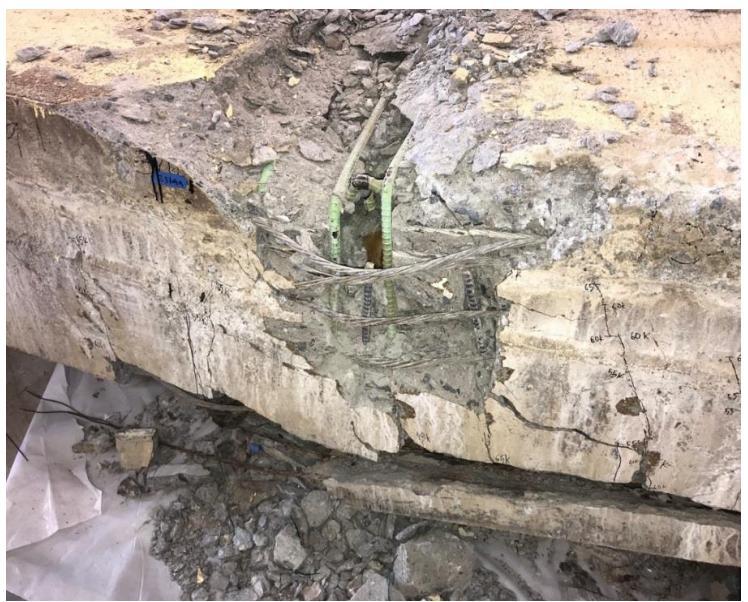
Figure 72. Crushing of the Top Flange of Box Beam 2

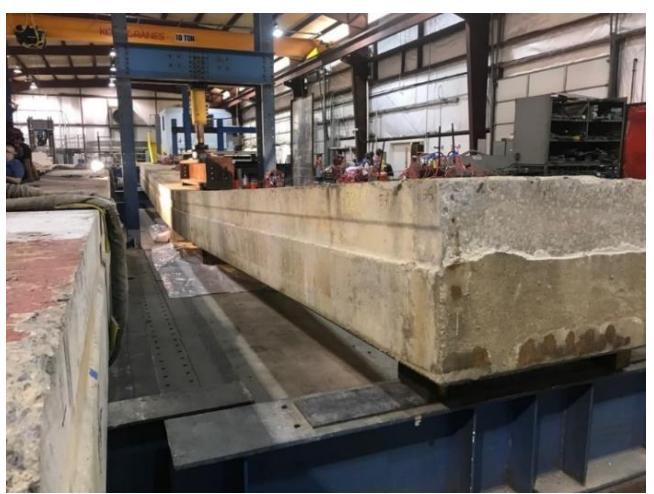
Figure 74 shows the very large deflection in the beam during the test. Figure 75 shows the severely corroded lower strand in the east side, which was observed before the test. After testing, the researchers found that the other strands were relatively undamaged.

Figure 74. Large Displacement of Box Beam 2

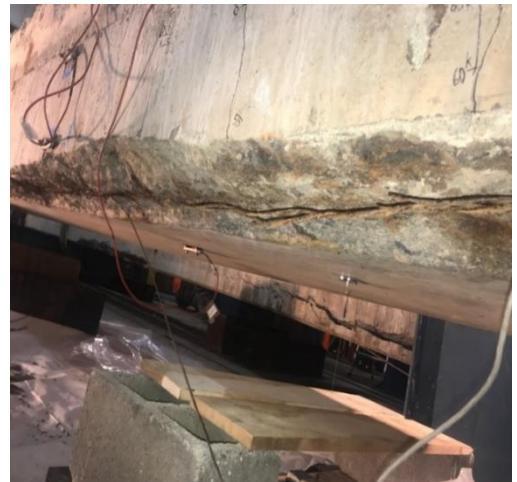
Figure 75. Corroded Strand on Bottom of Box Beam 2

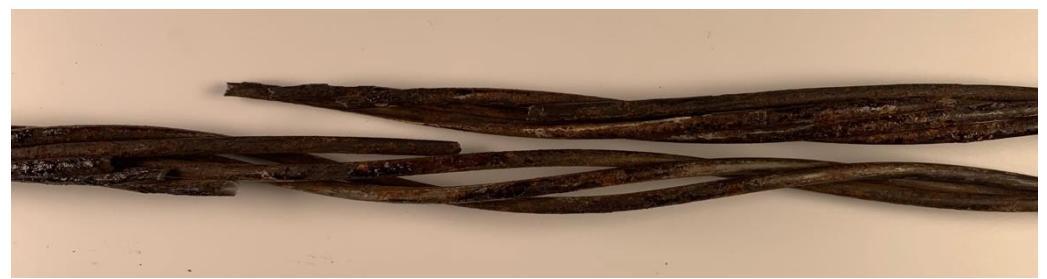
Figure 93. Strand Taken from Box Beam 2 after Testing
