Field Evaluation of Lightweight Noise Barriers and Development of Noise Barrier Inspection and Asset Management Program

<https://vtrc.virginia.gov/media/vtrc/vtrc-pdf/vtrc-pdf/26-R47.pdf>

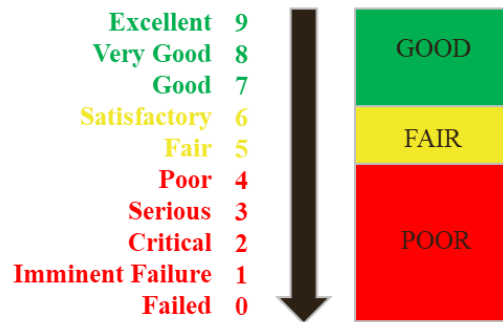
Figure 3. Example of Overall Condition Rating Scale

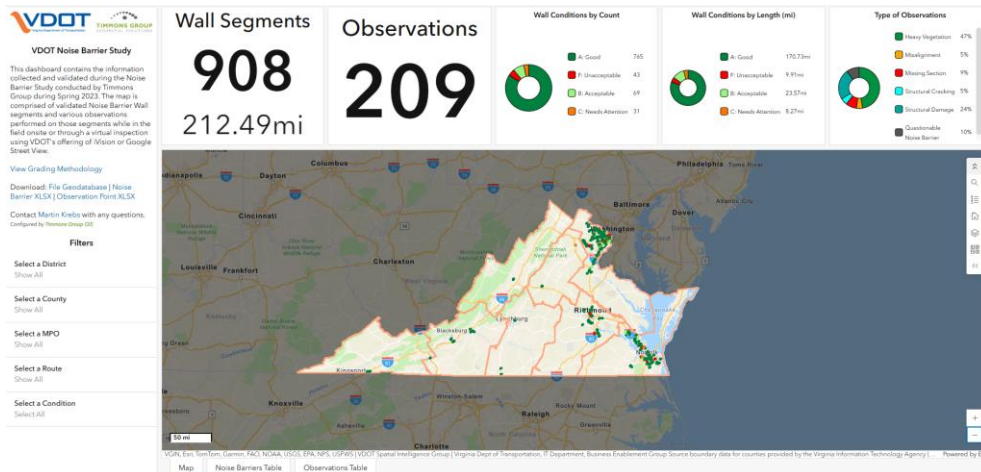
Figure 4. Screenshot of VDOT Maintenance Database for Noise Barriers

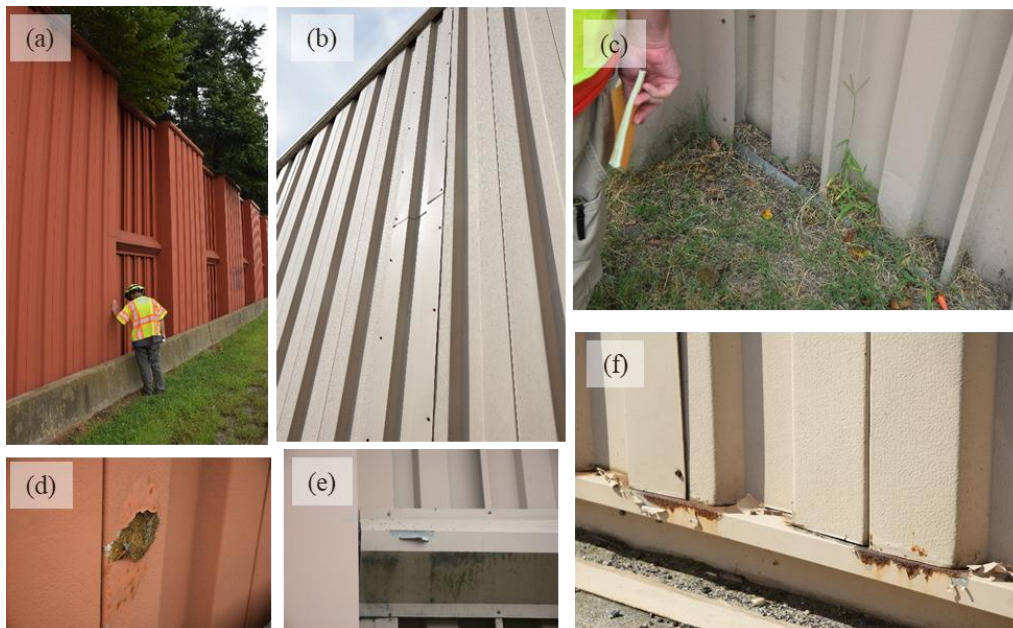
Figure 5. Photos of the Condition of Noise Barriers Constructed with Metal Panels Oriented Vertically: (a) Overall Condition of Ground-Mounted Barriers; (b) Overall Condition of Bridge-Mounted Barriers; (c) Susceptibility to Corrosion if Ponding Were to Occur; (d) Minor Section Loss at Intermittent Locations; (e) Minor Coating Failure at Intermittent Locations; (f) Corrosion Damage at Base and Flashing of Bridge-Mounted Barriers

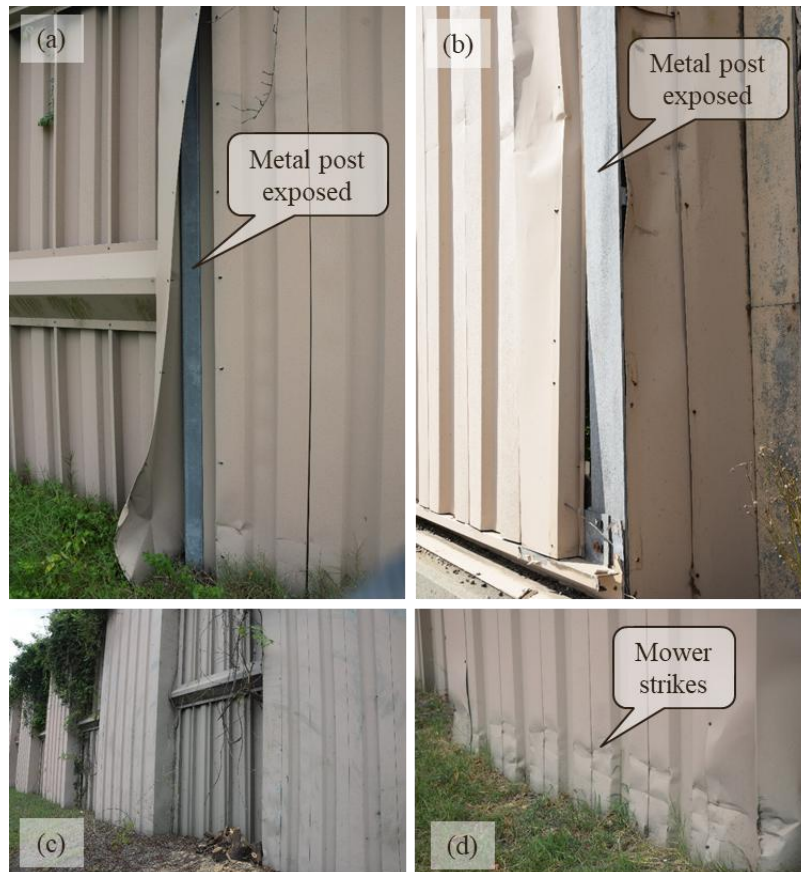
Figure 6. Additional Photos of the Condition of Noise Barriers Constructed with Metal Panels Oriented Vertically: (a) Impact Damage Leaving Metal Post Exposed on Ground-Mounted Barrier; (b) Impact Damage Leaving Metal Post Exposed on Bridge-Mounted Barrier; (c) Vegetation Growth; (d) Mower Impact Strikes on Ground-Mounted Barrier

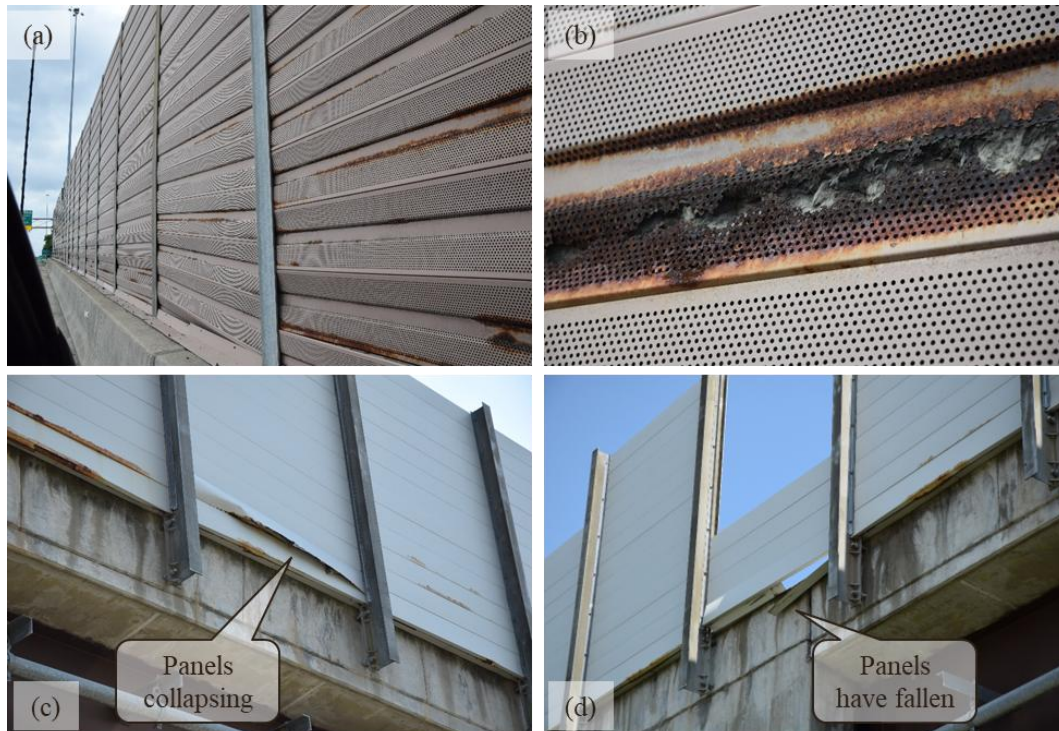
Figure 7. Photos of the Condition of Noise Barriers Constructed with Metal Panels Oriented Horizontally with Perforations: (a) Overall View from Roadway Side of Corrosion Present Throughout; (b) Closeup from Roadway Side of Corrosion Damage on Front Face of Panels; (c) Panels Collapsing Viewed from the Back Side; (d) Back Side View Showing Missing Panels that Have Fallen to the Ground

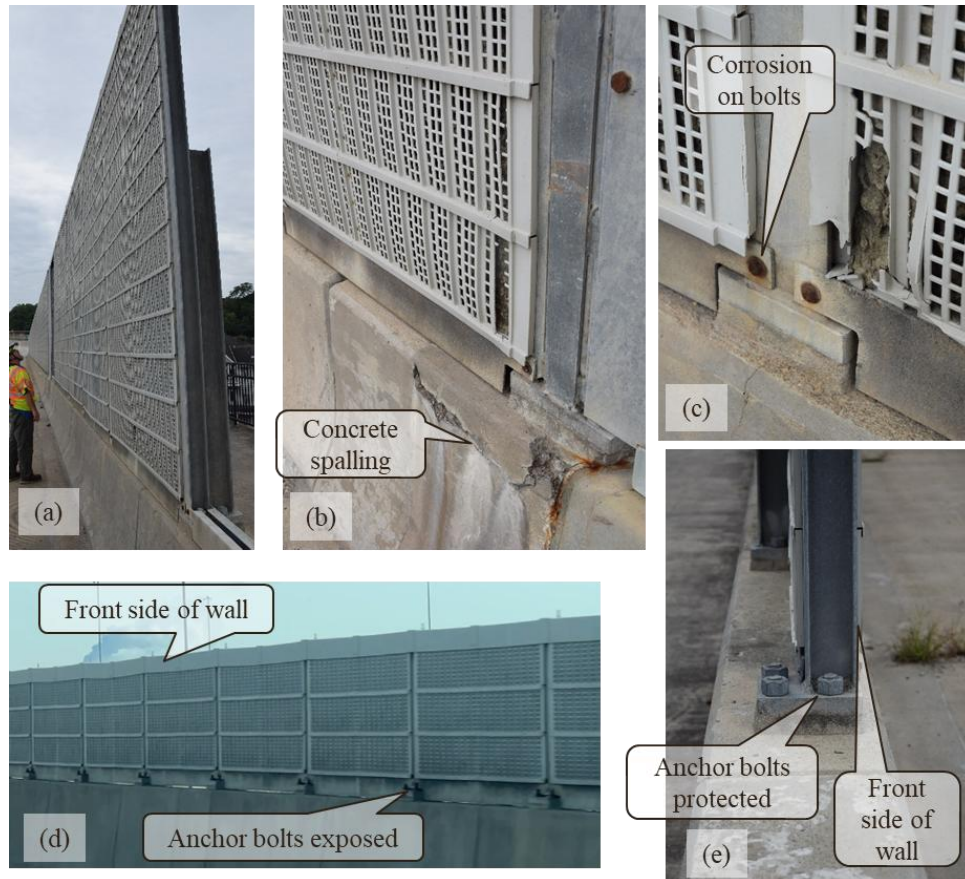
Figure 8. Photos of the Condition of Noise Barriers Constructed with Composite Panels: (a) Overall View with Barrier; (b) Closeup Showing Cracking at Intermittent Locations Near Panel-to-Post Connections and Concrete Spalling in the Barrier; (c) Closeup Showing Damage on Panels and Corrosion on Bolts Connecting Panels to Posts; (d) Exposed Anchor Bolts with Corrosion; (e) Anchor Bolts Protected from Salt Spray Showing no Corrosion

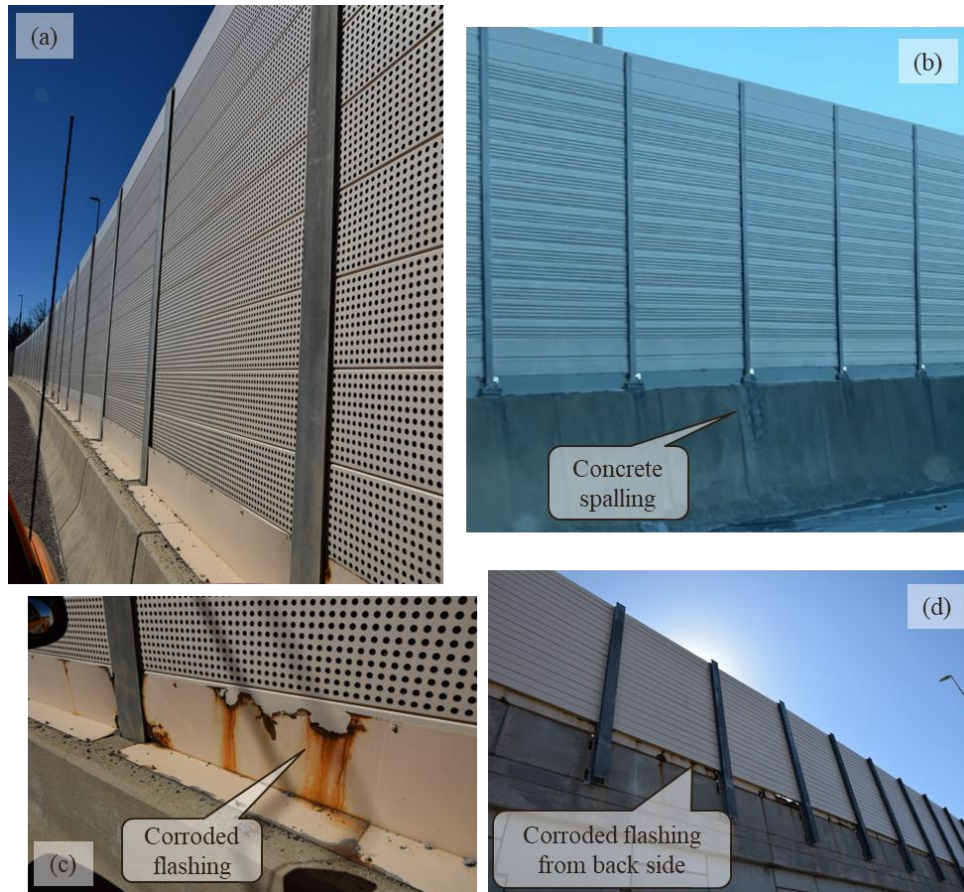
Figure 9. Photos of the Condition of Noise Barriers Constructed with Polyvinyl Chloride Panels: (a) Overall View of Barrier; (b) Concrete Spalling in Concrete Barrier at Post Connections; (c) Corroded Flashing at Panel Base; (d) Back Side of Noise Barrier Showing Post Connections and Corroded Flashing

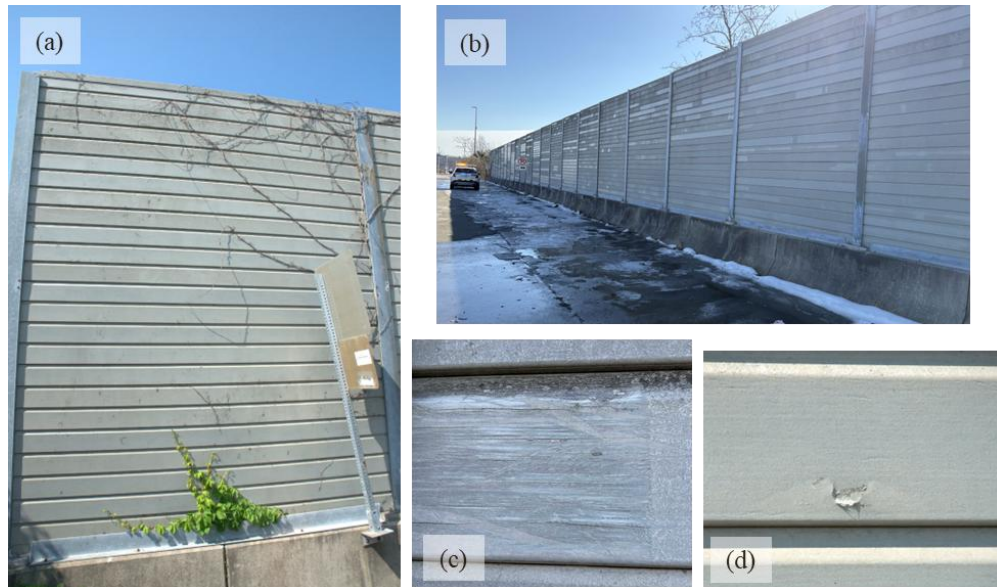
Figure 10. Photos of the Condition of Noise Barriers Constructed with Fiberglass Panels: (a) Single Panel with Vegetation Growth; (b) Overall View; (c) Closeup of Deterioration; (d) Closeup of Impact Damage

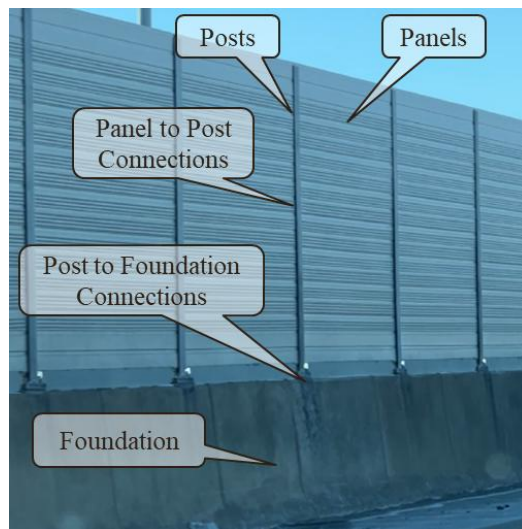
Figure 13. Proposed Categories of Noise Barrier Elements

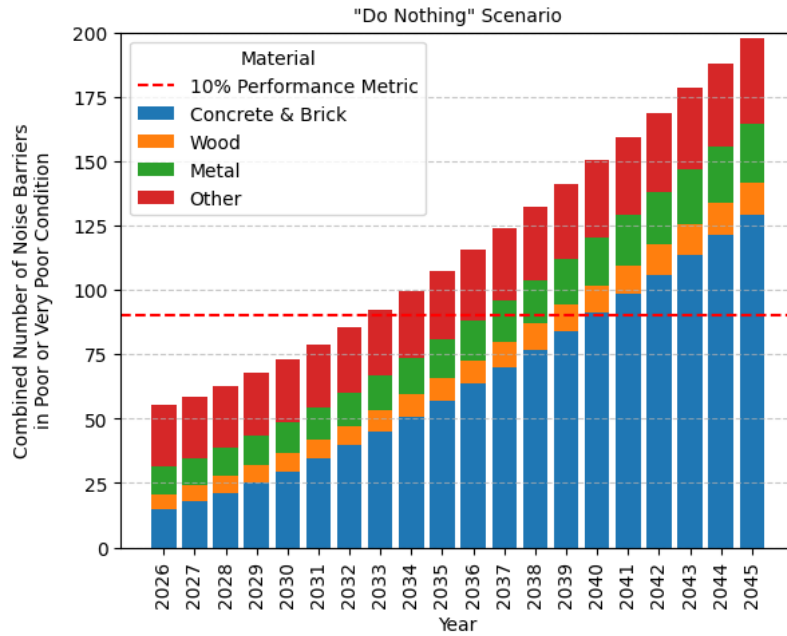
Figure 14. Markov Chain Analysis Results Showing Noise Barrier Inventory Condition After “Do Nothing” Scenario

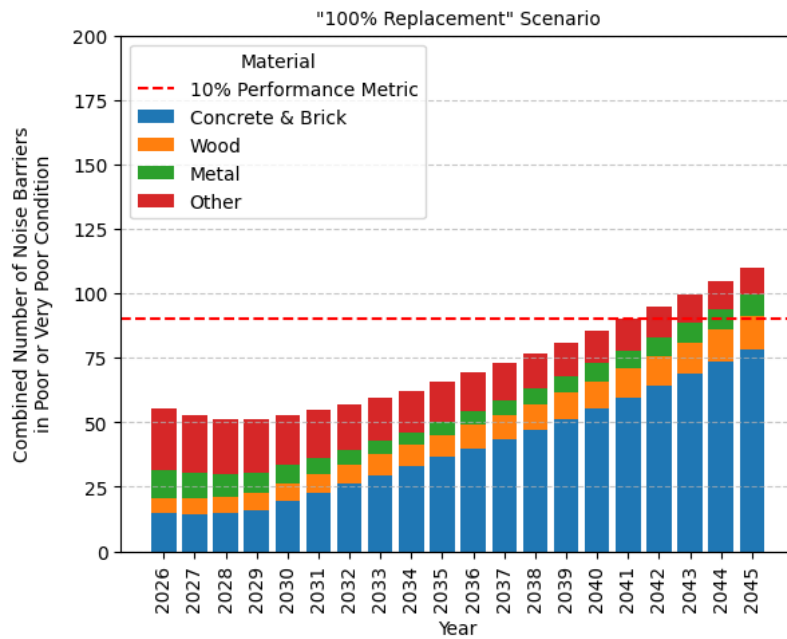
Figure 15. Markov Chain Analysis Results Showing Noise Barrier Inventory Condition After “100% Replacement” Scenario

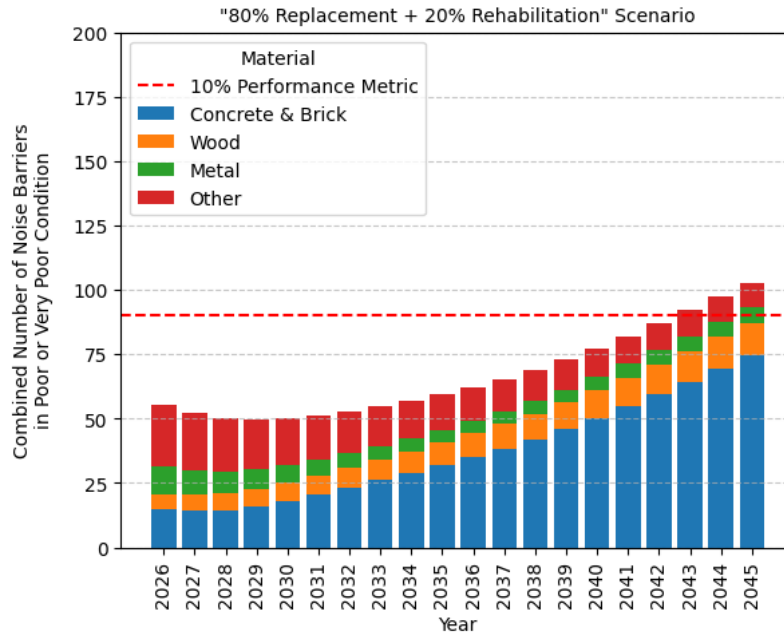
Figure 16. Markov Chain Analysis Results Showing Noise Barrier Inventory Condition After “80% Replacement + 20% Rehabilitation” Scenario

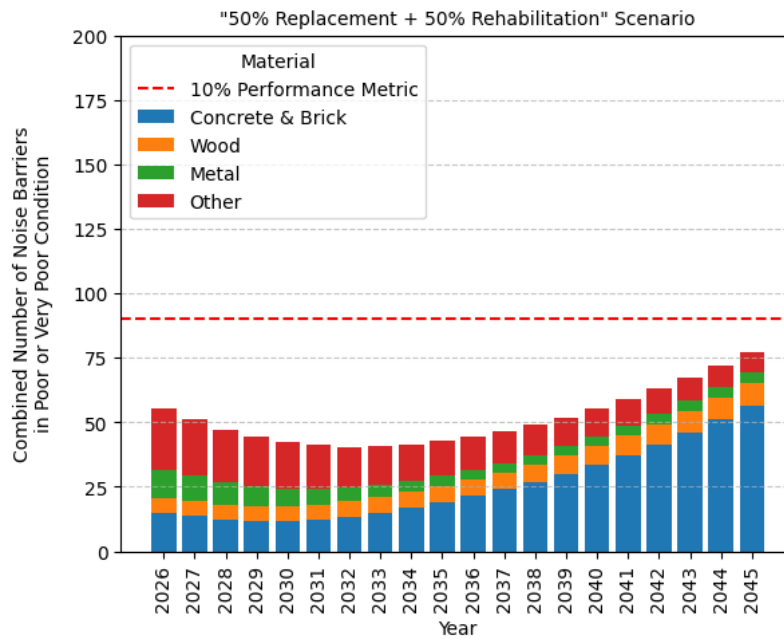
Figure 17. Markov Chain Analysis Results Showing Noise Barrier Inventory Condition After “50% Replacement + 50% Rehabilitation” Scenario

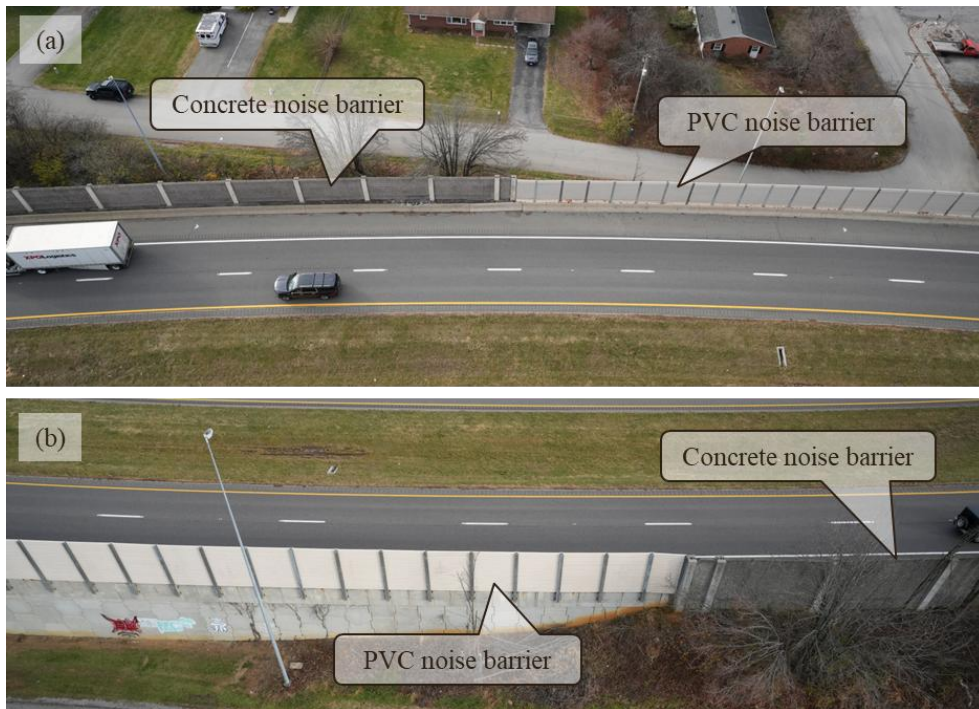
Figure 18. Oblique Imagery of PVC and Concrete Noise Barriers at Christiansburg Site: (a) Front Side of Noise Barriers; (b) Back Side of Noise Barriers. PVC = polyvinyl chloride.

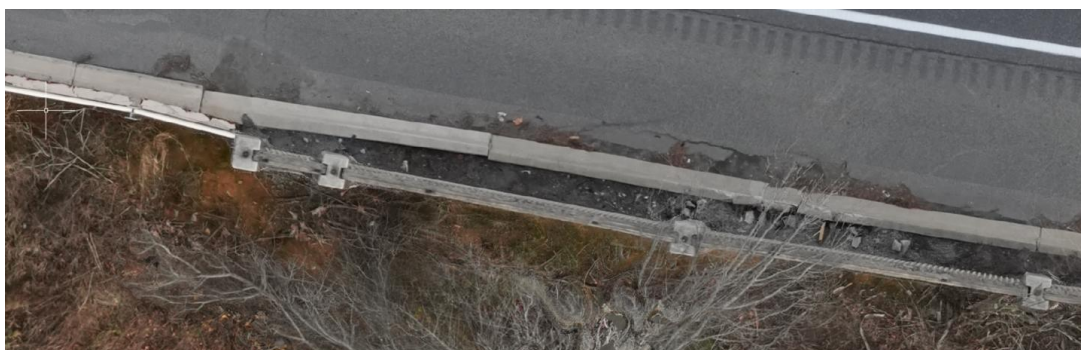
Figure 19. Orthomosaic “Top of Wall” Photo Where the Polyvinyl Chloride and Concrete Noise Barriers Join at Christiansburg Site

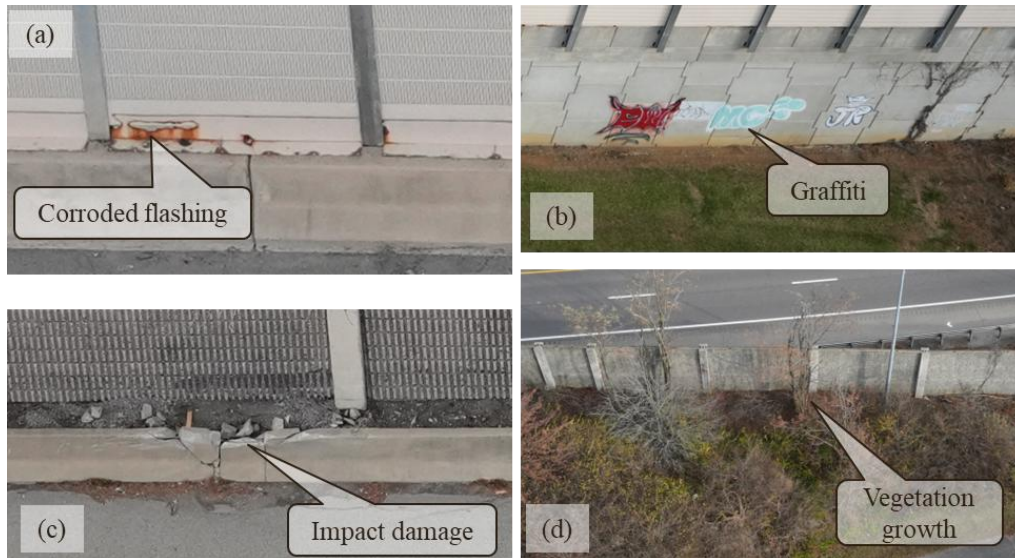
Figure 20. Screenshots of Colorized Mesh Model of Noise Barriers at Christiansburg Site: (a) Corroded Flashing at Base of PVC Noise Barrier; (b) Graffiti on Retaining Wall Below PVC Noise Barrier; (c) Impact Damage on Concrete Noise Barrier and Concrete Barrier; (d) Vegetation Growth Behind Concrete Noise Barrier. Photos were taken with a 61 megapixel camera at either 180 or 250 feet above ground level. PVC = polyvinyl chloride.

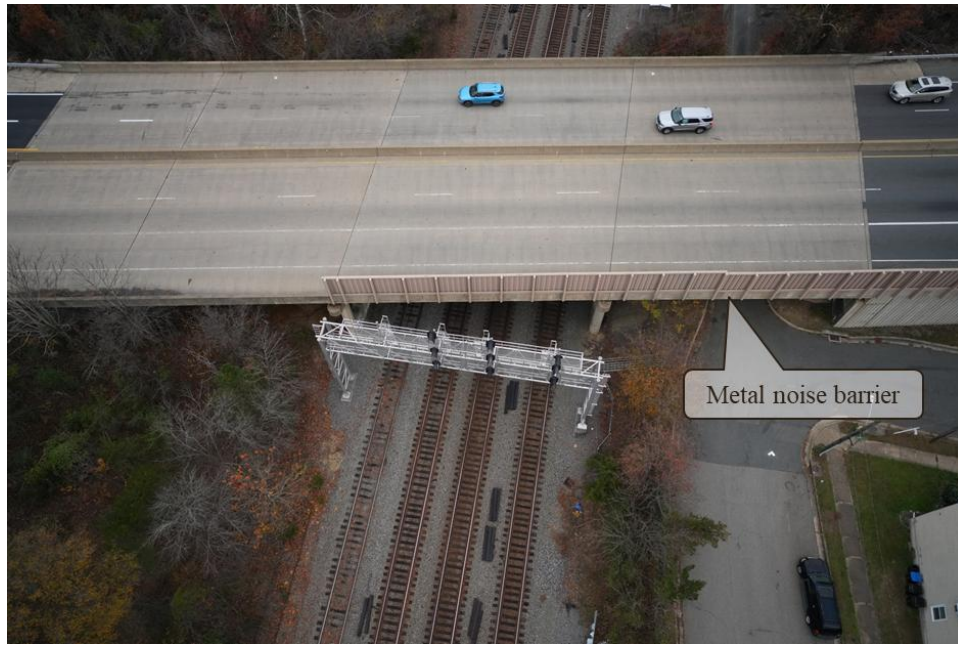
Figure 23. Oblique Imagery from the Fredericksburg Site Showing Metal Noise Barrier, Railroad Tracks, and Truss Structure over Railroad Tracks

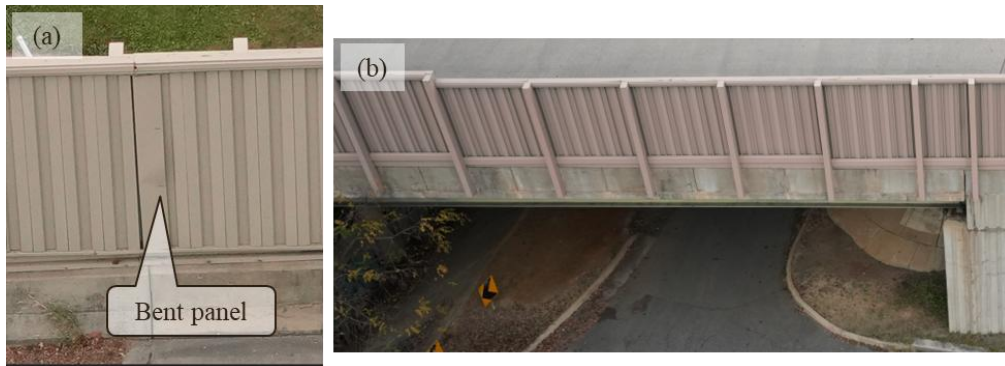
Figure 24. Screenshots from Colorized Mesh Model of Metal Noise Barrier at Fredericksburg Site: (a) Bent Panel on Front Side of Noise Barrier; (b) Back Side of Noise Barrier

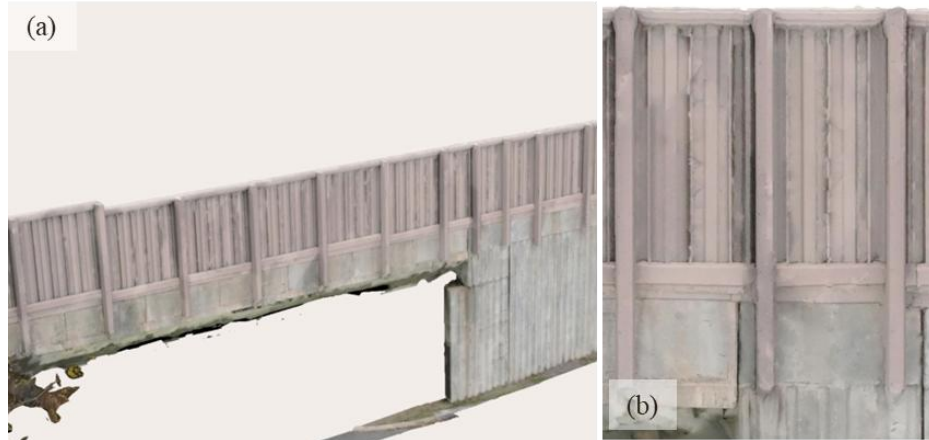
Figure 25. Screenshots from Colorized Mesh Model of Metal Noise Barrier at the Fredericksburg Site: (a) Overall View of Back Side of Noise Barrier; (b) Closeup View of Noise Barrier

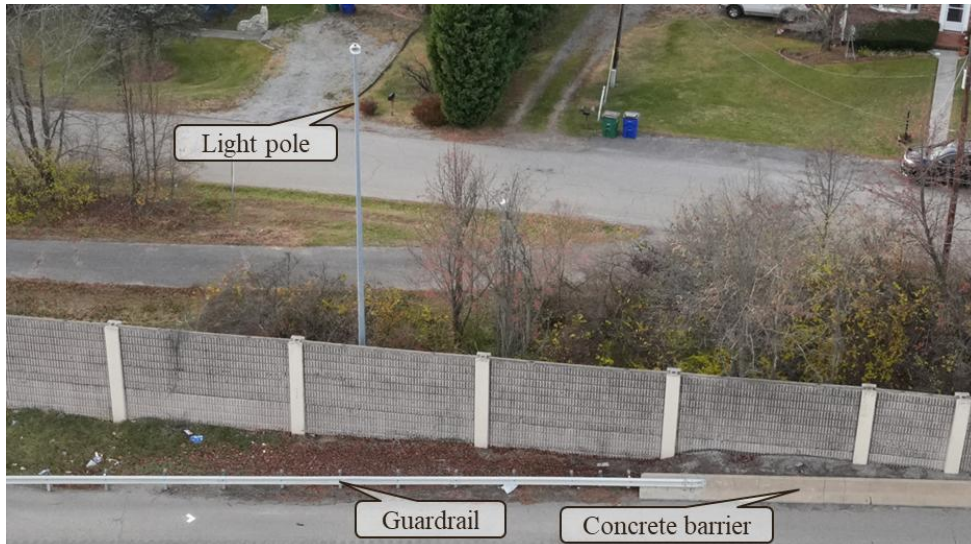
Figure 26. Other VDOT Assets Observed During Unmanned Aerial System Trial Inspections
