A COMPARISON OF FULL AND PARTIAL
LIGHTING ON TWO SECTIONS OF ROADWAY

M. H. Hilton
Senior Research Scientist

Virginia Highway & Transportation Research Council
(A Cooperative Organization Sponsored Jointly by the Virginia
Department of Highways & Transportation and
the University of Virginia)

June 1980
VHTRC 80-R52

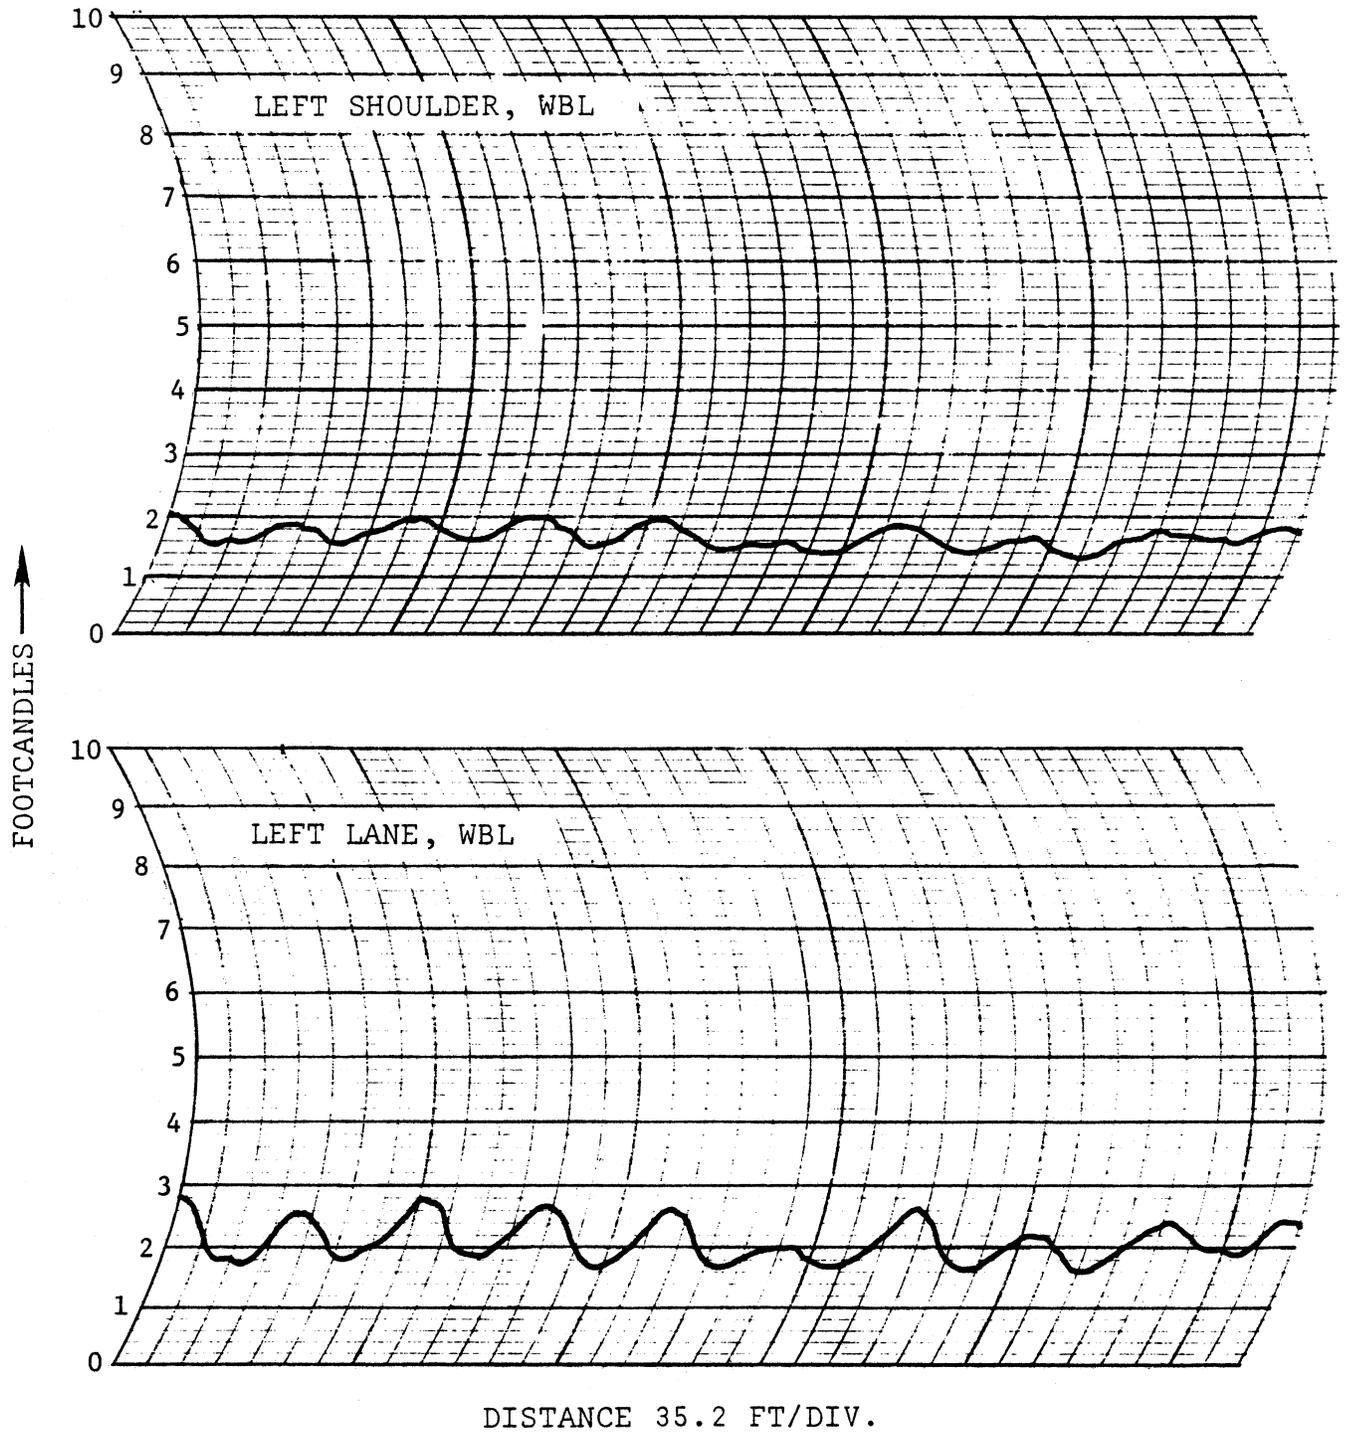
Figure 3. Typical illumination levels on the left lane and left shoulder of the WBL of Rte. I-64. (Study section 1, 1st data run.)

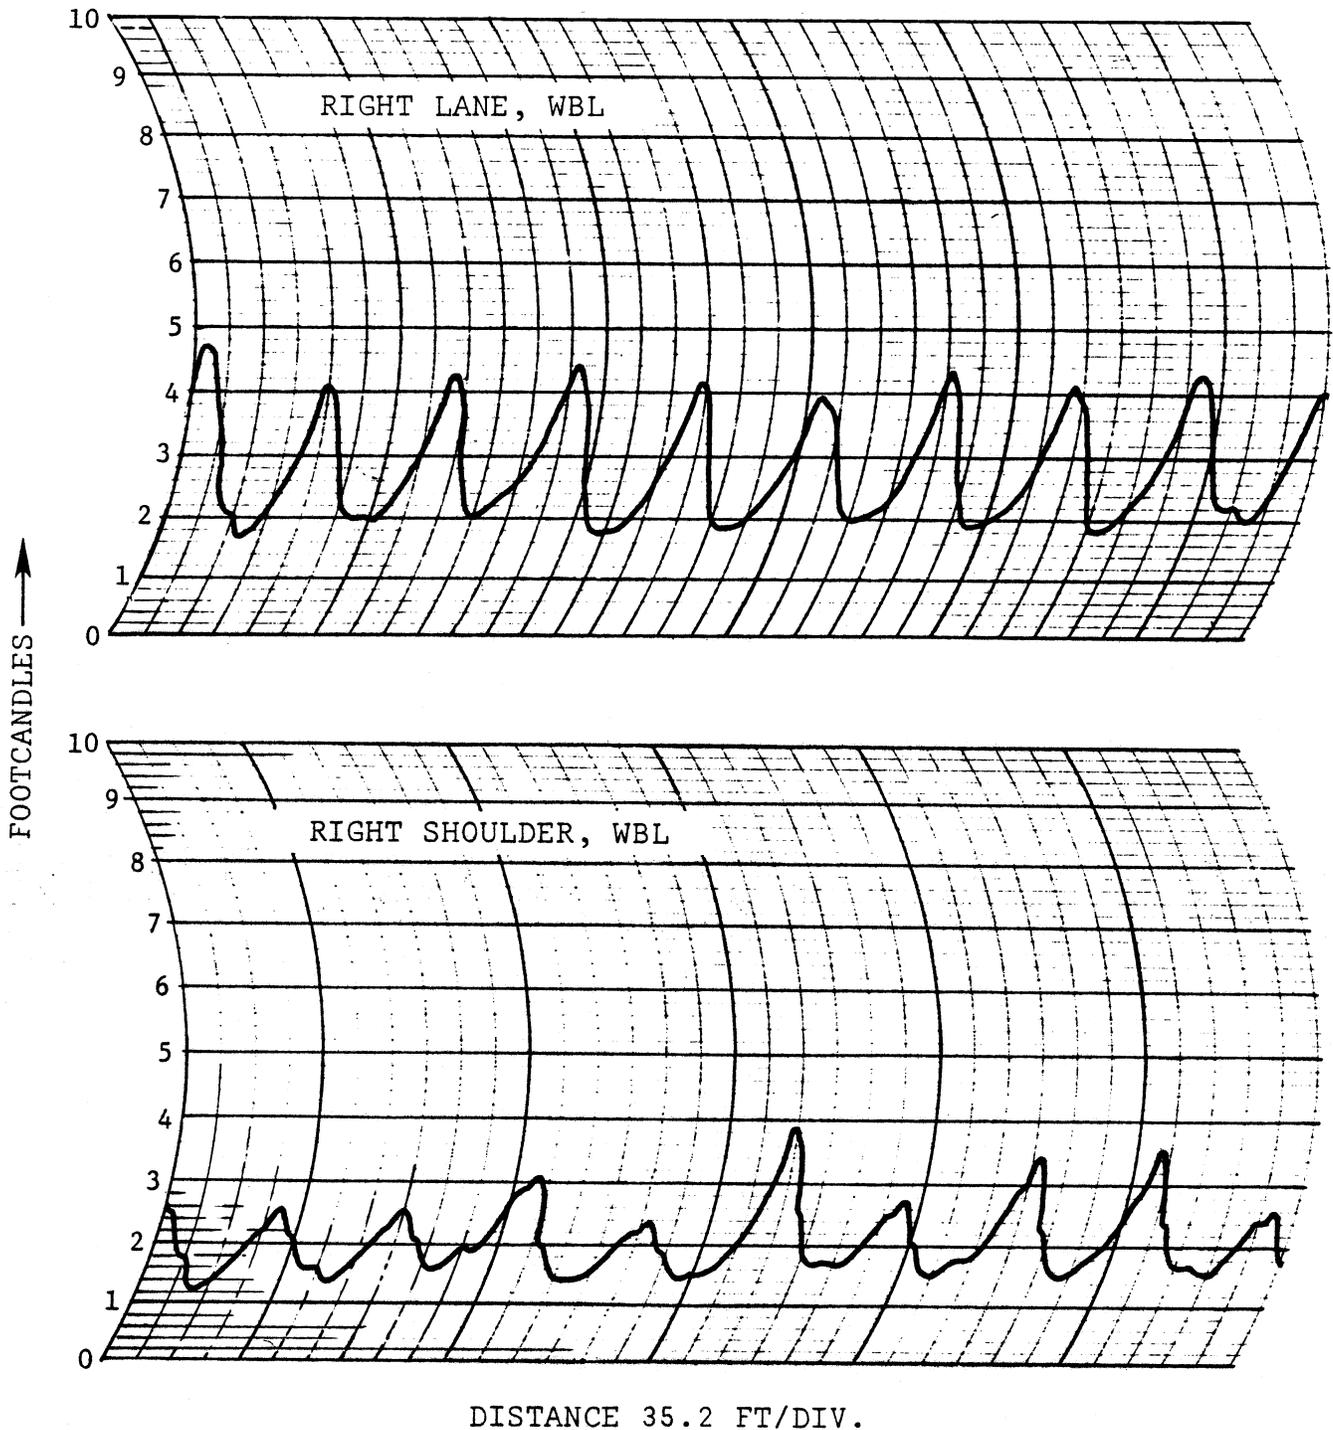
Figure 4. Typical illumination levels on the right lane and right shoulder of the WBL of Rte. I-64. (Study section 1, 1st data run.)

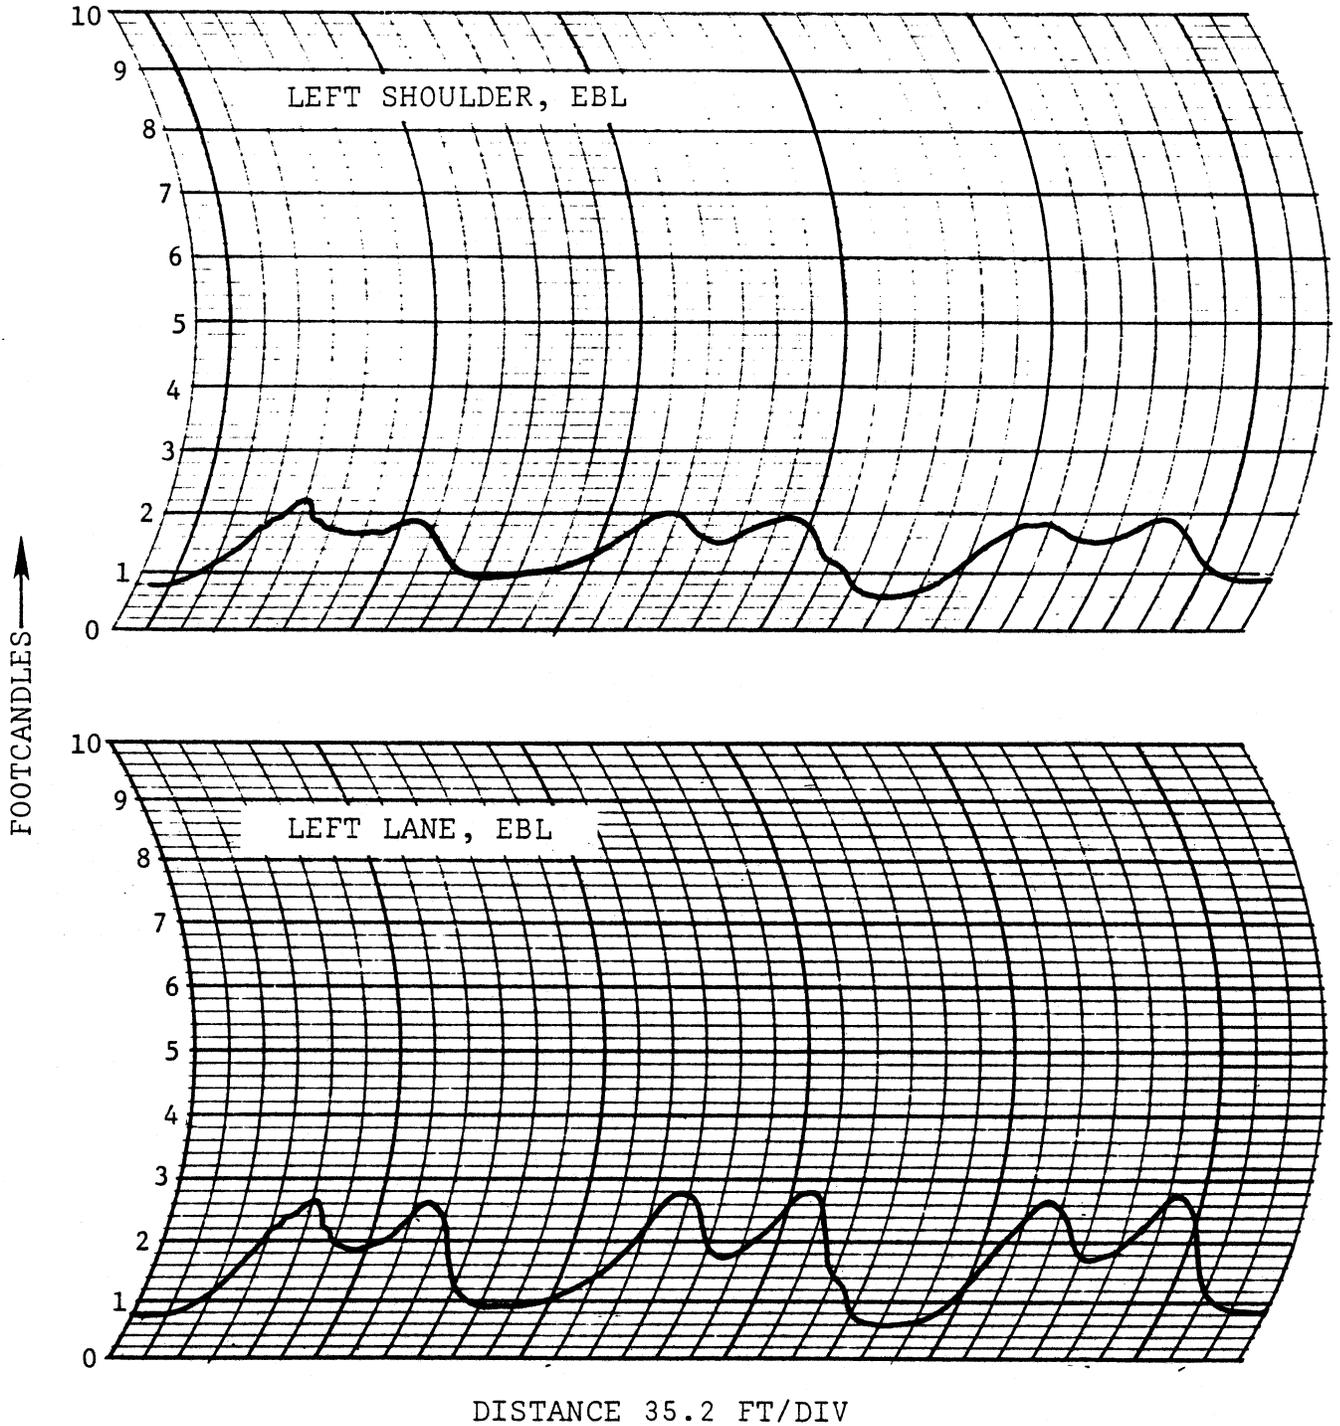
Figure 5. Illumination levels with every third light turned out on the EBL. (Study section 1, 1st data run.)

The uniformity ratios reported in Table 1 are also within the recommended standard of 3:1 for freeways. While the initial ratios for the WBL were quite low at 1.67:1 overall and 1.42:1 for the driving lanes only, those on the EBL were respectively 2.85:1 and 2.95:1. The uniformity ratio on the EBL was 71% higher than that on the WBL. Thus, although the lighting was reduced on the EBL, the initial data (taken shortly after the lighting was first activated) indicated that the average lighting levels and uniformity were still acceptable at that time.

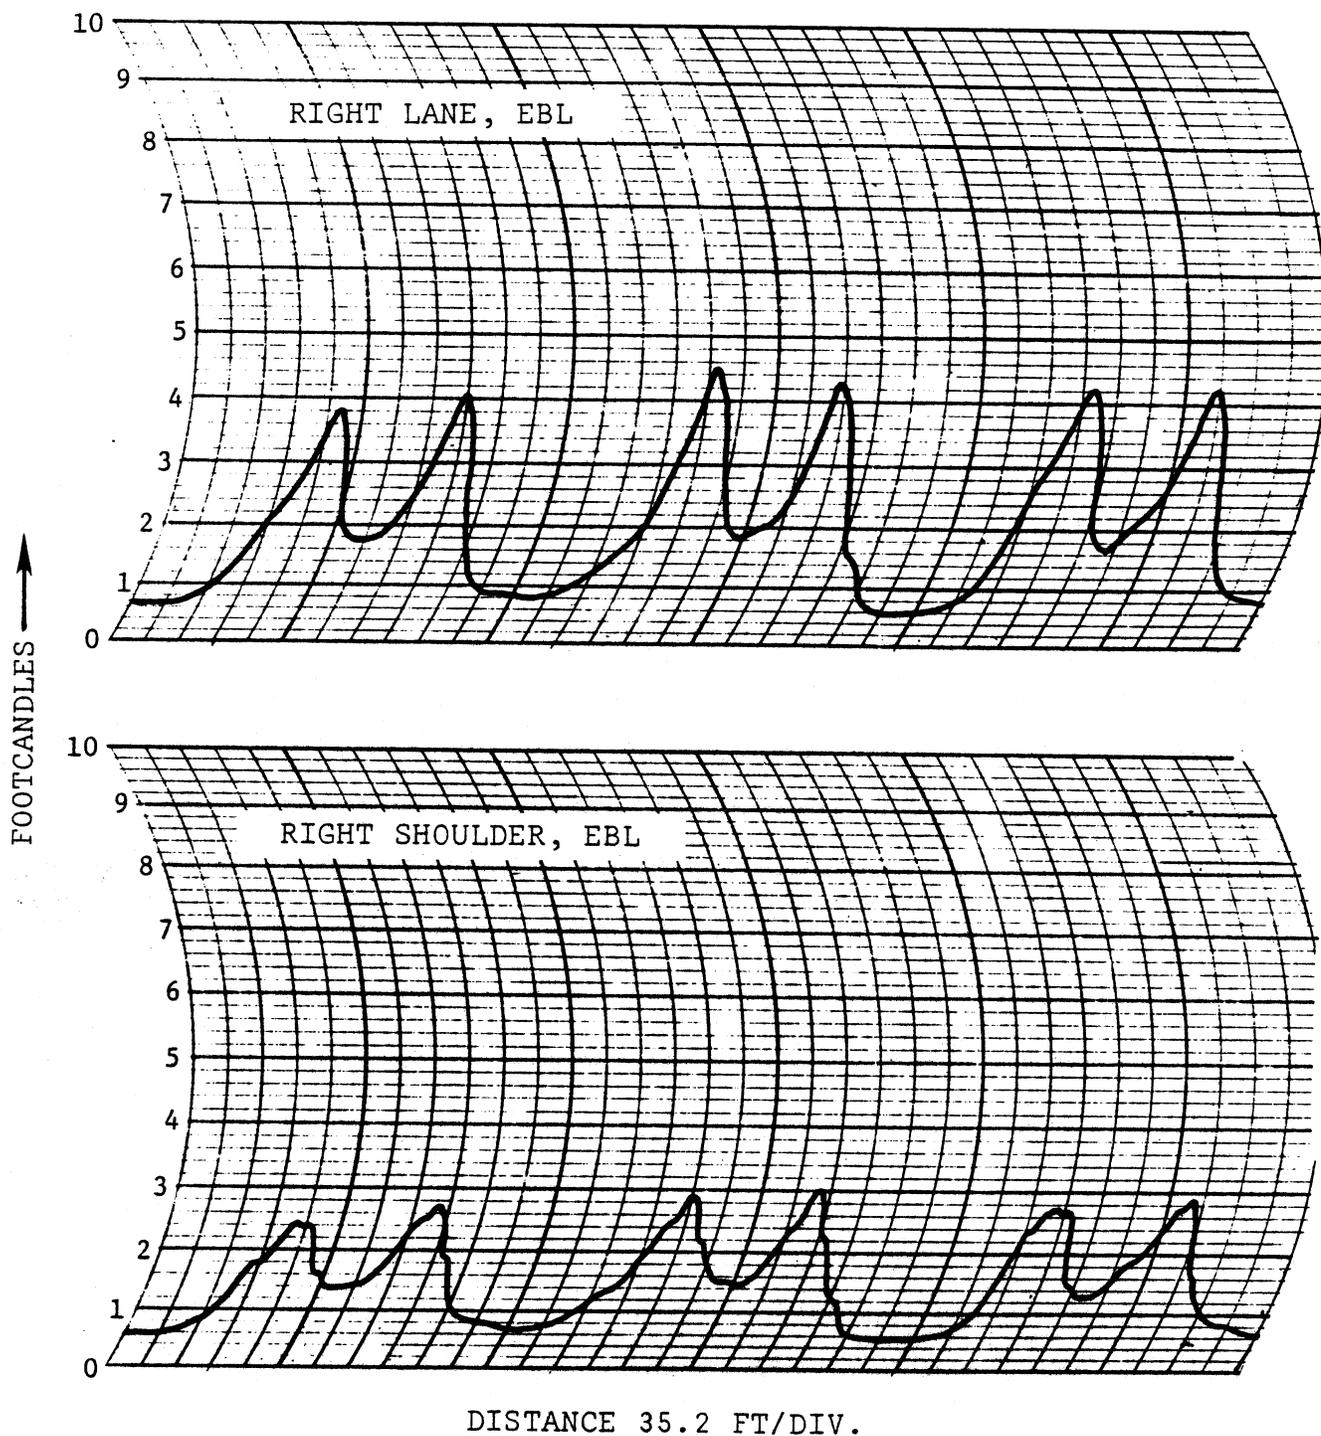
Figure 6. Illumination levels with every third light turned out on the EBL. (Study section 1, 1st data run.)

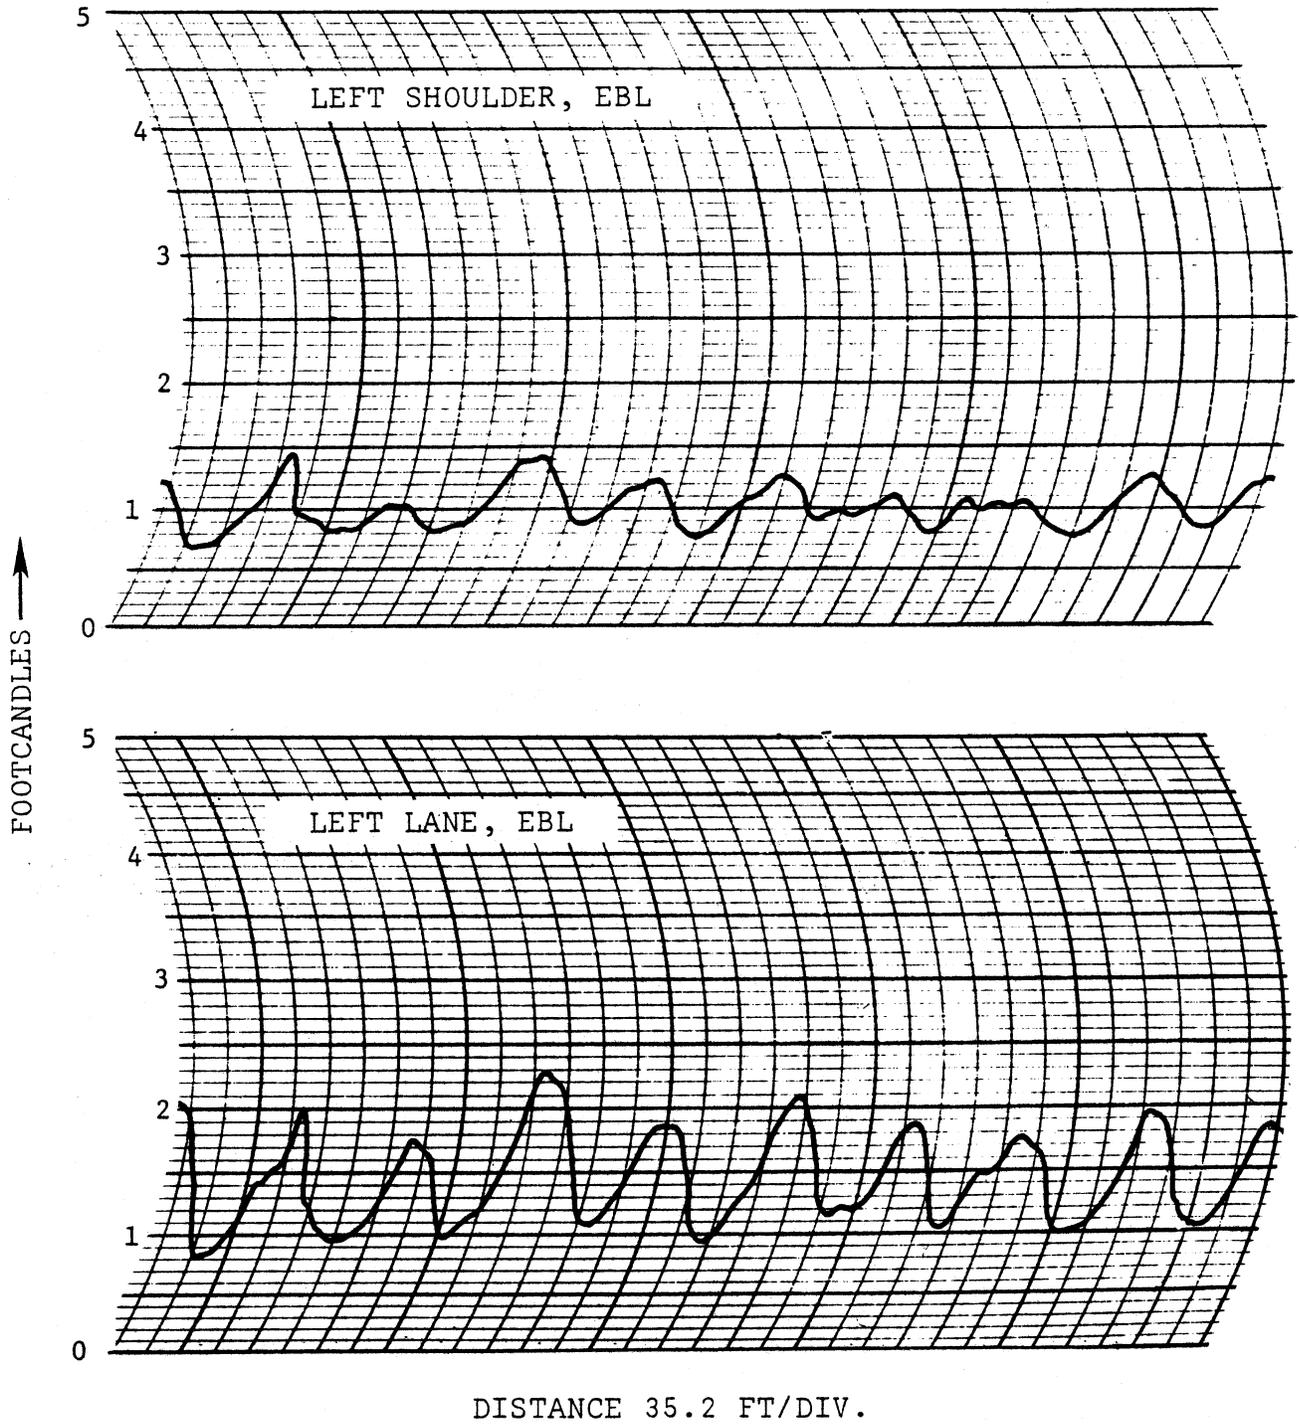
Figure 7. Typical illumination levels on the left shoulder and left lane of the EBL of Rte. I-64. (Study section 1, 2nd data run.)

The uniformity of the illumination would not be acceptable, however, if the increased ratio of 71% were experienced as it was in the first tests when one-third of the lighting was turned off. If the overall uniformity ratio of 2.72:1 (Table 2) were increased by 71%, a ratio of 4.65:1 would result, which would exceed the 3.0:1 maximum recommended. Considering only the driving lanes, the uniformity would be increased to 3.51:1 if the same assumption were applied.

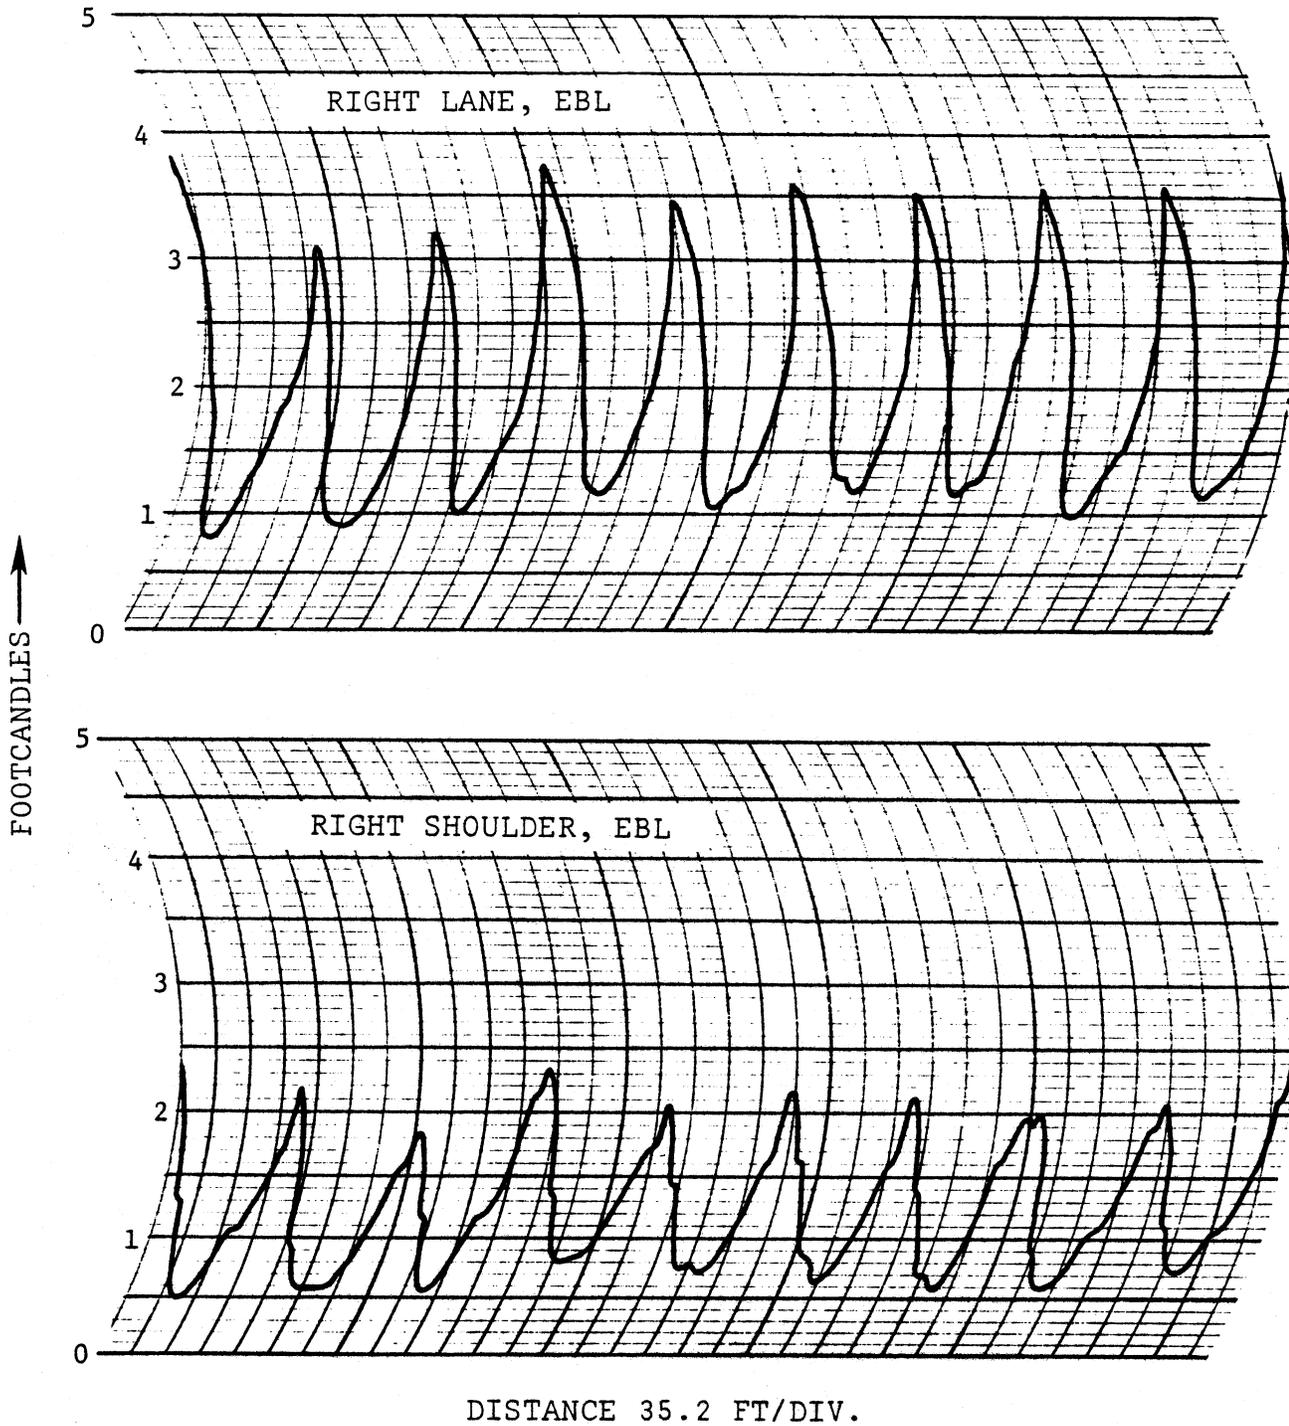
Figure 8. Typical illumination levels on the right lane and right shoulder of the EBL of Rte. I-64. (Study section 1, 2nd data run.)

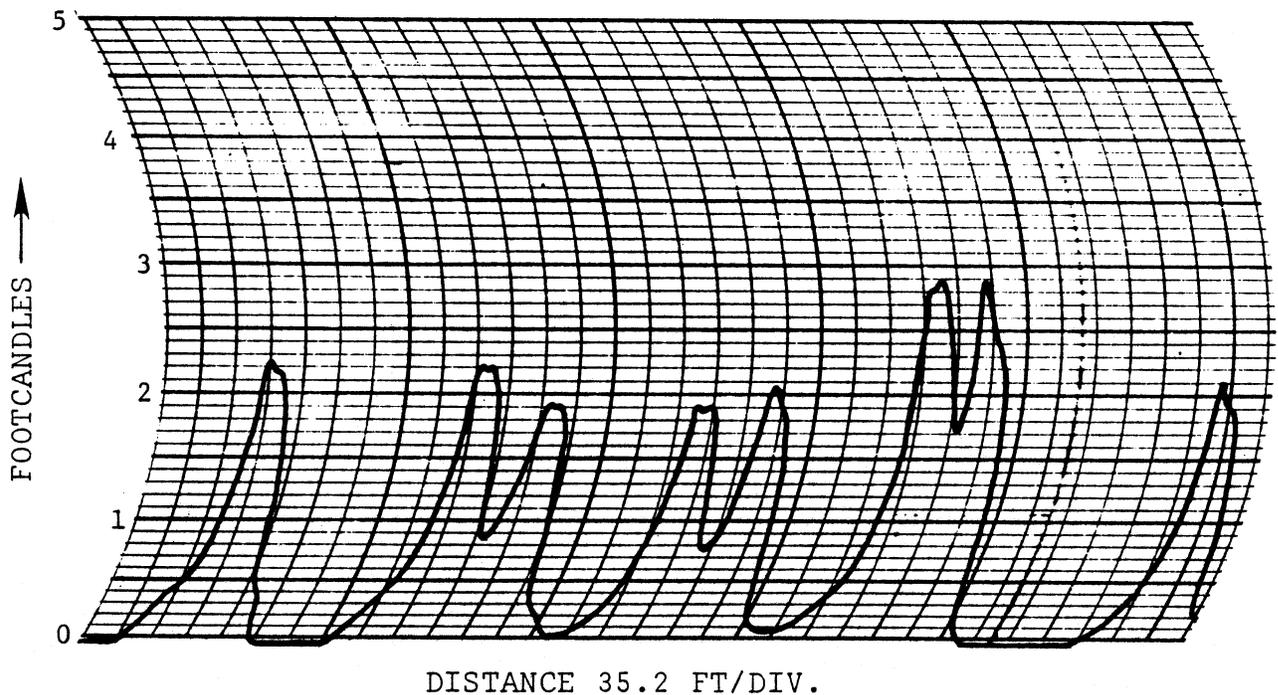
The second set of data were collected on study section 2 at the same time as those for section 1. In this case, however, the lighting was reduced on study section 2 during the second data run. The data chart shown in Figure 10 reveals that six of the fourteen lights that were on in the first tests were off during the second tests. As can be seen from Figure 10, considerable depreciation had occurred as indicated by the lower peak values. Also, the levels of illumination in the areas where the lights were out were, for the most part, nil. The total average level of illumination was less than one-third of the initial levels at 0.60 fc, and the uniformity ratio was extremely high, since the lowest level of illumination in the area was for all practical purposes zero.

Figure 10. Illumination levels down the center of the International Terminal Blvd. ramp with approximately 40% of the lights out. (Study section 2, 2nd data run.)

4. Reducing the lighting levels on the loop ramp (study section 2) by turning out 43% of the lights resulted in a borderline condition for the average maintained levels of illumination. The minimum standard of 0.6 fc would likely be violated as the lamp lumen and dirt depreciation factors further affect the output of the luminaires. The uniformity ratio under this reduced lighting condition was also extremely high and would not meet the quality standard.

Reducing the illumination levels on new lighting systems (or on systems that have been relamped and the lamp housing cleaned) by turning out approximately one-third of the lighting might be acceptable for a short period of time — probably not more than 6 months after activation. The standards for quality and quantity of illumination might not be violated in many situations until such time as the initial over design for lamp lumen and dirt depreciation ceases to compensate for the initial reduction. This approach could be used to reduce energy consumption in the operation of roadway lighting systems similar to that evaluated in the tests conducted in this study. The effects of reducing the lighting on loop ramps by turning out some of the lights will be harder to predict because of the geometric conditions involved.
