FINAL REPORT

**TRIAL APPLICATION OF ELECTROCHEMICAL CHLORIDE EXTRACTION
ON CONCRETE BRIDGE COMPONENTS IN VIRGINIA**

VTRC 00-R18
April 2000

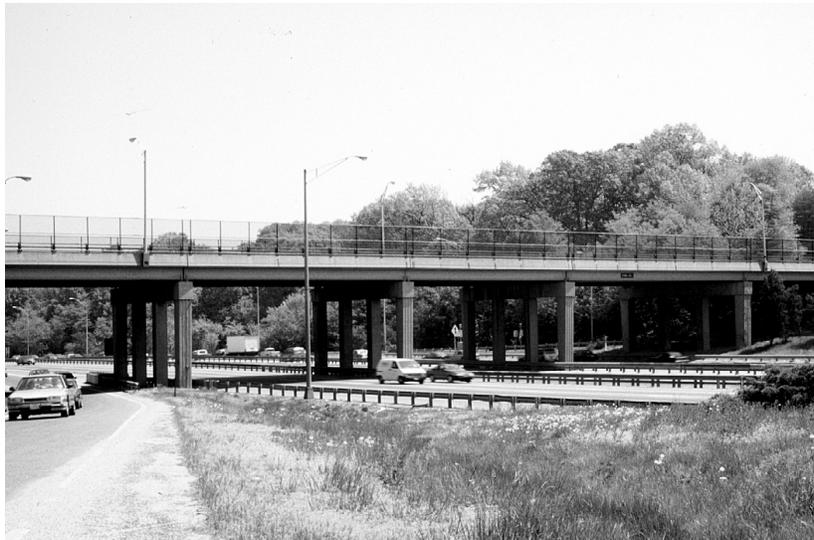
Figure 1. 34th Street Bridge Over I-395 in Arlington

The selected bridge deck, approximately 28 years old at the time of the treatment, is on the 34th Street Bridge over I-395 in Arlington (Figure 1). The reinforced concrete deck is 109 m long and 17 m wide with a curb-to-curb width of 14 m. The deck consists of five simple spans supported by steel beams. A previous inspection of the deck indicated that 2 to 29 percent of the concrete in each span was delaminated because of rebar corrosion. Two spans (4 and 5) were selected for treatment. The spans had delaminations and spalls in 2 to 5 percent of the concrete.

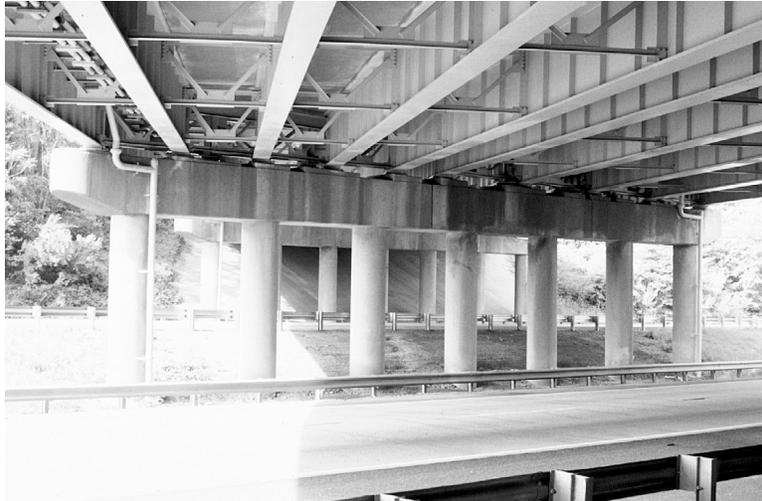
Figure 2. Concrete Piers of 5th Street Bridge Over I-64 in Albemarle County

The selected concrete piers, which were 27 years old at the time of the treatment, support the southbound lanes of 5th Street (Rt. 631) over I-64 in Charlottesville (Figure 2). The piers

have rectangular pier caps and cylindrical columns. The cross sections of the pier caps are 1.3 m by 1.5 m, and the lengths vary from 13.9 to 16.1 m. The columns have a diameter of 1.1 m and heights (above ground) ranging from 5.6 to 6.5 m. Approximately 4 years before the study, delaminated and spalled concrete (with exposed rebars), mostly in the bottoms of the pier caps and the tops of columns, was repaired. During preparation for the ECE treatment, 1.6 m² of delaminated concrete, mostly at the bottoms of caps and tops of columns, was detected and repaired.

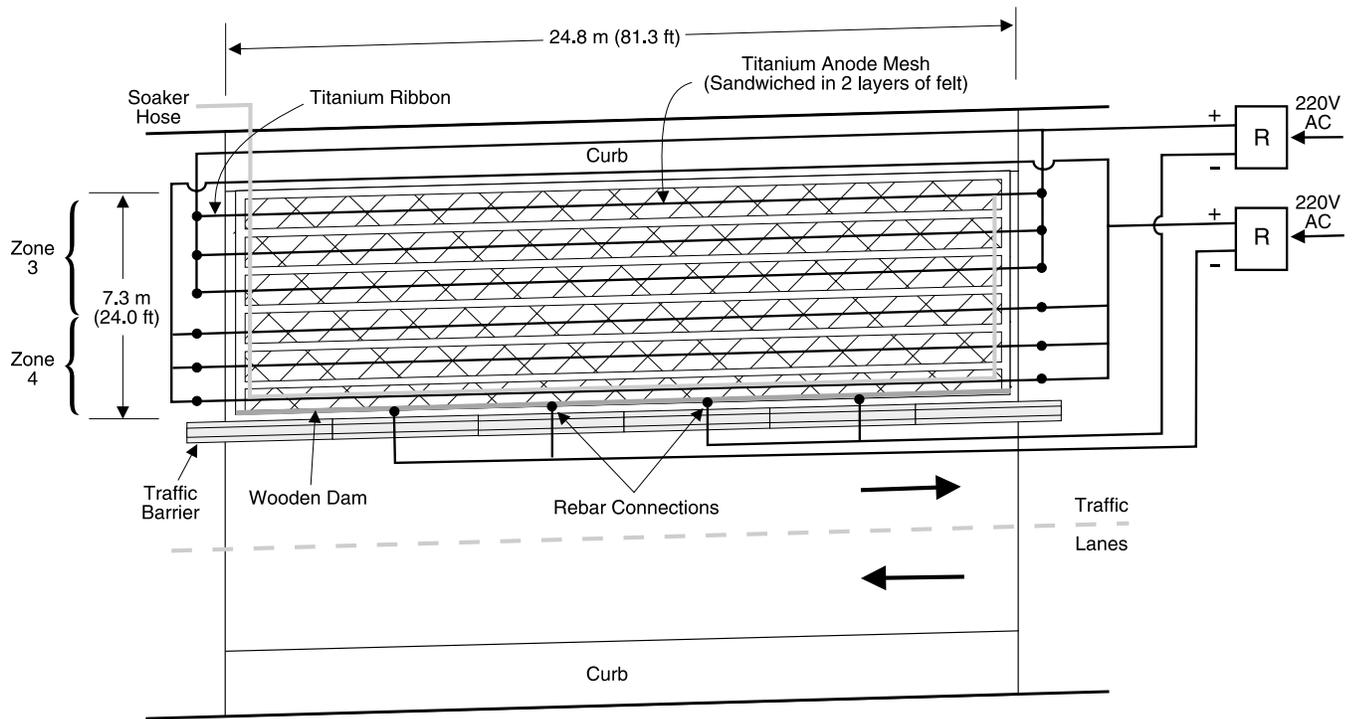
Figure 4. Layout of Setup Used for ECE Treatment of Northern Half of Span 5

1. *Connect an insulated copper lead wire of adequate gage (No. 6 AWG) to each of the four designated ground connections in each span.* As illustrated in Figure 4, these connections were located close to the centerline of each span so that the same connections could be used during treatment of to the remaining half of the span. Each connection was waterproofed with epoxy.

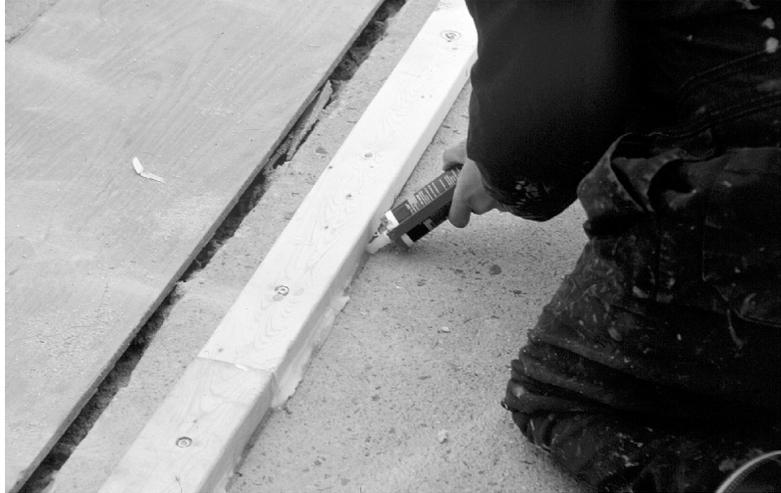
Figure 5. Installation of Ponding Dam with Wood Strips and Silicone Caulk

2. *Construct a wooden dam around the area to be treated, stopping within 8 cm of the joints. This was accomplished by securing wood strips, 5 cm x 10 cm x 365 cm, around the perimeter of the area with anchor bolts and applying enough silicone caulk underneath and all around the base of the wood strips to seal the edges (Figure 5).*
3. *Place the first layer of 6-mm-thick synthetic felt over the entire area within the dam (Figure 6). The 1.8-m-wide felt was placed longitudinally on each span, from end to*

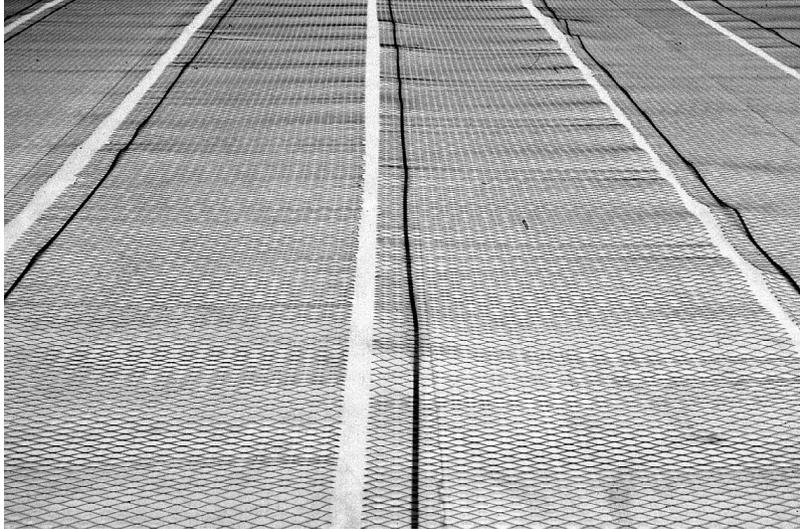
Figure 7. Strips of Catalyzed Titanium Mesh Placed Over First Layer of Felt

- end, before being cut to the length of the span. Adjacent pieces were allowed to overlap by 2 to 5 cm.
4. *Place a layer of titanium-mesh anode (Elgard 210) over the felt. (Any equivalent titanium anode mesh will suffice.) Similarly, place the 1.2-m-wide anode mesh longitudinally over each span, and then cut it to the length of the span. Five full-width strips and one half-width strip of the mesh were required to cover the entire 7.3-m width of each treatment area (Figure 4). The gap between adjacent strips was kept at less than 11 cm. .*
 5. *Perform electric-resistance welding of a continuous piece of 1.2-cm-wide titanium ribbon every 0.6 to 0.9 m to each strip of anode mesh (Figure 7). Each ribbon was*

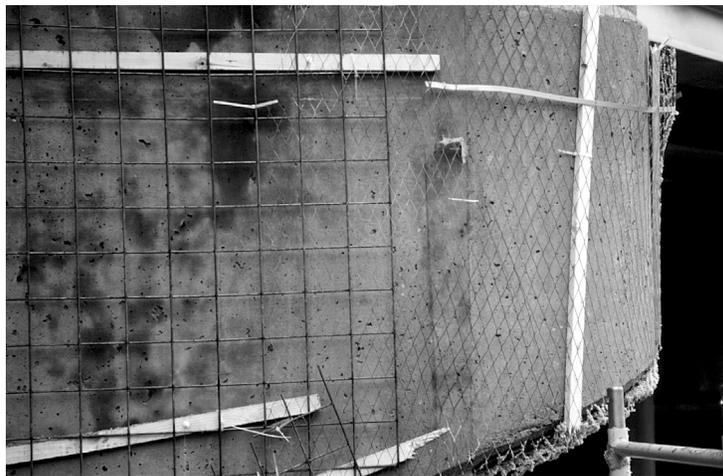
Figure 9. Steel Mesh and Titanium Mesh Secured Over Straight Section and Curved End, Respectively, of Pier Cap

3. *Install the mesh anode over the wooden spacers on the pier caps, taking care not to damage the lead wires from the ground connections. Two types of mesh, titanium and 6-mm-thick steel, were used as anodes. Because the titanium mesh is more pliable than the steel mesh, it was used over the curved concrete surfaces at the rounded end of each pier cap. The same titanium mesh used on the deck spans was securely tied with plastic cable ties to the wooden spacers anchored on the concrete. Each plastic cable tie was run underneath a wooden spacer and over the mesh. For the straight section of the caps, preformed sections of the steel mesh, which had 10-cm grids, were hoisted up to the cap, wrapped around it, and tied to the cap with the plastic cable ties (Figure 9).*

Both titanium mesh and steel mesh appeared to be suitable for use as anodes in ECE treatments. Since steel mesh is considerably more active than titanium mesh, it was expected to undergo significant mass loss during a treatment such that it would be usable only once. Examination of the steel mesh after the treatment of the piers did not show that the expected corrosion on the mesh led to any discernible loss of cross section. However, as anticipated, the steel mesh left rust stains on the concrete surface after treatment, which were removed easily by washing with a strong water jet.

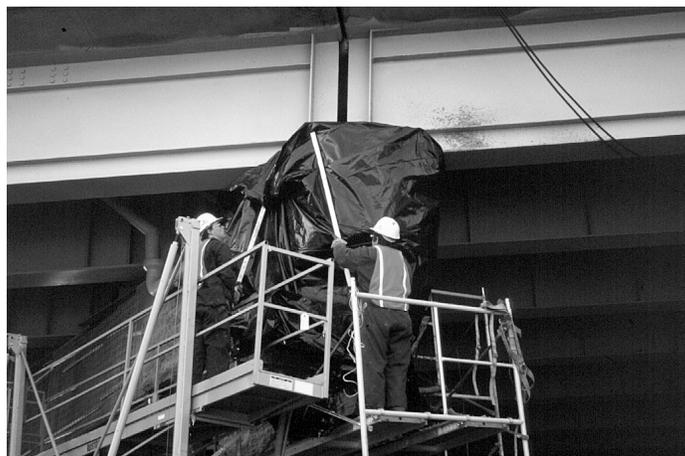
Figure 11. Wrapping of Fiber-Encapsulated Pier Cap with Heavy Plastic Sheet to Keep Cellulose Fibers in Place and Wet During treatment

overlapping of the plastic between turns. The plastic sheets were then secured by banding the caps with reinforced plastic straps.

Another problem with the treatment system for the piers was sagging of the black plastic wrapping around some sections of some pier caps. The sagging resulted from an accumulation of rainwater inside the plastic, particularly near the west end of the pier caps where there was no sheltering deck overhang. Since the layer of cellulose fibers can become detached from the concrete surface if it becomes too wet and heavy, the sagging caused concern. Again, because the plastic wrapping was not transparent, it was impossible to determine the extent to which the cellulose fibers had detached from those sections of the pier caps and to apply corrective measures if necessary.

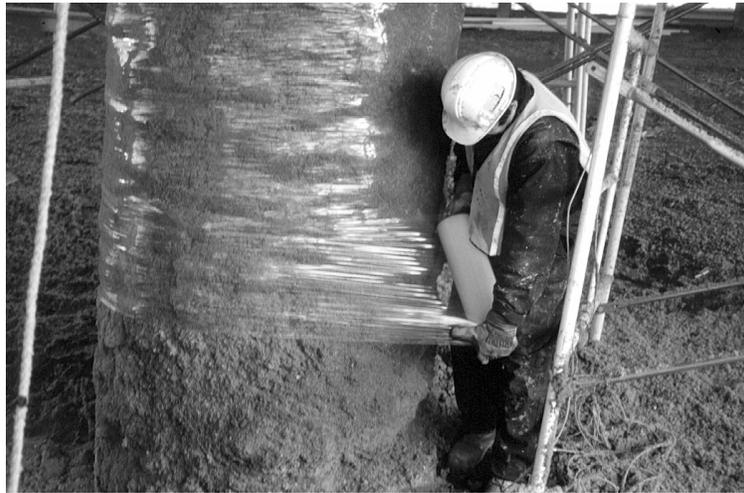
Figure 12. Wrapping of Fiber-Encapsulated Pier Column, From Top to Bottom, with Self-Clinging Transparent Plastic Film

8. *Connect the titanium ribbon welded to the titanium mesh on each column to an anode lead wire for later connection to the rectifier.*
9. *Immediately wrap each column tightly, from top to bottom, with a continuous piece of plastic film, such as Shrink Wrap, allowing for considerable overlapping between turns (Figure 12). Figure 13 shows an entire pier completely wrapped.*

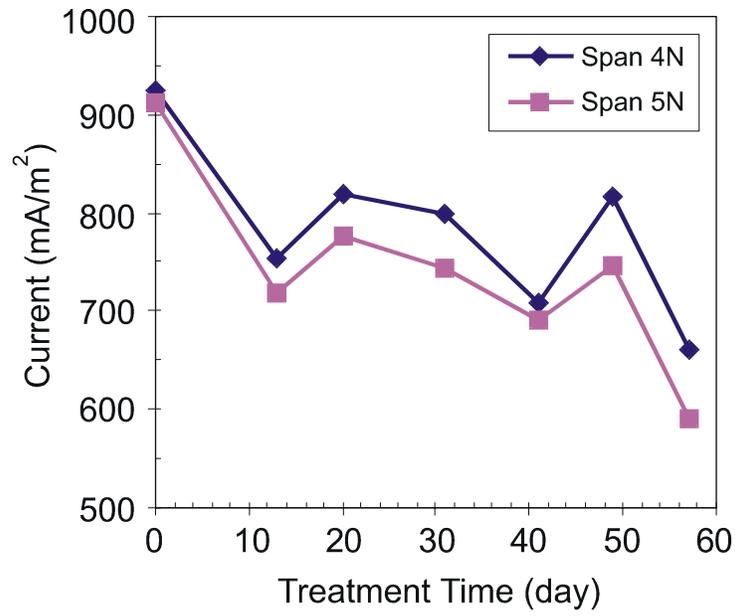
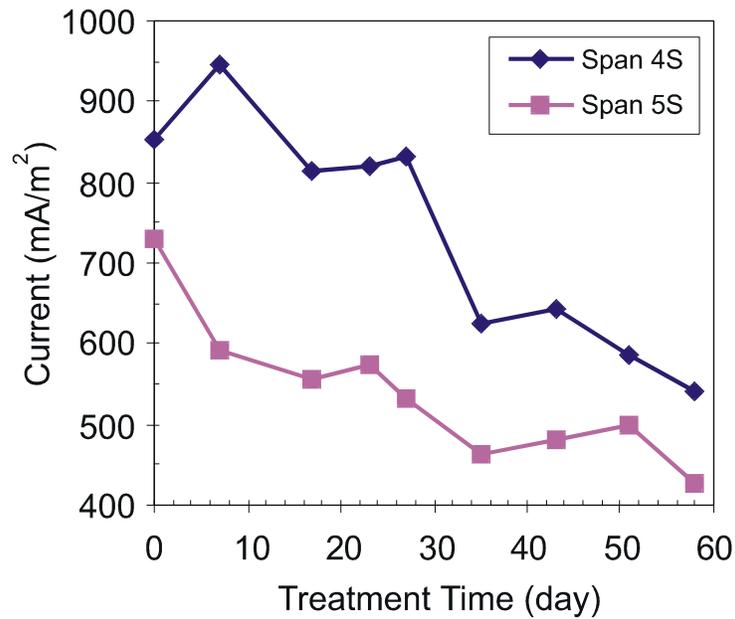
Figure 14. Treatment Currents for (a) Northern and (b) Southern Halves of Deck Spans

Figure 14 shows the current density passing through each deck area during treatment. As illustrated, except for occasional rises corresponding to increases in the driving voltage, the current generally decreased as the treatment progressed. This decreasing trend, which was expected in a constant-voltage mode of operation and is typically observed in CP systems operated in the same mode, resulted from an increasing trend in the effective circuit resistance of the treated areas (Figure 15). The increase in the resistance of any area during treatment is the net result of the electromigration of different ions of different charges into and out of the concrete and other auxiliary processes, such as crystallization of minerals in the pores of the concrete.

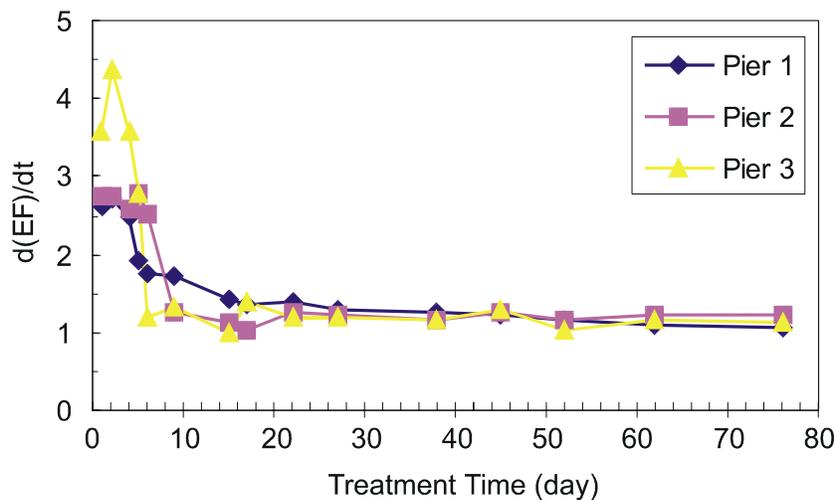
Figure 19. Increase in Accumulated Fractional Charge, as a Function of an Increase in Treatment Time

As noted earlier, it would be beneficial during the planning stage of a bridge rehabilitation project to be able to estimate how long a bridge needs to be treated so that lane closure can be minimized and the project can be scheduled efficiently, perhaps resulting in lower costs. Examination of the data on the amount of total charges passed through the three piers at different stages of treatment (Figure 18) offers a clue. When the derivative of the cumulative fractional charge is plotted against the treatment time, as in Figure 19, it shows that, for these piers, the gain in charge by extending the treatment diminishes significantly after 21 to 28 days of treatment. Since the amount of chloride removed at each stage is a fraction of the accumulated charge, as dictated by its transference number, this implies that the additional amount of chloride that will be removed becomes insignificant after approximately 21 to 28 days, which may be considered the “practical” treatment time for these piers. For a deck, being able to end the treatment after 21 to 28 days instead of at 56 days might mean considerably less interruption to traffic.
