FINAL REPORT
EVALUATION OF VIRGINIA'S FIRST HEATED BRIDGE

Edward J. Hoppe, Ph.D., P.E.
Senior Research Scientist

December 2000
VTRC 01-R8

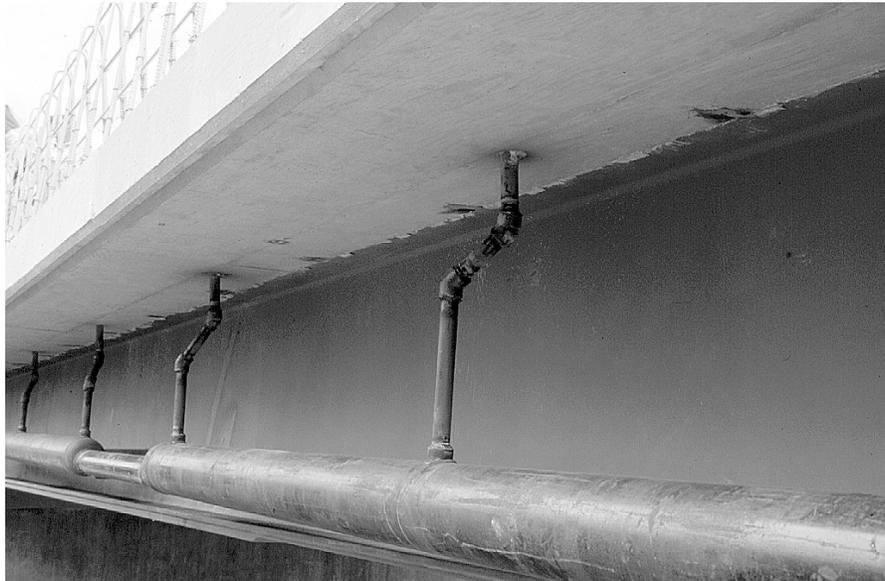
Figure 4. View of Evaporators and Risers

The evaporator consists of a pipe with an inner diameter of 152 mm (6 in) containing working fluid and is coupled with vertical risers, as shown in Figure 4. A pipe with an inner diameter of 89 mm (3½ in) carrying a 50% glycol solution runs longitudinally through the center of the evaporator. The smaller pipe forms a closed loop, supplying heat generated by a propane-fired boiler (Teledyne Laars, Mighty Term; 1,478,250 BTU/h output). A hydraulic pump is used to circulate water/glycol mixture in the primary supply loop. As heat is transferred to the working fluid in the evaporator, the mixture is returned to the boiler for reheating. The circulating water/glycol temperature was set at 88 °C (190 °F).

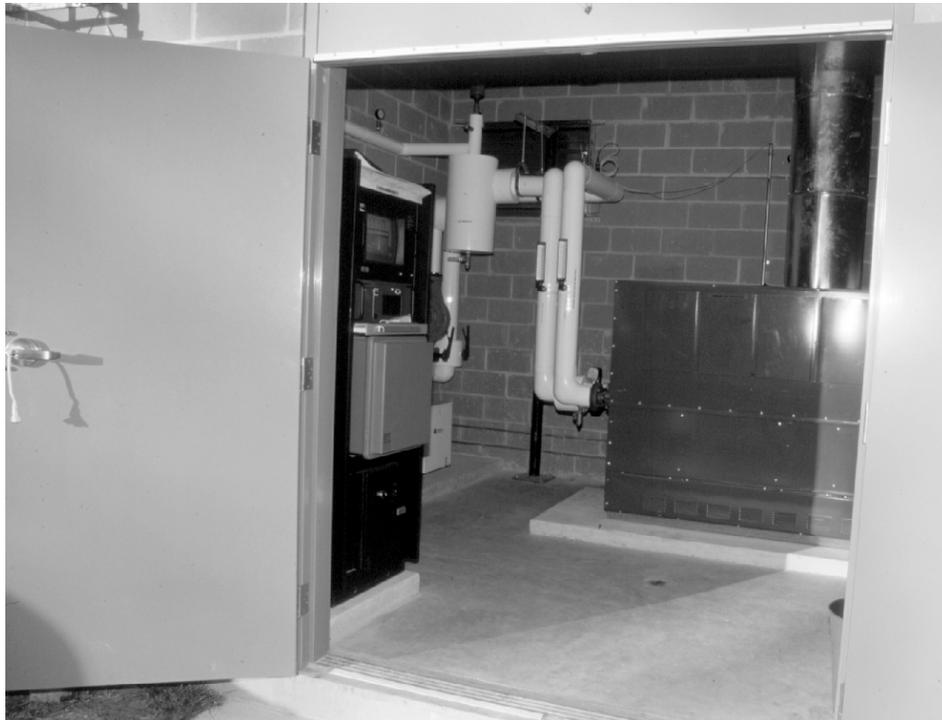
Figure 5. View of Control Computer, Boiler, and Piping

The heating system is programmed to shut off when the deck sensor reports a temperature above 4.4 °C (40 °F) or a clear surface (no ice/moisture) for more than 10 minutes. The control system was installed in a nearby building, together with the boiler and hydraulic pump. Figure 5 shows the control computer and the propane-fired boiler.

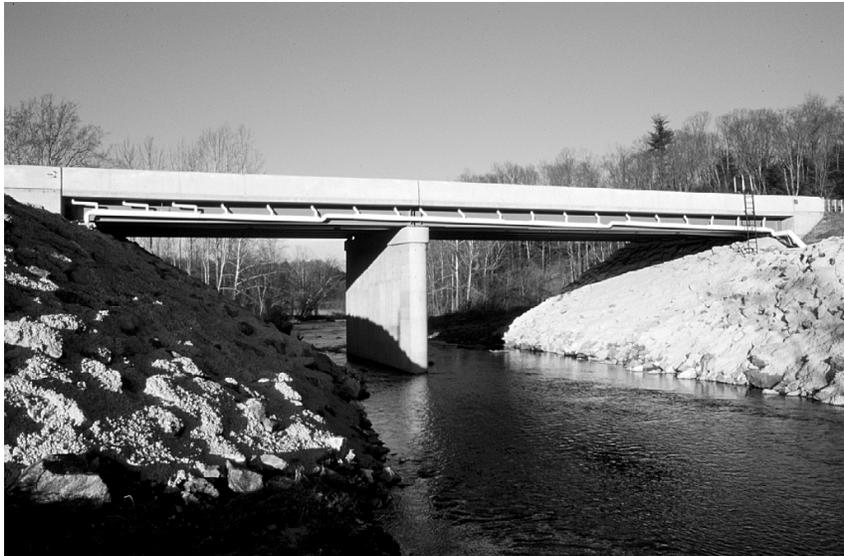
Figure 10. Elevation View of Heated Bridge

Construction of the new bridge commenced in spring 1995. The heating system was installed under the supervision of SETA Technology. No significant problems were reported. One minor delay occurred when reinforcement of the parapet was completed prior to placement of the condenser manifold, necessitating extra work to ensure a proper fit. VTRC personnel installed the monitoring system simultaneously. The project was completed in November 1996. Figure 10 shows the elevation view of the completed bridge.

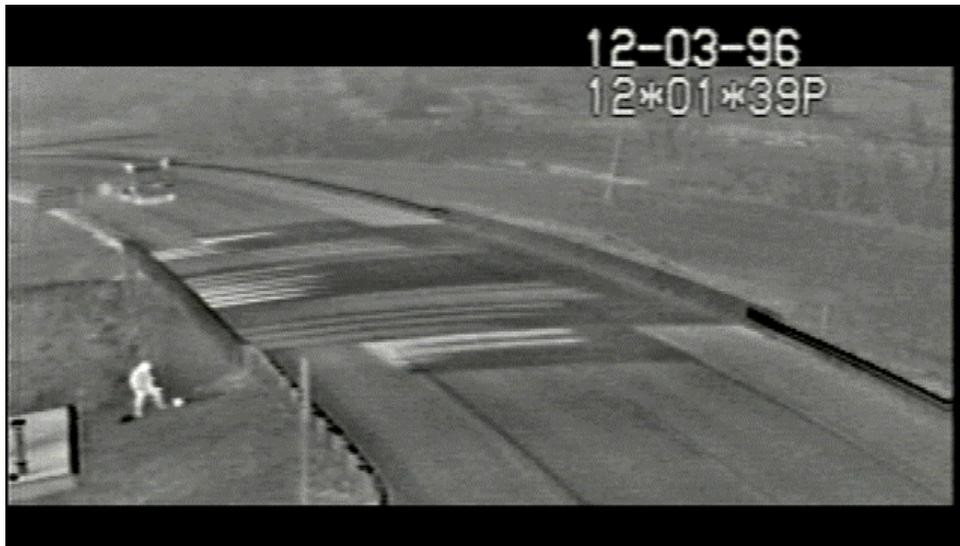
Figure 11. Infrared View of Bridge After Construction

The initial operation of the heating system revealed an uneven distribution of heat at the deck surface. Figure 11 shows an infrared scan of the bridge during a test conducted on

December 3, 1996. Light areas indicate “hot” locations. It became evident that heat was not being transferred uniformly across the deck, as indicated by inconsistent shading.

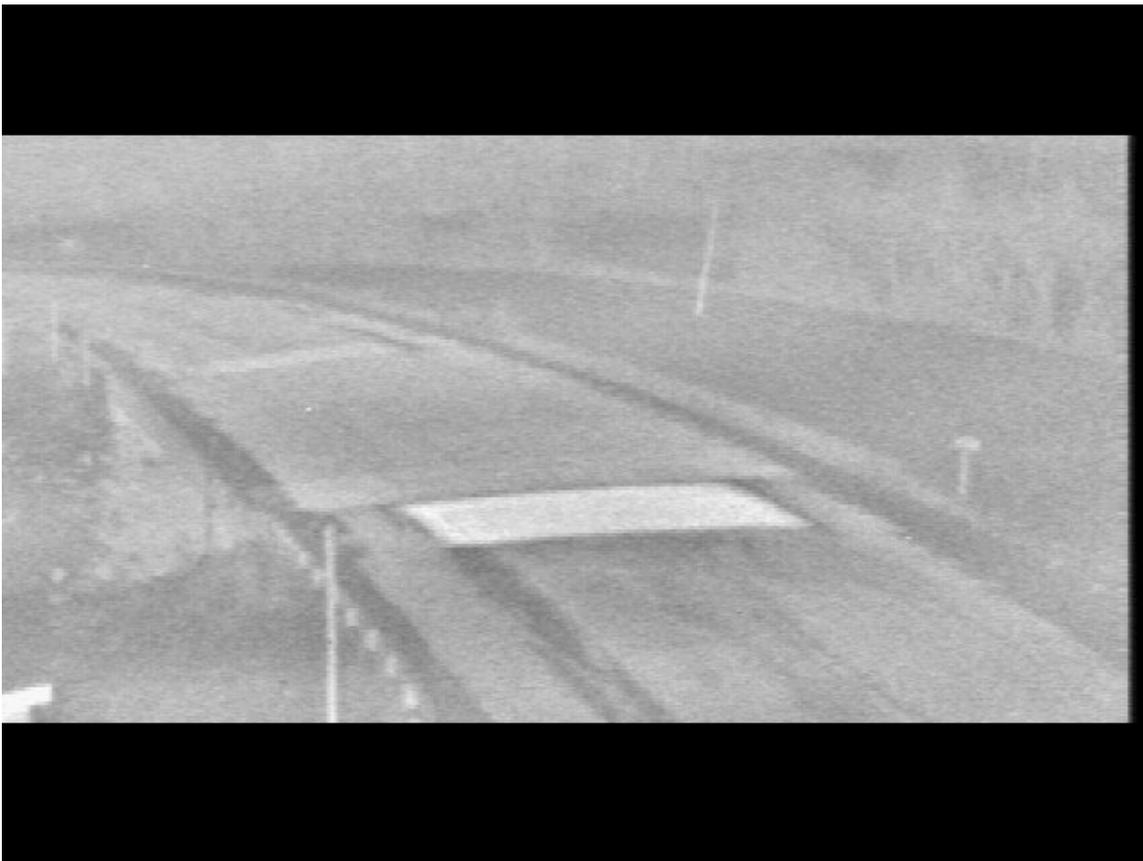
Figure 12. Infrared View on January 20, 2000, at 9:10 A.M.

Figure 12 shows the infrared scan of the bridge during a storm event on January 20, 2000. A bright area in the foreground represents approach slab A, where the surface condition sensor that controls the operation of the heating system was installed. Heat pipe evaporators were located under the “left” parapet. Sensor data from January 19 through 21, 2000, are presented in

the Appendix. These data illustrate the winter performance of the heat pipe system following the ammonia conversion. Near-surface temperature probe readings (probes 1 through 20) indicated a relatively uniform distribution of heat across the deck. The ice condition data (Ice/No Ice) shown in the Appendix originated from the Aanderra ice detector, mounted on span A, on a shoulder adjacent to the left parapet.
