**FINAL REPORT**

**TESTING OF SELECTED METALLIC REINFORCING BARS FOR EXTENDING  
THE SERVICE LIFE OF FUTURE CONCRETE BRIDGES:  
TESTING IN OUTDOOR CONCRETE BLOCKS**

**Gerardo G. Clemeña, Ph.D.**  
**Research Scientist**  
**Virginia Transportation Research Council**

December 2002  
VTRC 03-R6

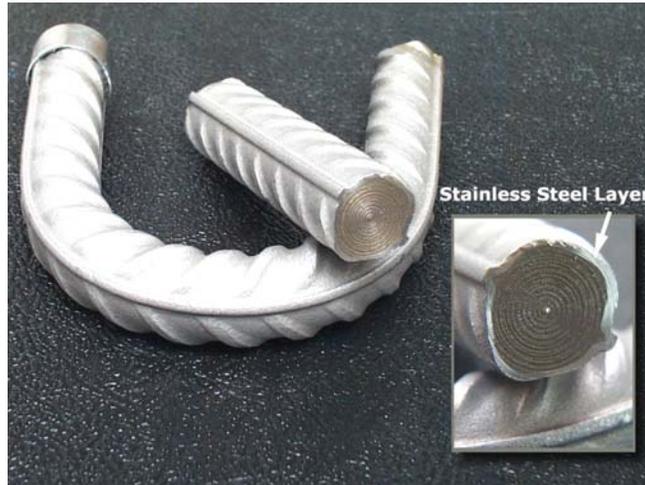
**Figure 1. Stainless Steel–Clad Bars Obtained From Stelax UK Limited, West Glamorgan, U.K.**

In addition to a stainless steel-clad carbon steel bar (Figure 1), bars made of the following materials were tested: (1) the widely used carbon steel (ASTM A 615M), (2) a solid AISI 316LN stainless steel, (3) a solid AISI 304 stainless steel, and (4) a duplex 2205 stainless steel. Both straight and U-bent bars of each material were used in the investigation. The clad bars from the United Kingdom had a nominal diameter of 19 mm, and the other bars had a nominal diameter of 16 mm. The average thickness of the stainless steel cladding on the clad bars was 1.08 mm, with a standard deviation of 0.23 mm. The minimum and maximum thickness was 0.44 mm and 1.43 mm, respectively. To assess the possible effects of damage in the stainless steel cladding on the carbon steel core, two holes 3 mm wide were drilled through the cladding in each of several randomly selected clad bars to expose the carbon steel core before

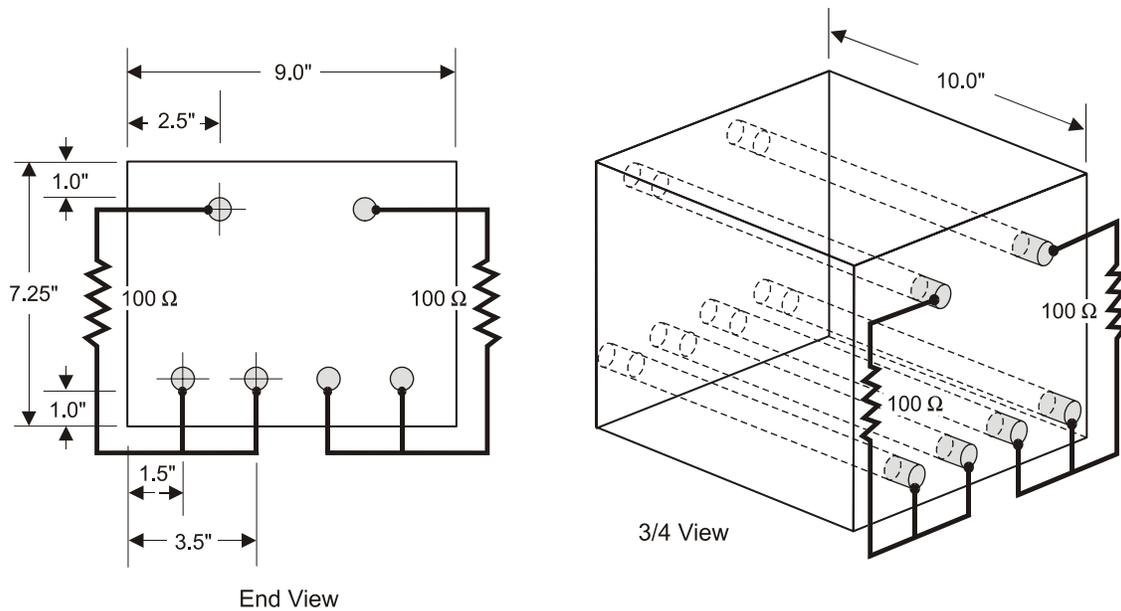
**Figure 2. Test Concrete Blocks With Straight Bars in Top Portion (1.0 in = 25.4 mm).**

The bars were embedded in concrete blocks (Figures 2 and 3) in various combinations to form the test matrix provided in Table 1. In some subsets of blocks, only the stainless steel bars or the clad bar was used in the top of the blocks and the carbon steel bars were used in the bottom. This was to reflect the situation in which a bridge deck owner decides to use such a

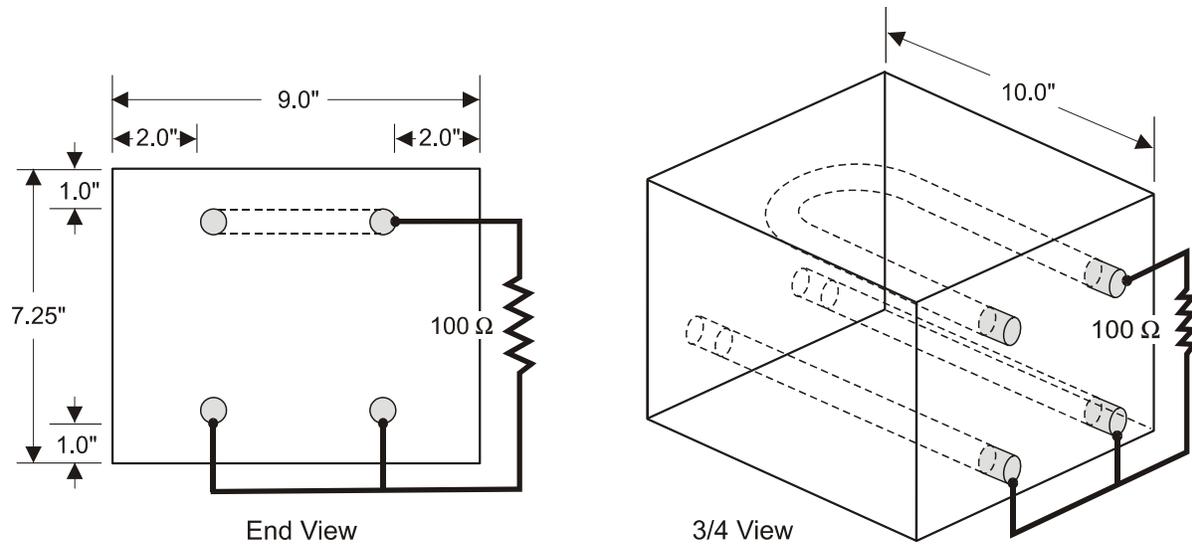
Figure 3. Test Concrete Blocks with U-bent Bars in Top Portion (1.0 in = 25.4 mm).

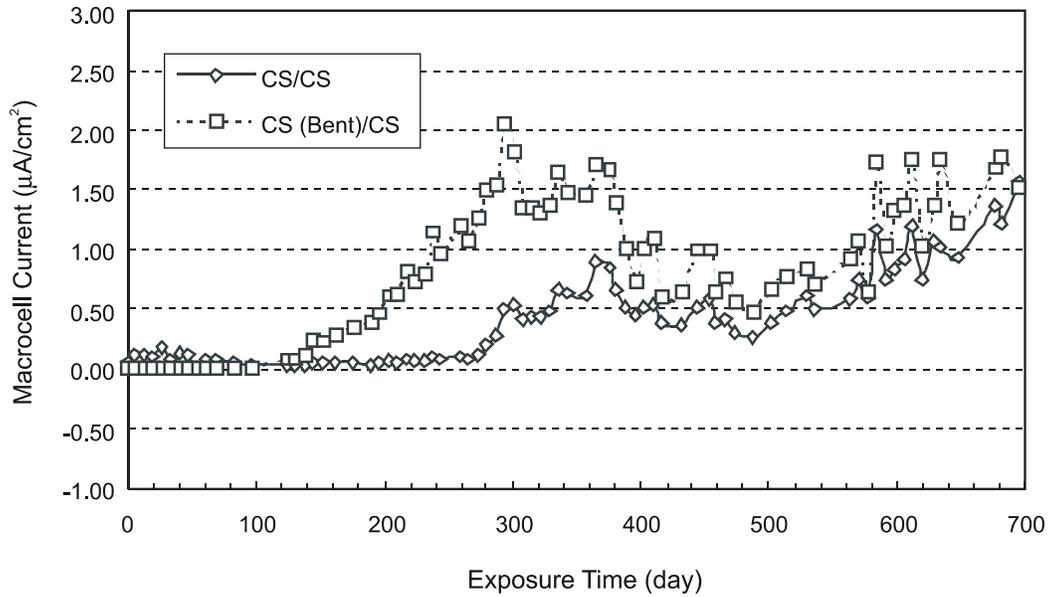
**Figure 4. Macrocell Currents of Test Concrete Blocks With Either Straight or Bent Carbon Steel Bars in Top.** The macrocell currents were normalized to the surface area of the top bars in the concrete blocks.

Figure 4 shows the mean macrocell currents of the two subsets of concrete blocks that were reinforced with carbon steel bars at the top and bottom portions, i.e., CS/CS and CS (bent)/CS, while these blocks were being subjected to weekly cycles of ponding and drying. For the CS/CS blocks, even from the very beginning of the salt-exposure regime, there was already a discernible macrocell current, which is an indication of corrosion activity. The direction of the current indicated that the top carbon steel bars were anodic to the bottom bars. The current was as much as  $0.182 \mu\text{A}/\text{cm}^2$  at day 26, followed by a brief decline through day 95. Then, after a plateau between days 95 and 120, the macrocell current began to rise steadily (with the exception of fluctuations caused by changing outdoor conditions). For the first 700 days, the average macrocell current for the entire set of concrete blocks reinforced with straight carbon steel bars at the top was  $0.414 \mu\text{A}/\text{cm}^2$  (Table 3).

Interestingly, the mean macrocell current of the CS (bent)/CS blocks, i.e., with bent carbon steel bars in the top portion, was practically indiscernible throughout the first 90 days of exposure (almost 13 exposure cycles), indicating that the top bars were initially passive. Then, the bars began to corrode, as indicated by the rapid rise in the macrocell current, at a rate that exceeded that of the blocks with the straight carbon steel bars and eventually reached a rate several times higher. The cause for this large difference in magnitudes of the macrocell currents

is uncertain; it might be attributable to an unknown difference in the surface conditions of the two groups of bars (of the same material), which perhaps resulted from bending. Noteworthy is that after approximately 400 days, the magnitude of the macrocell currents of the blocks with straight carbon steel bars had almost reached that of those with bent carbon steel bars (Figure 4).

The fluctuations in the macrocell currents for these two sets of blocks generally reflected changes in the outdoor exposure conditions (temperature and rainfall) with the seasons. Day 108 was approximately the start of winter in 2000, which was relatively mild.

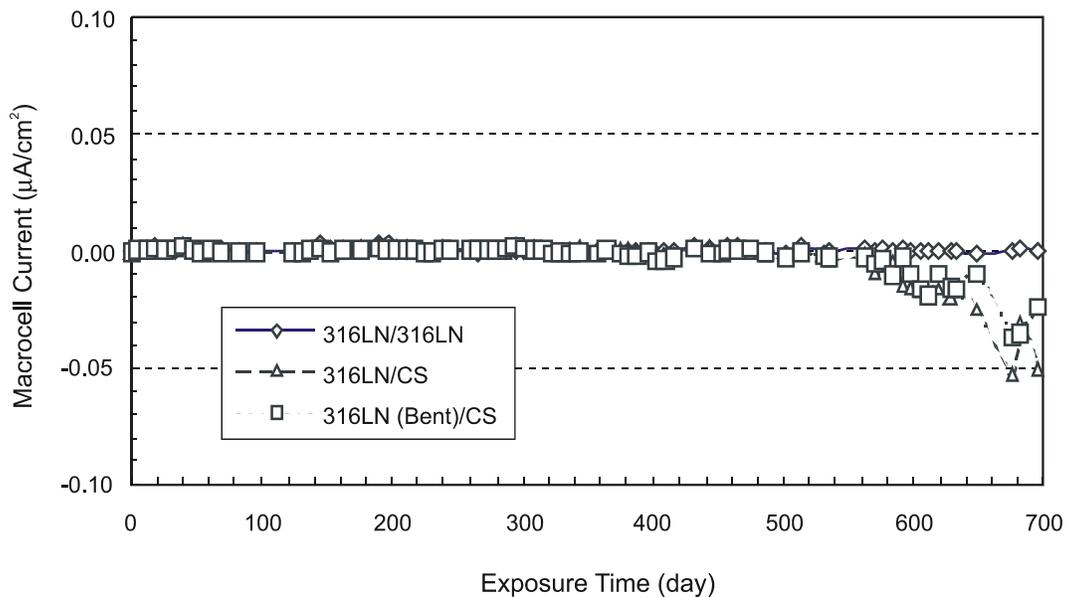
**Figure 5. Macrocell Currents of Test Concrete Blocks with 316LN Stainless Steel Bars in Various Bar Combinations.** The macrocell currents were normalized to the surface area of the top bars in the concrete blocks.

Figures 5 through 8 show the mean macrocell currents in the concrete blocks reinforced with the 316LN, 304, 2205, and clad bars, respectively, with the different bar combinations listed in Table 1. For those blocks with either the 316LN, 304, 2205, or clad bars in both the top and bottom portions (i.e., blocks 316LN/316LN, 304/304, 2205/2205, and CB/CB), the mean macrocell current after 700 days (100 weekly cycles) of exposure was still practically indiscernible, even when plotted on an expanded scale (20X). Even the macrocell current of the blocks with clad bars with drilled holes through the cladding was likewise indiscernible. As Table 3 indicates, the mean macrocell currents ranged from only  $-0.0002$  to  $0.0004 \mu\text{A}/\text{cm}^2$ , which are virtually negligible considering that the error of measurements was  $\pm 0.0007 \mu\text{A}/\text{cm}^2$ . In comparison, the mean macrocell current of the CS/CS blocks was at least 1,000 times larger (see Table 3).

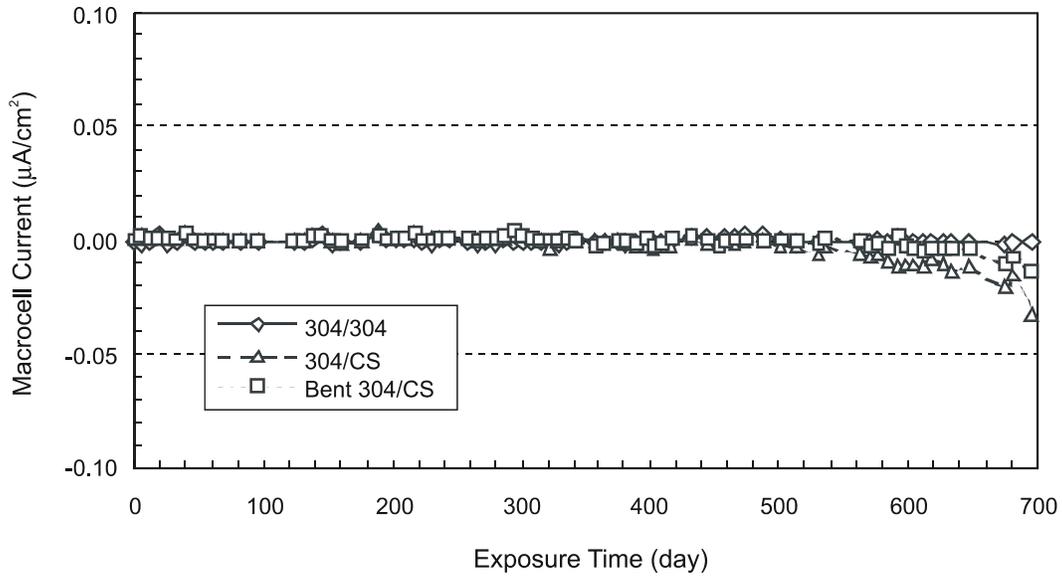
**Figure 6. Macrocell Currents of Test Concrete Blocks with 304 Stainless Steel Bars in Various Bar Combinations.** The macrocell currents were normalized to the surface area of the top bars in the concrete blocks.

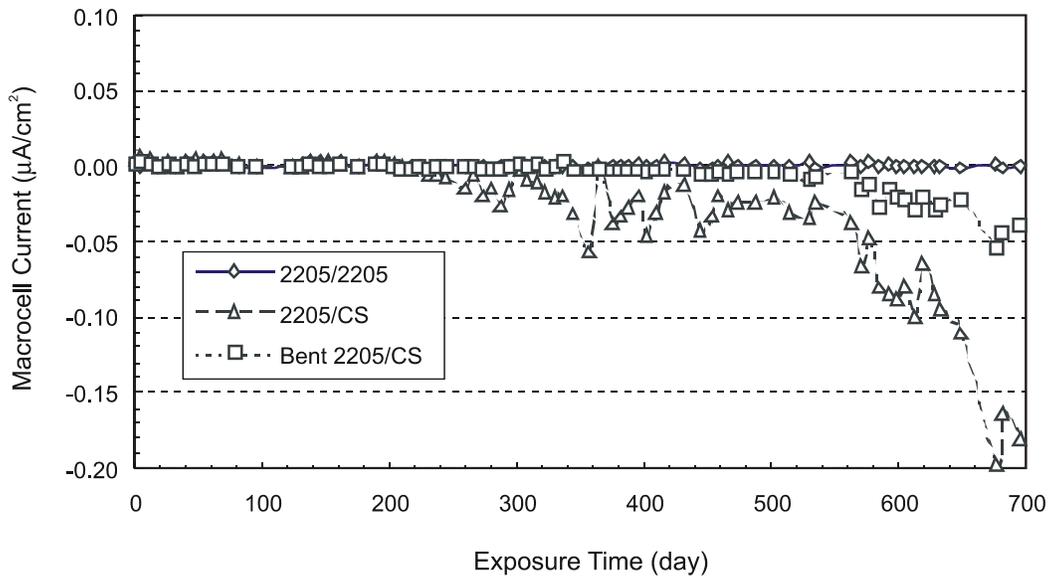
**Figure 7. Macrocell Currents of Test Concrete Blocks with 2205 Duplex Stainless Steel Bars in Various Bar Combinations.** The macrocell currents were normalized to the surface area of the top bars in the concrete blocks.

cycles. For example, as Figure 7 shows, blocks 2205/CS began to exhibit noticeable negative current flow at about 225 days. This phenomenon was not observed in the blocks where the top and bottom bars were of the same material. Except for expected fluctuations, this negative macrocell current continued to increase and reached  $-0.20 \mu\text{A}/\text{cm}^2$  in about 680 days. This is about 10 percent of the  $2.05 \mu\text{A}/\text{cm}^2$  positive macrocell current on day 294 for the CS (bent)/CS blocks (see Figure 4). Similarly, the 2205 (bent)/CS blocks began to exhibit a negative macrocell current, albeit after a longer salt exposure.

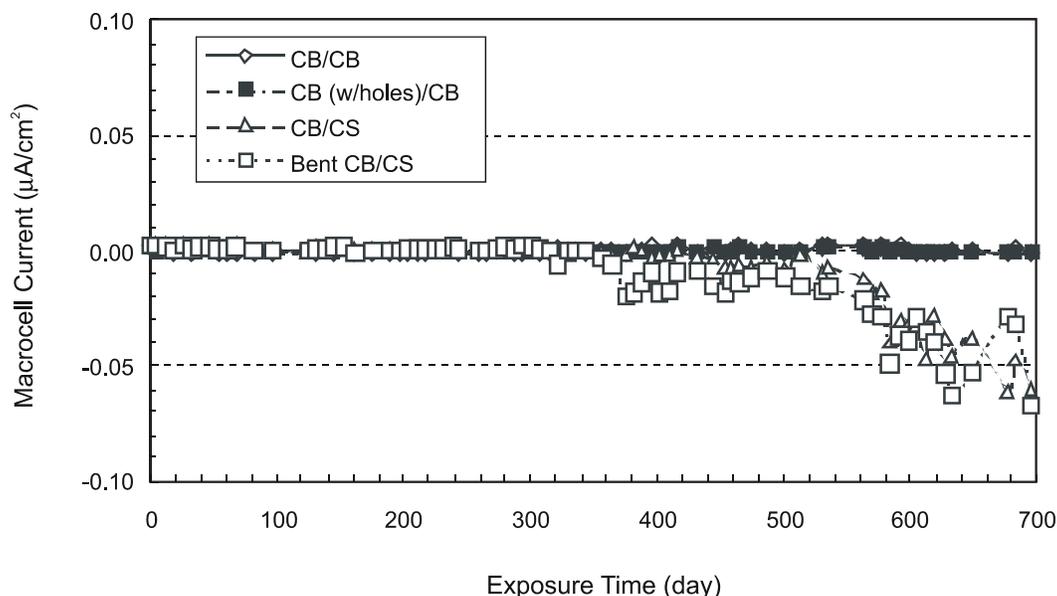
**Figure 8. Macrocell Currents of Test Concrete Blocks with Stainless Steel–Clad Bars, With or Without Holes Drilled Through Cladding, in Various Bar Combinations.** The macrocell currents were normalized to the surface area of the top bars in the concrete blocks.

Similarly, the CB/CS and CB (bent)/CS blocks began to exhibit a significant negative macrocell current after approximately 300 to 320 days (Figure 8). The 316LN/CS, 316LN (bent)/CS, 304/CS, and 304 (bent)/CS blocks also began exhibiting negative current flows at about 460 to 480 days. The time differences between the appearance of negative currents in the blocks were attributable to the heterogeneity in their permeability.

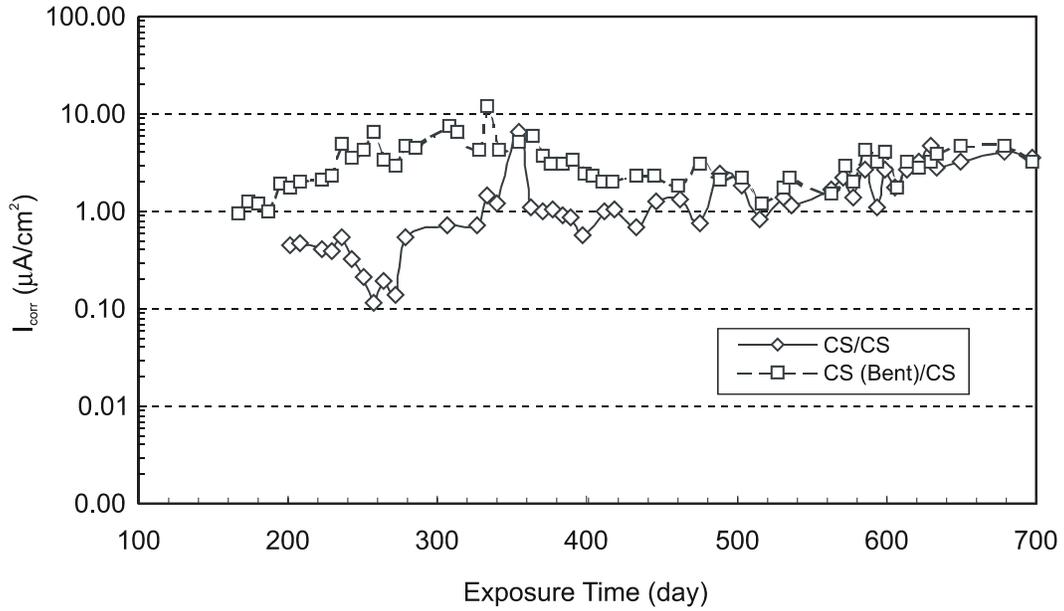
**Figure 9. Corrosion Rates of Carbon Steel Bars in Test Concrete Blocks.**

According to these broad criteria for corrosion rate values, with mean corrosion rates of 1.52 and 3.31  $\mu\text{A}/\text{cm}^2$  for the straight and bent carbon steel bars, respectively, the bars were, as expected, actively corroding. This interpretation is consistent with the macrocell current for these two sets of test blocks and was supported by the typical visual signs of corrosion, such as rust stains and surface cracking, on the surface of many of the blocks, even at only 160 days of exposure. Figure 9 shows that the mean corrosion rate of the bent carbon steel bars was already

0.94  $\mu\text{A}/\text{cm}^2$  on the first day (day 166) corrosion rates were measured for the blocks with bent bars at the top. For the blocks with straight carbon steel bars, the mean corrosion rate was 0.45  $\mu\text{A}/\text{cm}^2$  on the first day (day 201). Further, as indicated in Figures 4 and 9, these bars appeared to have reached the corrosion level of the bent carbon steel bars after approximately 470 days of exposure.

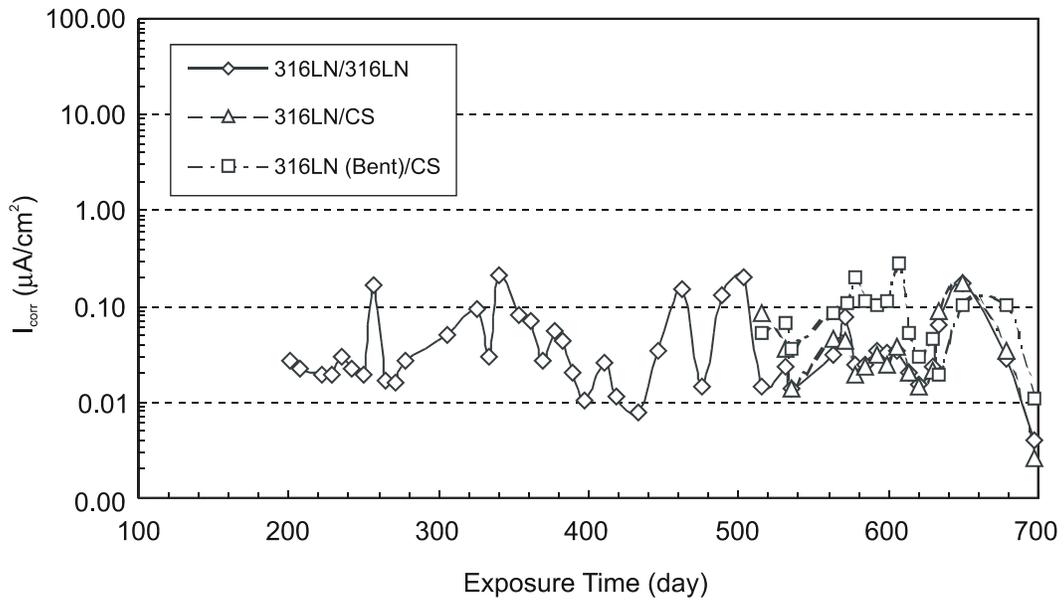
**Figure 10. Corrosion Rates of 316LN Stainless Steel Bars in Test Concrete Blocks.**

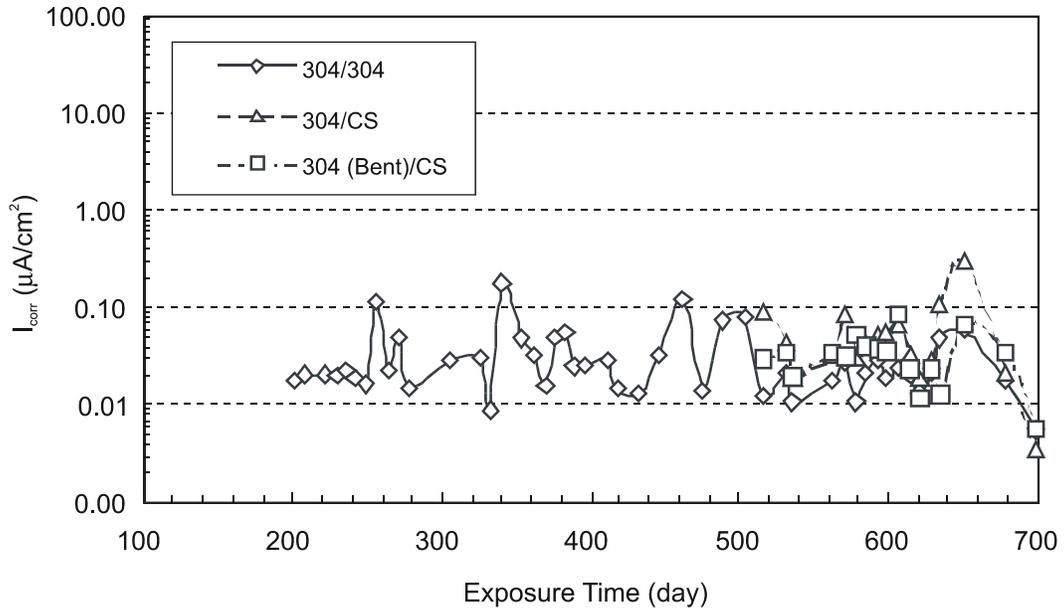
Figure 11. Corrosion Rates of 304 Stainless Steel Bars in Test Concrete Blocks

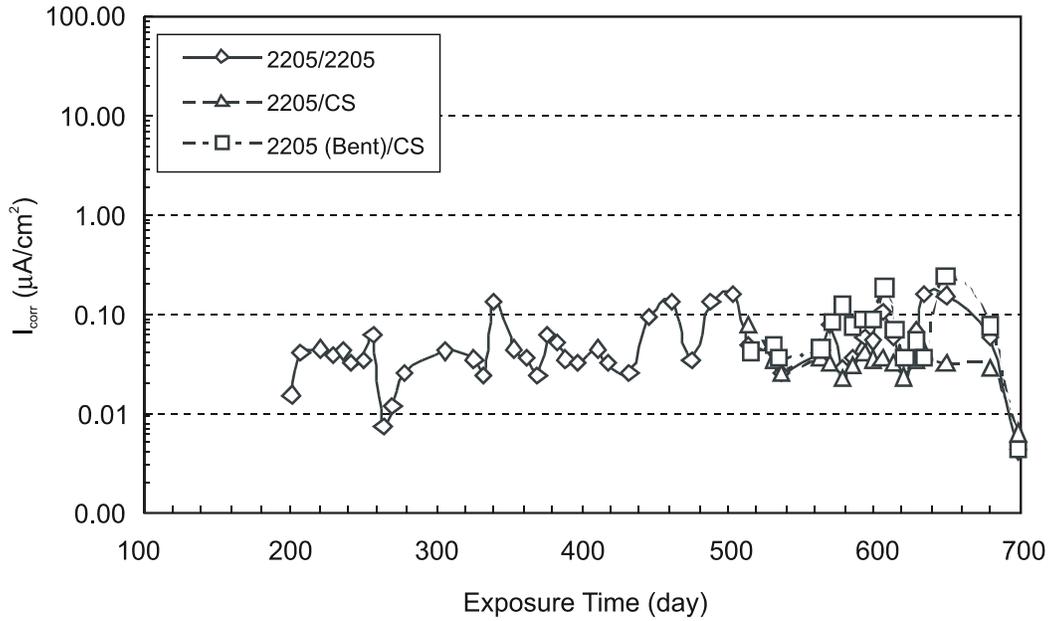
Figure 12. Corrosion Rates of 2205 Duplex Stainless Steel Bars in Test Concrete Blocks.

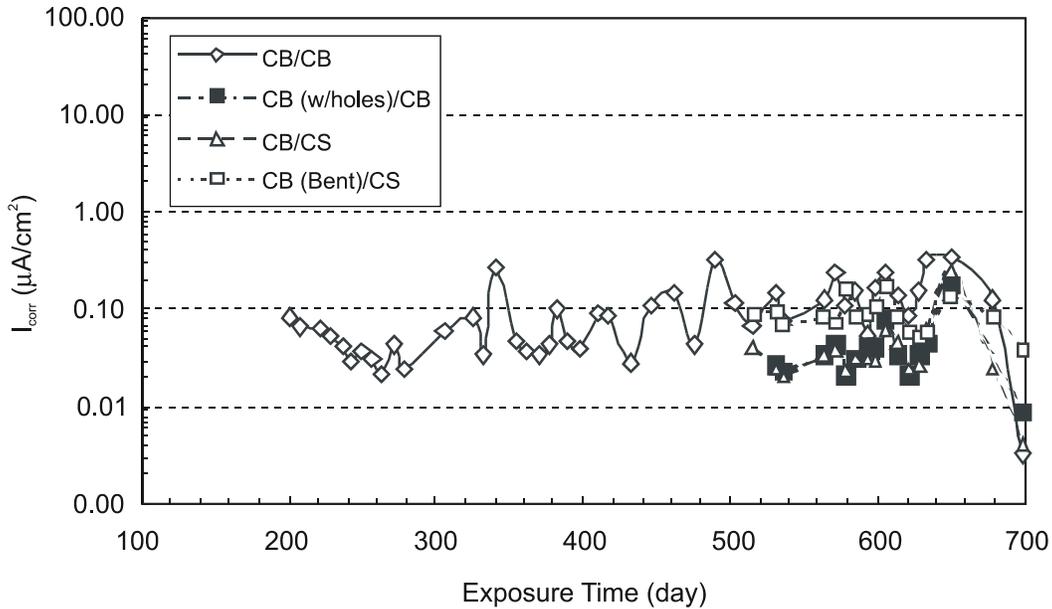
Figure 13. Corrosion Rates of Stainless Steel–Clad Bars in Test Concrete Blocks.

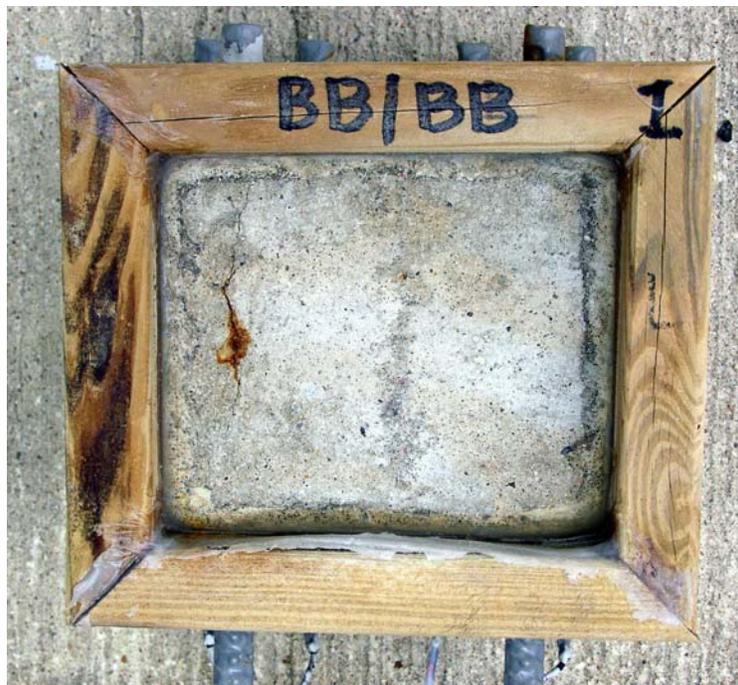
**Figure 14. Top View of CS/CS (BB/BB) Concrete Block Showing Severe Corrosion of Top Carbon Steel Bar and Resulting Concrete Damage, After 700 Days.**

With an overall mean corrosion rate for straight and bent bars of 2.41  $\mu\text{A}/\text{cm}^2$ , which is approximately 2 orders of magnitude greater than those for all other types of bars, there is no doubt that carbon steel was associated with the highest corrosion rate. Figure 14 shows the all-too-familiar concrete cracking and rust stain at the top of one of the blocks with straight carbon steel bars at both depths. For the other types of bars (not in combination with carbon steel bars), the ranking in terms of associated corrosion rates appears to be 2205 < 304 < clad < 316LN, in that increasing order. However, with standard deviations ranging from 0.03 to 0.11  $\mu\text{A}/\text{cm}^2$  for the various subsets of blocks, there is no clear indication that any one of these four types of bars was significantly more corrosion resistant than the others. Figure 15 shows the top of one of the blocks embedded with clad bars at both depths that was free of any outward sign of bar

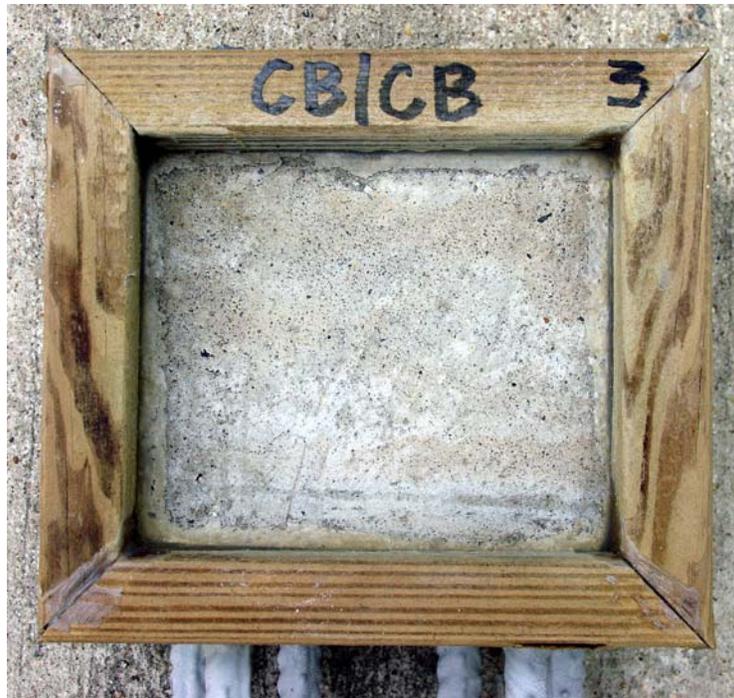
**Figure 15. Top View of Concrete Block With Clad Bars at Top And Bottom With No Sign of Corrosion, Even After 700 Days.** Blocks with stainless steel bars were similarly free of corrosion.

corrosion, even after 700 days of salt exposure; this is typical of the other concrete blocks embedded with the clad bars or any of the stainless steel bars.

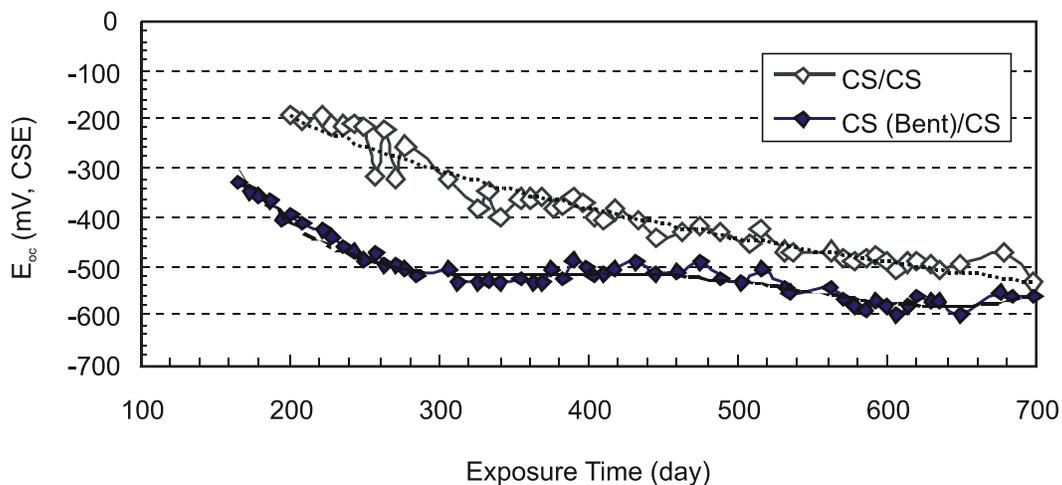
Figure 16. Potential of Carbon Steel Bars in Concrete Blocks With Straight or Bent Top Bars.

and corrosion rates (see Figures 4, 9, and 16); however, macrocell current, and perhaps even the corrosion rate, appeared to be a better early indicator of corrosion activity in steel bars. As a group, the averaged mean potential of the carbon steel bars in the two subsets of concrete blocks was  $-546$  mV at around 700 days, an indication that the bars were actively corroding.

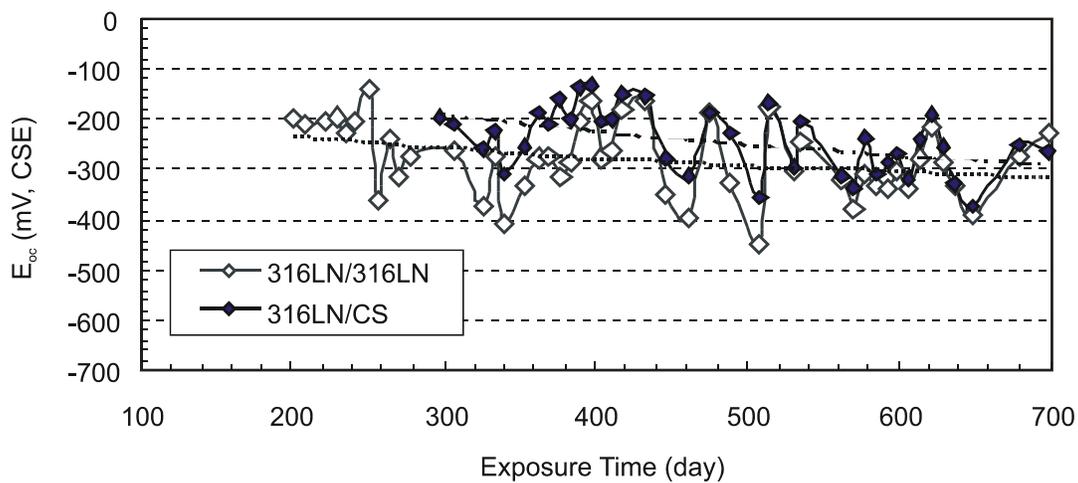
**Figure 17. Potential of 316LN Stainless Steel Bars in Concrete Blocks With Various Top and Bottom Bar Combinations.**

Figures 17 through 20 show the open circuit potentials of the other types of bars. A common characteristic is an anodic trend, albeit at significantly slower rates than those for the carbon steel bars, with the exception of perhaps the 304 stainless steel bars, which remained virtually stable throughout the observation period from 201 to 700 days. The mean potentials at about 700 days were  $-249$ ,  $-212$ ,  $-247$ , and  $-211$  mV for the 316LN, 304, 2205, and clad bars, respectively. This means that these types of bars were 297 to 336 mV more cathodic than the carbon steel bars.

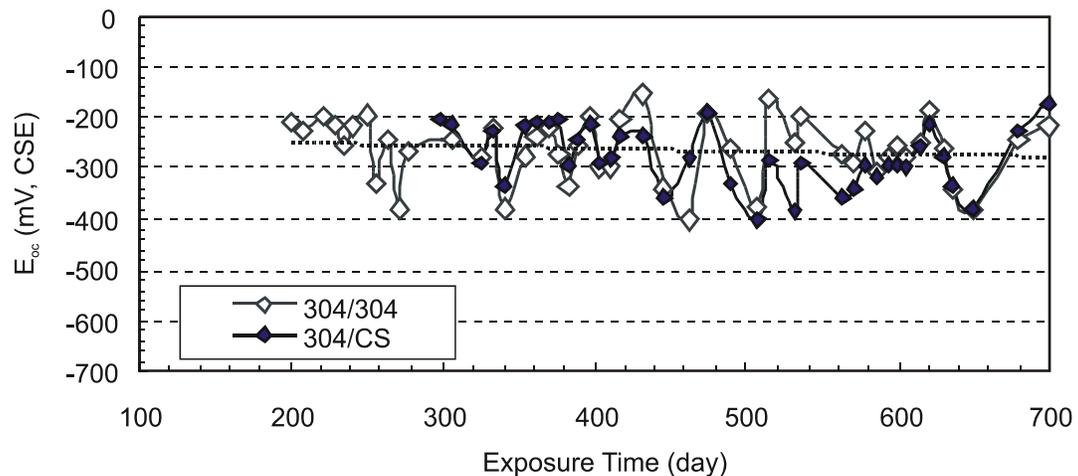
**Figure 18. Potentials of 304 Stainless Steel Bars in Concrete Blocks With Various Top and Bottom Bar Combinations.**

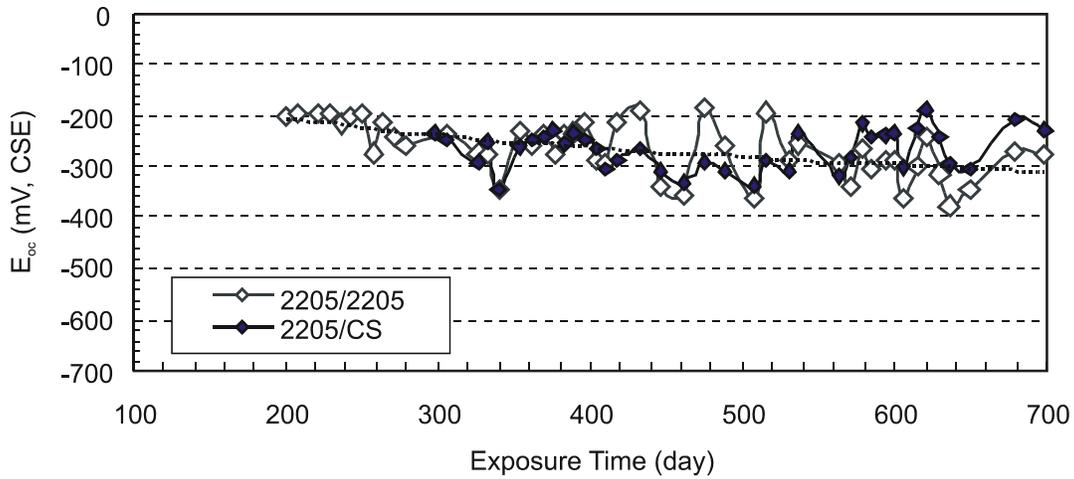
**Figure 19. Potential of 2205 Duplex Stainless Steel Bars in Concrete Blocks With Various Top and Bottom Bar Combinations.**

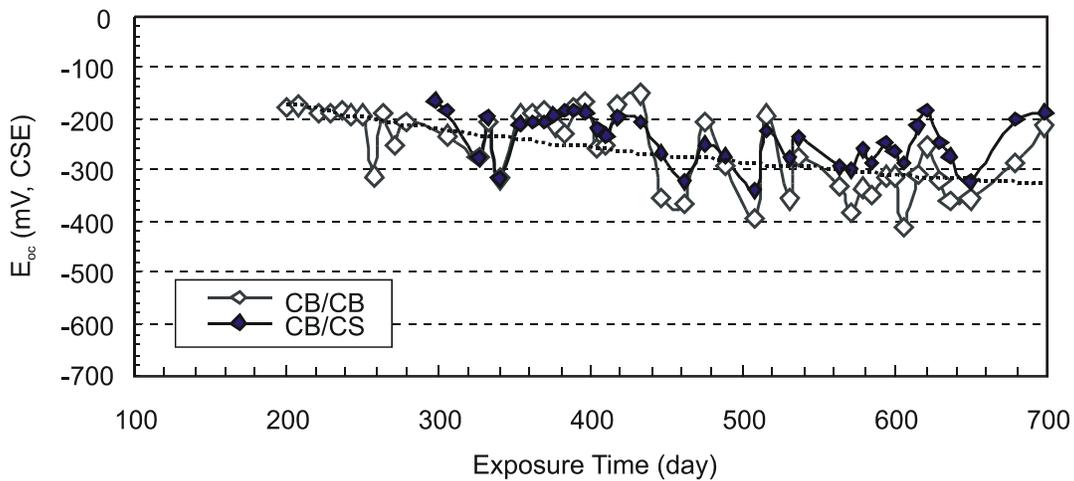
**Figure 20. Potential of Clad Bars in Concrete Blocks With Various Top and Bottom Bar Combinations.**

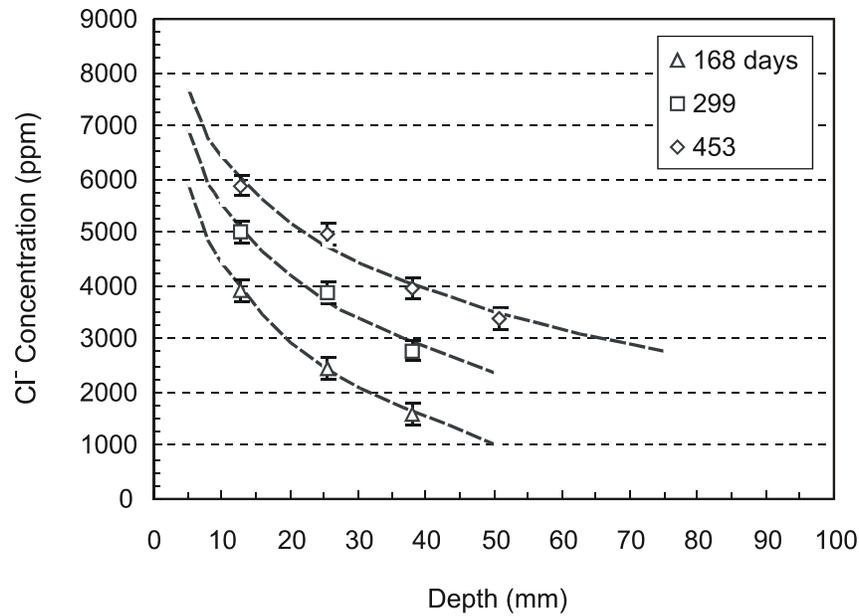
**Figure 21. Mean Chloride Ion Concentrations at Different Depths of Test Concrete Blocks After Different Exposure Times.**

Figure 21 shows the mean chloride concentrations in the blocks at different depths and exposure times, as determined by analysis of the ground concrete samples obtained from 10 randomly selected test concrete blocks, i.e., 2 from each group of blocks. From the best-fit curves for these chloride ion distributions, the mean chloride ion concentration in the blocks at different exposure times can be estimated for a specific depth. Figure 22 shows the estimated mean chloride concentration at different exposure times for the depth of 33 mm, which was the depth of the top-mat bars.

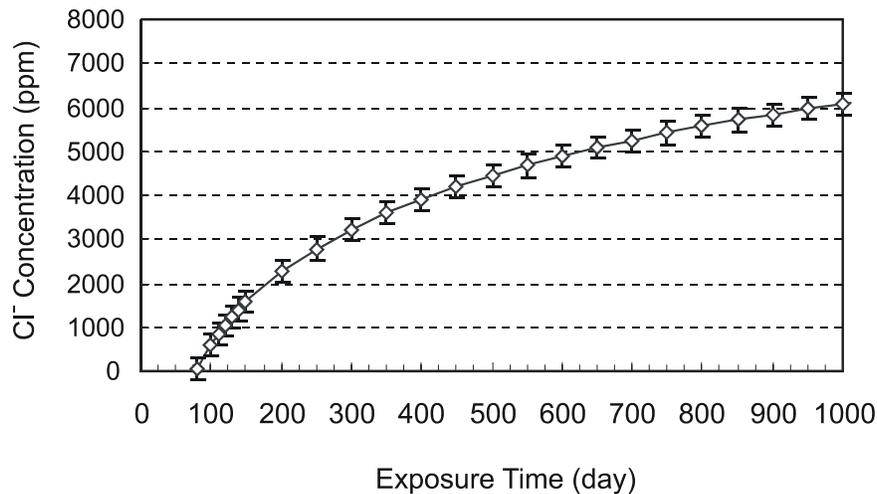
**Figure 22. Estimated Mean Chloride Ion Concentrations as Function of Exposure Time, at Depth of Top Bars (33 mm) in Test Concrete Blocks.**

In contrast, all the electrochemical parameters, including macrocell current, corrosion rate, etc., recorded after even approximately 700 days of exposure indicated that all the other types of bars remained passive. Figure 22 shows that at 700 days the mean chloride concentration around these bars would be approximately  $5200 \pm 100$  ppm ( $20.8$  lb/yd<sup>3</sup>). This means that the clad bars, including those with 3-mm holes drilled through the cladding, and all the stainless steel bars tolerated 15 times more chloride than the carbon steel bars were able to tolerate. This is in agreement with the findings reported recently by McDonald et al. that the threshold levels of 304 and 316 stainless steels were 15 and 24 times, respectively, higher than that of carbon steel.<sup>5</sup>

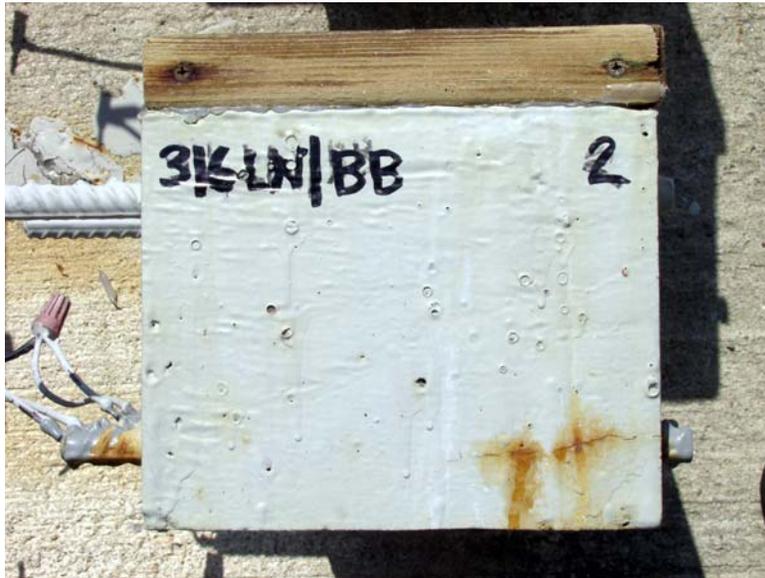
**Figure 23. Side View of Concrete Block With 316LN Stainless Steel Bars at Top and Carbon Steel Bars at Bottom.** Notice the rust stain and cracking at the lower right corner attributable to corrosion on the bottom carbon steel bars.

- *It would be risky to use a combination of a more corrosion-resistant but more expensive bar in the top-mat reinforcement of a bridge deck and a cheaper but corrosion-susceptible carbon steel bar in the bottom mat.* This investigation demonstrated, perhaps for the first time, that sufficient chloride ions will eventually reach the bottom mat of reinforcement to cause the bottom carbon steel bars to corrode before the more corrosion-resistant top bars (see Figures 23 and 24).

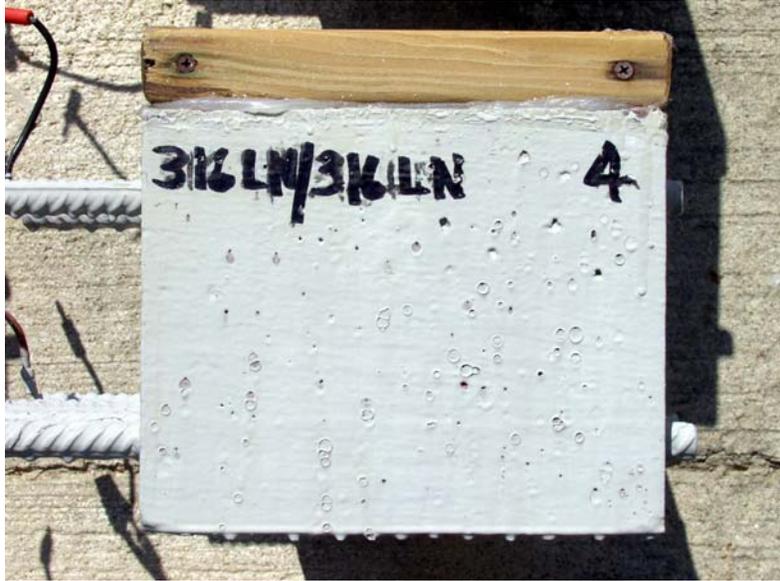
**Figure 24. Side View of Concrete Block With 316LN Stainless Steel Bars at Both Top and Bottom.** No sign of corrosion is present, even after 650 days of severe weekly cycles of salt ponding and drying.
