FINAL CONTRACT REPORT

**PLATE AND TUBE BRIDGE DECK EVALUATION IN THE DECK TEST BED
OF THE TROUTVILLE, VIRGINIA, WEIGH STATION**

March 2004
VTRC 04-CR12

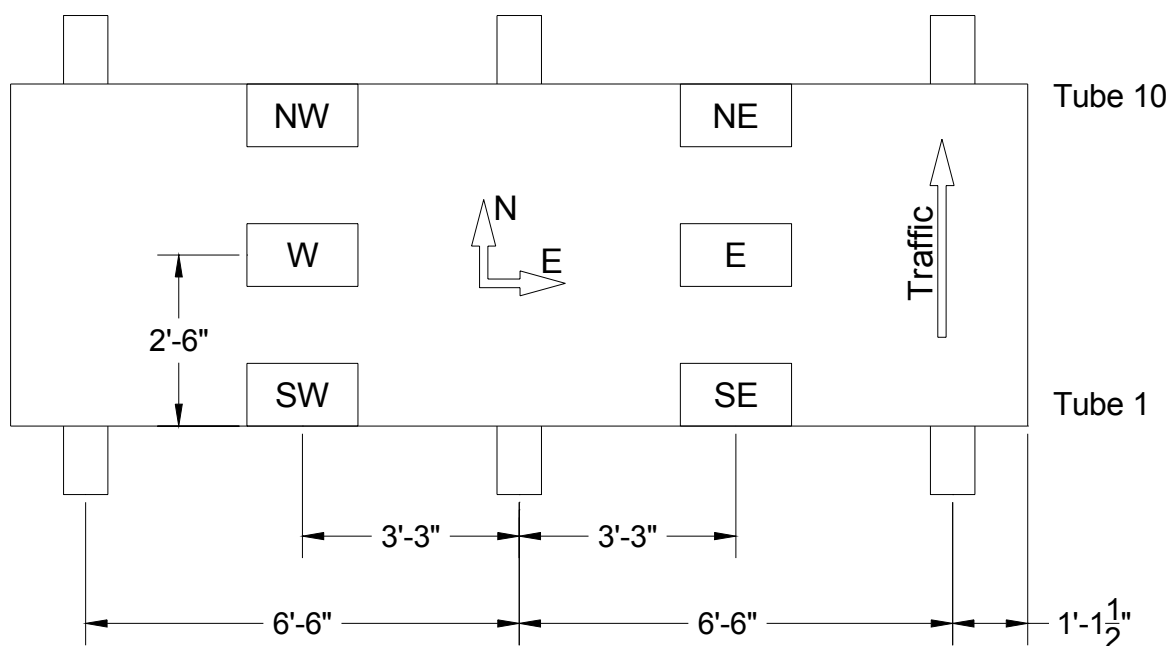
Figure 7 Locations of loading patches

The locations of loading patches as well as the determination of which patches would be loaded in each test were designed to simulate the support conditions on a real bridge (Figure 7). The transverse spacing of the girders was set to match what would be typical for this deck in a real bridge. Loading mode 2-5 (M2-5) will be used to simulate a truck axle load at the deck span centers. Loading modes 1-4 (M1-4) and 3-6 (M3-6) will be used to simulate an axle load at northwest & northeast and southwest & southeast regions, respectively. Modes 4-6 (M4-6) and 1-3 (M1-3) will be used as additional experimental reference data for results comparison from analytical work.²³ Mode 2 (M2) and mode 5 (M5) will be the loading locations for failure tests. Deflections were recorded at six locations, (NW–northwest, CW–central west, SW–southwest, NE–northeast, CE–central east, SE–southeast), as shown in Figure 7. Note that the NW (northwest) deflection was the vertical deflection of the bottom surface of the deck at the center of loading patch 1. The wheels of an AASHTO design truck are 183 cm (72 in.) apart; however, the East and West tire patches were spaced 198 cm (78 in.) apart to allow each tire patch to be placed in the middle of each span. With each tire patch positioned in the middle of each span, it was expected that the deck would experience higher strains (over the middle support) compared with tire patches spaced 183 cm (72 in.) apart. The orientations of the tire patches in the tests were selected to investigate the expected “worst-case” scenarios with respect to strains and deflections. Strain gages were placed along the middle of each span. Internal gages were placed during the fabrication process at the plant. These gages are placed on the tube corners/fillets prior to the application of the top and bottom plates. Strain gages were also mounted on the exterior of the top skin

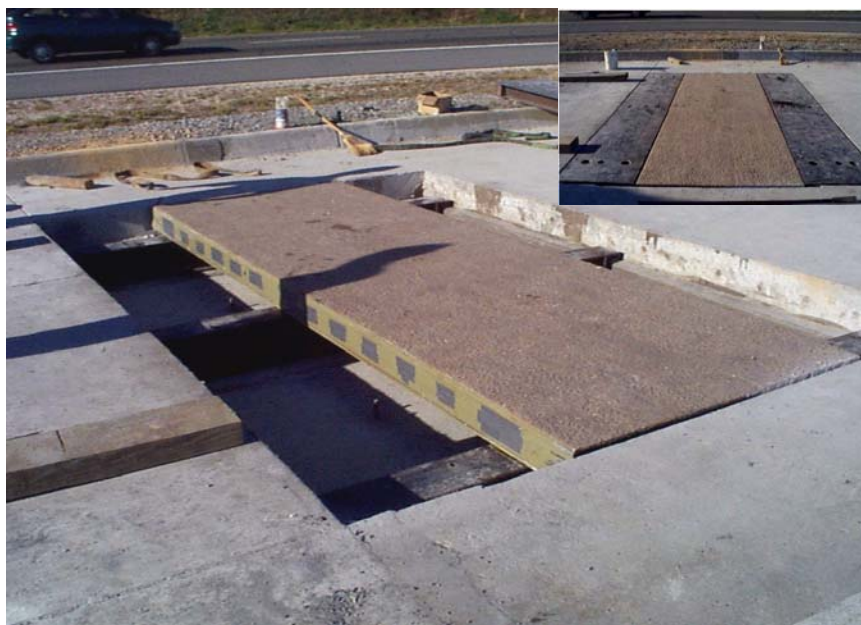
Figure 8 FRP deck field testing facility at the weight station

Phase II and Phase III decks were implemented in the deck testing facility and fully described by Temeles¹⁵ and Coleman.¹⁶ The decks were supported by three steel wide flange beams setting on a concrete slab (see Figure 8). The steel beams support the FRP deck and two 4.57 m × 0.76 m (15 × 2.5 ft) steel access panels on each side of the deck. The detailed design and installation procedures of the testing bed are provided by Temeles.¹⁵

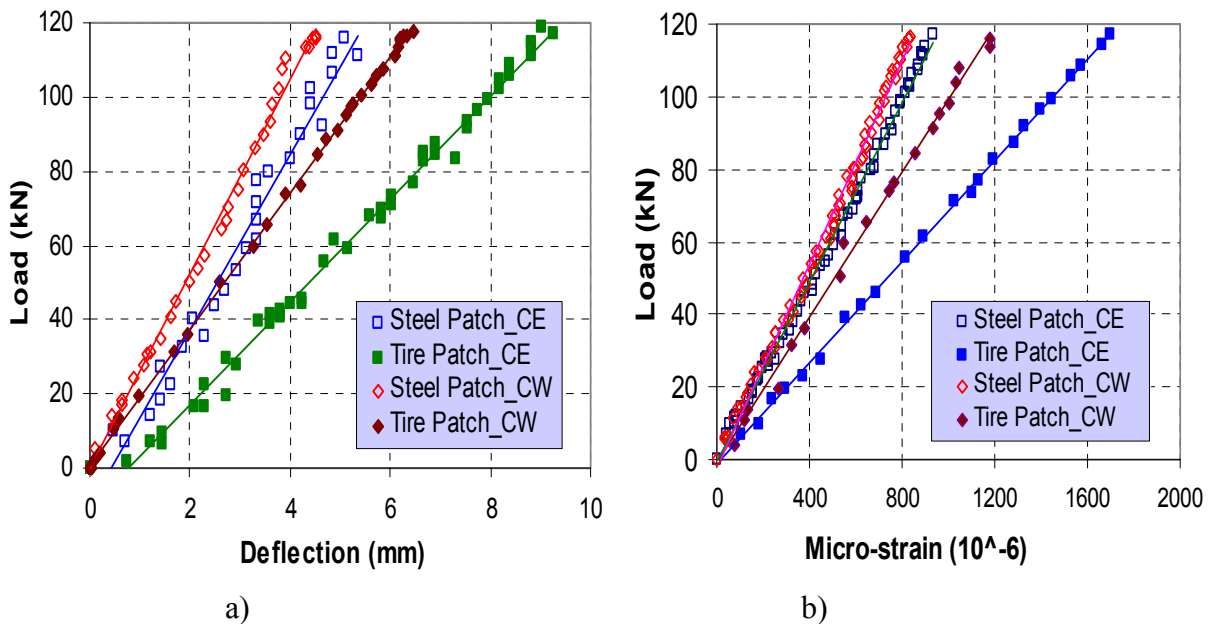
Figure 9 Deflection-load curves (a) and strain-load curves (b) of Phase IV deck when loaded at central east (CE) and central west (CW)

The effect of through rods on deck performance was evaluated because the installing of the through rods requires drilling through the square tubes. The cutouts in the tubes break reinforcing fibers and bring stress concentrations around the cutout regions. Studies from three dimensional finite element analysis showed that the contributions of the rods to the deck stiffness were insignificant, and a reduction of through rods in the deck would produce improved overall performance and reduce the cost of the deck.¹⁹ To investigate the effects of through rods on the stiffness and strength, a deck (Phase IV deck) was designed and fabricated for laboratory testing. The experimental results for this study are presented in this section. The deflection-load and strain-load plots for M2 and M5 loading modes from laboratory tests are summarized in Figure 9(a) and Figure 9(b) with both the steel patch and the simulated tire patch.

These strains are all longitudinal strains (i.e. tube direction) from the gages on the bottom surface. For both loading patch conditions, the load-deflection curves and load-strain curves are linear for both spans. However, some nonlinear behavior was observed in the decks just prior to failure. Larger slopes of the load-deflection curves were observed for the steel tire patch. From the maximum deflections and curve slopes of Figure 9(a), it is evident that the west span (with 1 transverse rod) is stiffer than the east span (with 5 transverse rods). The maximum strains and the load-strain curve slopes also showed a similar trend. The west span (with 1 transverse rod) has less strain per unit load than the east span. It was expected that the east span with 5 rods would be stiffer than the west span; however, the experimental results show that the opposite occurred. In fact, the stiffness of the west span

measured as much as 40% more than that of the East span. This difference is attributed to the extra cutouts in the webs of the tubes (to allow the passing of the transverse rods) in the east span as compared to the west span; this may have contributed to the reduction in shear section allowing for greater deflection.

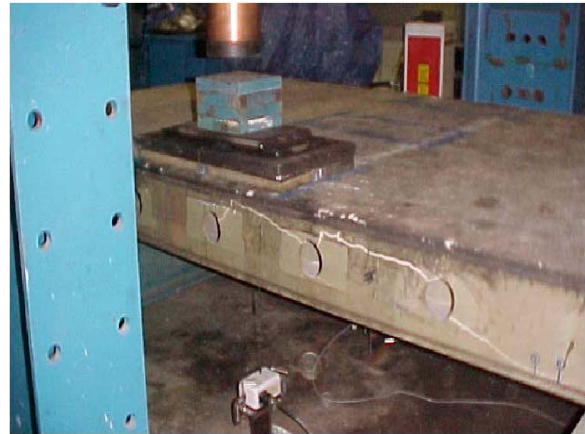
(a)

(b)

Figure 10 Failure of Phase I Deck at the center (a) and Phase II Deck at the edge (b) using steel loading patch

surface. The failure mode of the Phase II deck using steel loading patch is shown in Figure 10. Note that the failure mode of the Phase I deck was virtually identical to that of the Phase II deck. Detailed failure test data for the Phase II deck can be found in thesis of Temeles.¹⁵ During failure testing, debonding (between the face sheets and tubes) was observed during the loading cycle at a load of about 245 kN (55 kips) for both decks. The Phase I deck failed at 476 kN (107 kips) for central span loading and consisted of a local punching shear failure (see Figure 10-a) directly under the steel patch edges. For the Phase II deck, one side was loaded at the center to failure and the other side loaded at the unsupported edge to failure. The failure mode of Phase II deck when loaded at the center was the same as Phase I deck (Figure 10.a) but with a larger ultimate capacity of 587 kN (132 kips). Shearing in the sidewall of the cell initiating from the underneath the loading patch (Figure 10-b) and controlled the failure of the other side of the Phase II deck when loaded at the unsupported edge, with the ultimate capacity of 378 kN (85 kips).
