**STRUCTURAL LOAD TESTING AND FLEXURE ANALYSIS
OF THE ROUTE 701 BRIDGE IN LOUISA COUNTY, VIRGINIA**

June 2004
VTRC 04-R12

ABSTRACT

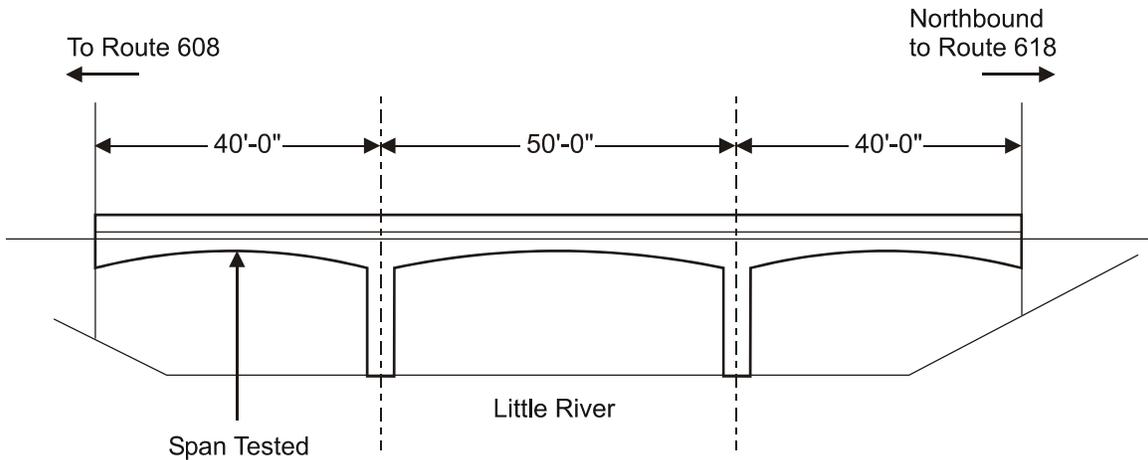
Figure 1. Route 701 Bridge over the Little River.

In the early 1980s, the Virginia Department of Transportation (VDOT, 1982) constructed a continuous slab bridge on Route 701 across the Little River, approximately 1.4 miles south of Route 618 in Louisa County, Virginia. The bridge is a three-span continuous reinforced concrete slab bridge with a 15° skew. The end spans are both 40 ft and the center span is 50 ft in length. The spans are haunched toward the piers, with an average thickness of 22.5 in at center span and 33.5 in at the piers. The overall width of the bridge is 29 ft 10 in, with a face-to-face distance between parapets of 28 ft (see Figure 1 and Figure 2).

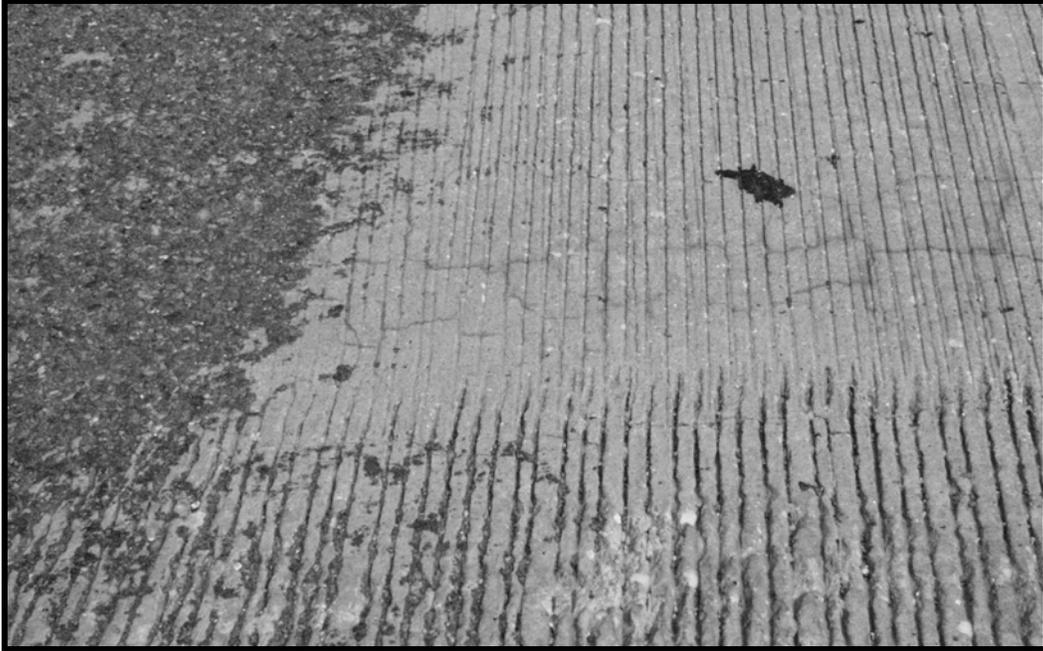
Figure 3. Route 701 Bridge deck surface.

During the preliminary VTRC survey, concrete cores were obtained for laboratory evaluations. A typical area of map cracking on the deck surface is shown in Figure 3. The horizontal crack, which can be observed on both sides of the deck, is shown in Figure 4 and Figure 5 and varies in width from hairline to 0.25 in. The disposition of this cracking suggested that it had likely propagated through the entire slab. Consequently, the investigators decided to conduct a non-destructive evaluation to determine the extent of the flaw and load testing to assess the structural capacity of the bridge. In the interim, the load rating of the bridge was reduced from 24 tons to 15 tons as a precautionary measure.

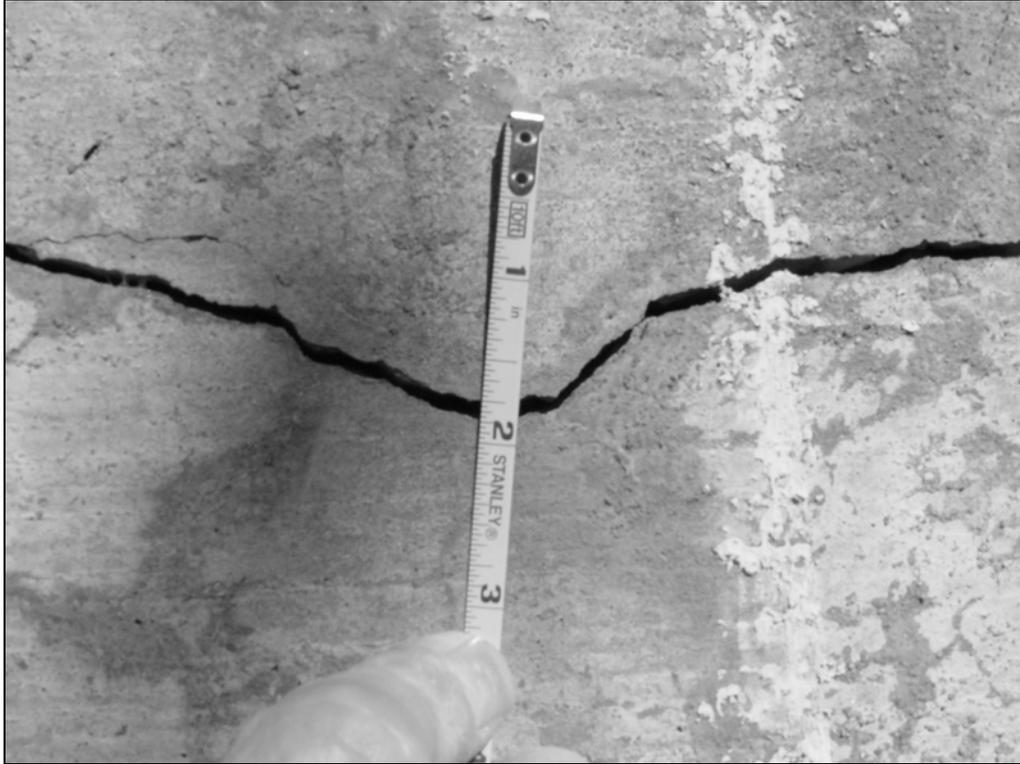
Figure 5. At some locations, crack was 0.25 in at surface.

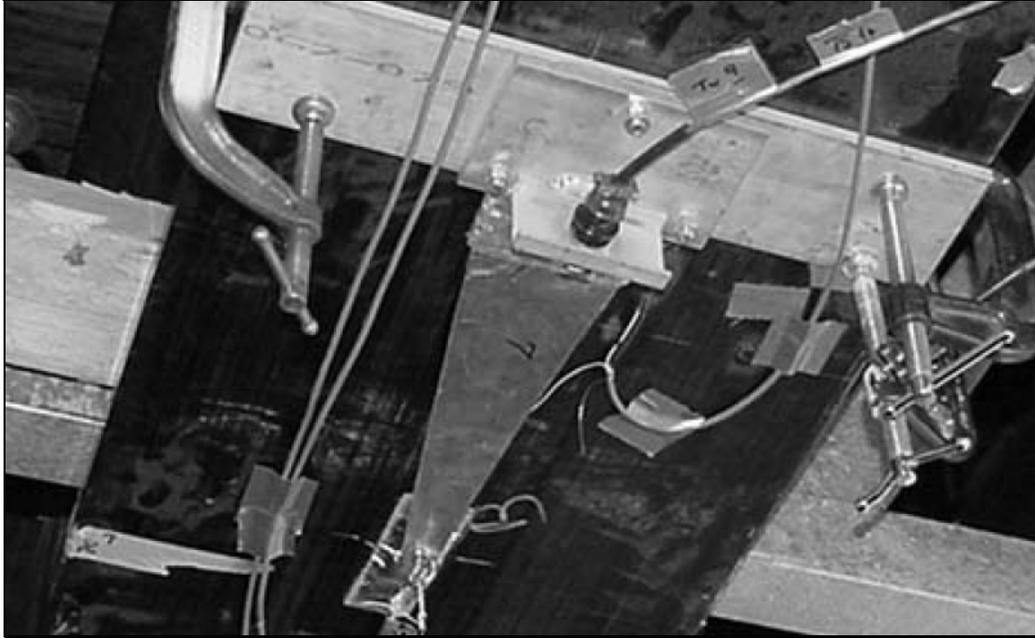
Figure 6. Deflectometer (not on Route 701 bridge).

Deflection sensors developed and fabricated by Virginia Polytechnic Institute & State University (Virginia Tech) in 1997 were used to measure deflections of the bridge (Figure 6). The sensors were calibrated to the nearest 0.003 in in conjunction with the Optim Electronics MEGADAC data acquisition system and Test Control Software (TCS).

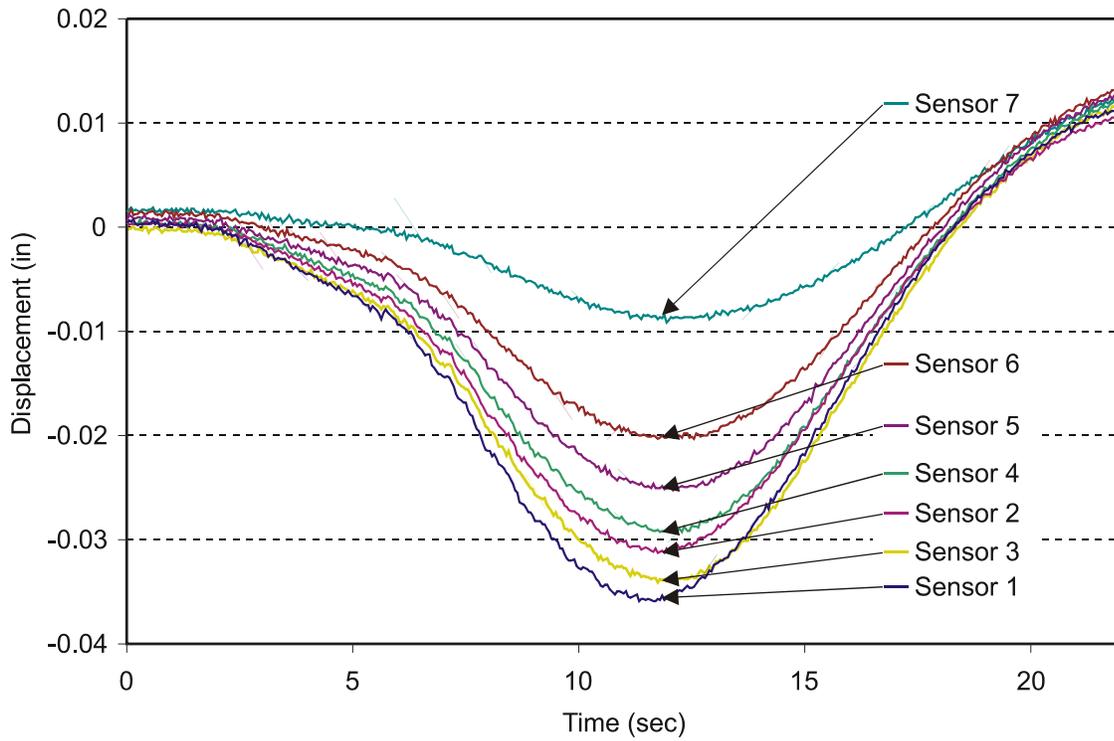
Figure 7. Refined data sample (data set ABRG701A002).

Seven deflection sensors, corresponding to test lanes, were placed on the bridge at midspan of the span on the Route 608 end of the bridge (Figure 1). The deflectometers were bolted to anchors in the concrete through the sensor's base plate. The deflectometers were pre-deflected approximately 0.75 in to allow for relaxation in the deflectometers as the slab displaced downward. The sensors were connected through seven separate channels to the data acquisition system, which was configured for a sample rate of 400 samples per second per channel measuring the change in deflection as the tests are run. A sample of refined data is provided in Figure 7.

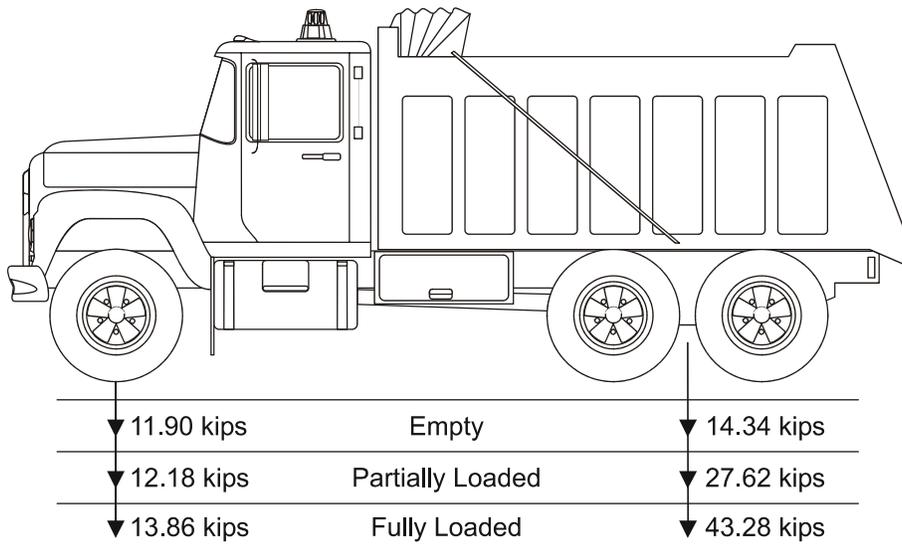
Figure 11 and Figure 12 show the weight distribution and dimensions of the test truck.

Figure 11. Truck weight distribution when empty (26.2 kips), partially loaded (39.7 kips), and full (57.0 kips).

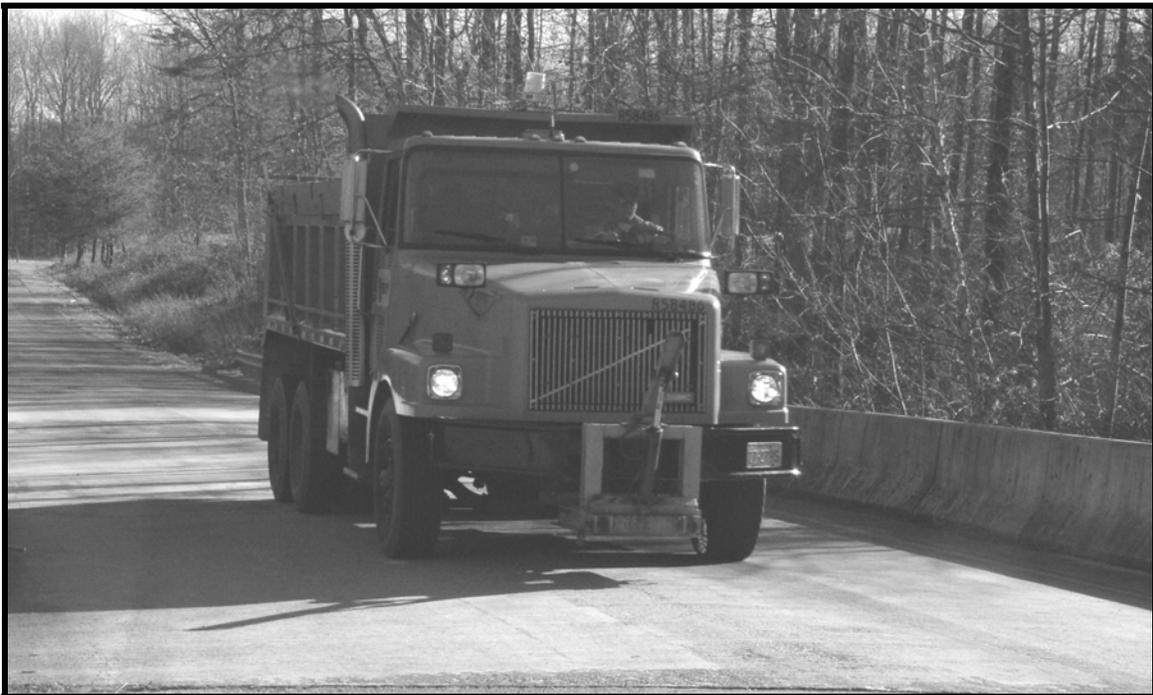
Figure 13. Typical truck pass.

Tests were first run with the truck fully loaded and weighing approximately 57 kips to guarantee a fully pre-cracked section (Figure 13). One mid-span flexural crack was observed on the tested span. There were five “static” tests run on each lane, where the truck, starting and stopping off the span being tested, traveled as slowly as possible along the span of the bridge. There were also six dynamic tests, three in each direction, along Test Lane 3. The truck

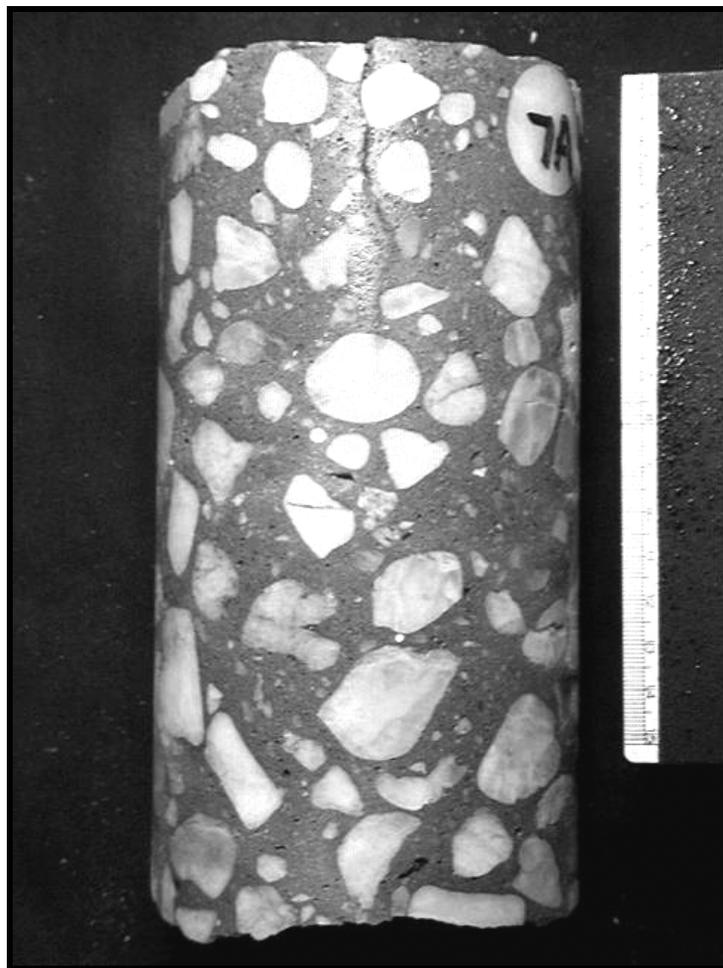
An examination of cores indicated that the cracks expressed at the surface trended perpendicular to the surface to a depth of about 2 in where they intersected with a network of sub-horizontal cracks (Figure 14). Cracked coarse aggregate particles are associated with the crack network, as are secondary deposits in voids. The aggregate types, quartz sand and gravel, have been associated with damage related to alkali-silica reactivity (ASR) in other structures in the region (Lane, 1993).

Figure 14. Core showing crack from surface extending to depth of approximately 2 in where it connects with sub-horizontal network of cracks associated with coarse aggregate particles.

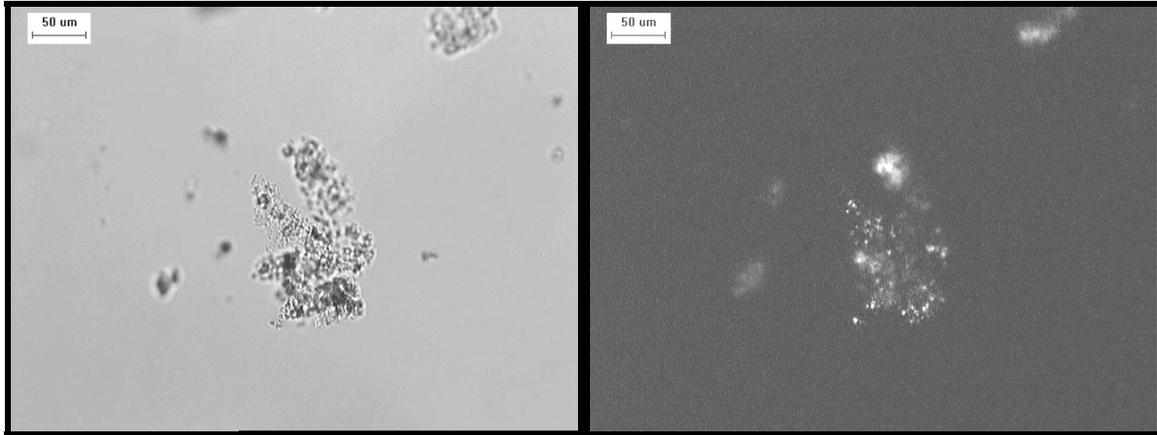
The secondary deposits in voids were examined in immersion mounts (Figure 15). Examination of thin sections also revealed the secondary deposits lining cracks and voids in the concrete (Figure 16 and Figure 17). The optical properties of the material forming these deposits are consistent with ASR product. The anisotropic character of the reaction products exhibited in these examinations indicates that it has begun to crystallize. ASR products first form as gels that can swell. This swelling can induce significant expansion of the concrete. As the gel begins to crystallize, the swelling tendency is reduced. The damage observed in this deck resulted from expansion caused by ASR of the quartzose gravel aggregate.

Figure 15. Alkali-silica reaction product from void in concrete. Left image: plane polarized light. Right image: in crossed polarized light material exhibits anisotropic character indicating material has crystallized.

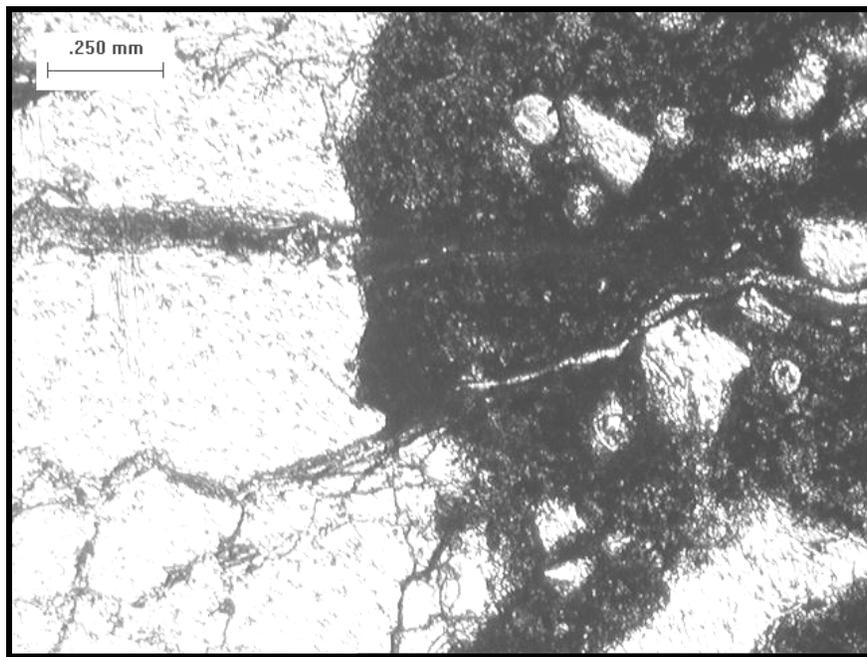
Figure 16. Thin section of concrete showing partially filled crack extending from coarse aggregate particle on left through paste.

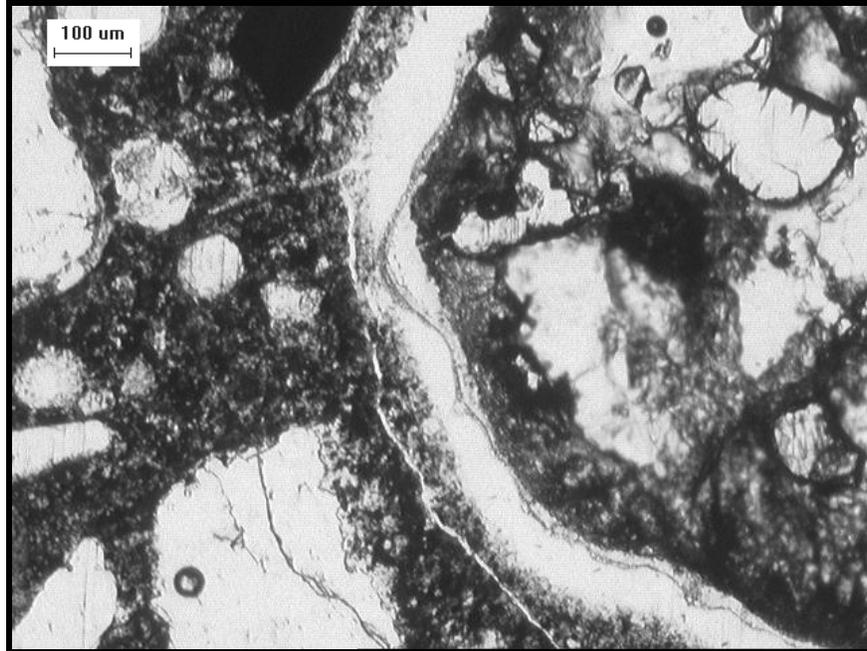
Figure 17. Thin section of concrete showing cracks and voids lined with alkali-silica reaction product.

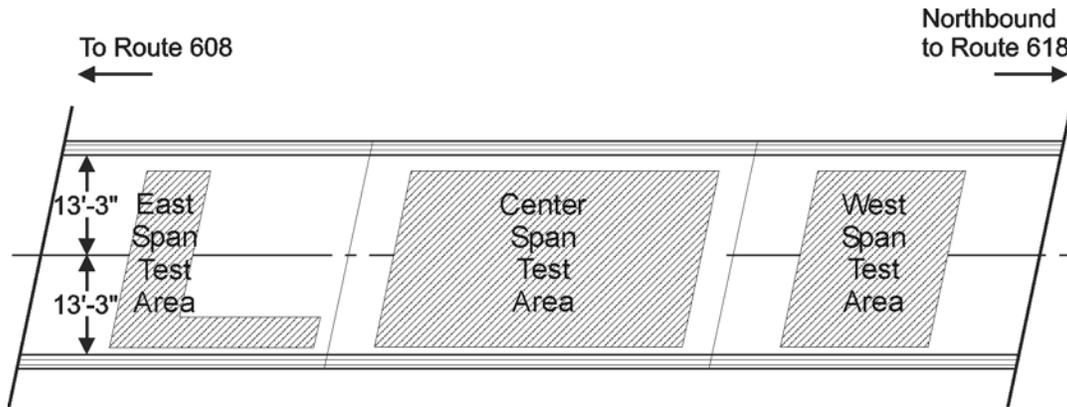
Figure 18. Areas surveyed using impact-echo.

Although, in general, the underside of the bridge was well suited for making measurements, some regions were inaccessible. Therefore, partial area surveys were performed on the end spans and a full area survey was performed on the center span. A snooper-truck was required in order to access the center span because of the river flowing beneath the bridge. The areas surveyed under each span are illustrated in Figure 18. Impact-echo measurements on all three spans indicated a gap throughout those regions surveyed. A summary of the data collected is provided in Table 2. Based on the impact-echo measurements and the continuous cracks visible along the length of the bridge (Figure 4), a planar crack had more than likely propagated through the entire slab of the bridge.

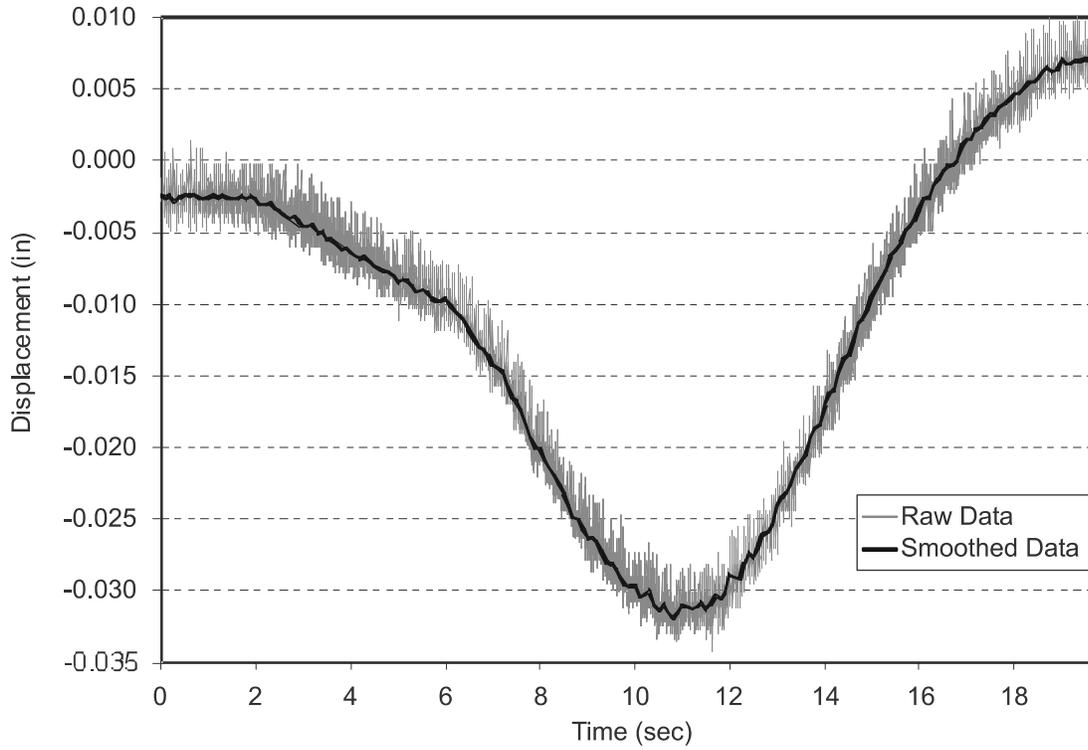
Figure 19. Comparison of raw and smoothed data.

The procedure described herein was performed on all static and dynamic tests. Using Microsoft Excel, the data were visually inspected to determine if all sensors were reporting reasonable trends. A nine-point running average was then used to smooth the data and reduce electronic noise. Figure 19 shows a typical comparison of raw to smoothed data. Maximum deflections were determined for each sensor by finding the maximum point and averaging that with the surrounding points to account for electronic noise (Figure 20). During some runs, the sensors detected the “wobble” of the truck from an uneven approach onto the span; in these cases

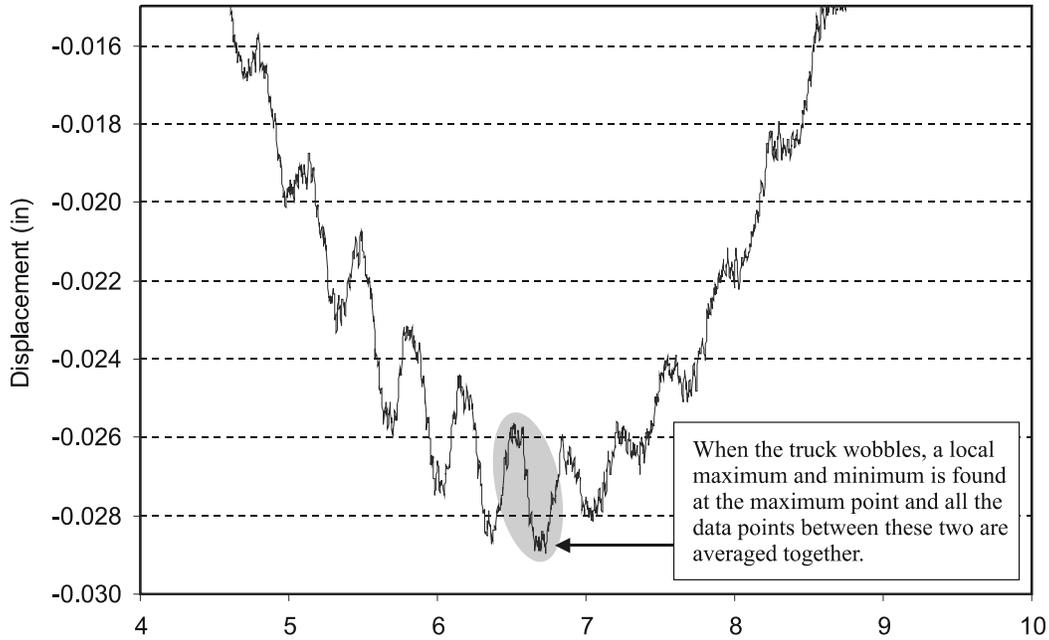
the average was found from the local maximum and minimum peak around that point (Figure 21). The maximums were graphed to find the deformed shape of the slab and to ensure that the deflections corresponded to prior assumptions of what the deformed shape should look like (Figure 22).

Figure 21. Determining maximum deflection when truck “wobbled.”

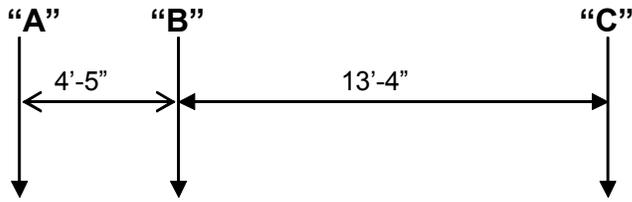
“A” Load	“B” Load	“C” Load	Truck Wt.
10.82 kips	10.82 kips	6.93 kips	57 kips
6.91 kips	6.91 kips	6.19 kips	39.7 kips
3.59 kips	3.59 kips	5.95 kips	26.2 kips
