Report No. VTRC 05-R12	Report Date January 2005	No. Pages 30	Type Report: Final Period Covered: March– October 2004	Project No.: N/A
				Contract No.
Title: Crossing Surface Recommendations for At-Grade Rail Crossings of U.S. Routes 29 and 15 in Prince William County, Virginia				Key Words: Rail Crossing Surface, Asphalt Underlayment, Intermodal Transportation
Authors: Brian K. Diefenderfer				
Performing Organization Name and Address: Virginia Transportation Research Council 530 Edgemont Road Charlottesville, VA 22903				
Sponsoring Agencies' Name and Address Virginia Department of Transportation 1401 E. Broad Street Richmond, VA 23219				
Supplementary Notes				
<p>Abstract</p> <p>The intersection of a rail line and a roadway at an at-grade crossing represents the meeting of two vastly different transportation modes. Although they may share a common crossing where they intersect, the typical structural design of the supporting foundation for each is quite different. The design of a roadway consists of multiple layers of low-permeability materials, whereas the design of a rail line includes rails and crossties supported by open-draining aggregate ballast. Because of the use of hig

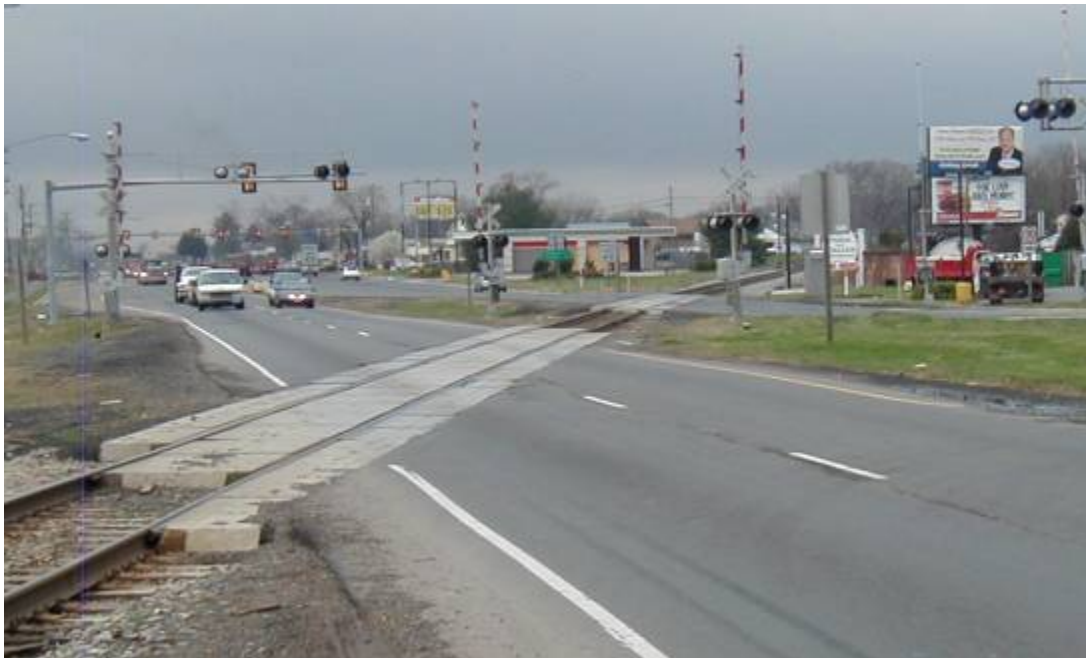
Figure 2. Overview of crossing at U.S. Route 29 (facing south).

These crossings are in close proximity and intersect the same rail line, a main east/west corridor through the Washington, D.C./Northern Virginia area operated by Norfolk Southern Corporation. Figures 2 and 3 show an overview of the crossings at Route 29 and Route 15, respectively. The current crossing structures consist of a precast concrete panelized system. The panels are placed on top of the compacted track ballast and act as the riding surface. Each panel is bolted in two locations (at two opposing corners of the panel) to the track ties below.

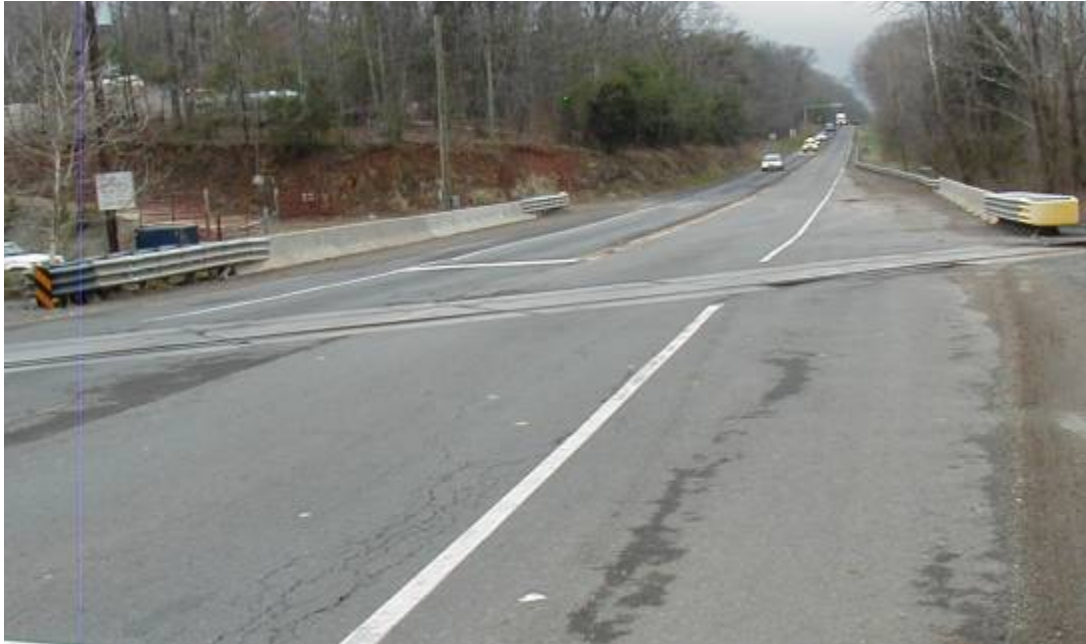
Figure 3. Overview of crossing at U.S. Route 15 (facing south).

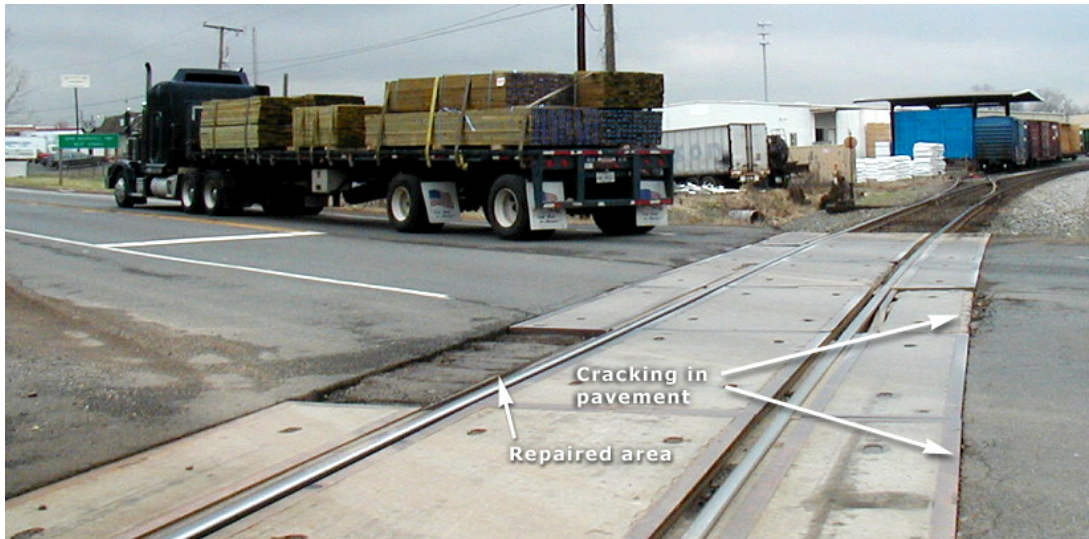
Figure 5 shows the recent condition of the rail crossing at Route 15. As may be seen, a deteriorated panel has been removed and patched with asphalt. In addition, cracking of the approach roadway (possibly fatigue from movement of the adjacent panel) is evident to the right of the concrete panels.

Figure 5. Concrete Panel Crossing Repaired with Hot-Mix Asphalt and Deterioration of Approach Pavement.

Although the most often used repair method for rail crossings is to restore the riding surface by placing an asphalt patch, this type of repair is often a temporary solution and does not address any underlying structural issues. Hastily performed repair work often results from a combination of traffic volumes and questions of right-of-way/ownership. The likely cause of most deterioration is the high volume of vehicular and rail traffic. However, it is this same condition that keeps substantial repair work from being performed, as it is desirable not to close the roadway or track. In addition, motorists are more likely to call the local highway agency rather than the railroad to fix any perceived problems with a rough crossing. Often, it is more efficient for the local highway agency to patch a rough crossing repeatedly in an effort to stem complaints from motorists than wait for the railroad/owners to address the issue.
