1. Report No. FHWA/VTRC 05-R28	2. Government Accession No.	3. Recipient's Catalog No.	
4. Title and Subtitle Field Study of Integral Backwall with Elastic Inclusion		5. Report Date April 2005

**FIELD STUDY OF INTEGRAL BACKWALL WITH ELASTIC INCLUSION**

April 2005  
VTRC 05-R28

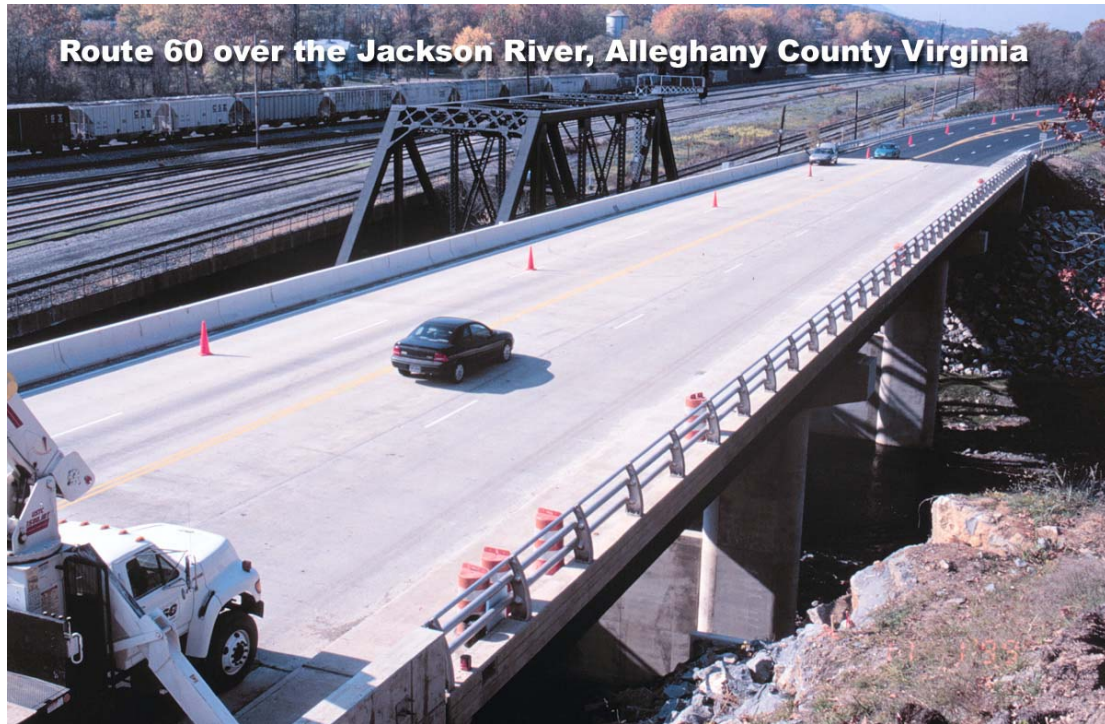
**Figure 1. Integral Backwall Bridge**

The project involved a replacement bridge on Route 60 over the Jackson River in Alleghany County, Virginia, as shown in Figure 1. The integral backwall (semi-integral) bridge is 100 m (331 ft) long and 16.6 m (54.5 ft) wide (overall), with three-span continuous steel plate girders and no skew. Fixed bearings are provided over two piers, and expansion bearings are

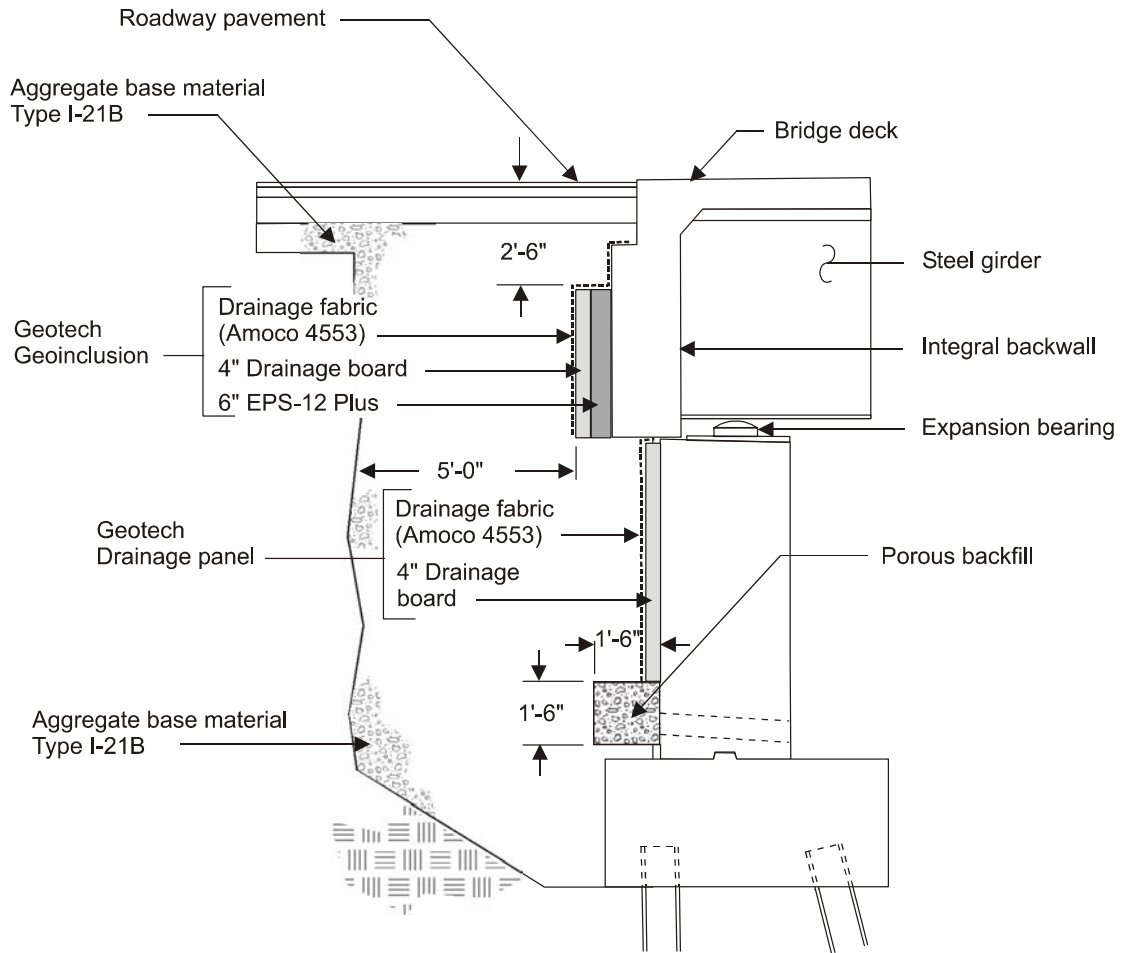
**Figure 2. Abutment Cross Section**

The experimental detail involves a layer of elasticized EPS 0.25 m (10 in) thick placed on the back of integral backwall to absorb a limited range of movement without adversely impacting the adjoining embankment fill. The EPS material terminates at 0.76 m (2.5 ft) below grade, as shown in Figure 2. This distance was selected arbitrarily to allow space for placement of one earth pressure sensor to measure backfill stress acting directly on the backwall. Two other pressure sensors were installed at the backwall, behind the EPS layer. A separation geotextile was placed on the EPS layer to prevent damage from the adjoining granular backfill material. Elastic drainage board was also installed at the back of the shelf abutment, below the integral backwall.

The elastic inclusion was composed of a layer of glued polystyrene porous drainage material 0.10 m (4 in) thick, laminated with a layer of elasticized polystyrene block 0.15 mm (6 in) thick. According to the manufacturer, the stress-strain behavior of both layers is essentially identical. The material cost was quoted at \$21.53/m<sup>2</sup> (\$2.00/ft<sup>2</sup>) in 1997. Material properties, as provided by the manufacturer, are shown in Figure 3.

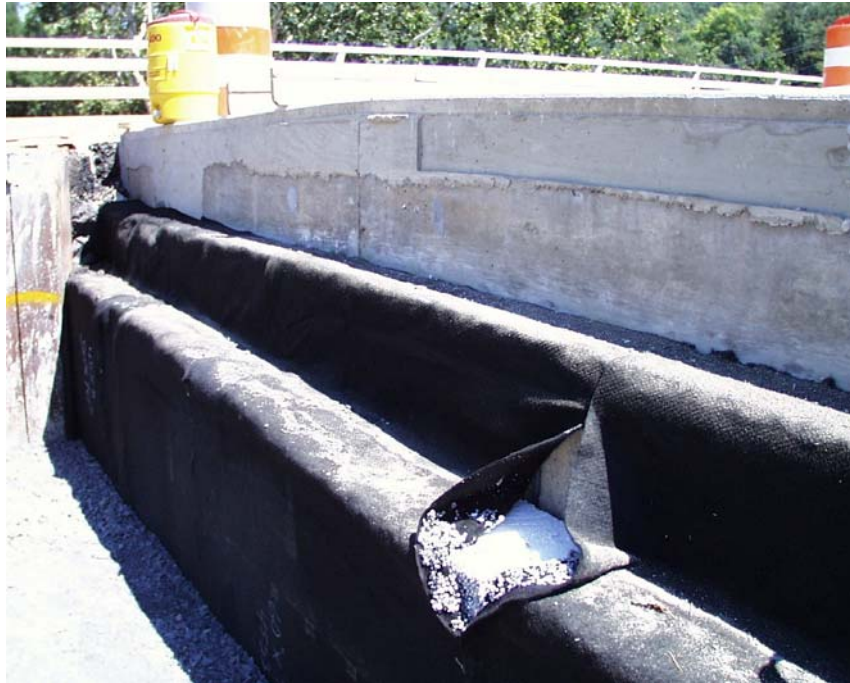
**Figure 4. Elasticized EPS at the Backwall**

Figure 4 shows the elastic inclusion, covered with geotextile fabric, installed at the bridge backwall. VDOT Type I-21B well-graded aggregate backfill material was used at the abutment. It had a grain size distribution as shown in Table 1. Granular backfill was compacted in lifts of approximately 0.20 m (8 in) each, with a hand-operated compactor used in the direct proximity to the backwall.

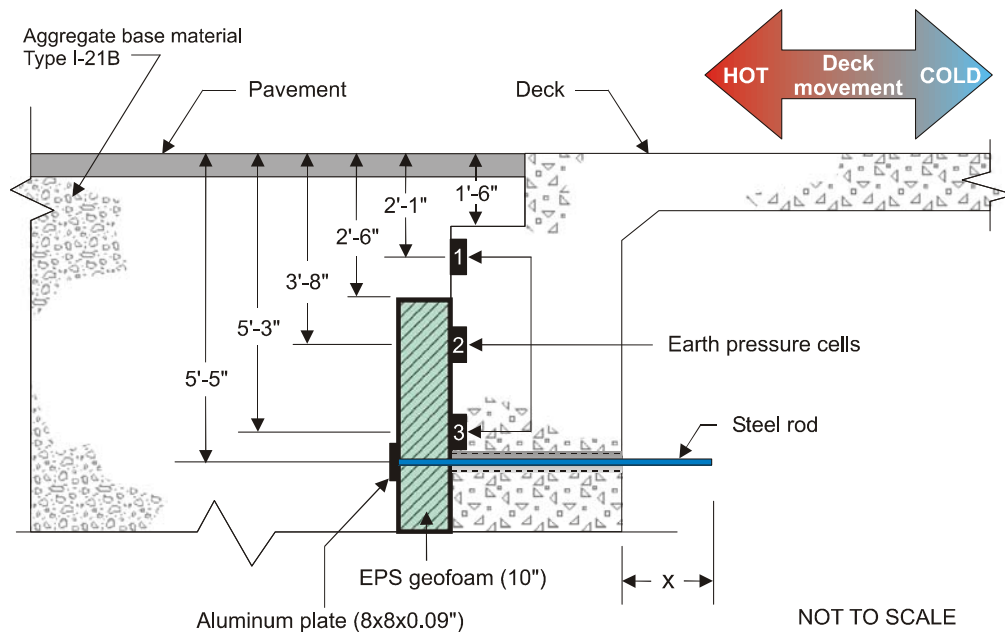
**Figure 5. Integral Backwall Instrumentation**

Electronic instrumentation included earth pressure cells installed at the backwall, strain gages attached to girder flanges, linear displacement transducers measuring girder movement

relative to the anchor bolt, and tiltmeters recording the shelf abutment rotation. Earth pressure cells and strain gages were of the vibrating-wire type for long-term stability. All sensors were interfaced with Campbell Scientific CR-10X dataloggers, sampling every hour. Figure 5 shows the locations of earth pressure cells installed at the integral backwall. These cells were positioned at 0.63 m (2.08 ft), 1.12 m (3.67 ft), and 1.60 m (5.25 ft) below grade and at a 6.3-m (20.6-ft) horizontal distance from the wingwall face. The uppermost cell (sensor 1) was in direct contact with the backfill material. The remaining cells (sensors 2 and 3) were placed behind the EPS layer. All pressure cells were recessed in the backwall, with the sensing surface flush with the backwall surface.

A simple telltale gage was installed to measure the thickness of the elastic inclusion in service. This gage consisted of a 200 by 200 by 2 mm (8 by 8 by 0.09 in) aluminum plate attached to the face of EPS, with a connecting stainless steel threaded rod of 5 mm (3/16 in) diameter, protruding through the opening in the backwall, as shown in Figure 6. The gage was located at approximately the same depth as the earth pressure sensor 3, but with a small horizontal offset of 0.45 m (18 in). Periodic measurements of the length of the protruding rod (distance  $x$ ) indicated the magnitude of EPS compression. These manual measurements were typically conducted during the hottest and coldest times of the year to reveal the full range of EPS working strains and to detect signs of the material creep. All ambient air temperatures were recorded under the deck, in the proximity of the backwall. These temperatures were typically more moderate (cooler in the summer and warmer in the winter by about 8 to 10 degrees) than were topside readings.

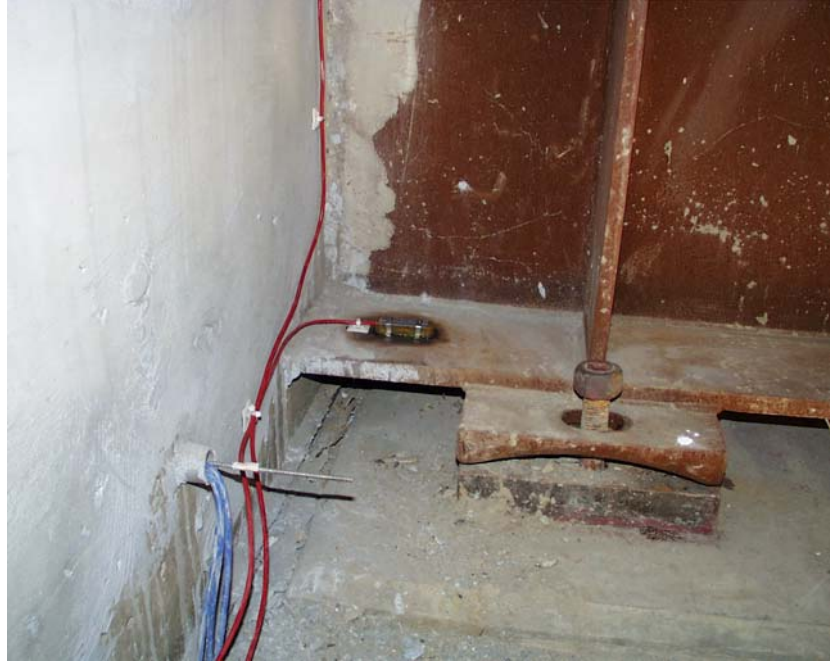
**Figure 6. EPS Rod and Lower Flange Strain Gage**

Two strain gages were installed at the end of one girder, between the bearing assembly and the backwall. One gage was placed on the top flange, 89 mm (3.5 in) away from the web and 160 mm (6.3 in) away from the stiffener. The other was placed on the lower flange, 101 mm (4 in) away from the web and 210 mm (8.3 in) away from the stiffener, as shown in Figure 6.

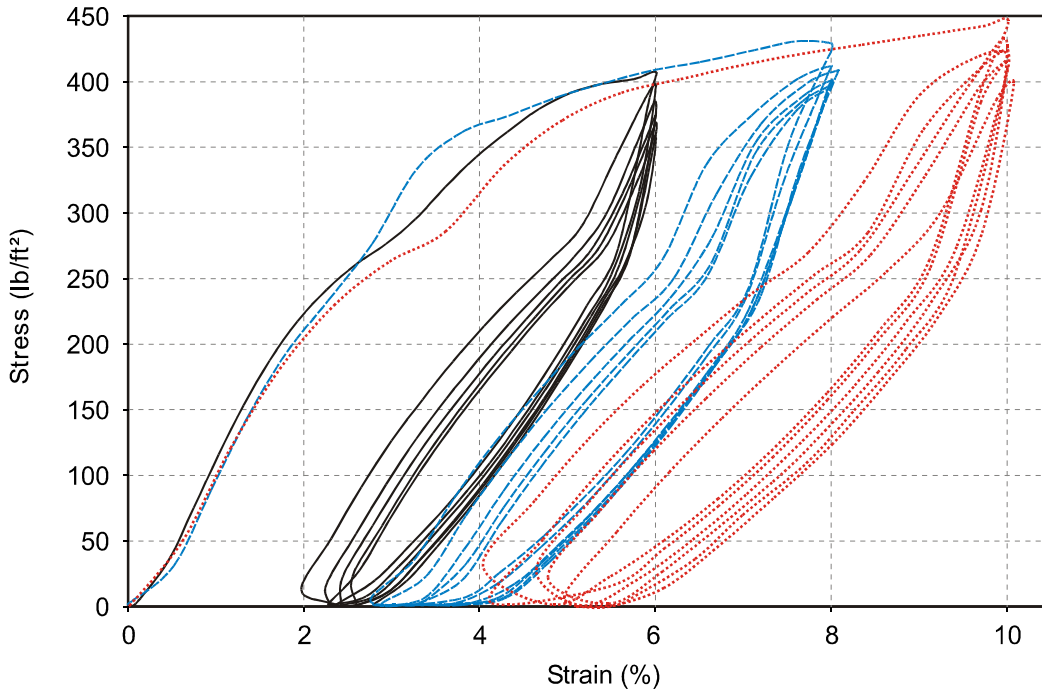
**Figure 7. Cyclic Stress-Strain Properties of the Elasticized EPS**

Cyclic stress-strain tests were conducted at the Virginia Military Institute (VMI) on EPS samples provided by VDOT.<sup>2</sup> The results are shown in Figure 7. A new sample was used for each cyclic test, and each specimen was loaded for a total of 6 cycles in 48 hours. The change in slope at a stress level of approximately 270 psf (13 kPa) was traced to a change in the stiffness of the measuring device. It is important to recognize that neither the VMI test results nor the ones presented in Figure 3 reflect the ASTM D1621 Standard Test Method for Compressive Properties of Rigid Cellular Plastics, which specifies the loading rate of 2.5 mm/min (0.1 in/min) for each 25.4 mm (1 in) of specimen thickness.

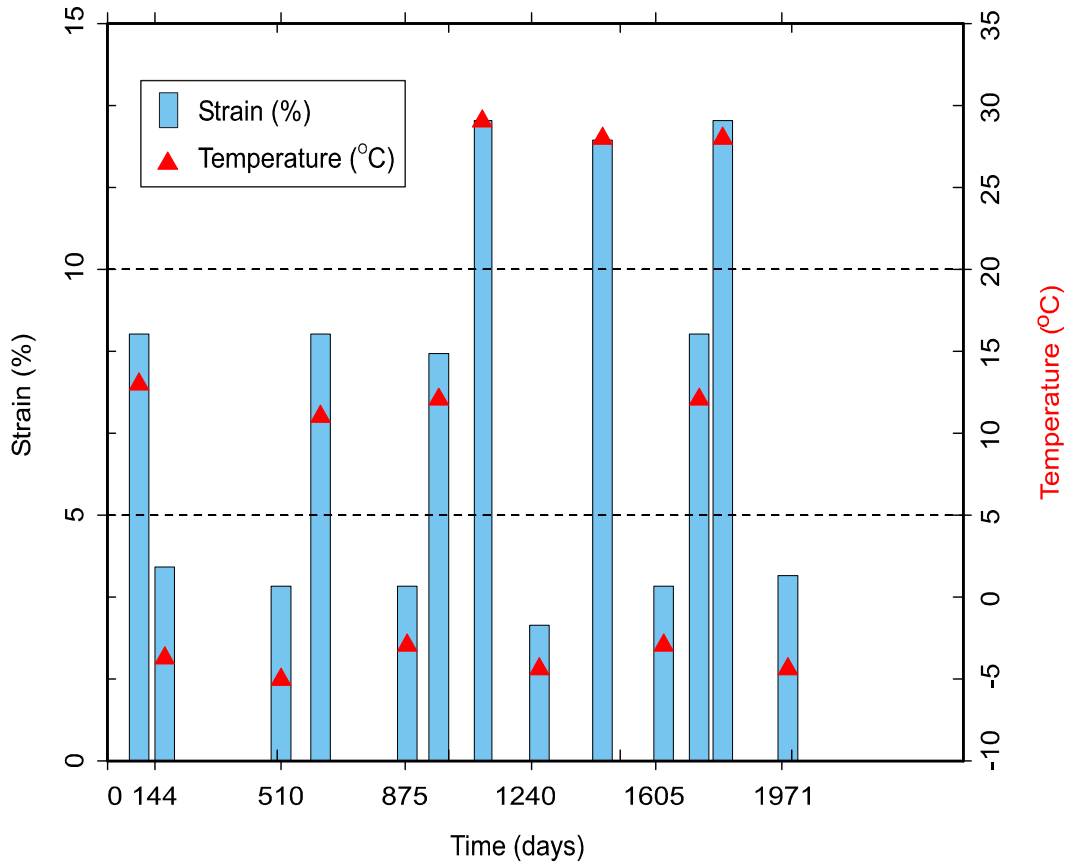
**Figure 8. Strain-Temperature-Time Behavior of Elasticized EPS**

Figure 8 shows the strain-temperature-time behavior of the elastic inclusion from November 1999 to January 2005. The graph shows data points reflecting measurements made during the highest, lowest, and mid-range of recorded ambient air temperatures. Bars represent the EPS strain, and triangles mark the corresponding air temperature under the bridge. The range of working strains from 4 percent to 13 percent corresponds to 23 mm (0.9 in) of backwall movement. Numbers on the time axis indicate days elapsed from the time of backfill compaction to the end of the following year. The latest reading was taken at 1,990 days, on 1/19/2005.

Backfill behind the instrumented bridge abutment was compacted on 8/11/1999. Immediately after compaction, the EPS strain was 11 percent, resulting from the lateral pressure exerted by the backfill material, coupled with compaction-induced stresses. Approximately 2 weeks later, on 8/25, the strain relaxed to 8 percent, with the ambient air temperature about 3 degrees lower. Subsequently, the observed pattern was that of EPS strain increasing and decreasing with the rising and falling of the air temperature.

The recorded range of girder displacements (LVDT measurements) relative to anchor bolt at Abutment A was 28.10 mm (1.1 in). With the estimated point of foundation pile fixity at a depth of approximately 2.5 m (8.3 ft), the shelf abutment tilt (rotation) was negligible (0.005 radian), corresponding to less than 1 mm (0.04 in) of lateral movement. Assuming that the girder displacement can be directly related to the EPS compression, the resulting strain ranged between 2.4 percent and 13.4 percent during the 5 years of monitoring.

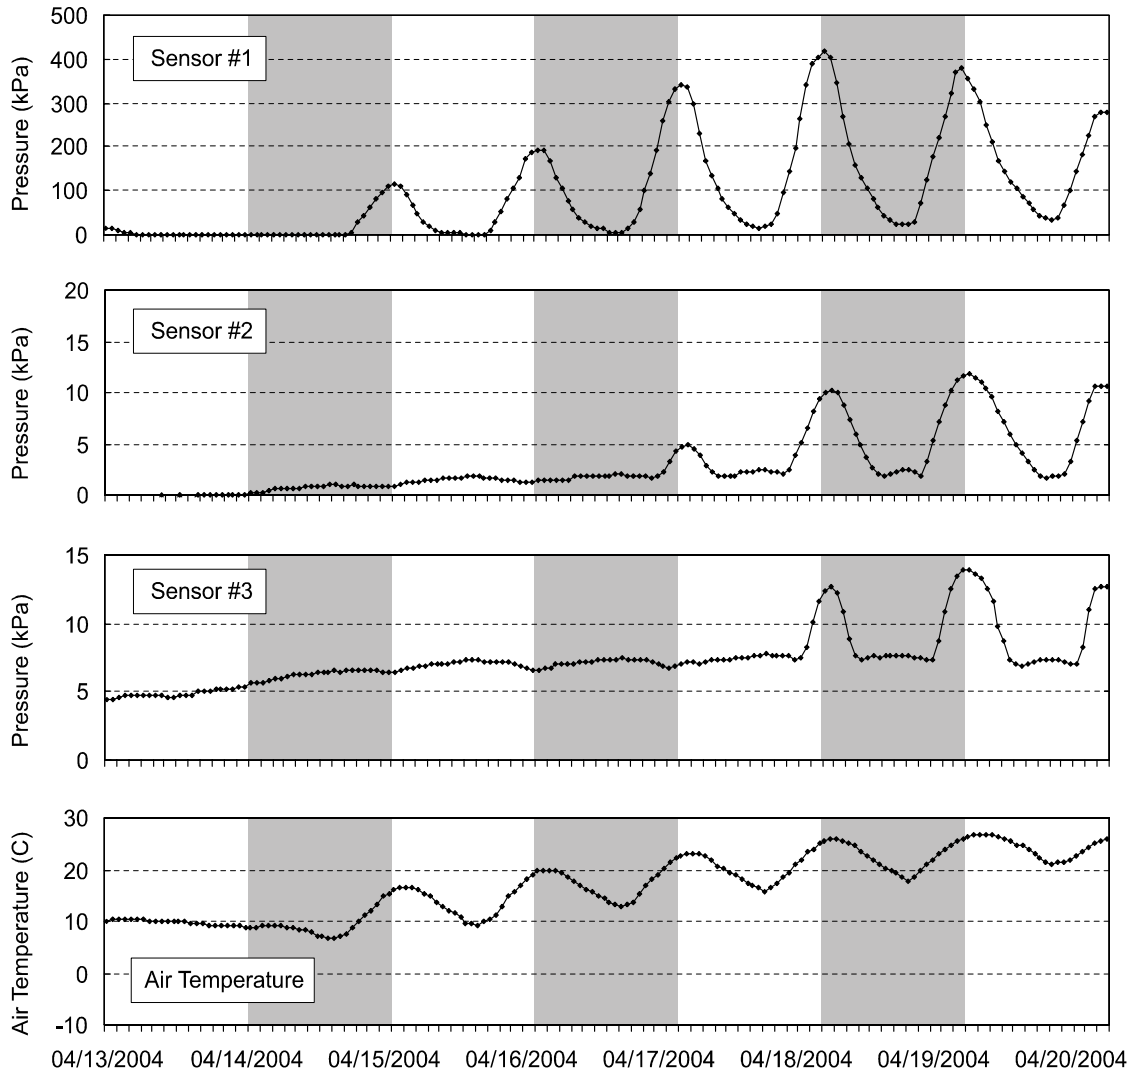
**Figure 9. Earth Pressures from 4/13/2004 to 4/20/2004**

The largest sensor 1 pressure reading of 417.8 kPa (8,723 psf) was recorded on 4/18/2004. Figure 9 shows earth pressure data for the period 4/13/2004 to 4/20/2004. As may be seen from the air temperature record, this was a period of a rapid warm-up from approximately 10 to 26 °C (50 to 80 °F), following a prolonged period of cool weather. At the same time, pressures registered by sensors 2 and 3 (behind the EPS) were much lower.

The pressure spike of 417.8 kPa (8,723 psf), registered at sensor 1, corresponds to the passive earth pressure coefficient of 27.3, based on the estimated bulk unit weight of the backfill material of 24.1 kN/m<sup>3</sup> (153 pcf). This translates into a substantial, although transient, passive load acting on the abutment. The pattern of observed backfill-structure interaction is that of a significant earth pressure buildup during a period of a sudden warm-up, corresponding to the superstructure expanding relatively quickly against the adjoining backfill. It is most likely indicative of a typical stress-strain behavior of a dense granular material, reaching high peak strength (and a correspondingly high internal friction angle) before decreasing to a residual strength. The magnitude of 417.8 kPa (8,723 psf) and the corresponding  $K_p$  of 27.3 should be kept in perspective. This event occurred only once in the 5-year monitoring period. A typical pattern of recorded earth pressures implies that the log spiral theory offers a reasonable approximation of  $K_p$ ; however, the occurrence of very high transient earth pressures should be accounted for in the bridge design process when no elastic inclusion is incorporated.

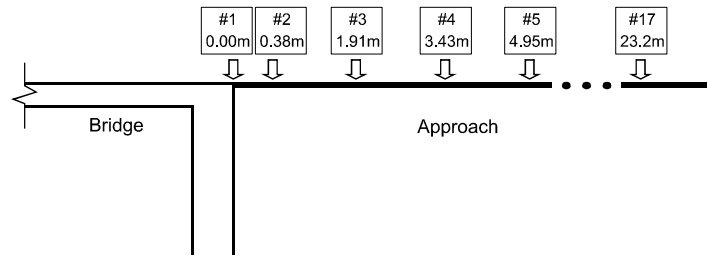
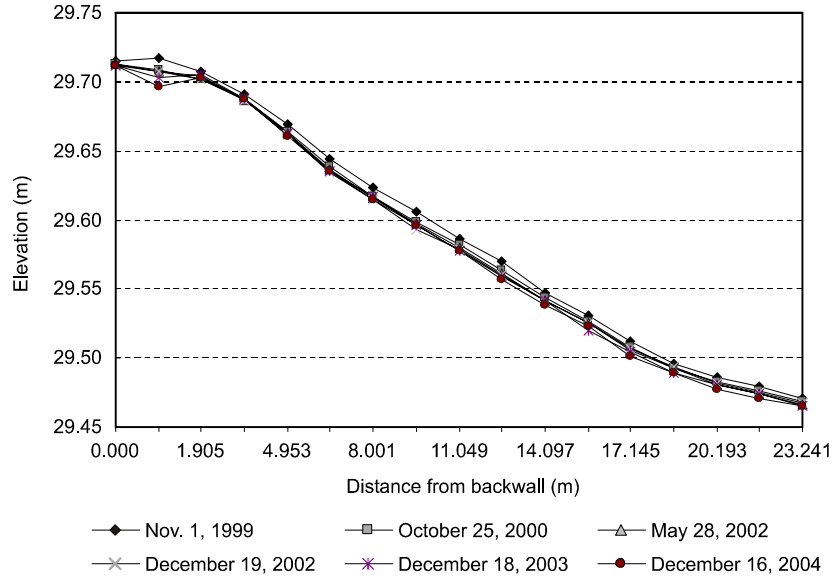
**Figure 14. Approach Elevations**

Approach elevations were monitored periodically between 11/1/1999 and 12/16/2004, as shown in Figure 14. Since the bridge was opened to traffic at the beginning of November 1999, the approach pavement was patched only once in the immediate vicinity of the bridge as a result of excessive differential settlement. The remedial work, consisting of placing approximately 50 mm (2 in) of asphalt plant mix over a strip of roadway 0.6 m (2 ft) wide, was performed on 9/5/2002. Figure 15 shows the resulting patch.

Roadway approach elevation records indicate that most of the post-construction settlement took place within 1 year of opening to traffic. Embankment elevation records point to the approach zone most prone to settlement (although still manageable) extending to about 1.5 m (5 ft) beyond the backwall, where approximately 11 mm (0.43 in) of settlement occurred between 12/19/2002 (following asphalt patching) and 12/16/2004. No excessive differential settlements were observed in the remaining segment of the bridge approach, with the maximum of 14 mm (0.6 in) recorded at 12.6 m (41 ft) beyond the backwall during the 5-year monitoring period. This magnitude of settlement can be regarded as tolerable.

The lateral extent of observed settlements indicates that a relatively short approach slab would adequately serve the purpose of providing a grade transition. A shorter approach slab would be easier for the superstructure to push and pull during cyclic movements if the embankment settlement and the corresponding slab rotation at the backwall were relatively small. Large anticipated settlements necessitate the use of long approach slabs.

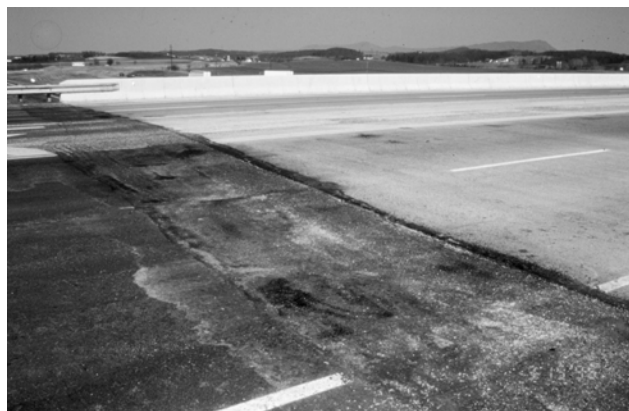
**Figure 16. Roadway Approach at the Route 257 Integral Backwall Bridge**

In addition to reducing passive earth pressures, the purpose of an elastic inclusion is to absorb cyclic backwall movements without disturbing the adjacent backfill material, which typically results in amplified settlement. This problem manifested itself at the integral backwall bridge on Route 257 over I-81 in Rockingham County.<sup>8</sup> Figure 16 shows the approach pavement that has been repeatedly patched because of persistent settlement. The bridge is approximately the same length as the one monitored in this study, but with no elastic inclusion installed at the backwall.

cost of approach repairs at the Route 257 bridge (Figure 16) has been \$2,300 annually.<sup>21</sup> Repairs have been carried out repeatedly for the past 12 years.
