FINAL
CONTRACT REPORT
VTRC 07-CR14

**DEVELOPMENT AND EVALUATION
OF AN ADHESIVELY BONDED PANEL-TO-PANEL
JOINT FOR A FIBER-REINFORCED POLYMER
BRIDGE DECK SYSTEM**

A fiber-reinforced polymer (FRP) composite cellular deck system was used to rehabilitate a historical cast iron thru-truss structure (Hawthorne Street Bridge in Covington, Virginia). The most important characteristic of this application is reduction in self-weight, which raises the live load-carrying capacity of the bridge by replacing the existing concrete deck with an FRP deck. This bridge is designed to an HL-93 load and has a 75-ft clear span with a roadway width of 22 ft. The panel-to-panel connections were accomplished using full width, adhesively (structural urethane adhesive) bonded tongue and groove splices with scarfed edges.

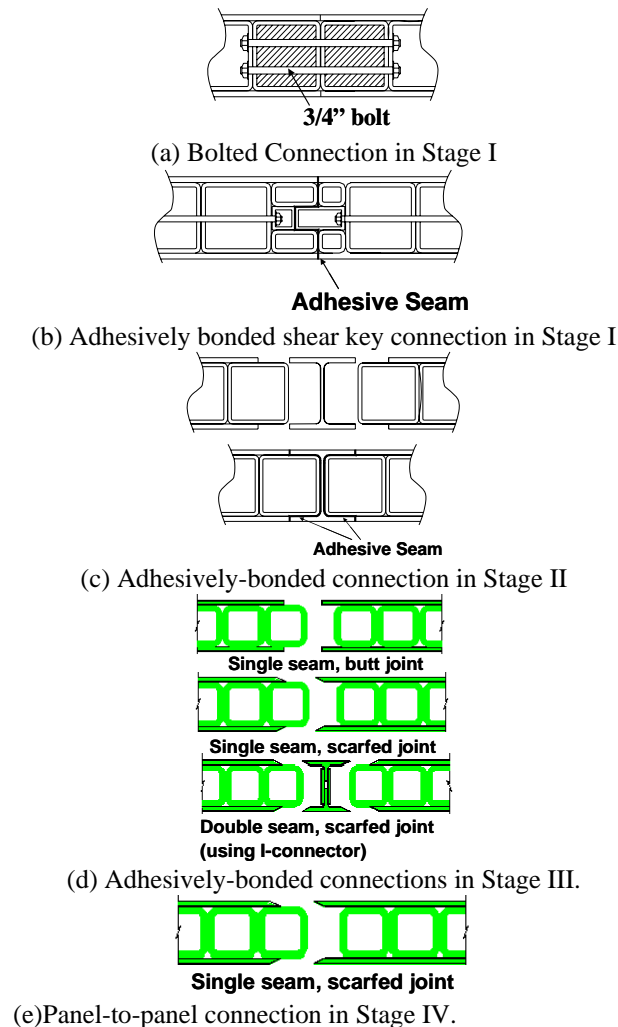
The research began with a project conducted by Christopher T. Link (Link 2003) and is referred to as Stage I. Two panel-to-panel connections were developed and tested, as shown in Figure 2(a) and (b). One was a bolted connection and the other was an adhesive shear-key joint. Results showed that the bolted joint could carry the design load, but was susceptible to fatigue damage. Although the adhesive shear-key connection showed less capacity than bolted connection, it showed more promise than a bolted connection because of better fatigue performance and a linear behavior up to failure, with a progressive, nearly “ductile” failure mode.

Figure 2. Evolution of panel-to-panel connections at Virginia Tech

In Stage II, a full-length, simplified adhesively-bonded tongue and groove panel-to-panel connection [Figure 2(c)] was tested in a weak-direction (beam) bending configuration. The testing showed some promising aspects: linear behavior up to failure stage; crack initiation after design service load strain was reached; and a factor of safety of 2.4 with respect to the anticipated service strain. Testing results indicated the adhesive bonding was a viable technique in using with panel-to-panel joint for FRP decks. Stage III research was aimed to further optimize this design.

Two types of adhesively-bonded panel-to-panel connections with scarfed joints were tested in Stage III: one single seam connection and one double seam connection, as shown in

Figure 2(d). A plate bending setup with three sides simply supported and one side free (which approximates the support condition near an abutment) was used to better represent the on-site situation instead of one-way bending setup in Stage II.

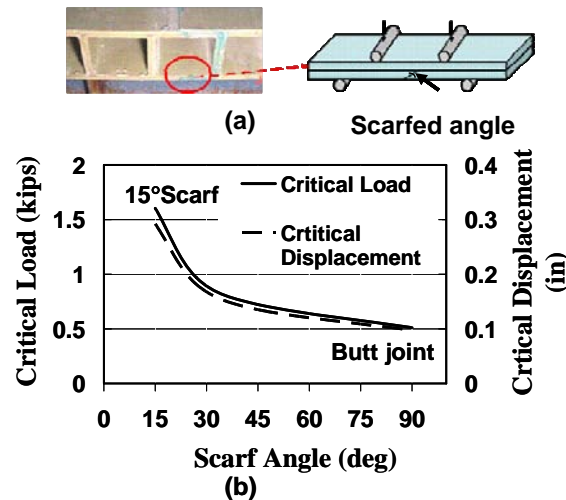
In Stage III, different connection geometries (scarfed vs. butt joint behavior) were investigated. The joining effectiveness of simple butt joint geometry was tested as shown in Figure 2(d). Premature cracking was observed in the butt joint area. To eliminate this tendency the joints in Stage III panels were sloped or scarfed, as shown in Figure 2(d). The testing setup and the mimic part of the FRP deck system are shown in Figure 3(a). Test results (Soto J et al. 2004) indicate that FRP samples with a scarfed edge have better performance than those having a butt joint (90°) under a four-point bending configuration, as shown in Figure 3(b). The critical load and displacement (at crack initiation) increased as scarf angle decreased. But for FRP deck panels, sharper scarf angles (smaller than $1/2$ slope) are difficult to manufacture and can be easily damaged during transportation and installation. Therefore, scarf joints with an angle of 27° ($1/2$ slope) were used on the test specimens and recommended for future field application.

Figure 3. Critical load and displacement increased as scarf angle decreased, under 4-point bend test.

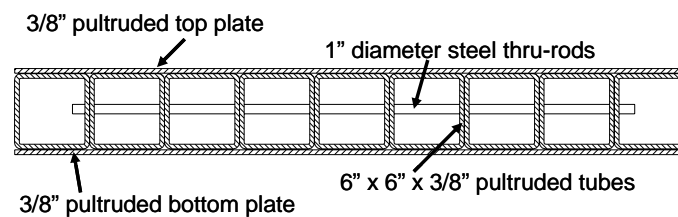
are made of E-glass roving and continuous strand mat embedded in polyester resin. The typical cross section of a deck panel is shown in Figure 4. The off-the-shelf components include: 6 in. x 6 in. x 3/8 in. pultruded EXTREN® tubes, 3/8 in. pultruded EXTREN® top and bottom plates as well as 1 in. diameter steel thru-rods. The tubes, top and bottom plate are adhesively bonded to form FRP bridge deck panels. The steel thru-rods are used to provide necessary binding forces when the deck panels are in curing. Bonding is accomplished in a vacuum bag to produce uniform pressure and continuous bonding.

Figure 4. Cross section of the Strongwell FRP Deck System

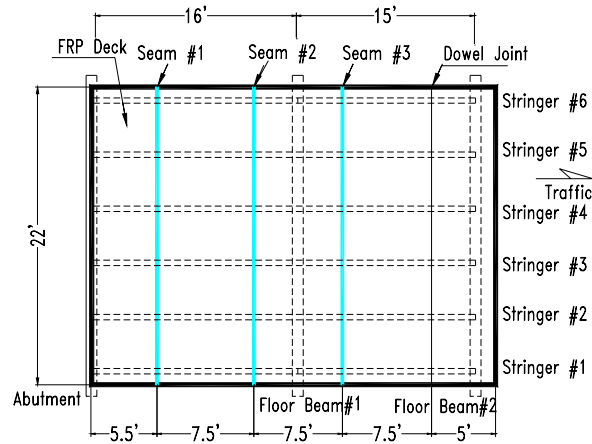
Figure 5 shows a plan view of deck panels, panel-to-panel connections, and supporting steel superstructure. The FRP deck specimen consisted of five individual modular deck panels that were jointed together using three adhesive panel-to-panel connections (Seam #1 through #3) and one dowel joint. The dowel joint was developed as an expansion joint for future applications, and will not be discussed here. Each individual panel was 22 by 7.5 ft., with the exception of the two end panels which measured 22 by 5.5 ft., and 22 by 5 ft. These individual panels were connected to form a full width 22 ft. panel that was about 33 ft. long in the direction of traffic.

Figure 5. FRP deck panels and joints of the Hawthorne St. Bridge mock-up.

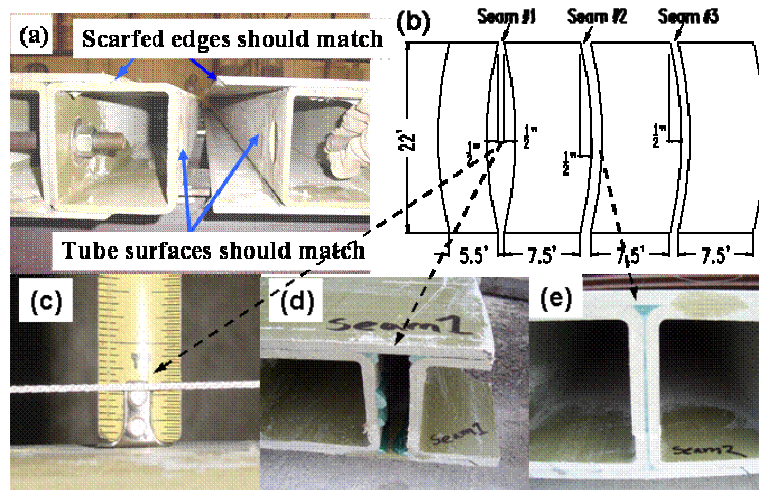
During dry-fitting of three panel-to-panel connections, it was found that the sweep of the tubes was not well controlled during pultrusion. Figure 6(b) shows the curved panels resulting from the use of curved tubes. Each panel had a pre-existent sweep with a midway deflection about 0.5 in. (Figure 6(c)). The worst case was Seam #1 with two opposite curvatures at the side walls of the tube bonding surface. Although Seam #2 and #3 also had similar curvatures, mating tubes were bent in the same direction. The deck panels were autopsied after testing was completed to further investigate the bonding quality. Figure 6(d) shows that the gap distance between two bonding tube surfaces of Seam #1 was about 1 in. The gap distances of Seam #2 and #3 were less than 0.1 in. and all scarfed edges matched well. Figure 6(e) shows the bonding quality of Seam #2.

Figure 6. Fitting of the adhesively-bonded panel-to-panel connection.

Quality control procedures were adopted to prevent such out-of-straightness of panels in future application. The manufacture quickly improved the panel quality by using stricter quality control procedures during pultrusion and bonding of tubes. The quality of the panels used in the actual bridge was much improved (described later in this report). The gap distance reported above for Seam #2 and Seam #3 were typical of what was seen in the field.

6. Aligning the tongue-end panel (the left side of the connection in Figure 6(a)) so that the tongue fits in the groove.

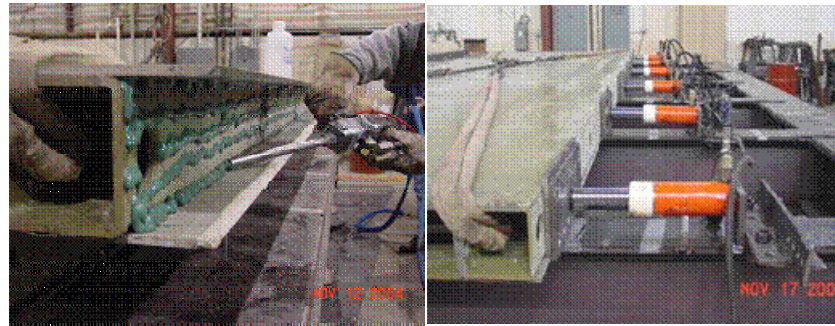
(a) Adhesive application

(b) Jacking system

Figure 7. Adhesive construction for panel-to-panel connection.

7. Joining deck panels by equal jacking pressure from six hydraulic jacks with a manifold system, shown in Figure 7(b). Enough pressure must be applied to close the joint and ensure that adequate adhesive squeezes out.
8. Maintaining the jack pressure for about 12 hours, until the adhesive cured.
9. Bolting down the deck panel to the stringers with deck-to-stringer connectors.
10. Going through steps (3) through (9) for another adhesive connection.

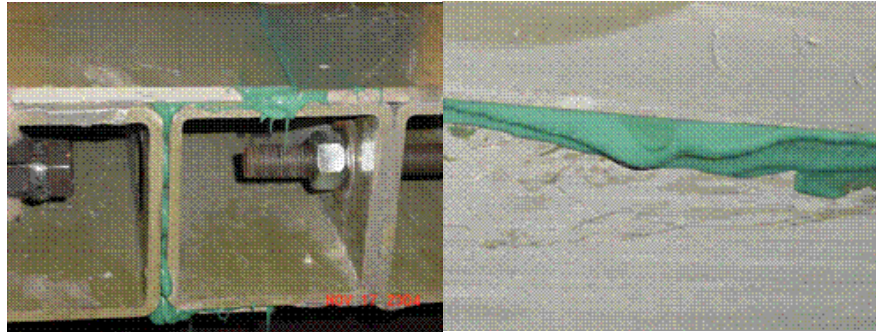
The performance of adhesive bonding is not only dependent on the matching condition of mating parts, surface preparation, and joint geometry as discussed above, but also the amount of adhesive applied. Adequate adhesive squeeze out is a sign that adequate adhesive was applied and is recommended as the quality control check-point in field construction. Increasing amounts of adhesive was applied to the three seams in order to compare performances of seams with different amounts of adhesive (Seam #3 had the most and Seam #1 had the least). Seam #3 was thought to be the best joint with the best fit and sufficient adhesive squeeze out. Figure 8 shows Seam #3 after adhesive was applied and adequate adhesive squeezed out from the top, side and bottom of the joint. Although Seams #1 and #2 performed well during static tests (discussed in a later section), the amount of adhesive used for Seam #3 was selected as enough to ensure adequate strength and life of the panel-to-panel connection.

(a) Side view

(b) Bottom view

Figure 8. Adhesive squeezing out from joints during adhesive construction.

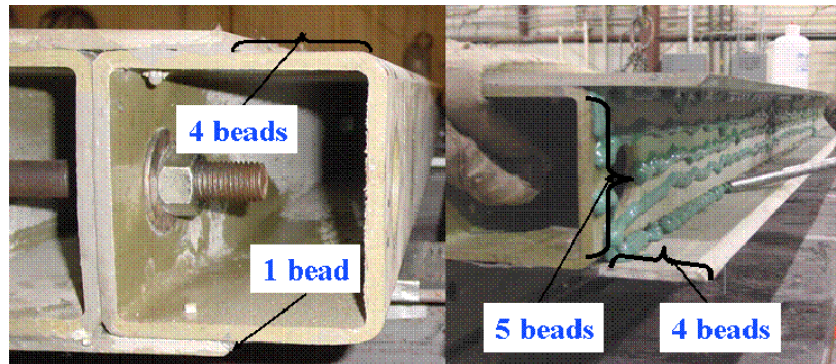
The Pliogrip 8000/6660 two-component, structural urethane adhesive system from Ashland Chemicals Inc. was used in this application for its superior adhesion property, UV resistance and proper glass transition temperature. Figure 9 shows how the adhesive beads were applied on the tongue and groove parts. Each bead had a width of about 0.4-0.6 in. and a thickness of about $\frac{1}{4}$ - $\frac{1}{2}$ in. One bead of adhesive was applied on each scarfed edges. The amount of adhesive applied per connection was about 14.2 Liters of Pliogrip 8000 and 6.3 Liters of Pliogrip 6660.

(a) Adhesive on tongue part

(b) Adhesive on groove part

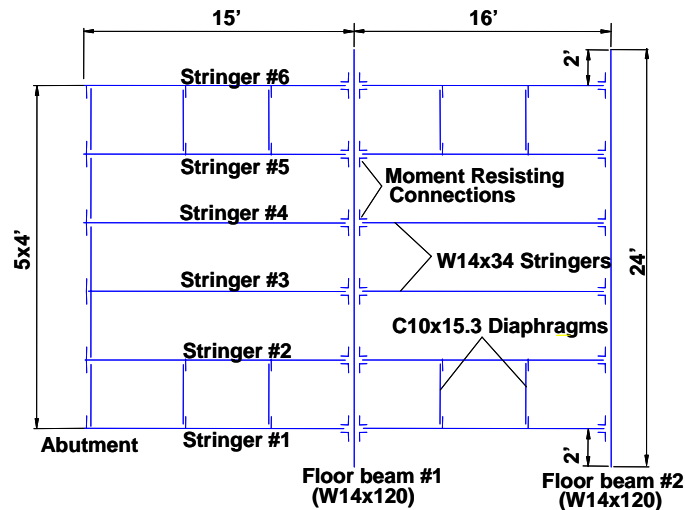
The steel frame mock-up of the Hawthorne St. Bridge superstructure consisted of two bays, which were 16 ft. and 15 ft. in length in the direction of traffic. Figure 10 shows a framing plan of the steel superstructure. Each bay had six wide-flange W14x34 stringers, having a transverse spacing of 4 ft. on-center. Diaphragm members, consisting of C10x15.3 steel sections, were bolted to connector plates, which were in turn welded to the stringers. Two W14x120 floor beams were supported by four pedestals that simulated the hangers in the through-truss bridge. All steel member sizes and dimensions mimic the actual ones in the Hawthorne St. Bridge superstructure. Neoprene pads were used between floor beams and pedestals to avoid direct contact of steel and to allow some movement at floor beam ends. Stringers and floor beams were jointed together using moment resisting connections. A W21x132 beam was used to simulate the concrete abutment in situ, and five end diaphragms (C10x30) were flush with the top stringer to avoid free edge effect of the FRP deck. All stringers at the abutment rested on the bearings anchored on the abutment.

Figure 10. Framing plan of the steel superstructure of the Hawthorne St. Bridge mock-up.

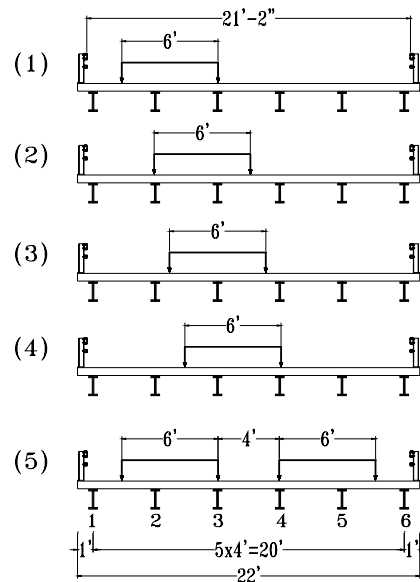
Five Load Cases used for service load tests are shown in Figure 11. All Load Cases followed HL-93 truck weights and dimensions to apply the worst-case load scenario to the FRP deck and superstructure. Load Cases 1–4 were single truck cases. Load Cases 1, 2 and 4 were the

critical cases for flexure of an FRP deck transverse to the traffic, with a wheel located at mid-span between two stringers. Load Case 3 represented a truck straddling on Stringer 3. Load Case 5 is the symmetric case, with double trucks representing the full lane Load Case.

Figure 11. Load Cases for service load test.

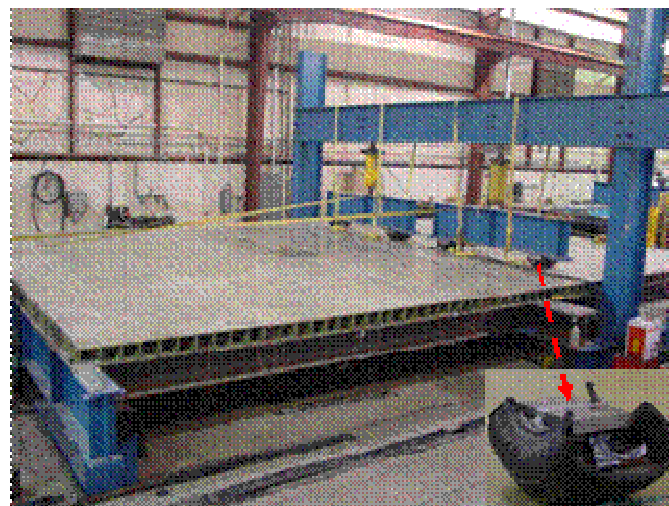
The double truck service load test (case 5) was simulated by two single-truck setups, as shown in Figure 12. A special loading patch (Figure 12) which consisted of a quarter tire internally reinforced with silicone rubber was used to mimic the cushioning effect of a pneumatic tire. This was done to minimize the local stress concentrations of a standard rectangular steel patch because of the relative local flexibility of the FRP composite cellular decks, as compared to the steel plate (Zhou et al. 2005).

Figure 12. Experimental Setup for service load test (Load Case 5) on Seam #3.

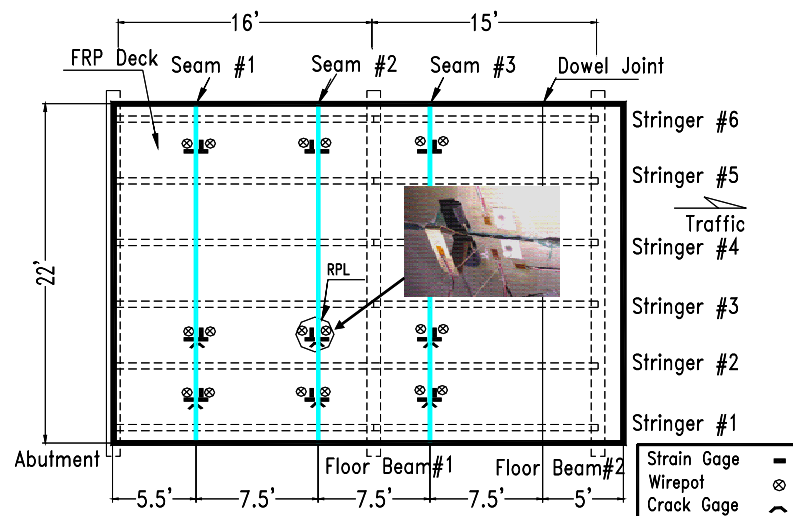
The schematic of the instrumentation plan used to investigate the performance of adhesively-bonded joints is shown in Figure 13. The stringers and floor-beams are referred to as “Stringer #1” through “Stringer #6” and “Floor Beam #1” and “Floor Beam #2.” For consistency throughout the discussion, all references to “longitudinal” and “transverse” are given with respect to the bridge deck orientation; thus, “longitudinal” implies parallel to the pultruded tube direction of the FRP deck system, and the “transverse” direction refers to the traffic flow direction (perpendicular to the tube axis).

Figure 13. Instrumentations for three adhesively-bonded panel-to-panel connections (underneath the deck).

The representative span deflection and crack gauge responses at one location, location RPL (shown in Figure 13) under Load Case 4 are shown in Figure 14. The load vs. strain and load vs. deflection behaviors were observed to be fairly linear elastic up to the design service load. The absolute deflection at the mid-span of the deck was 0.335 in., as shown in Figure 14(a), and the relative deflection at this point with respect to supporting stringers was 0.074 in. at the design service load, which indicated an L/649 response.

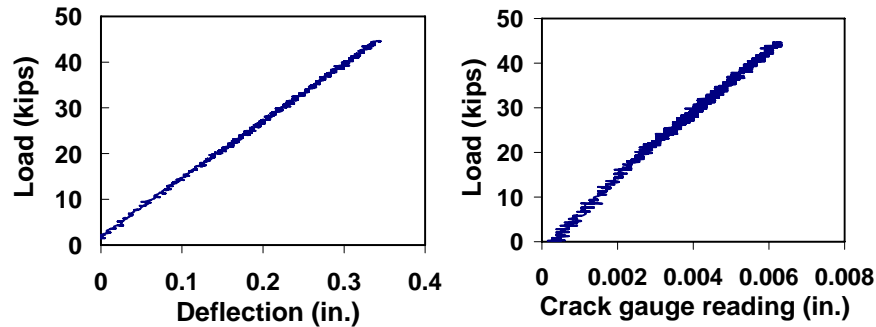
At location RPL under Load Case 4, the longitudinal strain on the bottom plate right under the load patch was $1090\ \mu\epsilon$, which is only 6% of the estimated ultimate strain of the bottom plate. Transverse strain at one side of the seam close to the loading patch was $490\ \mu\epsilon$ at the design service load, which was about 45% of the longitudinal strain at this load. However, transverse strain at the other side of the seam was $-290\ \mu\epsilon$ at the design service load, which was in compression; this indicated that this region experienced double curvature due to an applied load at one side of the seam. The linear response of crack gauge indicates that no crack was initiated up to design service load, as shown in Figure 14(b).

(a) Load vs. deck overall deflection (b) Load vs. crack gauge reading

Figure 14. Representative plots in service load tests

As shown in Figure 14, at the bottom surface of the deck, two strain gauges and two wire pots (displacement transducers) were used to measure transverse strains and displacements, respectively, at both sides of the joint. Another strain gauge was placed to measure longitudinal strain at the side of the adhesive joint adjacent to the load. A specially-designed crack detection gauge [shown in Figure 13] was installed across each joint to monitor crack opening, if any. This instrumentation pattern was repeated for each loading location while testing near a joint. Load, deflection, and strain were continuously recorded during testing using a high-speed data acquisition system.

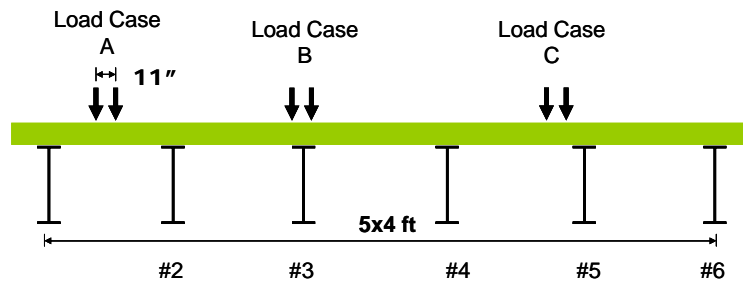
adhesively-bonded panel-to-panel connections. Figure 15 shows three different Load Cases. These cases were designed to study which one is the worst case and what is the corresponding failure mode. Load Case A was the critical case for flexure of the FRP deck transverse to traffic, with a pair of tire patches located at mid-span between Stringers #1 and #2. Load Case B is a pair of tire patches straddling Stringer #3, which is the critical case for compression. Load Case C is a pair of tire patches sitting just at the edge of Stringer #5, which is the critical case for punching shear. The same setup and procedure were used and will not be discussed in detail here. All testing data from strength tests are included in Table 3 for comparison. Test results show that Case A (flexure of the FRP deck transverse to traffic) is the critical case, Other Load Cases had larger safety factors, calculated as failure load at crack initiation divided by the design service load.

Figure 15. Load Cases for strength tests on as-received deck.

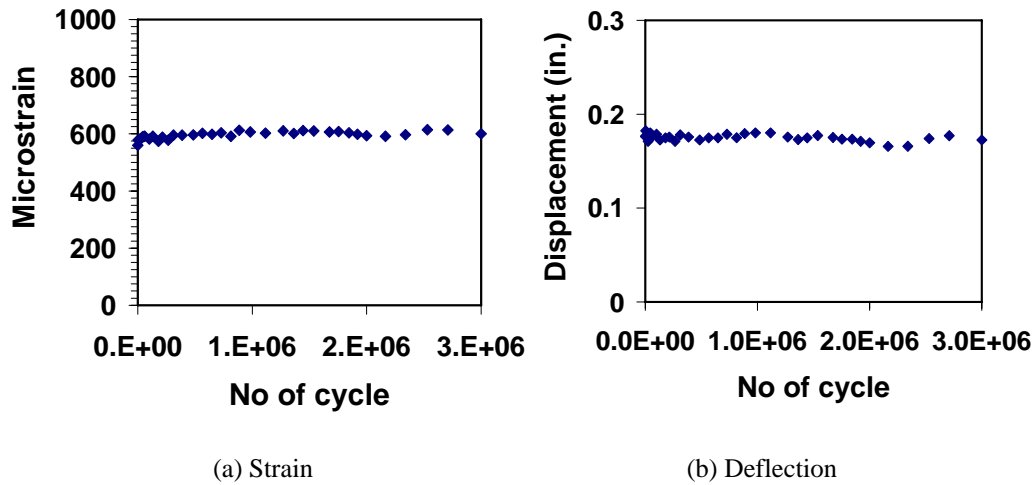
The maximum deflection and strain measurements at the service load (22 kips) taken during each static test can be seen in Figure 16(a) and (b), respectively. The deflection and strain responses remained fairly constant for all of the static service load tests, and the deck demonstrated no apparent loss in stiffness near the adhesive joint. The crack gauge measurements taken during the static test after 3,000,000 cycles show linearly response indicating no crack was initiated after 3,000,000 cycles. Similar deflection measurements at two sides of the adhesive joints during the static test after 3,000,000 cycles also demonstrated that no crack was initiated inside the joint.

Figure 16. Maximum strain and deflection at service load after interrupted fatigue loading.

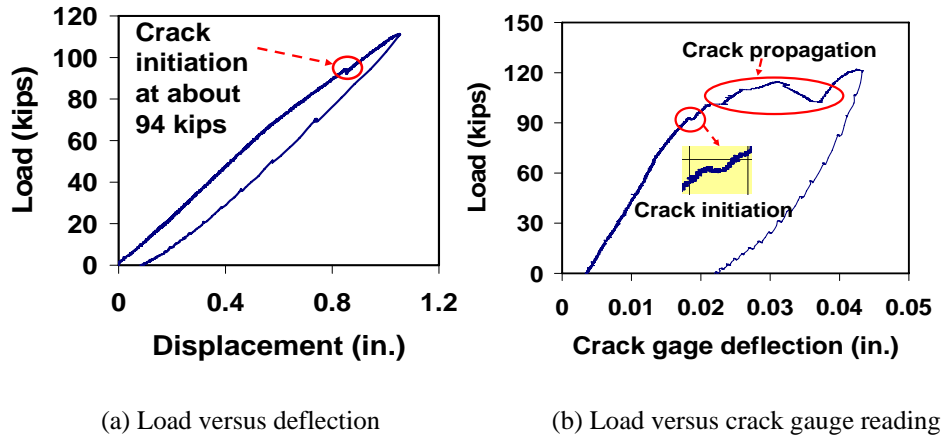
The fatigue test was followed by a residual strength test at the same location. Figure 17(a) shows the load versus deflection plot and Figure 17 (b) shows the load versus crack gauge plot. Both responses showed fairly linear-elastic behavior up to the crack initiation of the adhesive joint after 3,000,000 fatigue cycles. The first failure (crack initiation in the joint) occurred at 94 kips. At the crack initiation point, both plots showed a significant drop due to stiffness loss caused by cracking in the adhesive joint. Figure 17(b) also shows a clear crack propagation stage after crack initiation. The critical loads at initiation of crack after fatigue and without fatigue shown in Table 3 indicate no significant loss in strength after fatigue.

Figure 17. Crack gauge and deck deflection results from residual strength test after 3,000,000 cycles

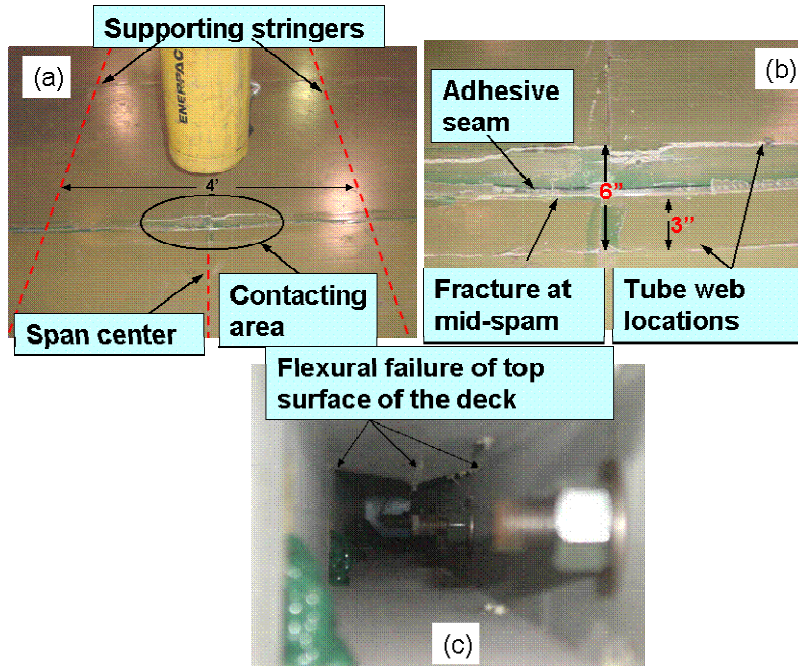
The failure mode observed on the seam that was fatigued to 3,000,000 cycles and then tested to failure is very consistent with that observed on two adhesive seams tested to failure without being fatigued. For all seams in the ultimate test, the failure areas were highly localized and right under the tire patches, as seen in Figure 18(a). Failure mode was flexural failure of the top plate and top flange of the tube. Three cracks could be seen (Figure 18(b)). Two cracks developed along two webs of the tube under the loading tire patch, and one crack was at about the center of the 6 in. span between two webs of the tube. Figure 18(c) shows a side view of the top surface flexural failure; no crack was observed on the tube webs. Also, no visible crack was observed at the bottom side of the deck near the adhesive joint after the top surface failed. From these results, it was concluded that the top plate and the top flange of the tube failed in weak-axis bending, with cracking parallel to the tube webs.

Another important observation from Figure 18(b) is that although the fracture at mid-span of two webs of the tube was near the adhesively-bonded line, no failure was observed in the adhesive layer or in the joint interface. This suggests the adhesive layer and adhesive-substrate interface are stronger than the FRP components and that adhesive bonding is a viable technique for the panel-to-panel connections in FRP bridge deck system. In addition, the tests demonstrated ductile failure rather than a total collapse, which would provide plenty of time for evacuation and maybe considered as another advantage of this FRP deck system.

Figure 18. Failure mode in strength test (a) Highly localized surface failure (b) Failure detail on top surface of the deck (c) Side view of the flexural failure of top surface.

5. The failure in the top plate and the top flange of the tube was caused by weak-axis bending, with cracking parallel to the tube webs. This is also consistent with the failure mode in strength tests of as-received decks.

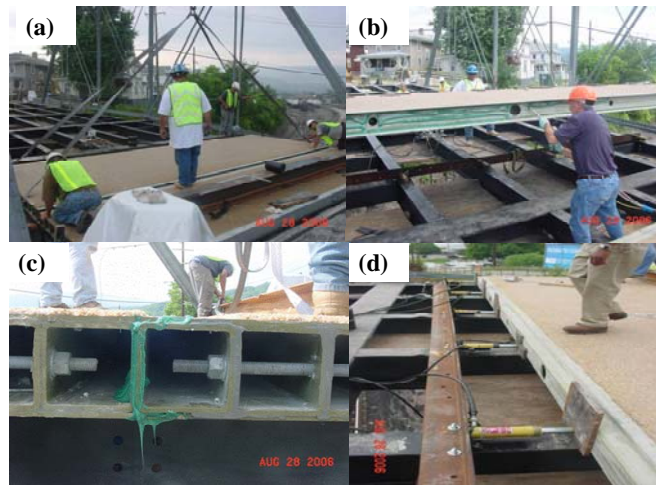
The FRP bridge deck installation was started at the Hawthorne St. Bridge on August 29th, 2006. Figure 19 shows the adhesive bonding process of the panel-to-panel connections during deck installation. The accuracy of panel dimensions of the mating parts was well controlled and installation protocols were strictly followed during the field installation. The bridge is scheduled for a controlled live load test and the response of the adhesively bonded panel-to-panel connection will be monitored.

Figure 19. Field installation of the FRP bridge deck (a) Dry fit (b) Adhesive application (c) Seam curing (d) Jacking system
