FINAL
CONTRACT REPORT
VTRC 08-CR5

PARAMETERS GOVERNING THE CORROSION PROTECTION EFFICIENCY OF FUSION-BONDED EPOXY COATINGS ON REINFORCING STEEL

FINAL CONTRACT REPORT

**PARAMETERS GOVERNING THE CORROSION PROTECTION EFFICIENCY
OF FUSION-BONDED EPOXY COATINGS ON REINFORCING STEEL**

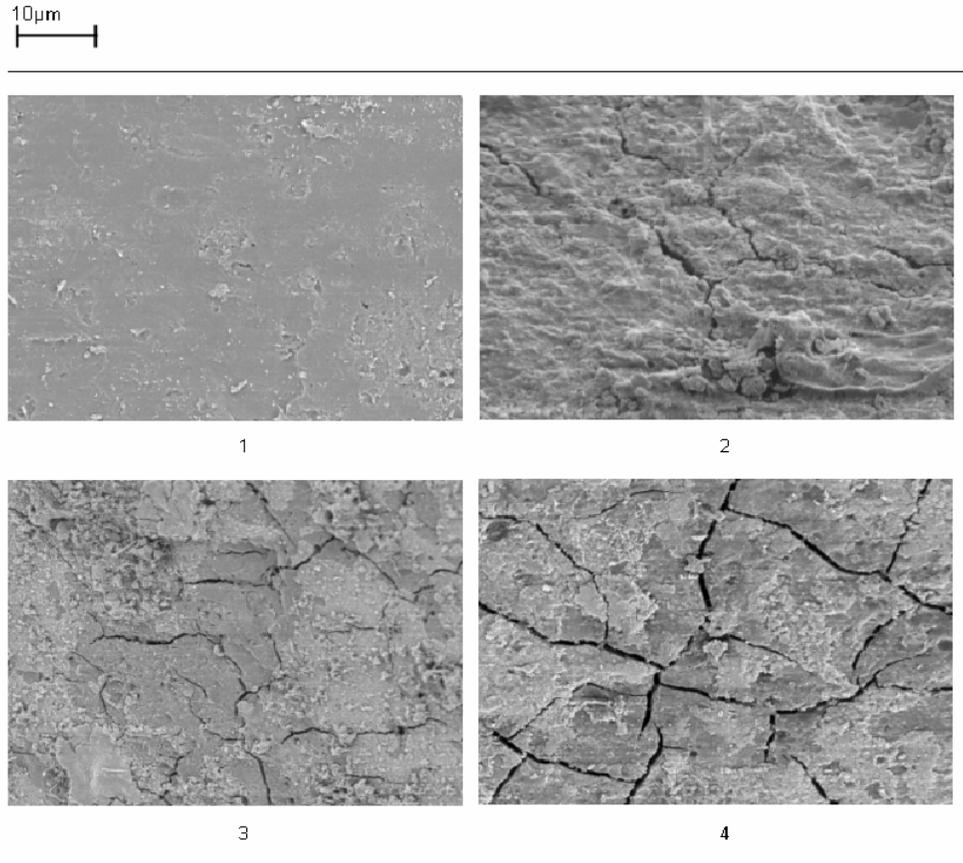
Figure 2. SEM Micrographs at 2k Magnification

The coating damage was assessed using three different techniques: 1) by counting the number of defects visible to the unaided eye. 2) By assigning a coating cracking number from 1 through 4 based on the SEM micrograph guidelines illustrated in Figure 2.

A coating cracking value was assigned to each examined specimens using a 2000x magnification scanning electron micrograph. Figure 20 illustrates the average and 95% confidence interval for each structure. The coating samples of only three structures showed no cracking. Those structures were: 1031-9, 1042-8 and 6058-9. The remaining structures presented a mean of 2 with a standard deviation of 1.

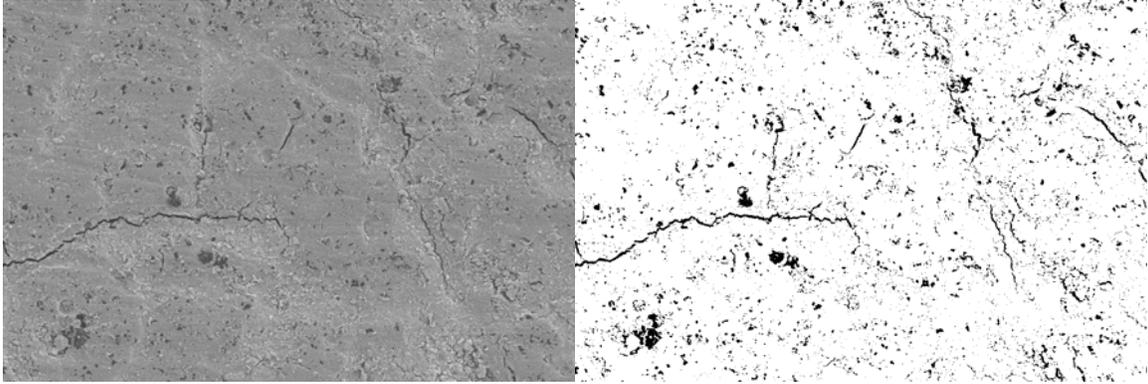
Figure 3. Structure 1019-8 C-4 5Kx SEM Micrograph and Binary

3) Finally, by using the image analysis program ImageJ on images collected during the SEM investigation. ImageJ is a shareware image analysis program developed by the National Institutes of Health (NIH). A 5k magnification SEM micrograph is converted to a binary image, which is then used to quantify the surface coating damage. The damage is recorded as a percentage of the surface area. Unlike technique 2, which takes into account only cracks, all damage types (cracks, pores, gouges) are included, using this method. Figure 3 illustrates a typical SEM 5k micrograph and its accompanying binary image.

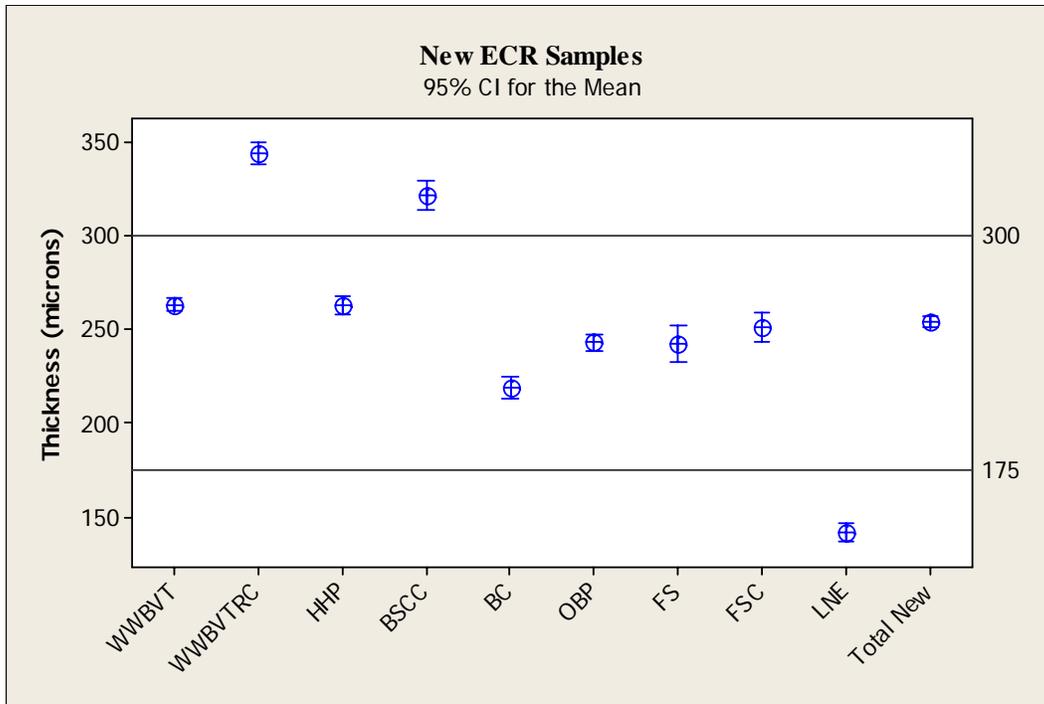
Figure 6. New ECR Coating Thickness

The average thickness measurements and the 95% confidence intervals are presented in Figure 6 for the individual samples with the minimum and maximum specified thickness represented by the two horizontal lines at 175 μm and 300 μm . Three sample sets, WWBVDOT, BSCC, and LNE failed to meet the current coating thickness specifications. The average thickness of WWBVDOT is 344 μm with a standard deviation of 46 μm , and the average thickness of BSCC is 321 μm with a standard deviation of 60 μm . The average thickness of both sample sets is above the maximum current specification. Inversely, the average thickness of LNE is below the current specified minimum of 175 μm at 141 μm with a standard deviation of 34 μm .

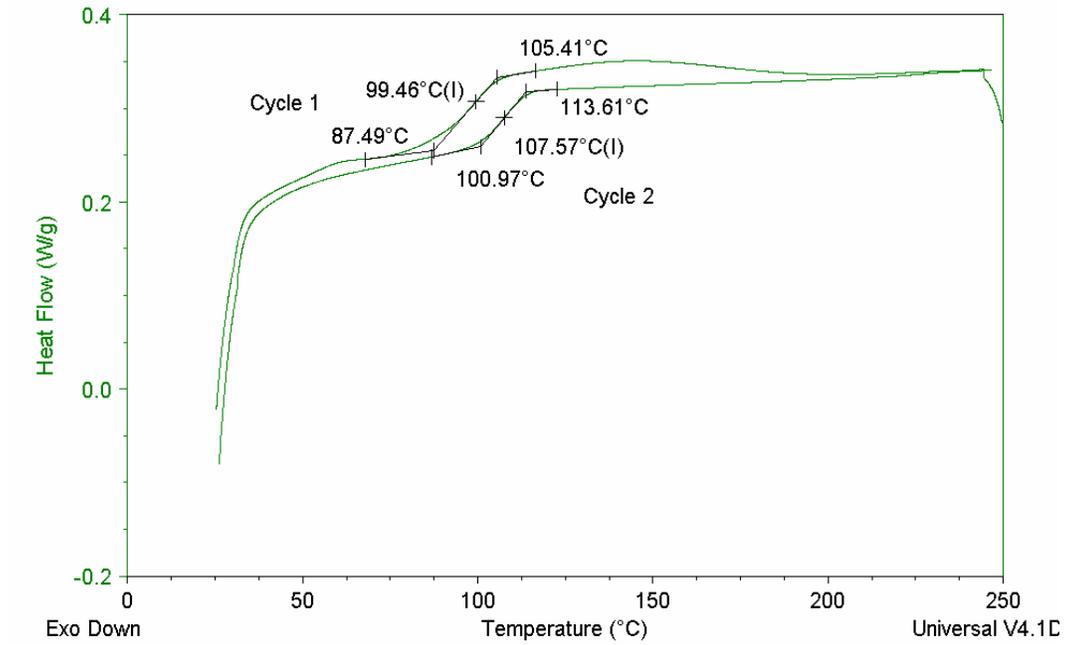
Figure 7. 1017-3 C1 DSC Plot

Figure 7 illustrates a typical DSC plot showing the difference in T_g due to additional curing. The initial T_g of sample 1017-3 C1 was 99.46°C as shown by the upper plot in the figure, with maximum additional curing occurring at 150°C. The fully cured T_g of this sample was 107.57°C, with the sample showing no additional curing as evidenced by the constant slope of the lower plot at 150°C.

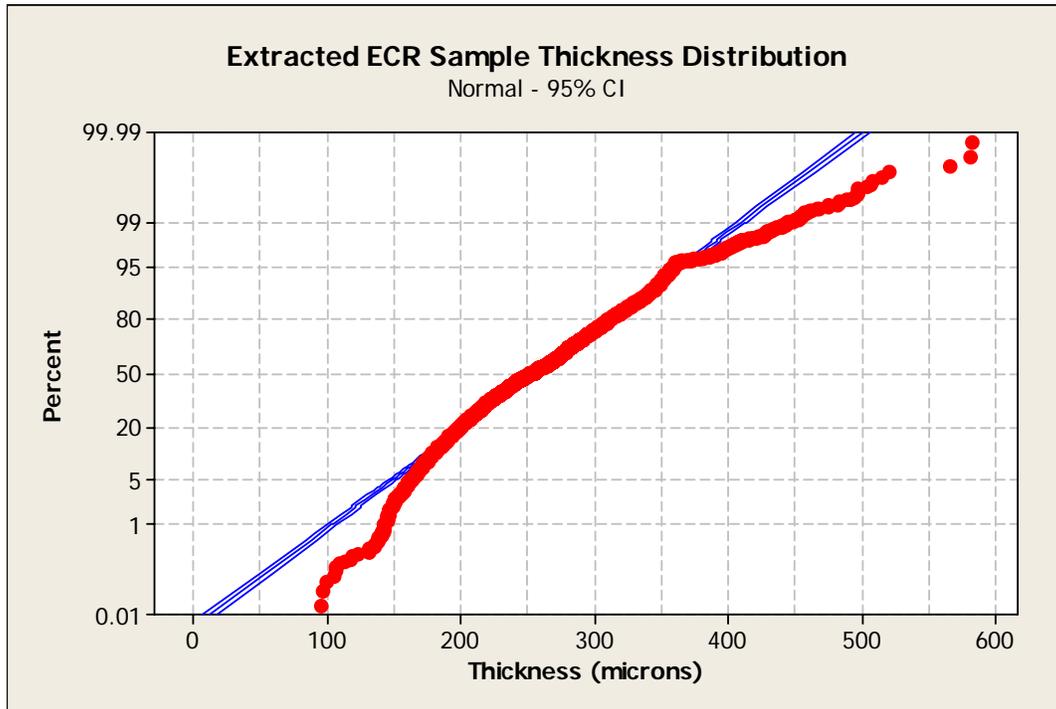
Figure 8. EECR Epoxy Coat Thickness Measurements Distribution

The thickness measurements were performed at 6 random locations along the bar sample. Three measurements were taken at each of the 6 locations and the results averaged. As illustrated in Figure 8, the thickness measurements were normally distributed.

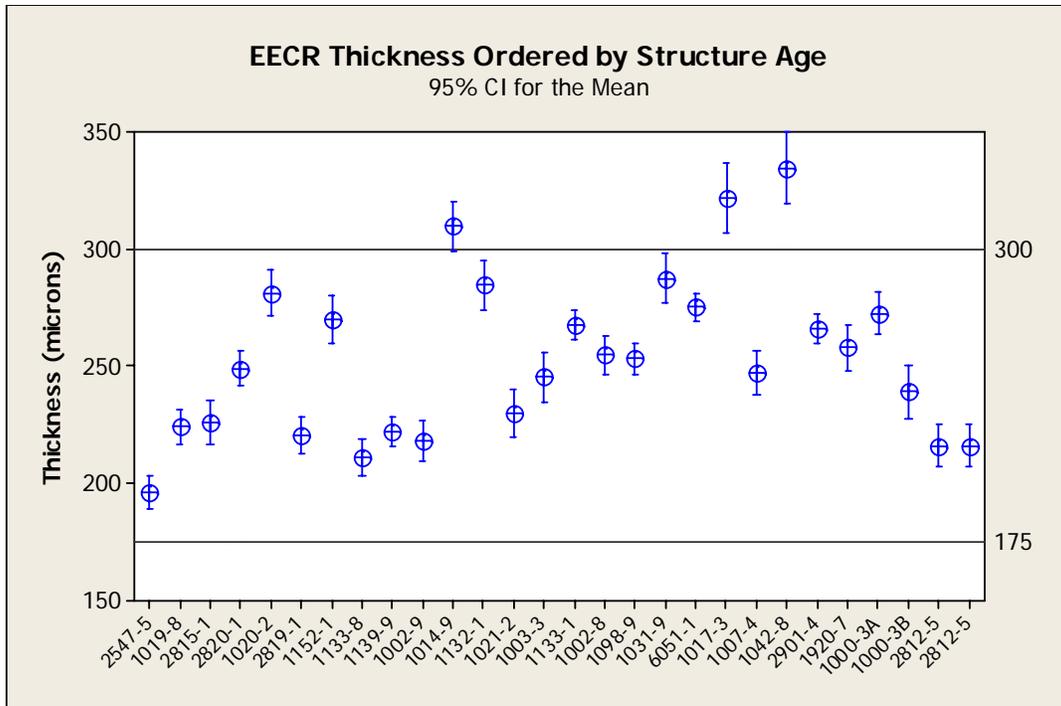
Figure 9. EECR Coating Thickness

The average thickness measurements and the 95% confidence intervals are presented in Figure 9 with the minimum and maximum specified thickness represented by the two horizontal lines at 175 μm and 300 μm . Three sample sets, 1014-9, 1017-3, and 1042-8 failed to meet the current coating thickness specifications. The average thickness of 1014-9 is 310 μm with a standard deviation of 67.1 μm , the average thickness of 1017-3 is 322 μm with a standard deviation of 78.5 μm , and finally, the average thickness of 1042-8 is 335 μm with a standard deviation of 79.1 μm . The average thickness of the three specimens is above the maximum current specification. There were no samples failing the minimum specified thickness.

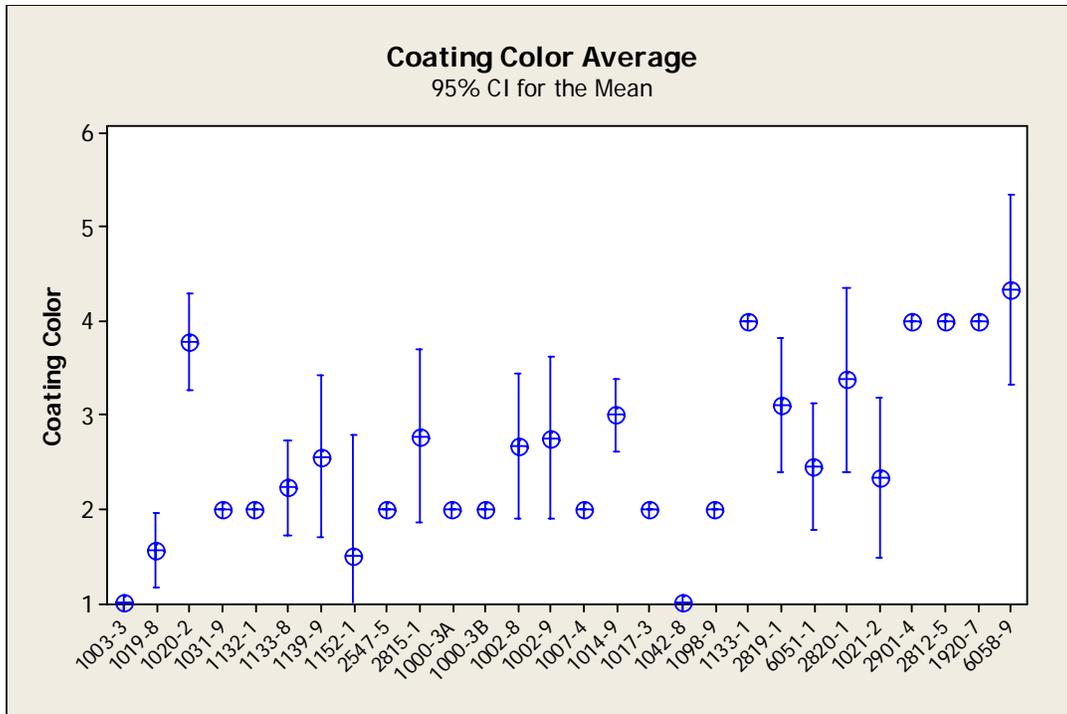
Figure 11. EECR Coating Color

Since a change in color from the original glossy green can be an indicator of coating degradation, this color change was recorded on a scale from 1 through 5, and the interpretation scale is presented in Methods and Materials. From the sample population, the coating color of two structures showed no apparent change from new. The structures were 1003-3 and 1042-8. The remaining structures all presented some degree of coating color degradation with most experiencing loss of gloss rather than pigmentation. The distribution of color values is presented in Figure 10, while the mean and the standard deviation of each structure are presented in Figure 11.

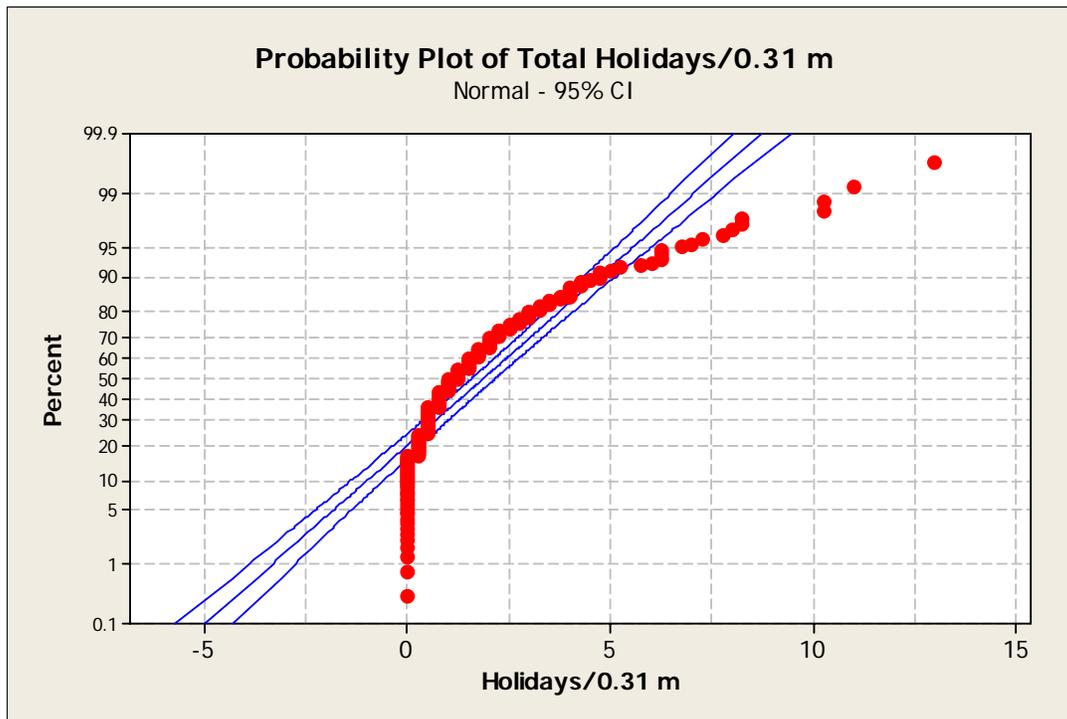
Figure 15. EECR Holiday Probability Plot

line at 1 holiday/0.31m. The number of holidays/m is also highly positively skewed as shown in Figure 15.

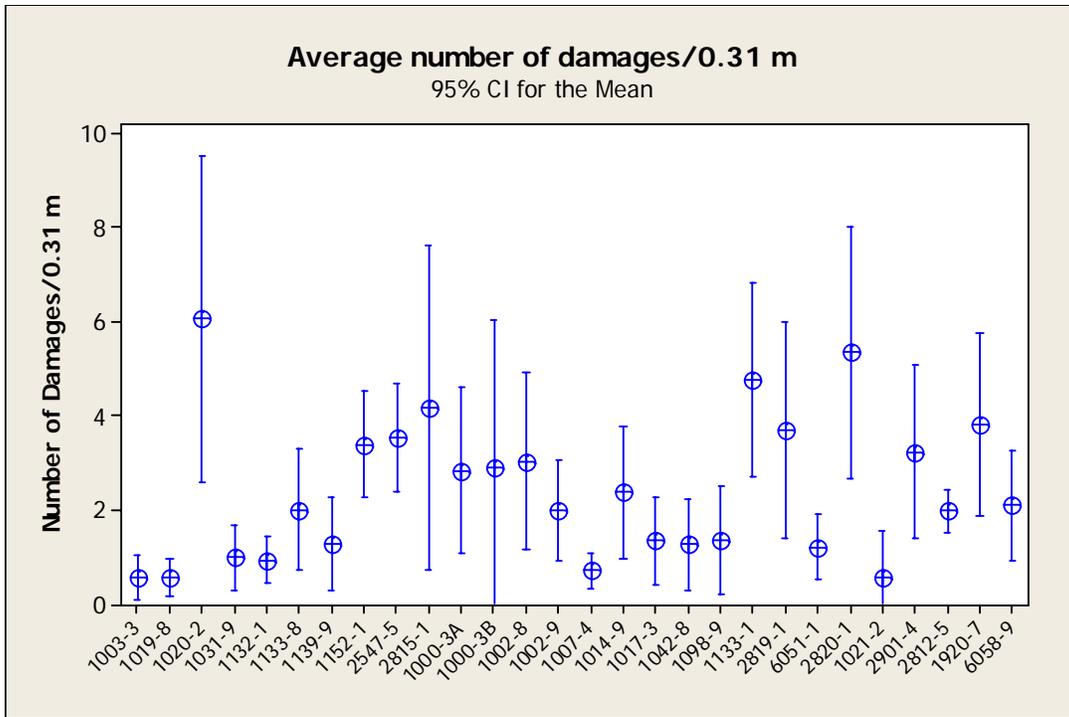
Figure 17. EECR Number of Damaged Areas

there were no structures with zero damages per 0.31 m as shown in Figure 17. The lowest number of damages was shown by structure 1021-2 with 1.77 damages/m and a standard deviation of 3.18. Structure 1019-8 had a similarly low number of damages with 1.84 damages/m, but a significantly lower standard deviation at 1.64. The highest number of damages was exhibited by structure 1020-2 with 20.00 damages/m and a standard deviation of 4.5. The average number of damages for the entire sample population is 8.04 damages/m and a standard deviation of 8.13. There were however, individual bars with zero counted damages. Specifically, out of 244 individual specimens, 26 specimens had 0 damages/m, while 46 specimens had 3 damages/m or less. This leaves 172 specimens with more than 3 damages/m and one sample with damages as high as 50.02 damages/m.

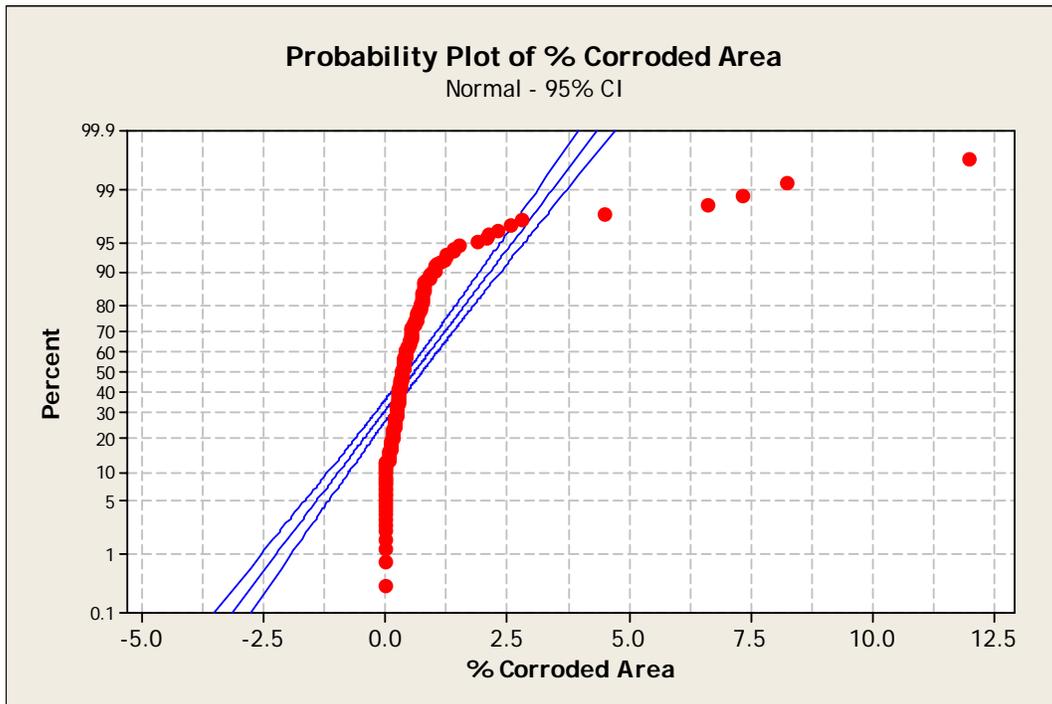
Figure 18. EECR Percent Corroded Area Probability Plot

The probability distribution of the measured percent corroded area followed a pattern similar to the holidays and the number of damages as illustrated in Figure 18. As with the number of damages, there were no structures showing absolutely no signs of corrosion although there were individual bars that showed no visible signs of corrosion. The average percent corroded area and the standard deviation of each structure are presented in Figure 19. Out of 244 specimens, 28 showed no visible signs of corrosion leaving 216 specimens with corrosion ranging from a low of 0.05% to a high of 12%. From the investigated structures, 1132-1 showed the least average amount of visible corrosion with 0.15% corroded area and a standard deviation of 0.14. Structure 2820-1 had the greatest corrosion with an average of 3.57% corroded area and a standard deviation of 3.49. The total average for the sample population is 0.59% corroded area with a standard deviation of 1.22.

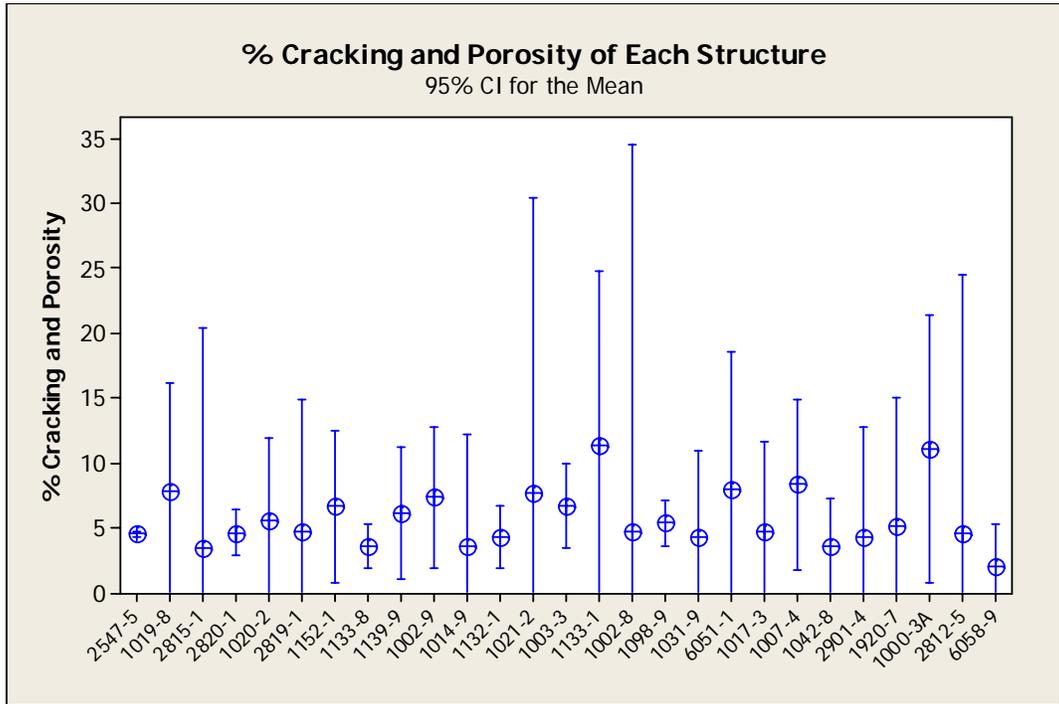
Figure 21. EECR Percent Cracking and Porosity

The average percent cracking and porosity for each structure are presented in Figure 21. Structure 6058-9 had the lowest percent cracking and porosity with an average 2.017 and a standard deviation of 0.37. Structure 1133-1 had the highest percent cracking and porosity with an average of 11.36 and a standard deviation of 5.39. Out of the individual samples examined, sample 1014-9 C6 had the lowest percent cracking and porosity with 0.71, while sample 1133-1 C1 had the highest percent cracking and porosity with 17.29. The total average and standard deviation for the entire sample population were determined to be 5.77 and 3.16, respectively. Unlike holidays and the number of damaged areas, the percent cracking and porosity were normally distributed as illustrated in Figure 22.

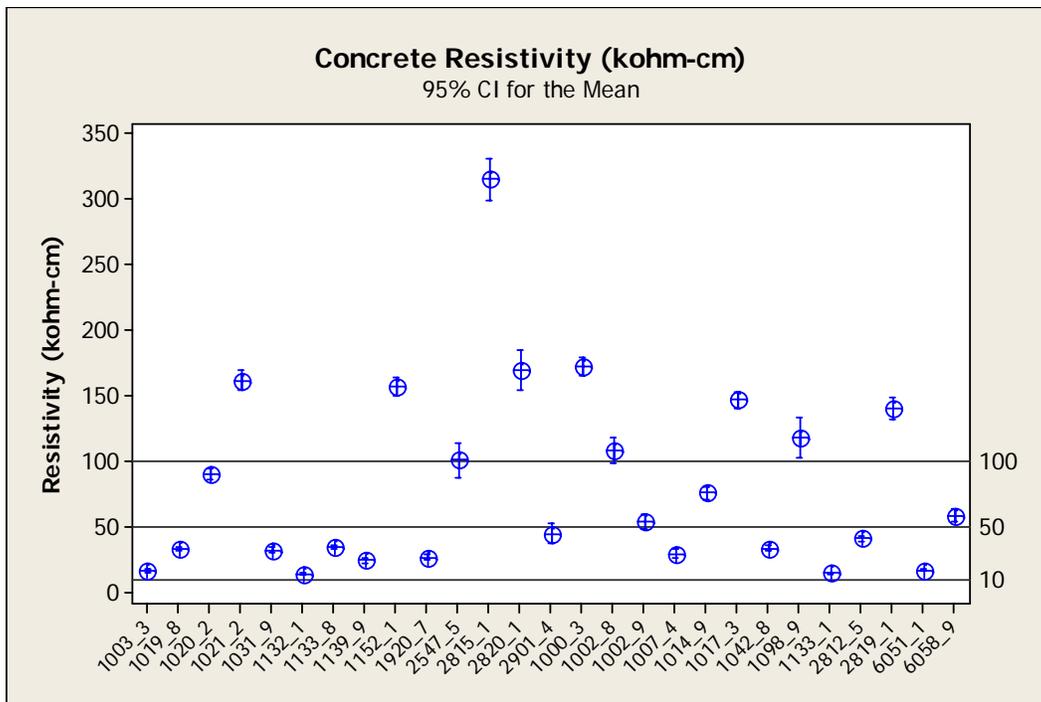
Figure 23. EECR Structures Concrete Resistivity

For the resistivity range of values, the interpretation guidelines proposed by Feliu et al were chosen (Feliu, et al., 1996) and are presented as the three horizontal lines at 10, 50 and 100 kΩ-cm in Figure 24. From 10 to 50 kΩ-cm the potential corrosion rate is high to moderate; between 50 and 100 kΩ-cm the potential corrosion rate is low; above 100 kΩ-cm the potential corrosion rate is negligible. Based on these interpretation guidelines, almost half of the structures investigated, 13 structures, lie within the high to moderate potential corrosion rate region while 5 structures are located in the low potential corrosion rate region of Figure 23. The remaining 9 structures theoretically would have low potential corrosion rates or the concrete was too dry to support a high or moderate active corrosion when tested.

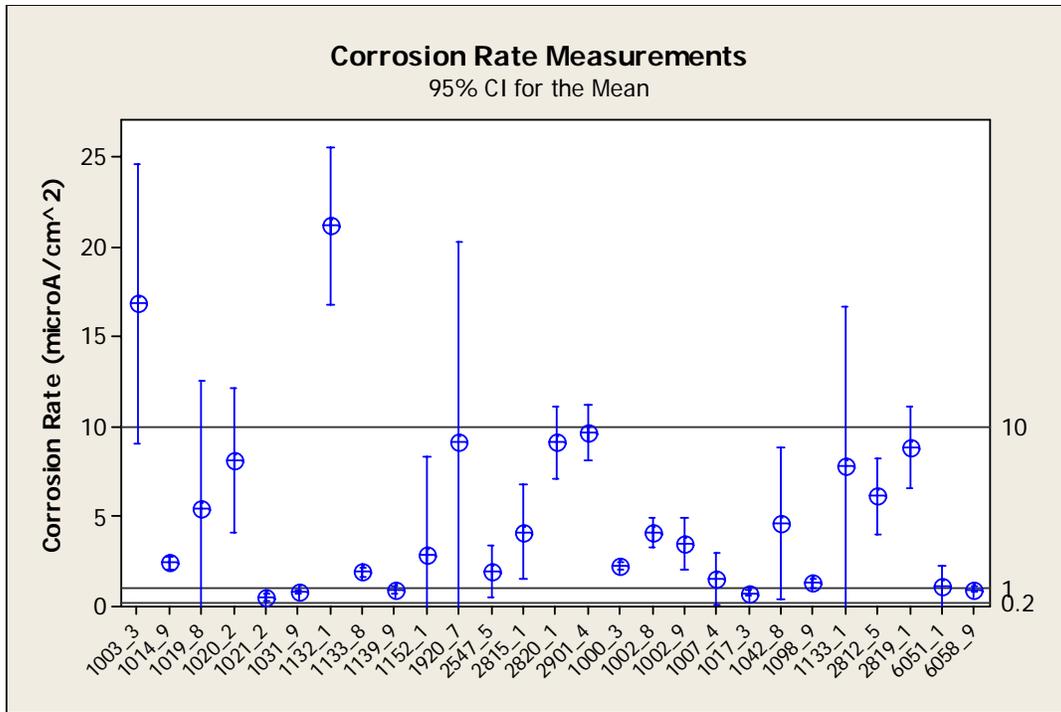
Figure 25. Corrosion Rate Measurements

The corrosion rates, obtained using an unguarded 3LP instrument, are presented in Figure 25. The horizontal lines at 0.2, 1 and 10 $\mu\text{A}/\text{cm}^2$ represent the instrument provided interpretation guidelines for uncoated bar (Clear, 1989). From the figure, it is clear that the majority of structures investigated are located between 1 and 10 $\mu\text{A}/\text{cm}^2$. In that region, damage to concrete due to corrosion activity is expected to take place between 2 to 10 years. Two structures, 1003-3 and 1031-9 presented significantly higher corrosion rates with values of 16.8 and 21.1 $\mu\text{A}/\text{cm}^2$, respectively. In these cases, concrete damage due to corrosion activity is expected to occur within 2 years or less. Five structures, 1021-2, 1031-9, 1139-9, 1017-3 and 6058-9 presented very low corrosion rates with damage due to corrosion activity expected between 10 to 15 years.

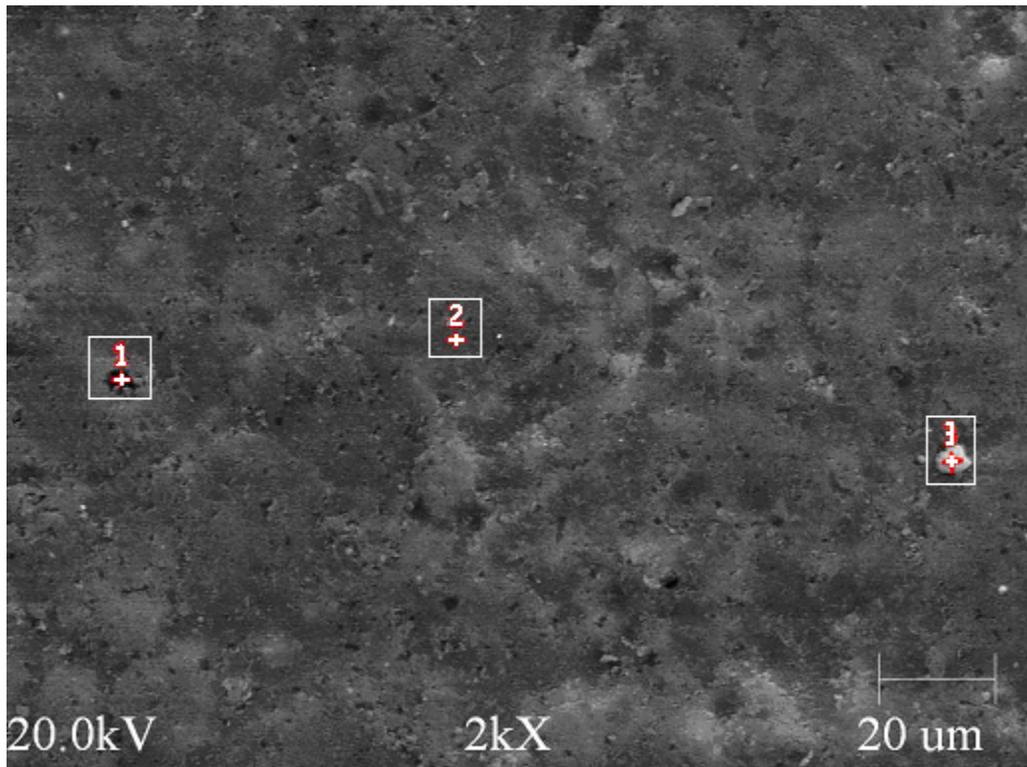
Figure 27. Structure 1020-2 C6 SEM Micrograph

Finally, SEM and EDS analyses were performed. Figure 27 illustrates an electron scanning micrograph of structure 1020-2 C6. The EDS spectra were collected at the numbered locations and are presented in Figures 28, 29 and 30.

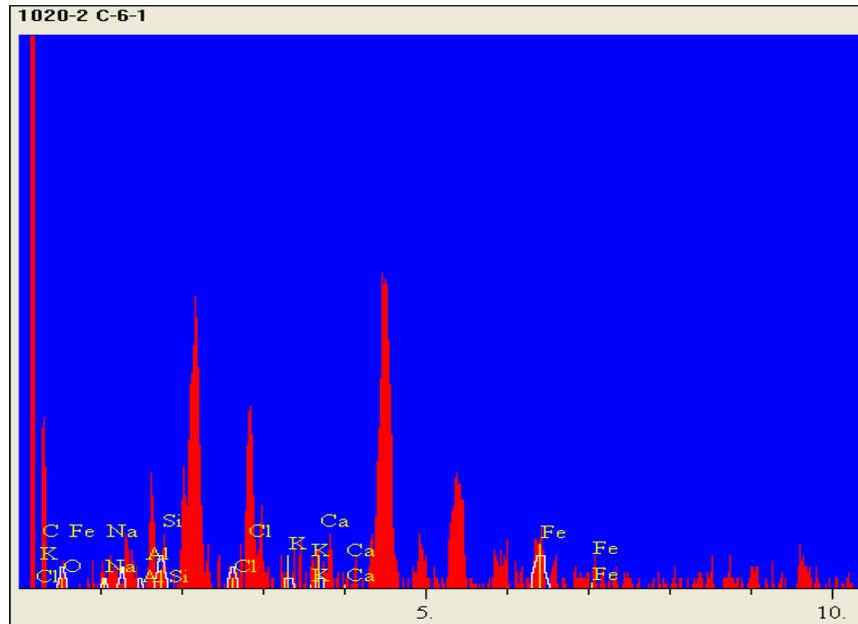
Figure 28. EDS Spectra 1020-2 C-6-1

The spectrum at location 1 (Figure 28) would indicate that the pore in the coating is continuous to the steel substrate. Although the signals are weak due to interference from the

pore walls, iron still presents the strongest peak, followed by silica, chloride, potassium and calcium, which may all be found in the concrete pore solution. Location 2 (Figure 29) spectra is dominated by the carbon signature as expected from an organic coating. There are traces of other elements that are commonly found in concrete or the concrete pore solution. This is due to adsorption of the pore solution on the coating surface. Finally, the third spectrum (Figure 30) illustrates the typical signature of cement. There is no carbon present, as expected from an organic coating, but the calcium and the silica signatures dominate.

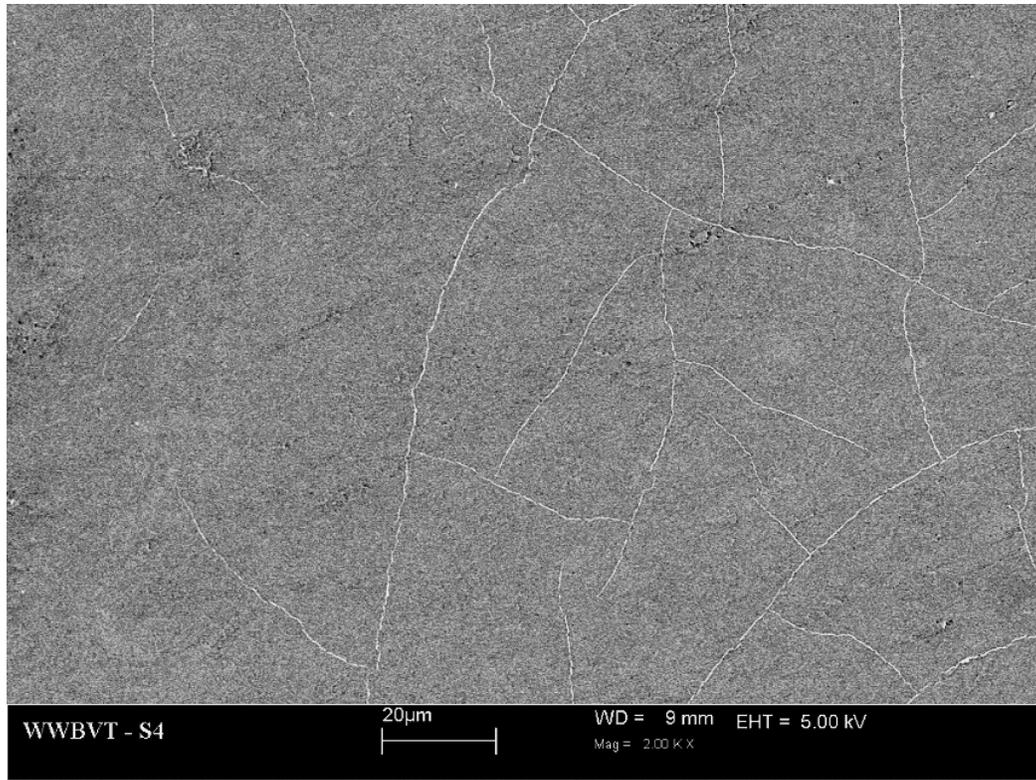
Figure 31. New ECR WWBVT – S4 cracking SEM micrograph

With the exception of only one new specimen (WWBVT-S4), which is presented in Figure 31, no map-like cracking was noted in the remaining new ECR samples. Based on the interpretation guide, WWBVT-S4 was assigned a cracking value of 3. The colors in Figure 31 were inverted for better contrast. Unlike the new ECR samples, the majority of the extracted ECR samples showed surface coating cracking spanning the severity scale with a total average cracking value of 2. This significant difference between the new and the extracted ECR samples indicates that while it is possible that there are factors that may contribute to coating cracking prior to concrete embedment, the majority of the cracking occurs in concrete.

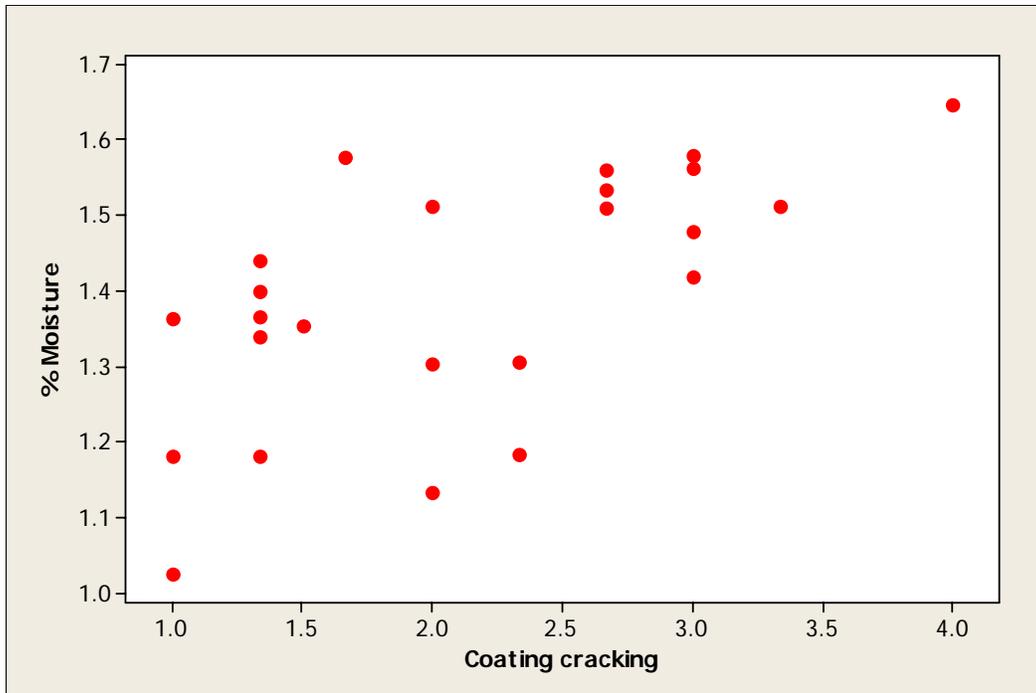
Figure 32. EECR scatter plot of % moisture vs. coating cracking

Using a confidence level of 80% allows for the inclusion of chlorides at bar level, residual adhesion, color of corrosion products under the coating and % moisture as cracking prediction parameters. The individual P-values were 0.171, 0.115, 0.118 and 0.186, respectively. Further regression performed using only the parameters with P-values ≤ 0.20 ultimately yielded only the coating color as the strongest predictor of coating cracking. At the 95% confidence level, the coating color P-value was 0.003. Based on individual correlations, excluding combined effects, the cracking value correlated with the % moisture, with a Pearson correlation value of 0.637 and a P-value of 0.001 (Figure 32).

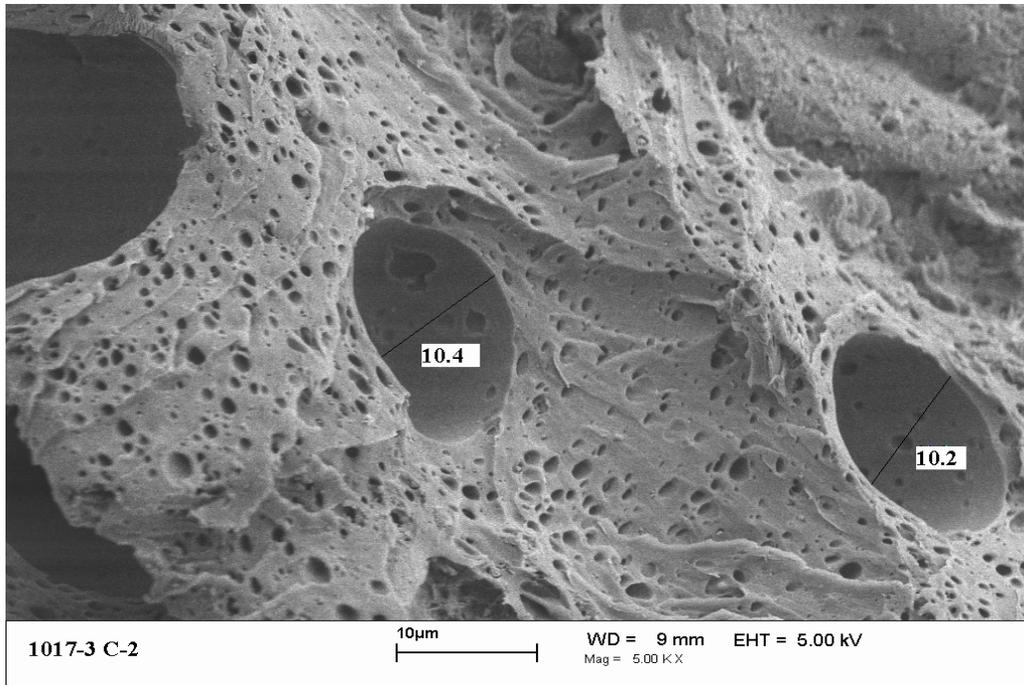
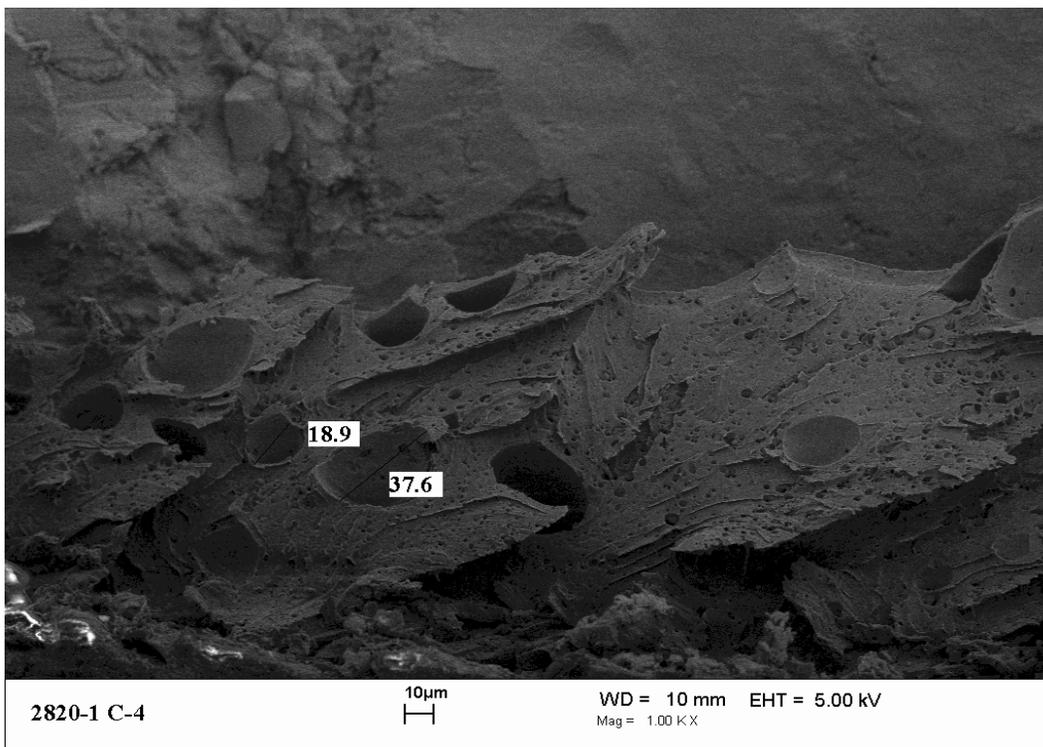
The porous structure of coating samples collected from structures 1017-3 C-2 and 2820-1 C-4 is illustrated in Figures 34 and 35. The ΔT_g of sample 1017-3 C-2 is 26.42 °C while the ΔT_g of sample 2820-1 C-4 is 9.63 °C. Both coating samples have capillary-sized pores throughout the bulk of the coating. The size of the pores was 10.4 and 10.2 μm for the 1017-3 C-2 sample and 18.9 and 37.6 μm for the 2820-1 C-4 sample in addition to the multitude of pores 1 μm or less occupying the bulk of the coating. Since the examples of the porous structure presented were obtained from three structures only, we cannot conclusively state that this is a common condition. However, based on the random nature of the investigated samples, this may in fact be the prevailing coating condition. Using the 1% moisture to 8°C conversion leads to ΔT_g due to insufficient curing of 16.50°C and -5.49°C, respectively. The -5.49°C in this case may be explained by the fact that some of the moisture is in fact free or bulk water residing in the large pores, which has no plasticizing effect as does the moisture within the epoxy structure.

The presence of the pore network throughout the bulk of the coating also addresses the question of whether the cracks go to the steel surface as being irrelevant. The large capillaries providing not only open conduits for moisture, oxygen, and later chloride transfer between the concrete environment and the steel substrate, but also crevices which allow moisture to collect creating an ionic conductive path.

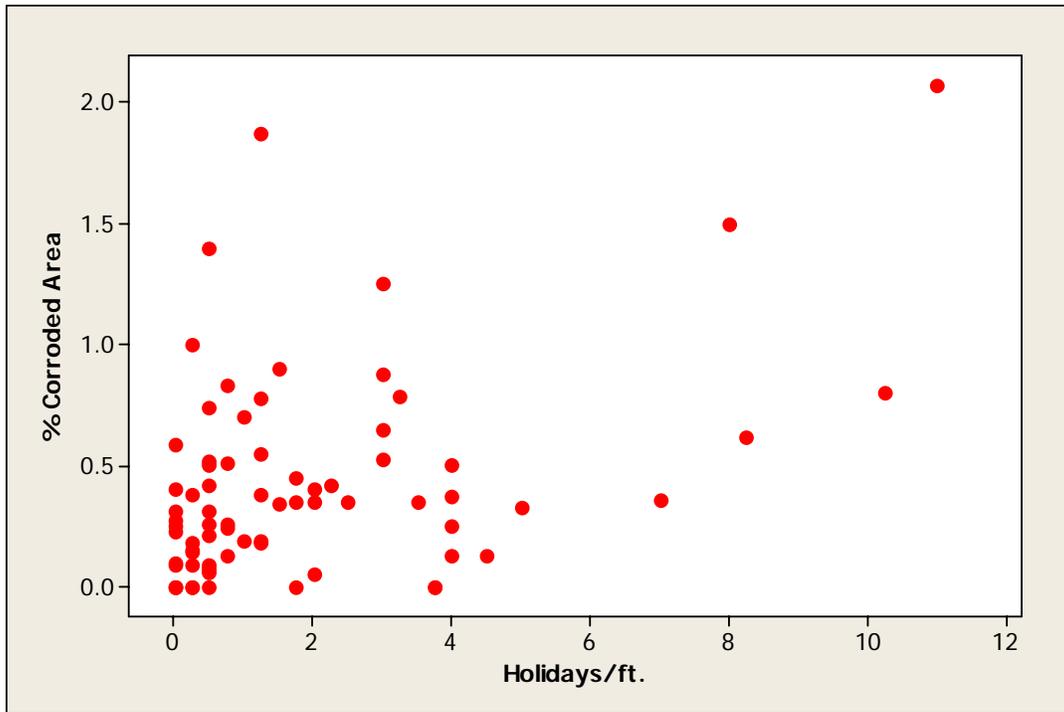
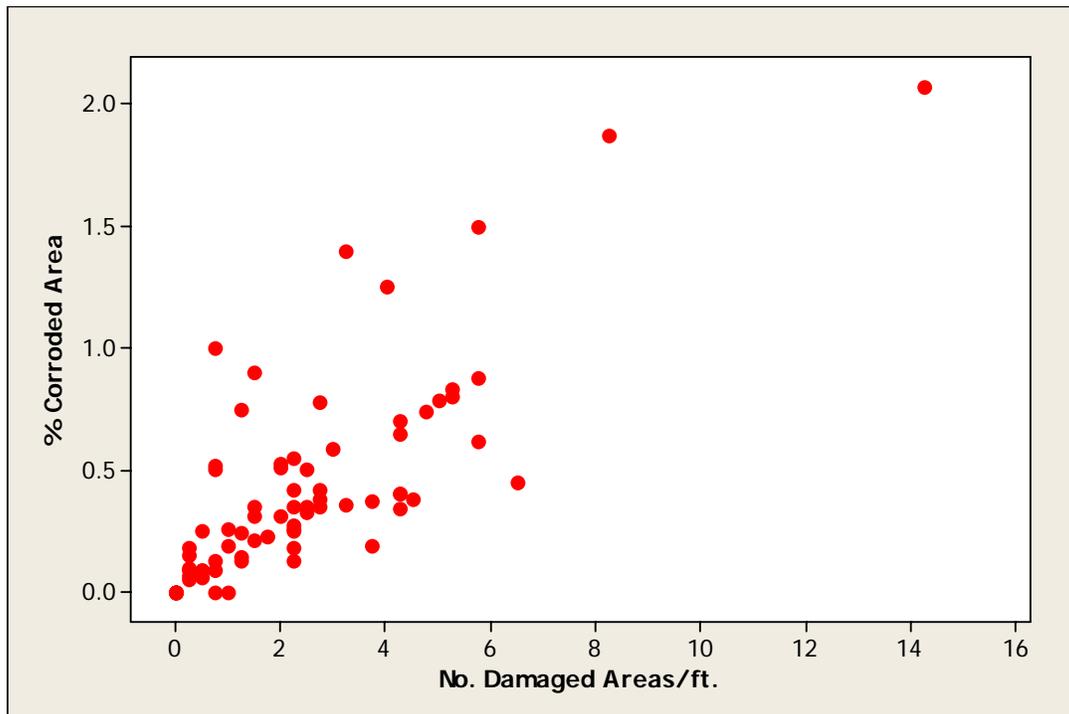
As expected, the % corroded area correlated well with the number of holidays per unit length of bar and the number of damaged areas per unit length of bar. The Pearson correlation values were 0.382 and 0.657. The corresponding P-values were 0.001 and 0.000, respectively. These relationships are presented in Figures 47 and 48.

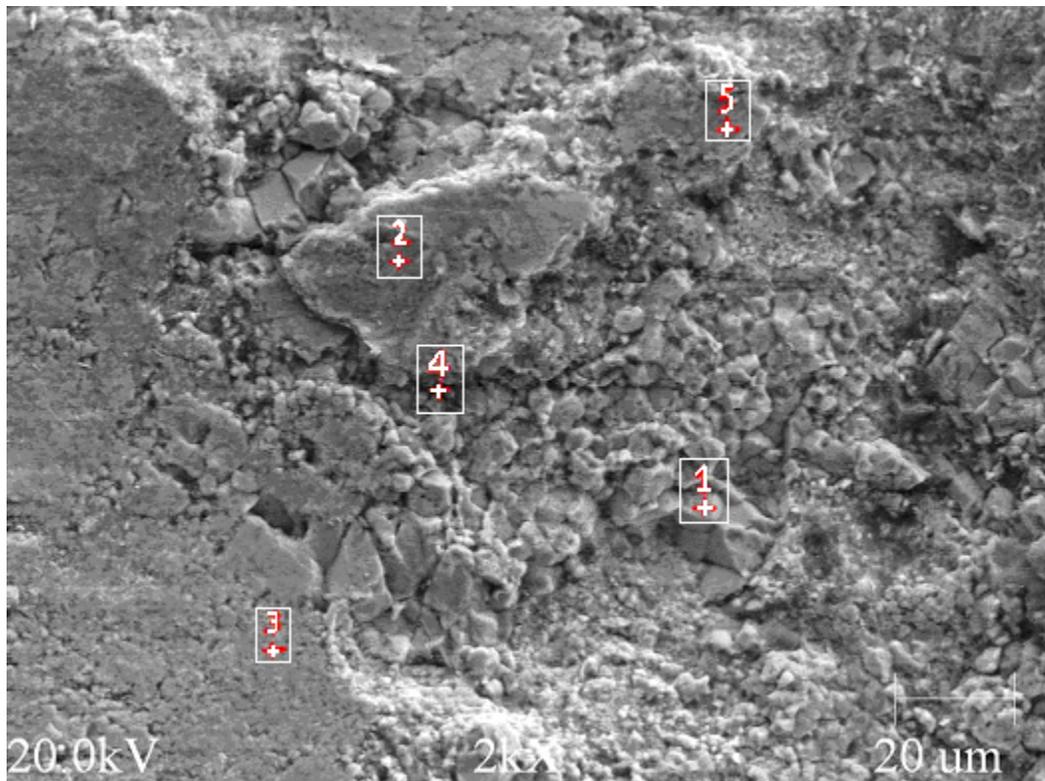
Figure 49. Structure 1007-4 C-3 SEM Micrograph

Additionally, the EDS analysis (Table 16) showed only traces or the complete absence of chlorides on the steel surface, as illustrated by the typical spectra from sample 1007-4 C-3 in Figures 50 and 51. The referenced spectra were obtained from locations 1 and 4 in Figure 49.

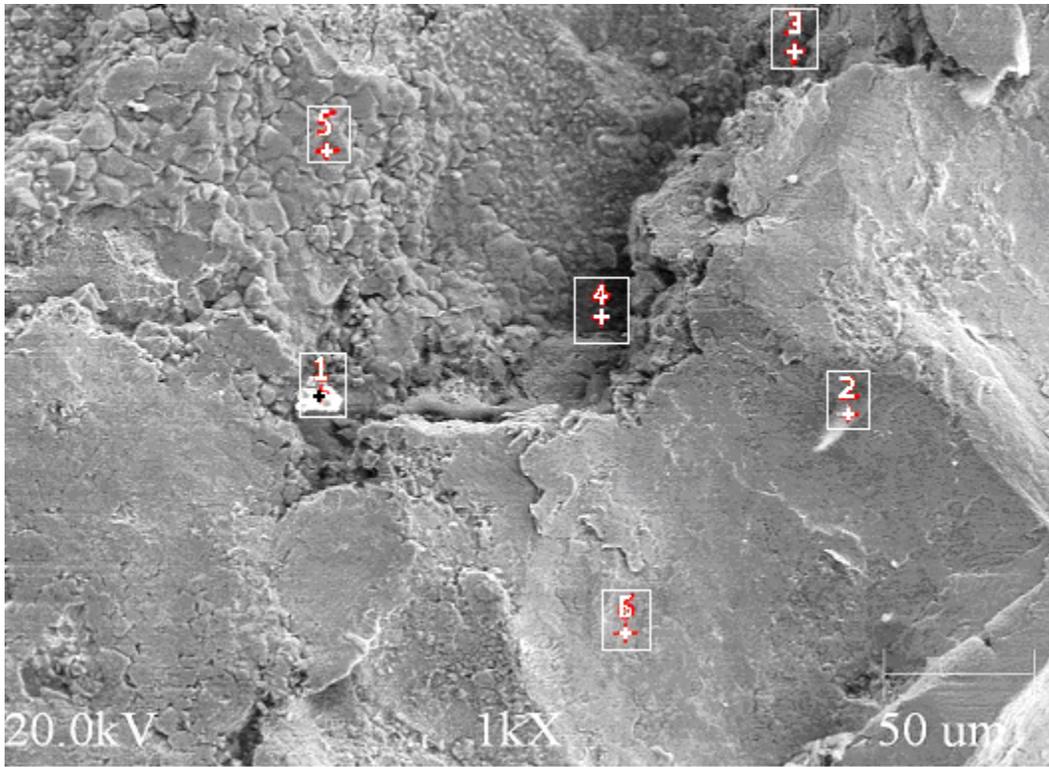
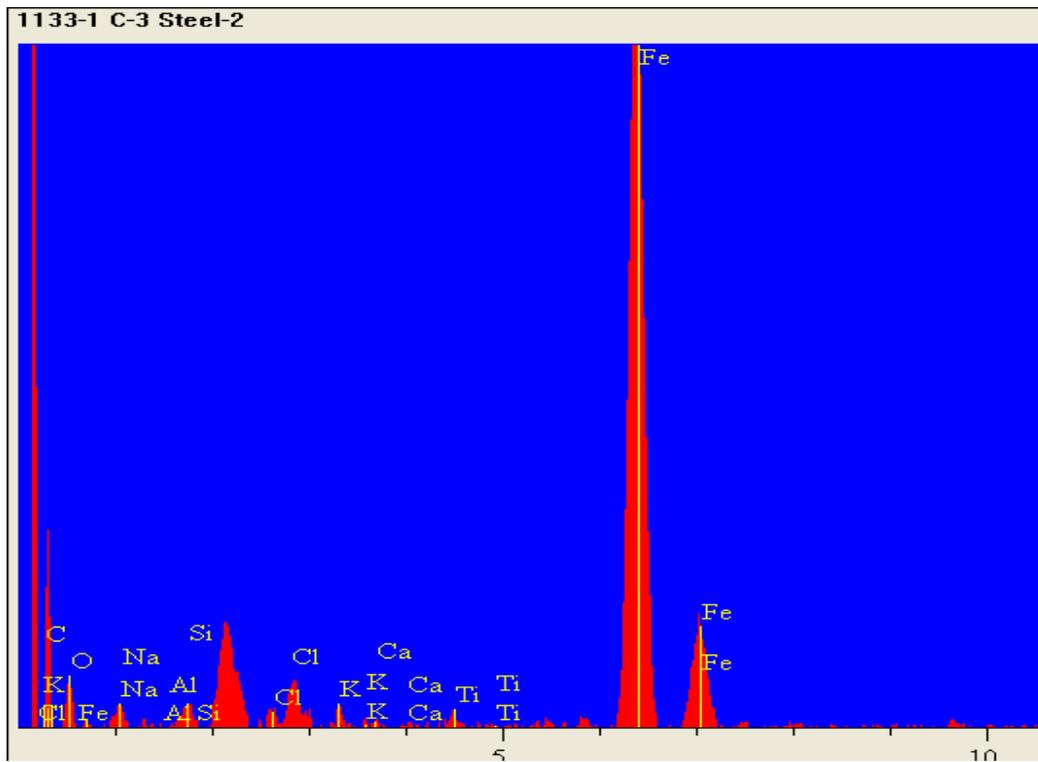
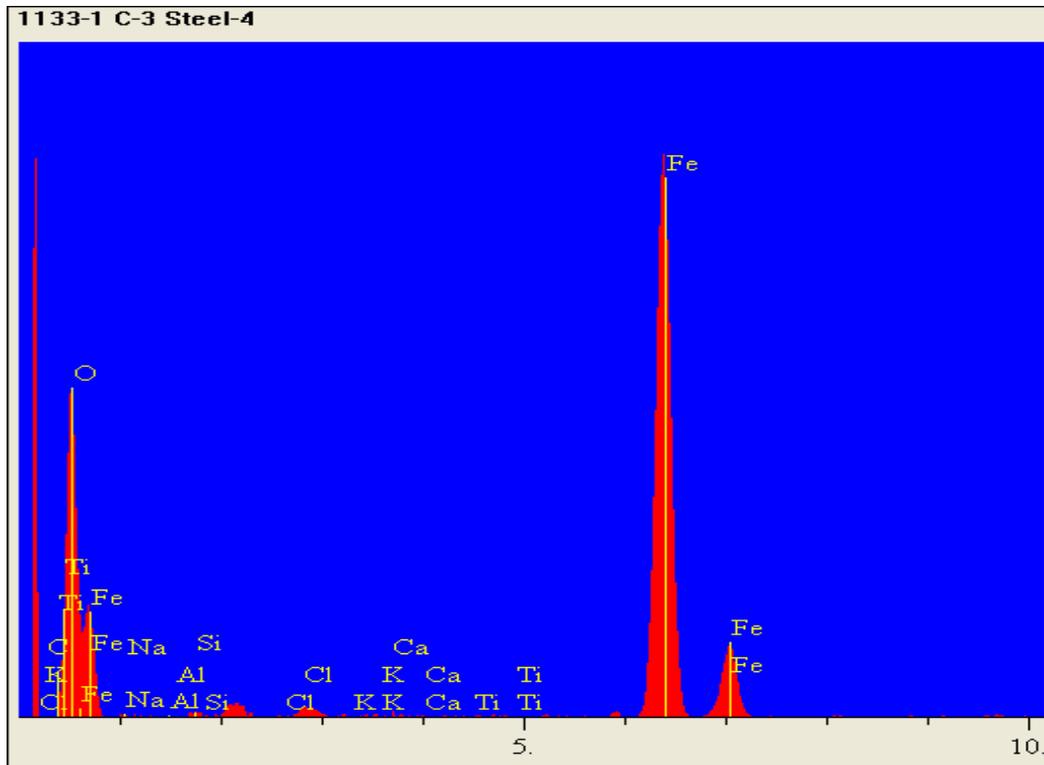
The absence of chlorides on the steel surface is also supported by the spectra collected from sample 1133-1 C-3 (Figure 52) illustrated in Figures 53 and 54, while Table 17 presents the surface chemical composition at the referenced locations.
