Virginia Transportation Research Council

Material Investigation of the Full-Depth, Precast Concrete Deck Panels of the Old Woodrow Wilson Bridge

September 2007
VTRC 08-R2

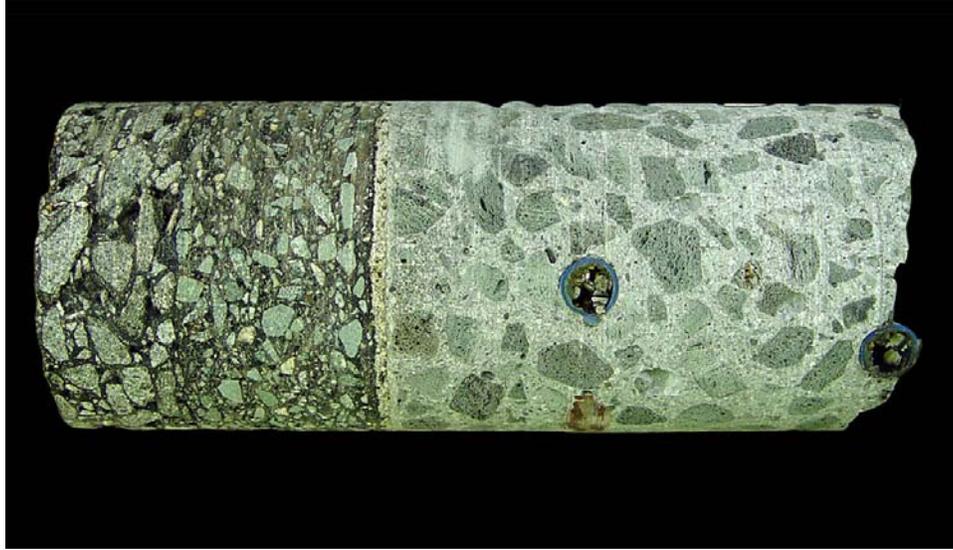
Figure 5. Typical Sample from Group B

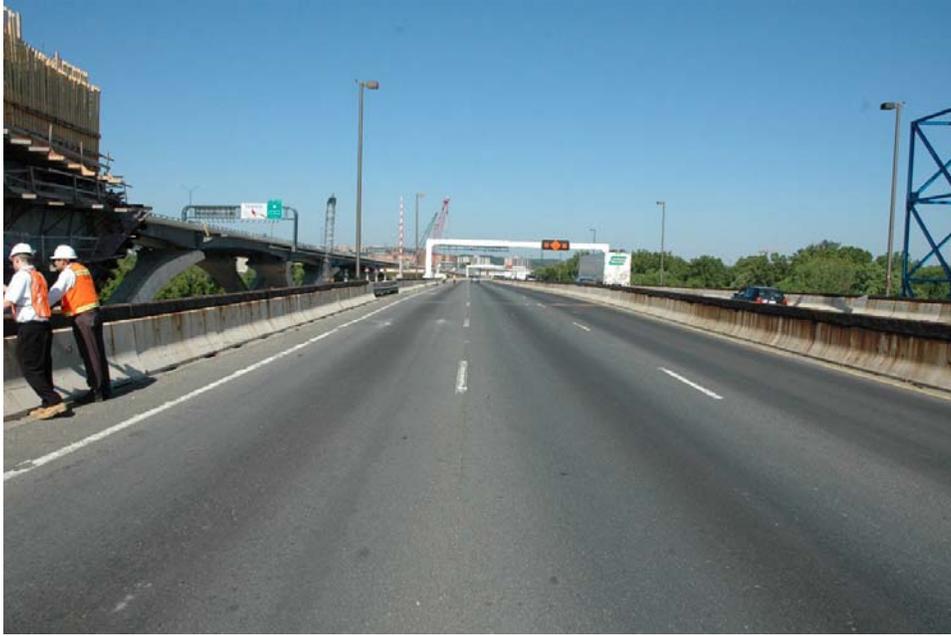
As mentioned previously, the surface of the full-depth, precast concrete deck panels for the Woodrow Wilson Bridge had been topped with an asphalt wearing surface after the panels had been set in place and longitudinally post-tensioned, as shown in Figure 6. This wearing surface was in addition to the 1/4-in (6 mm) layer of sand-epoxy overlay that the fabricator had applied at the precasting yard. At the time of the survey, a few spans adjacent to the bascule span had been milled to remove the asphalt and epoxy mortar prior to demolition of that portion of the structure. Given the rough surface texture after the milling operation, the concrete deck appeared to be in good condition. There were no discernible cracks or signs of impending spalls. Even the expansion joints appeared to be in fairly good condition. As for the rest of the approach spans, there were only a few signs of distress near the west abutment, as evidenced by asphalt patches.

Figure 6. Looking West at Eastbound Approach to Old Woodrow Wilson Memorial Bridge

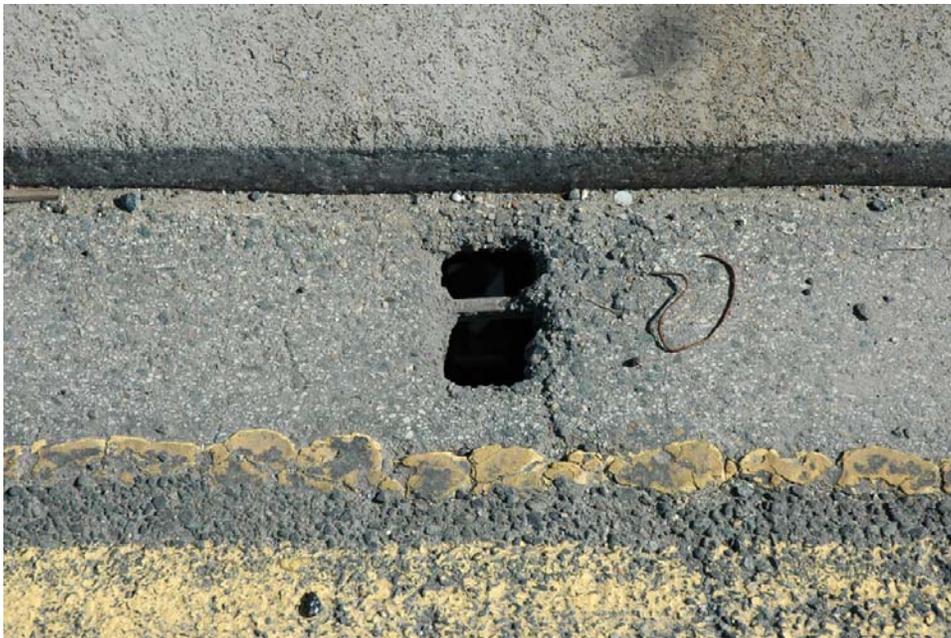
Deck drainage was facilitated by slotted scupper drains beneath the exterior parapet walls and drain holes in the shoulder lanes. Generally, drainage scuppers were clogged with debris, as is common with deck drainage system designs of this type. In some cases, the scuppers had been partially covered up with asphalt over time, as shown in Figure 7. Although the deterioration of the median barrier is exemplified in Figure 8, the inspection teams found that the barrier

Figure 7. Drainage Scupper Partially Obstructed by Asphalt Overlay

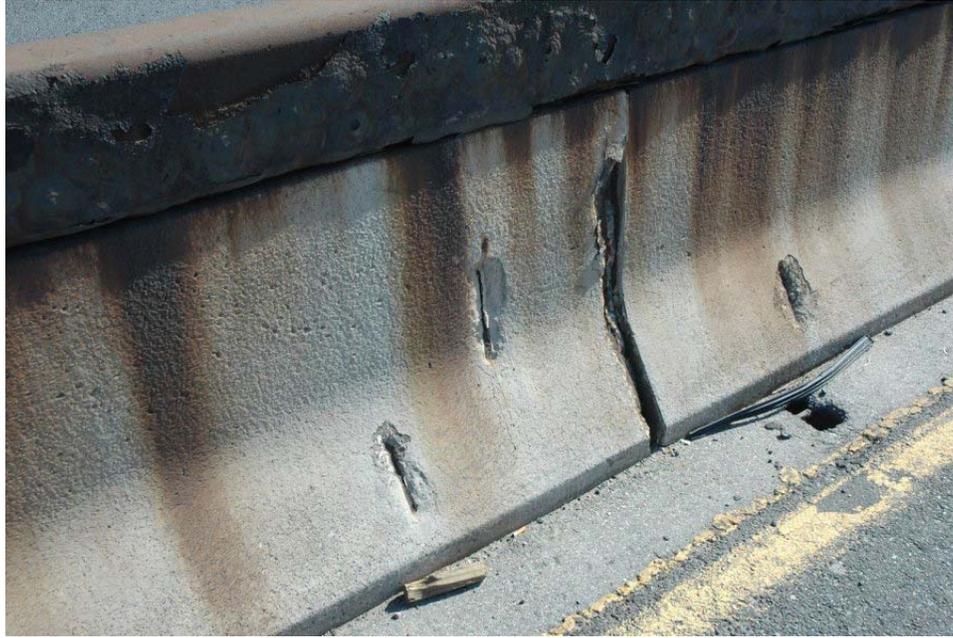
Figure 8. Concrete Spalls Attributable to Rusted Rebar in Median Barrier

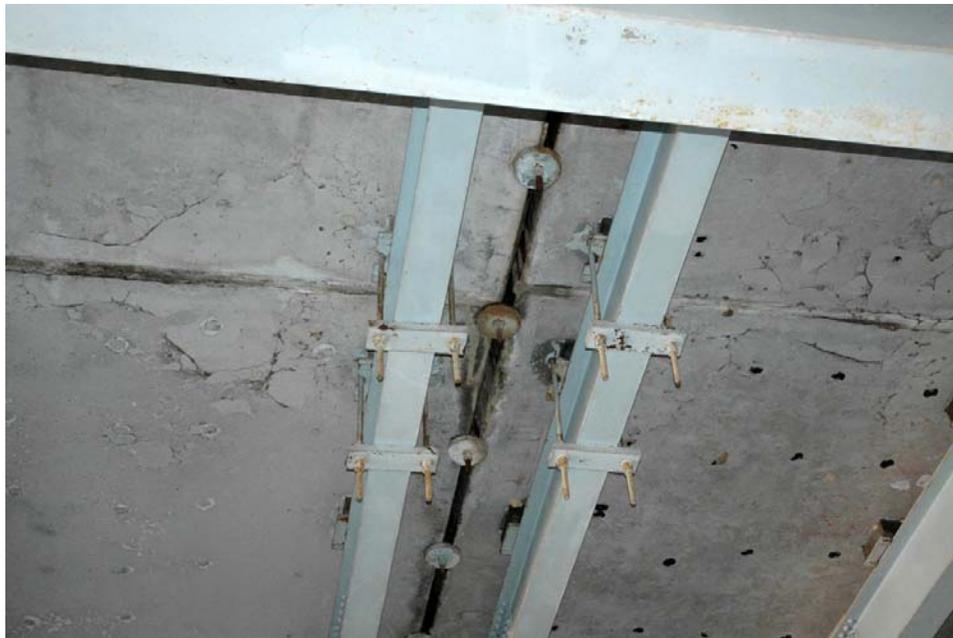
connections to the concrete deck from below were in good condition. Figure 9 shows these connections with minor rust staining and efflorescence occurring around the connections and the longitudinal joint.

Figure 9. Median Barrier Connection to Underside of Full-Depth, Precast Concrete Deck Panels. The black circles are plastic reinforcing bar chairs used during the fabrication process.

initially appeared to be pattern cracks were cobwebs, as seen in Figure 9. Figure 10 shows the concrete deck and panel joint in good condition. Some panel joints exhibited rust staining; efflorescence; and, on occasion, small pop-out spalls, as shown in Figure 11.

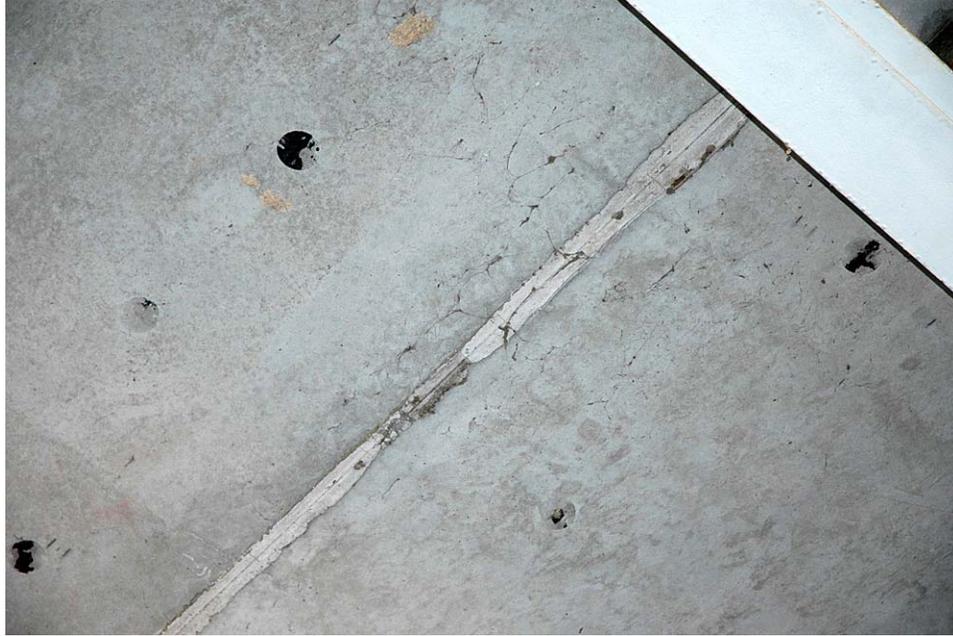
Figure 10. Underside of Adjacent Deck Panels and Accompanying Joint in Good Condition

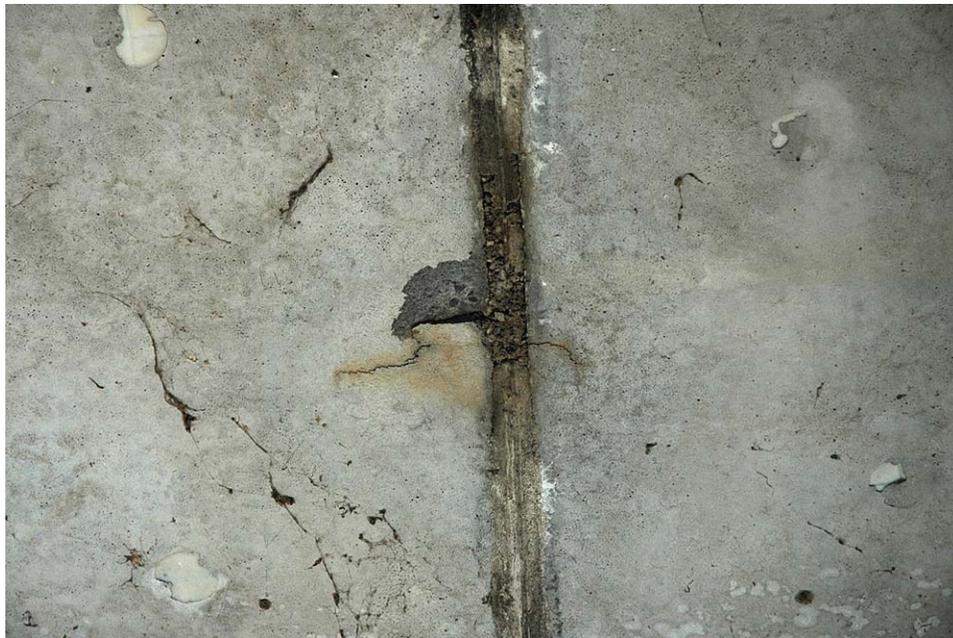
Figure 11. Panel Joint with Rust Staining and Spall

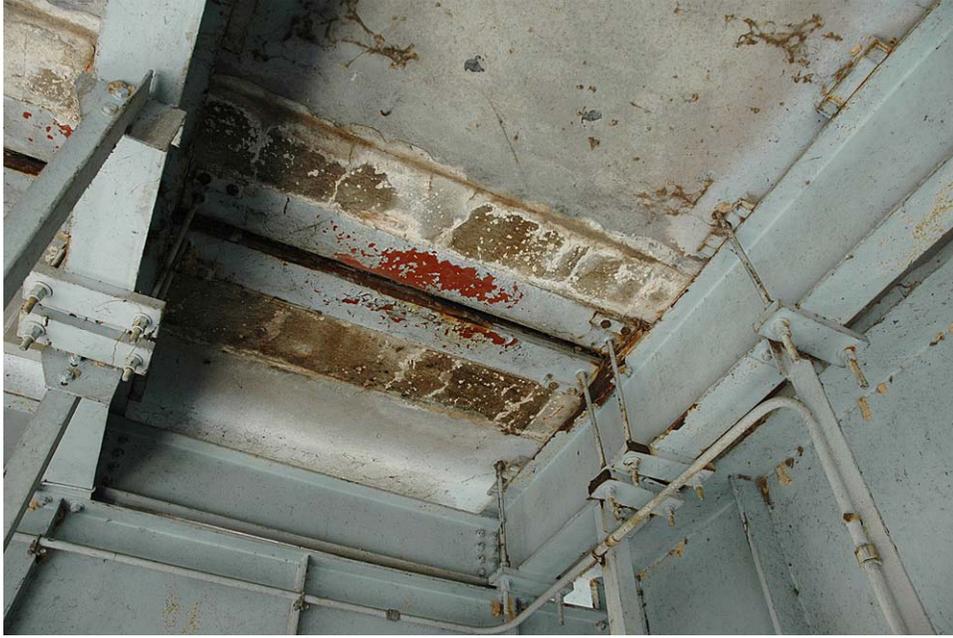
More corrosion and efflorescence were evident at the joints where construction crews placed closure pours after longitudinally post-tensioning a group of panel segments together.

Typically, the armor plating at these joints was moderately rusted and moisture from a prior rainfall was evident at many closure pour locations. Further, the stringers supporting the deck panels at these locations had rust and scaling, as seen in Figures 12 and 13. In addition to the joints, some steel bearing plates and hold-down rods were corroded where water had apparently seeped down between the interface of the precast concrete and the methyl methacrylate polymer concrete used for the pour backs that served as bearing pads, as seen in Figures 14 and 15. Although most of the hold-down rods affected by the water had only moderate corrosion, some had significant section loss.

Figure 12. More Efflorescence and Rust Staining at Closure Pours

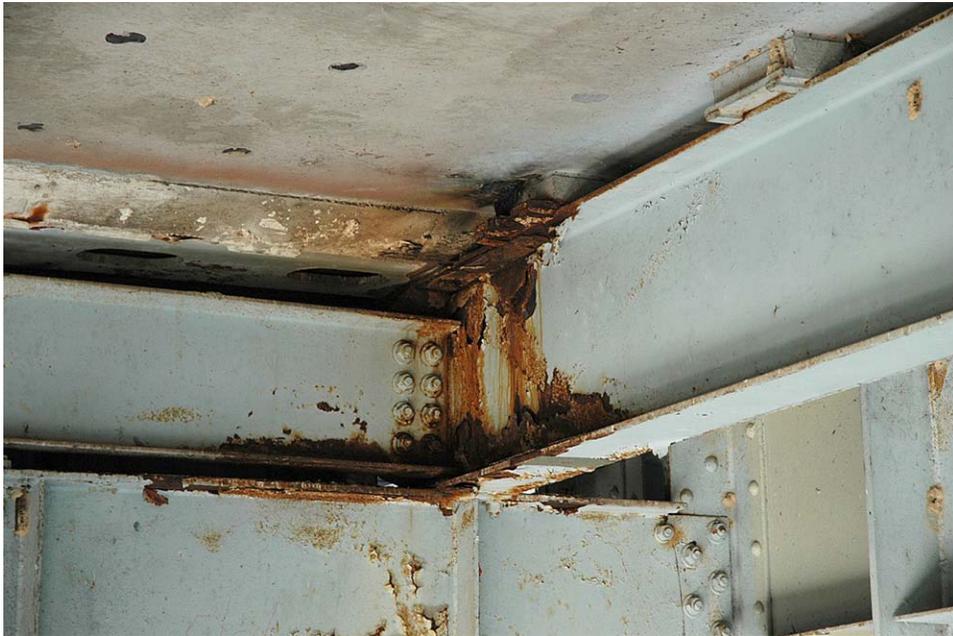
Figure 13. Corroded Steel at Expansion Joint

1. *VDOT's Structure & Bridge Division should continue to use full-depth precast concrete deck panels in bridge rehabilitation projects as a means of minimizing disruptions to the traveling public.*
2. *VDOT's Structure & Bridge Division should use epoxy concrete overlays or other protective wearing surface applications with low transport properties as a means to protect the lightweight concrete in its bridge decks, particularly in panel-to-panel joints, from exposure to deleterious contaminants.*
3. *VDOT's Structure & Bridge Division should consider using longitudinal post-tensioning once closure pours have been placed between deck panels.*
4. *VTRC should continue research on the design of and the material used in the pour-back locations at the expansion joints in order to reduce costly maintenance issues.*

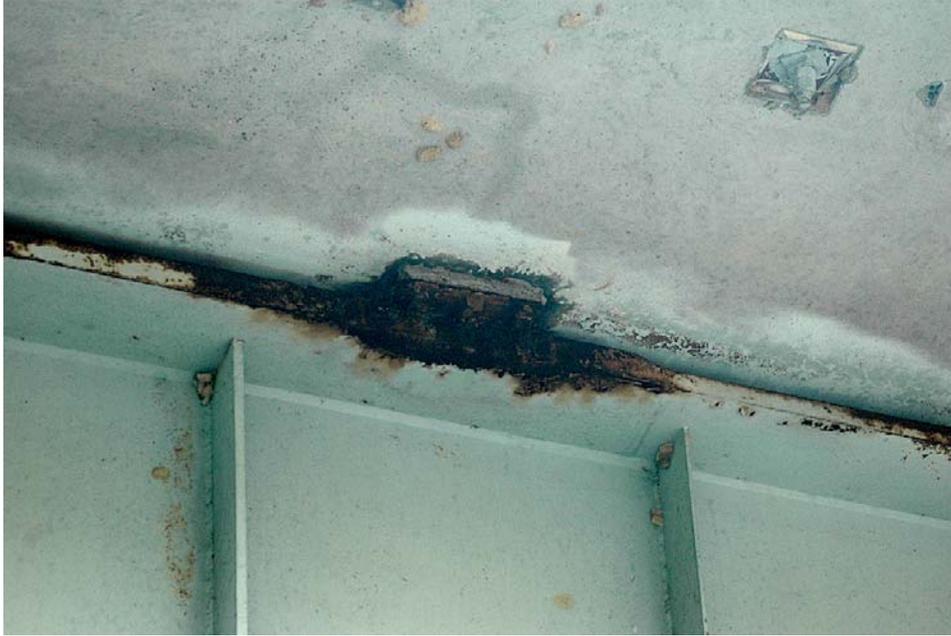
Figure 14. Bearing Seat Subject to Corrosion

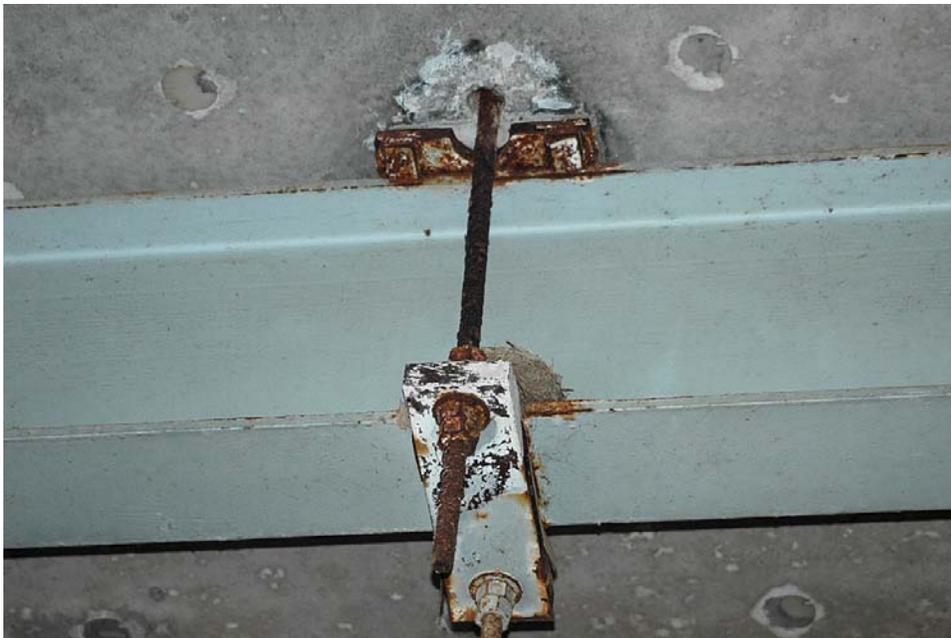
Figure 15. Corroded Hold-Down Bar Connecting Deck to Stringer

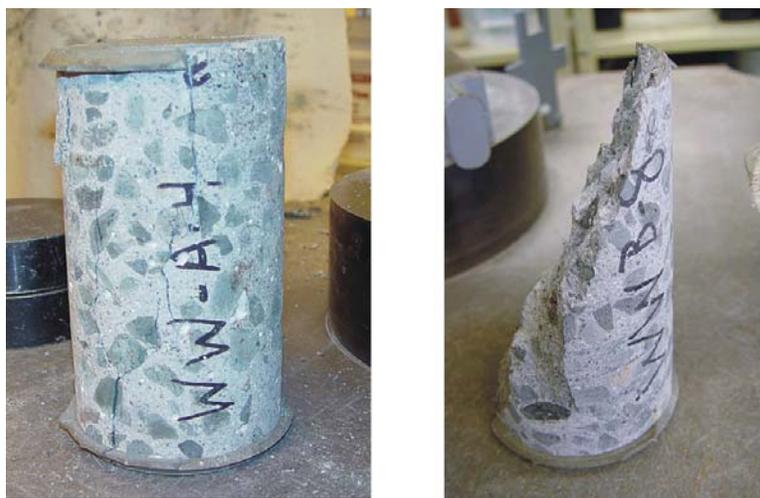
The four cylinders had either Type 3 or Type 4 fracture patterns described in ASTM C 39 and seen in Figure 16. None of the cores had fracture planes near any reinforcing bar that might have been present. Reinforcing steel, if present, was removed and visually inspected after compressive strength testing. As with all cores removed from the bridge, the mild-steel reinforcement was observed to be coated with a brown epoxy and appeared to be in excellent condition, except for minor rust on exposed ends of the reinforcing bar at the surface of the cylinder, which had occurred in storage. The post-tensioning strands also appeared to be in good condition. The steel retrieved from the cylinders was sent to Pennsylvania State University for further analysis and is discussed later in this report.

Figure 16. Typical Fracture Patterns from Compressive Strength Tests

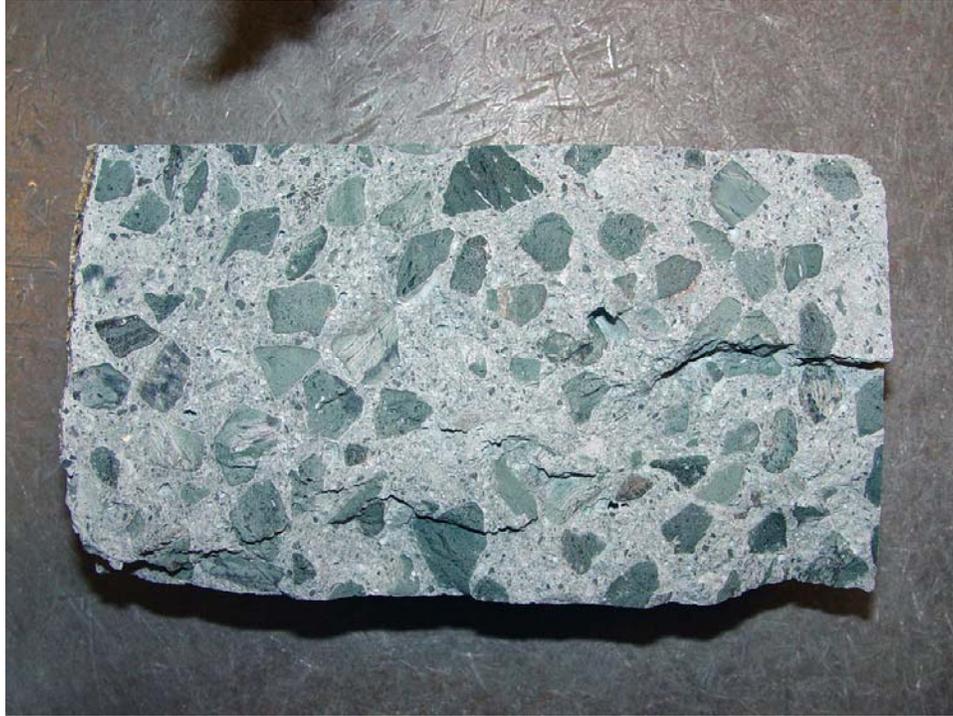
Generally, the plane of fracture in these splitting cylinder tests passed through the lightweight aggregate, indicating a good bond between the mortar and the aggregate, as seen in Figure 17. In core A-1, however, the researchers observed that a secondary crack formed around a piece of reinforcing bar embedded in the core. The result for core A-1 was about 9% below both the splitting tensile strength of sample A-6 and the average splitting tensile strength of all four cores. The reinforcing bar, shown in Figure 18, may have influenced this lower result.

Figure 17. Fracture Plane Passing Through Aggregate After Splitting Tensile Test

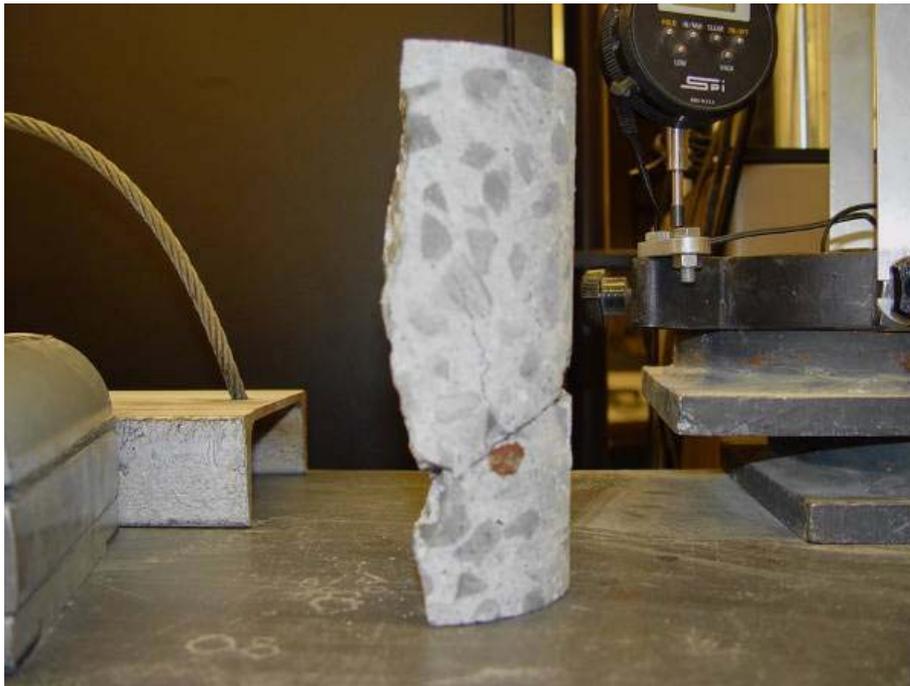
Figure 18. Crack Forming Near Rebar After Splitting Tensile Test

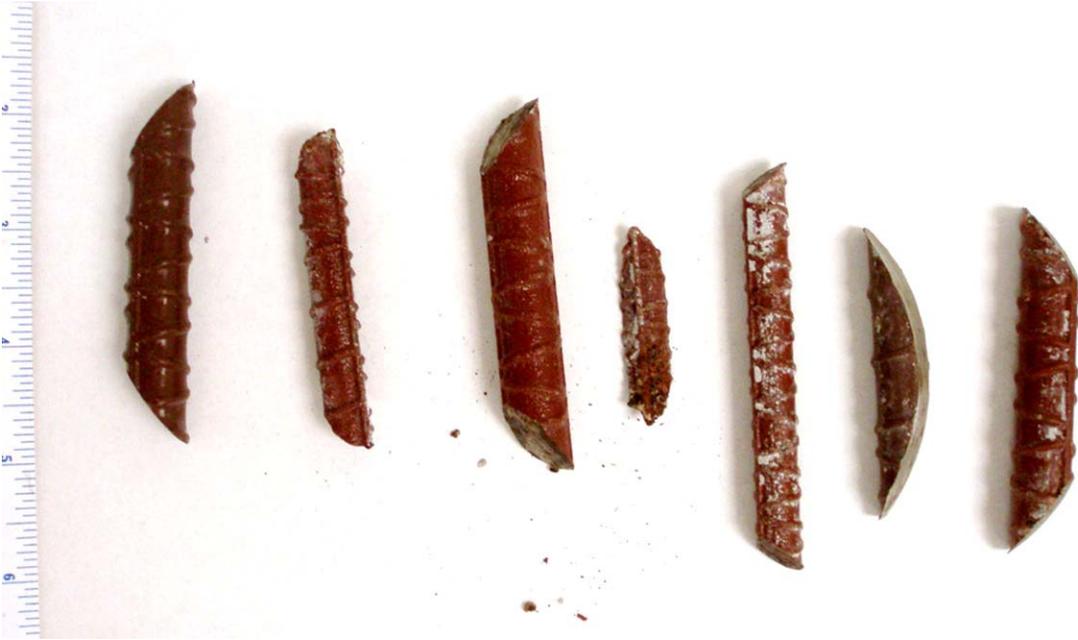
The sections of mild reinforcement taken from the bridge were in excellent condition, with no corrosion apparent (other than surface corrosion at the cut ends initiated after removal from the bridge). The seven portions of reinforcement extracted from the cores are shown in Figure 22.

Figure 22. Mild Reinforcement Bars from Precast Deck Slab Core Samples. The brown pigment color of the reinforcement coating should not be mistaken for corrosion product.

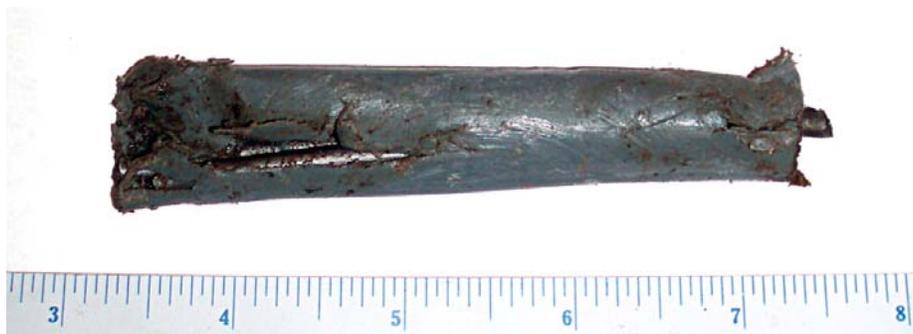
Three greased/sheathed tendon samples were obtained from the cores. Figures 23 through 25 show the three samples prior to coating removal. Tendon A2 sustained heavy coating damage during the coring process. Otherwise, the tendon sheathing was in excellent condition.

Figure 23. Tendon A2 Prior to Sheathing Removal

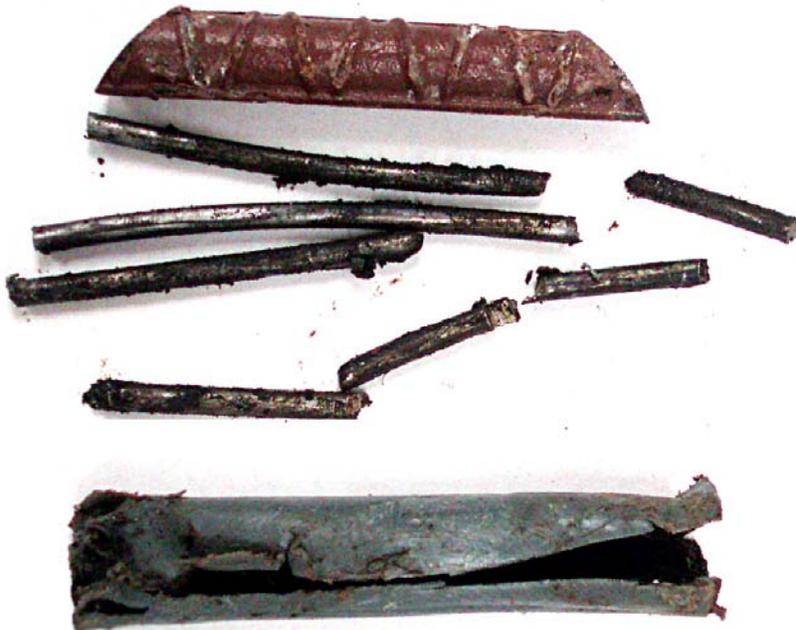
The sheathing was then removed to inspect the condition of the PT coating (post-tensioning grease) on the strand surface. A longitudinal slice was made along the length of the tendon to expose the strand. Figures 26 through 28 show the greased strand. (The reinforcing

Figure 26. Mild Reinforcement and Tendon A2 Strand and Casing After Sheathing Removal

bar shown in Figure 26 was a bar from the same core.) The strand wires were cut or ruptured in several cases, likely from the coring process. The grease coating was still covering the tendons and providing a protective barrier for the wires in all cases. The strand appeared also to have the remains of a paper-like wrap between the grease and sheathing. This can be seen most easily in Figure 27, where portions of the “paper” are adhered to the grease on the strand.

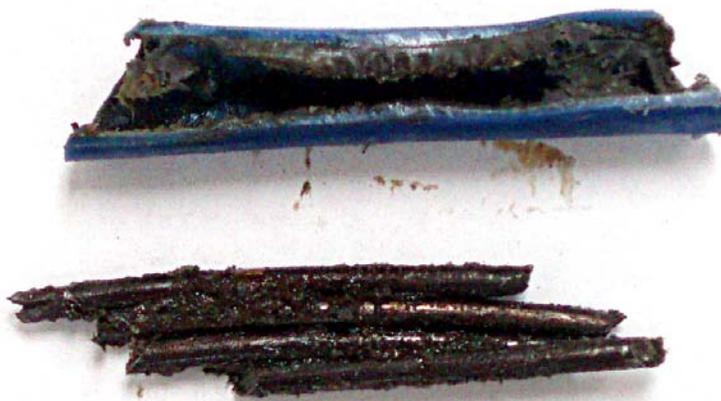
Figure 28. Tendon B1 After Sheathing Removal

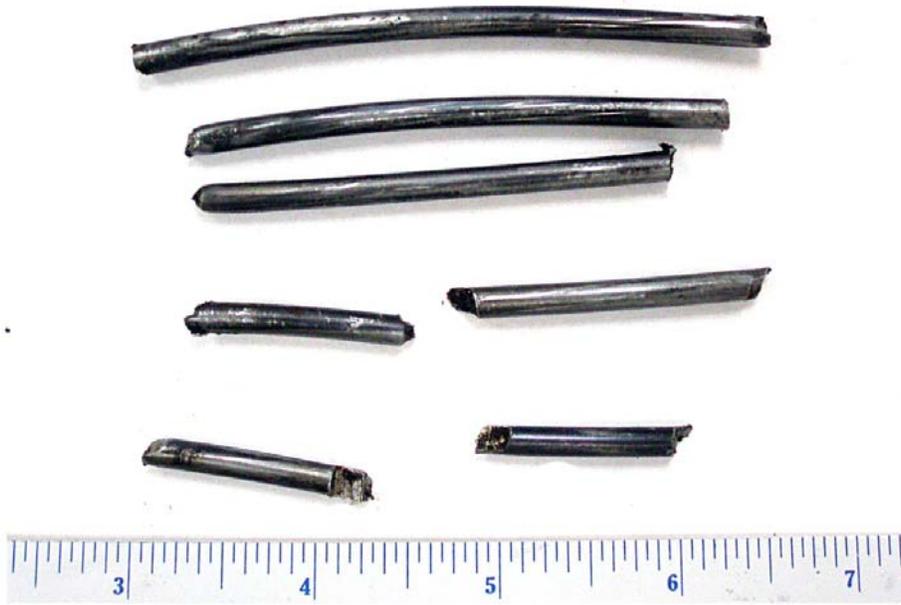
The individual wires were then cleaned to remove the grease coating for a visual inspection of the strand condition. Figures 29 through 31 show the cleaned wires for each specimen. In all cases, the condition of the wires was excellent with no corrosion evident.

Figure 29. Tendon A2 Wires

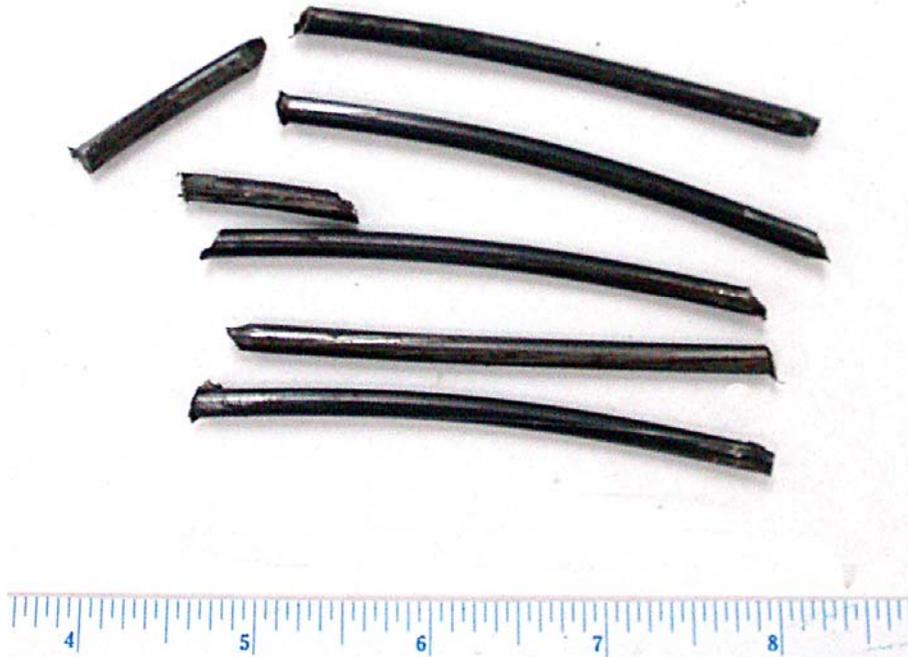
Figure 30. Tendon A7 Wires

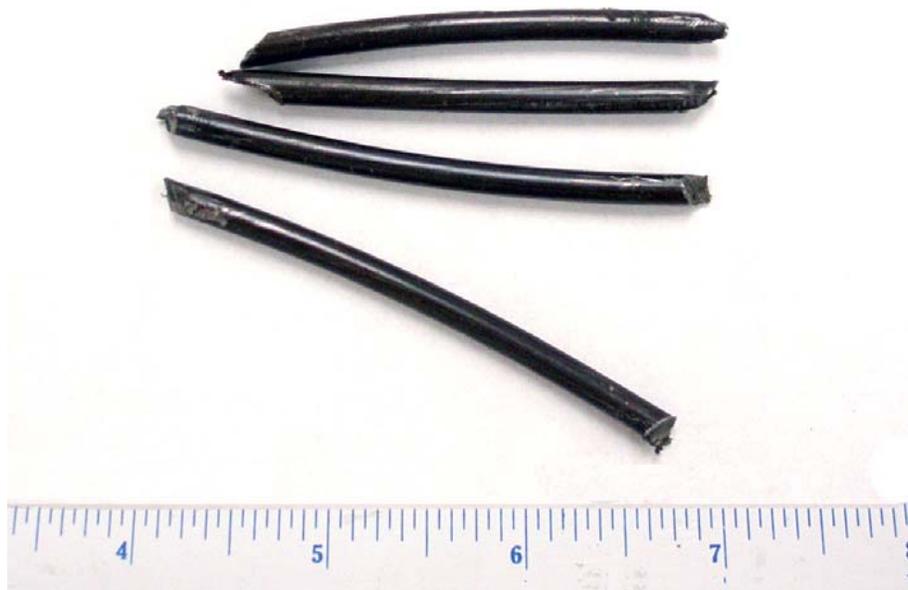
Figure 31. Tendon B1 Wires

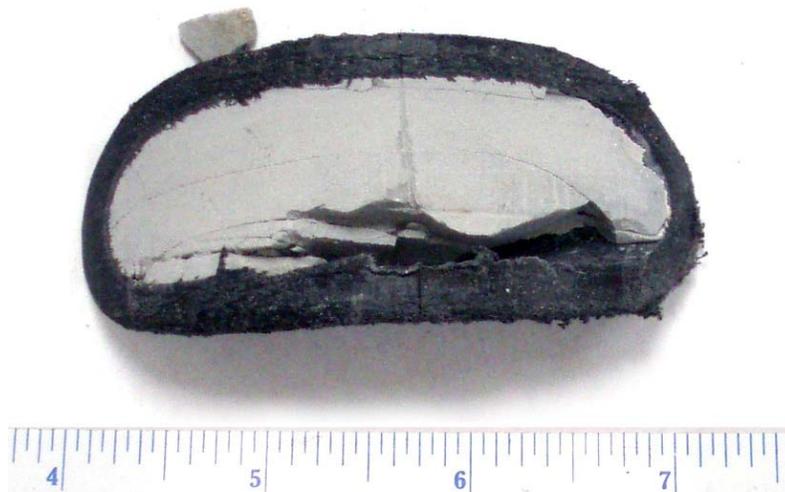
A small portion of grouted post-tensioning duct was obtained from a core sample. As shown in Figure 32, the condition of this sample was excellent. Even with the disruption of coring, the grout was intact and held without the duct section. This portion of grout showed consistent color, indicating that no settlement or segregation occurred during placement in this area. No voids or air bubbles were visible in the grout sample.

Figure 32. Grout Sample in Duct
