## Performance of a Skewed Semi-Integral Bridge: Volume I: Field Monitoring

EDWARD J. HOPPE, Ph.D., P.E.  
Senior Research Scientist

June 2008  
VTRC 08-R20

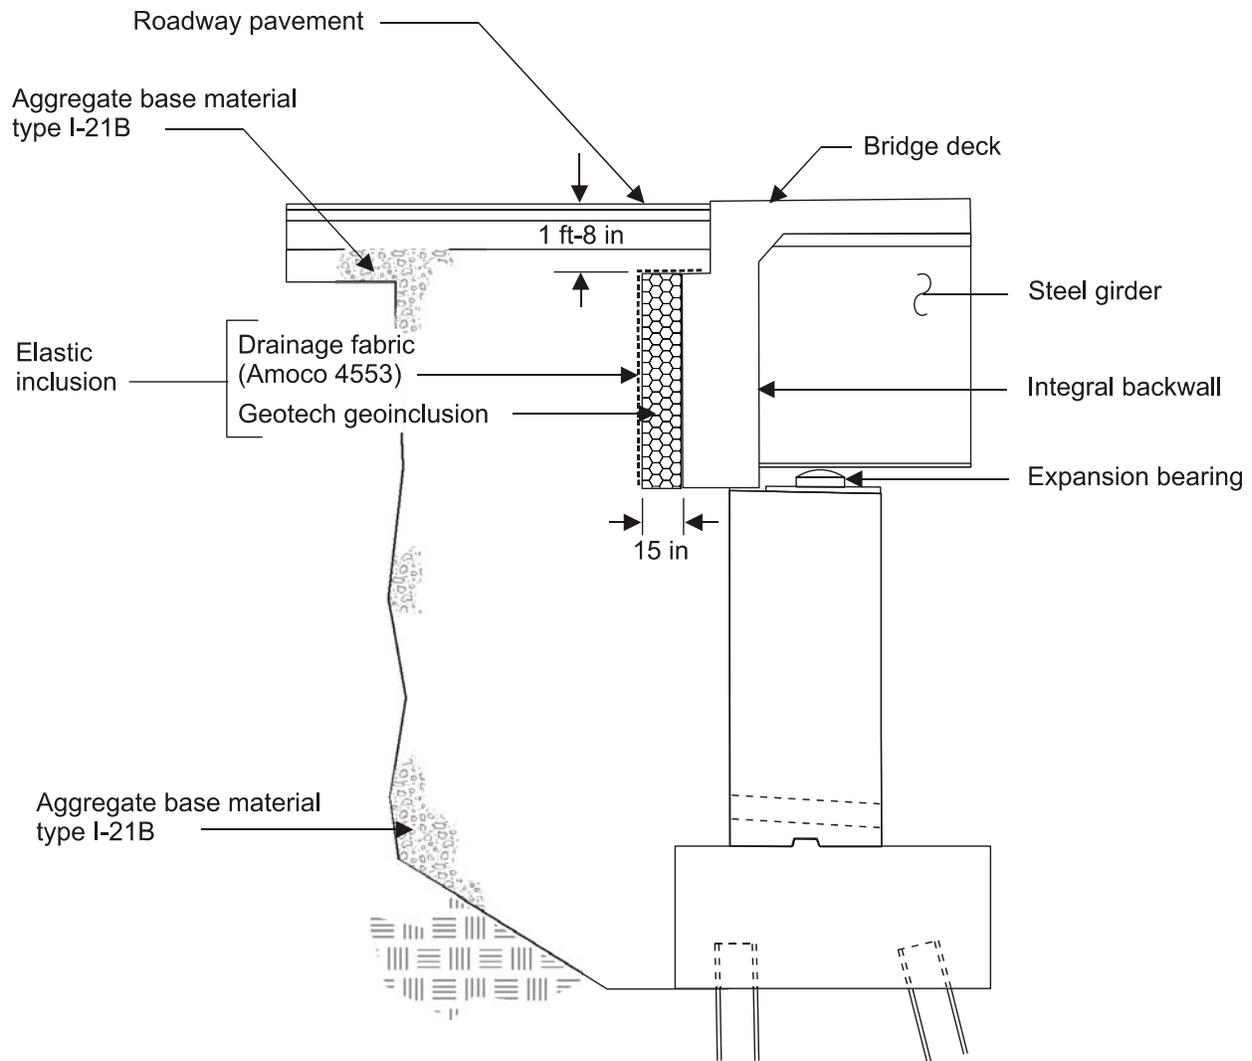
**Figure 5. Abutment A Cross Section**

This was the first integral bridge with a 45-degree skew constructed in Virginia. The design incorporates a 15-in (38-cm) layer of elasticized expanded polystyrene (EPS) faced with a separation geotextile, installed at the integral backwall of Abutment A. The EPS serves as an elastic inclusion, accommodating thermally induced displacements of the superstructure while reducing the lateral earth pressures and minimizing the approach embankment settlement. It also serves to dissipate lateral pressure exerted by the adjoining structural backfill. Figure 5 shows the cross-section detail of Abutment A, with the elastic inclusion placed against the integral backwall. VDOT's Special Provision for Elastic Inclusion is included in Appendix A.

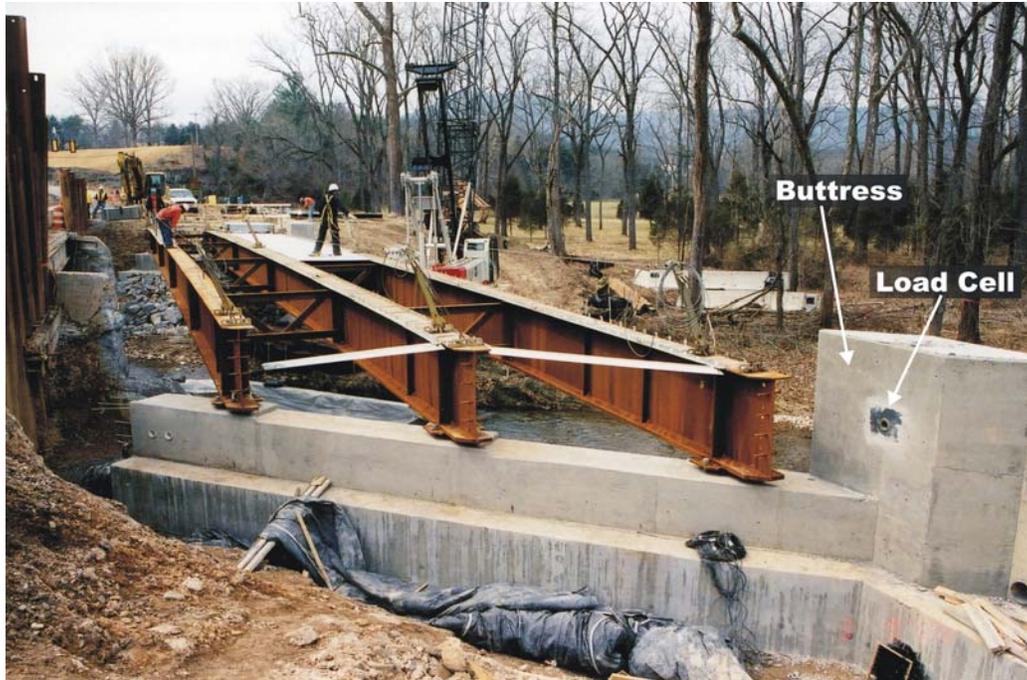
**Figure 6. Concrete Buttress at Abutment B**

The superstructure is restrained from rotating in the horizontal plane by two concrete buttresses constructed at the southwest (Abutment A) and northeast (Abutment B) corners. Figure 6 shows the buttress with the embedded load cell used to measure the restraining reaction force.

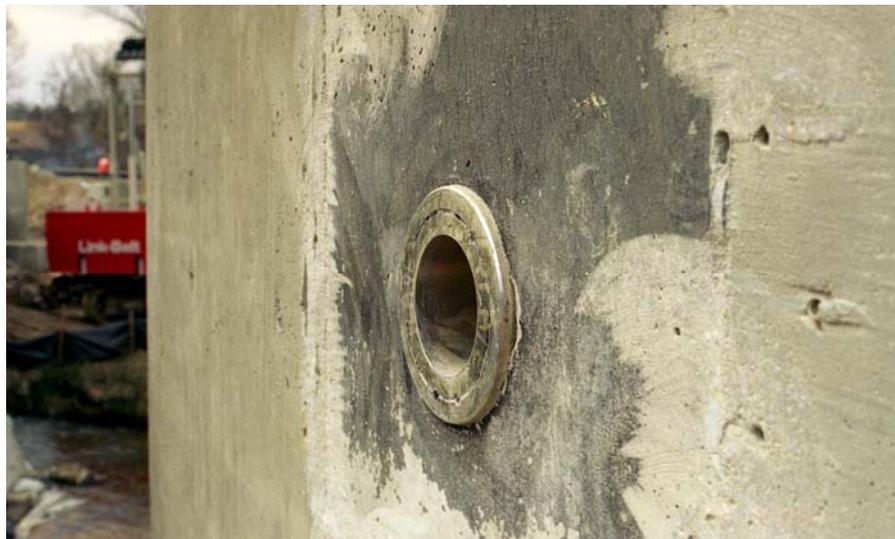
**Figure 7. Load Cell at Buttress of Abutment B**

Figure 7 shows the Geokon Model 4900 vibrating wire load cell embedded into the Abutment B buttress. The purpose of the load cell is to measure the magnitude of the lateral force exerted by the adjacent superstructure as a result of thermally induced deformation. The load is transferred from the superstructure through two stainless steel rub plates that allow for transverse sliding while the load cell registers the lateral force. Another bearing plate is attached to the back of the cell in order to distribute the load inside the abutment buttress. The design detail is shown in Figure 8. Baseline load readings were collected with the superstructure in place, but with no backfill placed behind the backwall.

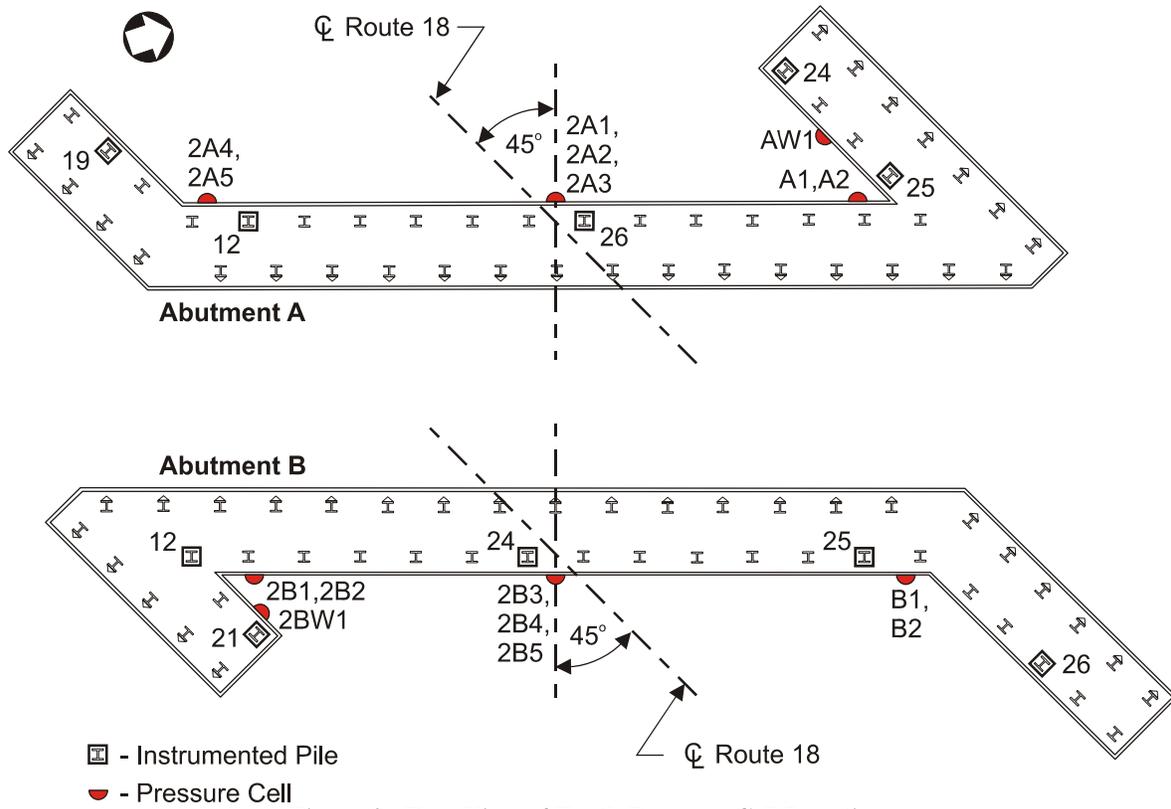
**Figure 9. Plan View of Earth Pressure Cell Locations**

Figures 9 through 12 show the layout of Geokon Model 4810 vibrating wire earth pressure cells installed at each backwall. Each cell was installed in a recessed area so that the sensing surface of the cell coincided with the plane of the concrete surface. Seven pressure cells were installed at each integral backwall. Pressure cells A1, A2, 2A2, 2A3, 2A4, and 2A5 at Abutment A were subsequently covered with elastic inclusion. Pressure cell 2A1 and all cells at Abutment B were in direct contact with the adjoining aggregate base material, VDOT Type 21B.

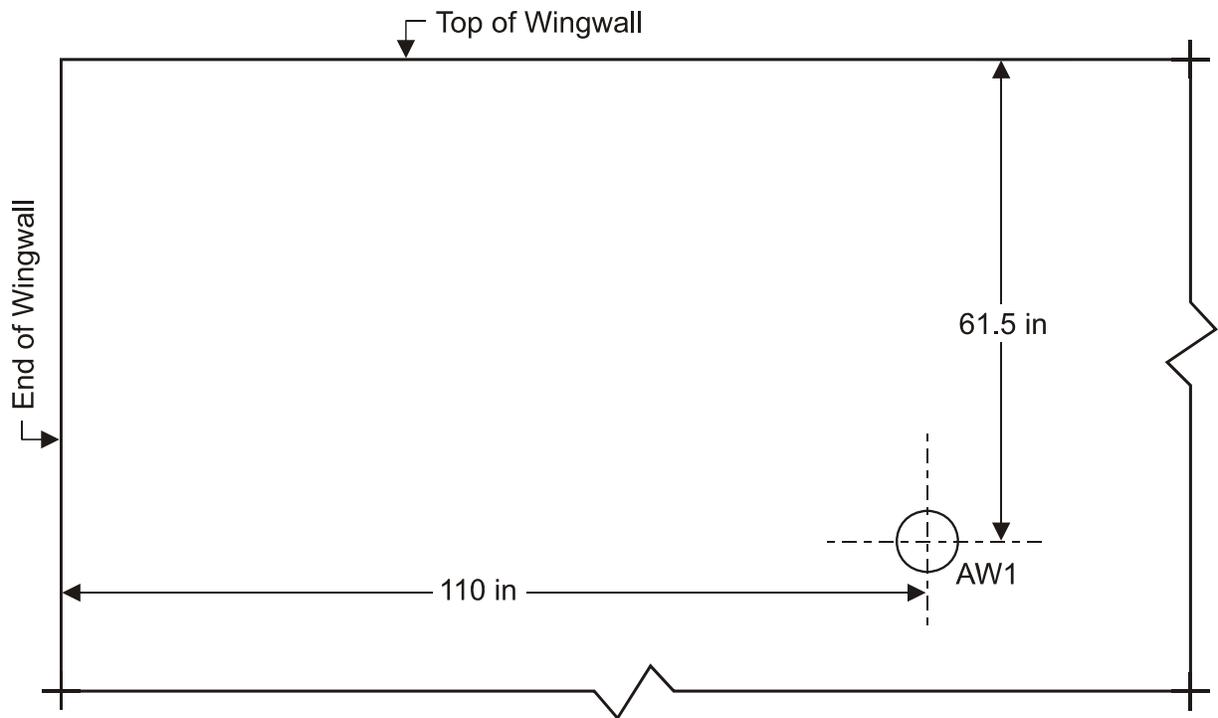
**Figure 13. Location of Earth Pressure Cells at Wingwall A**

Two pressure cells were installed at wingwalls of each abutment (one per abutment), as shown in Figures 13 and 14. Pressure cell AW1 was covered with a layer of MiraDRAIN 2000 composite drainage material, applied to the wingwall surface. A circular opening was cut out in the drainage layer at the location of the 2BW1 cell to allow measurements in a direct contact with the aggregate base material.

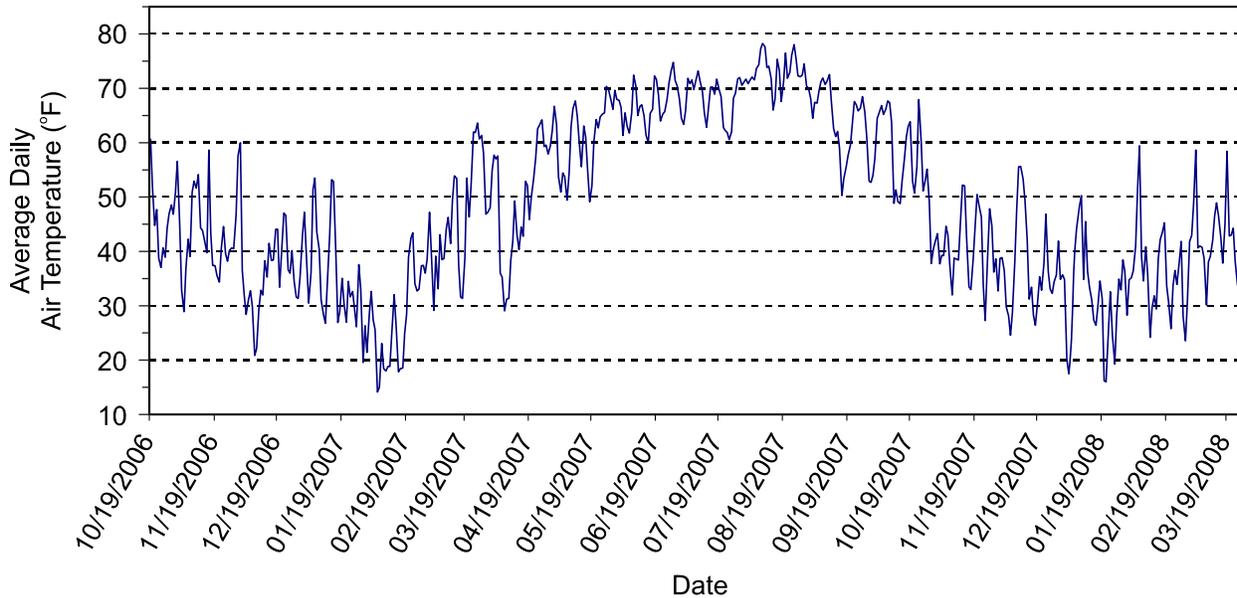
Figure 15. Average Daily Air Temperatures During Monitoring Period

Figure 15 shows average daily air temperatures for the entire monitoring period. The range extends from approximately 14°F (-10°C) to 82°F (28°C). It represents a fairly typical seasonal distribution of air temperatures encountered in western Virginia.

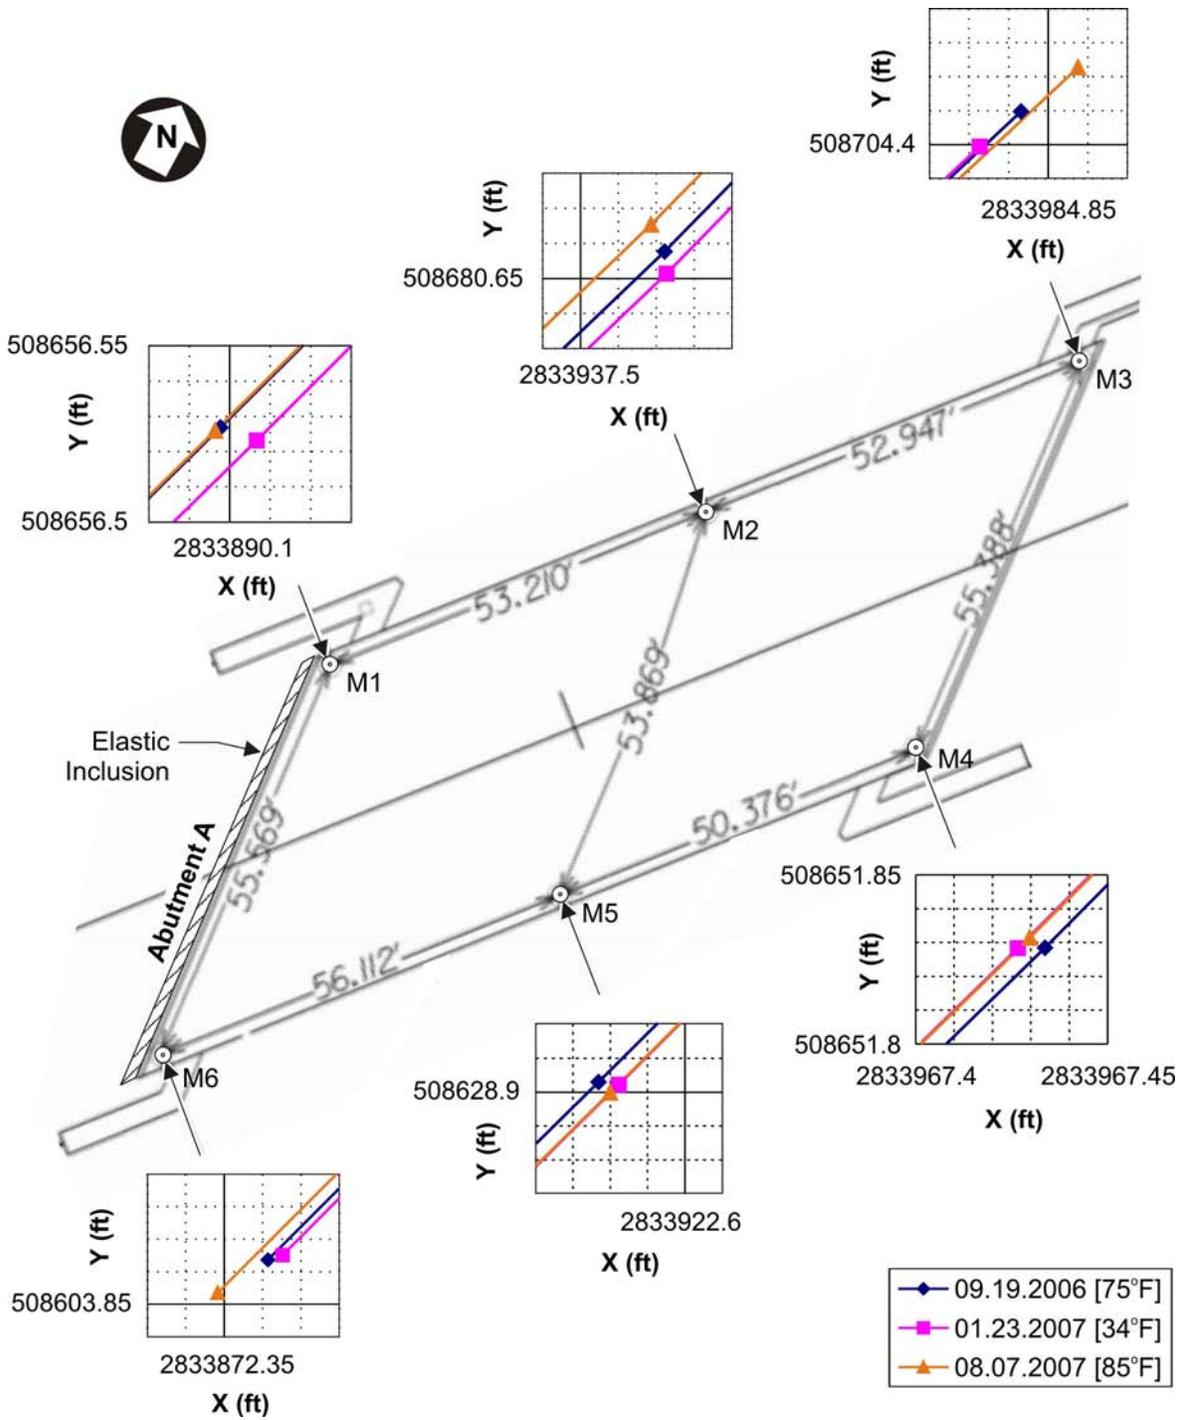
Figure 16. Results of Bridge Coordinate Surveys

Figure 16 shows the results of deck surveys conducted at various climatic conditions. The baseline survey, consisting of a precise coordinate location of each marker installed on the deck surface, was performed on September 19, 2006, at an ambient air temperature of 75°F (24°C). Two additional surveys followed, on January 23, 2007, and on August 7, 2007, at ambient air temperatures of 34°F (1°C) and 85°F (29°C), respectively. The figure shows magnitudes of thermally induced deformations at each corner and at the mid-span of the deck. Table 1 summarizes the resultant overall displacements of each corner as vector sums of x and y components.

The results of the deck coordinate survey clearly demonstrate that the predominant direction of thermally induced expansion and contraction at the skewed superstructure is along the long diagonal. This finding is equally applicable to a skewed conventional bridge and may explain difficulties encountered with the alignment of beams and diaphragms in the hot weather construction. It may also be the cause of significant variations in the lateral earth pressures registered at each backwall.

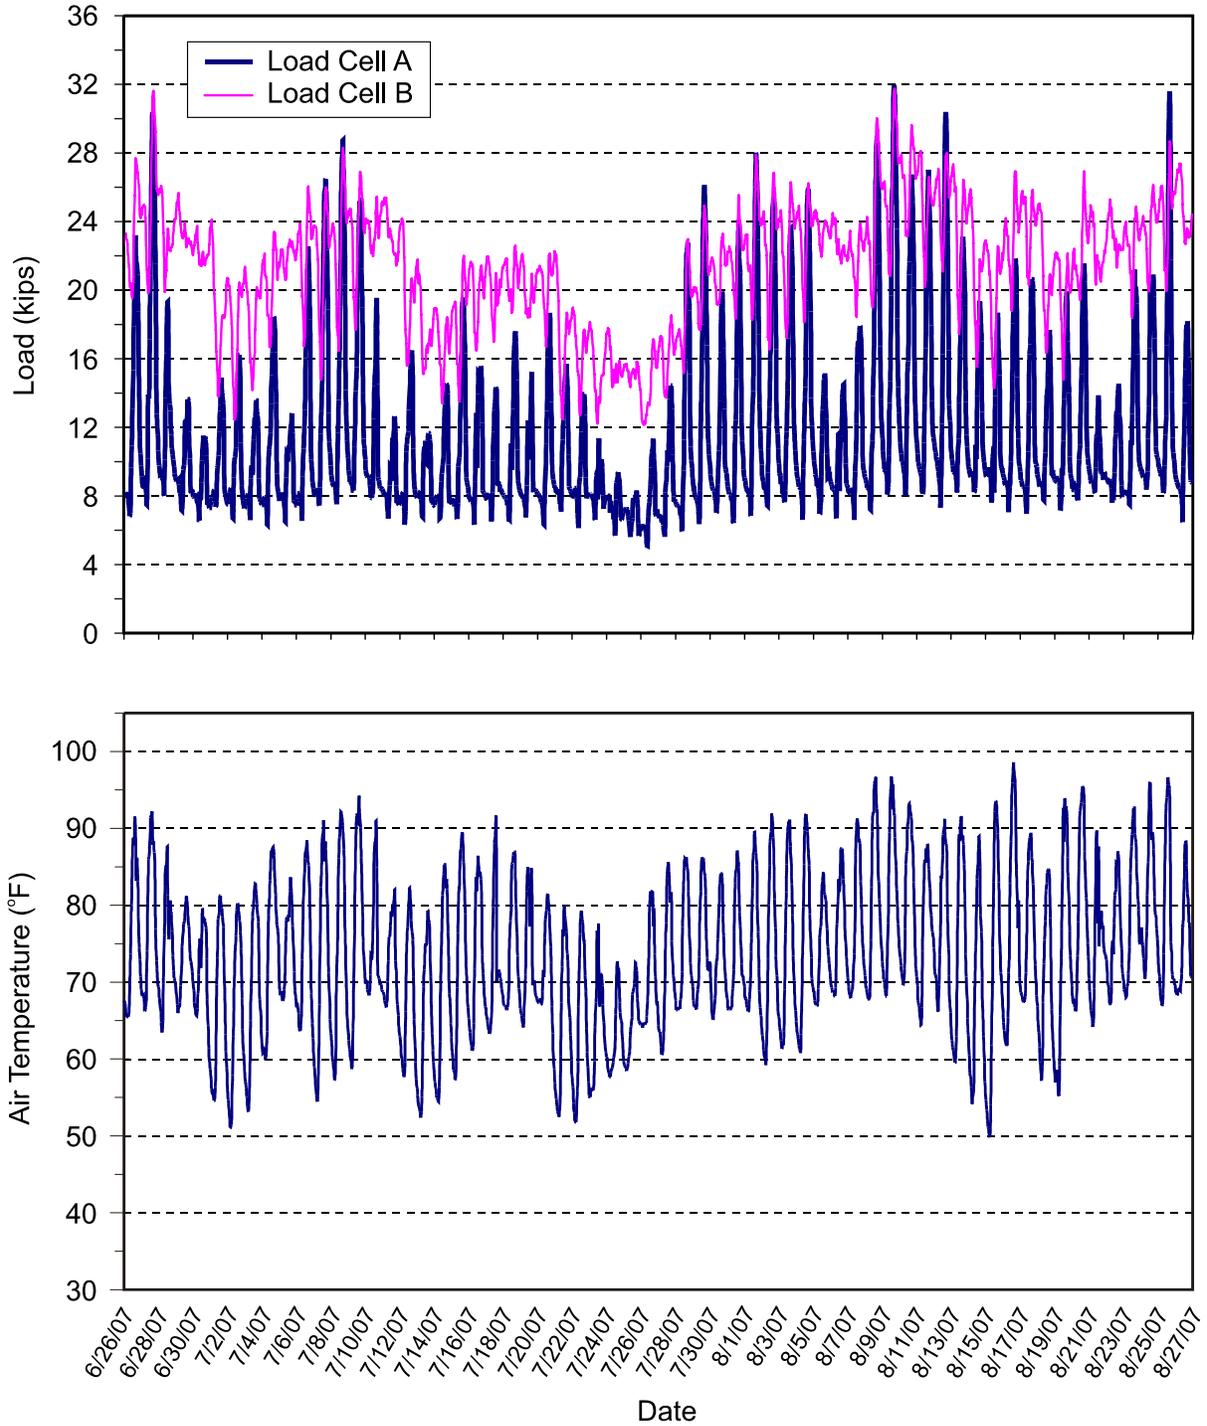
**Figure 17. Load Cell Data: 6/26/07–8/26/07**

Load cell data indicate that the maximum force of 32 kips (14.6 tonnes) was registered by both cells in the late afternoon of August 9, 2007, at an ambient air temperature of 91°F (33°C). Figure 17 shows load cell data acquired between June 20 and August 31, 2007, reflecting a period of highest recorded values. Corresponding horizontal earth pressures acting on the Abutment B backwall are shown in Table 2.

Load cell data show virtually identical maximum forces recorded at both cells at the same time. The maximum registered force of 32 kips (14.6 tonnes) was observed on August 9, 2007. It culminated after an approximately 2-week period of steadily increasing ambient air

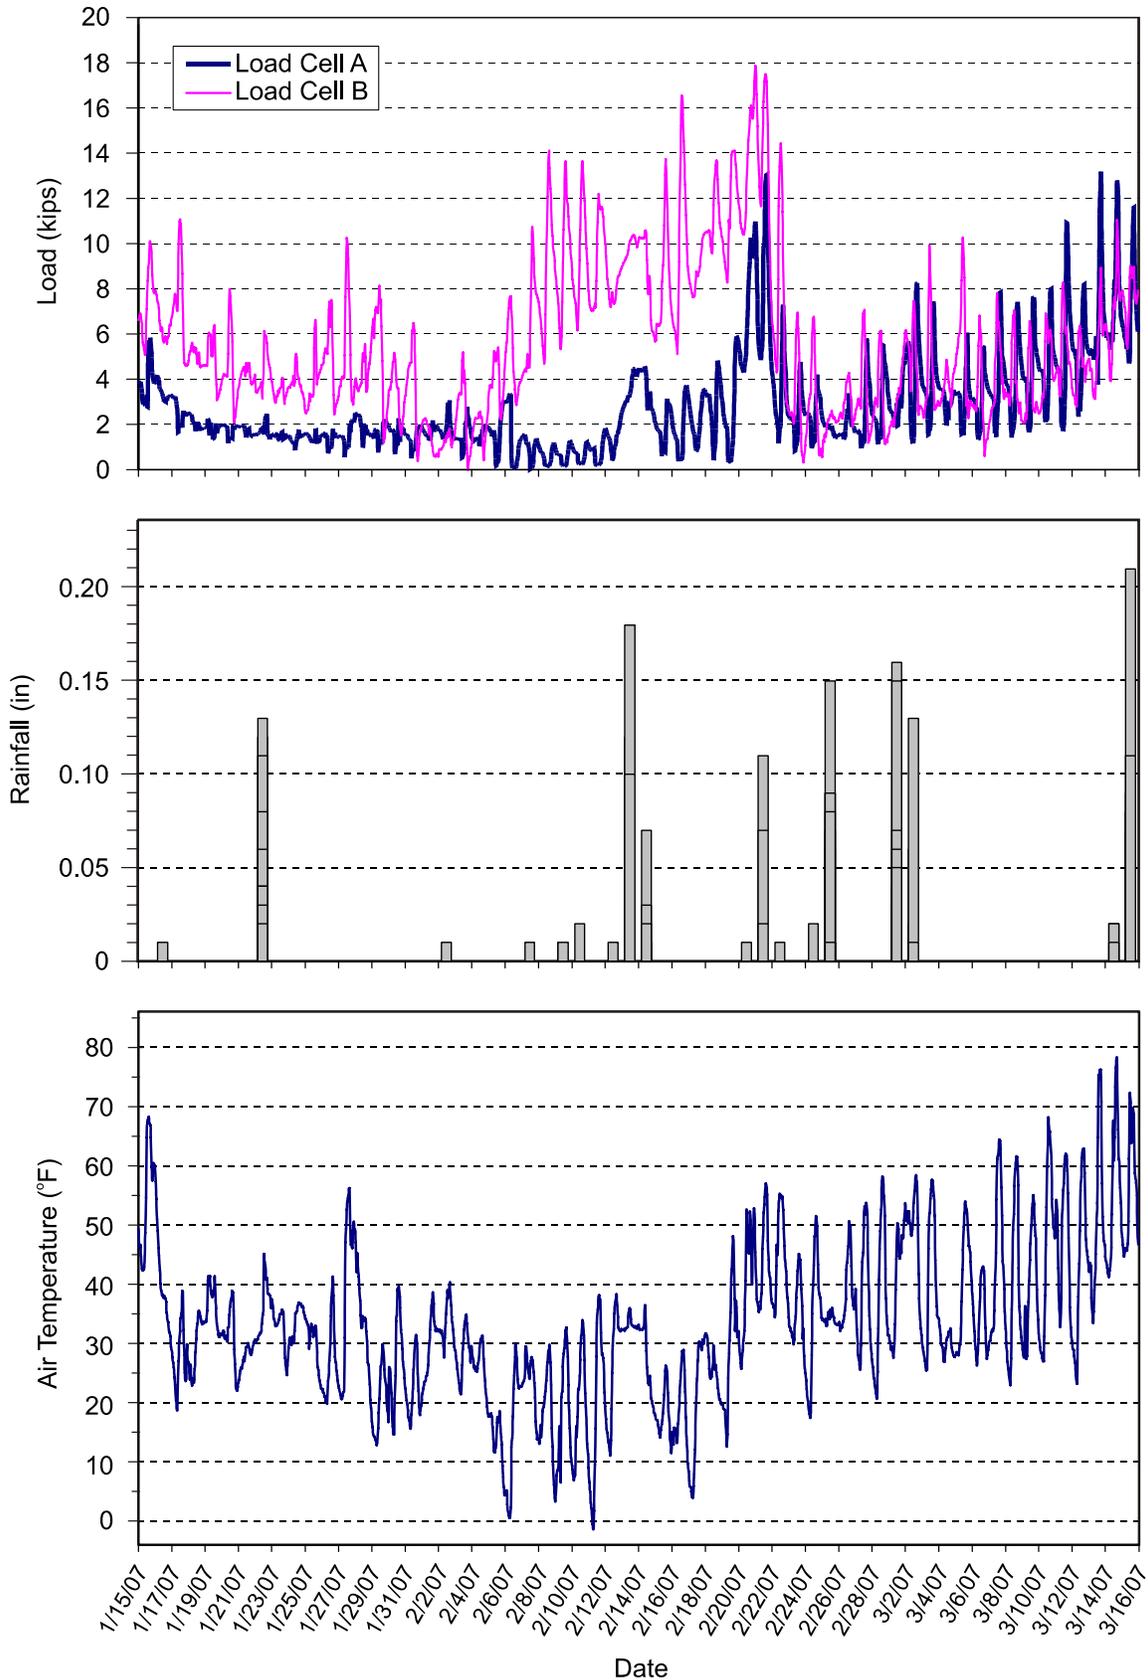
Figure 18. Load Cell Data: 1/15/07–3/15/07

Figure 18 shows the load cell data for a relatively cold weather period of January 15 to March 15, 2007. It is evident that the Load cell B registered significantly higher forces than the Load cell A. This phenomenon may be explained by weather conditions at the time. Figure 18 also shows rainfall and air temperature values. Records indicate a period of sub-freezing temperatures from January 17 to February 20, 2007, combined with a fair amount of precipitation occurring around February 12, 2007. A period of a rapid warm-up followed, causing bridge expansion and elevated load cell readings. It is possible that the bridge was expanding against a partially frozen backfill, resulting in higher loads recorded at the Abutment B load cell. At the same time, Abutment A was effectively shielded from a frozen backfill effect by the EPS material.

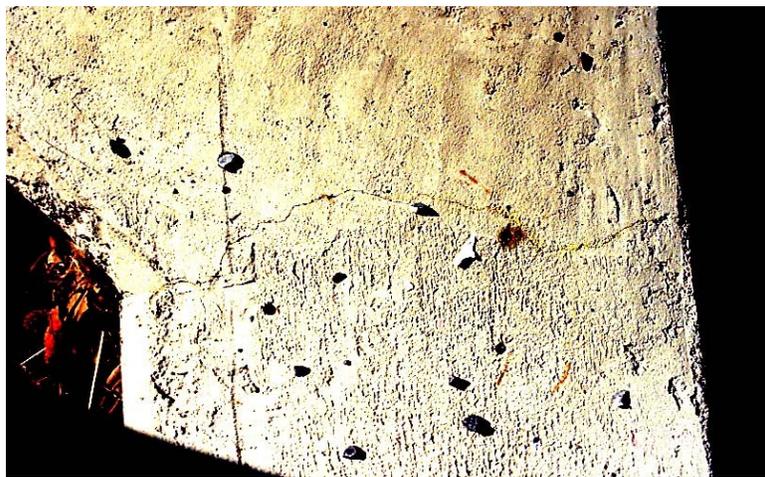
**Figure 19. Plan View of Cracked Wingwall at Abutment B**

The structure was inspected periodically for any visible signs of distress. At the end of February 2008, hairline cracks were discovered in the wingwall-backwall plane at both abutments. It is not evident at this time that the cracks are propagating. Figure 19 shows a crack that formed at the north wingwall of Abutment B. Follow-up field measurements are planned to assess the possible cause and the severity of this problem. No other cracks were detected.

Earth pressure variations detected at the wingwall cells (AW1 and 2BW1) are a cause for concern, because they may be indicative of some unintended lateral movement (otherwise, these pressures would have remained essentially constant). If the movement was sufficiently large, it could have mobilized an unbalanced passive pressure on the wingwall, possibly causing the observed cracks. Additional field studies are needed to determine the probable cause of the wingwall distress and to update design guidelines if warranted.

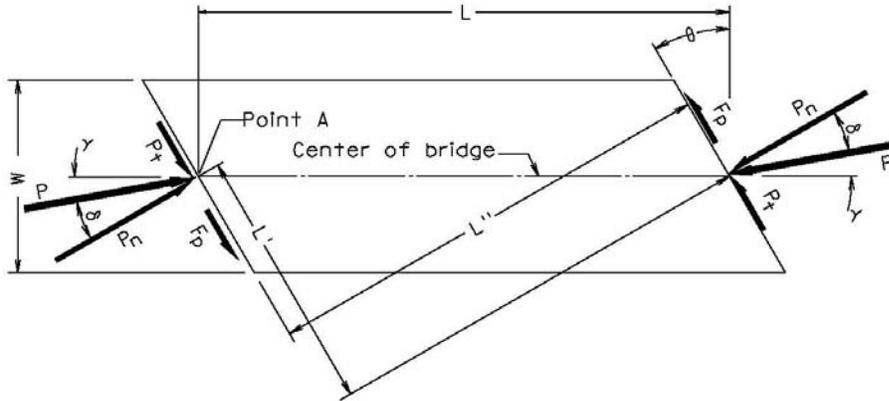
$F_p$  Total lateral pile force required to resist rotation of superstructure (kips)

$P = \frac{qW}{\cos(\theta - \delta)}$  Full passive force across the width of the bridge (kips)

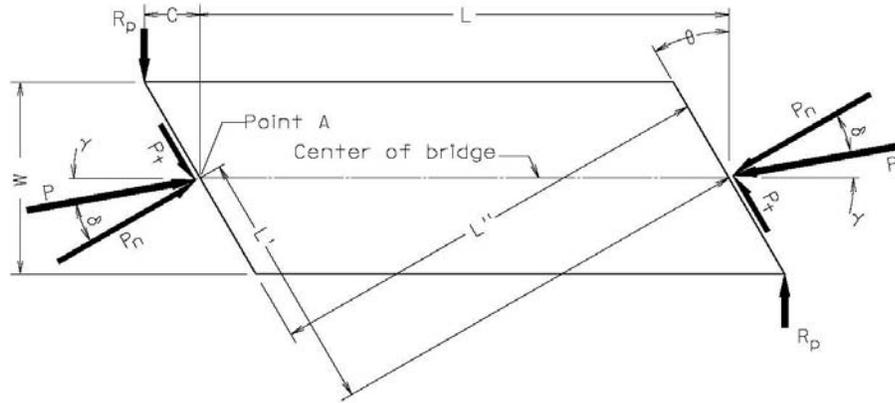
- $R_p$  Buttress force required to resist rotation of superstructure (kips)
- $P = \frac{qW}{\cos(\theta - \delta)}$  Full passive force across the width of the bridge (kips)
- $P_n = P \cdot \cos \delta$  Component of "P" normal to the backwall (kips)
- $P_t = P \cdot \sin \delta$  Component of "P" tangential to backwall (kips)
- $\delta$  Angle of Wall Friction
- $\theta$  Skew angle of bridge
- $\alpha$   $\theta - \delta$
- $q = \frac{1}{2} \cdot \gamma_s \cdot K_p \cdot H^2$  Resultant of passive force at a point along the backwall. (kips/LF)
- H Height of integral backwall (ft)
- $K_p$  Coefficient of passive earth pressure
- $\gamma_s$  Unit weight of soil (pcf)
- $C = \frac{W}{2} \cdot \tan \theta$  Moment arm for buttress force
- $L' = L \cdot \sin \theta$  Moment arm for normal passive force
- $L'' = L \cdot \cos \theta$  Moment arm for tangential passive force
