Virginia Transportation Research Council

research report

Evaluation of the Cross Alert System on the Virginia Capital Trail in James City County

June 2008
VTRC 08-R23

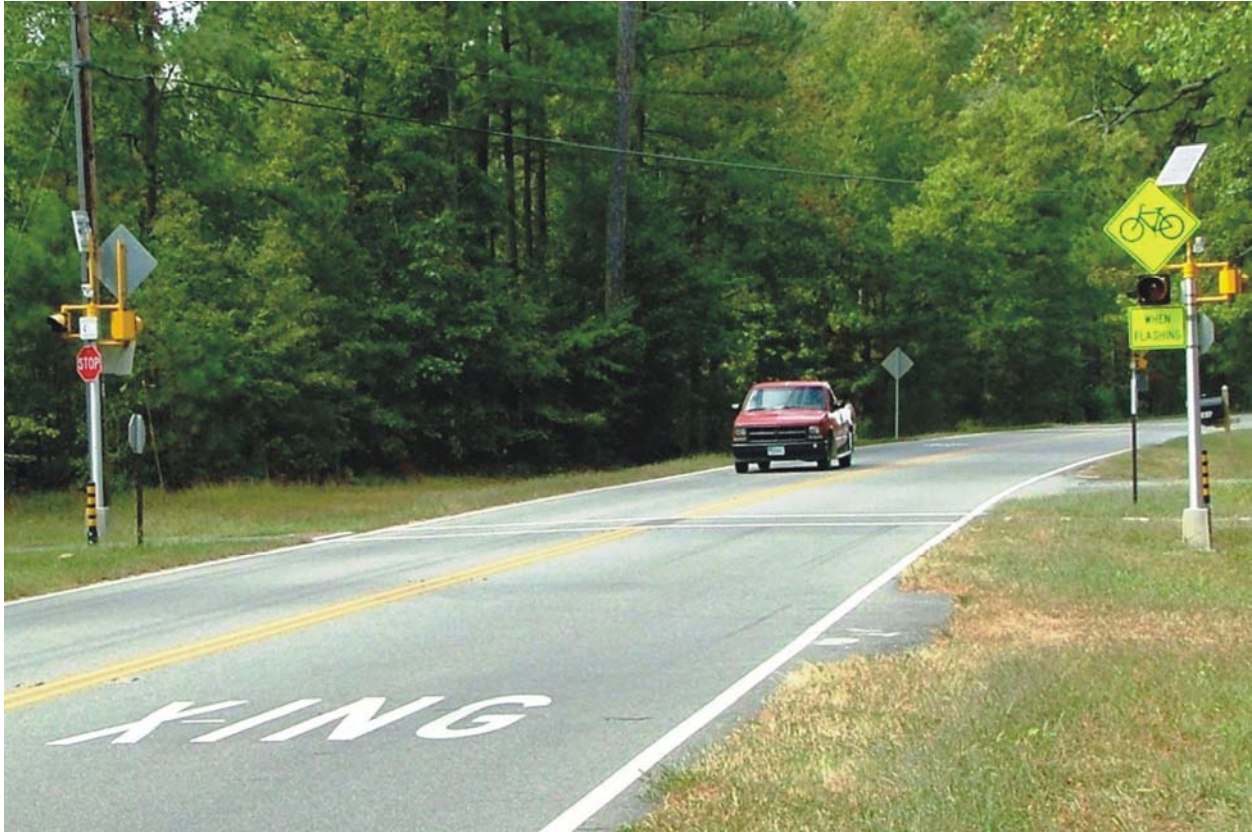
The Cross Alert system consists of a red light-emitting diode (LED) light and stop sign that are aimed at path users and an amber LED light and warning sign that are aimed at roadway vehicular traffic. The system is powered by a solar panel with a battery backup and activated by path activity via an infrared motion sensor. The companion signs on the other side of the road are activated via radio signal when the first sign detects motion on the path. This system also

Figure 1. Cross Alert System on Route 5 in James City County, Virginia. *The photograph was taken prior to the official opening of the Chickahominy Riverfront Phase on May 1, 2007.*

includes an integrated trail counter to provide a count of trail users who cross the intersection. All signs comply with the requirements of the *Manual on Uniform Traffic Control Devices*.⁵

Solar power significantly reduces installation costs for the system by eliminating the need for connection to the power grid. Radio linkage between signs eliminates the need for hanging or burying wires. The system is capable of running in a configuration with up to four sign poles, all of which can be triggered together by path activity. This allows for amber warning lights to be placed and aimed at oncoming vehicles up to 500 ft from the crossing, which is the case at the Route 5 crossing.

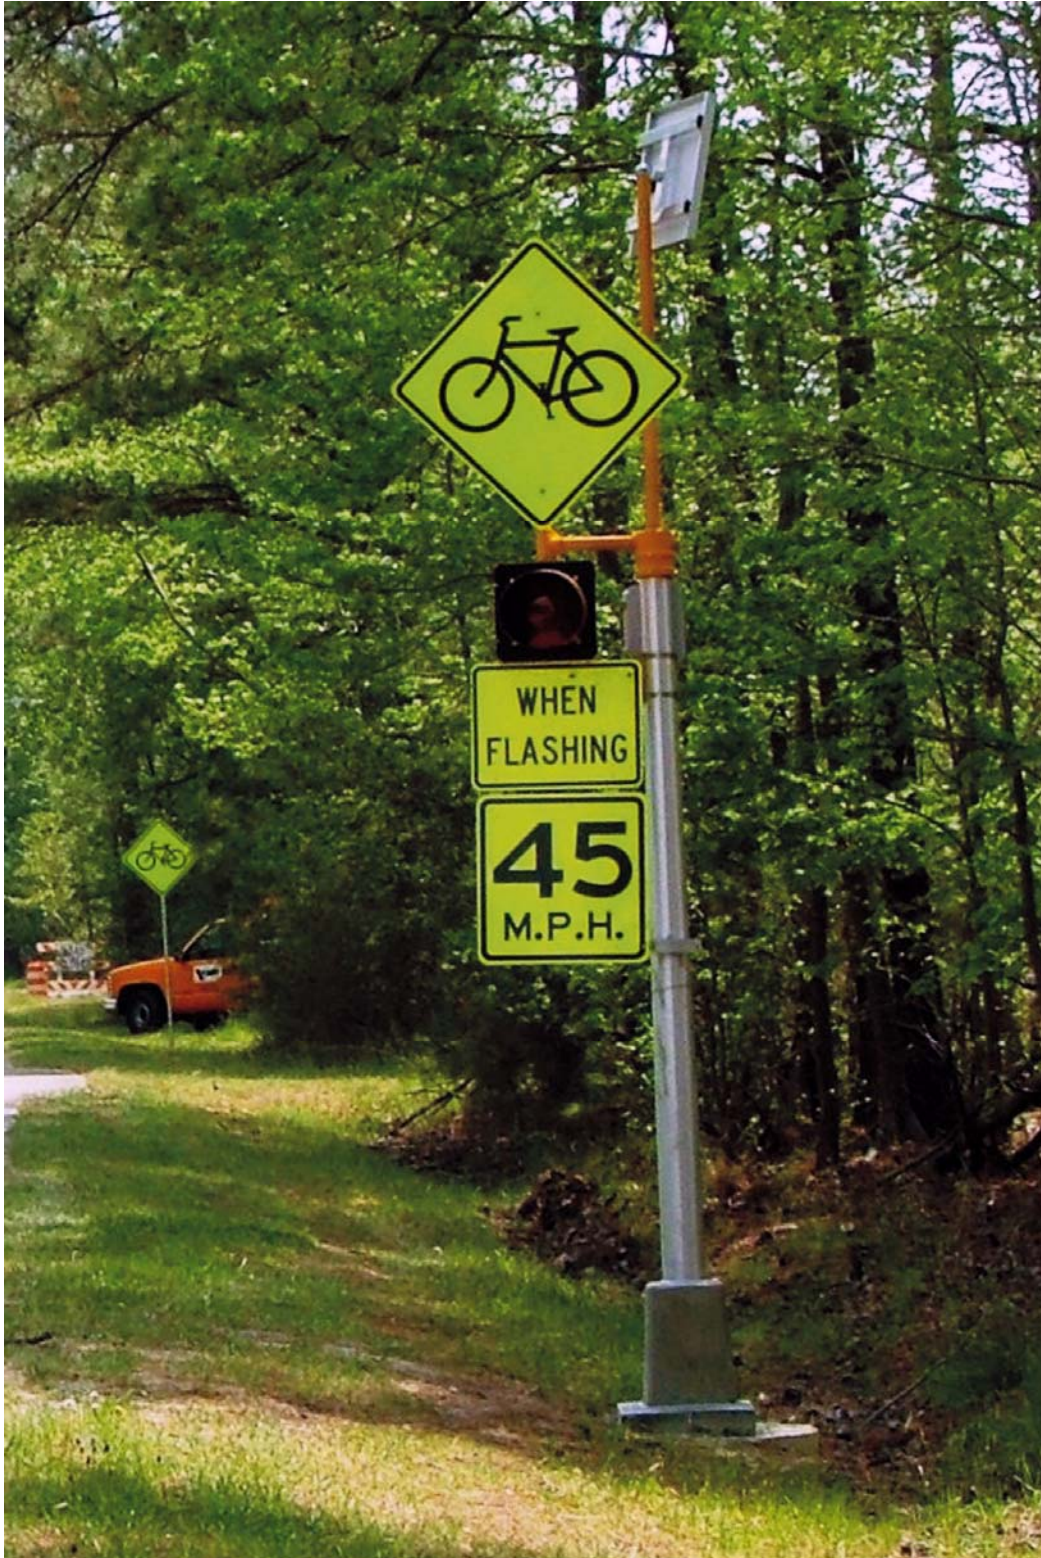
Figure B2. Advance Warning Sign

- set of transverse rumble strips
- post-mounted advance warning bicycle crossing ahead sign (W11-1), a single flashing yellow beacon, an advisory plate “when flashing,” and an advisory plate with “45 mph”; signs and plates are fluorescent yellow-green; the flasher is remotely

activated by a radio signal from actuation at the crossing (part of the Cross Alert system)

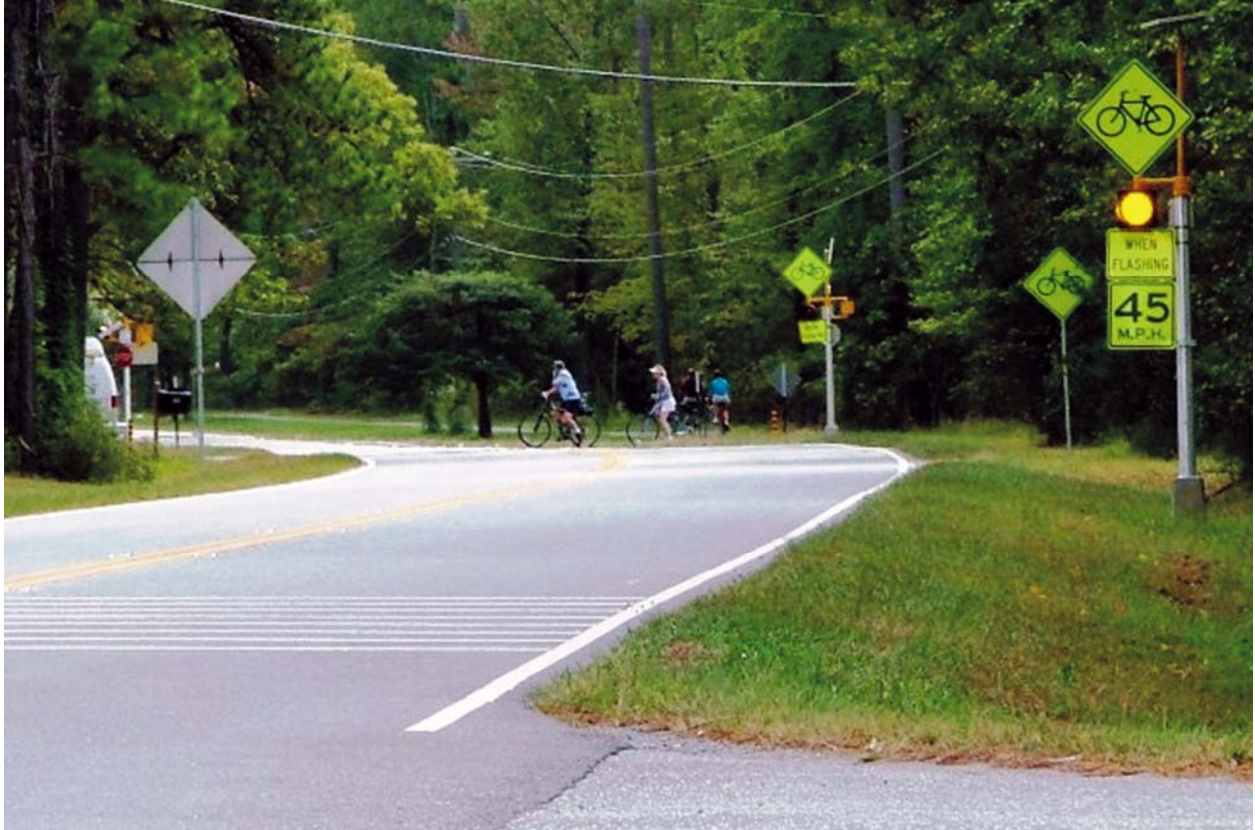
Figure B3. Route 5 Eastbound Approach to Crossing

VDOT has installed a number of other safety enhancements on each approach to the crossing to supplement the Cross Alert system, and these can be seen in the photographs of the crossing in Appendix B. Signs and pavement markings that motorists encounter as they approach the crossing are listed here; components of the Cross Alert system are also listed for reference.

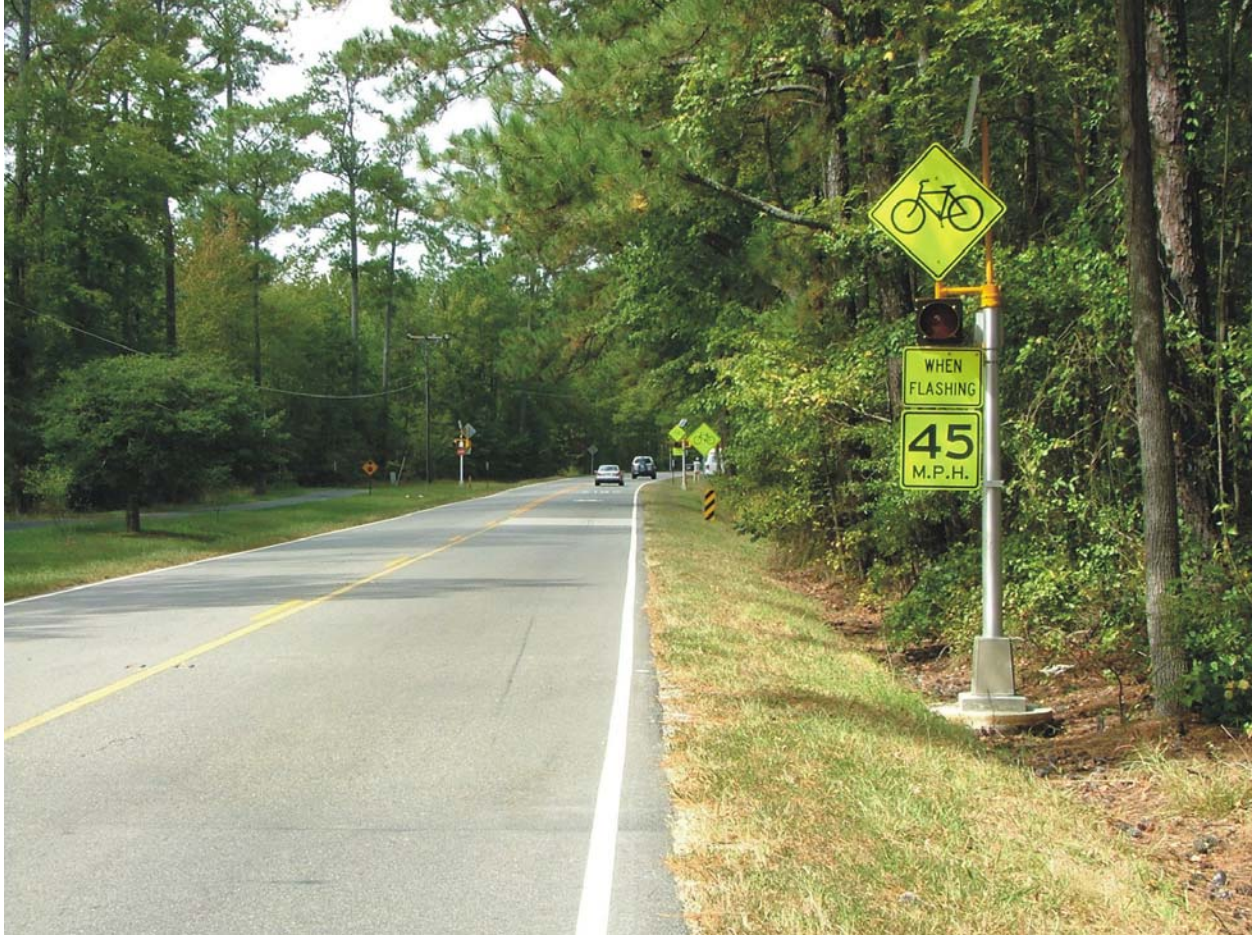
Figure B4. Route 5 Westbound Approach to Crossing
