FINAL
CONTRACT REPORT
VTRC 09-CR11

SHEAR STRENGTH OF A PCBT-53 GIRDER FABRICATED WITH LIGHTWEIGHT SELF-CONSOLIDATING CONCRETE

1. Report No.: FHWA/VTRC 09-CR11		2. Government Accession No.:		3. Recipient's Catalog No.:	
4. Title and Subtitle: Shear Strength of a PCBT-53 Girder Fabricated with Lightweight Self-Consolidating Concrete				5. Report Date: April 2009

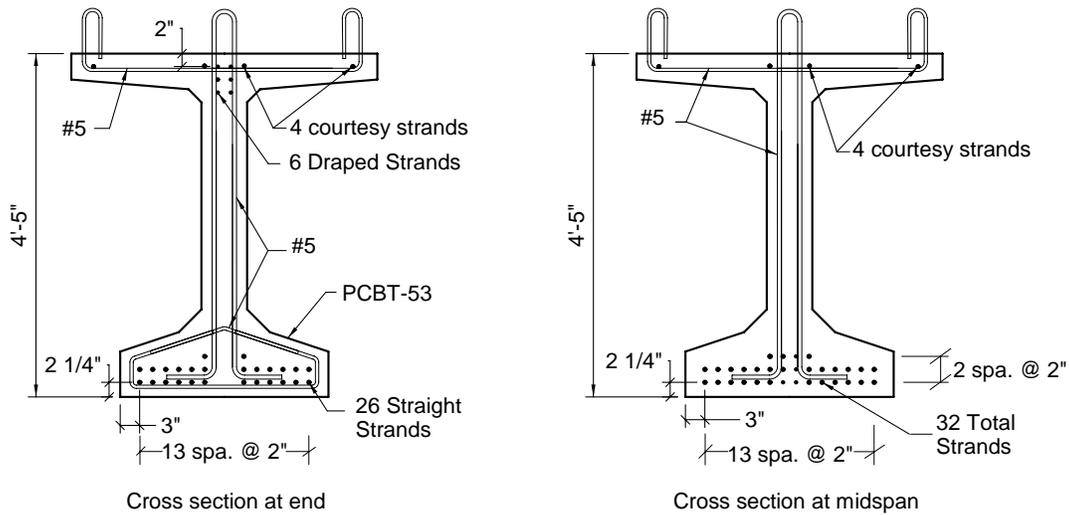
Figure 1. Cross section details of PCBT-53

concrete used in the design was 5,500 psi. Since the beam was fabricated with lightweight concrete, the design unit weight was assumed to be 120 pcf. Beam details including cross section views, side elevations, and a final composite cross section are shown in Figure 1 through Figure 4. Vertical shear stirrups throughout the length of the girder consisted of a double leg No. 5 bar, bent at 180° with a standard hook on the bottom. Anchorage zone confinement reinforcement was made up of two pieces spliced together, enclosing all of the straight strands at the ends of the beam. For horizontal shear strength, the 180° bend bars extended out of the beam and additional No. 5 U-stirrups were added in the top flange. The stirrup geometry is presented in Figure 1. Stirrup spacing is shown in Figure 2 and Figure 3 for the north end and the south end of the beam, respectively. Figure 4 shows the top portion of the composite cross section including the horizontal shear reinforcement. Stirrup reinforcing steel material properties are assumed to be those typically used for reinforced concrete design and in accordance with ASTM document A615 (2005). These material properties can be seen in Table 1 for No. 5, Grade 60 rebar, which has a minimum yield strength of 60 ksi.

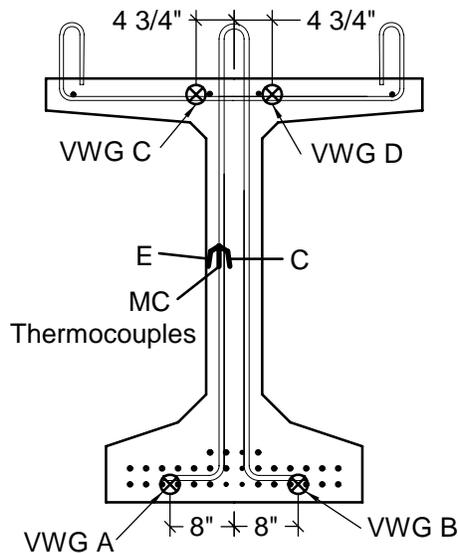
Figure 5. VWG and thermocouple locations

Thermocouples were installed to monitor the temperature of the concrete and formwork during casting, curing, and long-term conditions. The thermocouple locations can be seen in Figure 5 and Figure 6. Data from the VWGs and thermocouples were recorded by a Campbell Scientific CR-23X Micrologger. The data were recorded by the micrologger every 90 minutes except during casting of the beam, casting of the deck, and during testing. The data recording interval was changed to one minute during casting of the beam and testing of the composite system. During casting of the deck, data were recorded every fifteen minutes. These smaller recording windows allowed the researchers to better understand the change in temperature and strain over time in the concrete and strand.

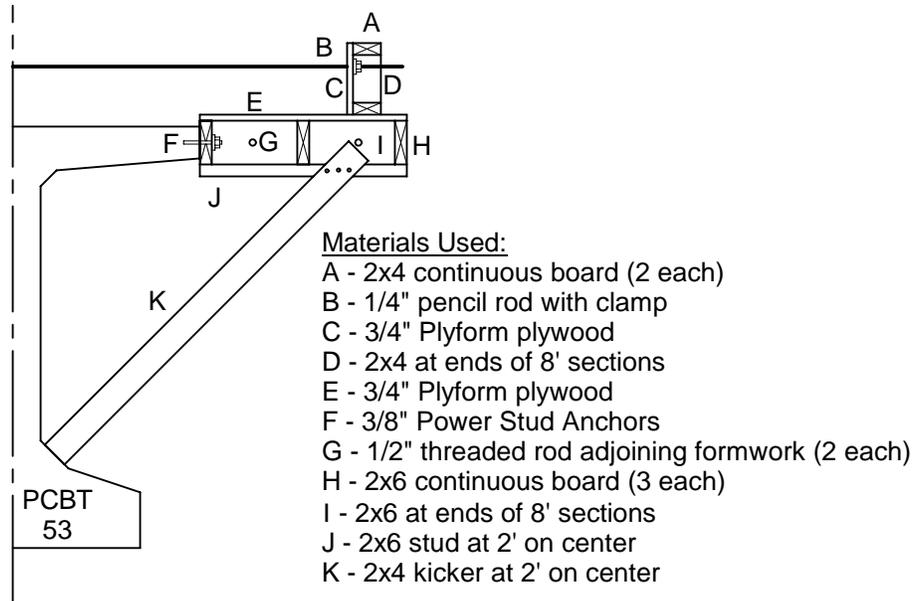
Figure 9. Deck formwork

Pencil rods with a 1/4 in diameter (labeled B) were installed to run transversely across the 9 in thick deck to provide lateral support from the concrete pressure. Additional longitudinal support was provided for the formwork when two adjoining 8 ft sections were connected. At this connection, the two 2x4 studs (labeled D) on the 9 in tall deck sections were screwed together, and the two 2x6 sections (labeled I) at the ends of the deck formwork were fastened together using two 1/2 in threaded rods. The two ends of the deck were closed to complete the formwork using 3/4 in Plyform plywood and all of the formwork was sealed to protect against water leakage. In addition, PVC tubing was installed to extend the holes for the girder lifting devices so that the composite section could be moved when testing was complete.

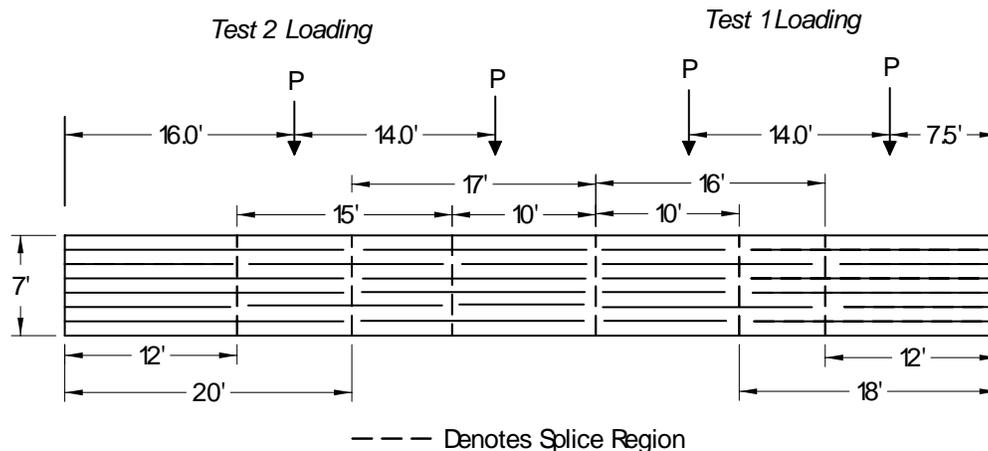
Figure 10. Deck longitudinal reinforcement splices

After sealing the formwork, the reinforcing steel for the deck was placed. The deck reinforcing steel was supported off of low and high chairs and tied together with wire ties. The longitudinal rebar of the deck required splices since the beam was 65 ft long and rebar for this project came in 20 ft sections. These splices were designed as 20 in compression splices and placed as shown in Figure 10. All of the rebar splices are offset to avoid putting a spliced section of reinforcement directly below a loading point for either test one or test two.

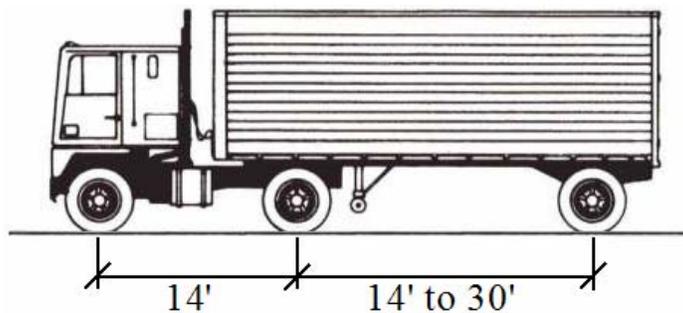
Figure 12. AASHTO design truck

Each test setup consisted of a simply supported beam and two load frames representing the AASHTO truck rear axle spacing. To achieve the simply supported, pin-and-roller support conditions, a single, solid, 4 in thick steel cylinder that was the full width of the bottom bulb (32 in) was used to support each end of the beam. Because this steel cylinder would only touch the beam across a single line, a steel plate was used between the roller and the beam to distribute the load. This steel plate was 14 in long and 32 in wide, hence the entire bottom bulb of the girder was supported through this plate to the steel cylinders. Figure 13 depicts both the roller and pin support conditions with the additional steel plate in place to distribute the load. The girder and rollers sat on steel W-shapes with stiffeners welded under the top flange where the beam rested on the support. The steel beams were W14x90 shapes.

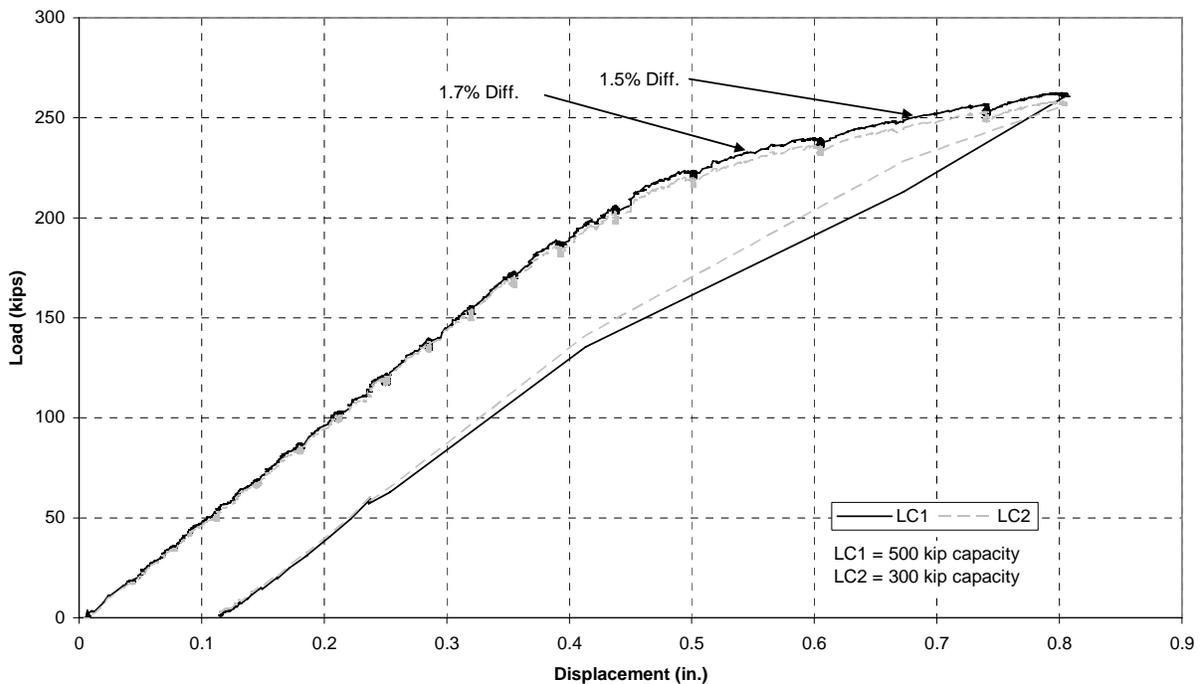
Figure 14. Shear test #1 load cell comparison

The applied load from each actuator was monitored during two of the tests using individual load cells. The remaining tests only used the higher capacity load cell to measure the applied load and an assumption was made that the loads were equal during the test and subsequent analysis. For this reason, a comparison was done using load vs. displacement plots to determine if the percent difference in load reported between the two load cells was significant. Figure 14 and Figure 15 show a comparison of the two load cell values as reported at different displacements. A typical percent difference was in the range of 1.5 to 1.8 percent. The maximum percent difference, as evident in the initial flexure-shear test, was approximately 3.4 percent. Based on these small percent differences, the researchers felt that the assumption to set the applied loads equal in both actuators for data analysis was not unconservative. In addition, the researchers believe that the slight difference should not influence the test results.

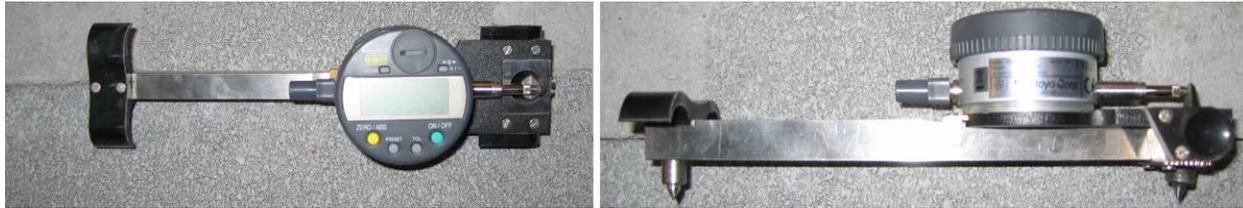
Figure 16. DEMEC gage

Strain was measured in two different ways at two different parts of the composite system. During the first test of the beam, concrete surface strains were measured to determine when and where the first crack initiated in the bottom bulb using a detachable mechanical strain gage (DEMEC) and surface mounted gage points manufactured by Mayes Instruments Limited, from England (www.mayes.co.uk). The DEMEC strain gage has a gage length of 200 mm (roughly 7 7/8 in) and measures changes in strain between the surface mounted points to an accuracy of $\pm 5 \mu\epsilon$. The DEMEC strain gage apparatus consists of a main beam with two conical locating points, one fixed and the other able to pivot on a knife edge. Figure 16 shows a top view and a side view of the DEMEC gage apparatus; the main beam, fixed locating point, and pivoting locating point are visible in the figure. The locating points are positioned in the surface gage points that are stainless steel discs attached to the girder with a five minute epoxy. Movement of the pivoting point is measured by the dial gage located on the main beam, and reported by the digital readout. The stainless steel discs were affixed to each side of the girder at the lowest level of

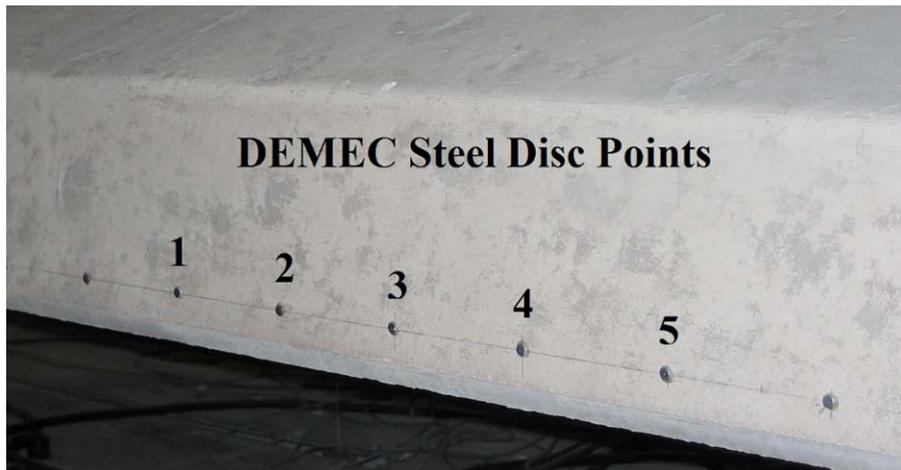
Figure 17. DEMEC steel disc affixed to the girder

prestressing strands, directly below the point of maximum applied moment created by the loading setup, so that five strain measurements could be taken. Figure 17 shows the steel discs affixed to the side of the girder. The first flexural crack was monitored and observed through the use of these strain readings and a plot of load vs. strain. When the plot became nonlinear, the beam was visually inspected for cracking to determine if a flexural crack was present.

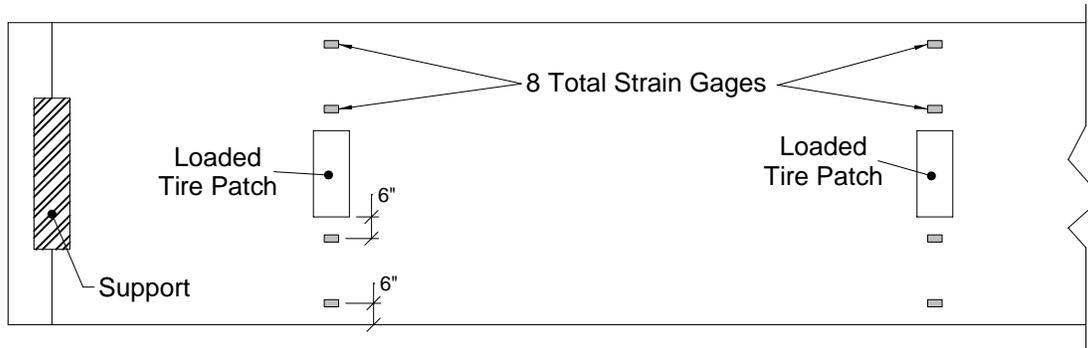
Figure 18. Strain gage plan view

Secondly, strain was measured at the extreme compression fiber of the composite system with surface mounted, resistance-based strain gages produced by Vishay (www.vishay.com). Each strain gage had a gage length of 4 in so that the gage gave an average strain across the mortar paste and the 3/4 in coarse aggregate in the deck concrete. These strain gages were placed 6 in from the outer edge of the deck and 6 in from the bearing pad. Figure 18 shows the locations of the compressive fiber strain gages in plan view.

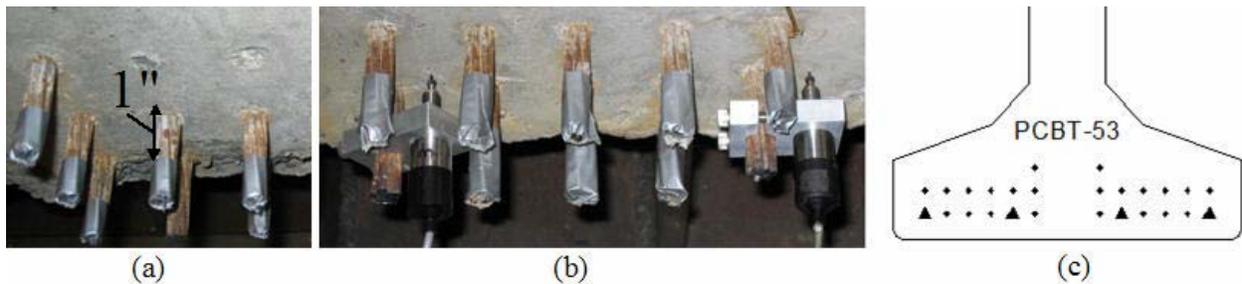
Figure 19. Strand slip (a) duct-taped strands (b) LVDTs on strands (c) location of LVDTs

Finally, strand slip was measured on four of the prestressed strands along the bottom row. This enabled the researchers to determine if a development length failure took place. Strand slip was monitored using linear variable differential transformers (LVDT), produced by Trans-Tek Inc., of Ellington, Connecticut (www.transtekinc.com). The LVDTs have a total plunger range of approximately 0.15 in and were calibrated to measure movement as small as one thousandth of an inch. Each LVDT was fastened to the appropriate strand using a small bracket fabricated at Virginia Tech. The spring loaded spindle touched the face of the end of the girder itself and detected movement of the strand relative to the end of the beam. If the strand slipped inward, the LVDT spindle would retract inward yielding a displacement measurement. Figure 19 (b) and (c) show how and where (triangles represent strands with LVDTs) each of the four LVDTs were

mounted to monitor strand slip. The other 22 strands (not including the harped strands) were marked 1 in from the face of the concrete with a piece of duct tape as shown in Figure 19 (a) to physically record slip with a ruler.

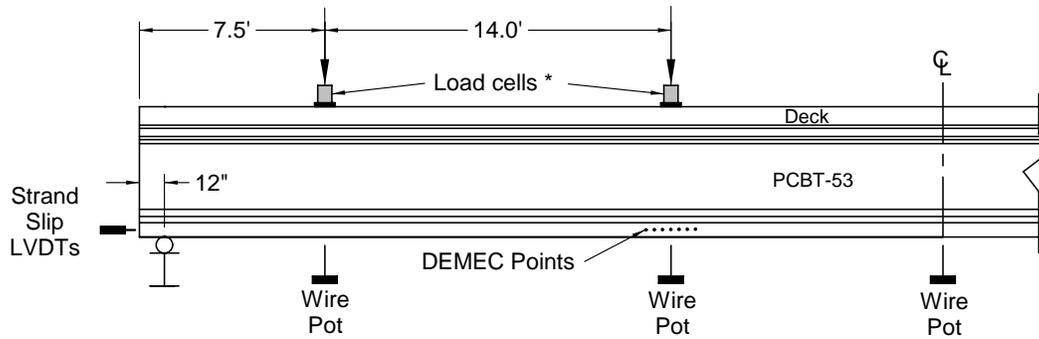
The focus of the first test on the beam and the initial test setup was to collect data pertaining to the predicted web shear strength of the girder. The 65 ft girder was simply supported with a span of 63 ft and a 1 ft overhang past the center line of each support. The two load frames were placed at a distance of 7.5 ft and 21.5 ft from the south end of the beam. The support conditions were set up to allow for the pinned end to be the tested end of the beam and the roller end to be the non-tested end of the beam. The test setup, load placement, and instrumentation locations are shown in Figure 20.

* Strain gages transversely linear with load cells

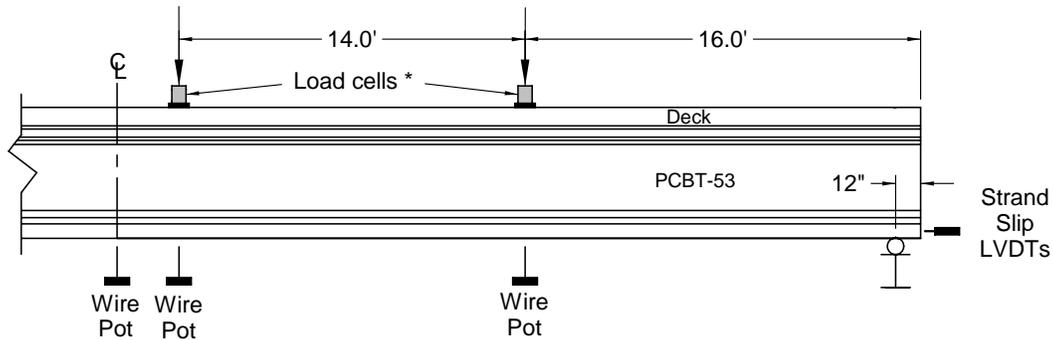
The focus of the third and final test on the beam was to collect data pertaining to the predicted flexure-shear failure. The 65 ft girder was moved longitudinally after conclusion of the shear test on the south end of the beam, by Abbott Rigging, Inc. of Rocky Mount, VA. This resulted in a simply supported span of 59 ft. This was achieved with a 5 ft overhang past the center line of the support at the south end of the beam and a 1 ft overhang past the center line of the support at the north end of the beam. During the move by Abbott, the support conditions were changed to allow for the pinned end to be the tested end of the beam and the roller end to be the non-tested end of the beam. The two load frames were placed at a distance of 16 ft and 30 ft from the north end of the beam as shown in Figure 22. As this test proceeded, the capacity of the 300 kip load cell was exceeded, and the test was halted for a few minutes while this load cell was removed. This load cell was initially left in during the test to evaluate the accuracy of the two load cells in relation to each other; it allowed for a comparison of how the two loads differed

* Strain gages transversely linear with load cells

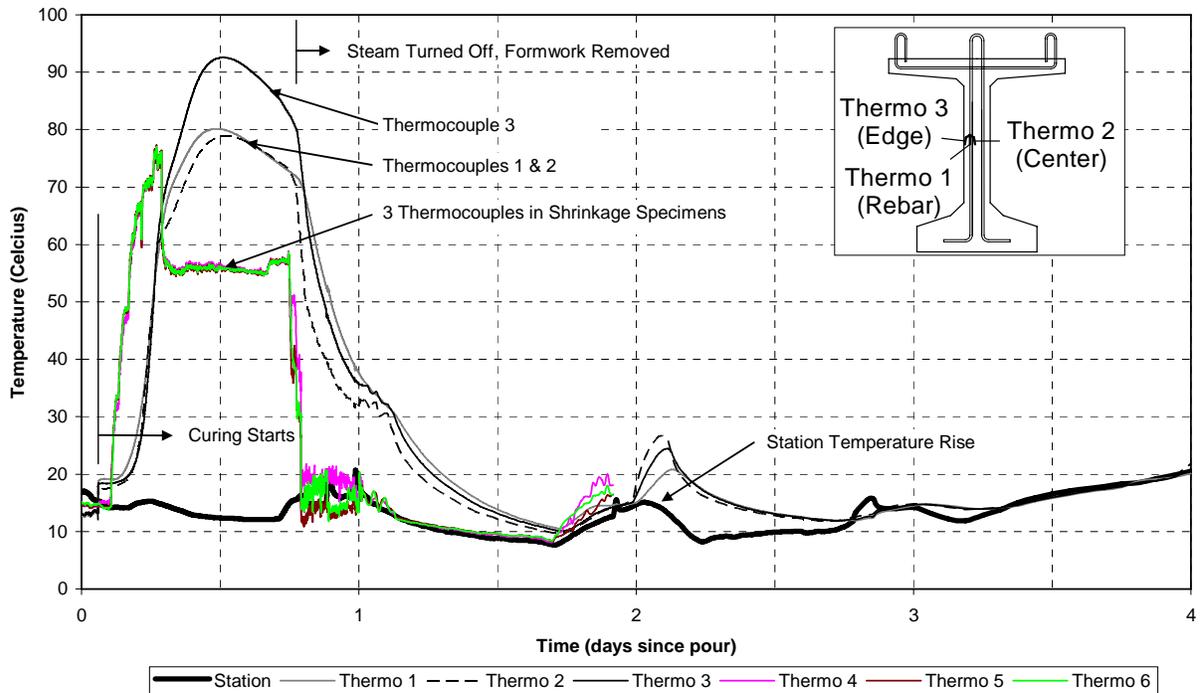
Figure 29. PCBT-53 thermocouple temperature change over time

The thermocouple data show that all measured locations in the girder exceeded the maximum allowed temperature as shown in Figure 29. This is interesting to note because of the large difference between these readings and those recorded by the VWGs. The difference in the maximum temperatures shown in Figure 28 and Figure 29 is significant but unexplained. The shrinkage specimens exhibited an interesting change in thermocouple temperature while steam curing. They indicate a sharp increase in temperature correlating with the girder temperatures, but then the blocks lost approximately 20° Celsius over a four to six hour time period. This may be from someone removing the blocks from underneath the steam blankets, or some other type of curing conditions felt by the blocks. The temperature began a sharp decline when the steam was turned off approximately 19 hours after the pour started. At this time the formwork was also removed from the girder and the concrete was exposed to the ambient temperature. A jump in temperature can be seen in both plots two days after casting the concrete. This temperature rise could be due the fact that the station or ambient temperature also saw a sharp increase at that time.

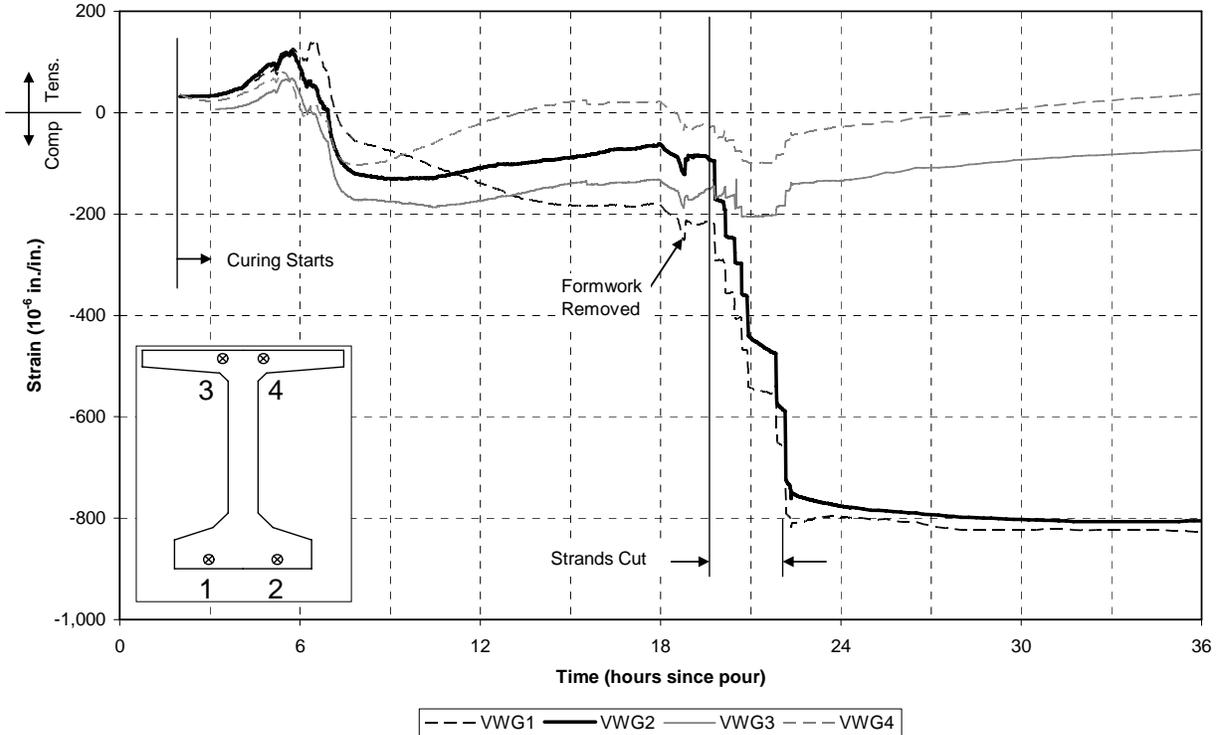
Figure 30. VWG strain over 36 hours since casting

The vibrating wire gages were also used both in the PCBT-53 and the additional shrinkage specimens to track the change in strain over time. Time zero again corresponds to the beginning of the concrete pour. The strain recorded by the VWGs was adjusted using a recommended temperature correction factor. This factor, using the coefficients of thermal expansion for steel and concrete, is used because the concrete and the tensioned wire within the gage do not expand the same amount. The coefficients of thermal expansion were assumed to be 12.2 and 9.0 $\mu\epsilon/^\circ\text{C}$ for steel and lightweight concrete, respectively. The coefficient of thermal expansion value for steel was provided by Geokon who manufactured the VWGs, and the coefficient of thermal expansion for lightweight concrete is reported in the AASHTO LRFD Specifications Article 5.4.2.2 (2006). Strain recorded by the vibrating wire gages is shown in Figure 30. Any changes in strain observed should not be due to thermal expansion or contraction since the temperature correction is made for all of the gages. Therefore, the strains observed should most likely be due to shrinkage effects or expansion of the girder concrete from hydration. The VWGs located in the shrinkage specimens were not connected to the Campbell Micrologger until after the steam curing process began due to human error. This leaves a blank, as shown in the plots, in the strain data recorded by the VWGs in those specimens.

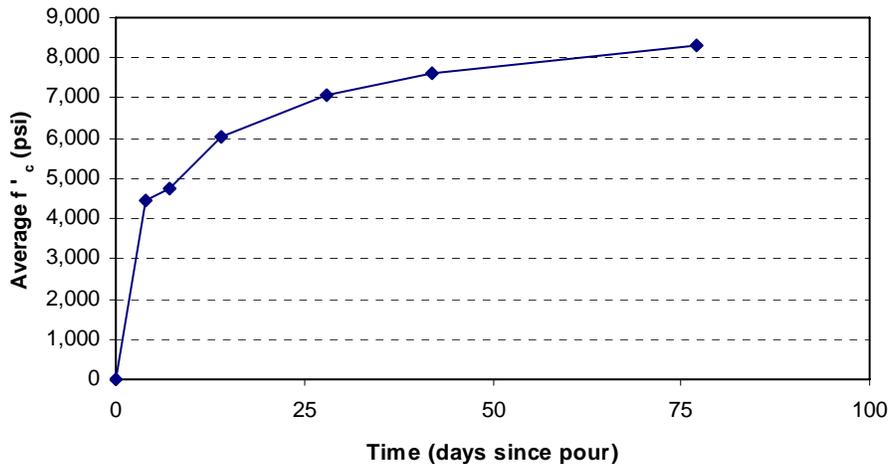
Figure 31. Deck compressive strength plot

Compressive strength tests were done in accordance with ASTM Document C39 (2005), and the results can be seen in Table 10 and in Figure 31. The deck's splitting tensile strength data were collected following ASTM Document C496 (2005), and the results and corresponding plot can be seen in Table 11 and Figure 32, respectively. Finally, the modulus of elasticity tests were completed following ASTM Document C469 (2005), and the results for the deck can be found in both Table 12 and Figure 33.

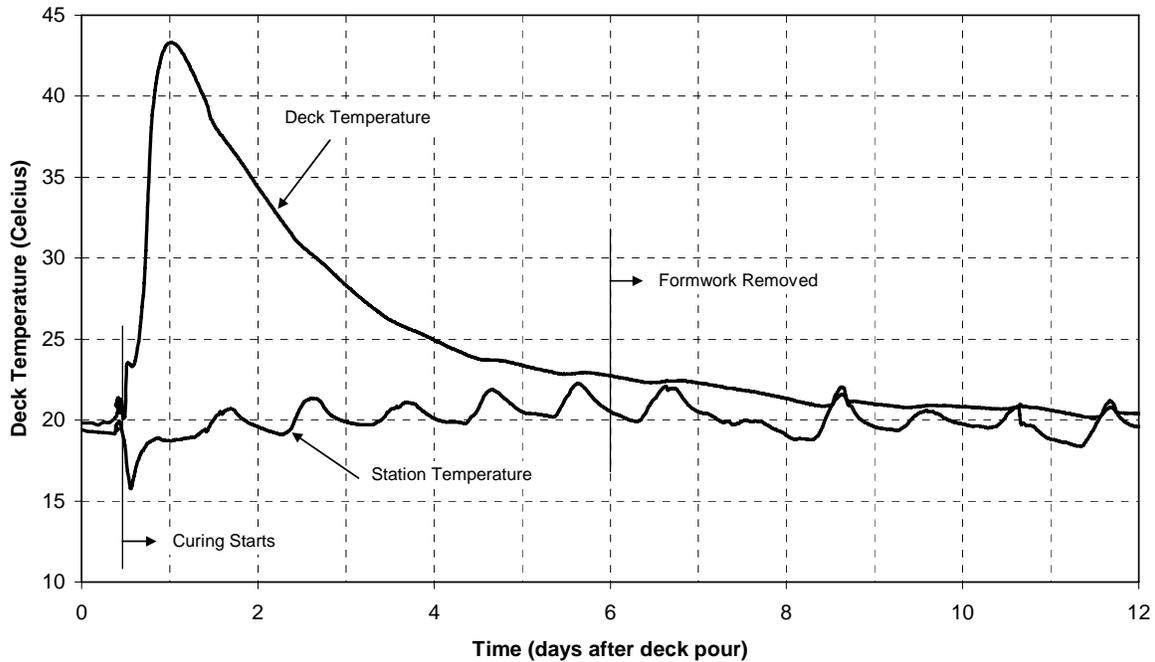
Figure 34. Deck thermocouple temperature change over time

Deck instrumentation consisted of a single thermocouple to measure the temperature change during the curing process of the deck concrete. Time zero corresponds to the beginning of the deck concrete pour. This thermocouple was placed at mid-span of the composite system and at mid-height of the deck (4.5 in below the surface of the concrete). The temperature change over time can be seen in Figure 34. The maximum temperature achieved during the curing process was approximately 43° Celsius and the temperature returned to the laboratory ambient temperature approximately eight days after casting of the deck.

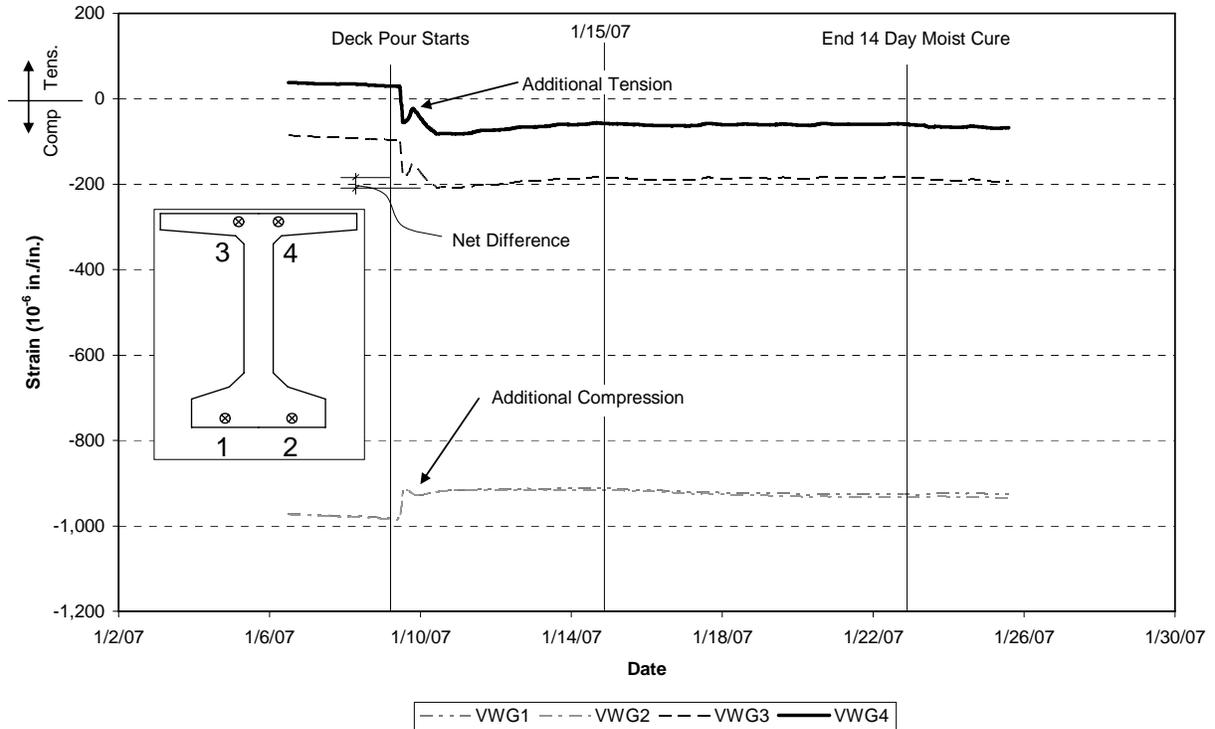
Figure 35. PCBT-53 VWG strain over time as composite deck is cast

The change in strain, as recorded by the girder vibrating wire gages, experienced by the PCBT-53 as the composite deck was cast and cured can be seen in Figure 35. It is evident that the weight of the deck concrete caused compression in the top of the girder and induced tension in the bottom of the girder. The plot also shows that the top of the beam experienced a small amount of tension while the bottom of the beam had a small amount of compression. This can be attributed to the top flange of the beam expanding from the hydration temperature effect. The deck heated up the top flange of the beam causing it to expand (increase in strain) followed by a short cooling period (decrease in strain) during which the net difference before and after this phenomena is noted. This net difference could be due to some strain or stress locked in the beam. After the formwork was removed on January 15, 2007, the concrete was again allowed to contract.

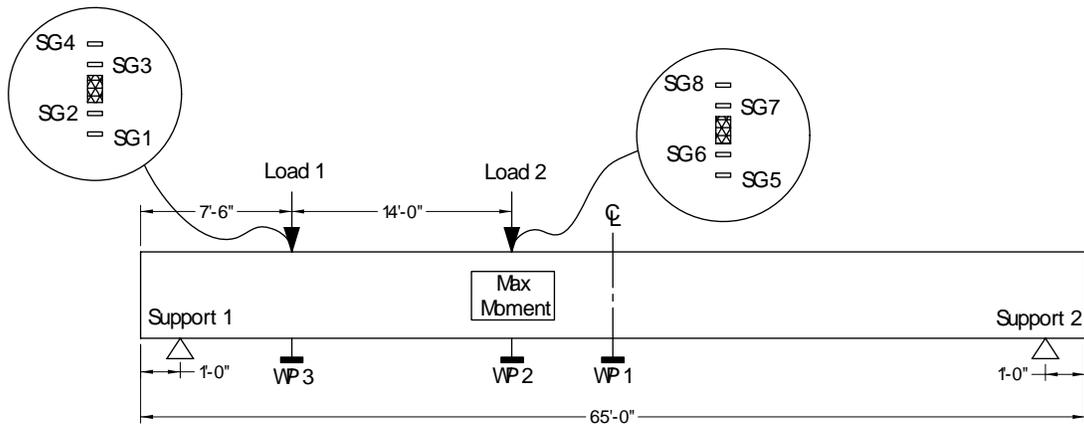
Figure 36. Shear test #1 instrumentation labels

The testing instrumentation setup for both the initial shear test and the following shear test after the load cells were re-calibrated is shown in Figure 36. Note the location of the wire pots, load cells, and strain gages because the accompanying plots are labeled in the same fashion.

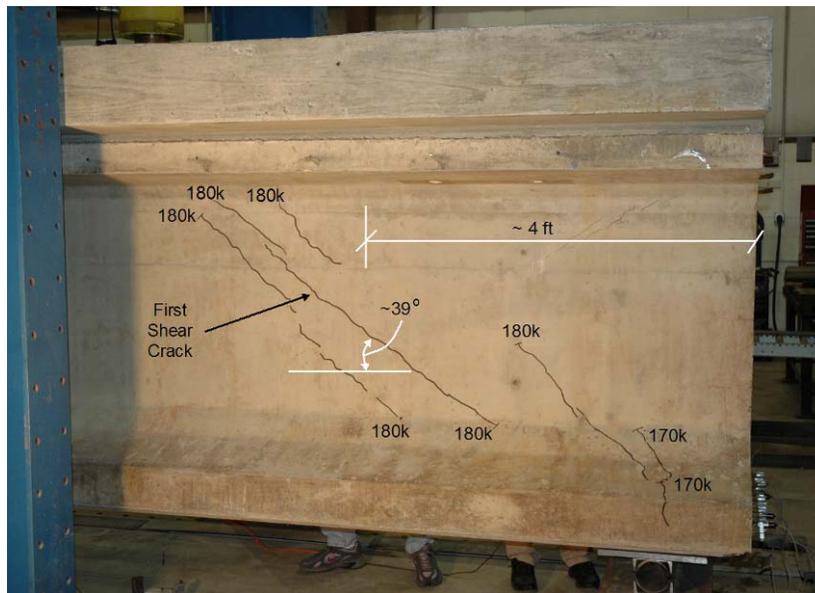
Figure 37. Initial web shear cracks (noted loads are per each actuator)

The first web shear crack, shown in Figure 37 with the corresponding crack angle, in the PCBT-53 occurred around 180 kips per actuator, which is equivalent to a support reaction of 327 kips. These first shear cracks formed at an angle of approximately 39 degrees running from the support towards the first loading point. Just beyond this load (at a support reaction of 350 kips), the beginning of non-linear behavior can be seen. Figure 38 shows the non-linear behavior as the load was increased until the 300 kip capacity load cell was removed from the system. Unloading of the girder was a fast process because of the hydraulic pressure built up inside the actuators. During this unloading process, illustrated in Figure 38, the researchers had limited control of how fast the load was removed; hence, the plateau at a support reaction of 140 kips in Figure 38. This event is typical for all of the different tests and times of loading with differences in the load remaining after the hydraulic fluid recovered. It is important to note that all of the plots of support reaction vs. deflection throughout the study contain a calculated support reaction based on the two applied actuator loads and the self weight of the composite member.

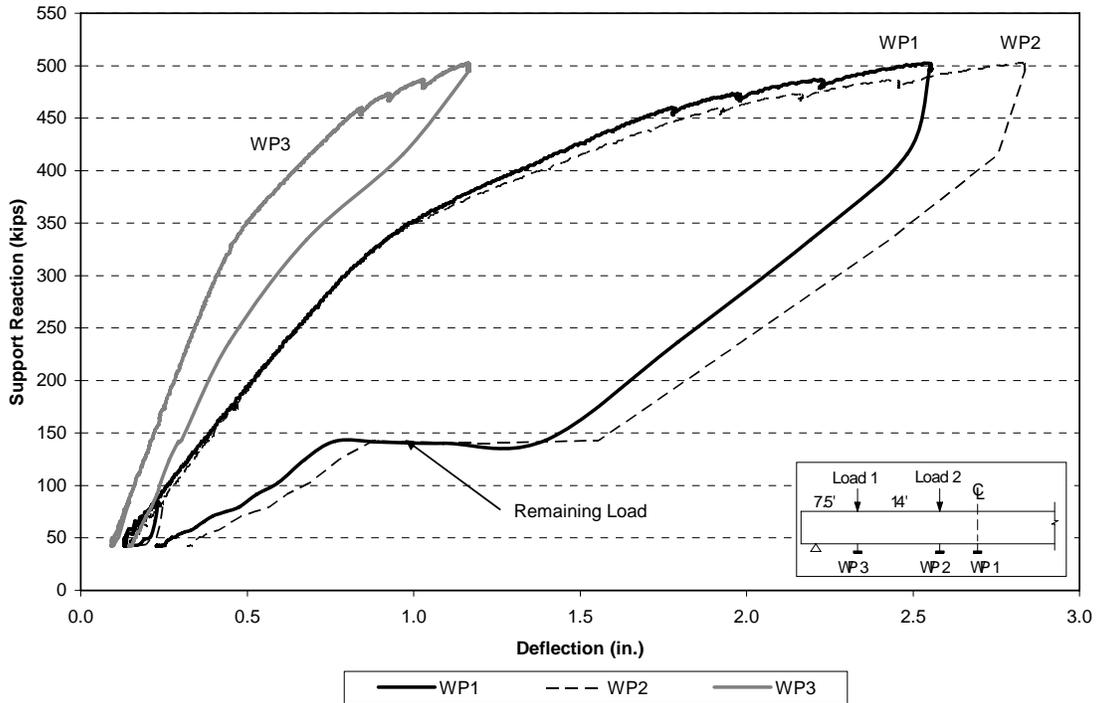
Figure 39 Shear test #1 displacements after removing 300k load cell

Figure 39 shows the support reaction vs. displacement during the second test that occurred after the 300 kip load cell was removed. The plot again shows non-linear behavior when the support reaction reaches approximately 300 kips. This load is lower than the first time the beam was loaded, since the concrete was previously cracked. The first flexure-shear crack did not propagate toward Load 2 until a support reaction of 437 kips. At this point, additional flexure-shear cracks opened until the test was stopped at a load of approximately 290 kips per actuator (support reaction of approximately 500 kips) for the re-calibration of the load cells with a new universal testing machine as previously mentioned.

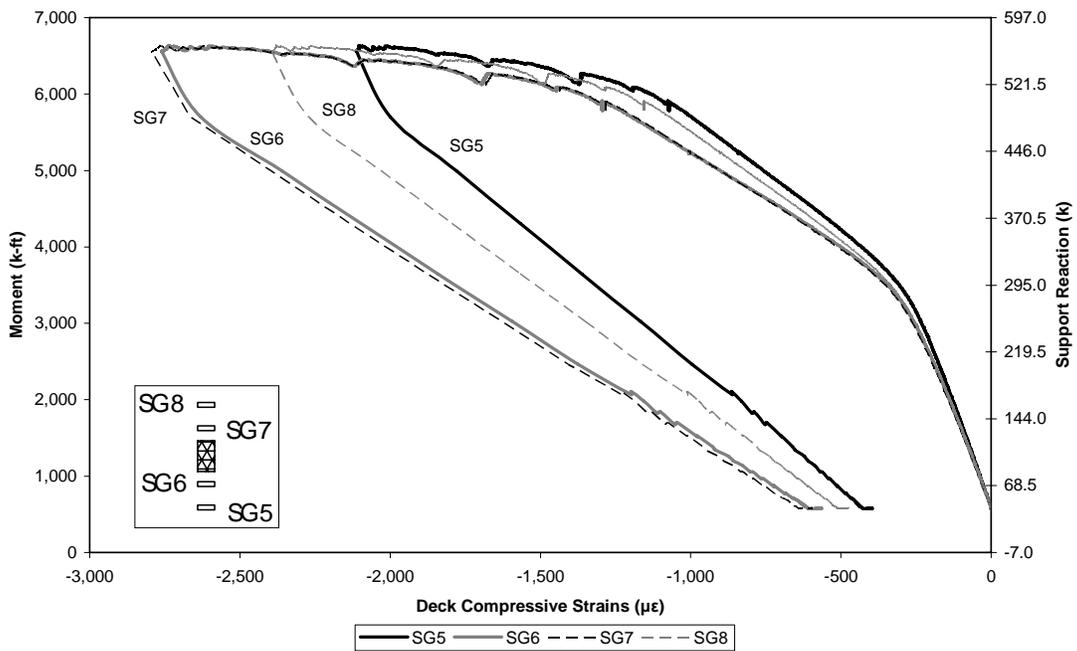
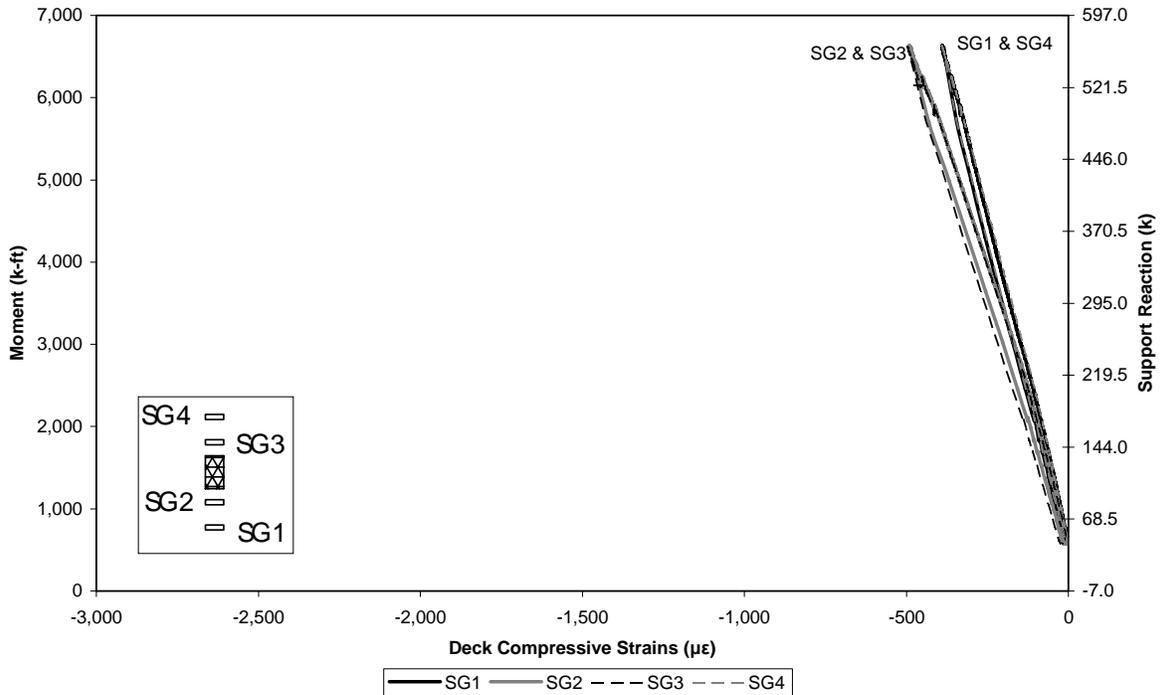
The maximum compressive strain during this test was approximately 2,700 $\mu\epsilon$. This strain was recorded under the point load located at 21.5 ft from the end of the beam. Figure 43 shows a maximum recorded moment of approximately 6,500 k-ft. Figure 44 shows the deck strain under the actuator located at 7.5 ft from the end of the beam. Again, in both plots there is evidence of the shear lag effect.

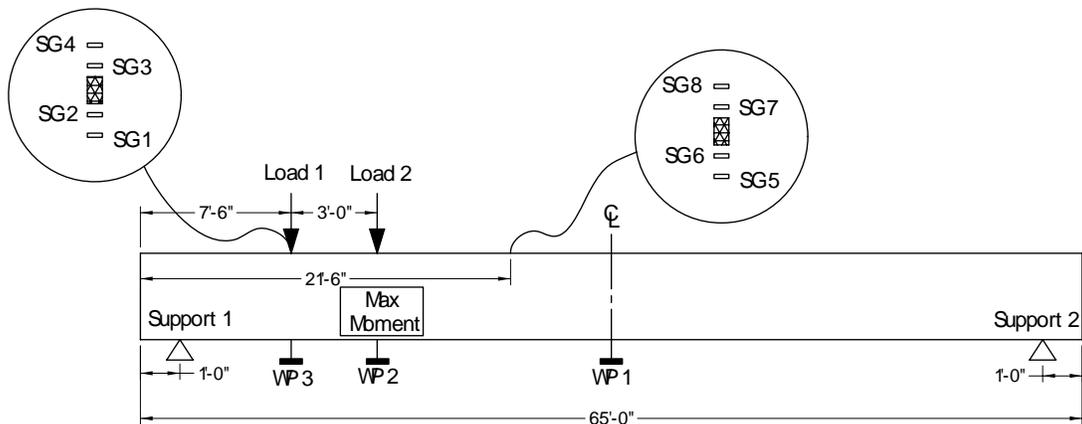
Figure 45. Shear test #2 instrumentation labels

The focus of the second shear test on the beam was the same as the first, to collect data pertaining to the predicted web shear failure, but the loading configuration was altered to induce higher support reactions. The testing instrumentation setup for the second shear test is shown below in Figure 45. Note the location of the wire pots, load cells, and strain gages because the plots shown are labeled the same way.

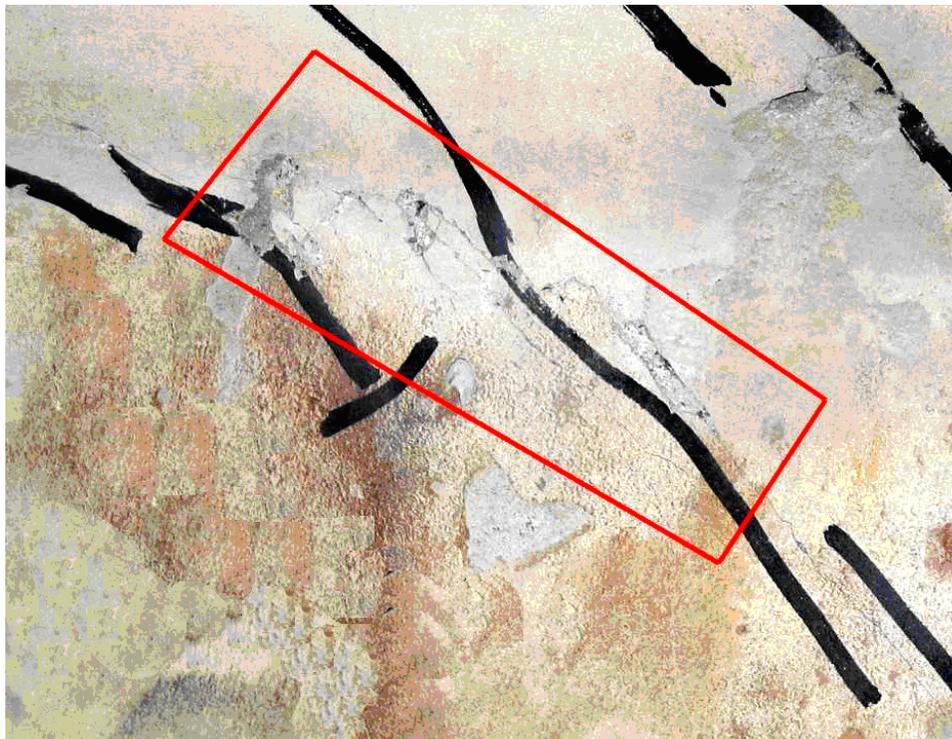
Figure 46. Indication of web shear failure

The maximum load reached during this test was 353 kips per actuator or a support reaction of 661 kips, and at this point some flaking of concrete in the web of the girder was noticed. This flaking in the web was located between load 1 and support 1. This type of cracking indicates an imminent web crushing failure and the researchers believe this form of total failure would have occurred if an additional 5 to 10 kips could have been applied to the girder. Figure 46 illustrates the initial signs of web shear failure in the beam where the concrete was starting to crush.

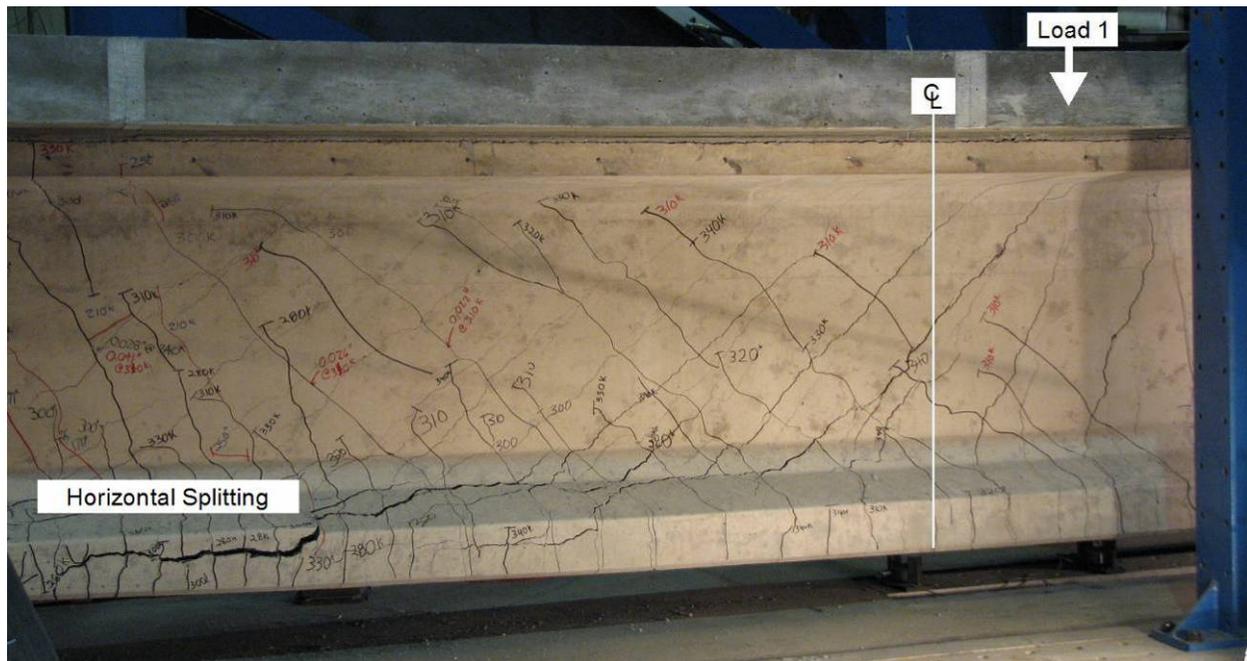
Figure 51. Horizontal bottom flange splitting failure

wide flexure-shear cracks and horizontal bottom flange splitting cracks between the loading point located at 30 ft from the end of the beam and Support 1.
