FINAL
CONTRACT REPORT
VTRC 09-CR8

**LIVE LOAD TEST
AND FAILURE ANALYSIS
FOR THE STEEL DECK TRUSS BRIDGE
OVER THE NEW RIVER
IN VIRGINIA**

Via Department of Civil and Environmental Engineering
Virginia Polytechnic Institute & State University

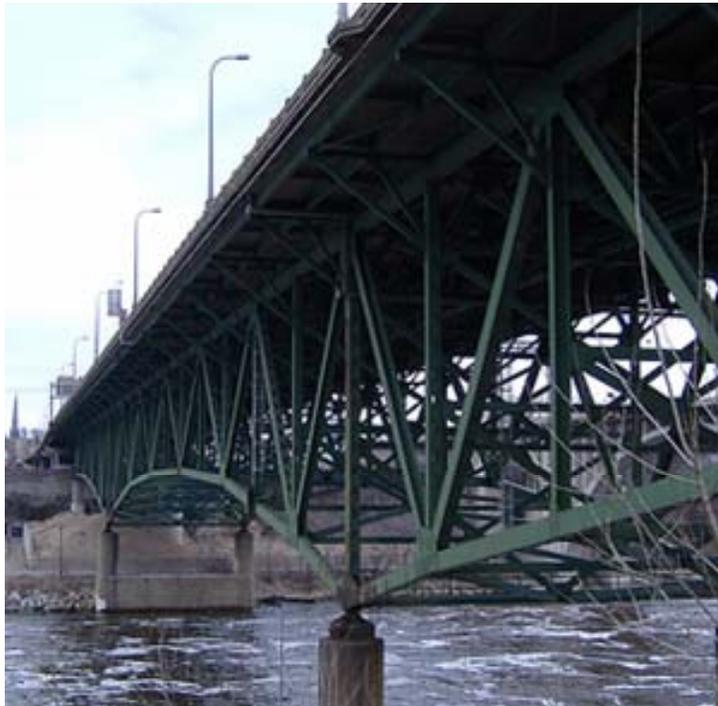
Figure 1. I-35W Truss

On Wednesday, August 1, 2007, the I-35W bridge in Minneapolis, Minnesota, collapsed into the Mississippi River. The bridge was an eight-lane, arched deck truss bridge made of steel. It had opened in 1967 with a total length of 1,907 ft and a maximum span of 456 ft. Figure 1 shows the steel arch and concrete deck spanning the Mississippi. The collapse occurred while the bridge was carrying standard vehicular loads on a warm August afternoon. Steel deck truss bridges are abundant in the bridge inventories of almost all state departments of transportation; hence, it is important to understand the causes of this failure.

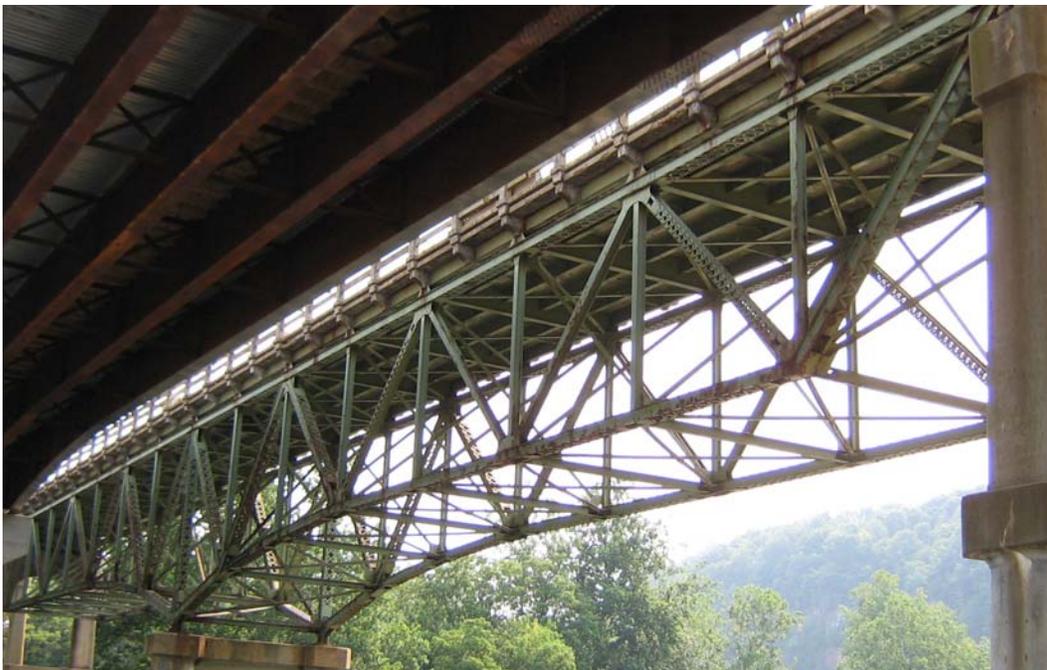
Figure 2. Hillsville Truss

Virginia Route 100 crosses the New River between Pulaski and Hillsville. The bridge over the river is a steel deck truss bridge, constructed in 1941 with only two lanes. Its total length is 846 ft, 300 ft of which is spanned by the deck truss. Figure 2 shows the Hillsville truss. The Federal Highway Administration (FHWA) and the Virginia Department of Transportation (VDOT) believed that results from tests of this bridge would be useful for understanding the behavior of older steel deck truss bridges and would provide insight into the cause of the collapse of the I-35W bridge. The research presented herein is a concerted attempt to approximate mathematically the behavior of the Hillsdale Bridge under load so that a plan for a test to failure could be developed. This imposed failure was expected to provide valuable information to transportation authorities with regard to the evaluation and future design of steel deck truss bridges.

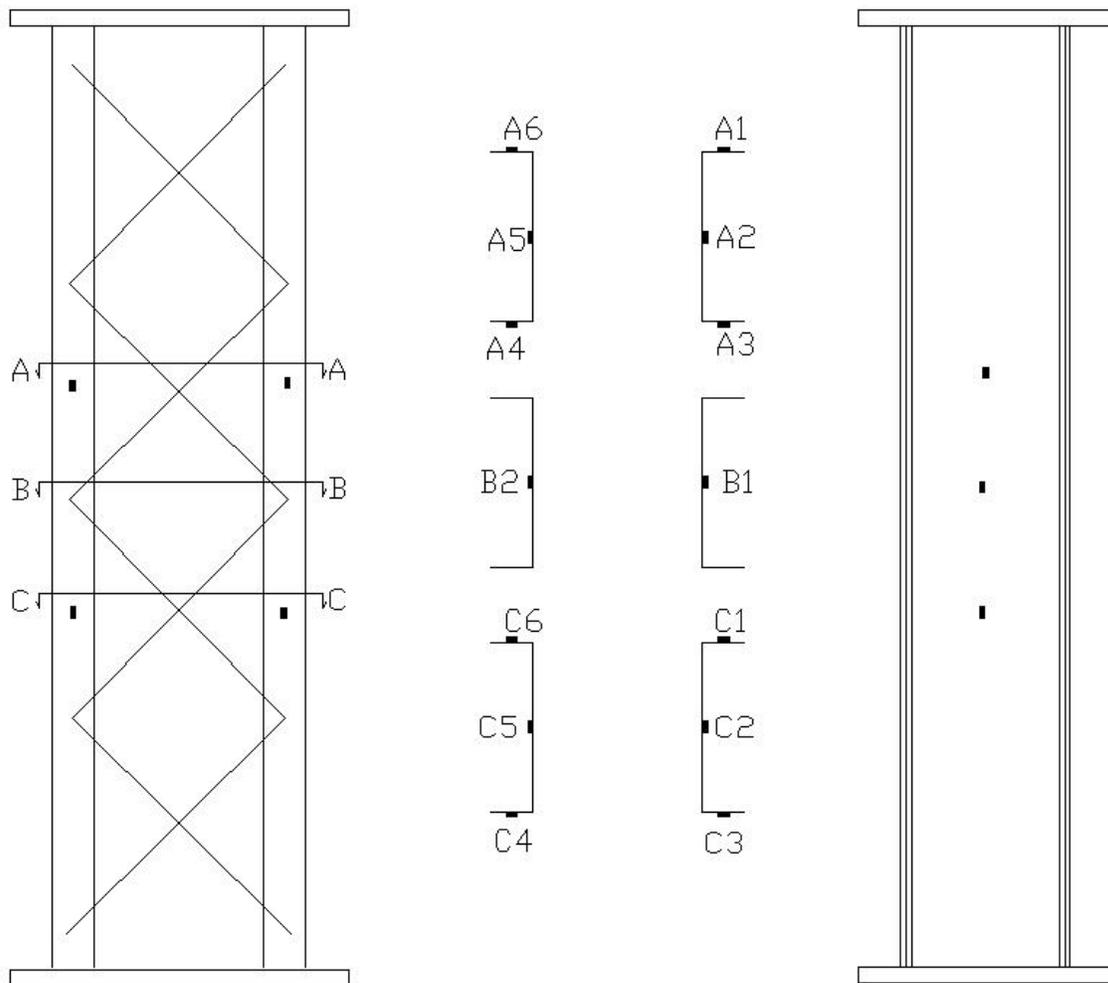
Figure 3. Column Gaging Diagram

Knowing which strain gage attachment location on the channels yields the most accurate average strain results is crucial to proper truss instrumentation and force calculation. To accomplish this objective, a two-thirds size mockup of a typical built-up section was tested in the Virginia Tech Structures Lab. It was built of two 4-ft sections of C8 by 13.75 channels doubly

laced at five spacings with bars measuring 2 in by $\frac{1}{4}$ in. The assembly was capped by welding a plate with the dimensions of 12 in by 16 in by $\frac{3}{4}$ in on each end.

Figure 3 presents the tested member and gage installation locations. The column was instrumented with an array of gages. One gage was installed at each web centroid at locations where bolts attached the lacing bars. At sections equidistant between the lacing connections, six gages were attached as shown in Figure 3, Sections A and C. Gages used in this setup were adhered to the steel with a cyanoacrylate adhesive. Gages used for live load testing in the field however, were welded to members, as this is a faster installation. Prior to gages being welded in the field, one was welded to the built-up column to confirm its accuracy. The column was then placed in a SATEC testing machine to apply load and monitor deflection.

Figure 19 presents the average readings taken on strain gages located in the webs at column sections A, B, and C (see Figure 3). Although web strain in section C diverges from the other sections somewhat, this may be attributed to imperfect end conditions in the testing machine. The figure does demonstrate that there is no substantial difference between strains measured at section B, where no lacing is attached, and strains measured at section A, where lacing is bolted to the channels. Thus it is conclusive that the lacing does not have a significant effect on axial strain measurements.

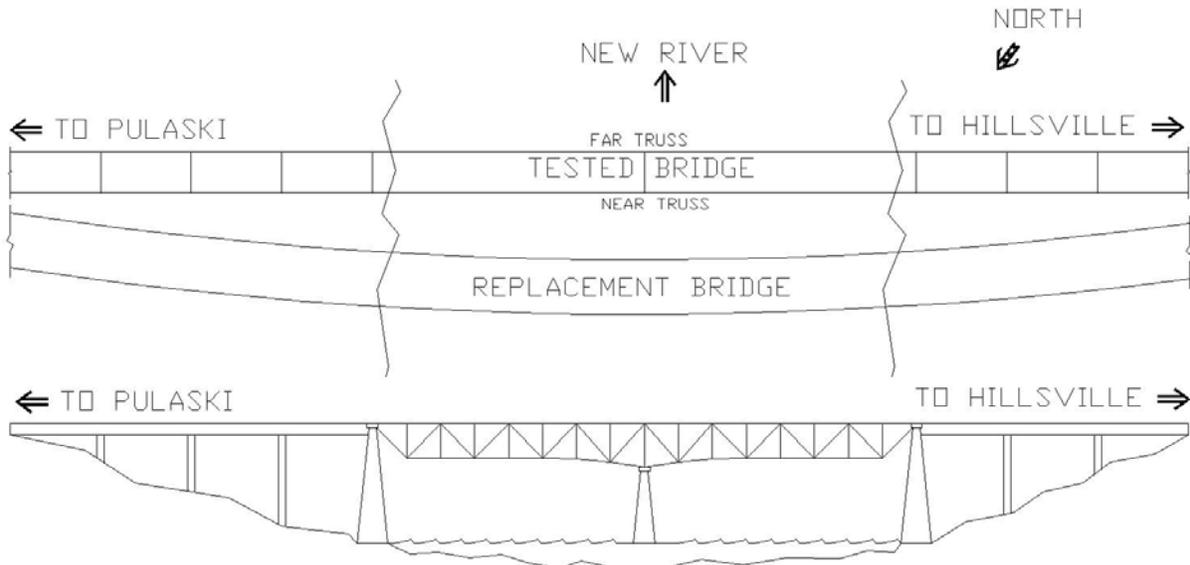
Figure 4. Plan and Profile View of Bridge

The result of Item 1 in the preceding list was used to determine the necessary layout of strain gages to be used on each member. Once this was selected, the members to be monitored were chosen. Initial reports after the I-35W Bridge collapse indicated the second top chord truss connection out from the center pier was a crucial failure location. This was confirmed by a preliminary truss analysis. Thus, all members framing into Node U6 were selected for monitoring. On the truss designated “Far” (farther from the new replacement bridge, on the south/downstream side), seven members were instrumented with four strain gages each. Figure 4 presents a plan view of the old bridge and shows its position relative to its replacement structure. The New River and the bridge’s orientation between Pulaski and Hillsville are also shown.

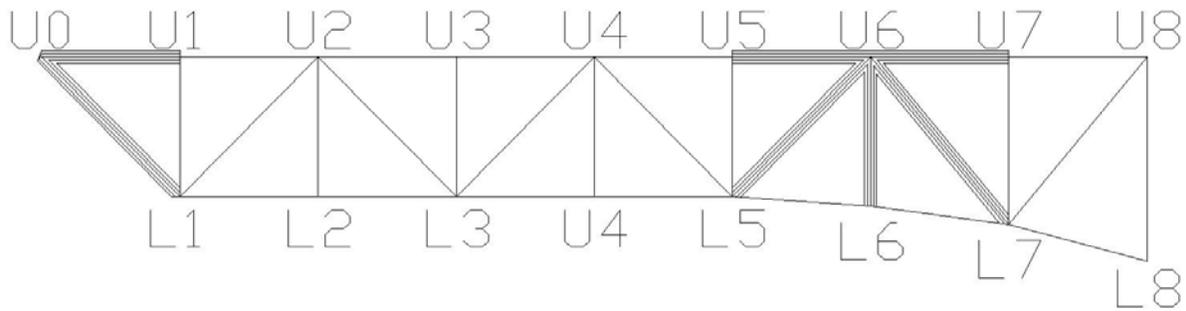
Figure 5. Instrumentation of Far Truss. All monitored members have 4 gages.

Figure 5 shows the member instrumentation for the far truss; all highlighted members have four gages. On the truss designated “Near” (nearer to the new replacement bridge, on the north/upstream side), two members were instrumented with four gages each, and the remaining

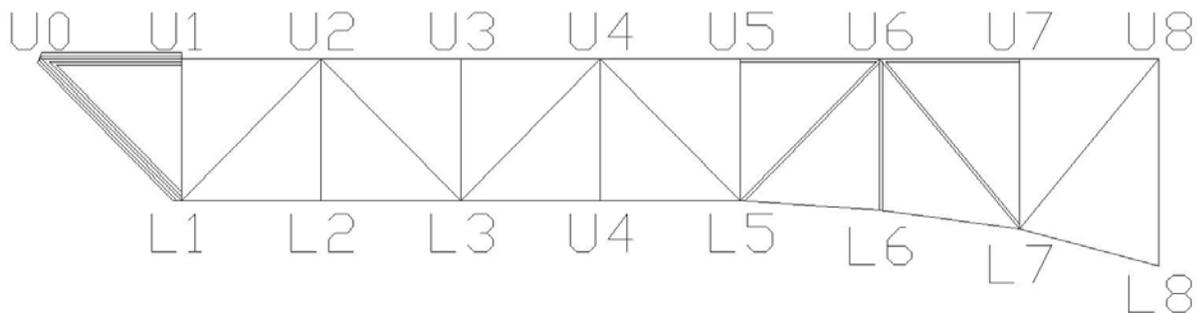
Figure 6. Instrumentation of Near Truss. Only end members have 4 gages.

five members were instrumented with one gage each. Figure 6 shows the member instrumentation for the near truss. Boldly highlighted members have four gages each; faintly highlighted members have only one gage each. This was done to save time on gage installation but still provide rough data on the second truss for comparison. On each truss, only members on the Pulaski side of the central pier were instrumented. The assumption of perfect structural symmetry between the Pulaski and Hillsville truss halves was made. Models used to reflect bridge behavior were developed as complete, two-span trusses.

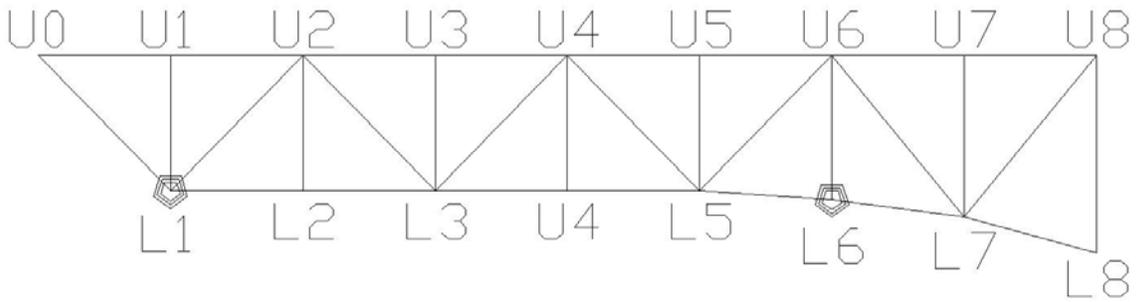
Figure 7. Twanger Installation on Near and Far Trusses

Deflectometers, referred to as twangers, were used to measure vertical deflection at Nodes L1 and L6 on each truss as well. These were calibrated at the Virginia Tech Structures Lab and were installed on the day of testing. Figure 7 shows the installation locations for twangers on both trusses.

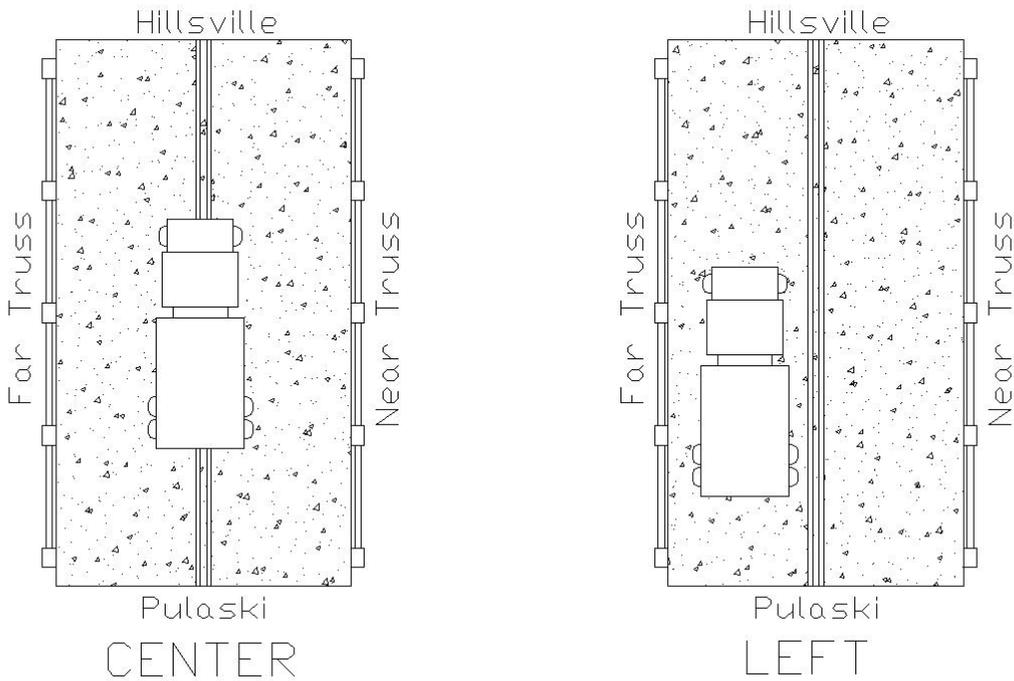
Figure 8. Center and Left Load Regimes

After instrumentation, two trucks of known weights and dimensions were used to impose live load on the bridge. Four load regimes were imposed on the bridge, each moved incrementally from Nodes U1 to U8. The first regime was one truck traveling down the center; the second was one truck traveling down the left (far truss) lane; the third was two trucks side by side; and the fourth was two trucks rear to rear traveling down the left lane. Figures 8 and 9 illustrate the four load regimes.

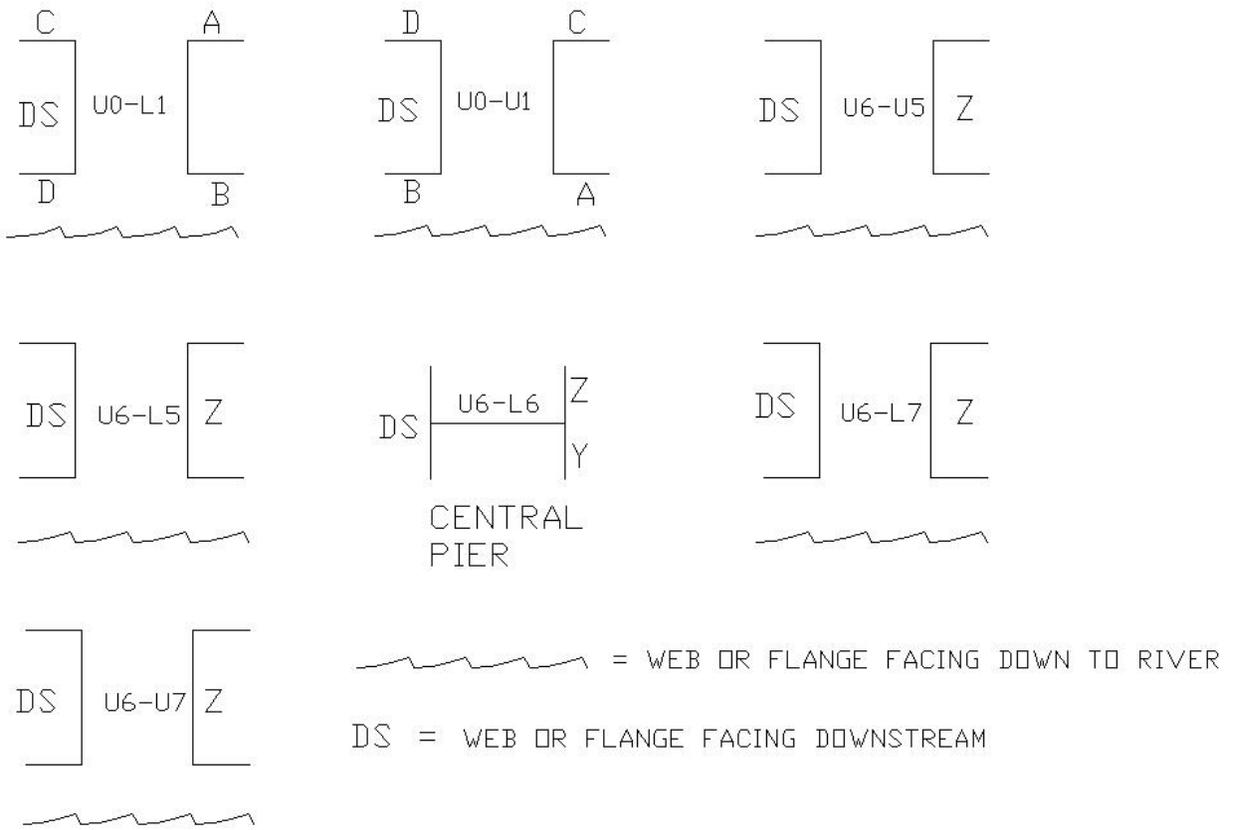
Figure 11. Gage Designations for Members on Near Truss

Proper identification of gage members and locations was necessary to calculate average strains at the load stages. Gage B on Member U0-U1 on the near truss malfunctioned because of damage at the terminal block and could not be used. The gage on Member U6-U5 on the near truss malfunctioned because of an unknown cause and could not be replaced. As a consequence, no data were available for this member on the near truss in any of the tests. Gage C on Member U0-U1 on the far truss was successfully balanced and zeroed but was reading strains approximately 10 times the amount expected. The suspected cause of this malfunction was

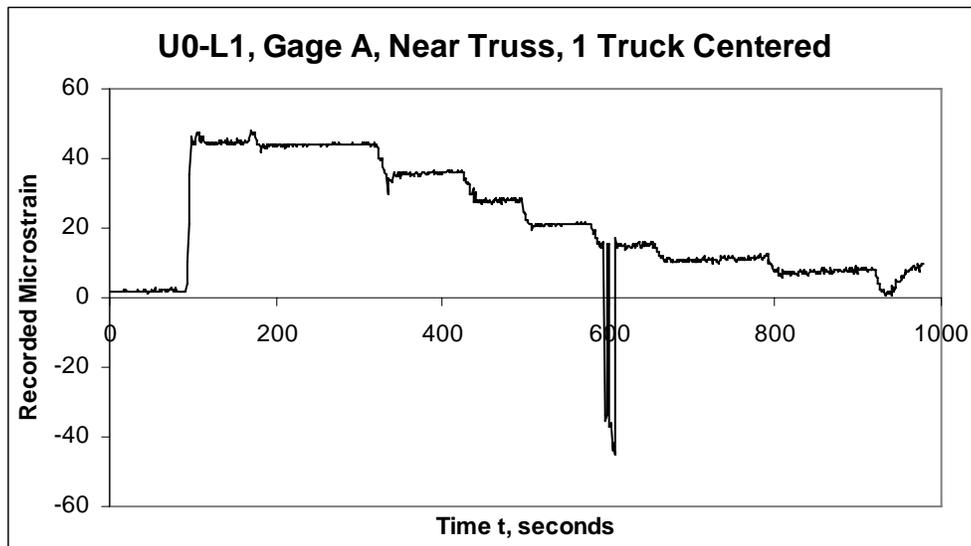
Figure 12. Full Strain Record in Gage A of U0-L1 on Near Truss, Single Centered Truck

All channels in each load regime were inspected for plateau alignment so overall load position intervals could be determined. These intervals identify uniform start and stop times for all channels within one data file for a load regime. It is these data in these intervals that were used to calculate strains in the members for each load position. The lengths of the intervals were maximized in order to maximize the sample size on the plateau of data. Table 1 identifies the intervals used for each load position in each load regime. These same intervals were used to calculate average deflections recorded during the load position by the twangers.

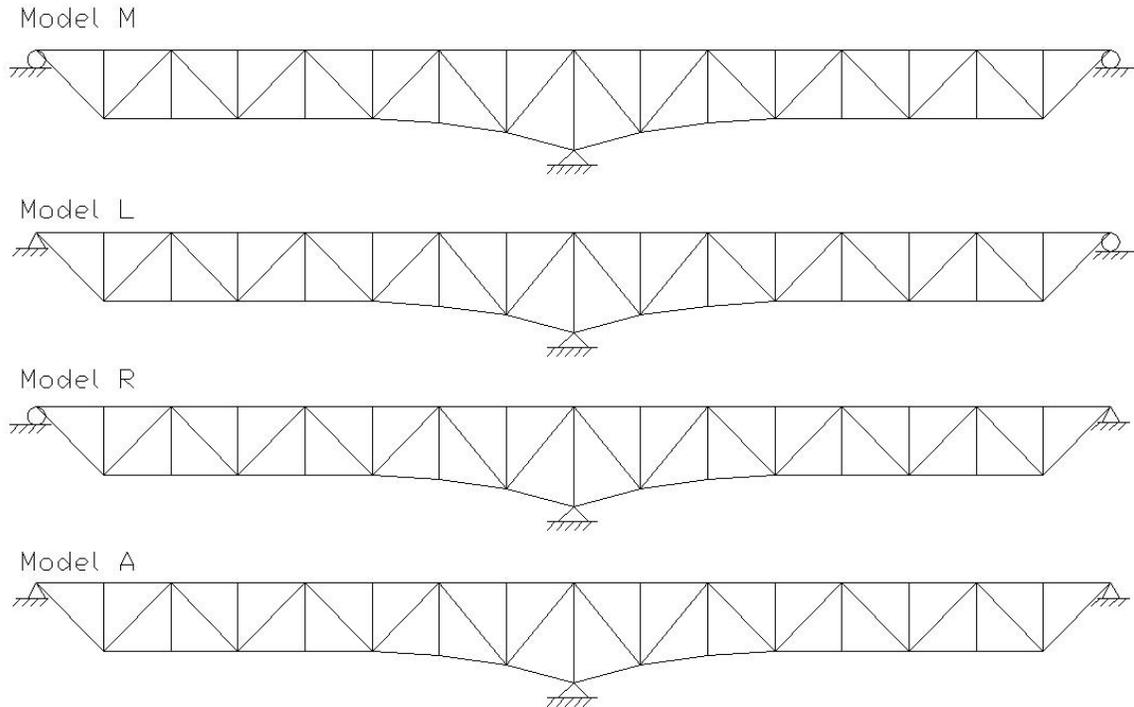
Figure 14. Truss Models

It was not expected that the data recorded would match an idealized model perfectly. Although designed as a truss, most connections have large, rigid gusset plates that prevent some rotation (ideal truss connections may freely rotate). Differences in conditions of connection, restraint, and material properties also affect the model's validity. For this reason, four different models were created in order to determine the best modeling techniques. The first model had a pin at the middle support, and rollers on the right and left ends. The second model's supports, from left to right, were pin-roller-roller. The supports of the third model were roller-roller-pin. All supports in the fourth model were pins. All restraints were assumed to be able to freely rotate (no bearing seizure) based on inspection at the site. Table 11 summarizes these conditions and Figure 14 illustrates the models.

The first structural model whose response was compared to the recorded data was a simple truss. Only the actual truss members from the plans were included, stringers, floor beams, and bracing were omitted. The deck was neglected as well. The included members could resist load and deflect only along their long axes and loads could be applied only at their end nodes. ANSYS input consisted of node locations and member areas determined from the bridge plans. All elements were 2D spars. Free rotations were permitted at nodes. Four models were prepared as described previously. These models were identical except for their support conditions.

Model designations M, L, R, and A correspond to the location of resistance to translation along the bridge's longitudinal axis. These designations are summarized in Table 11. Truck loads were first apportioned to the near and far trusses by statics, treating the deck as a simply

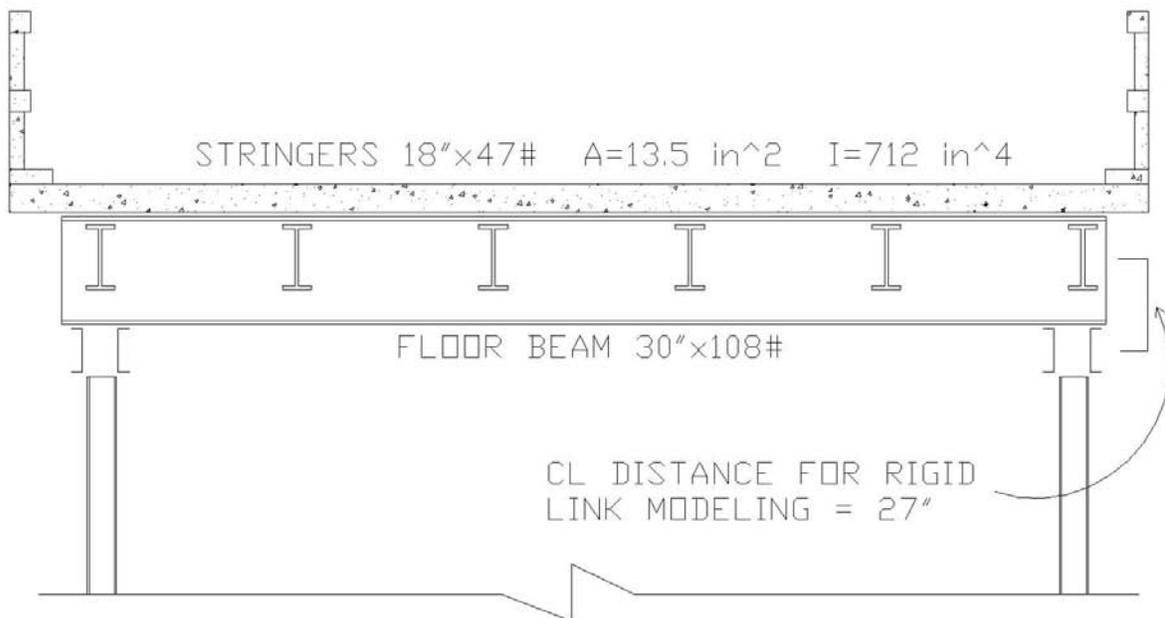
Figure 15. Bridge Cross Section

To include these in the analysis, three stringers were apportioned to each truss. The section parameters were entered as one member having area and moment of inertia values exactly three times that of a single specified stringer. The stringers were entered as rigid vertical links separating the floor beams from the truss members. The deck itself was still excluded, as it was substantially cracked and weakened. The included members could resist axial load and bending moments. Rear axle loads were applied at member end nodes. No rotations were permitted between members, as almost all the connections on the truss contain stout gusset plates. Four models were prepared as described previously. Truck loads were first apportioned to the near and far trusses by statics, treating the deck as a beam whose ends were fixed. Rear axle loads were assumed to act directly at the nodes at which the trucks were parked. Front axle loads were treated as point loads within the span of the floor beams they acted upon. Figure 16 presents the new models including the extra members.

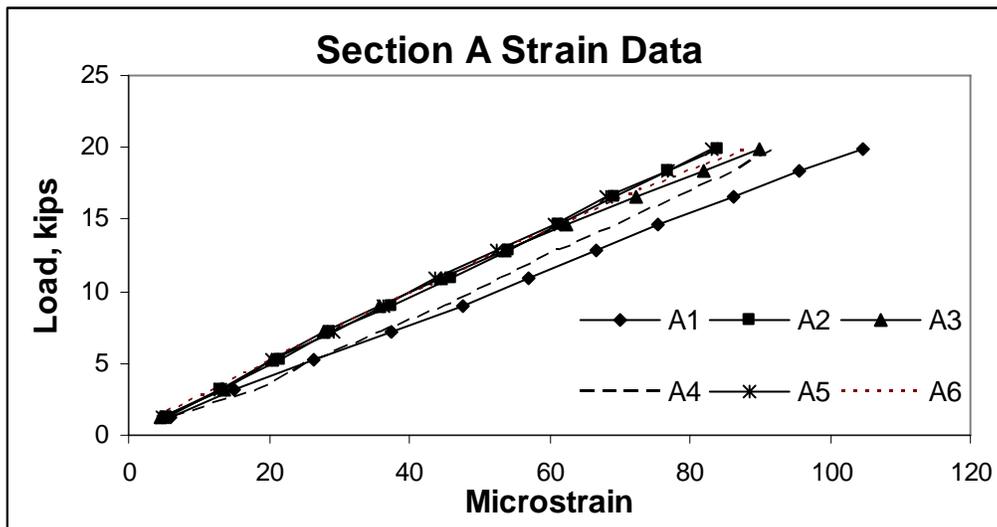
Figure 17. Section A Raw Strain Data

There were two plane sections on the column on which six gages were mounted. In these locations, there was one gage in the middle of the extreme fiber on each column flange and in the middle of the web of each channel (see Figure 3). Although there was substantial difference in the strains measured in each gage, the averages taken in a plane were very similar. In each plane section, the average of the four flange-mounted gages was compared to the average of the entire array of six gages. These averages were compared throughout the entire load range. Figure 17 presents the raw strain data from section A, prior to averaging for comparisons. This was typical of all column sections analyzed.

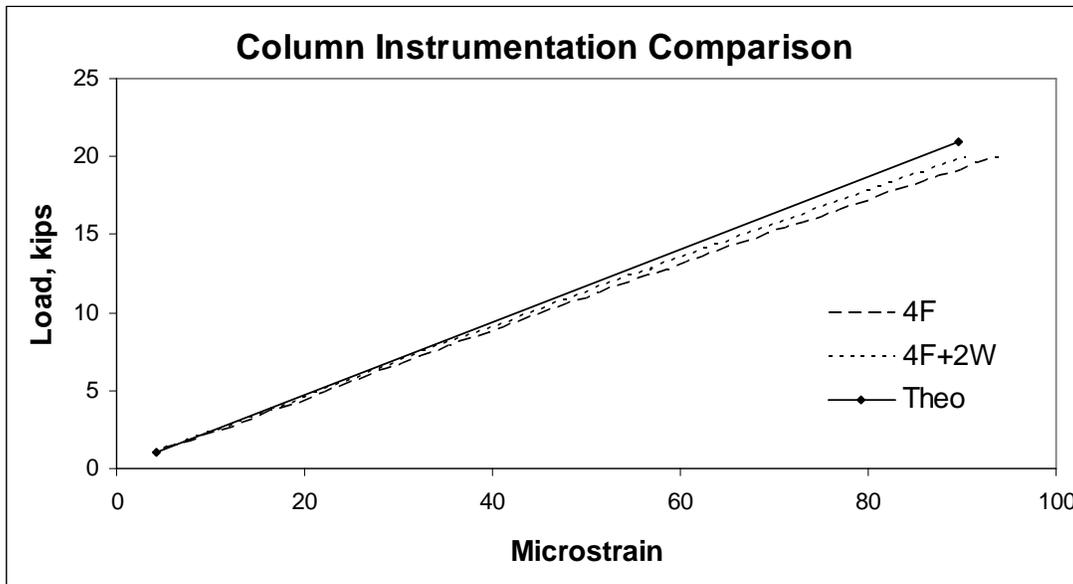
Figure 18. Instrumentation Comparison Between 4 and 6 Gage Layouts

Except where very low strains were recorded at the lower end of the load range, the difference between the four and six gage averages was typically less than 2%. These results diverged somewhat as strains increased. This is accurate for use in bridge instrumentation; an error on the order of magnitude of a few microstrain is acceptable.

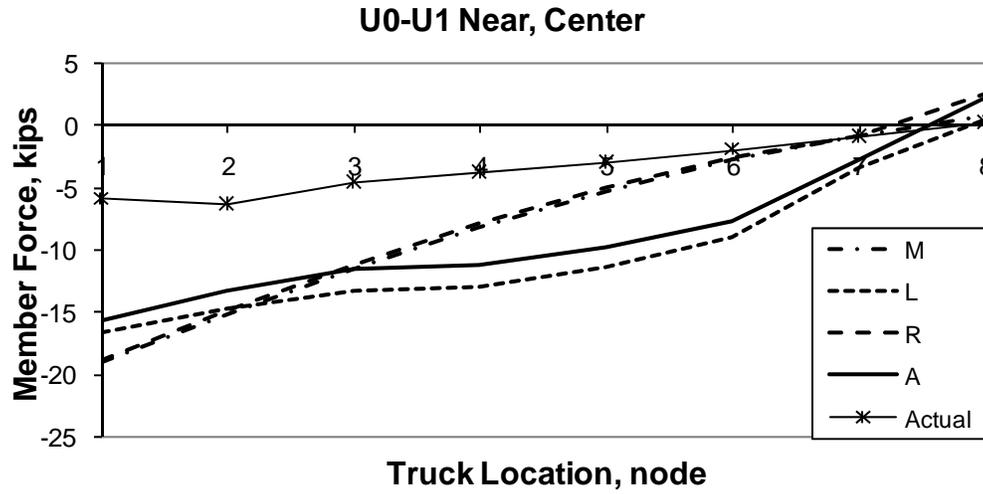
Figure 20. Member U0-U1, Near Truss, Truck Centered, Truss Model

Figure 20 shows that the truss model does not match the data very well, especially when load is far from the central pier beneath Node U8.

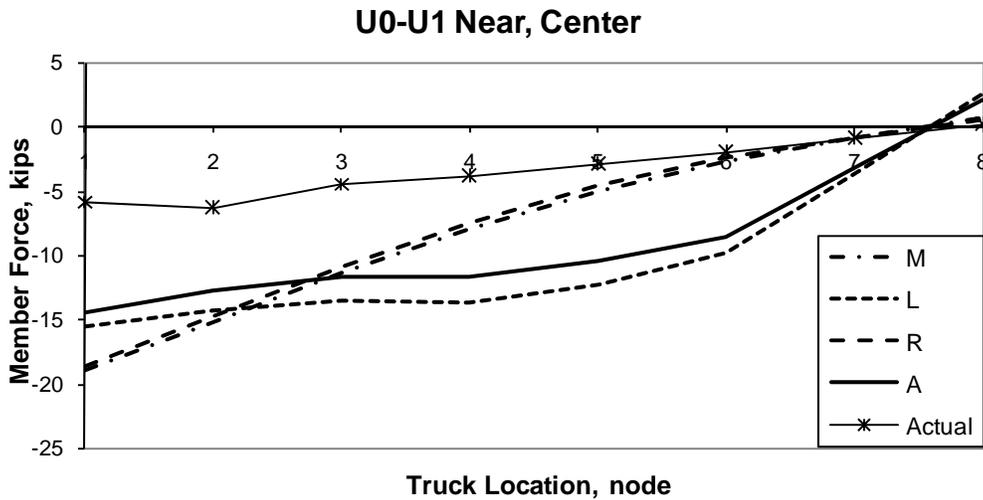
Figure 21. Member U0-U1, Near Truss, Truck Centered, Frame Model

Figure 21, the frame model results, shows some improvement over the results from the truss model, although these results would still not be useful for behavior predictions.

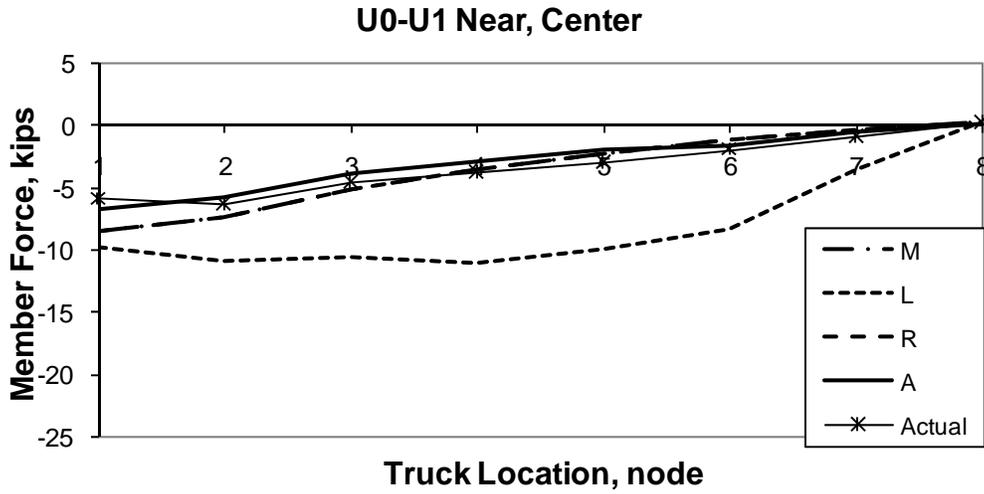
Figure 22. Member U0-U1, Near Truss, Truck Centered, Stringer Frame Model

Figure 22, the stringer frame model results, matches the data very well and bracketing between some end conditions is evident over the entire truss span.

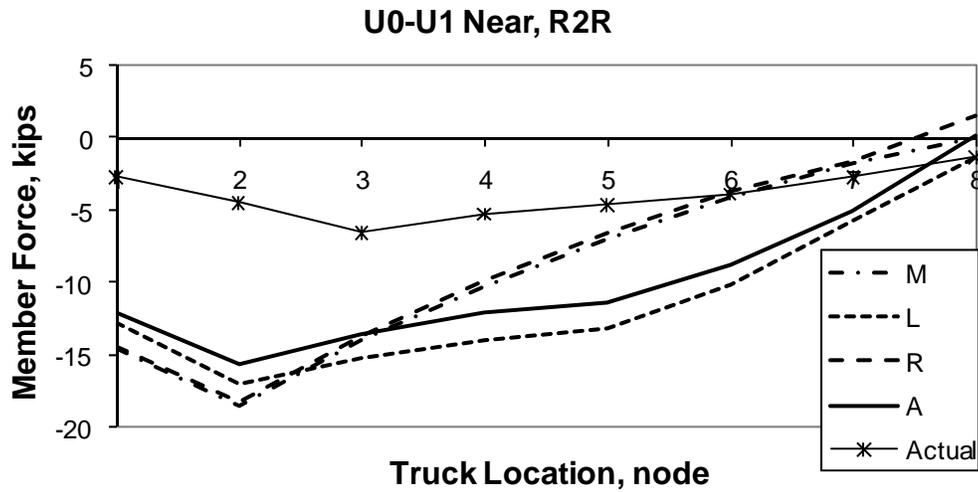
Figure 23. Member U0-U1 on the Near Truss, Trucks Rear to Rear, Truss Model

Figure 23 shows that the truss model does a poor job of replicating the bridge's behavior, especially when load is far from the central pier.

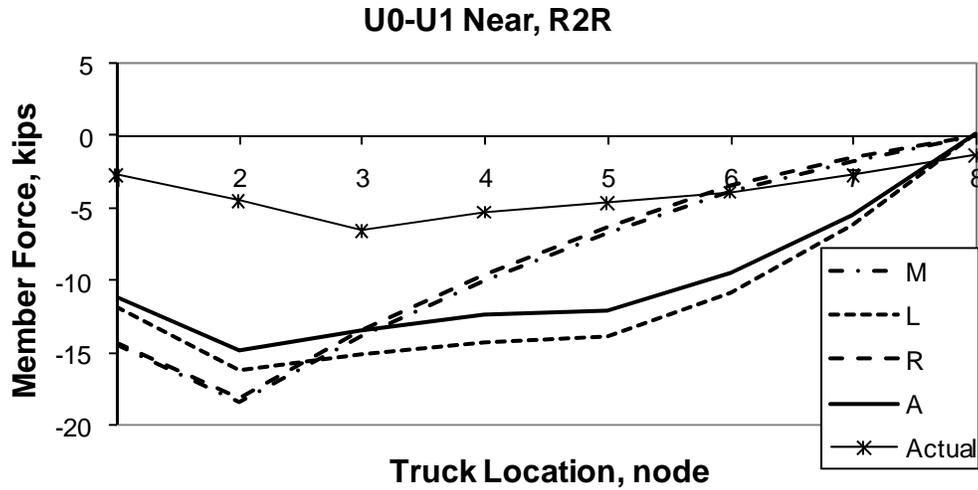
Figure 24. Member U0-U1 on the Near Truss, Trucks Rear to Rear, Frame Model

Figure 24, the frame model, shows some improvement over the truss model, although these results would still not be useful for behavior predictions.

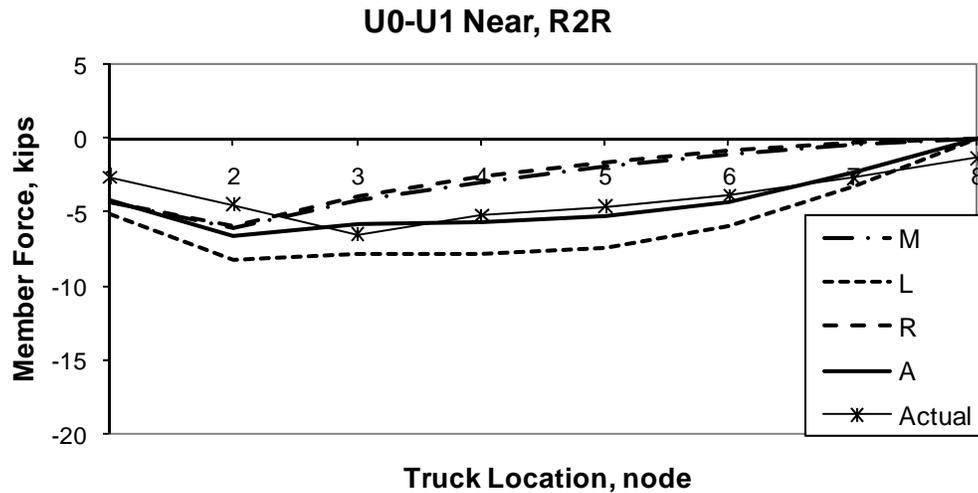
Figure 25. Member U0-U1 on the Near Truss, Trucks Rear to Rear, Stringer Frame Model

Figure 25, the stringer frame model results, demonstrates that this model matches the recorded data most accurately. The recorded data are bracketed by different end conditions in more than 75% of the truss span.

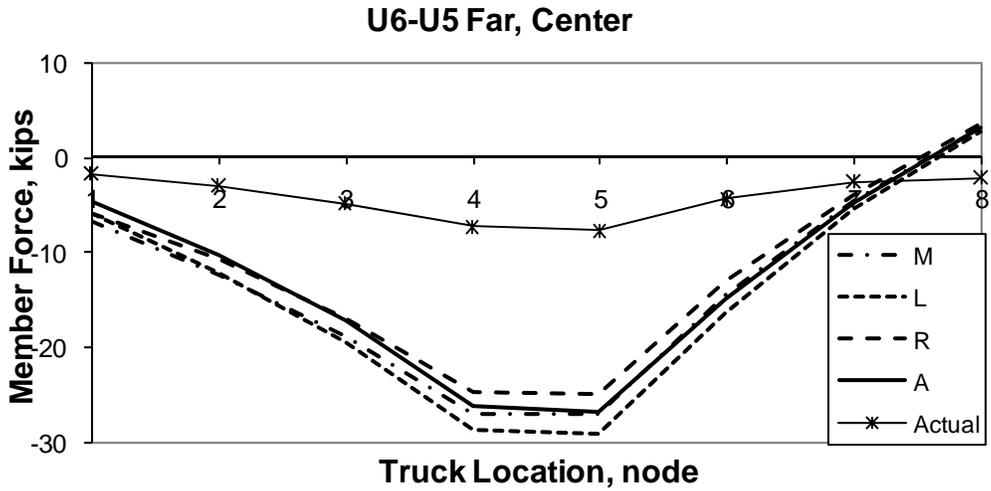
Figure 26. Member U6-U5 on the Far Truss, Truck Centered, Truss Model

Figure 26 shows that there is a great gulf between the bridge's actual behavior and the truss model's expectations.

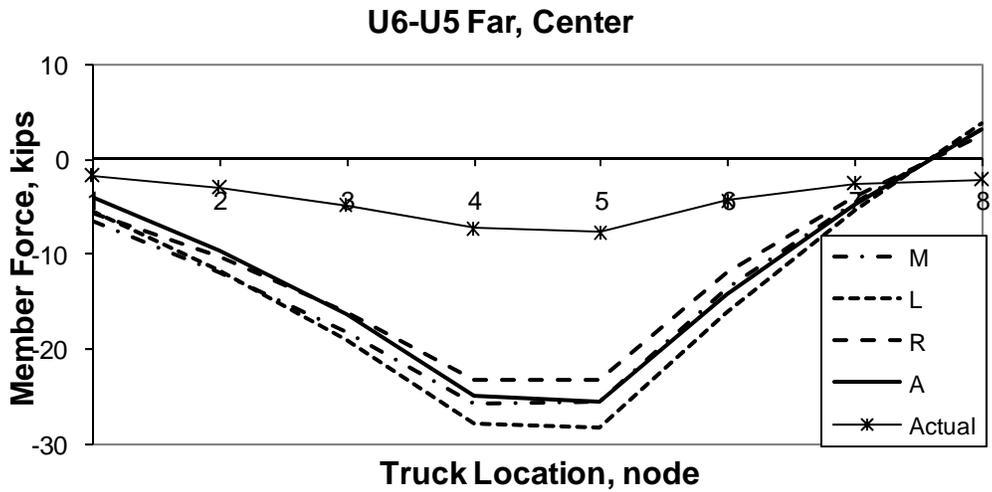
Figure 27. Member U6-U5 on the Far Truss, Truck Centered, Frame Model

Figure 27 shows that the frame model is only a small improvement over the truss model for this member in this load regime.

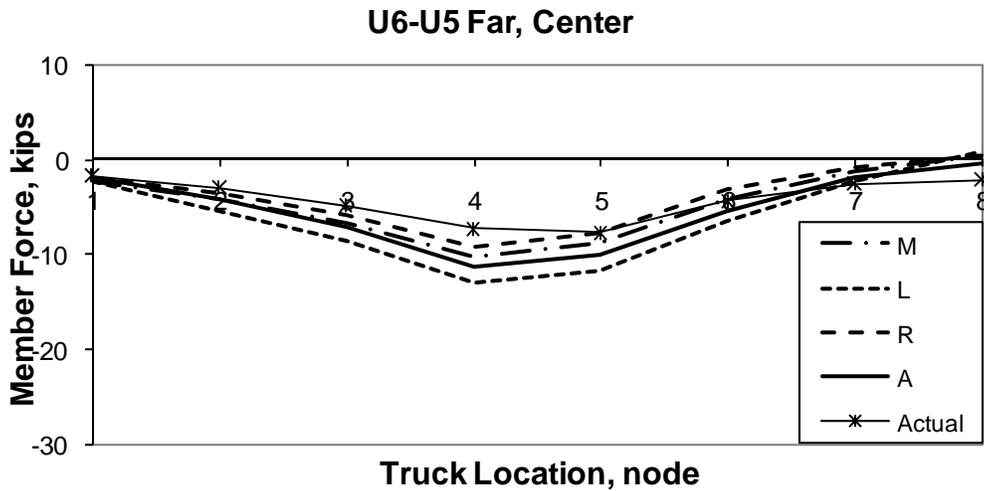
Figure 28. Member U6-U5 on the Far Truss, Truck Centered, Stringer Frame Model

Figure 28 shows that the stringer frame model comes very close to replicating the data recorded from live load testing. Member forces could be predicted with other loads using this model.

These three examples illustrate that the stringer frame model predicts the member forces far more accurately than the basic truss model or the basic frame model. It is difficult to determine, however, which of the four boundary conditions is most accurate.

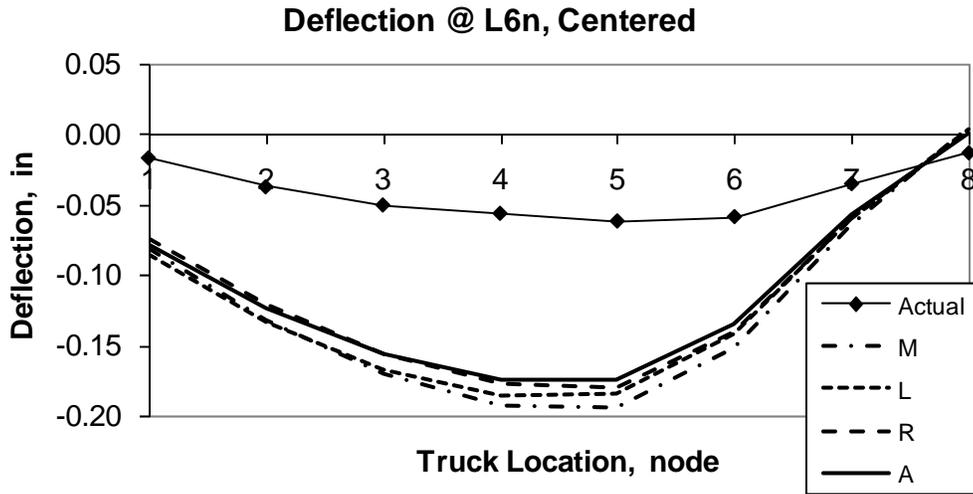
Figure 29. Node L6, Near Truss, Truck Centered, Truss Model

Figure 29 shows that there is a vast difference in the data recorded and the expectation of the truss model.

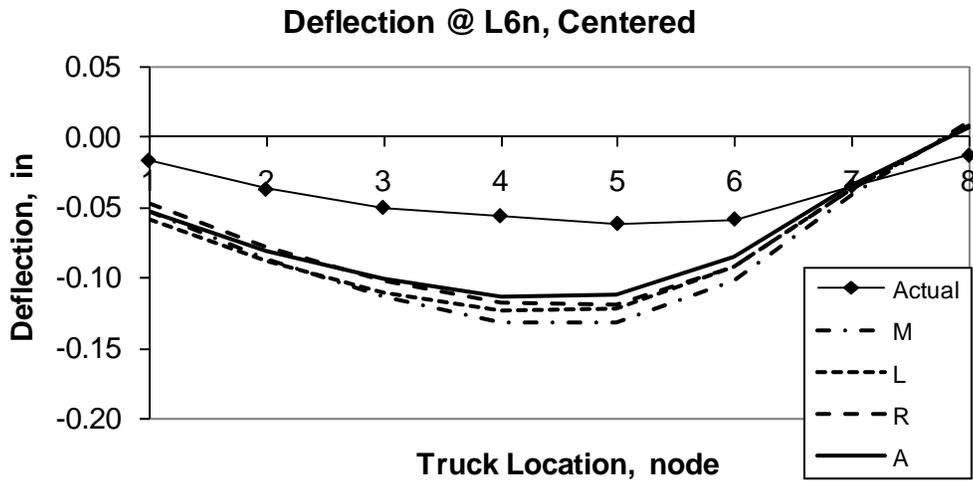
Figure 30. Node L6, Near Truss, Truck Centered, Frame Model

Figure 30 shows that the frame model is a great improvement on the truss model for this node in this load regime.

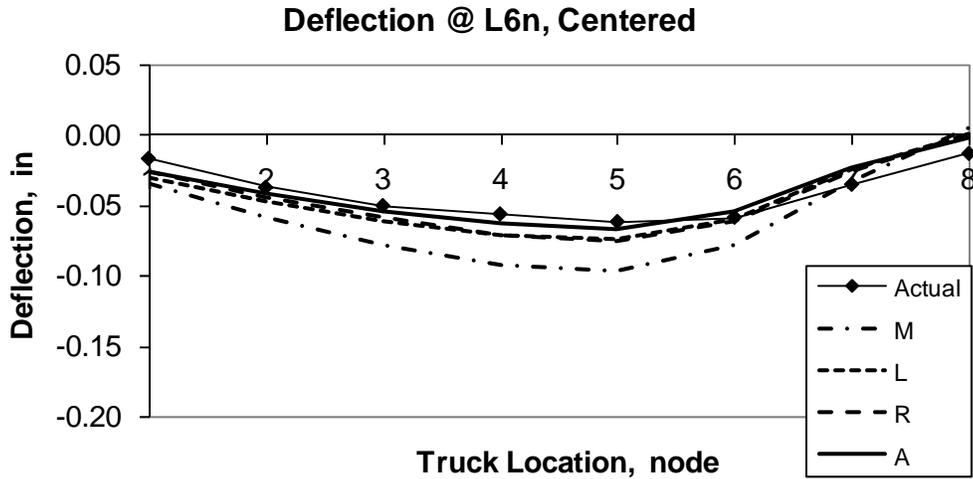
Figure 31. Node L6, Near Truss, Truck Centered, Stringer Frame Model

Figure 31 shows that the stringer frame matches the recorded data best and would be useful for predicting deflections due to other loads.

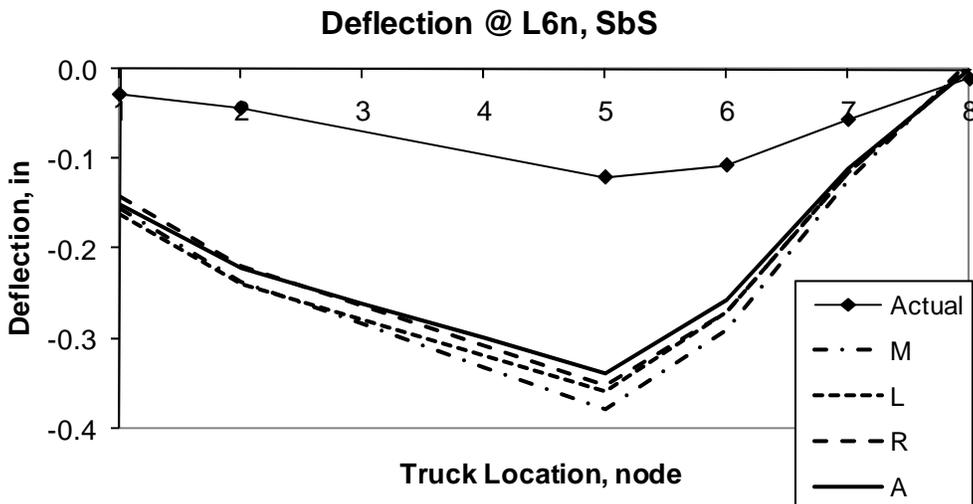
Figure 32. Node L6 on Near Truss, Trucks Side by Side, Truss Model

Figure 32 shows that once again, the truss model does a poor job of matching recorded data. It is observed that there are no data points in the recorded data at load positions 3 and 4. The van containing the DAS was parked on the bridge between these nodes. As the bridge is only two lanes wide, it was impossible to fit the two trucks side by side at these locations. Thus their load position data were omitted.

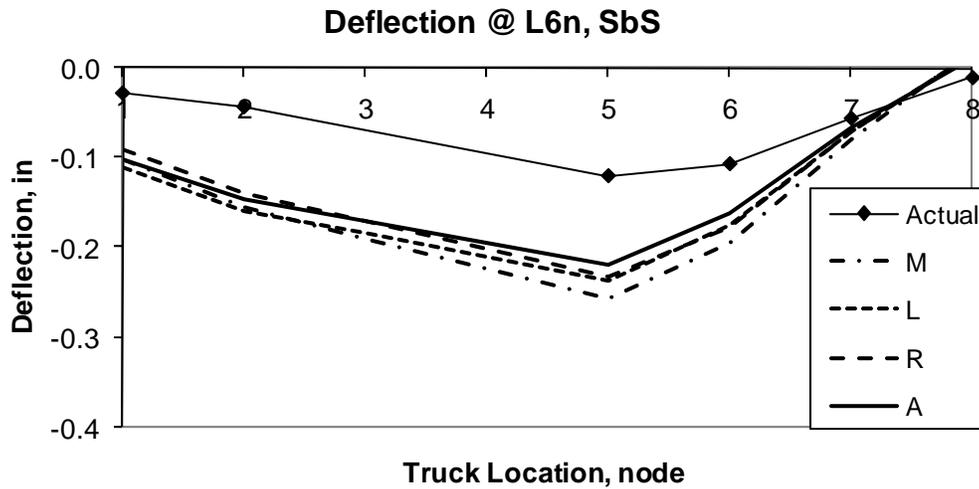
Figure 33. Node L6 on Near Truss, Trucks Side by Side, Frame Model

Figure 33 shows that the frame model is a great improvement on the truss model for deflection prediction for this node in this load regime.

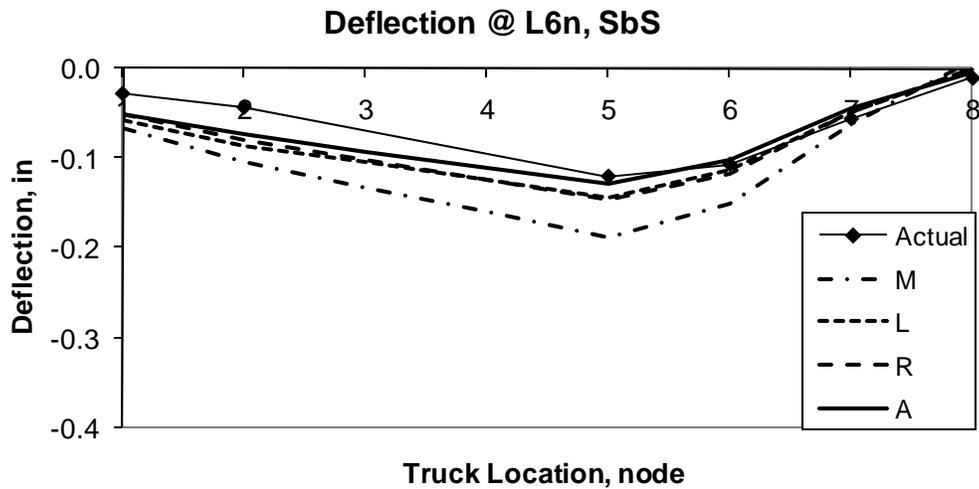
Figure 34. Node L6 on Near Truss, Trucks Side by Side, Stringer Frame Model

Figure 34 shows that once again, the stringer frame model best matches the live load data. It is especially accurate (with bracketed data) as the load is placed closer to the central pier.

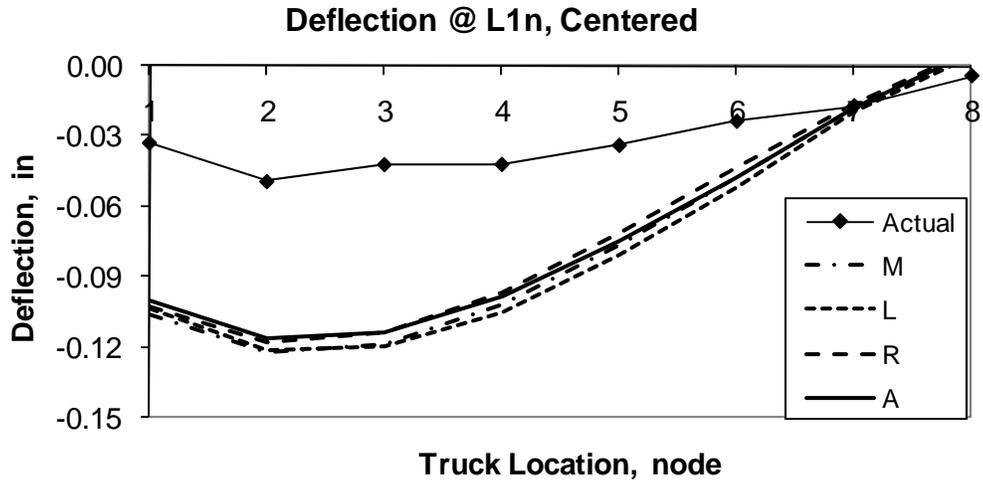
Figure 35. Node L1 on Near Truss, Truck Centered, Truss Model

Figure 35 shows that the truss model is accurate only for load position U7. Otherwise it poorly approximates the bridge's behavior.

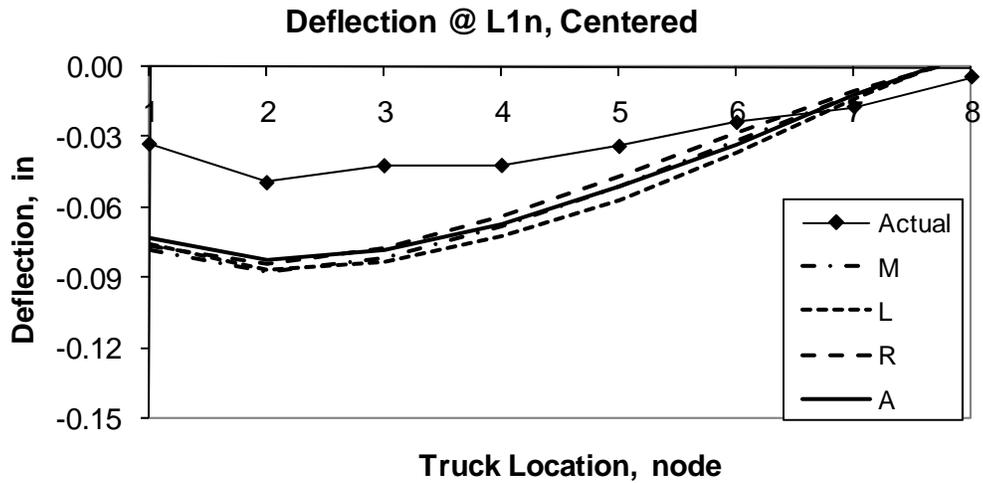
Figure 36. Node L1 on Near Truss, Truck Centered, Frame Model

Figure 36 shows that the frame model comes much closer to predicting the actual truss behavior than the original truss model. It would still not be useful enough for future use, however.

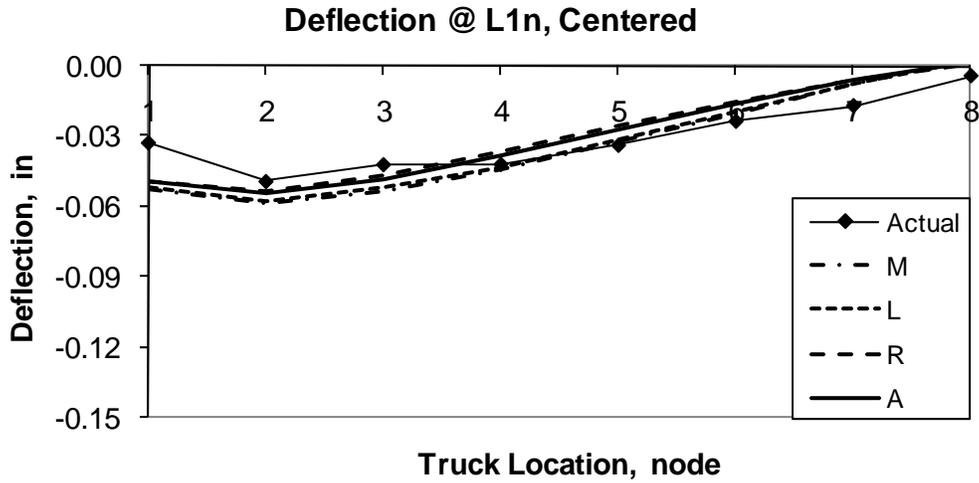
Figure 37. Node L1 on Near Truss, Truck Centered, Stringer Frame Model

Figure 37 shows that the stringer frame model performs best at approximating the bridge's actual behavior for this node in this load regime.

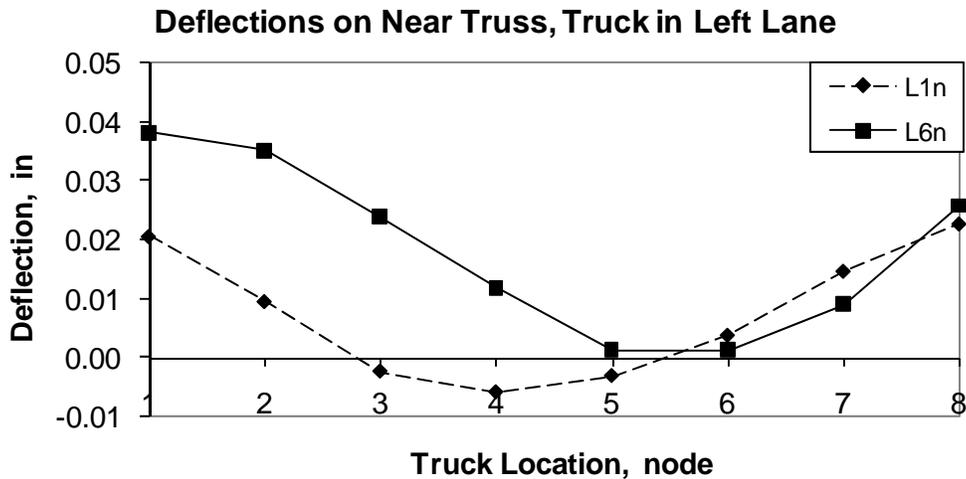
Figure 38. Near Truss Deflections, Truck in Left Lane

According to the data recorded for deflections on the near truss with one truck in the left lane, the nodes actually deflected upward for much of the load regime. This seems to indicate that the deck and bracing provide enough stiffness between the trusses that the entire structure acts like a rigid member experiencing torsion about its center. In this case, load in the left lane causes downward deflection in the far truss and upward deflection in the near truss. Figure 38 illustrates this trend. This effect would best be investigated with a three dimensional model.
