FINAL
CONTRACT REPORT
VTRC 09-CR8

**LIVE LOAD TEST
AND FAILURE ANALYSIS
FOR THE STEEL DECK TRUSS BRIDGE
OVER THE NEW RIVER
IN VIRGINIA**

Via Department of Civil and Environmental Engineering
Virginia Polytechnic Institute & State University

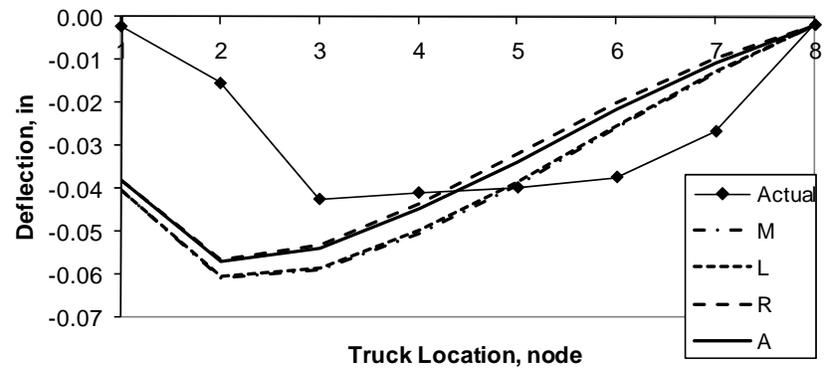
Deflection @ L1n, R2R

Although twanger devices were installed at Nodes L1 and L6 on each truss, only data on the near truss were able to be used. All twangers were tested and calibrated the night prior to installation, but the twangers on the far truss did not yield any data outside of their electronic noise ranges. There was likely damage incurred or moisture infiltration along their lead wires during installation. The same data sampling intervals used to calculate the mean member strains were used to calculate the mean nodal deflections. Average vertical nodal deflections at each load position during each load interval were calculated from continuous data in the same way as member strains were. Tables 7 through 10 present these mean deflections.
